**SITE-SPECIFIC QUALITY ASSURANCE
& QUALITY CONTROL AUDIT**

PERMIT CLOSURE REPORT – CROPLAND

Location Name MASSEY-64N68W/1NWNE

25 Oct 2024

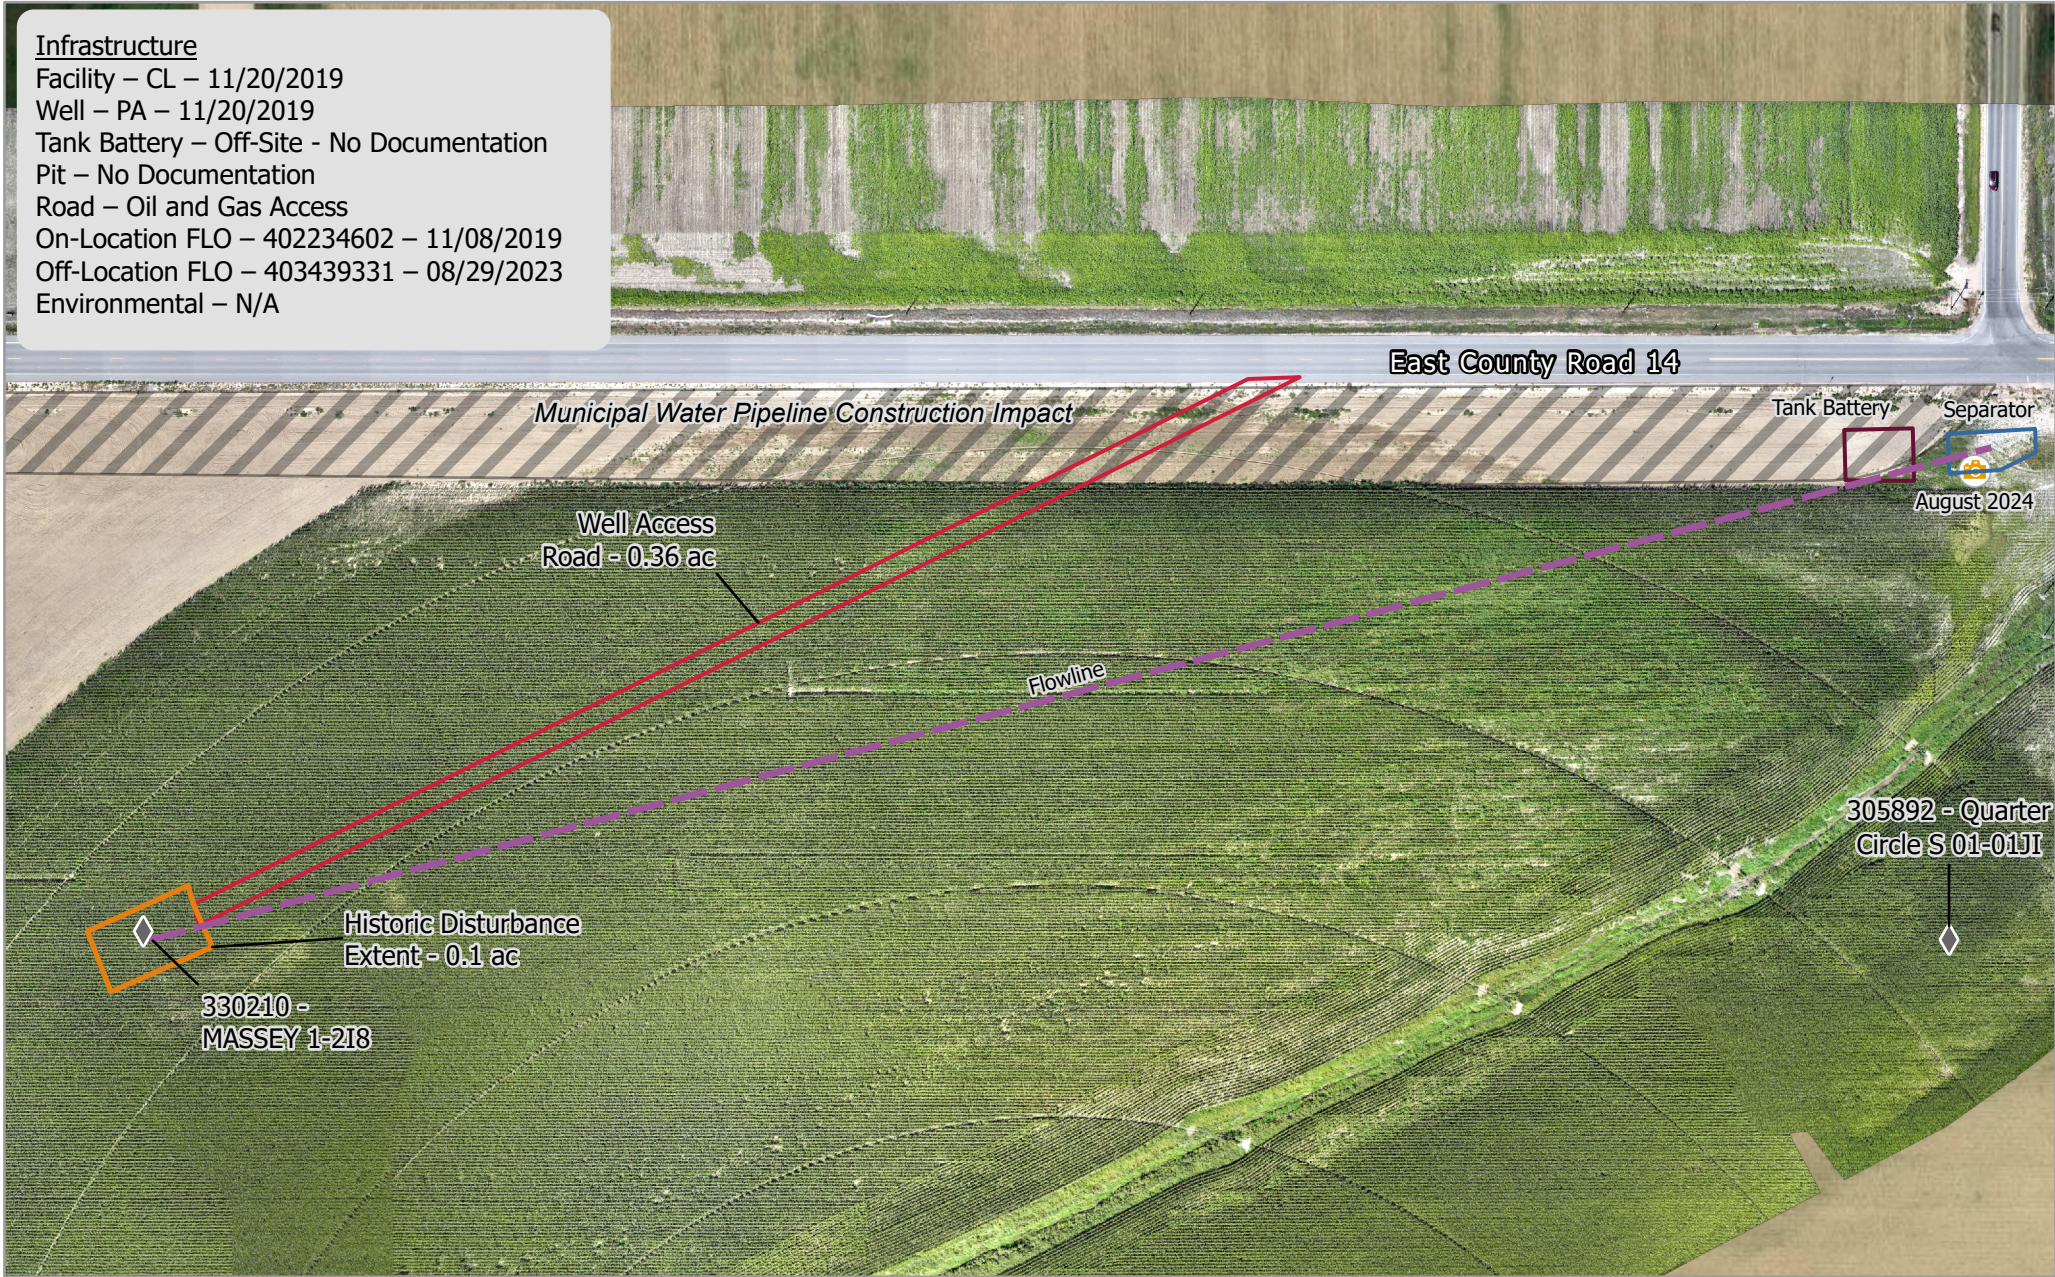
**CIV - 330210- MASSEY 1-2I8
Map Extent - Post-Plugging Overview**

The Well Access Road Disturbance Extent is impacted by Municipal Water Pipeline Construction Impact, which occurred after reclamation.

Soil Sage drone imagery confirms that no equipment was left on site at this location after reclamation activities occurred.

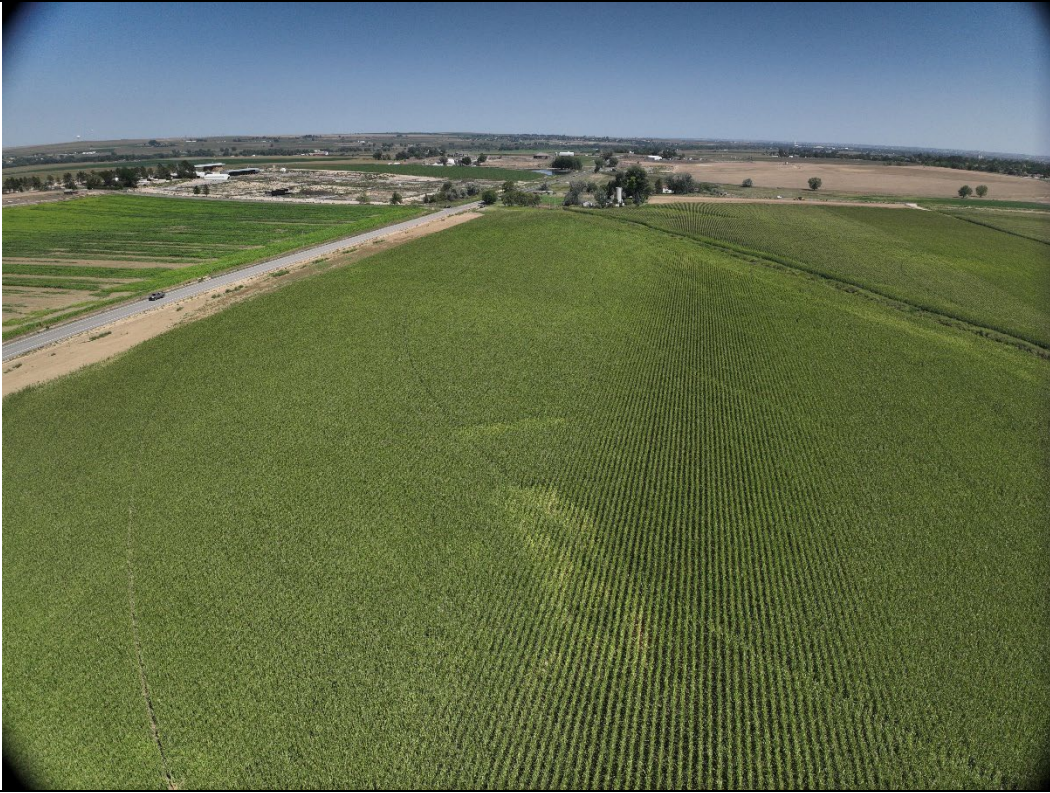
In View – Well, Tank Battery (Loc ID [463217](#)), Access Road, Flowlines, Municipal Water Pipeline Construction Impact
EAST – 40.347695 / -104.951351

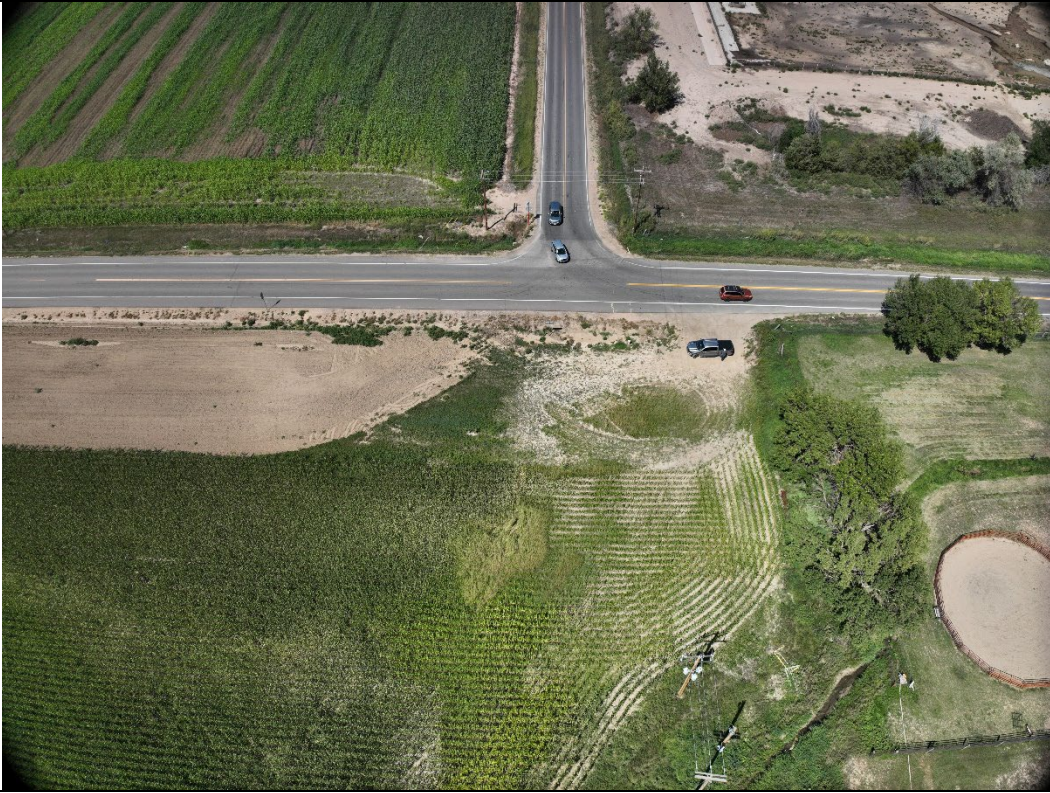
In View – Tank Battery (Loc ID [463217](#)), Flowlines, Municipal Water Pipeline Construction Impact
NORTH – 40.348410 / -104.945607

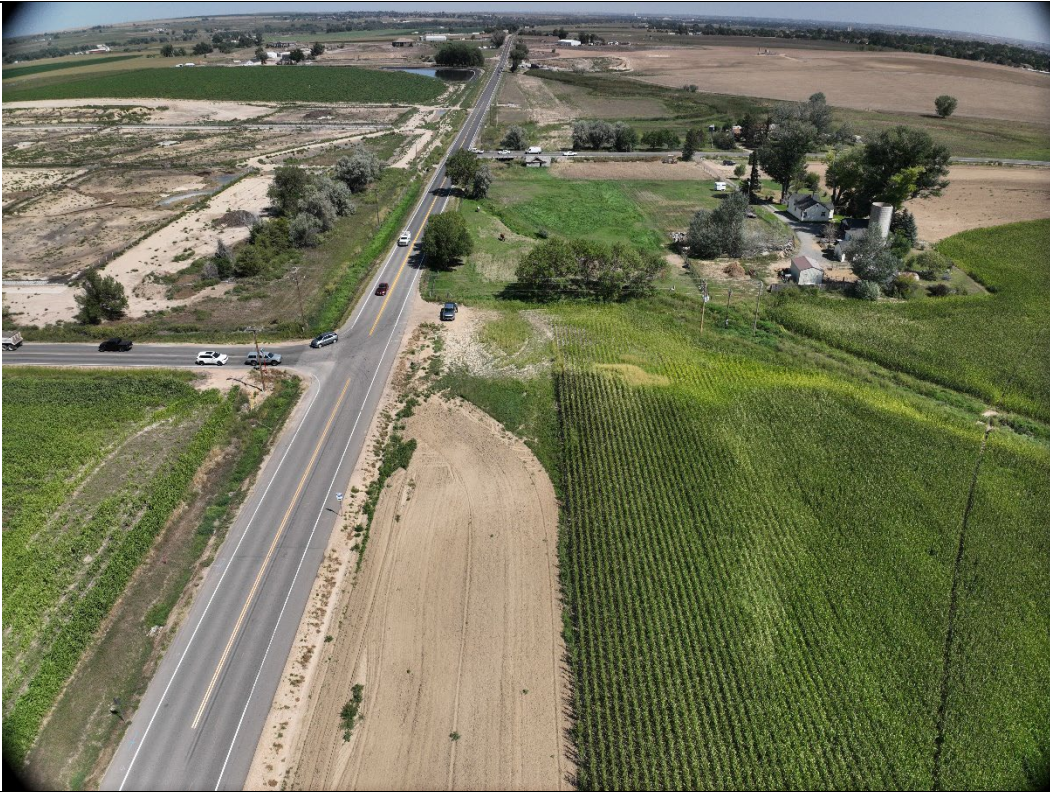
In View – Tank Battery (Loc ID [463217](#)), Flowlines, Municipal Water Pipeline Construction Impact
EAST – 40.348877 / -104.946819

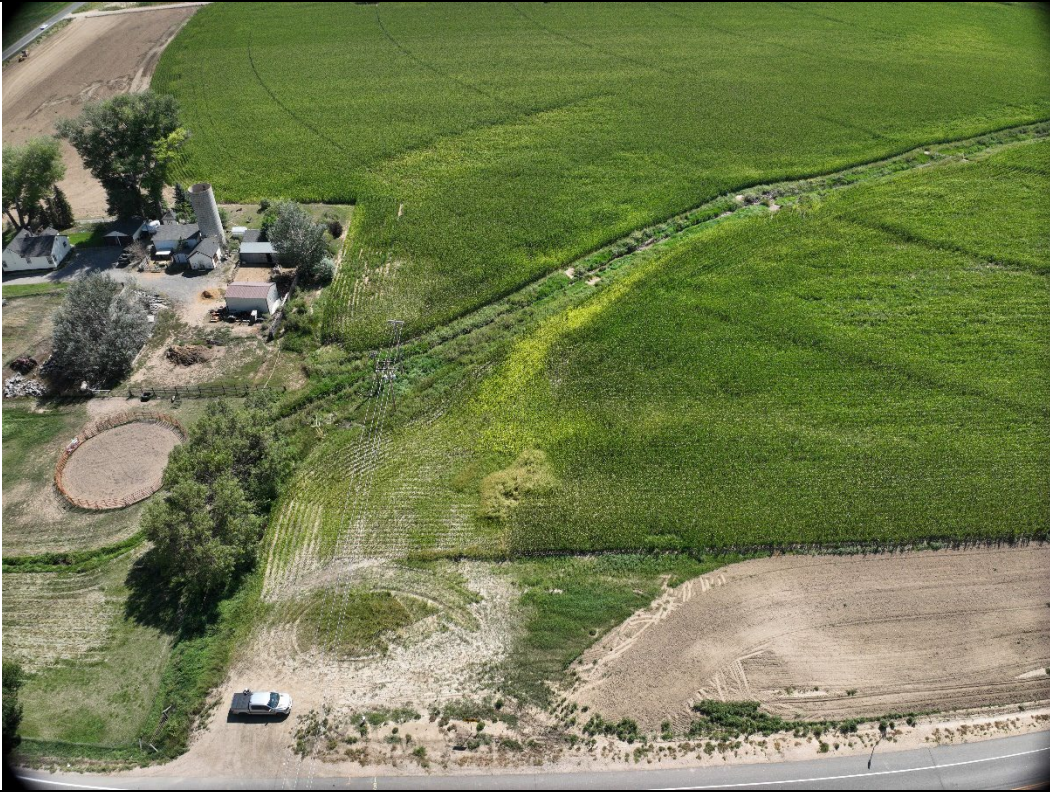
In View – Tank Battery (Loc ID [463217](#)), Flowline, Municipal Water Pipeline Construction Impact
SOUTH – 40.349315 / -104.945659
