Inspection Photos

Location Name: MUSTANG RESOURCES LLC RULISON FEDERAL 35-94-6S-94W Pad

Location ID: 322314

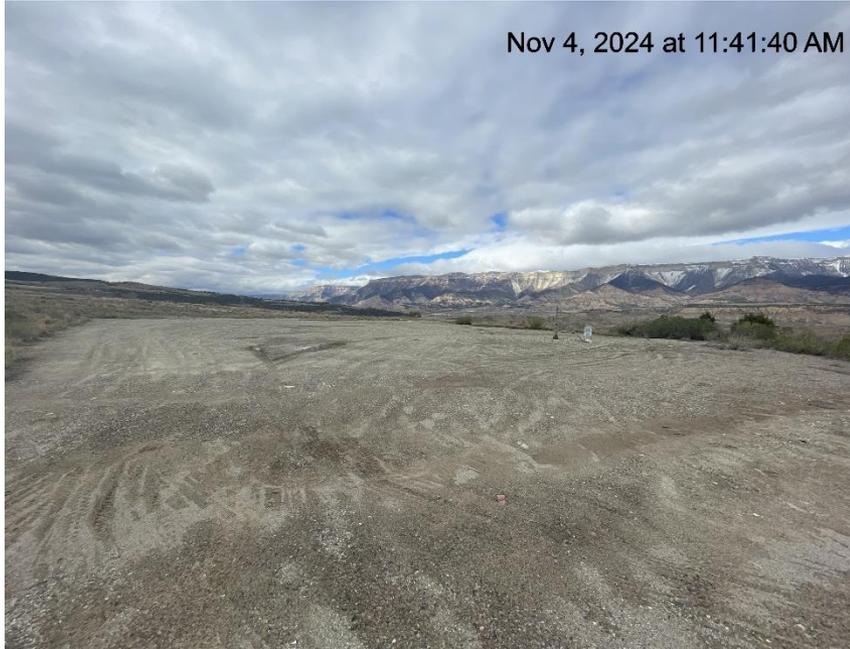
Photo # 8657 From entrance to location

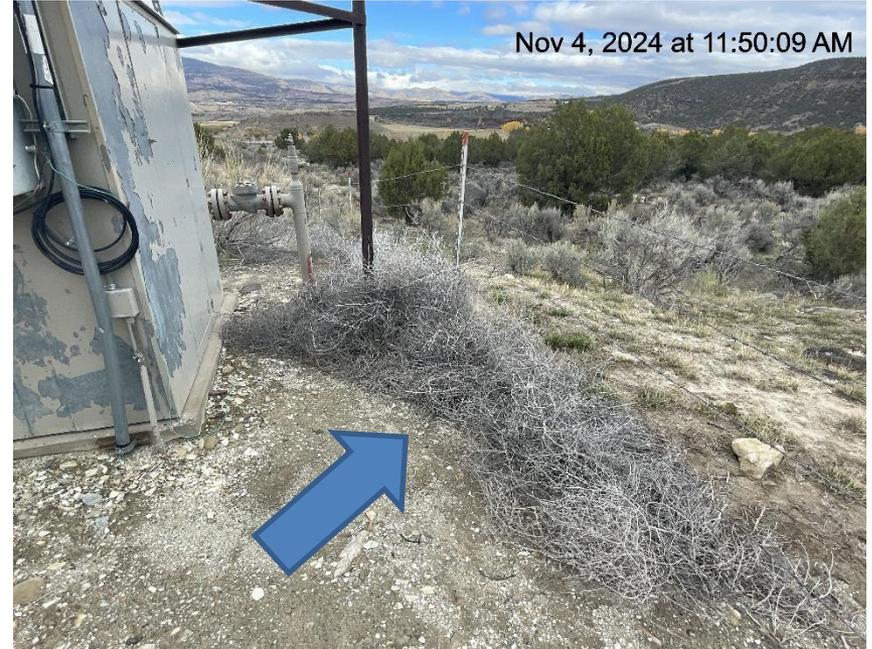
Photo # 8662 Dead weeds/debris

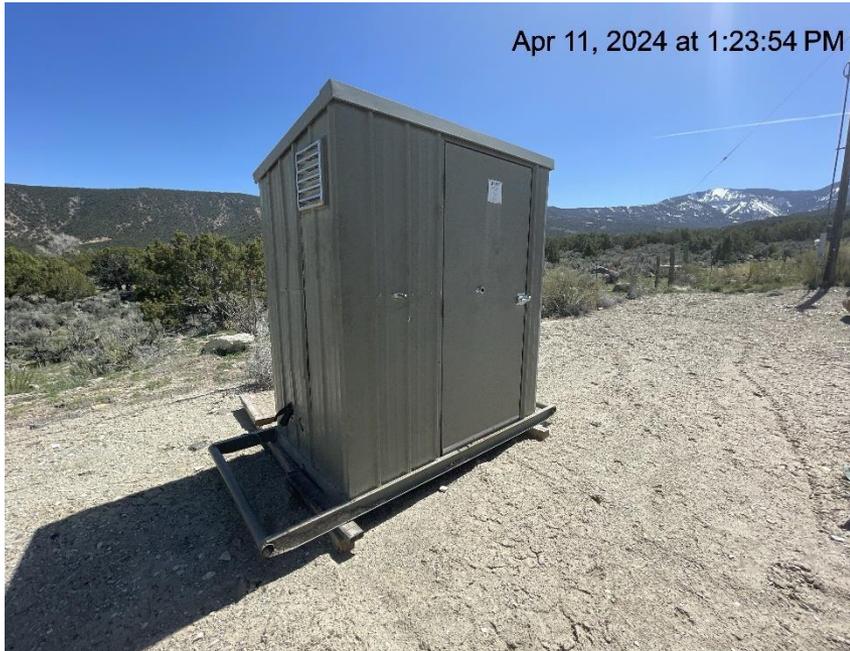
Photo # 3768 From inspection 708903514 conducted on 04/11/2024 - Unused equipment

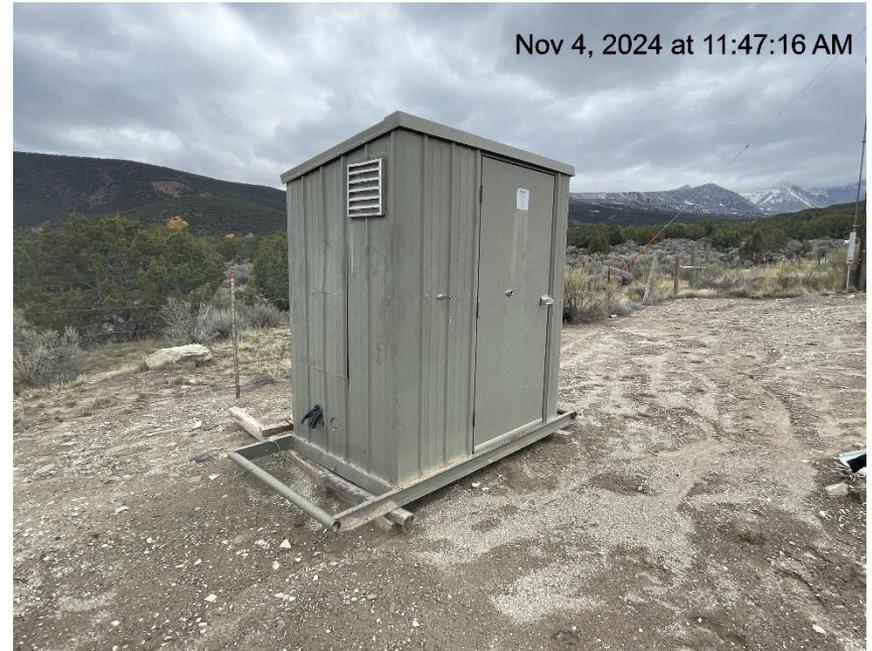
Photo # 8663 Unused equipment

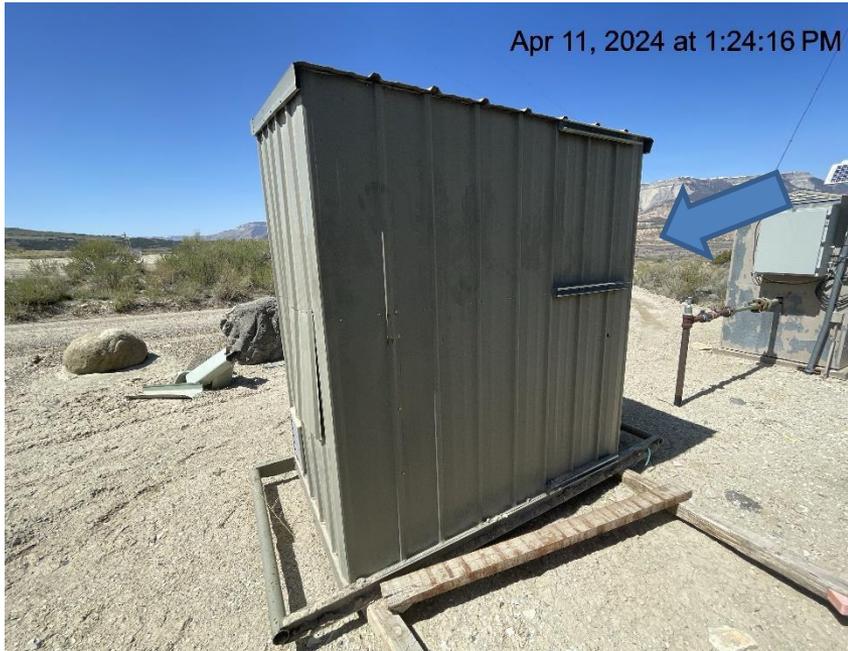
Photo # 3769 From inspection 708903514 conducted on 04/11/2024 - Unused equipment

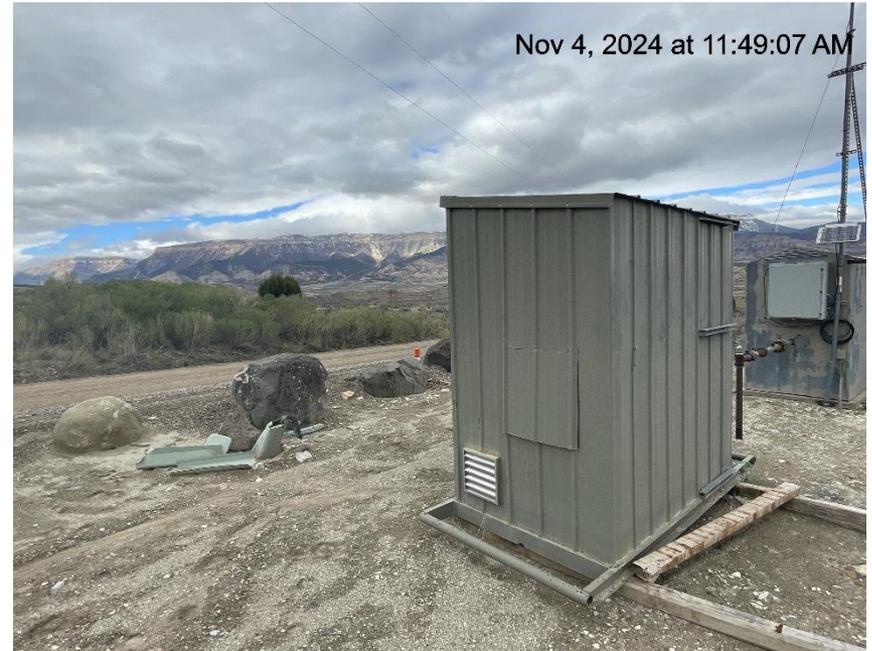
Photo # 8664 Unused equipment
