**Storm Water Management and Erosion control**  
**Location Name: TEP ROCKY MOUNTAIN LLC FEDERAL RWF 331-11 Pad**  
**Location ID: 335638**

**Location Overview: Location is within High  
Priority/Density/Black Bear Habitat areas.**

**Section/Township/Range: 11 6S94W**

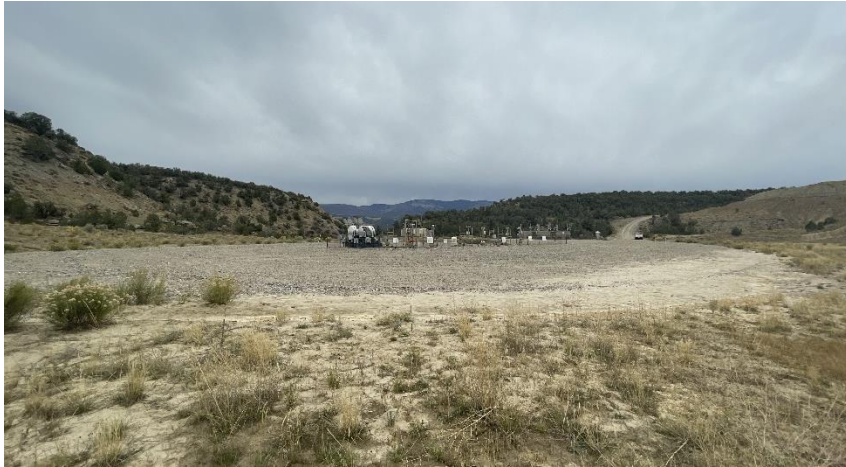
**North West corner of location.**

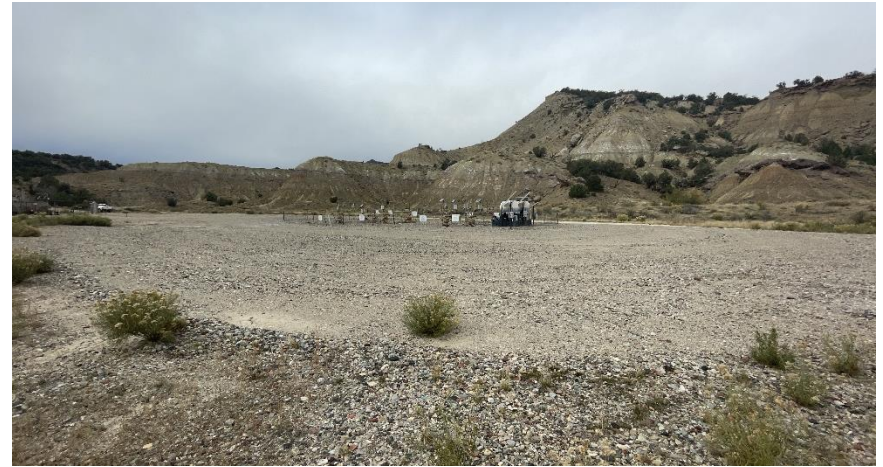
**North East corner of location.**

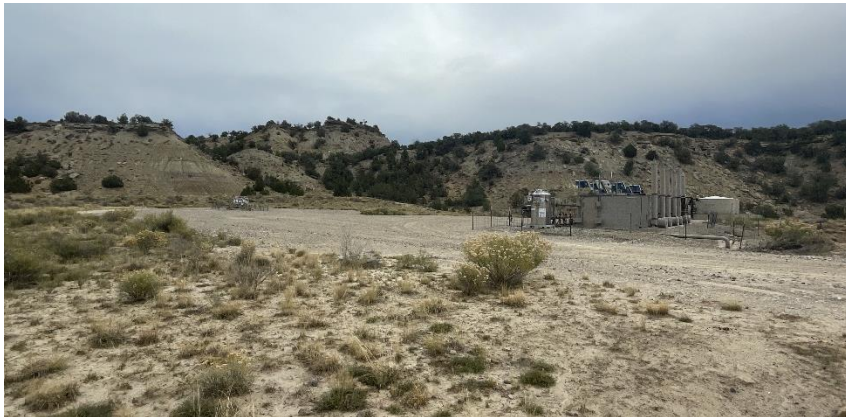
**South West corner of location.**

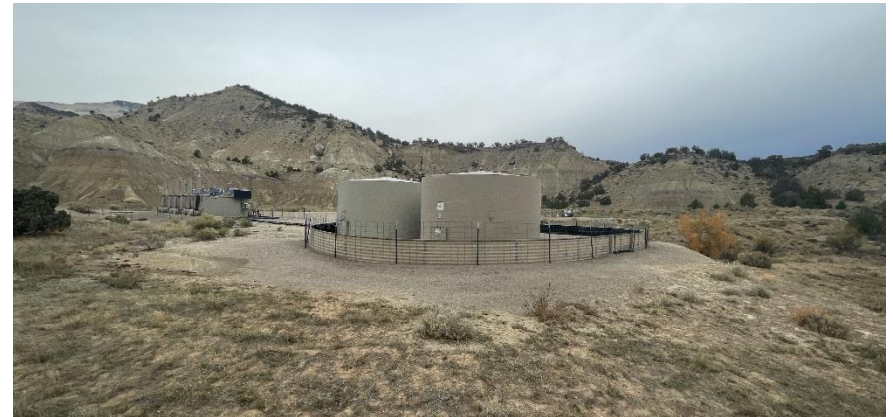
**South East corner of location.**

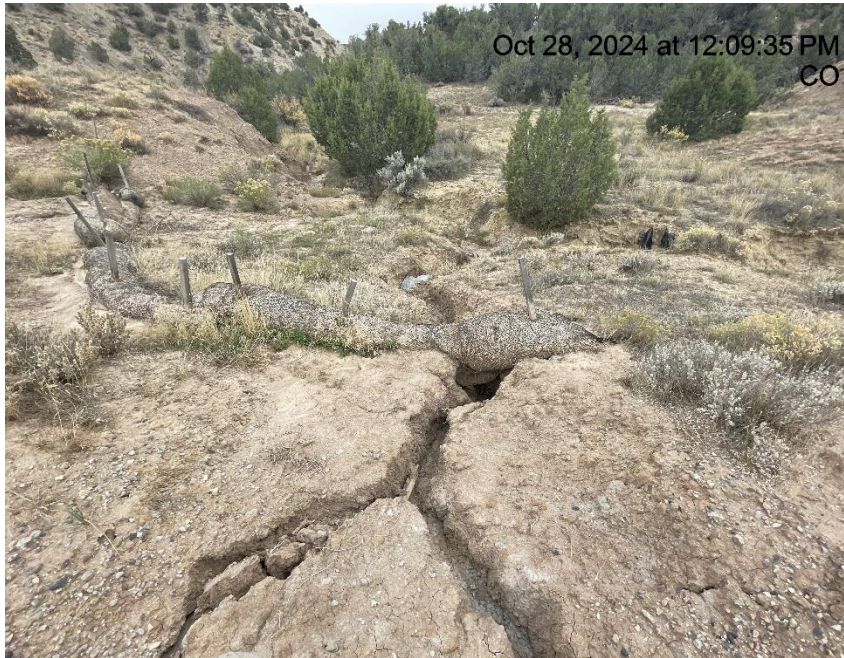
**Photo # 7540 Failure to minimize erosion & transport of sediment/BMP's need maintenance**

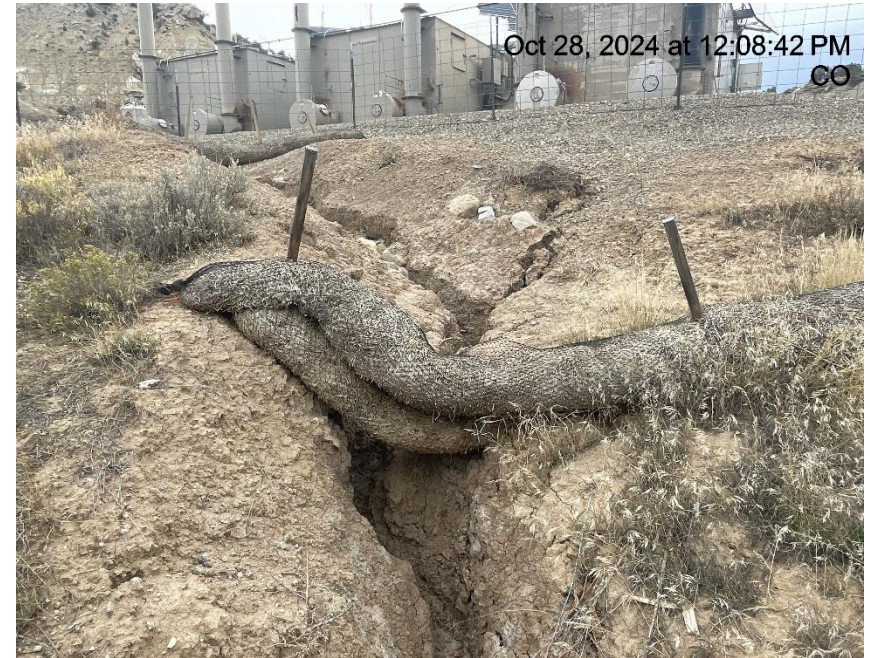
**Photo # 7541 Failure to minimize erosion & transport of sediment/BMP's need maintenance**

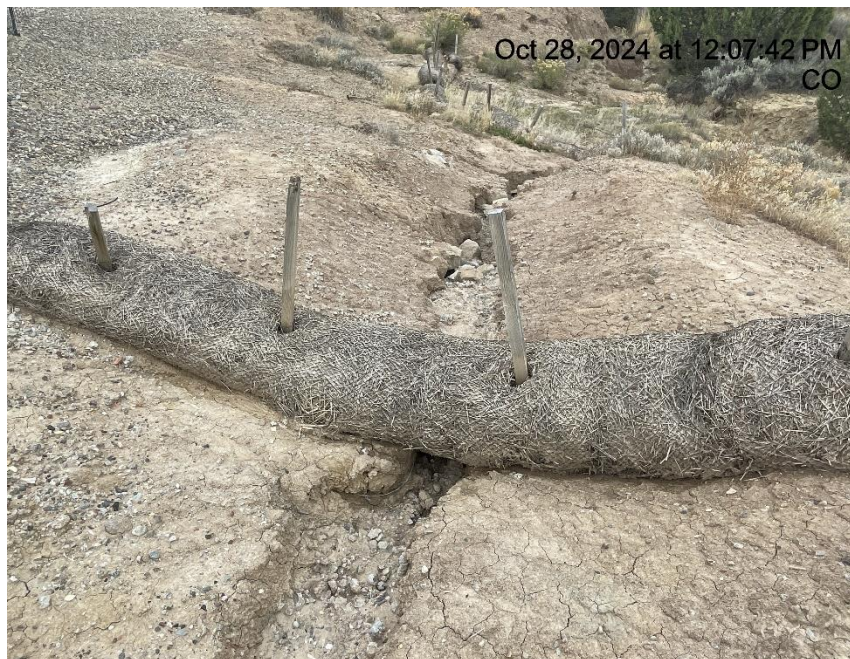
**Photo # 7542 Failure to minimize erosion & transport of sediment/BMP's need maintenance**

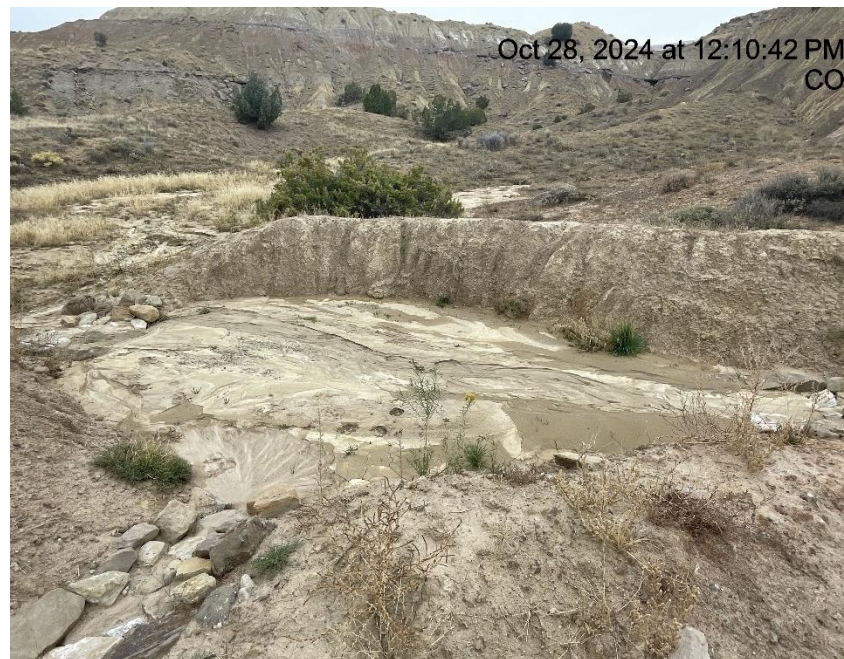
**Photo # 7543 Sediment trap needs maintenance (S/SW corner of location near entrance to location)**

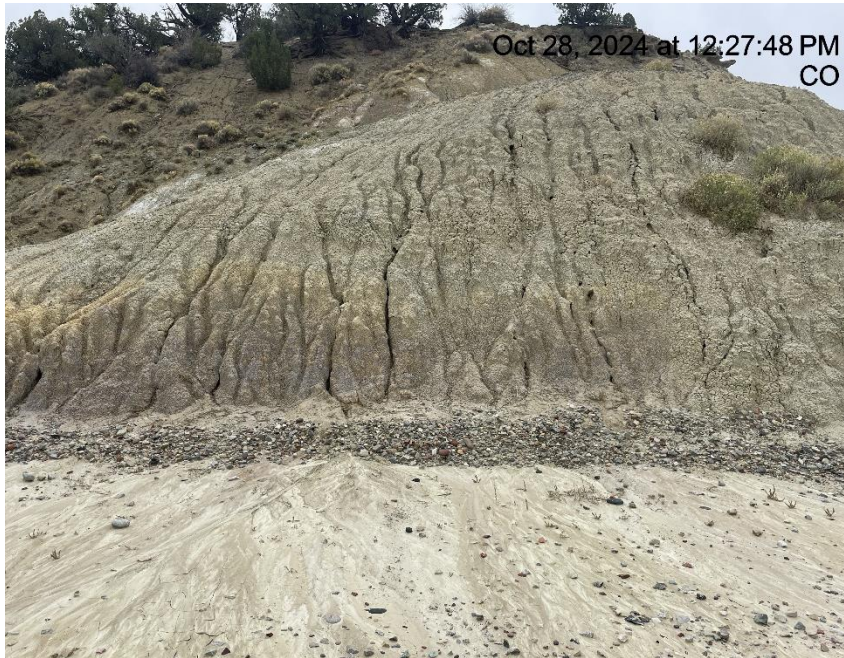
**Photo # 7544 Erosion & transport of sediment onto lease road/insufficient BMP's (approximately 2/10<sup>th</sup> of a mile from entrance to location)**

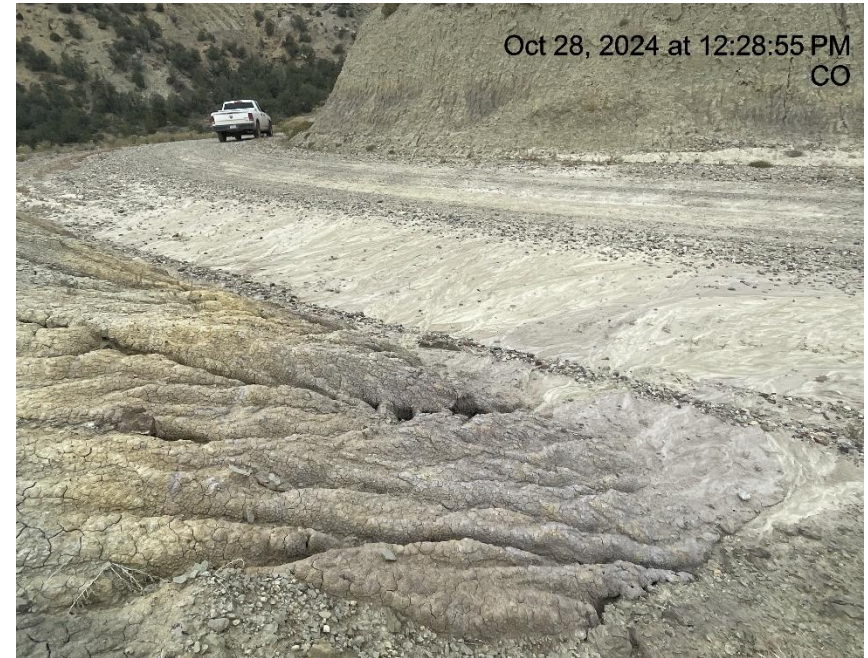
**Photo # 7545 Erosion & transport of sediment onto lease road/insufficient BMP's (approximately 2/10<sup>th</sup> of a mile from entrance to location)**

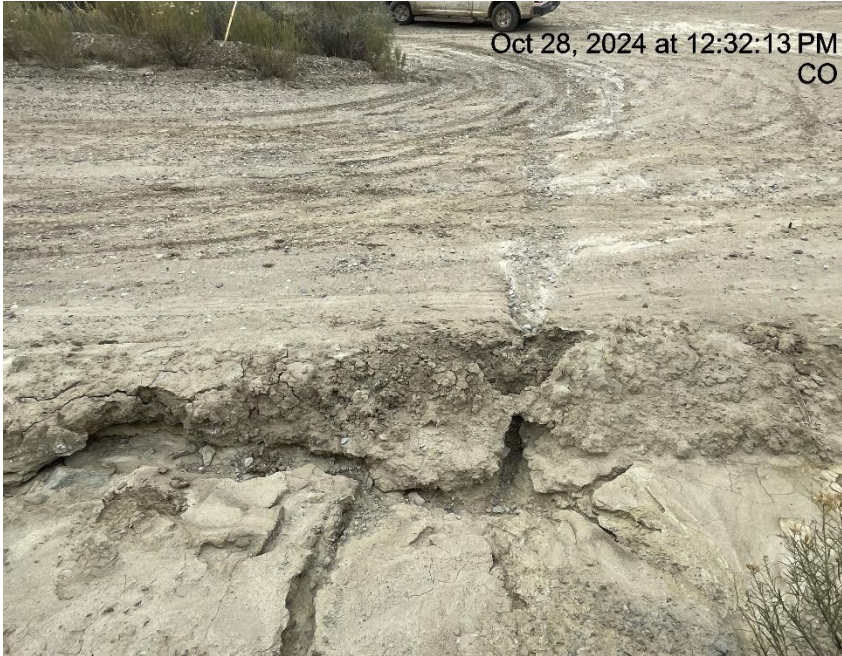
**Photo # 7546 Tunnel erosion & transport of sediment onto lease road/BMP's need maintenance (approximately 3/10th of a mile from entrance to location)**

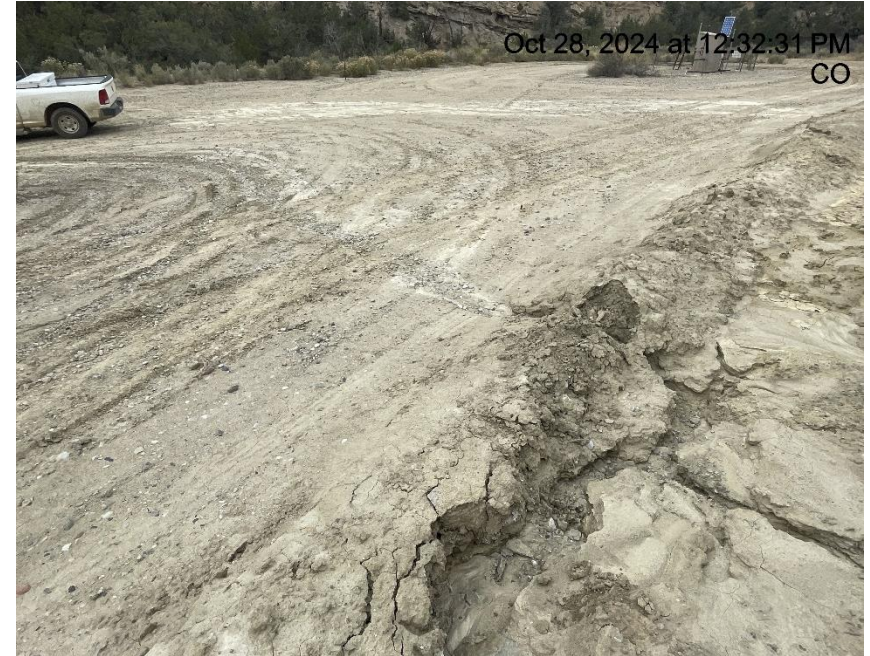
**Photo # 7547 Tunnel erosion & transport of sediment onto lease road/BMP's need maintenance (approximately 3/10th of a mile from entrance to location)**

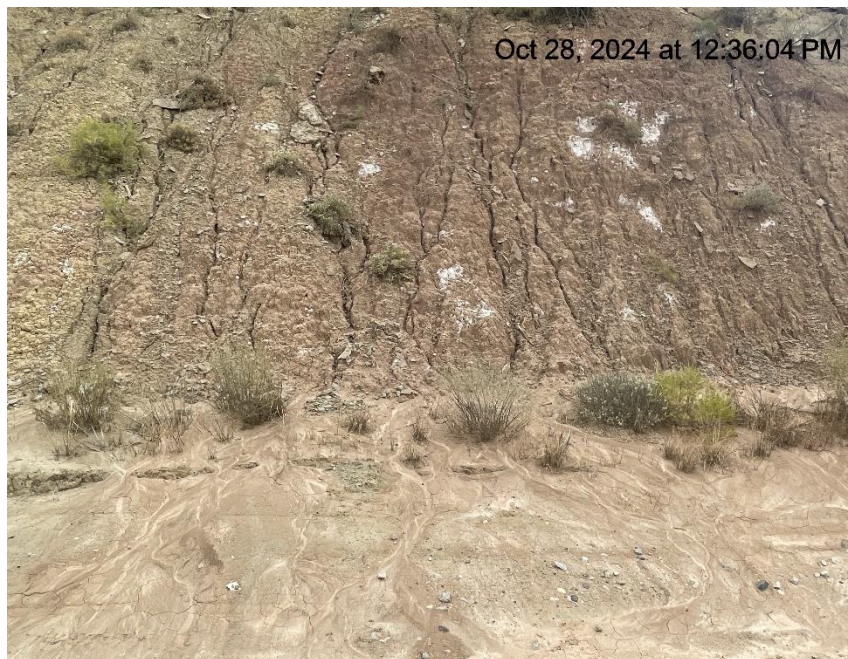
**Photo # 7548 Erosion & transport of sediment onto lease road/insufficient BMP's (approximately 5/10th of a mile from entrance to location)**

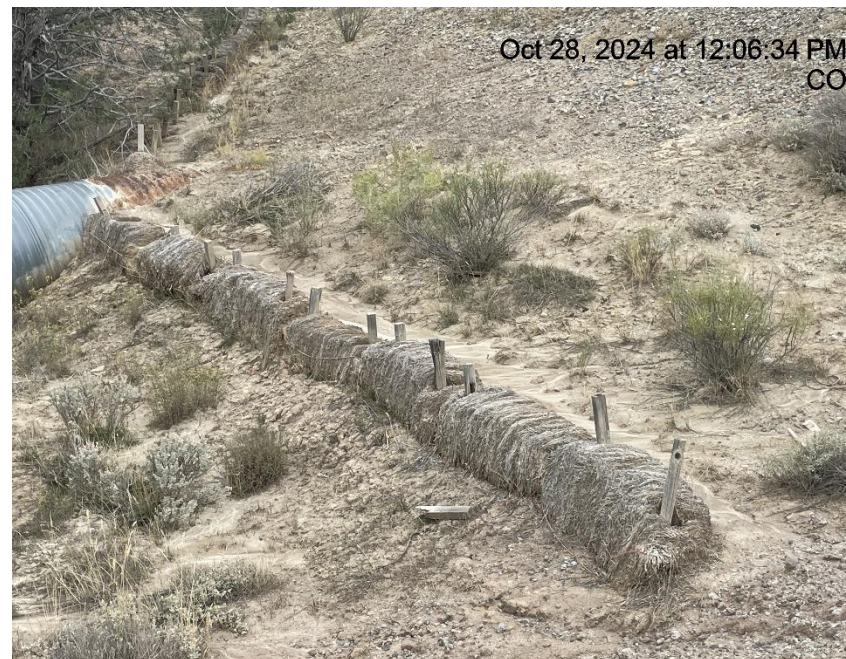
**Photo # 7549 Large amount of sediment buildup at hay bales /BMP's may need maintenance in near future (Off edge of lease road near entrance to location)**
