# Interim Reclamation and Stormwater Inspection

Date: 10/29/2024

Operator: WESTERN OPERATING COMPANY - 95620

Location ID: 312292

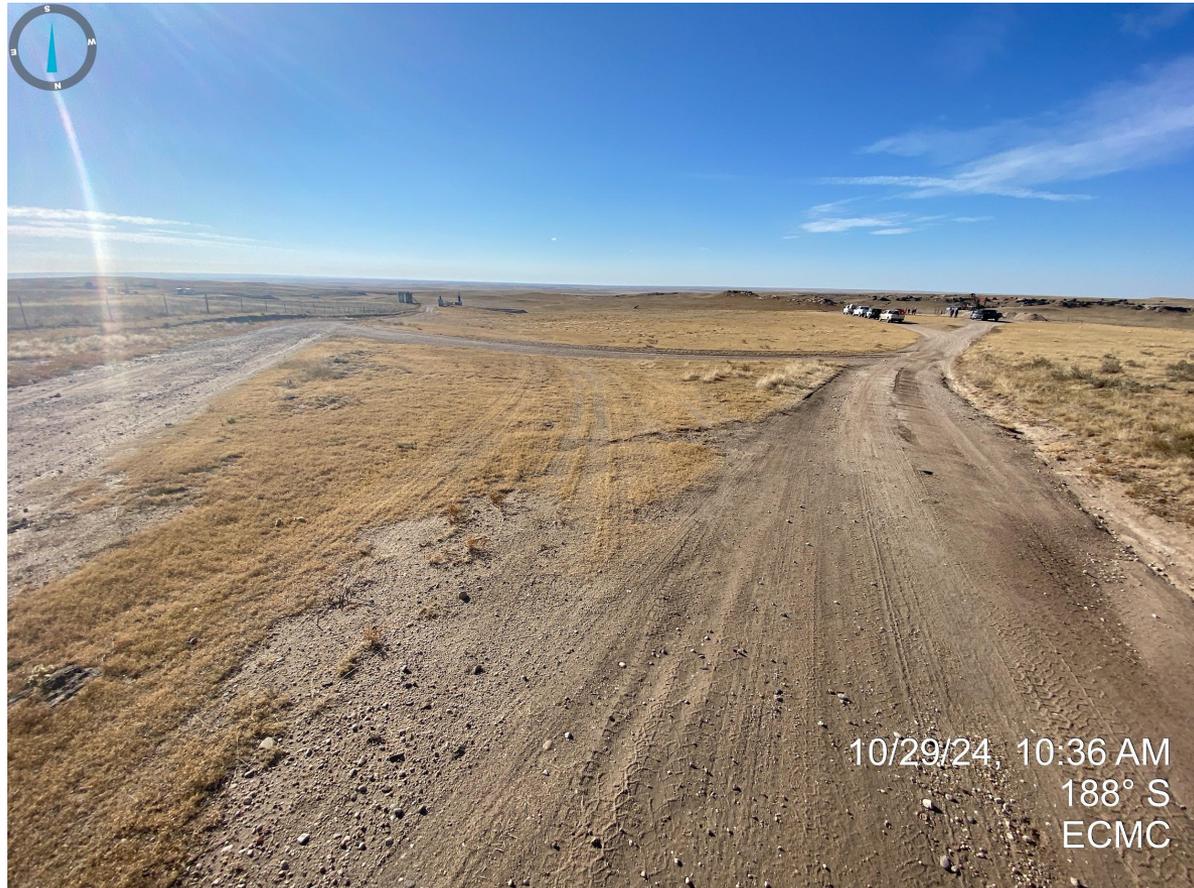
**Photo 1.** Taken near the Y intersection of the access road. Vehicle traffic observed outside of the established access roads. Additional reclamation activities may be required if the disturbed area fails to meet Rule 1003 standards.

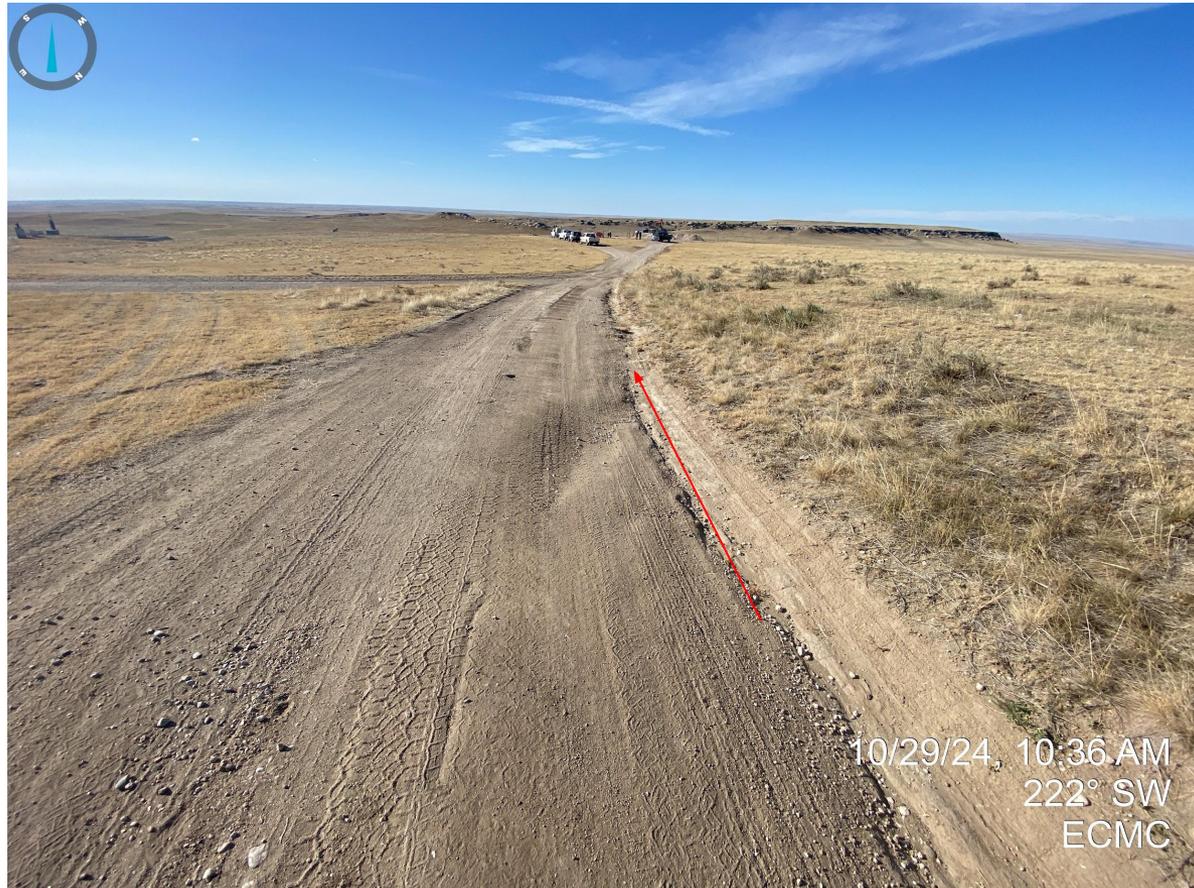
**Photo 2.** Erosion degradation observed along the access road.

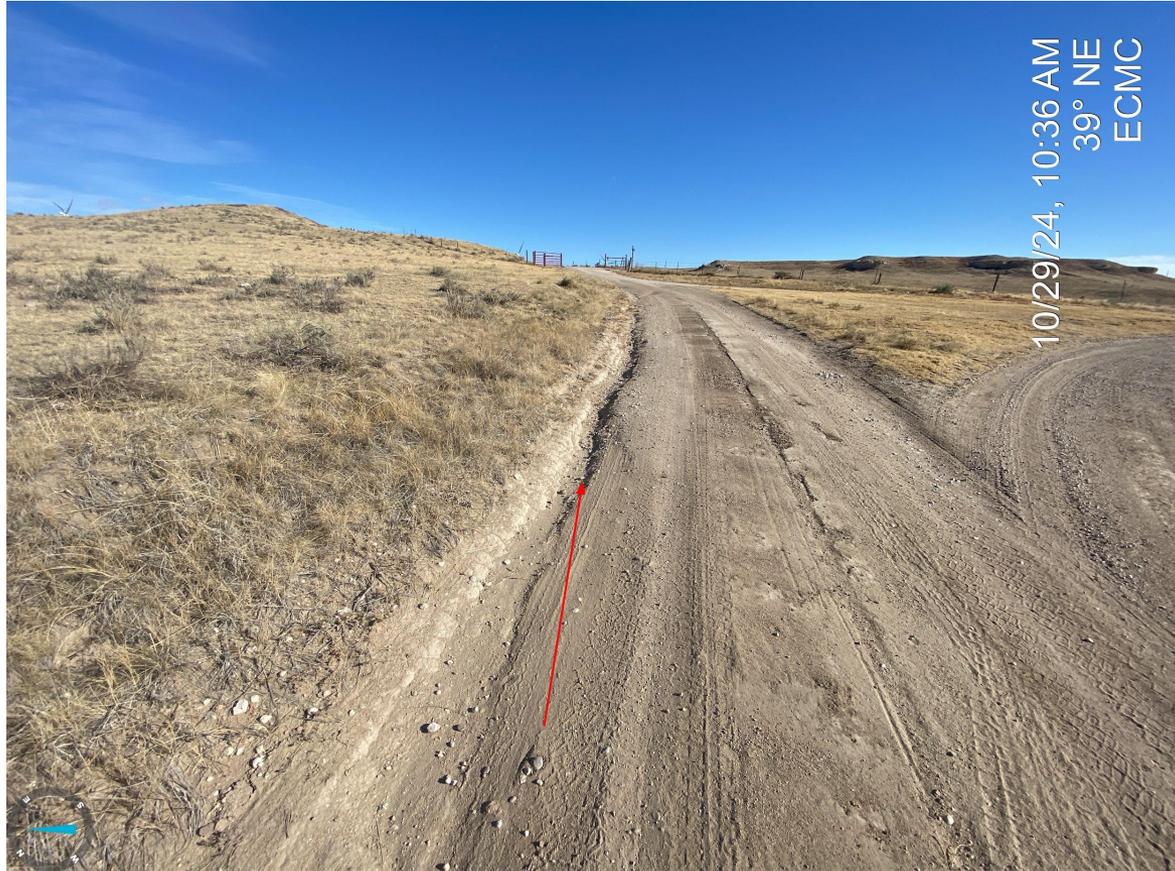
**Photo 3.** Continued from Photo 2; erosion degradation observed along the access road.

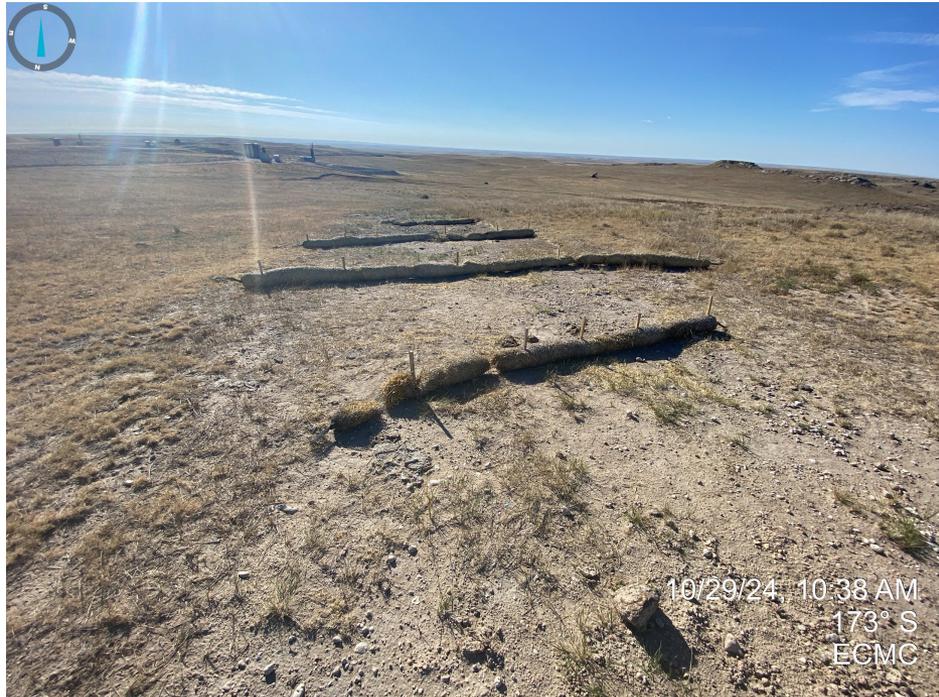
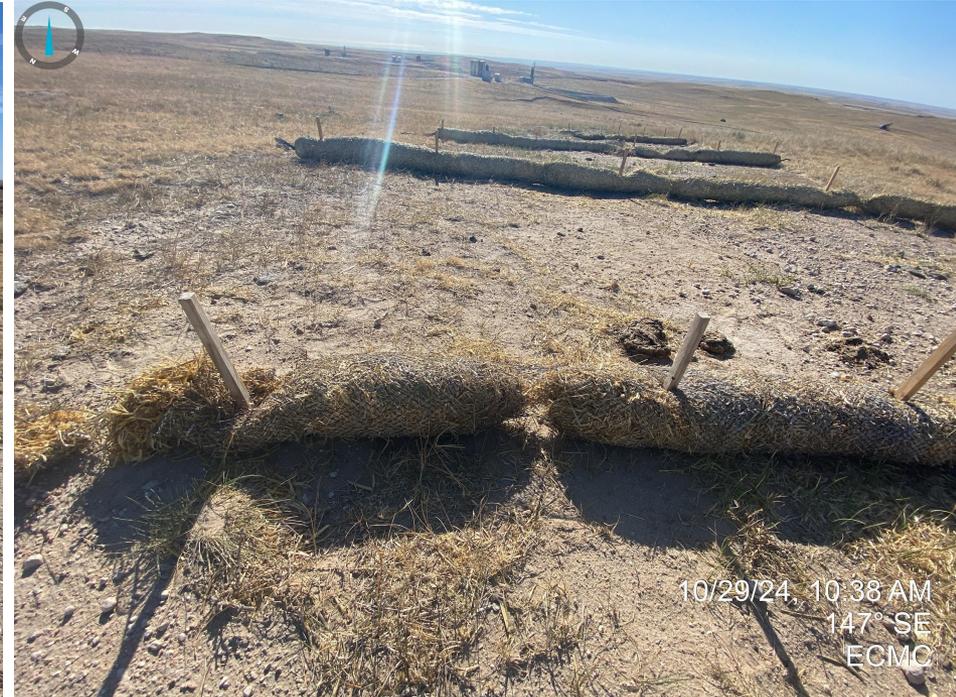
**Photos 4 & 5.** Straw wattles appear to have been reinstalled south of the former heater treater, however, the straw wattles do not appear to be installed per good engineering practices (e.g. trenched and backfilled) and are damaged/degraded.

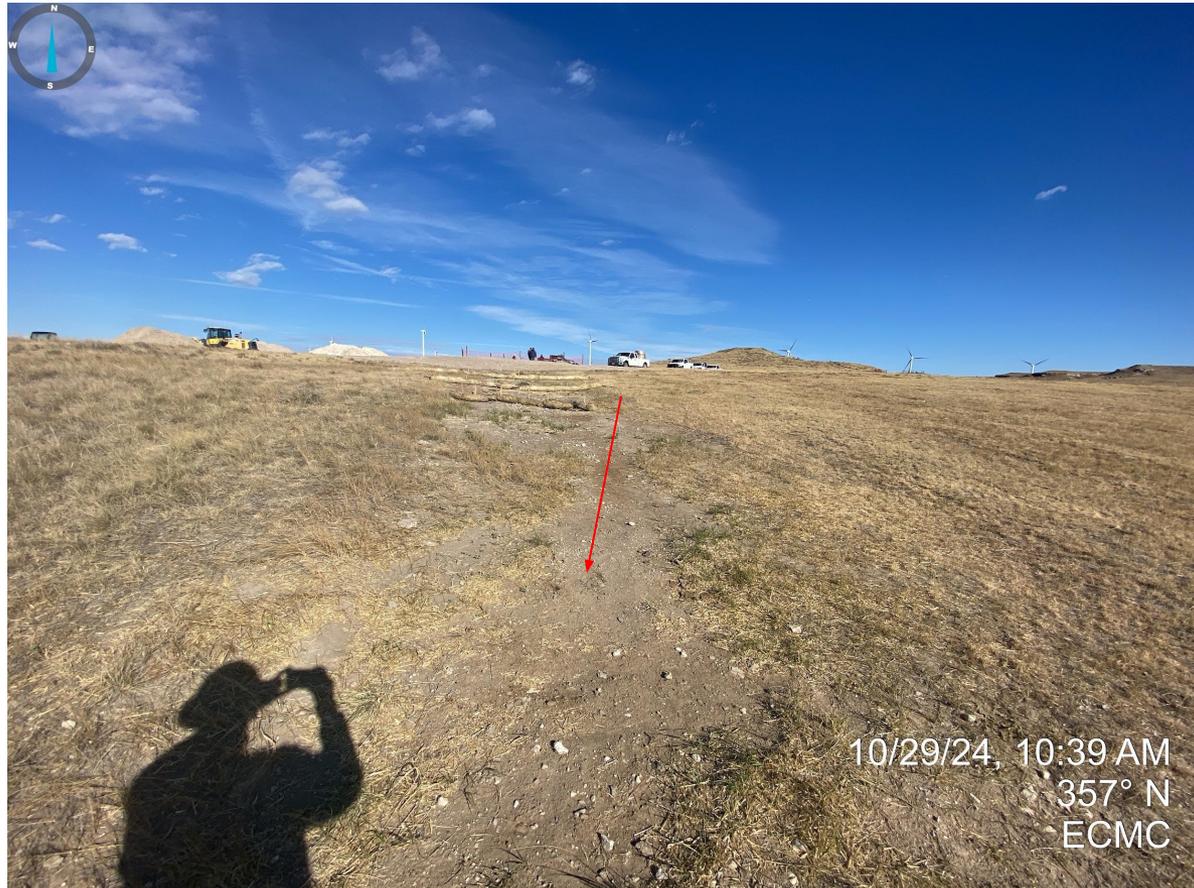
**Photo 6.** Continued from Photos 4 & 5. Erosion degradation evident from lack of proper stormwater control measures.

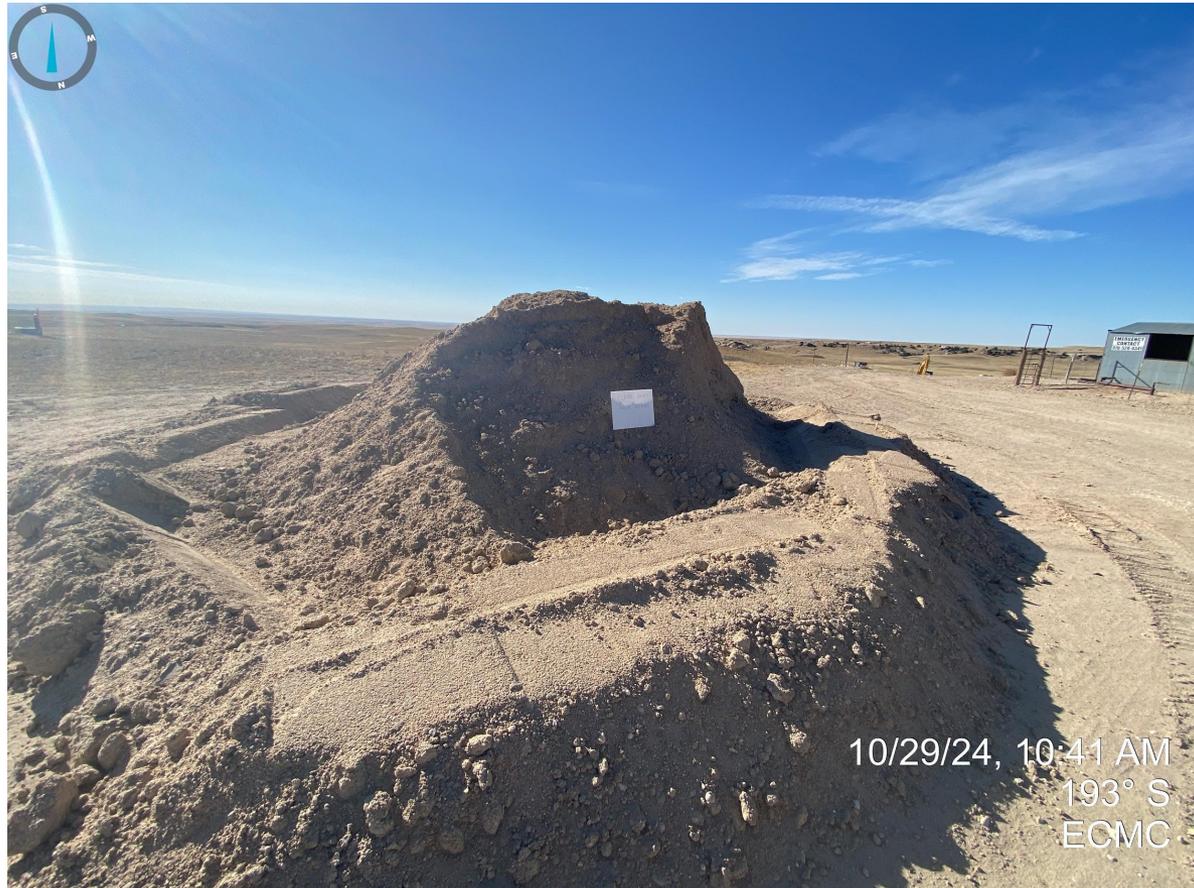
**Photo 7.** Stockpiled materials located near the wellhead appear to have perimeter stormwater controls and adequate signage.

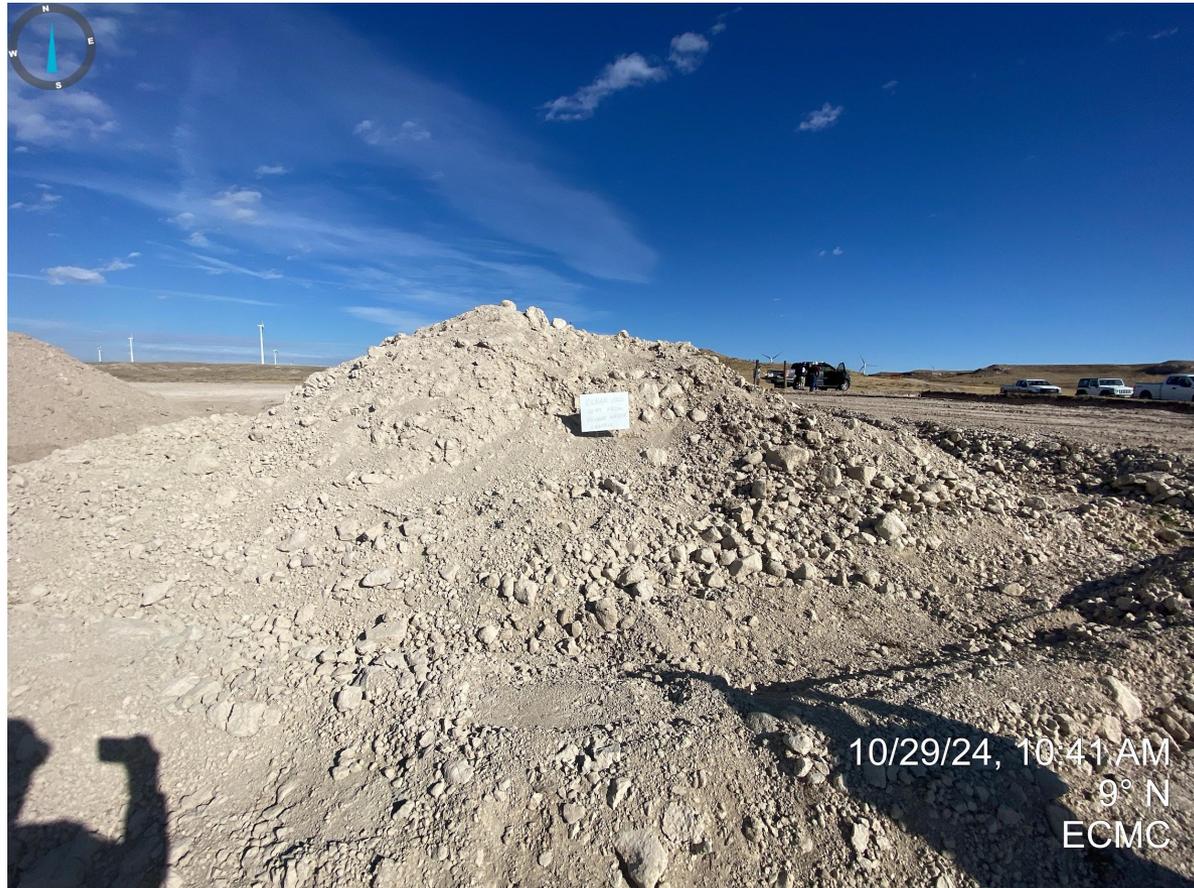
**Photo 8.** Stockpiled materials located near the wellhead appear to have perimeter stormwater controls and adequate signage.

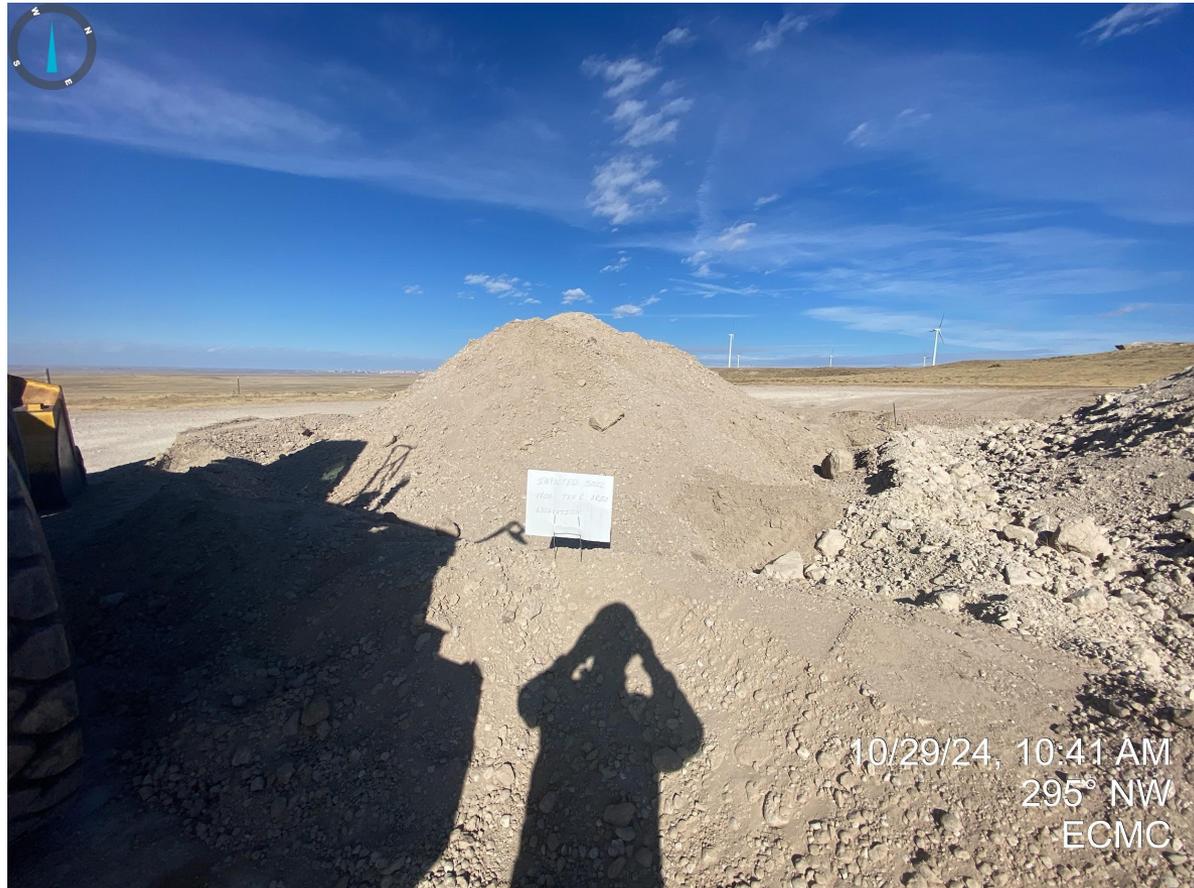
**Photo 9.** Stockpiled materials located near the wellhead appear to have perimeter stormwater controls and adequate signage.

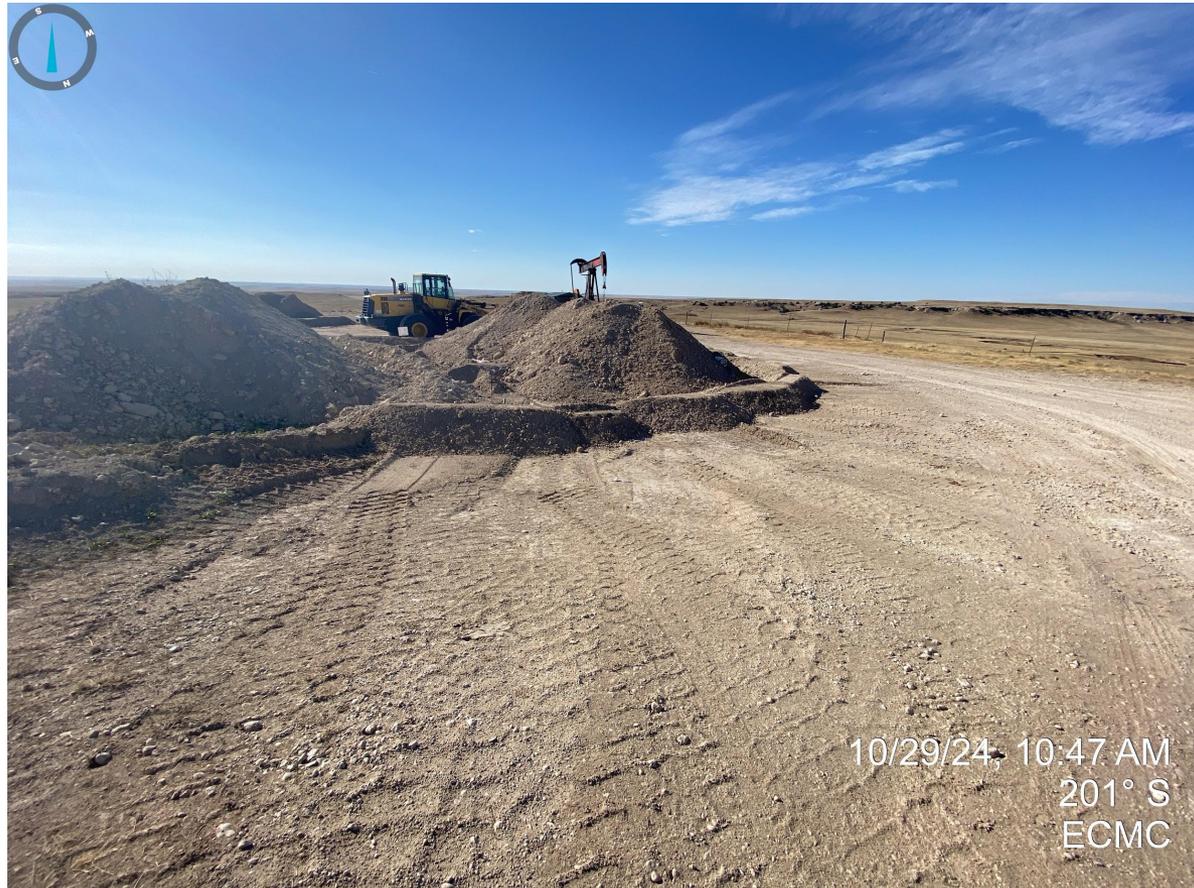
**Photo 10.** Continued from Photo 9. Stockpiled materials located near the wellhead appear to have perimeter stormwater controls and adequate signage.

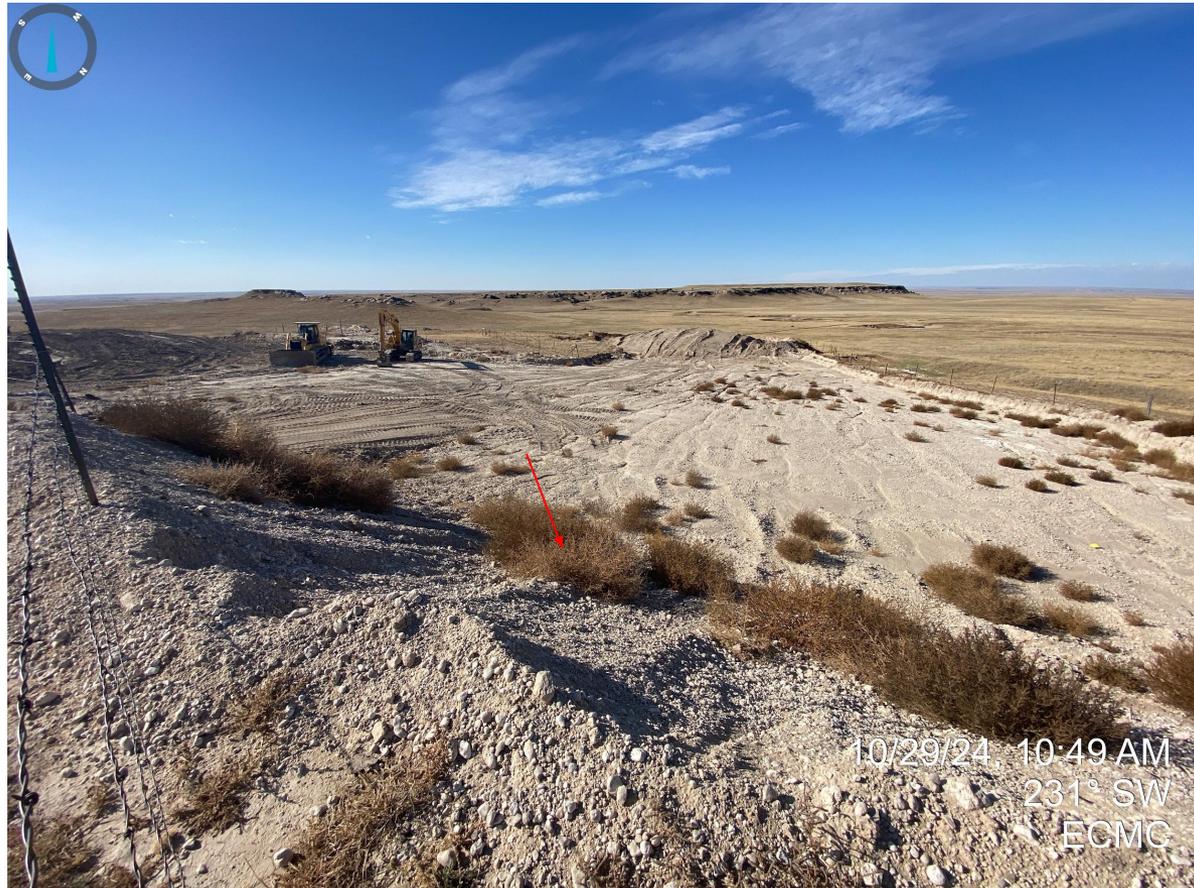
**Photo 11.** Evidence of undesirable vegetation (russian thistle) observed within the former pit/excavation.

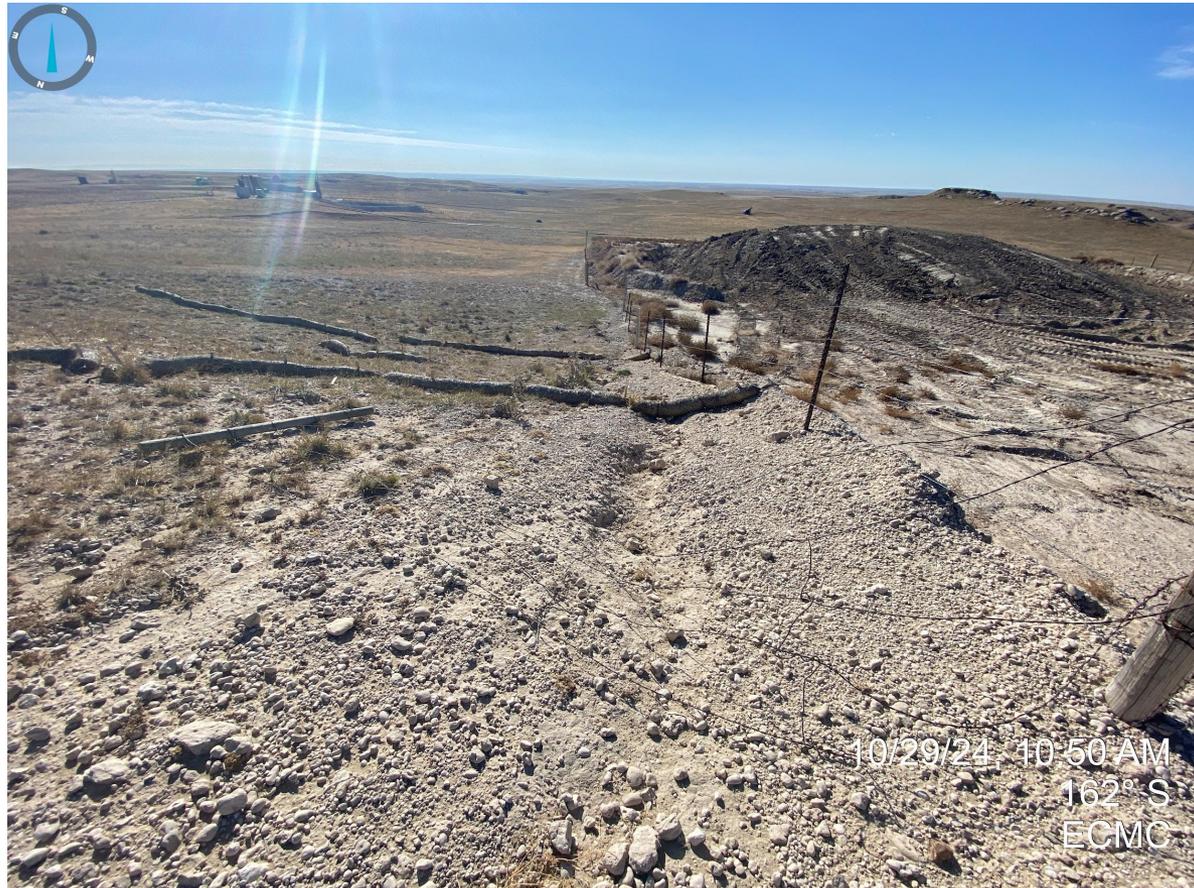
**Photo 12.** Stormwater control measures east of pit remain inadequate; additional maintenance and/or implementation of more robust stormwater control measures/BMPs required.

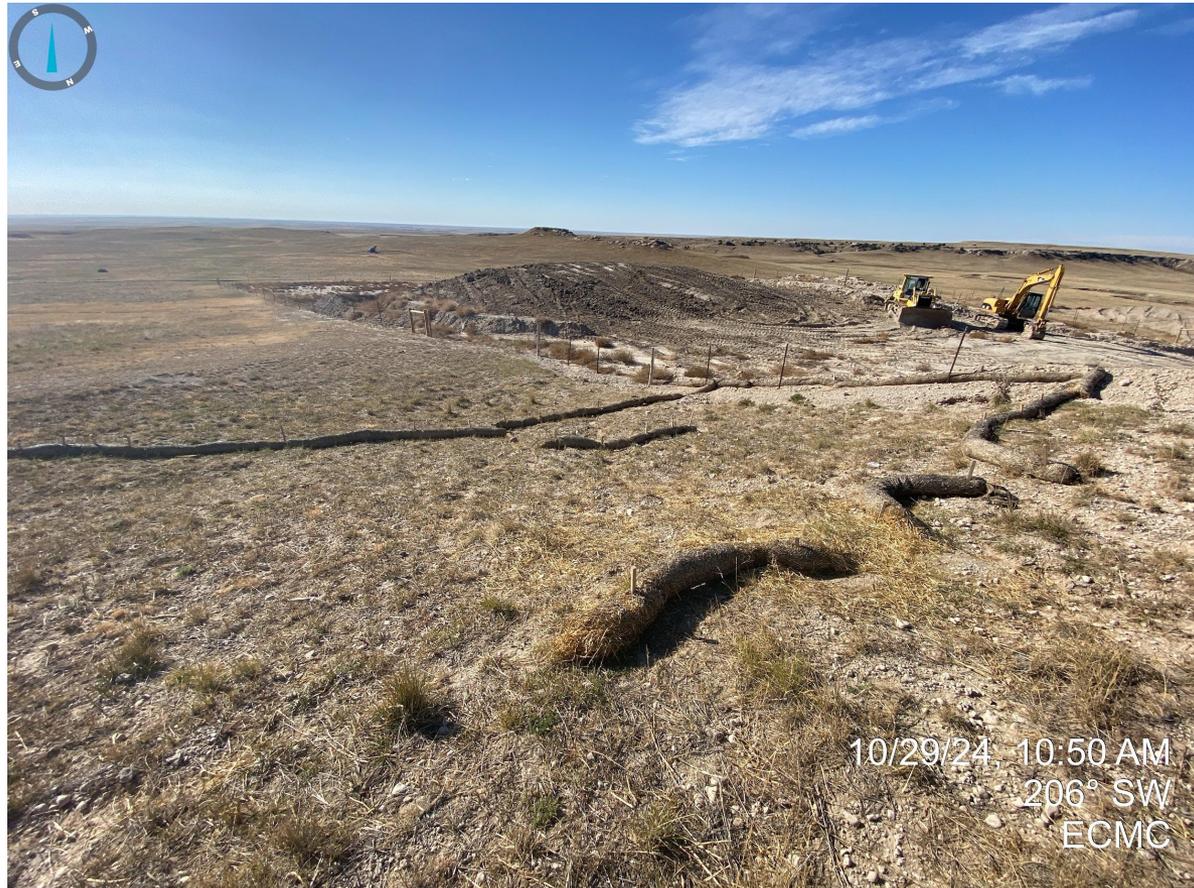
**Photo 13.** Stormwater control measures east of pit remain inadequate; additional maintenance and/or implementation of more robust stormwater control measures/BMPs required. Straw wattles do not appear to be installed properly and are damaged.

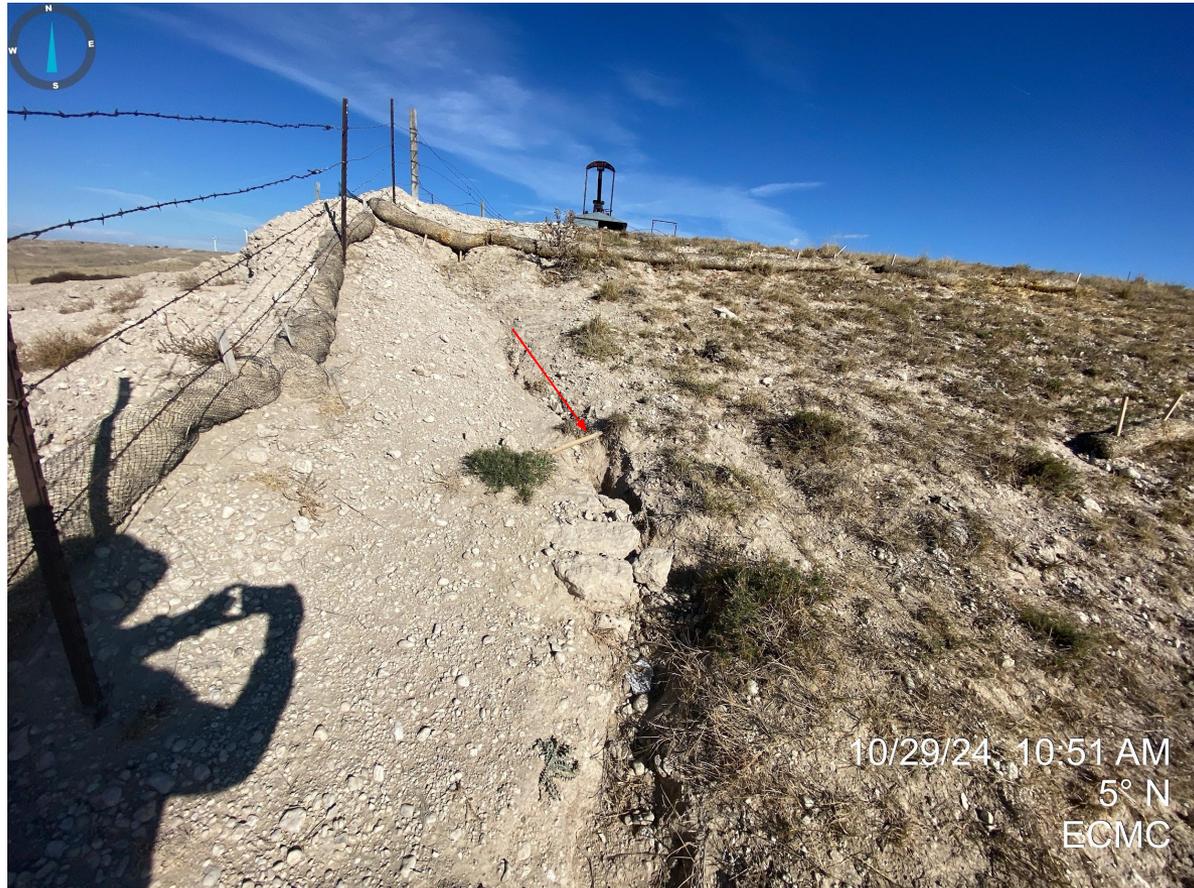
**Photo 14.** Erosion degradation east of pit remain evident; additional maintenance and/or implementation of more robust stormwater control measures/BMPs required.

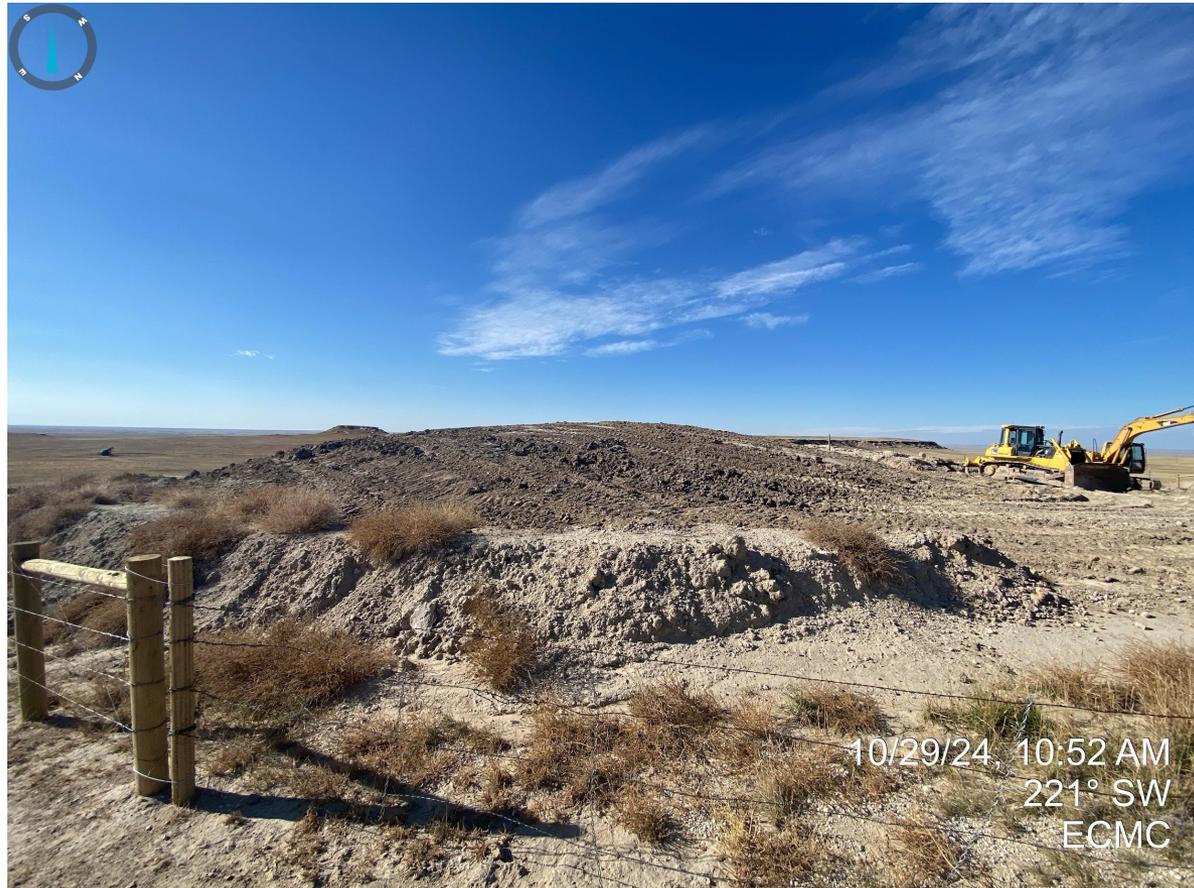
**Photo 15.** Stockpiled material from the salt kill excavation appear to have been compacted and equipment tracked to stabilize the soils.

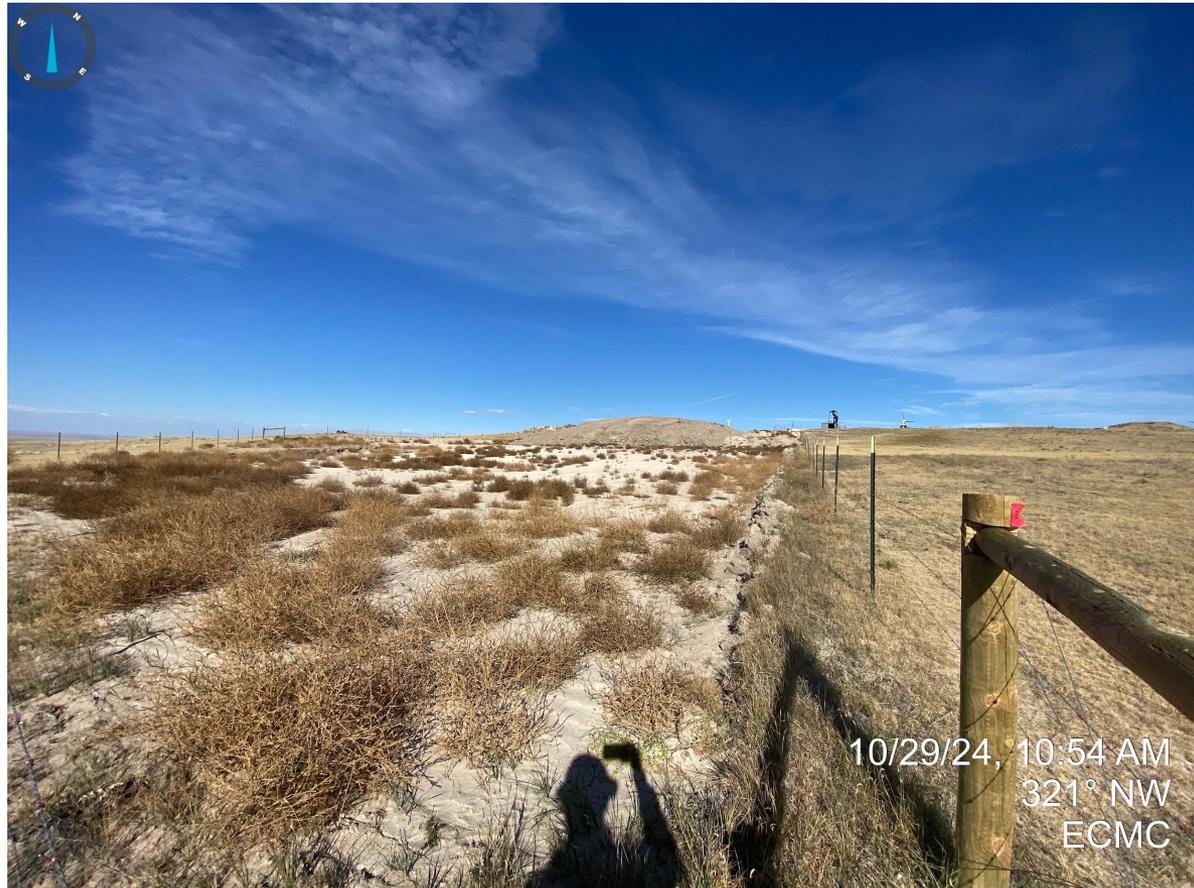
**Photo 16.** Undesirable vegetation observed throughout the salt kill excavation.

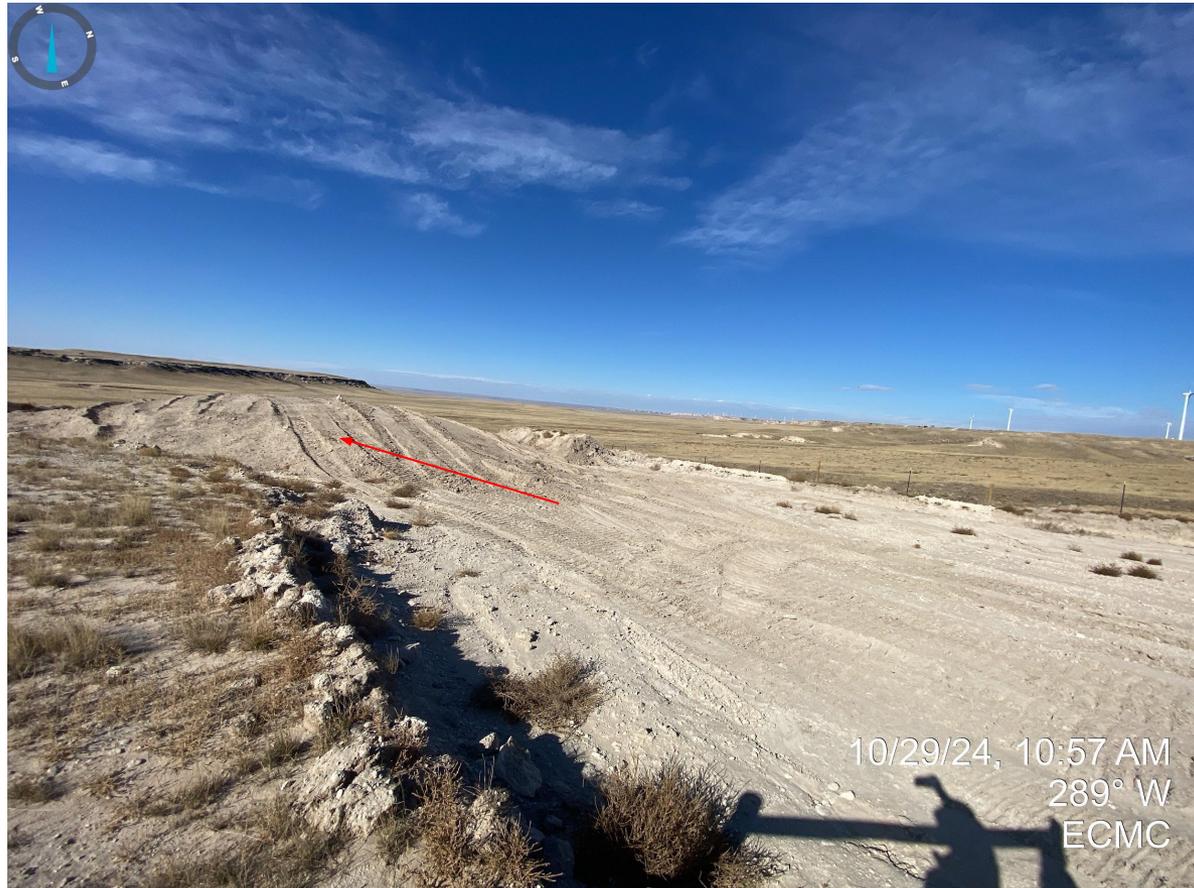
**Photo 17.** Stockpiled material from the salt kill excavation appear to have been compacted and equipment tracked to stabilize the soils.

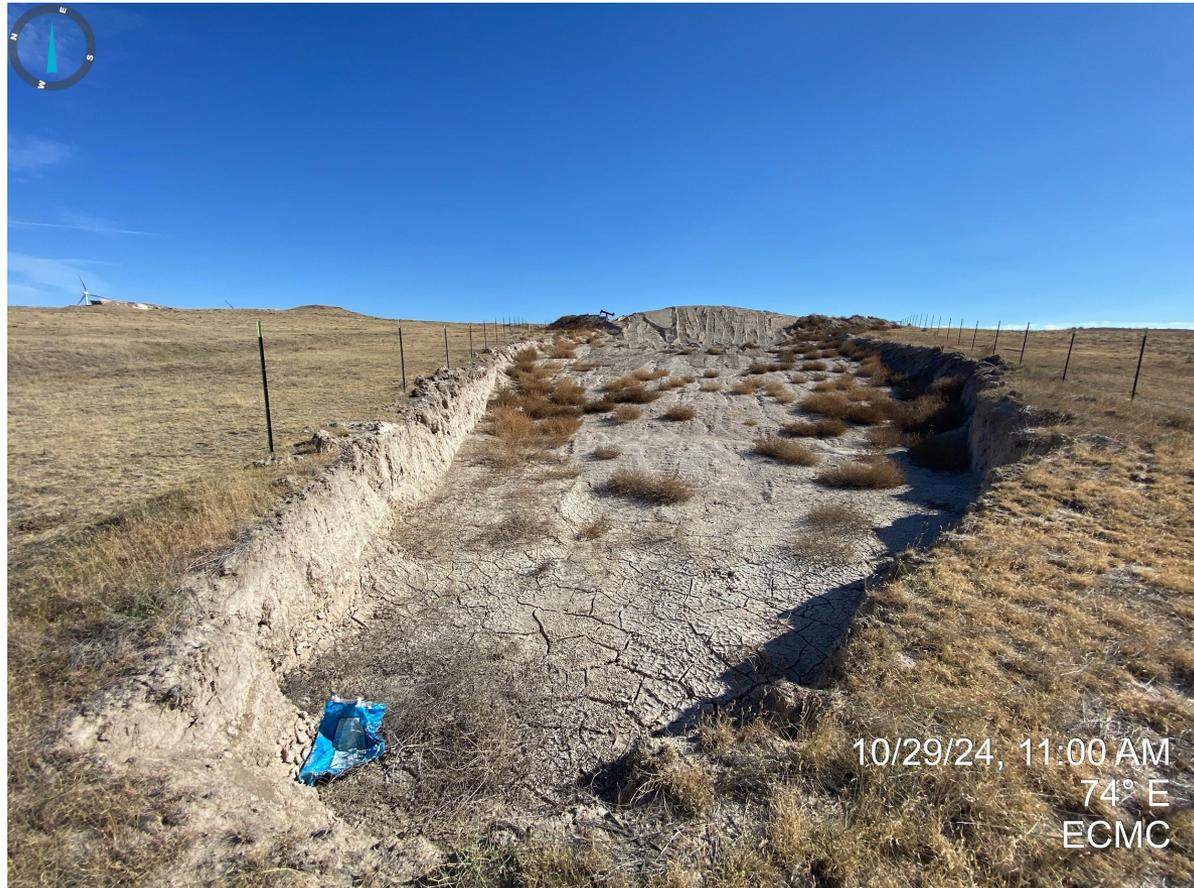
**Photo 18.** Undesirable vegetation and trash/debris observed within the western salt kill excavation.

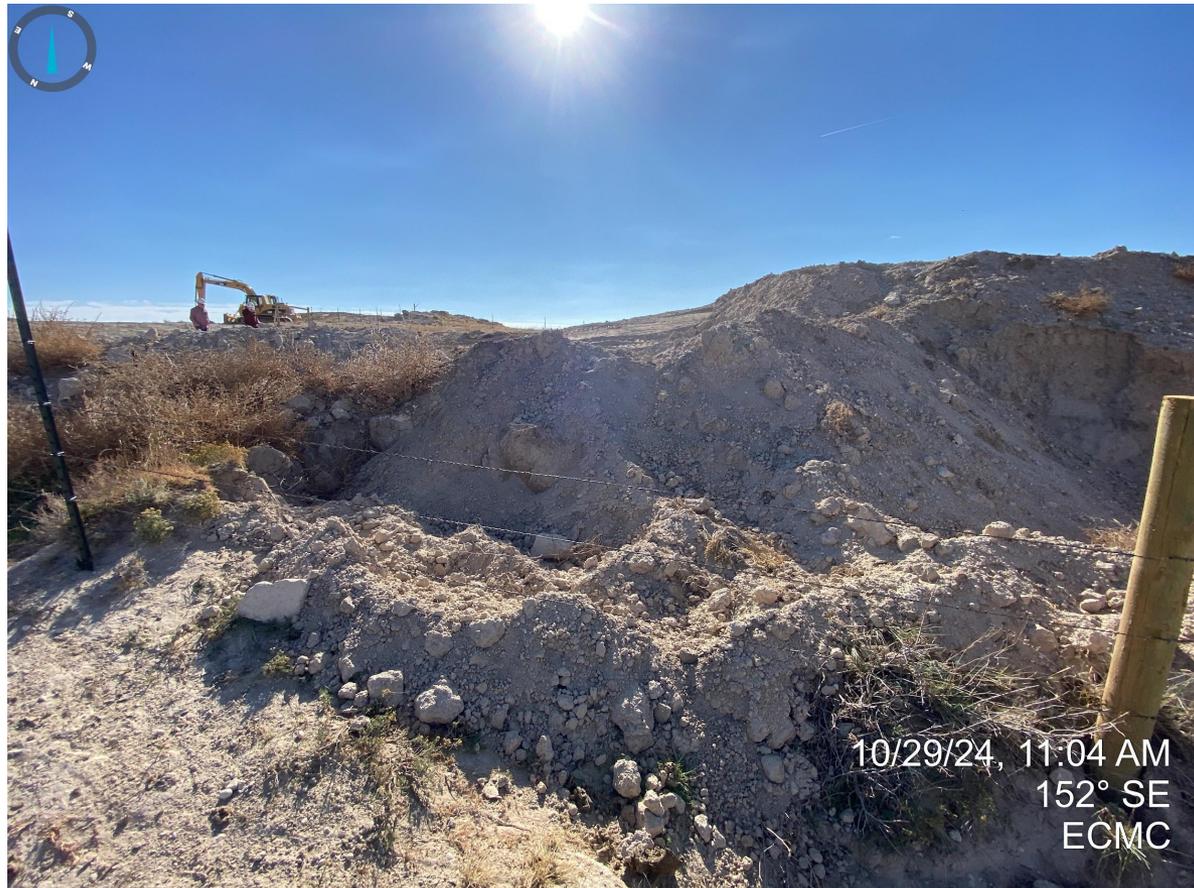
**Photo 19.** Northwest corner of the excavated pit; photo illustrates unstabilized soils. It appears that stormwater may have breached the berm and discharged stormwater, rock/sediment/debris and E&P waste into the adjacent drainage (see preceding photos).

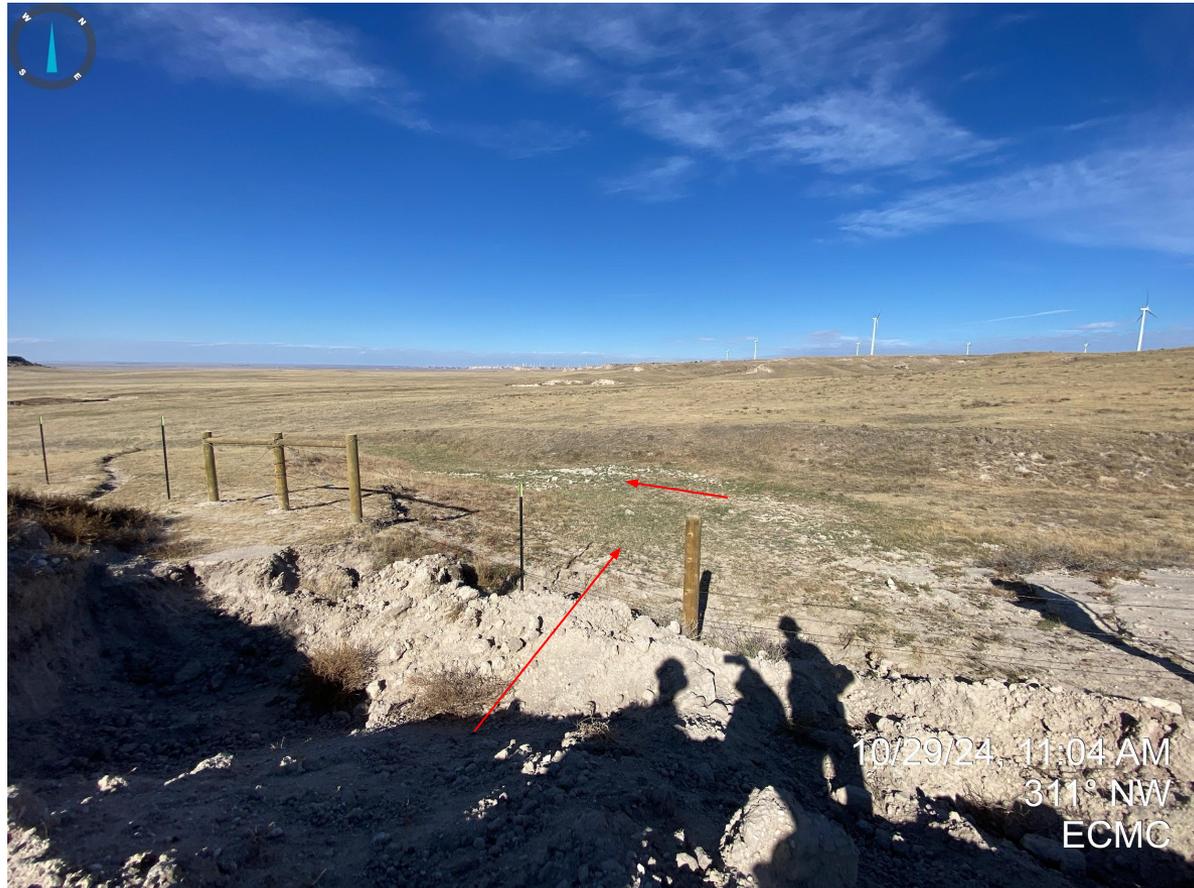
**Photo 20.** Continued from Photo 19, facing northwest. Evidence of off-location sediment transport observed.

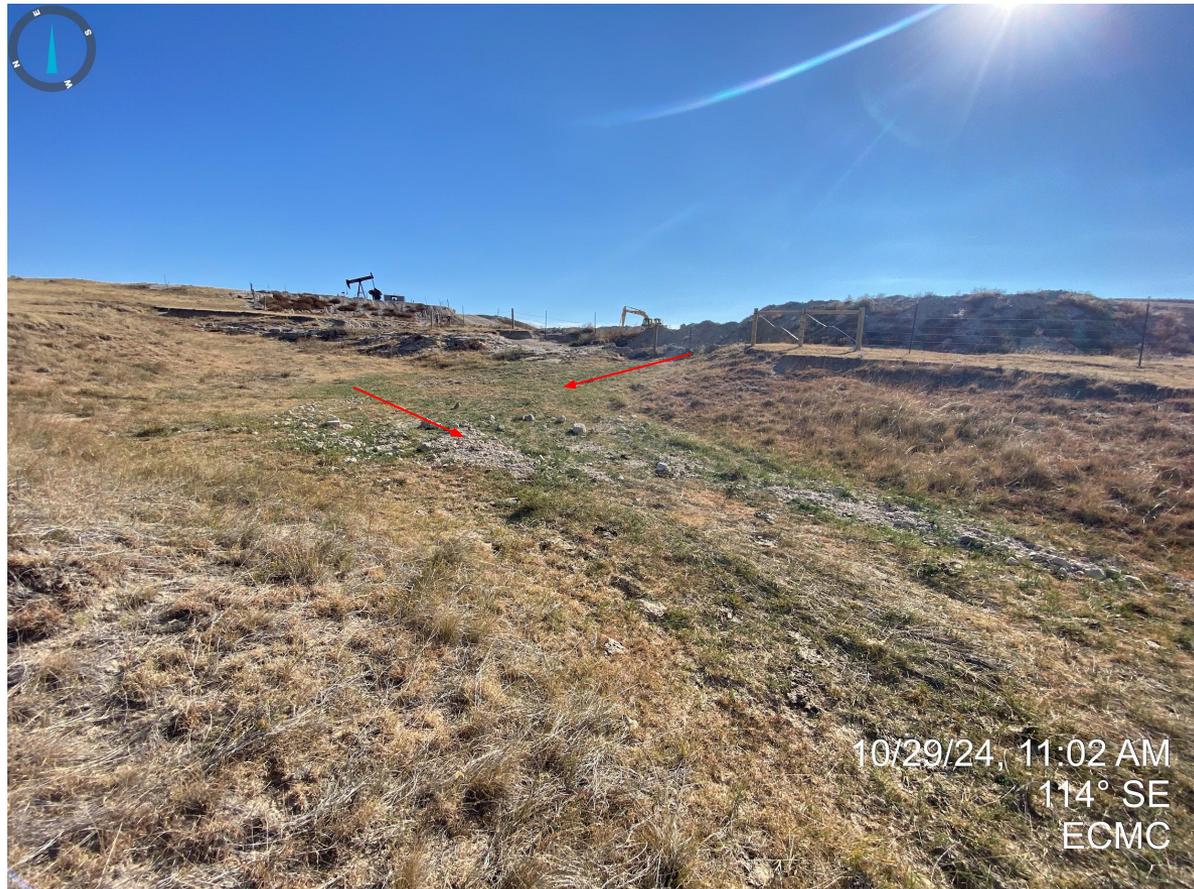
**Photo 21.** Continued from Photo 19, facing southeast. Evidence of off-location sediment transport observed.
