# Interim Reclamation and Stormwater Inspection

Date: 10/29/2024

Operator: WESTERN OPERATING COMPANY - 95620

Location ID: 312292

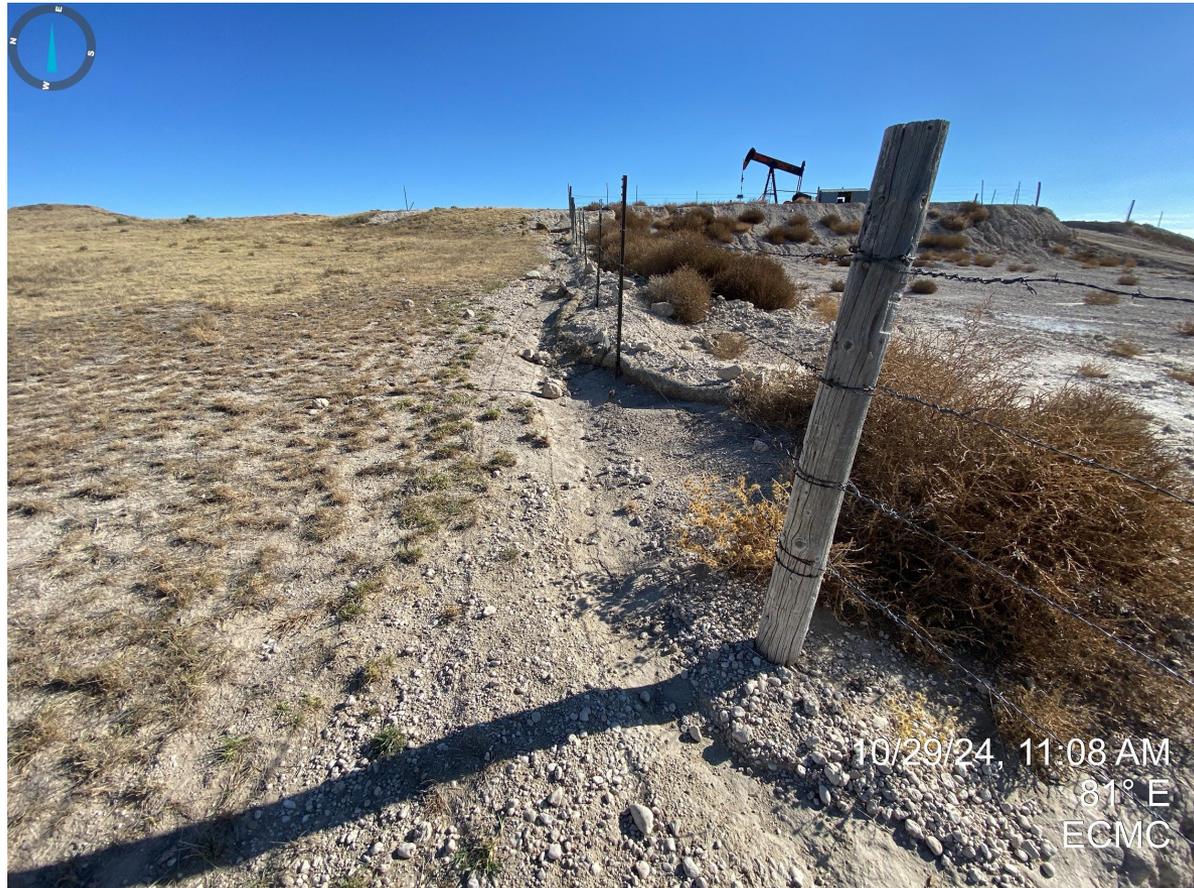
**Photo 22.** Erosion degradation north of pit remain evident; additional maintenance and/or implementation of more robust stormwater control measures/BMPs required. Undesirable vegetation (russian thistle) also pictured.

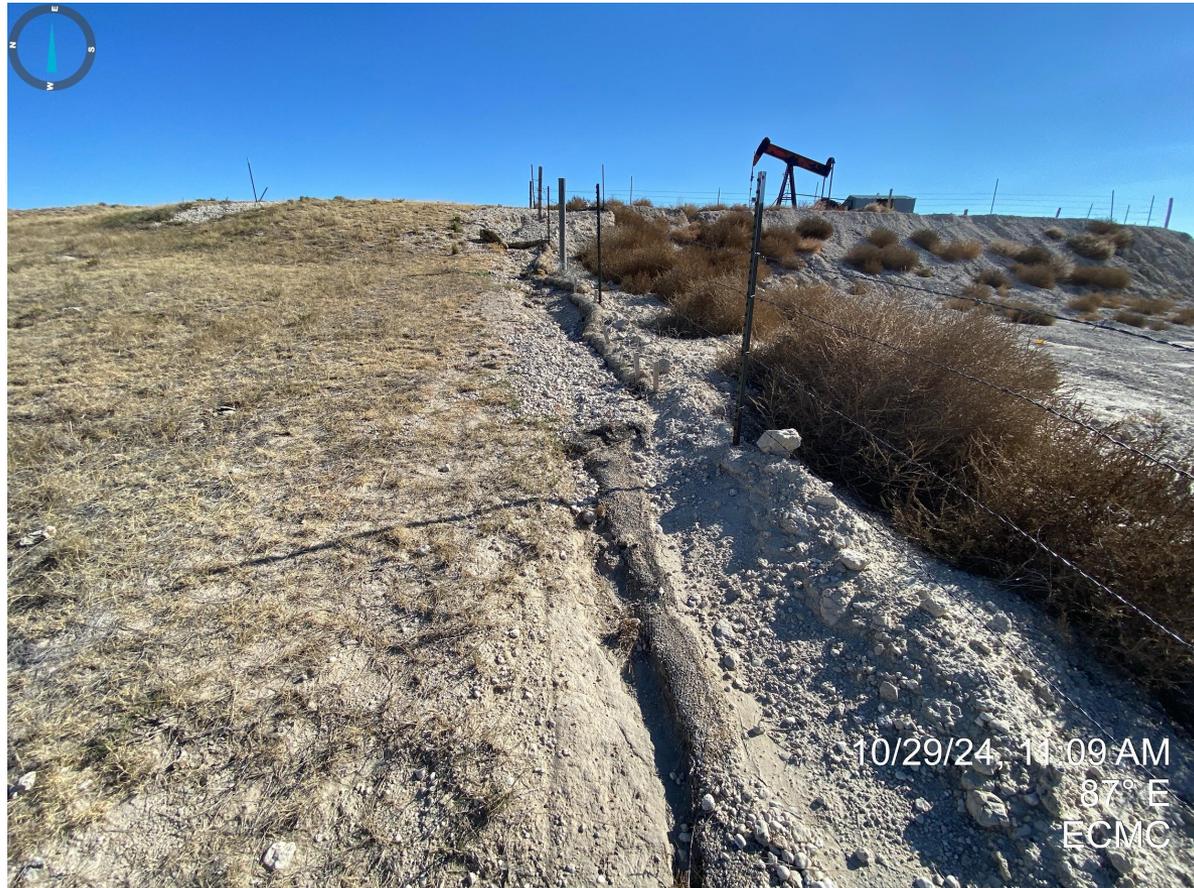
**Photo 23.** Continued from Photo 22; north side of pit.

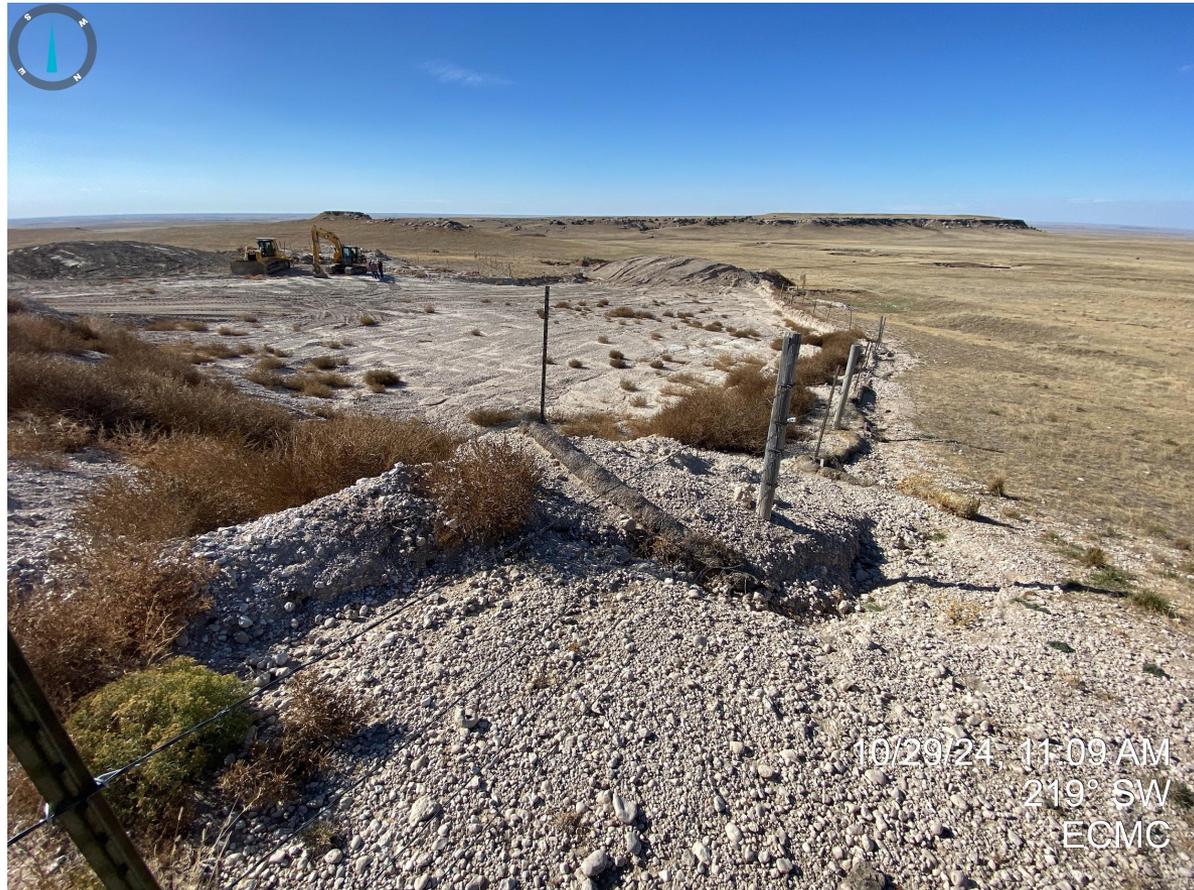
**Photo 24.** Continued from Photo 22; northeast of pit.
