Interim Reclamation and Stormwater Inspection

Date: 10/29/2024

Operator: WESTERN OPERATING COMPANY - 95620

Location ID: 312229

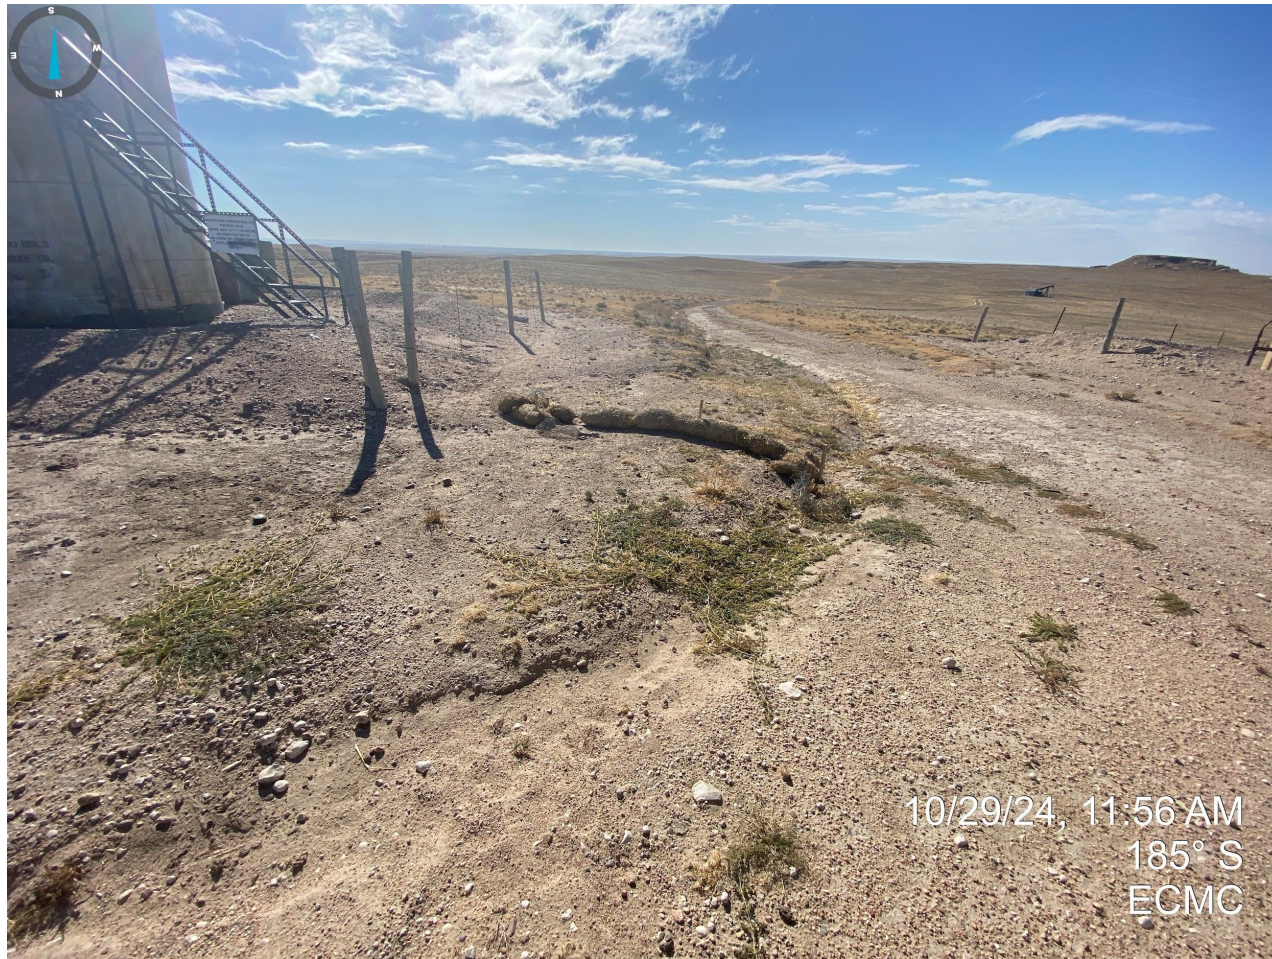
Photo 1. Erosion degradation observed around the production areas. Degraded straw wattle appears to have been reinstalled, however, it does not appear to have been installed per good engineering practices (e.g. trenched and backfilled) and is not properly function in its current state.

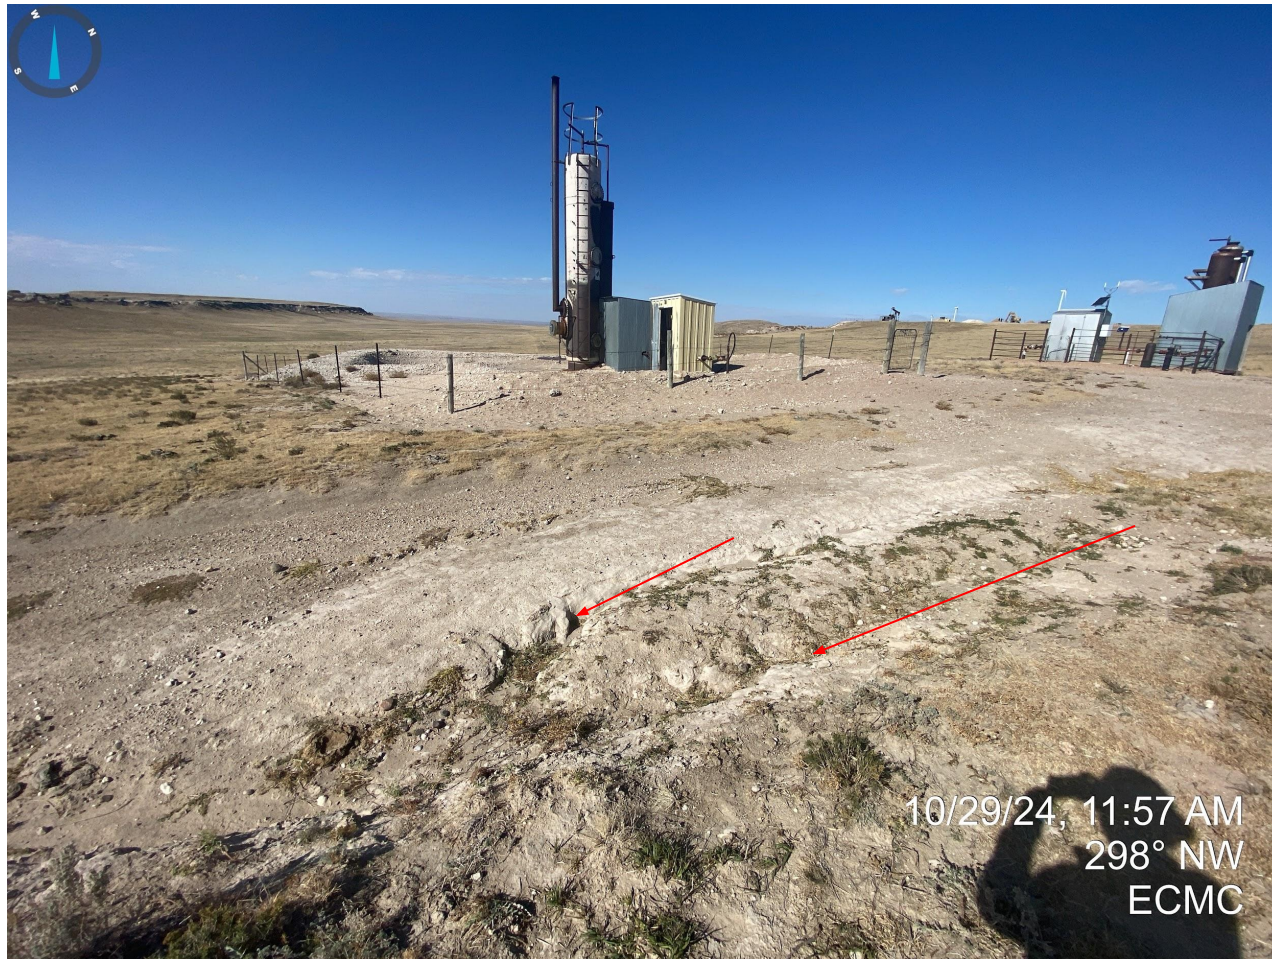
Photo 2. Continued from Photo 1; erosion degradation and absence of stormwater controls measures.

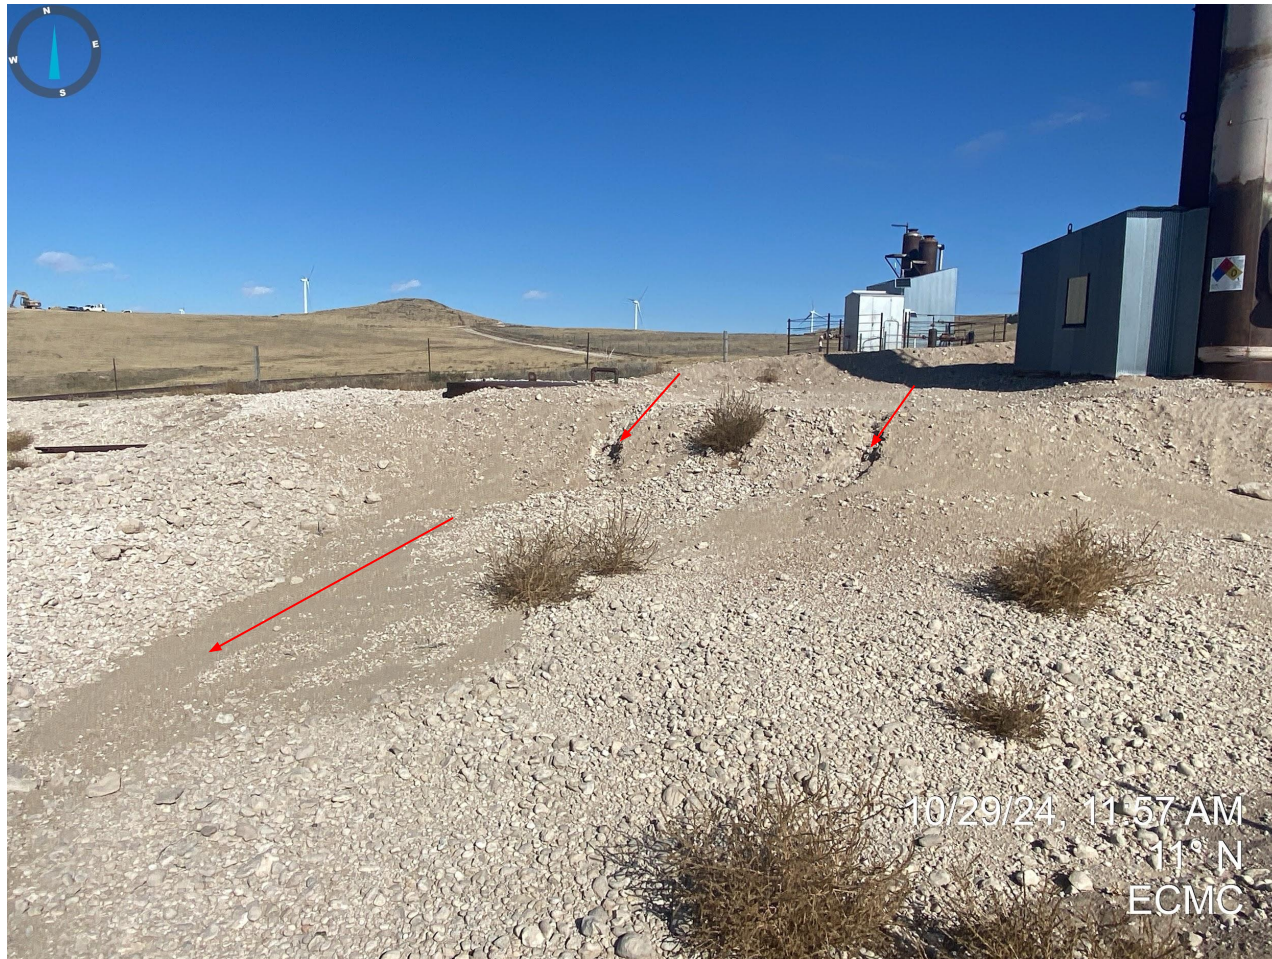
Photo 3. Erosion degradation and undesirable vegetation observed around the pit.

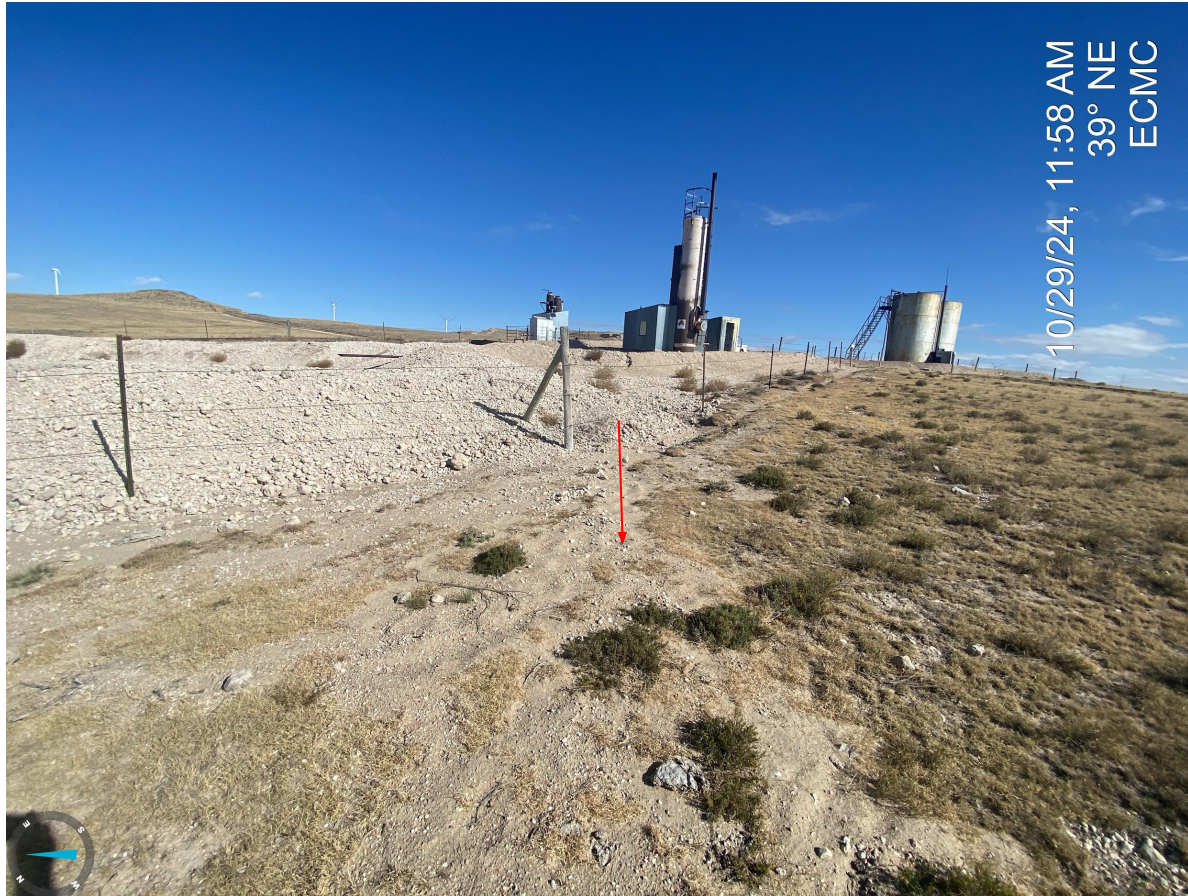
Photo 4. Continued from Photo 3; photo illustrates erosion degradation and sediment transport.

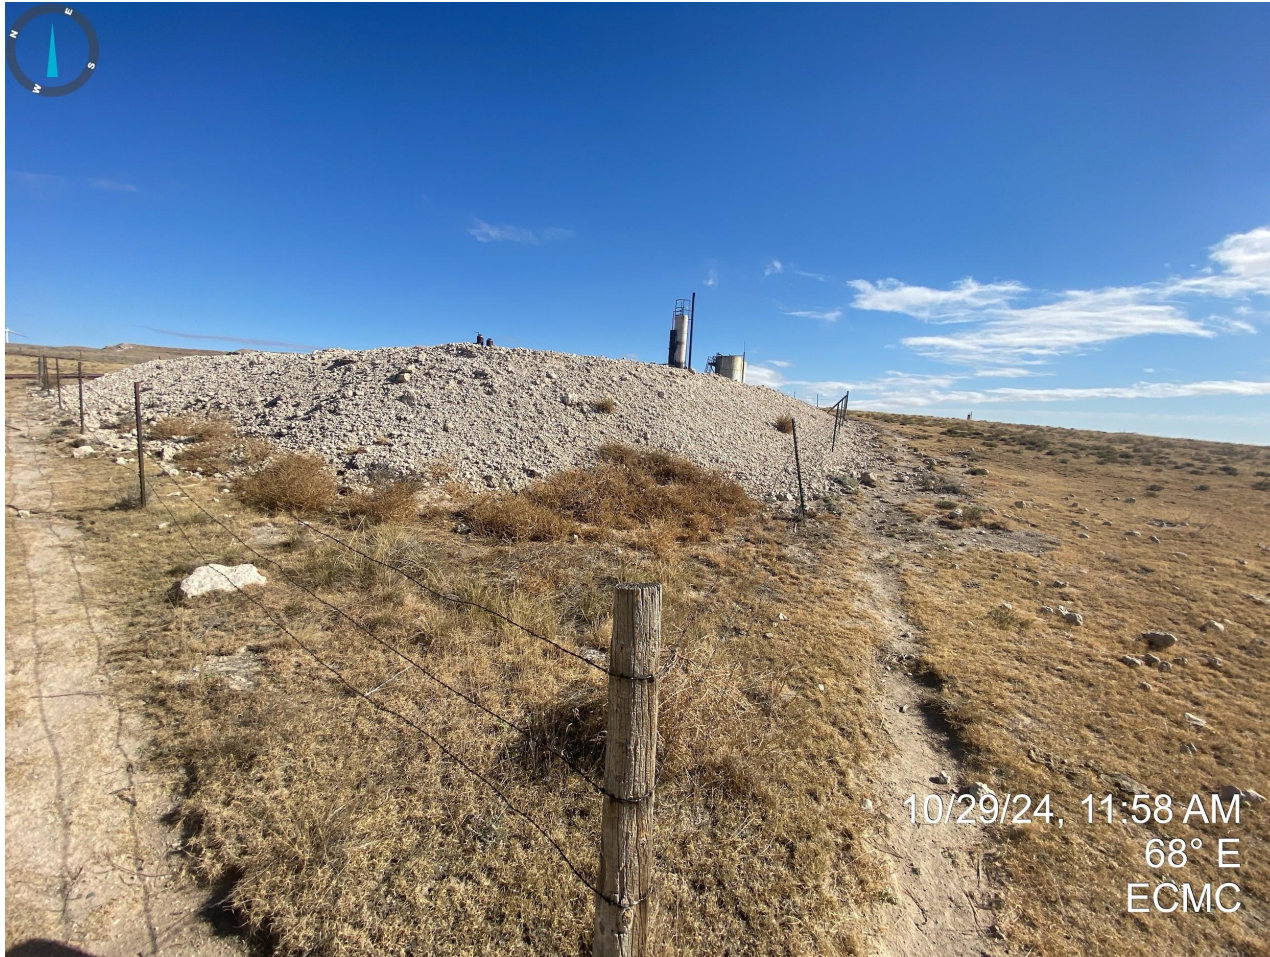
Photo 5. Undesirable vegetation observed around pit.

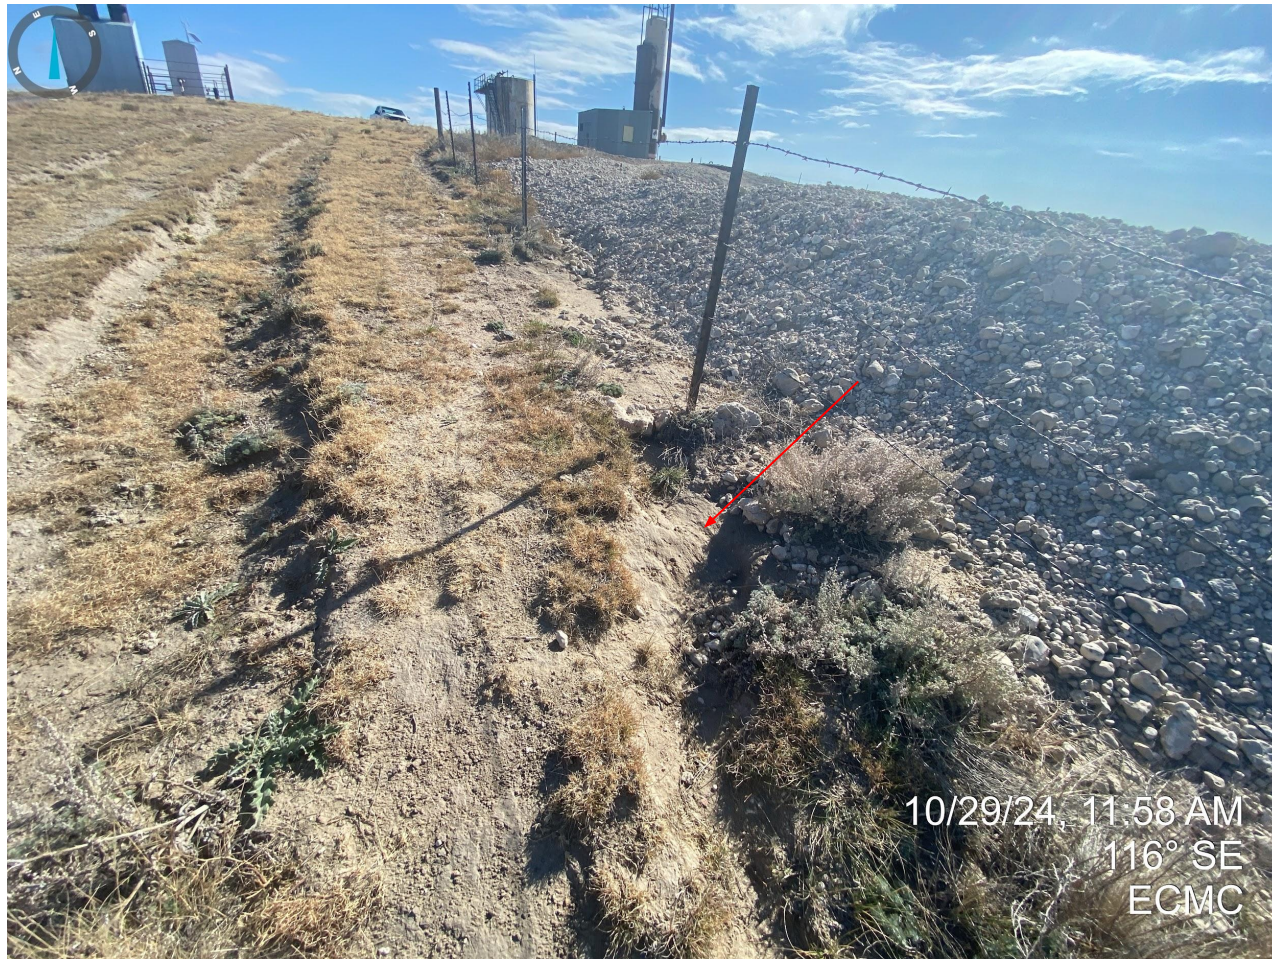
Photo 6. Erosion degradation on north side of pit.

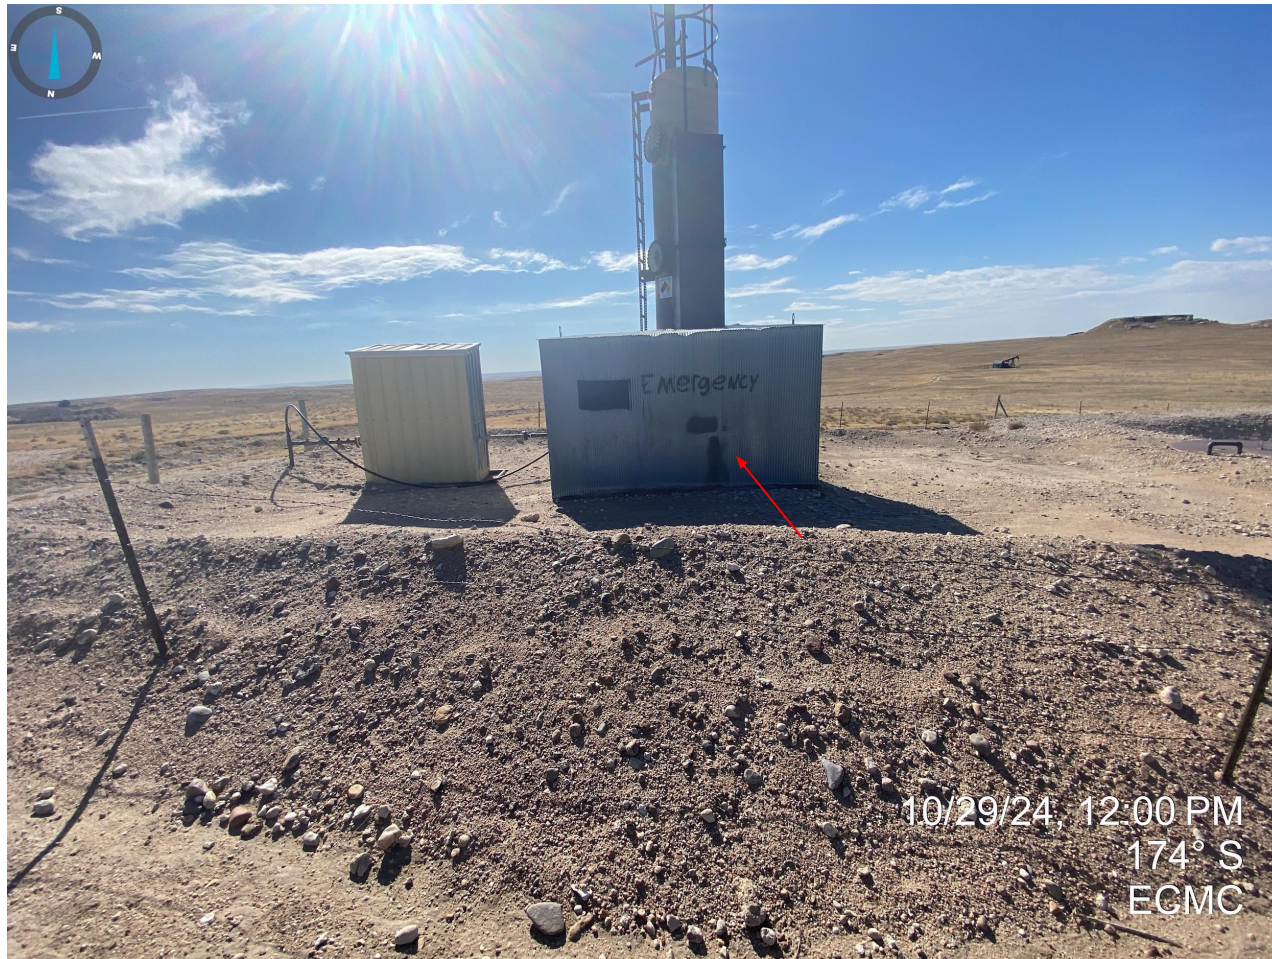
Photo 7. No emergency contact information/number posted at the vertical heater treater.

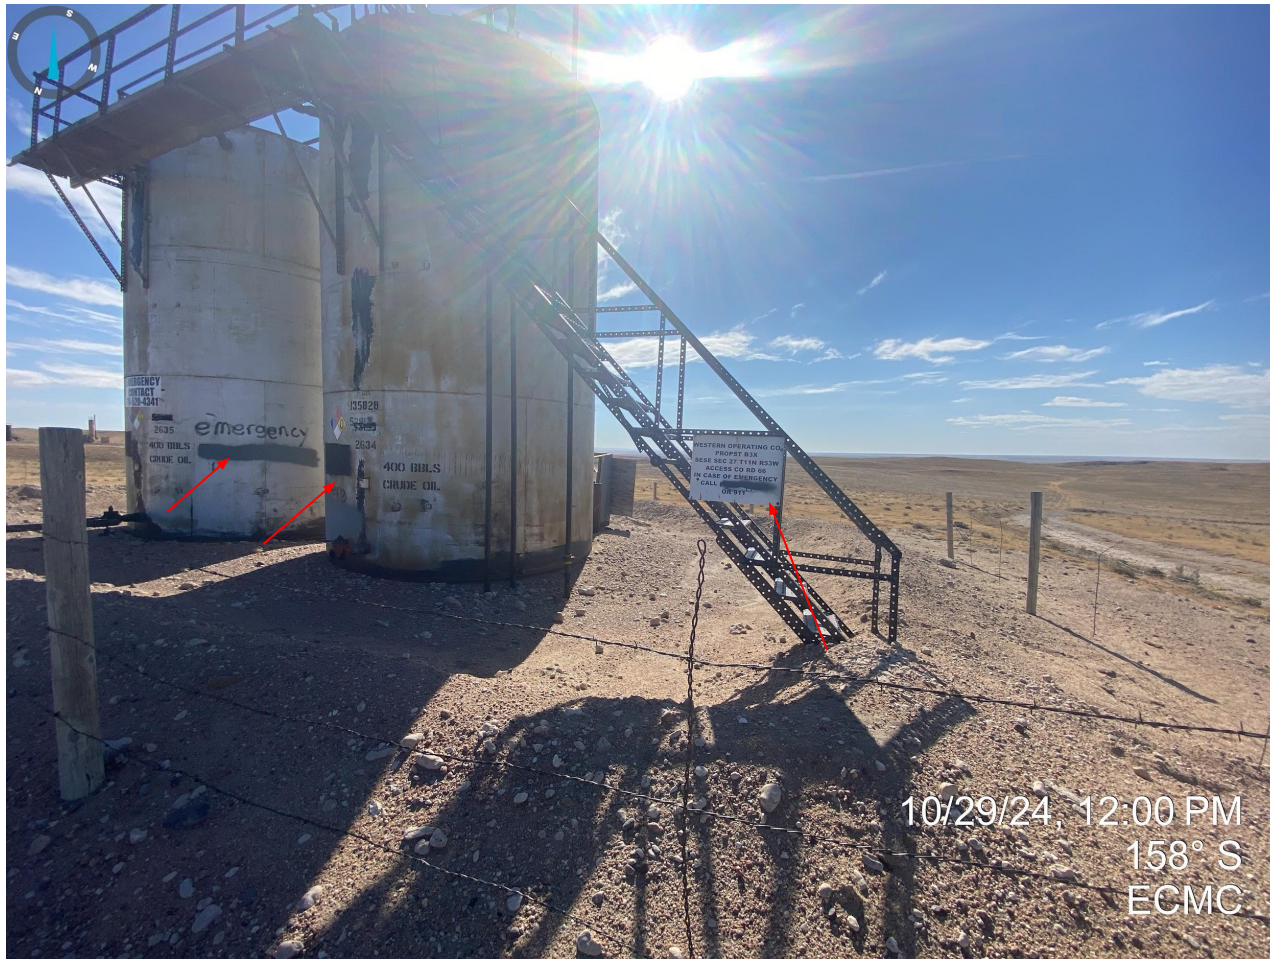
Photo 8. No emergency contact information/number posted at the tank battery.

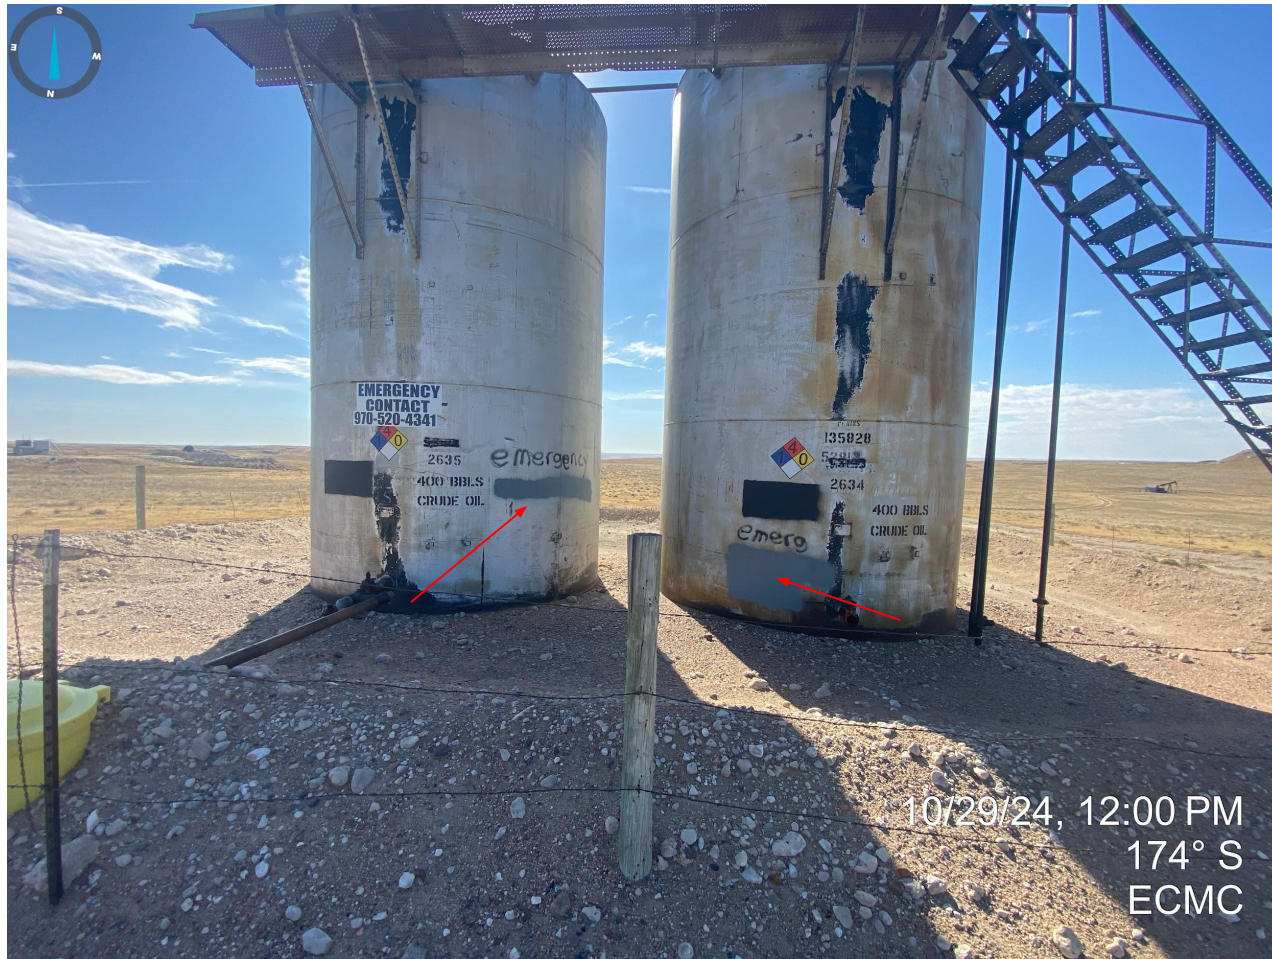
Photo 9. See comments in previous Photo 8.

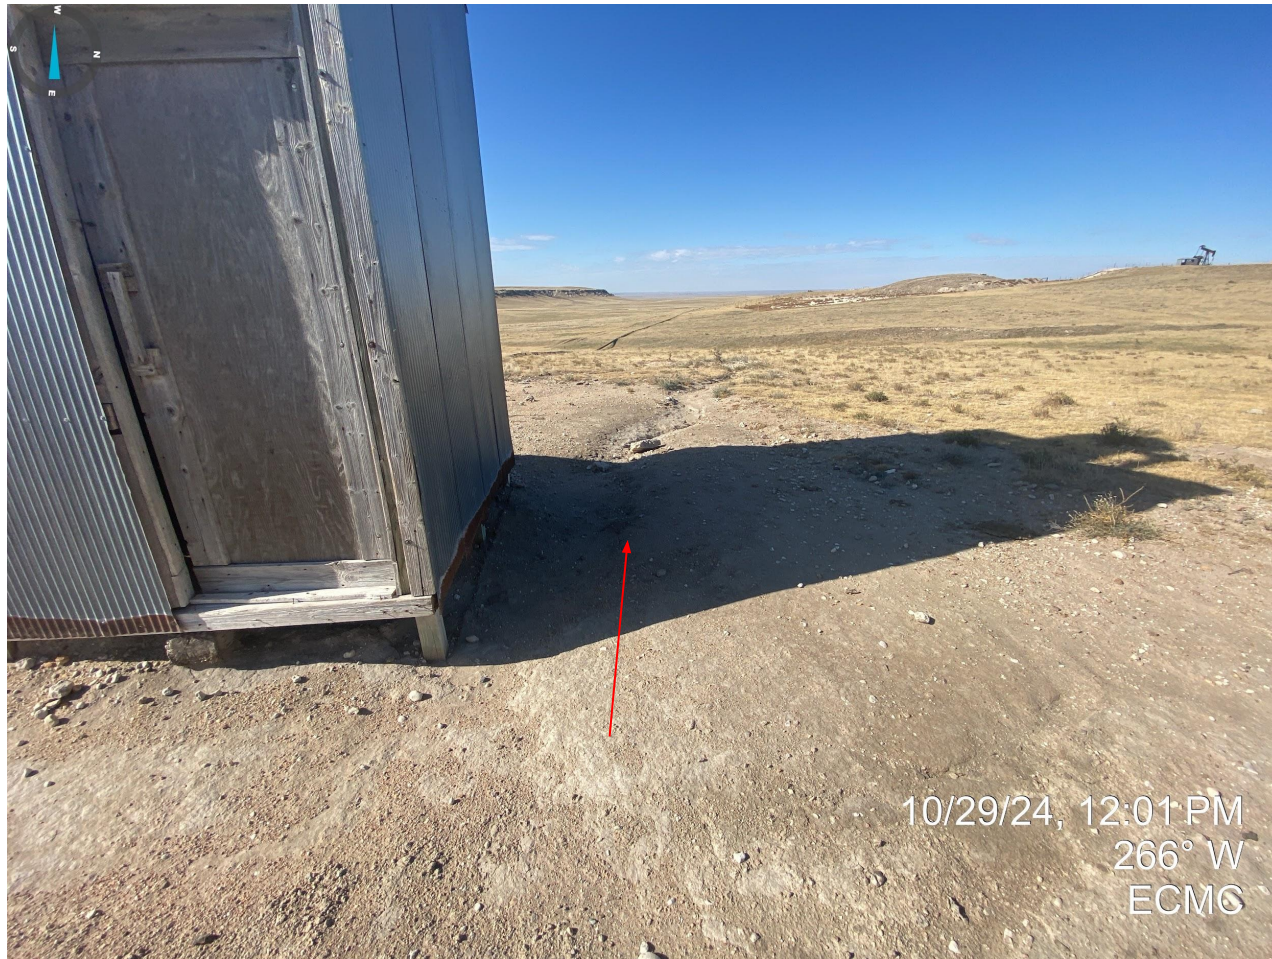
Photo 10. Erosion degradation observed on northside of meter shed.

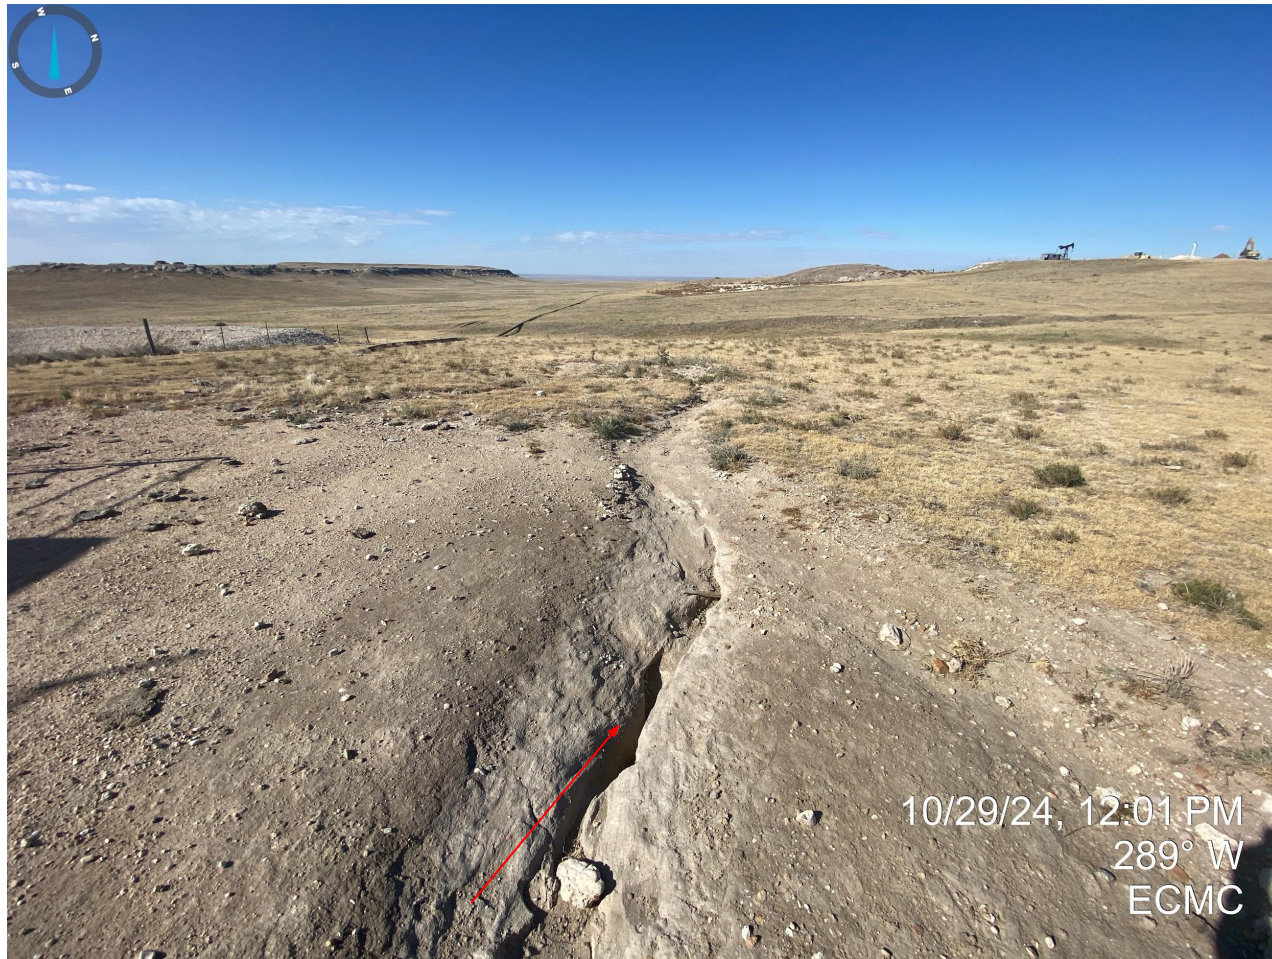
Photo 11. Continued from Photo 10; see comments in Previous photo.

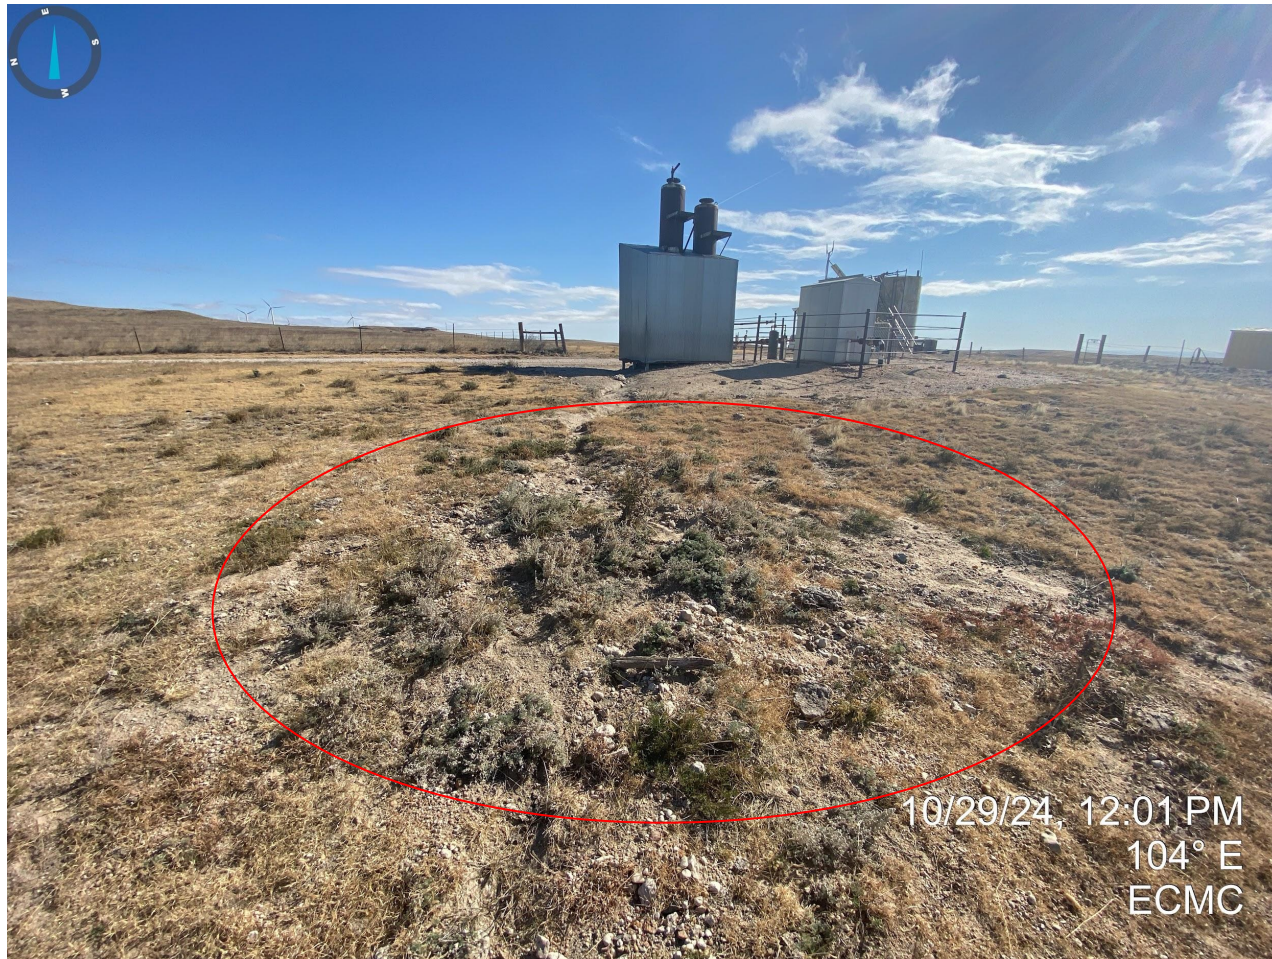
Photo 12. Continued from Photo 10; sediment deposition observed.
