Site Specific Final Reclamation Completion Notice – Cropland Drone Imagery

Permit Closure Report – Cropland

Location Name: HUNGENBERG-64N66W/13SWSW

10/21/2024

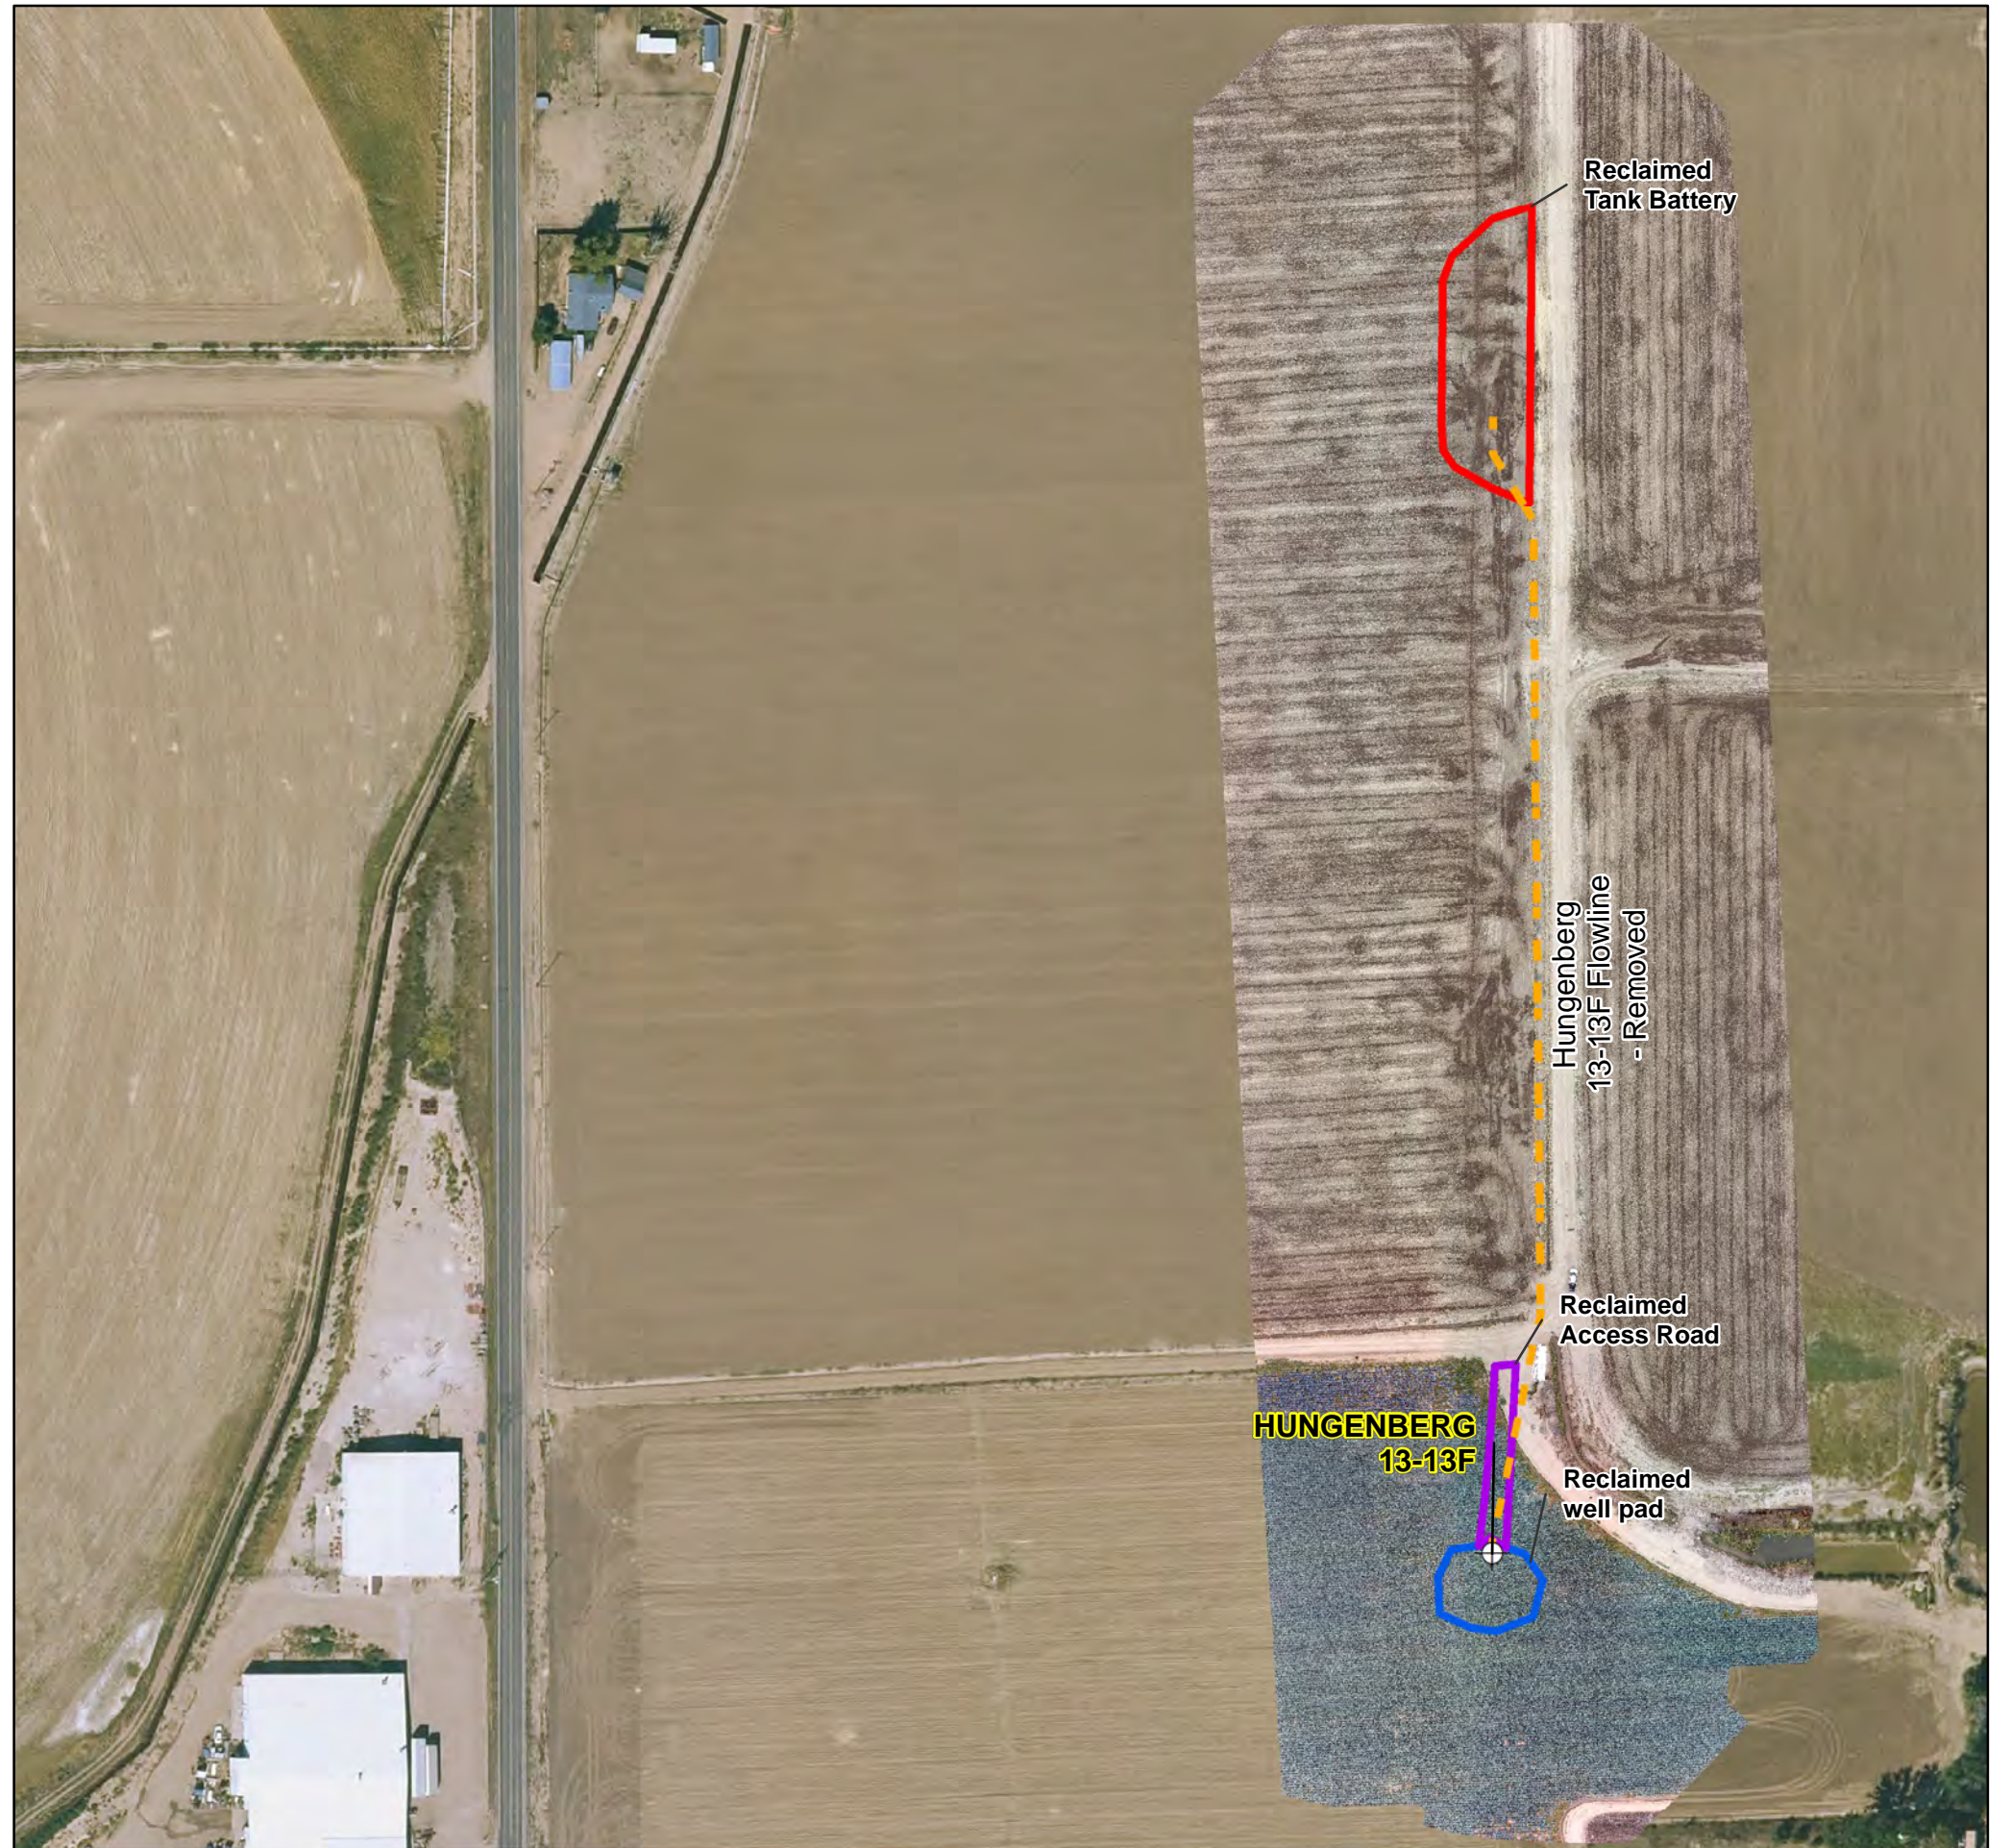
PDC Form 4 Final Reclamation - Post Plugging Overview

Drone imagery confirms that no equipment was left on site at this location after reclamation activities occurred.
