Inspection Photos

API: 073-06513

Operator: WIEPKING-FULLERTON ENERGY

Inspection Date: 11/5/2024

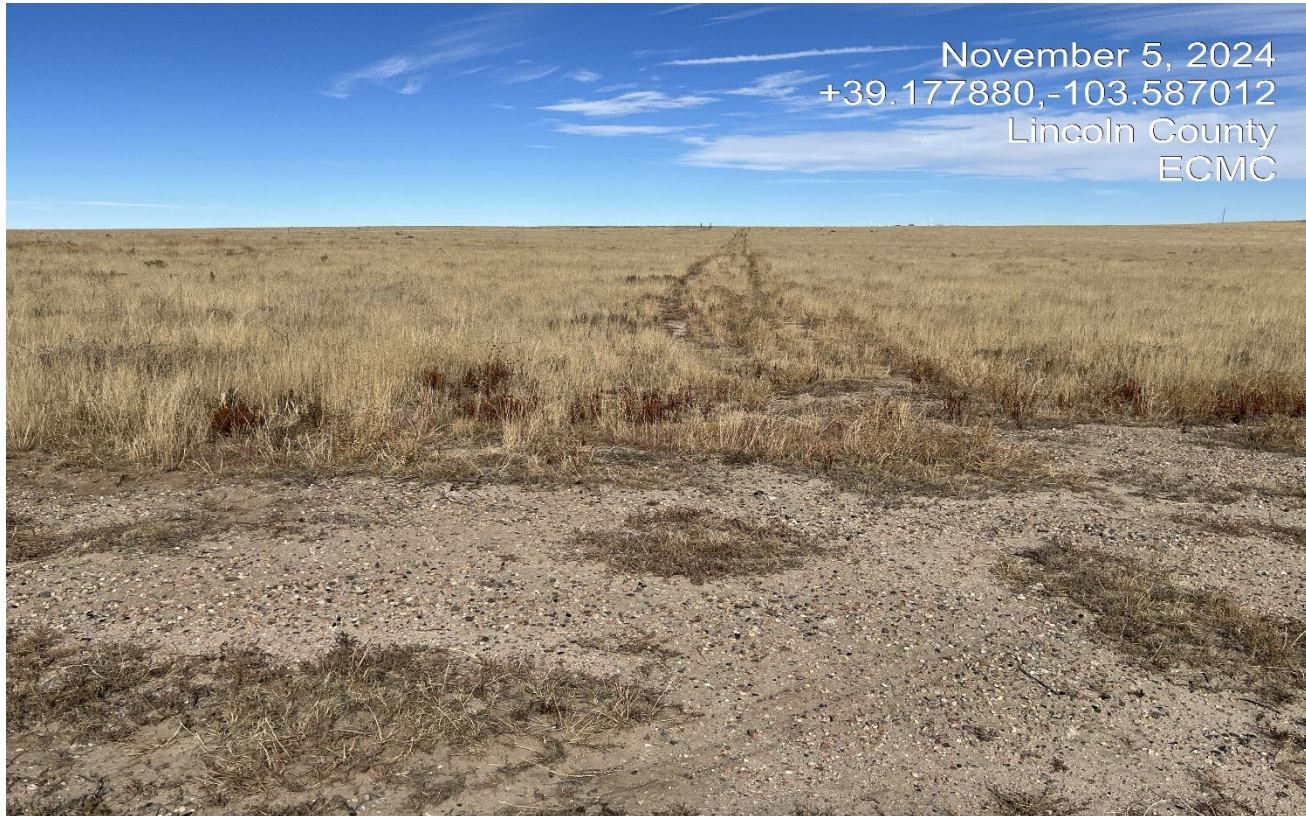
Photo 1. Facing north toward the former access road.

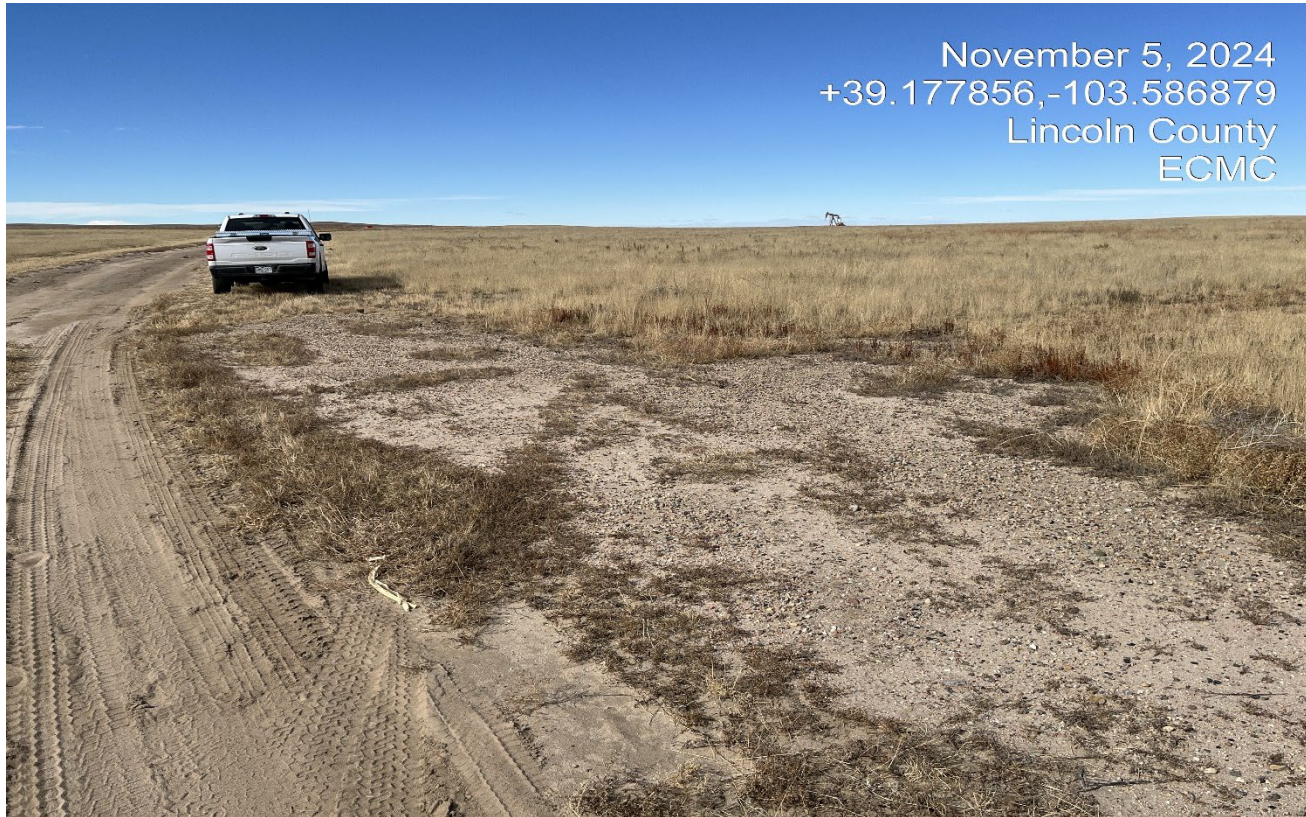
Photo 2. The area at the beginning of the road is not reclaimed and perennial vegetation has not established.

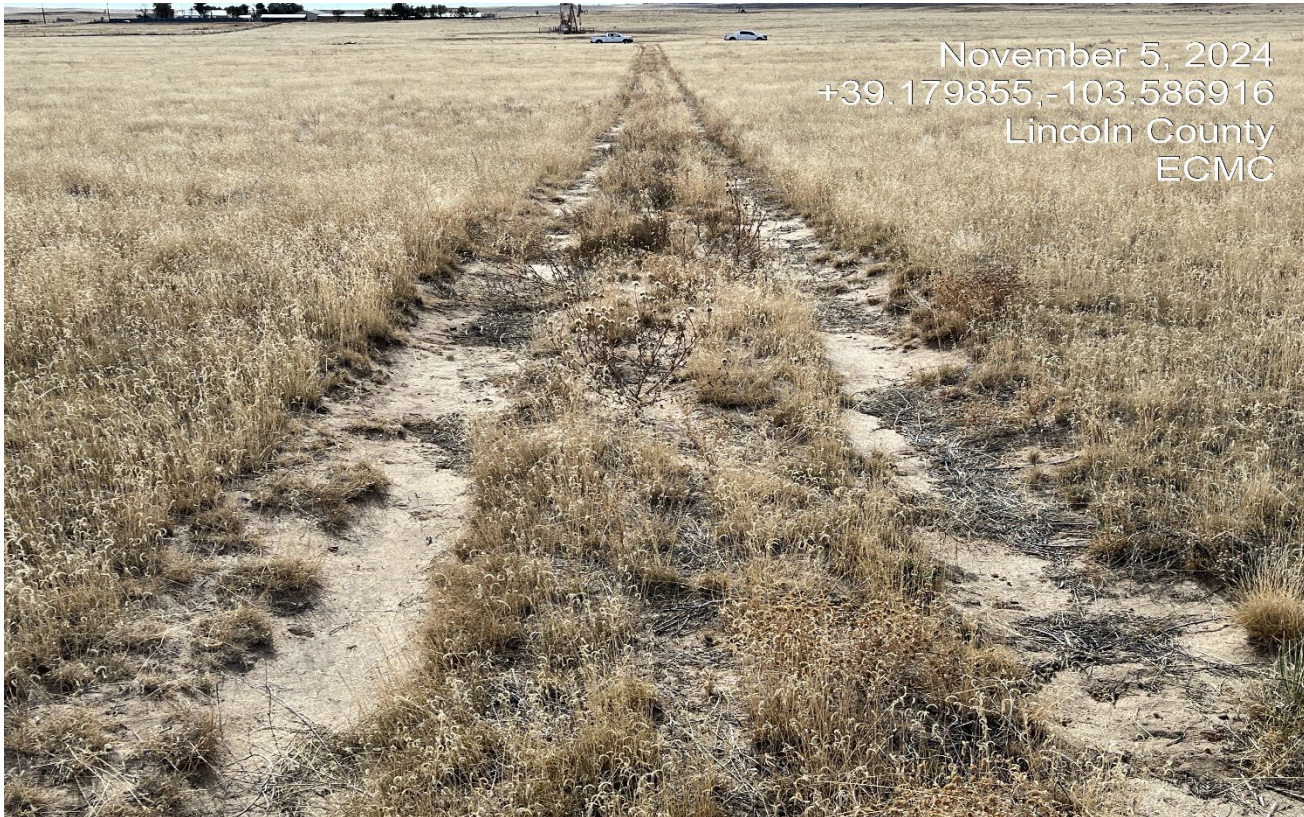
Photo 3. Facing south along the access road. There are areas along the road that have not established perennial vegetation and these areas appear to be compacted.

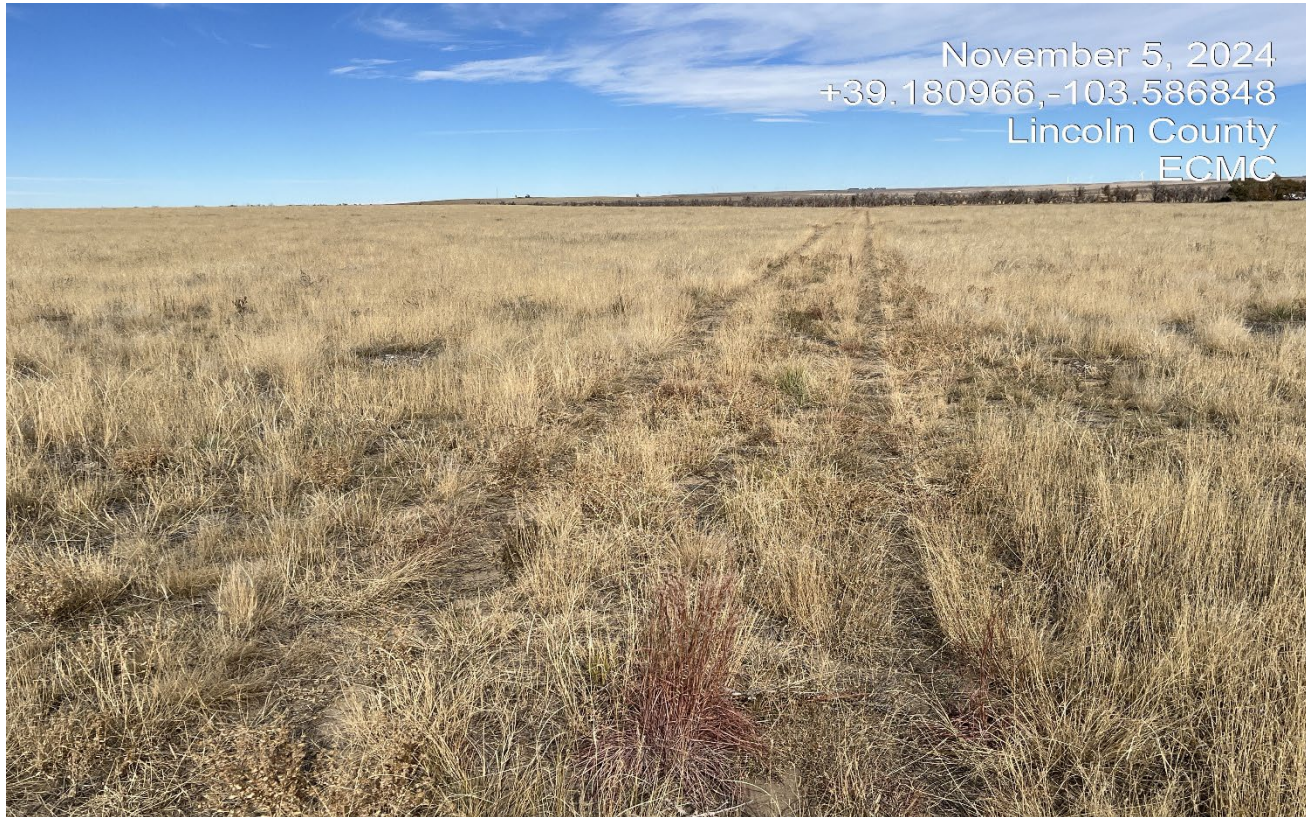
Photo 4. Facing north further along the former access road. The perennial vegetation has re-established along most of the former road.

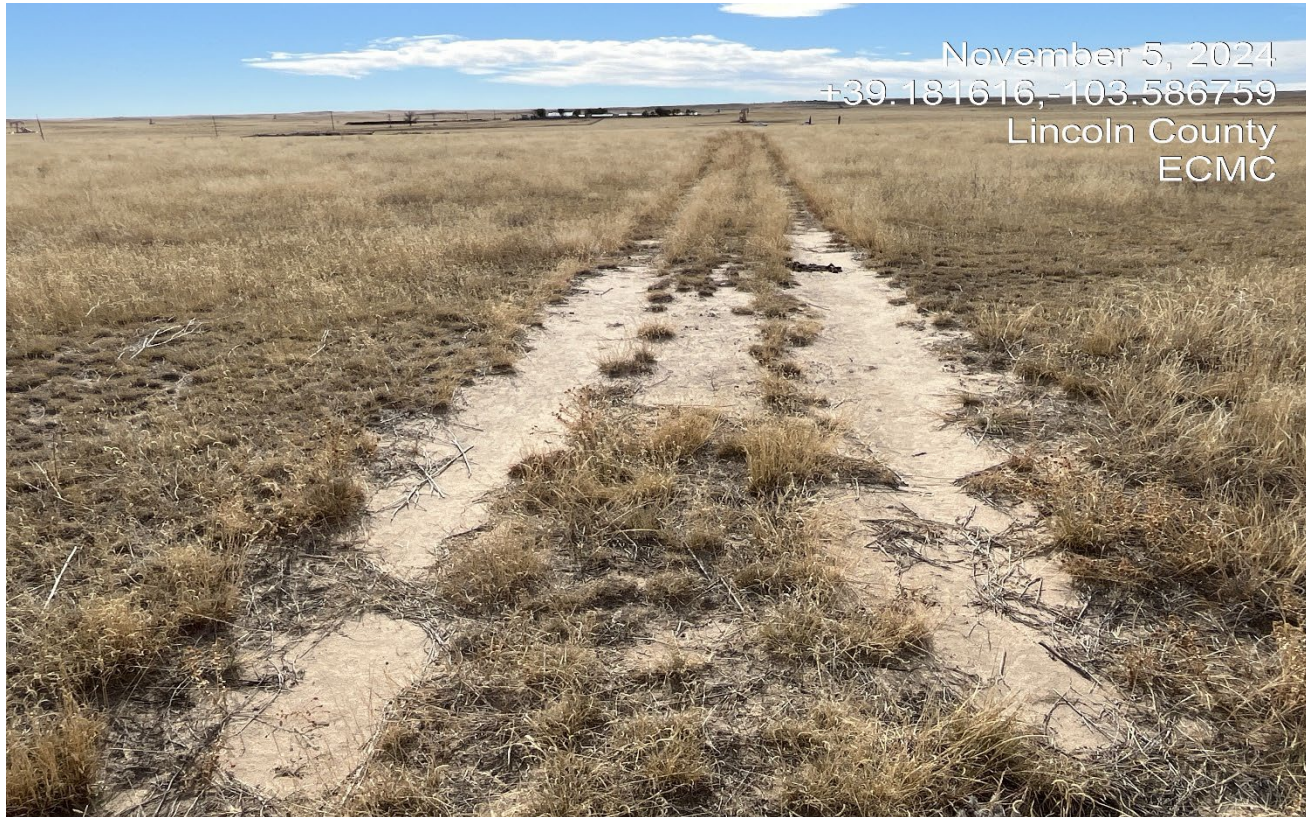
Photo 5. Facing south along the access road. There are areas along the road that have not established perennial vegetation and these areas appear to be compacted.

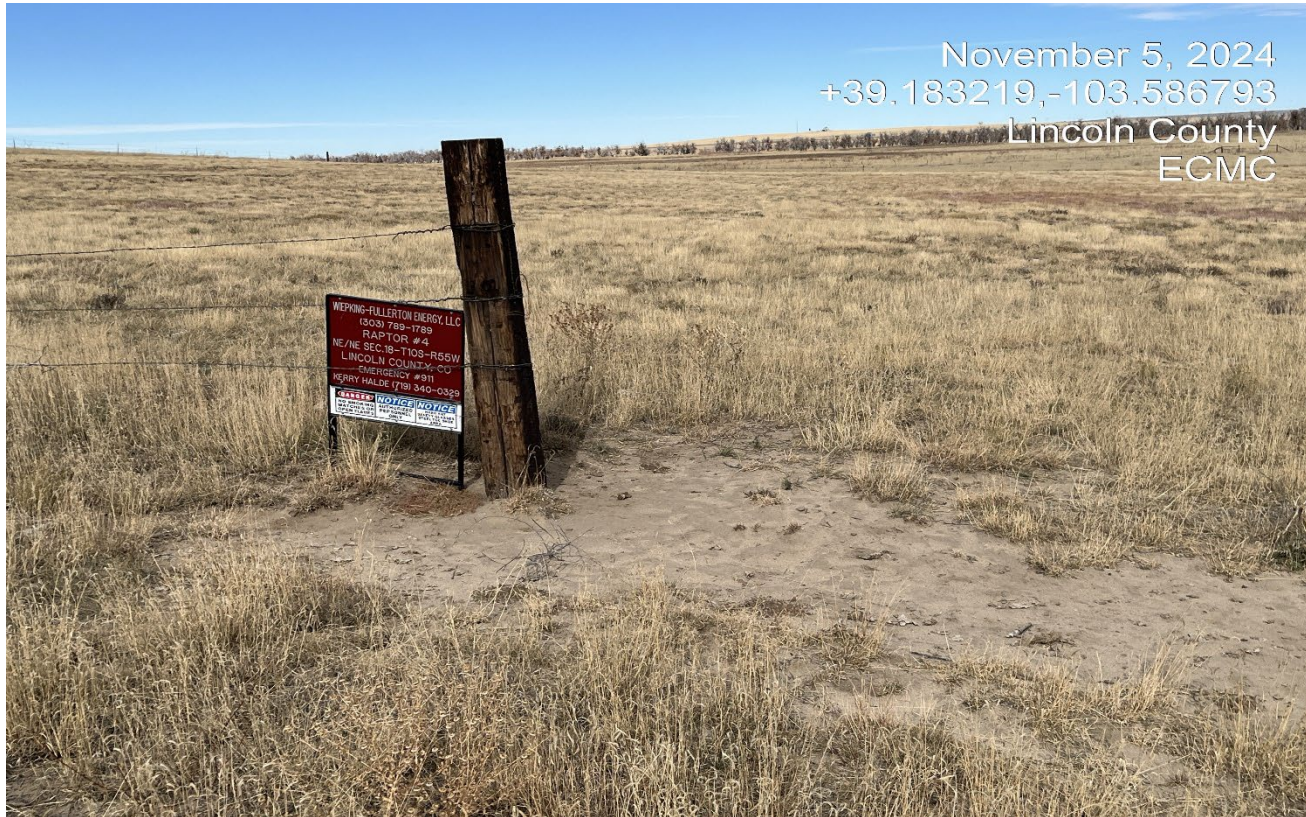
Photo 6. Facing north toward the location. The fence remains around the location and will need to be removed prior to final inspection.

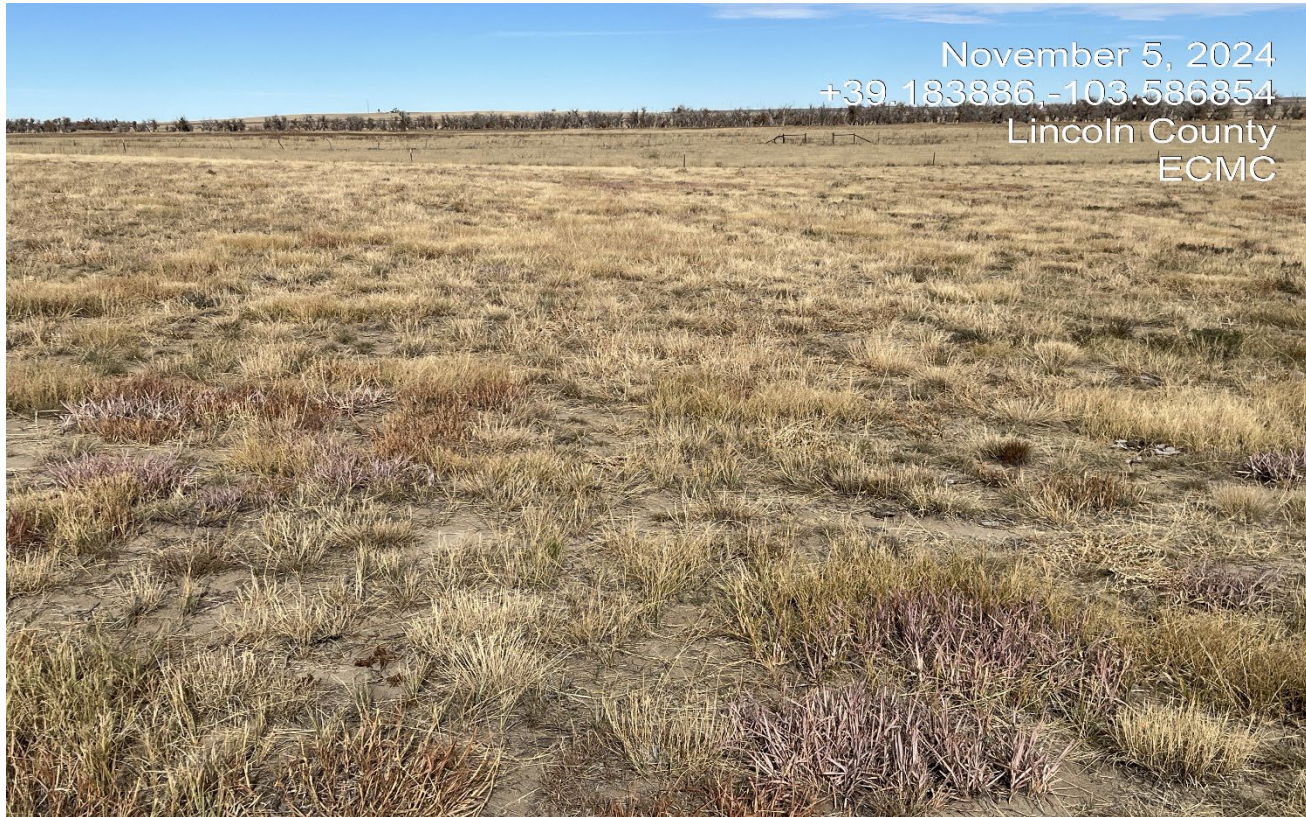
Photo 7. Facing north at the center of the location. Perennial vegetation is established throughout the location.

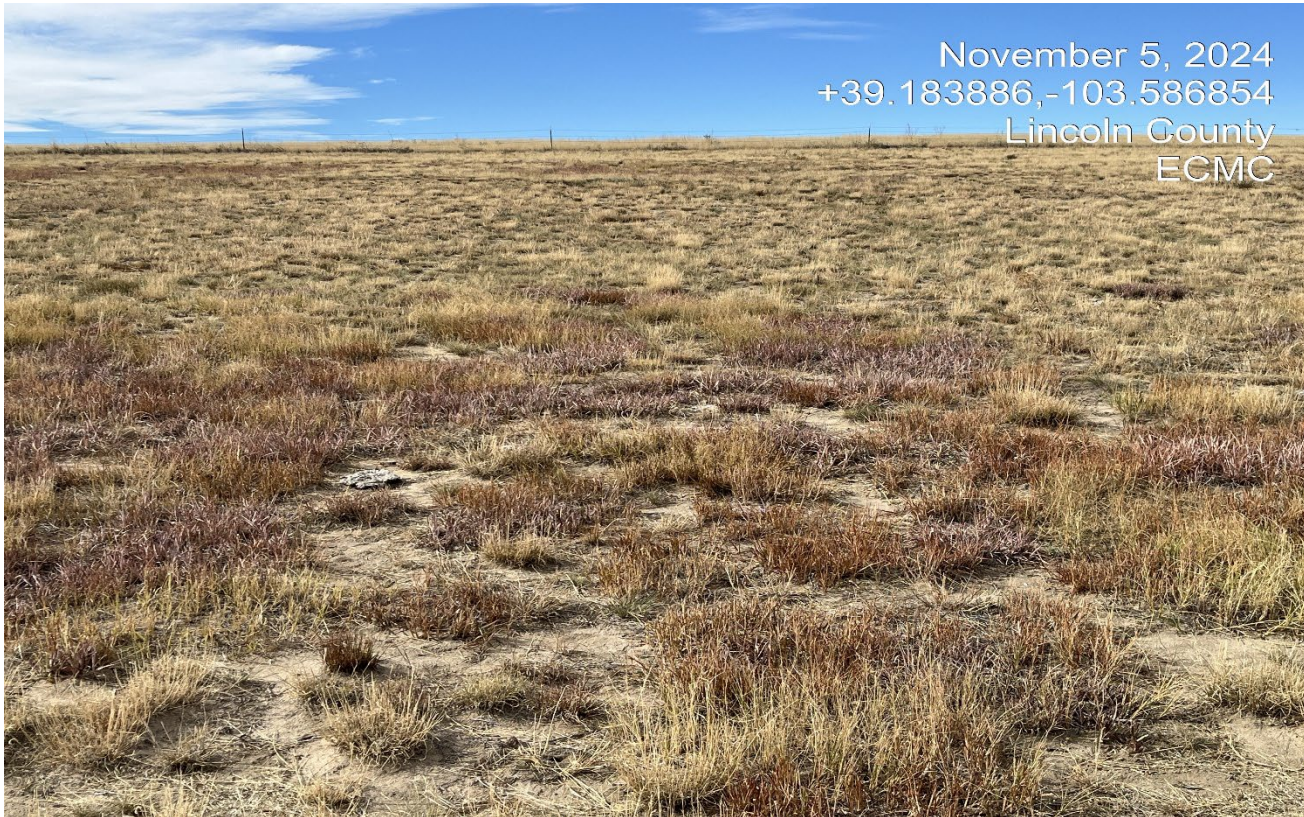
Photo 8. Facing east at the center of the location. Perennial vegetation is established throughout the location.

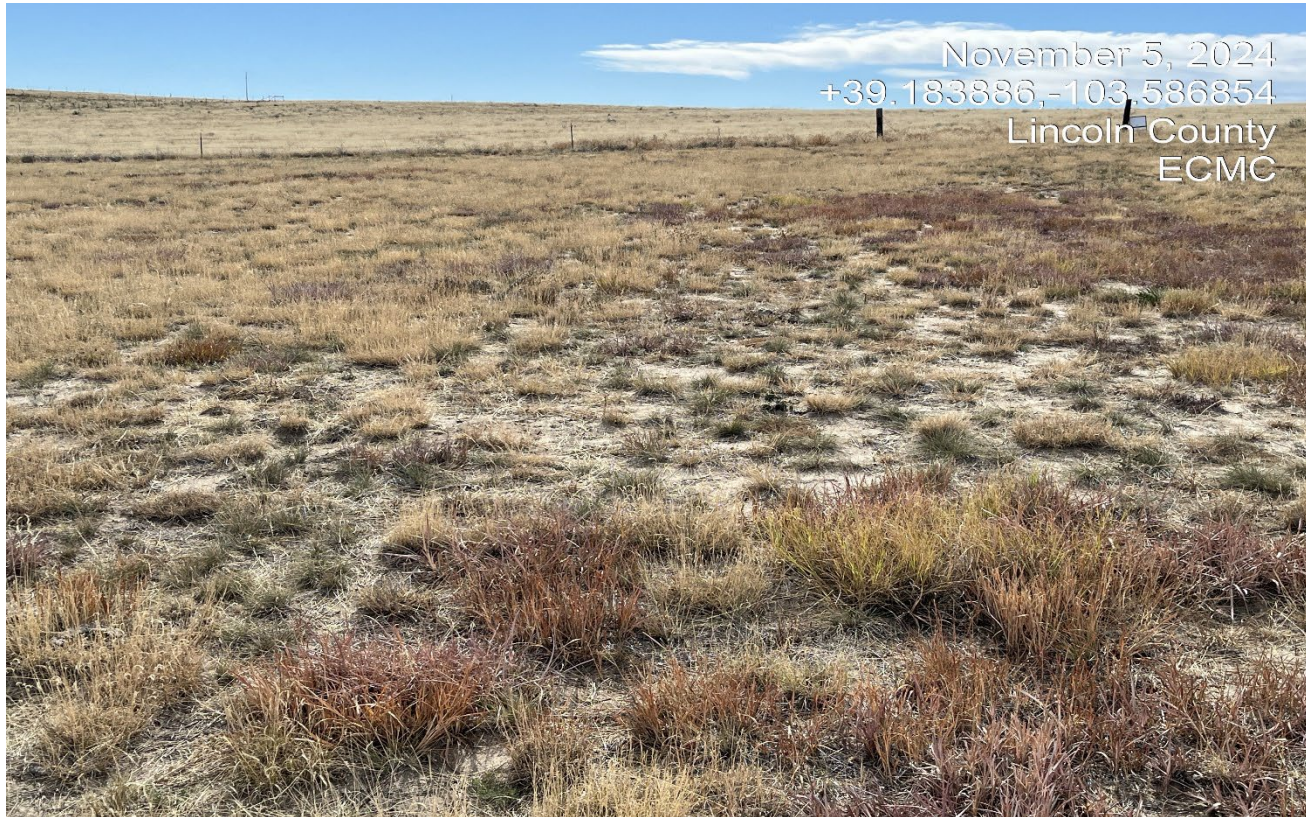
Photo 9. Facing south at the center of the location. Perennial vegetation is established throughout the location.

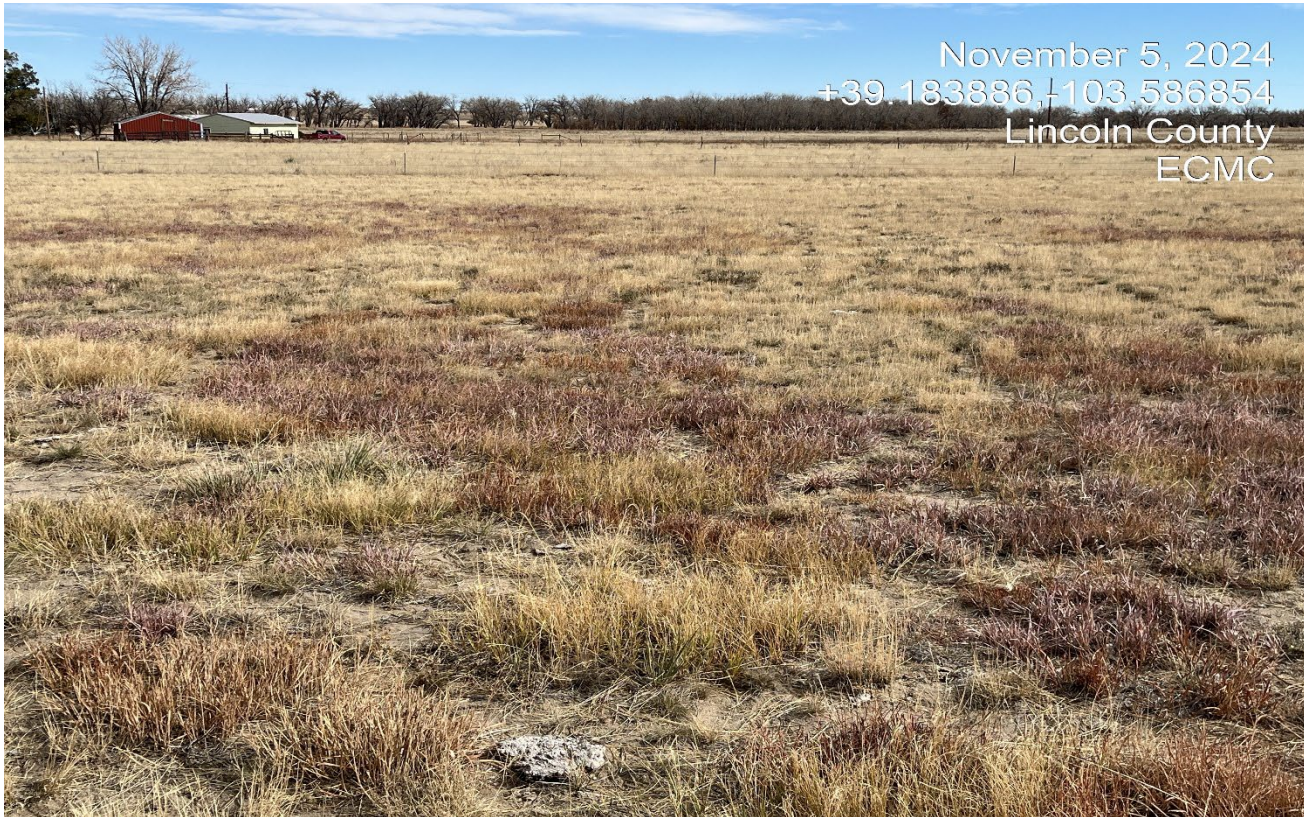
Photo 10. Facing east at the center of the location. Perennial vegetation is established throughout the location.
