Interim Reclamation and Stormwater Inspection

October 30, 2024

Operator: GMT EXPLORATION COMPANY LLC #10243

Location ID: 484163

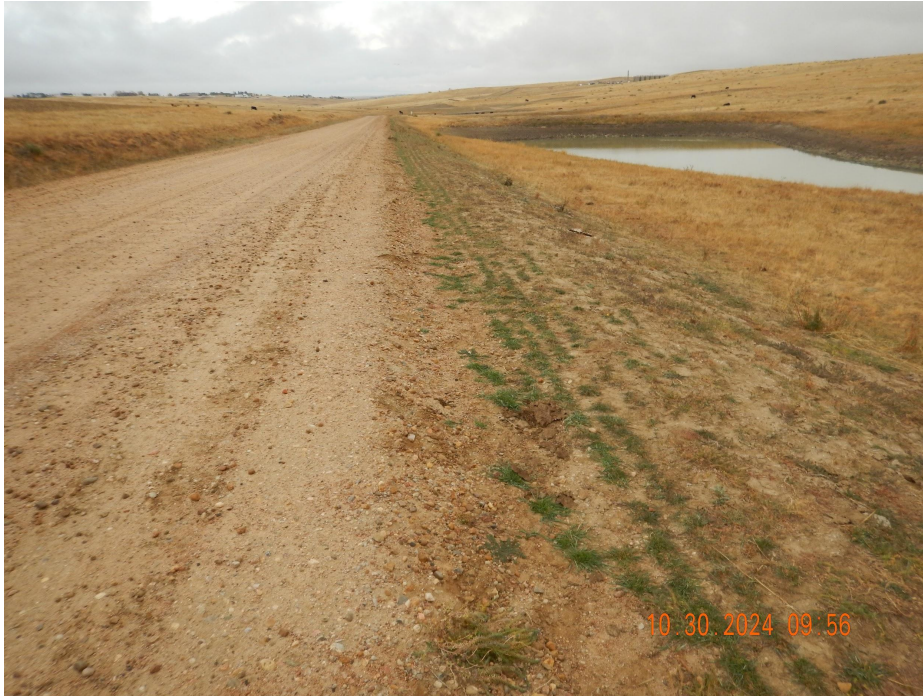
Photo 1. Photo taken from a portion of the southern access road, facing North. Photo illustrates topsoil stockpiled along the access road, which has been seeded and in-process of establishing.

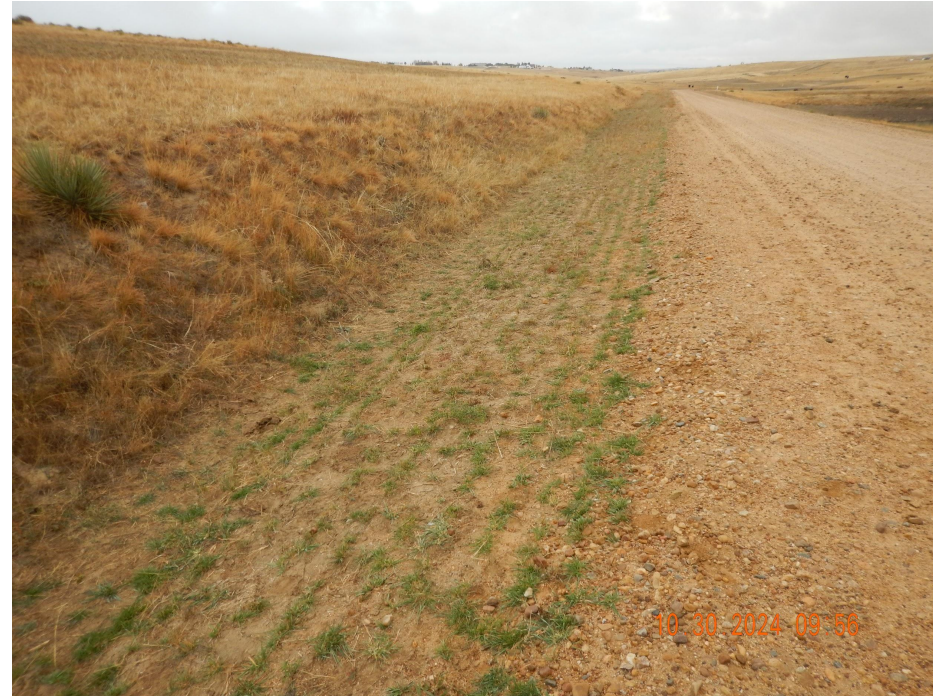
Photo 2. Photo taken from a portion of the southern access road, facing North. See comments under Photo 1.

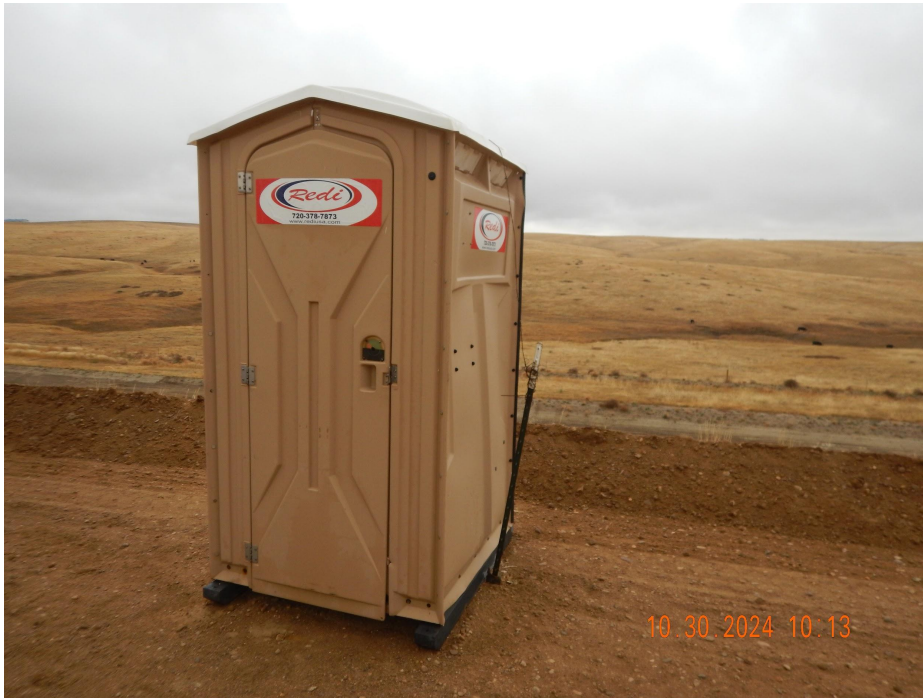
Photo 3. Photo taken from western pad, facing West. Photo illustrates the port-o-let is secured. Operator should consider relocating this to be outside of the 500 feet OHWM of any river, perennial or intermittent stream, lake, pond, or wetland.

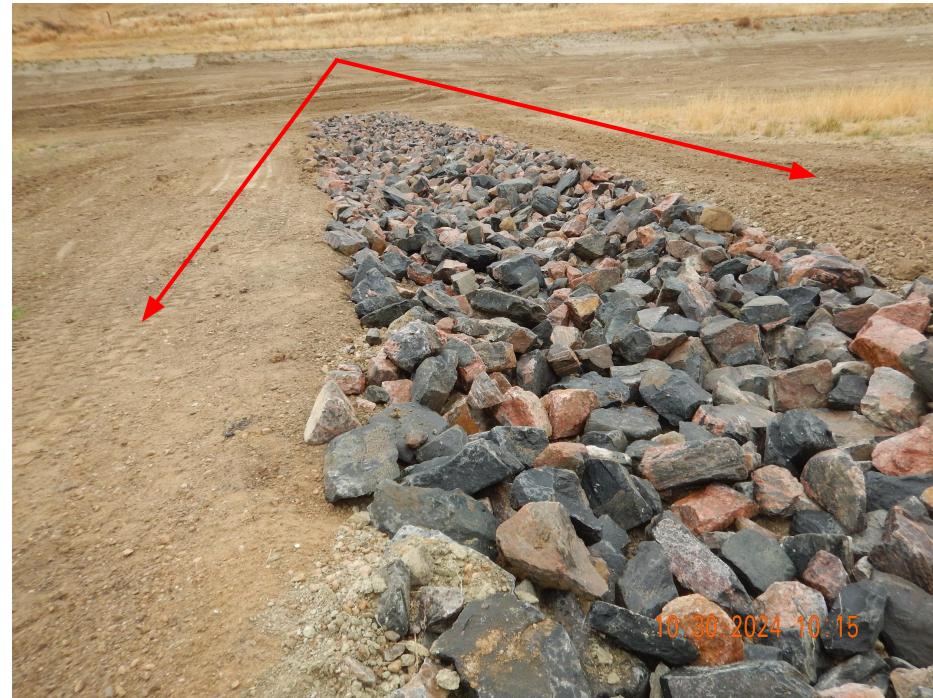
Photo 4. Photo taken from the western location, facing West. Photo illustrates the Operator has performed repairs but it was not evident whether or not repairs were performed per good engineering practices (i.e., not sure if geotextile was installed below the rock).

Also, Operator shall stabilize areas on other side of the rock.

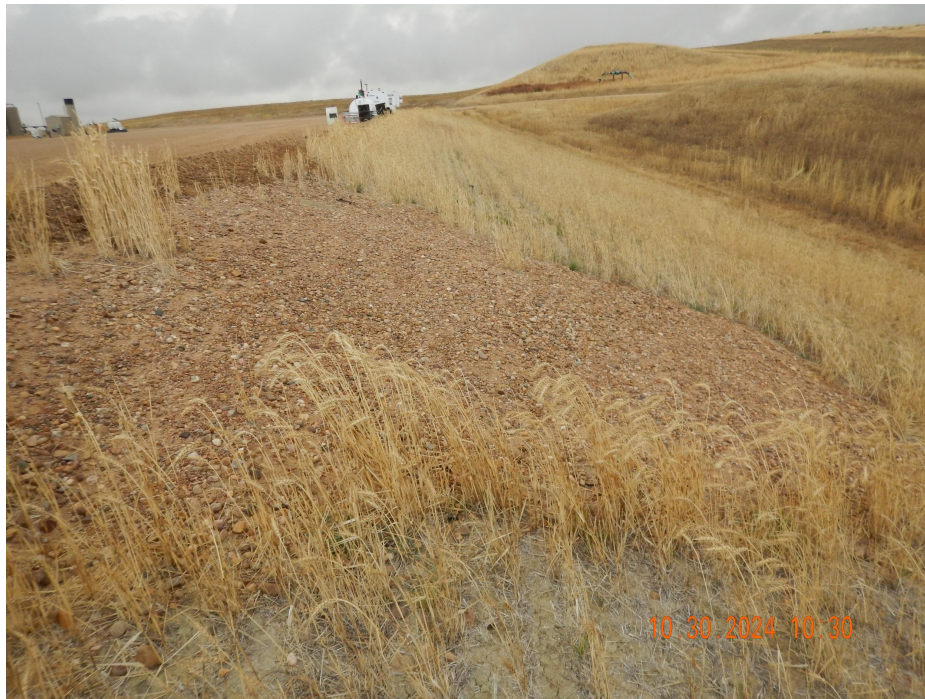
Photo 5. Photo taken from southwestern pad, facing East. Photo illustrates road base that appears to have washed off pad. Operator shall recover road base and reseed fill slope.

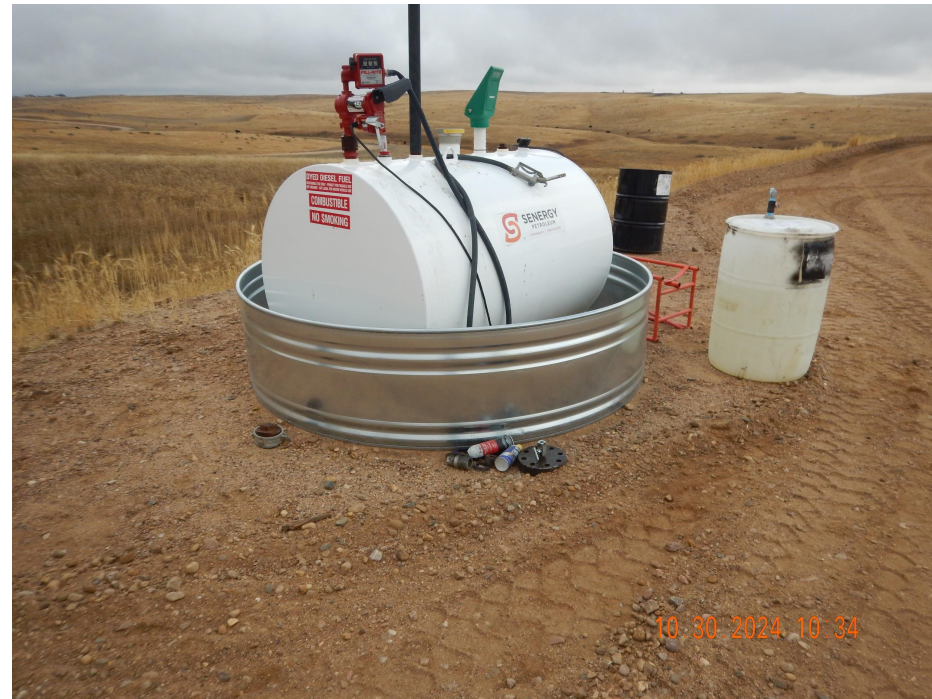
Photo 6. Photo taken from the southwestern location, facing Southwest. Photo illustrates chemical and refueling storage that appears to be within 500 feet of an OHWM of an intermittent stream and wetland. Also, drums are outside of secondary containment. Refer to Photo 24.

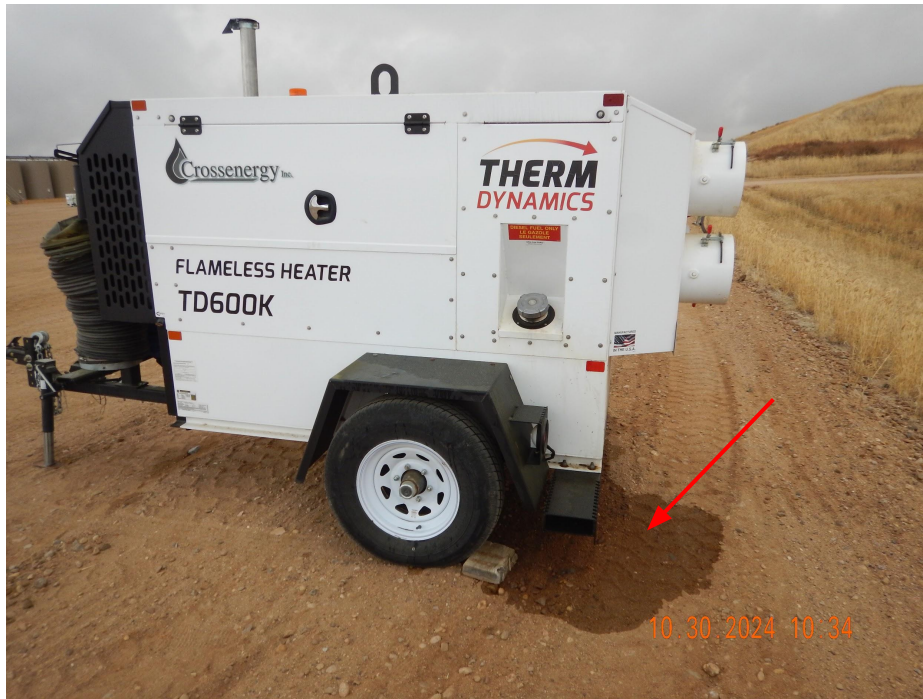
Photo 7. Photo taken from southwestern pad, facing East. Photo illustrates equipment is leaking fluid or fluid being spilled during operations.

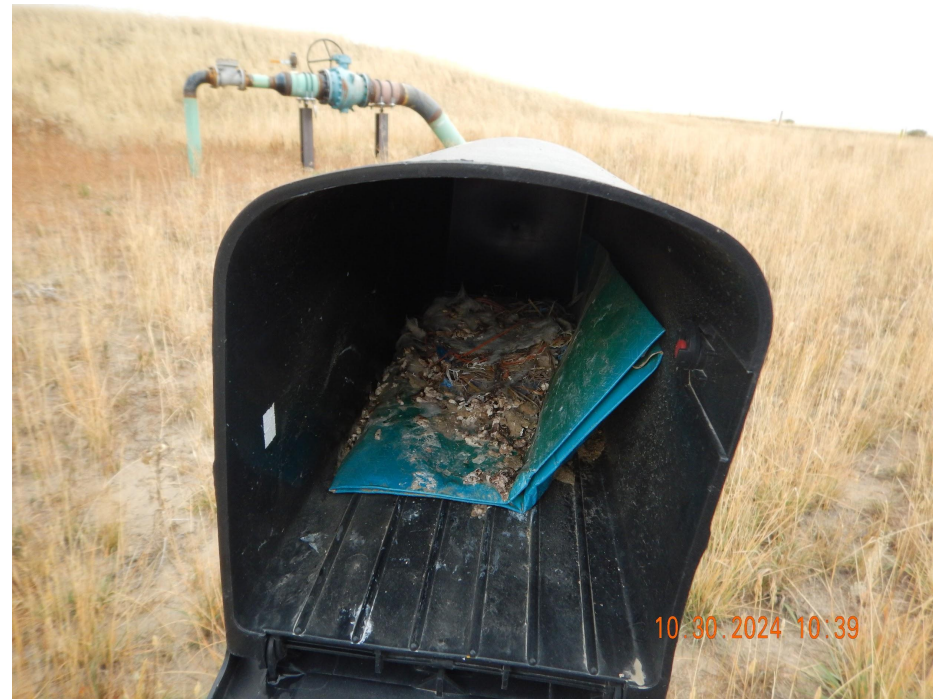
Photo 8. Photo illustrates the mailbox on location per Rule 406.c. Operator may want to clean out box and ensure it is securely closed.

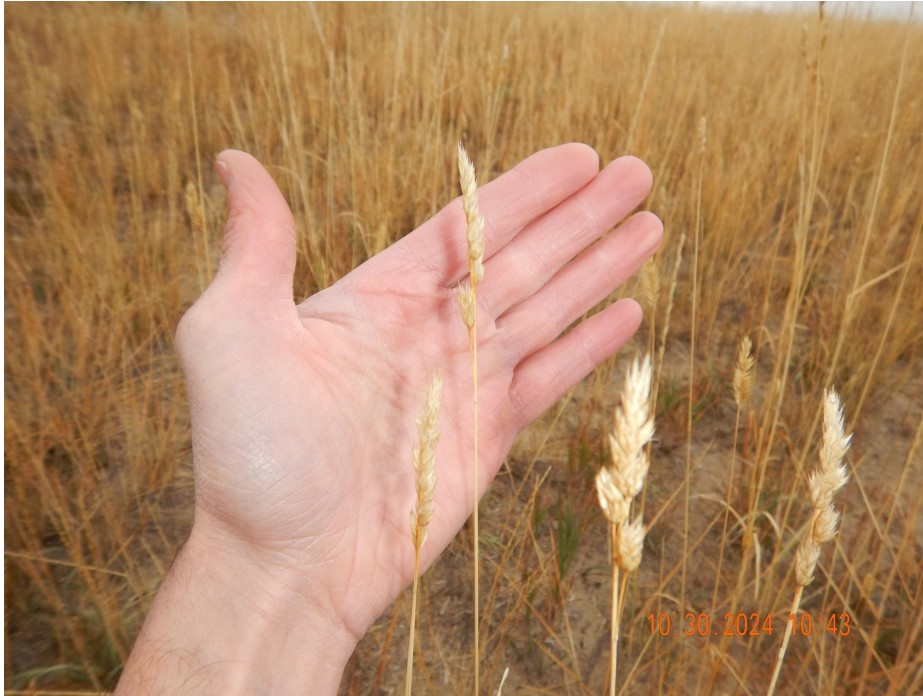
Photo 9. Photo taken from the southern screening berm. Photo illustrates an introduced grass species- Orchard grass, that was not included in any proposed seed mix.

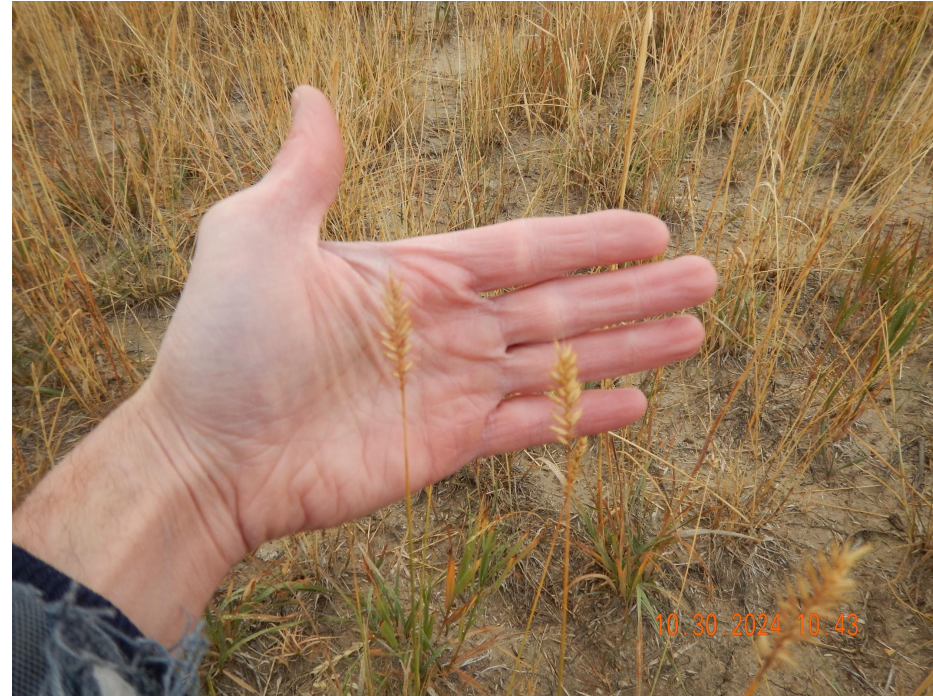
Photo 10. Photo taken from the southern screening berm. Photo illustrates an introduced grass species- Crested wheatgrass, that was not included in any proposed seed mix.

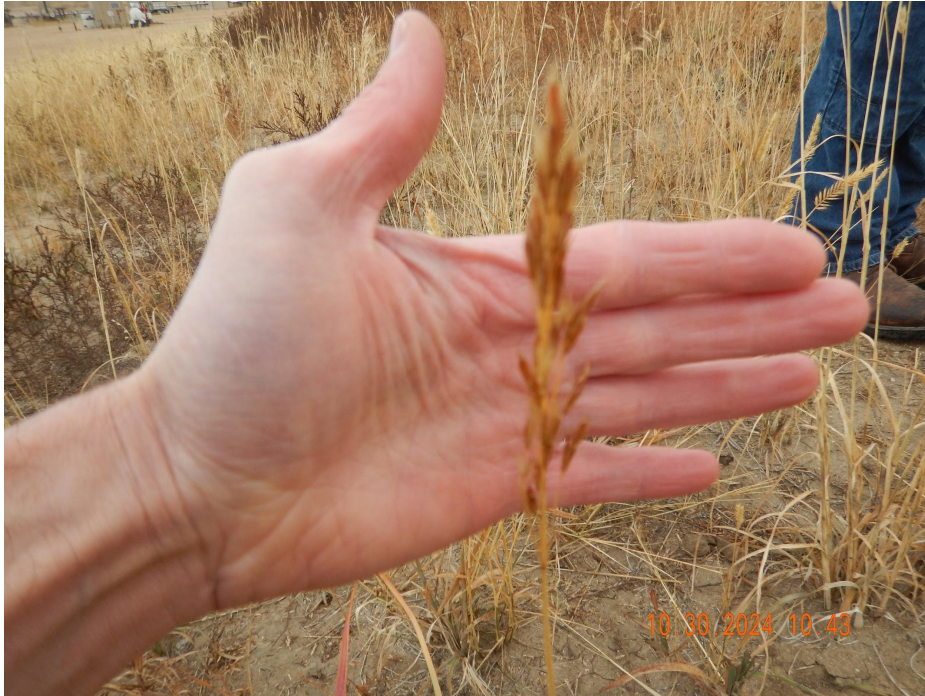
Photo 11. Photo taken from the southern screening berm. Photo illustrates an introduced grass species- Smooth brome, that was not included in any proposed seed mix.

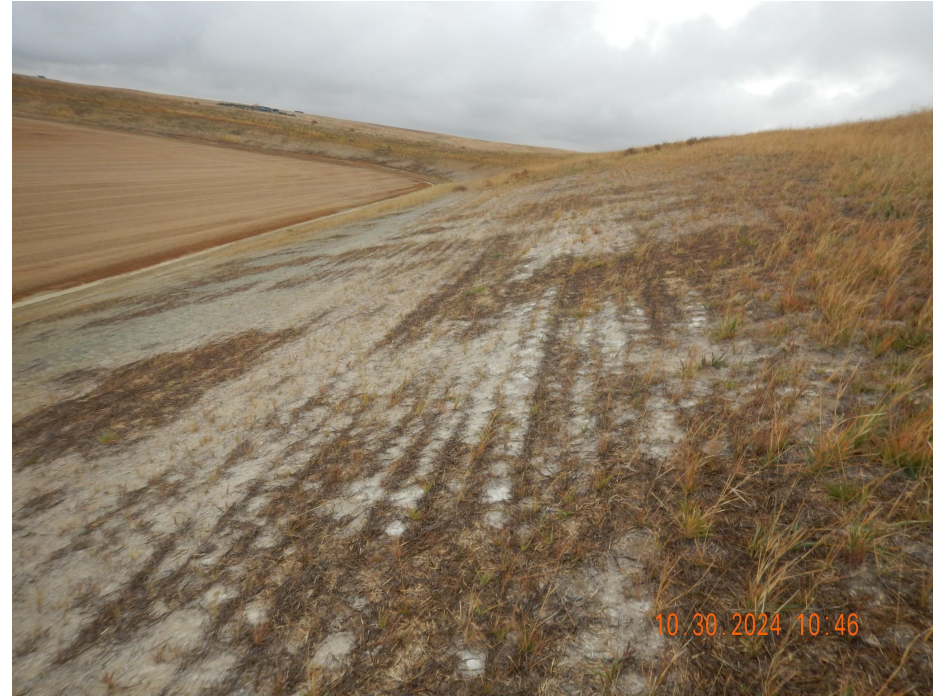
Photo 12. Photo taken from a portion of the southeastern cut slope. Photo illustrates the lack of establishment of perennial vegetation.

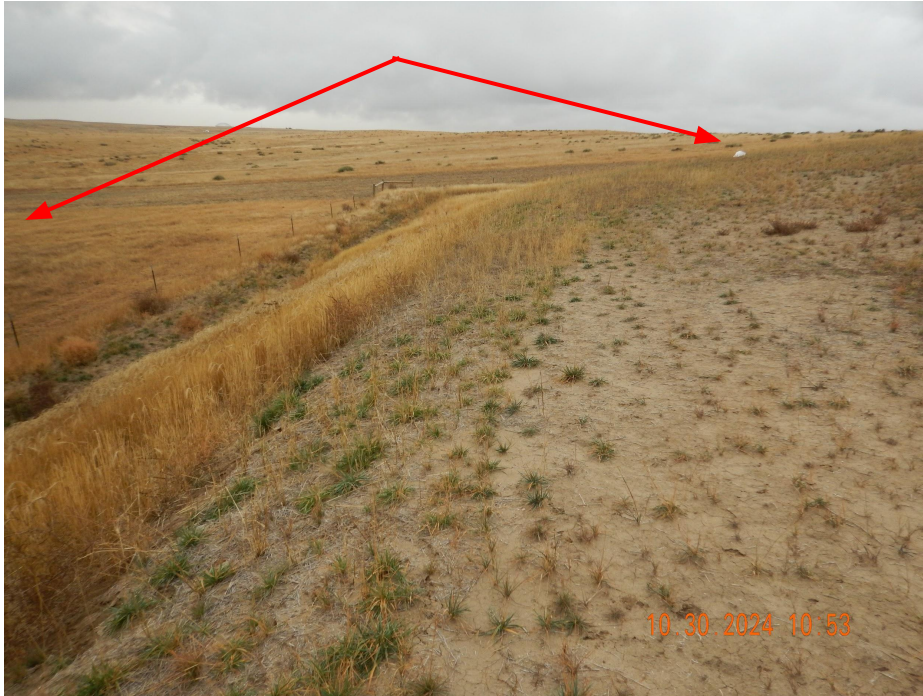
Photo 13. Photo taken from the southeastern screening berm, facing South. Photo illustrates trash blowing off location.

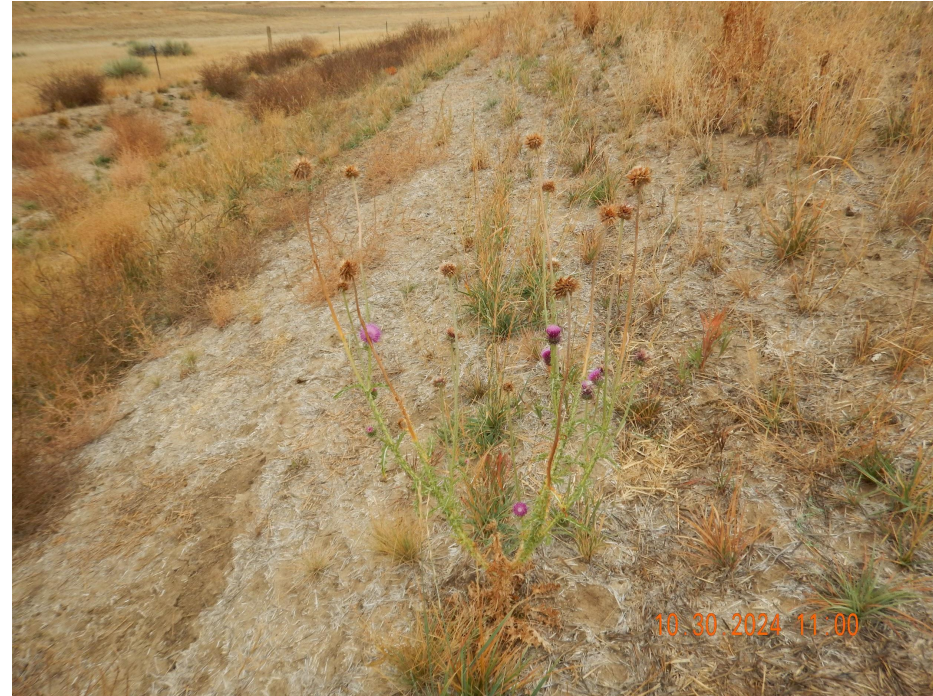
Photo 14. Photo taken from the eastern screening berm. Photo illustrates a List B Colorado Noxious Weed, Musk thistle. Note- only a few musk thistles were observed.

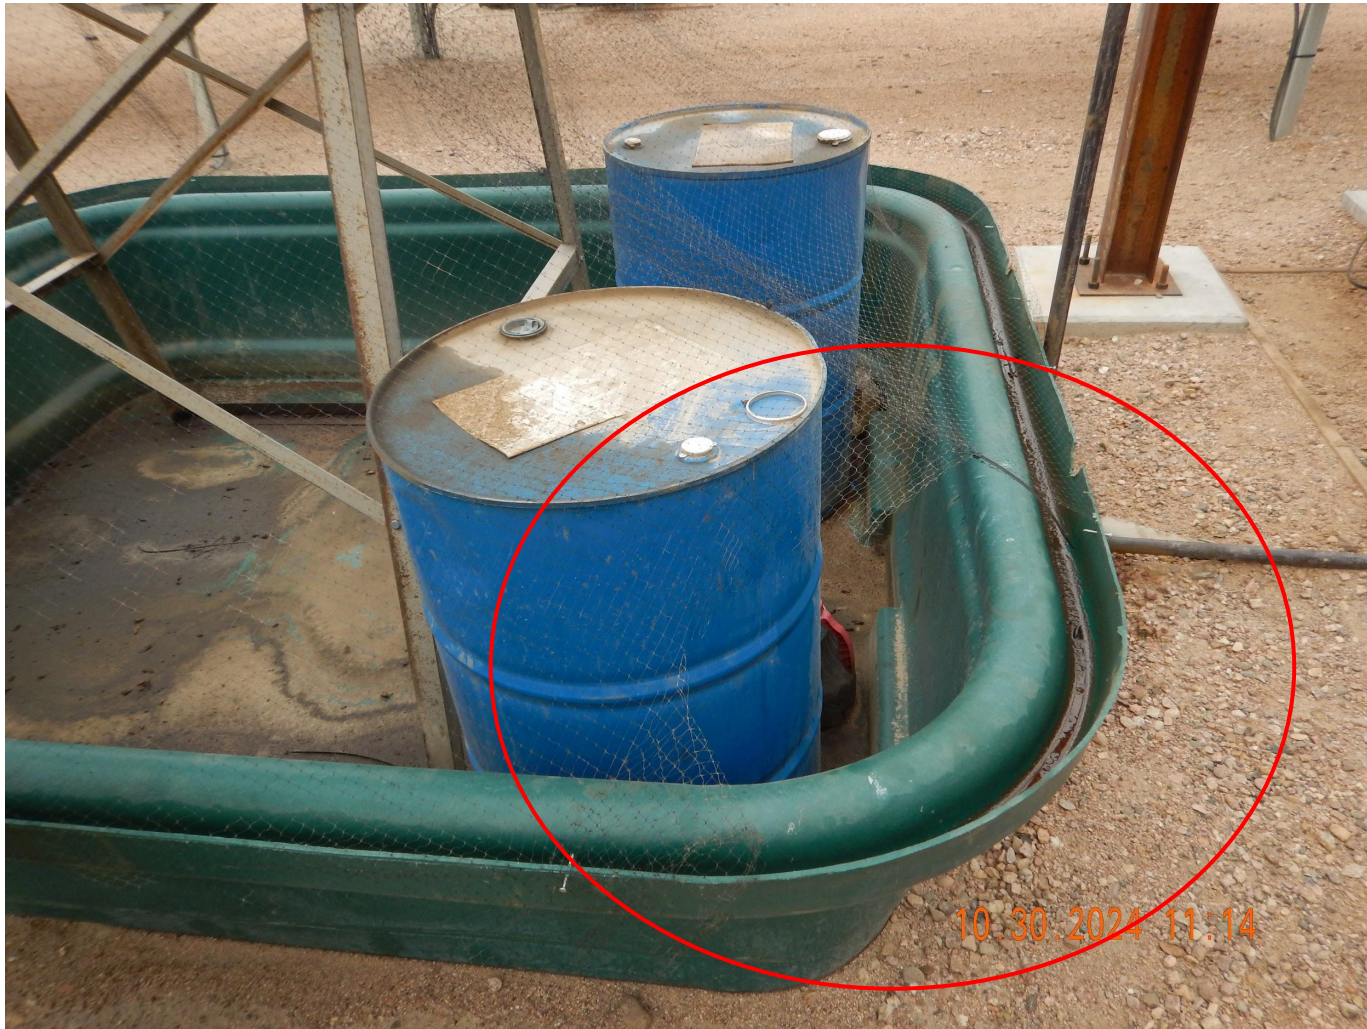
Photo 15. Photo taken from the working pad surface by the facilities. Photo illustrates wildlife netting in disrepair.

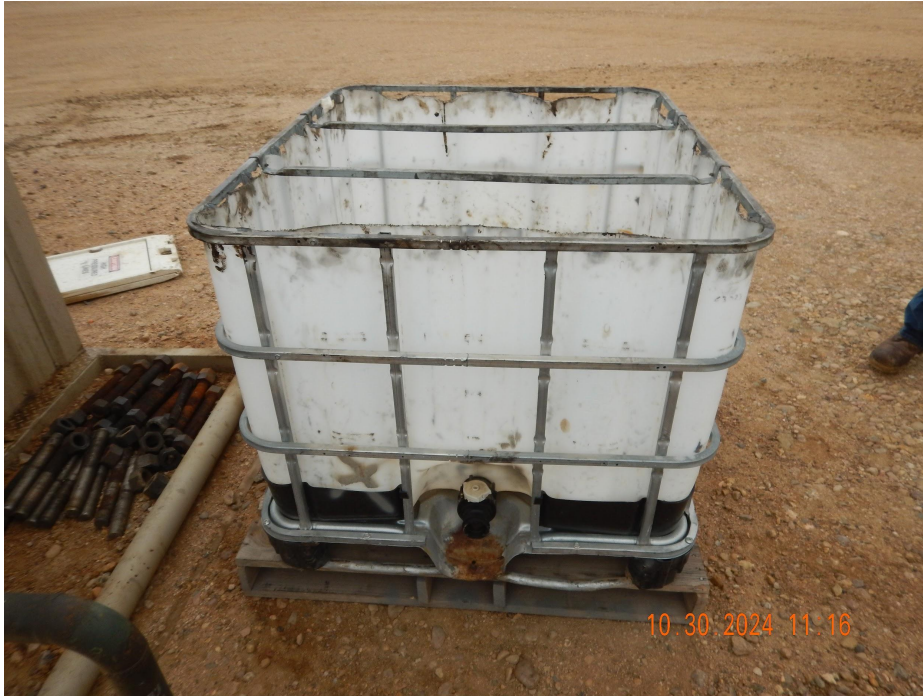
Photo 16. Photo taken near the wellhead. Photo illustrates a containment device without wildlife protection BMPs.

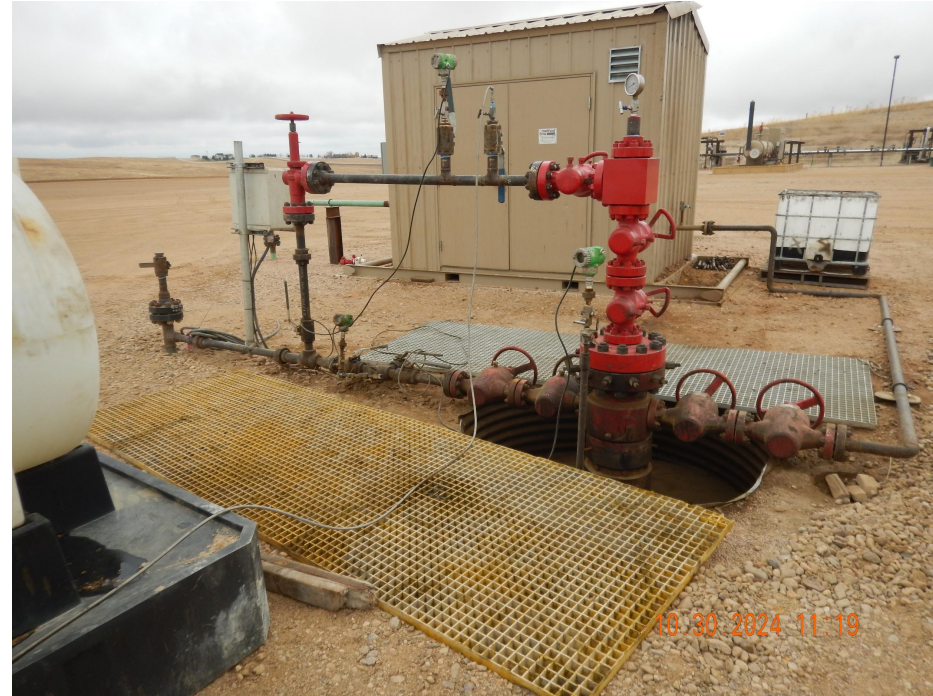
Photo 17. Photo taken at the wellhead. Photo illustrates the cellar is not secured to prevent accidental access by people, livestock, or wildlife when active work on that conductor is not occurring, and the wellhead lacks signage.

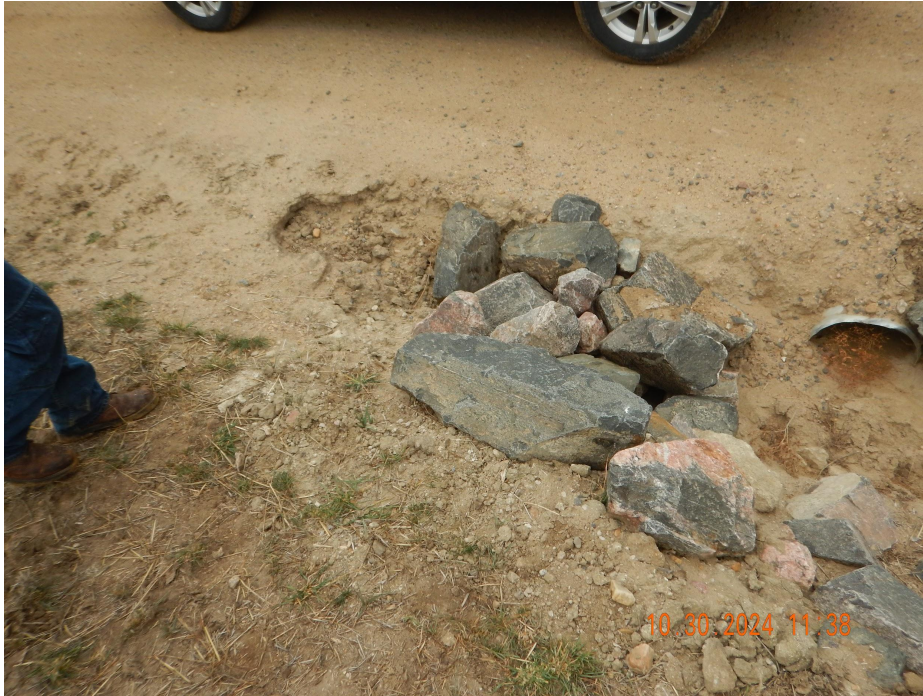
Photo 18. Photo taken along a portion of the access road. Photo illustrates the inlet of the culvert needs maintenance and additional erosion is occurring beyond in the inlet riprap.

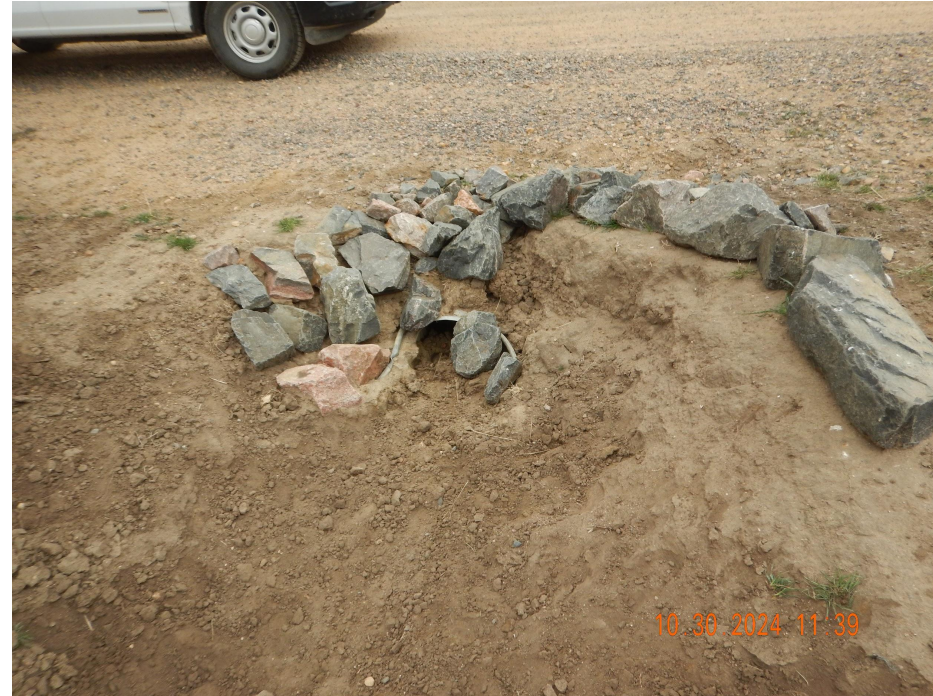
Photo 19. Photo taken at the outlet of the culvert previously shown. Photo illustrates the culvert needs maintenance and there is no stabilized outlet for the culvert.

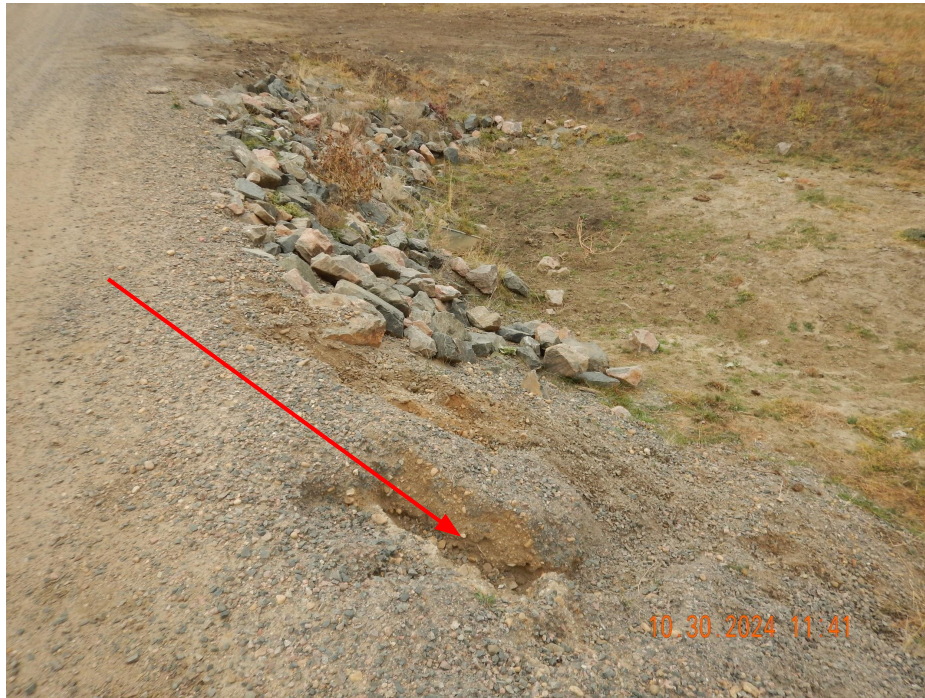
Photo 20. Photo taken along a portion of the access road and the northern intersection of the intermittent stream. Photo illustrates rill erosion adjacent to the crossing.

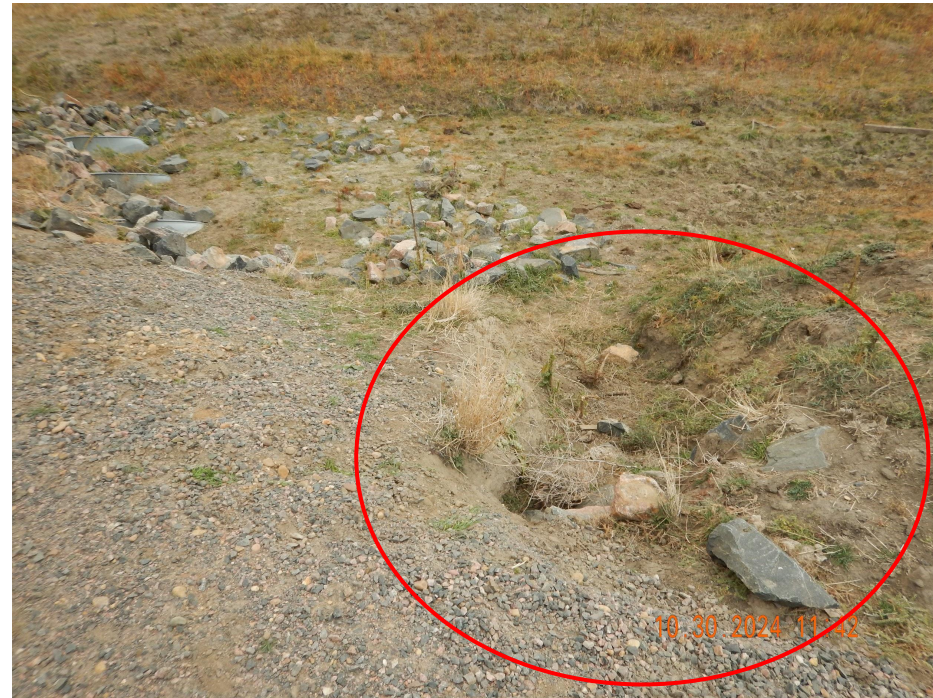
Photo 21. Photo taken along a portion of the access road and the southern intersection of the intermittent stream. Photo illustrates gully erosion adjacent to the crossing.

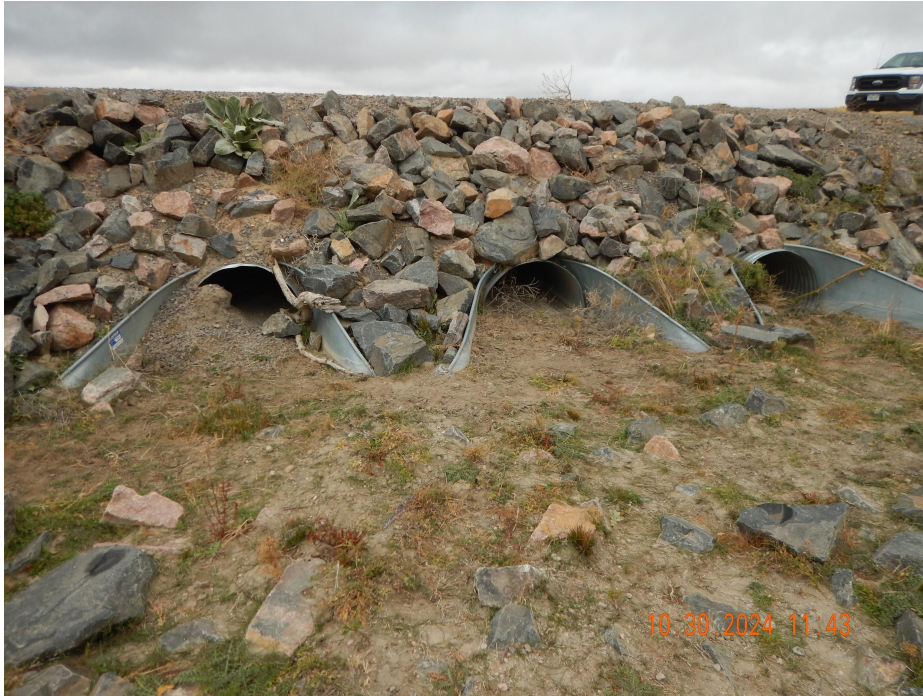
Photo 22. Photo taken along a portion of the access road and the southern intersection of the intermittent stream. Photo illustrates culverts are in need of maintenance.

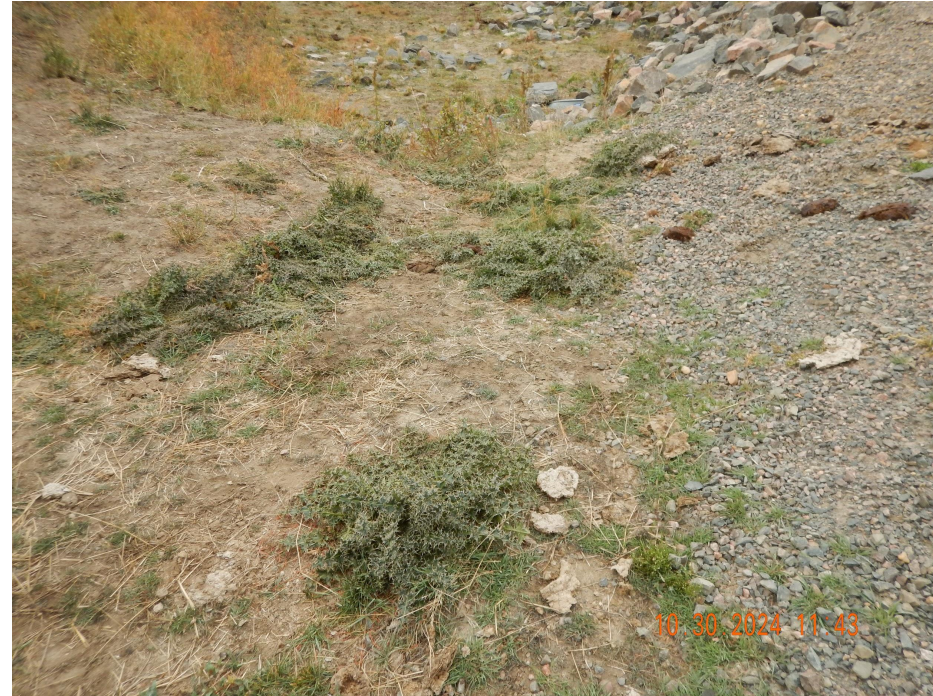
Photo 23. Photo taken along a portion of the access road and the southern intersection of the intermittent stream. Photo illustrates List B Colorado Noxious Weeds, Musk thistle.

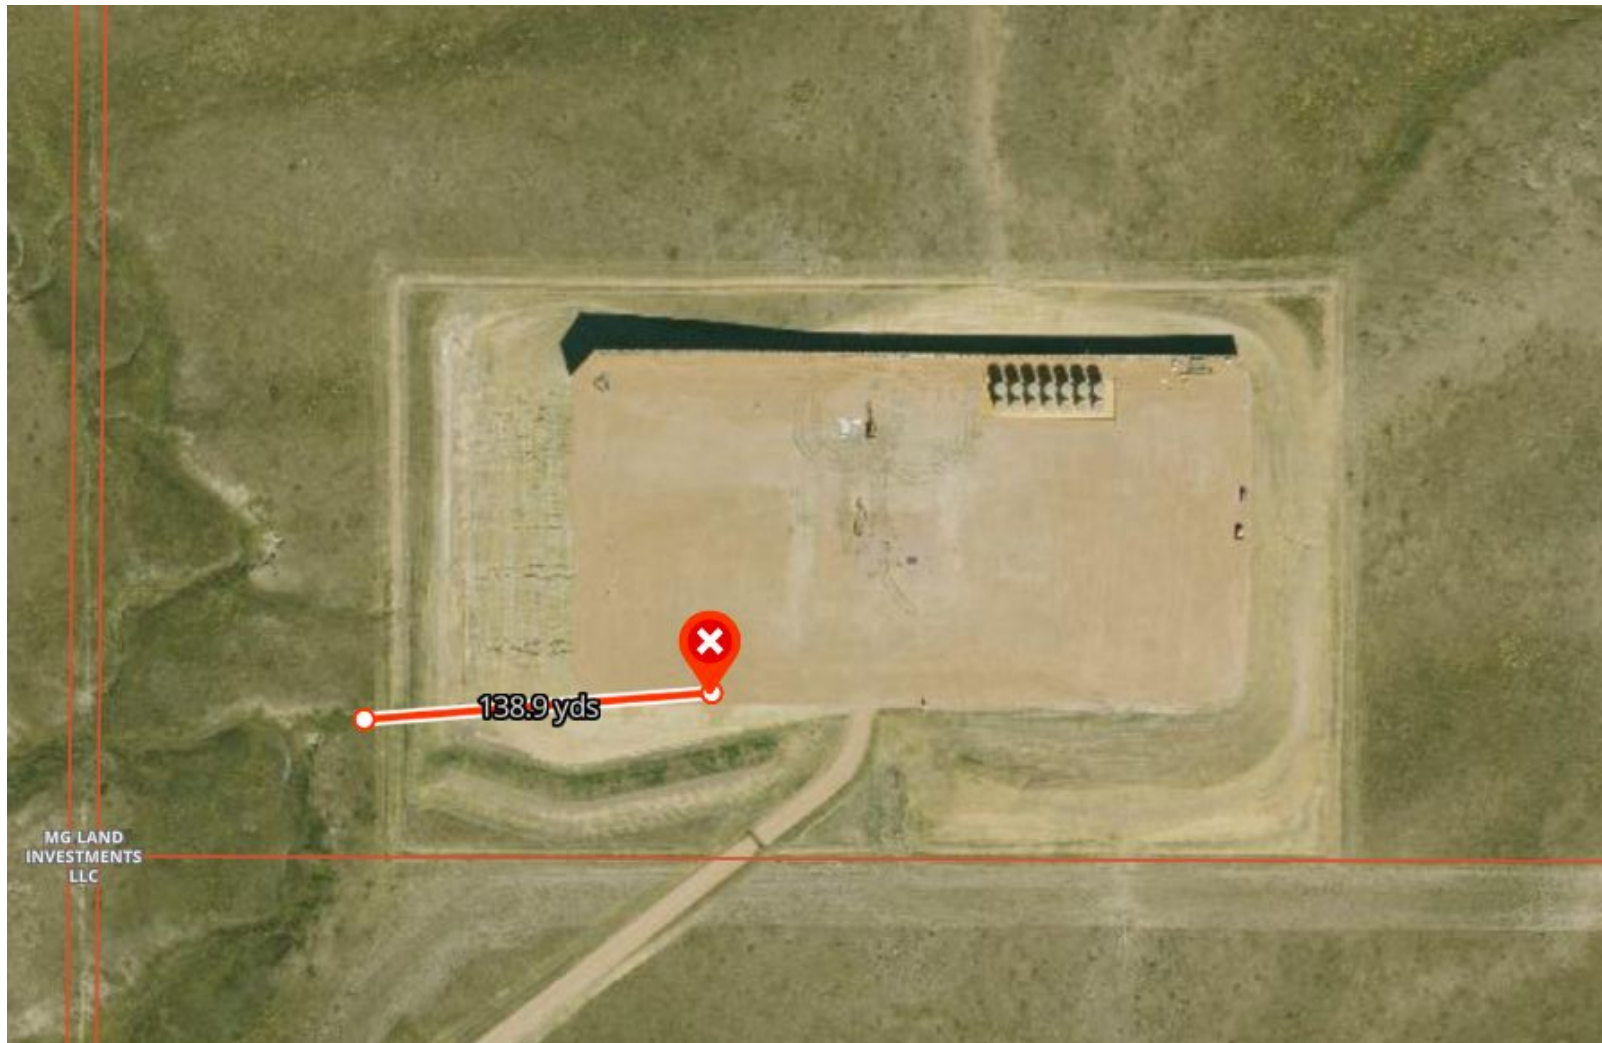
Photo 24. Aerial imagery illustrates chemical and fuel storage (red x) within 500 feet of an OHWM of an intermittent stream and wetland. Storage is approximately 416 feet from the OHWM.
