# Inspection Photos

Location Name: TEP Rocky Mountain LLC CLOUGH RMV 25-20 Pad

Location # 335236

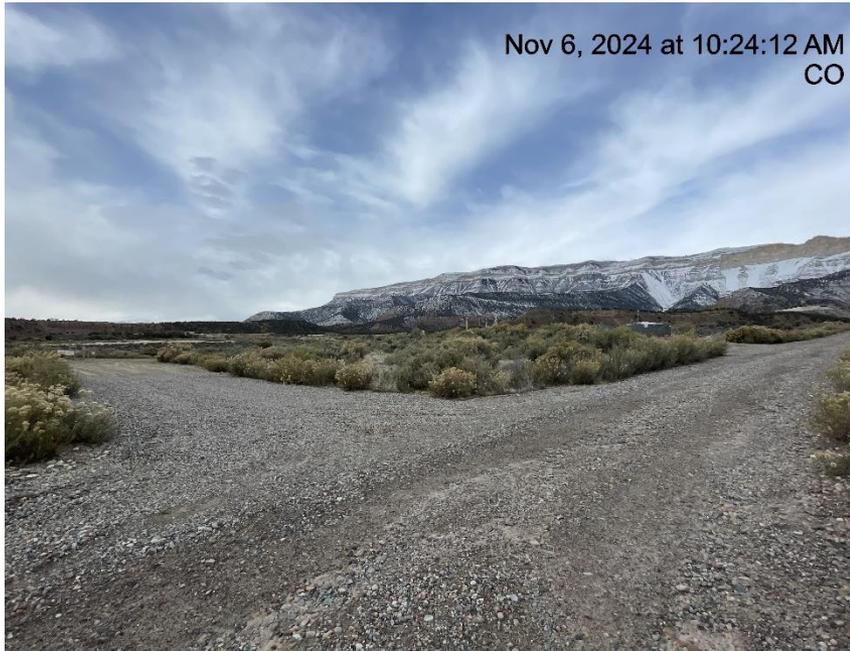
Photo # 9184 From entrance to location

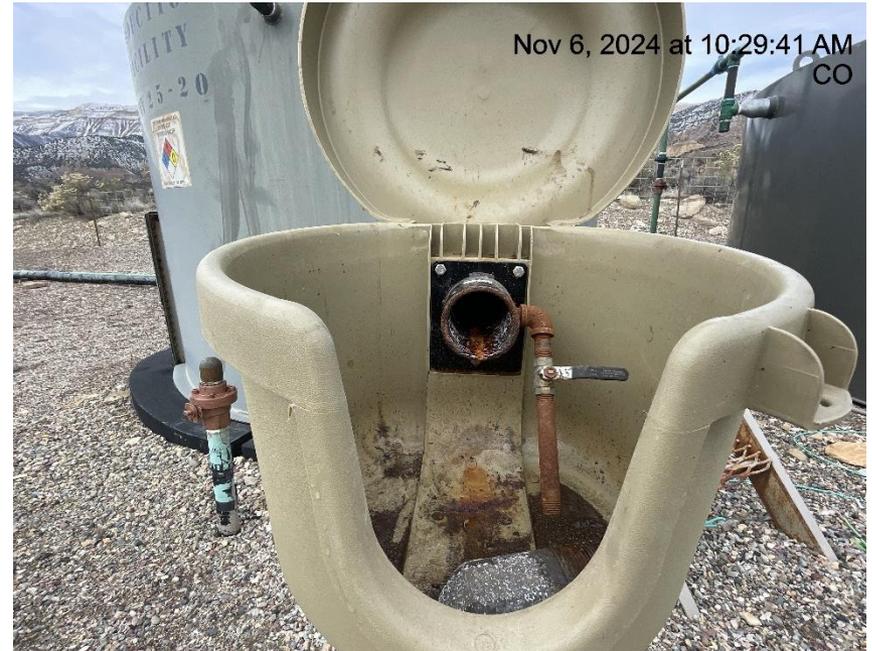
Photo # 9193 Open ended load line

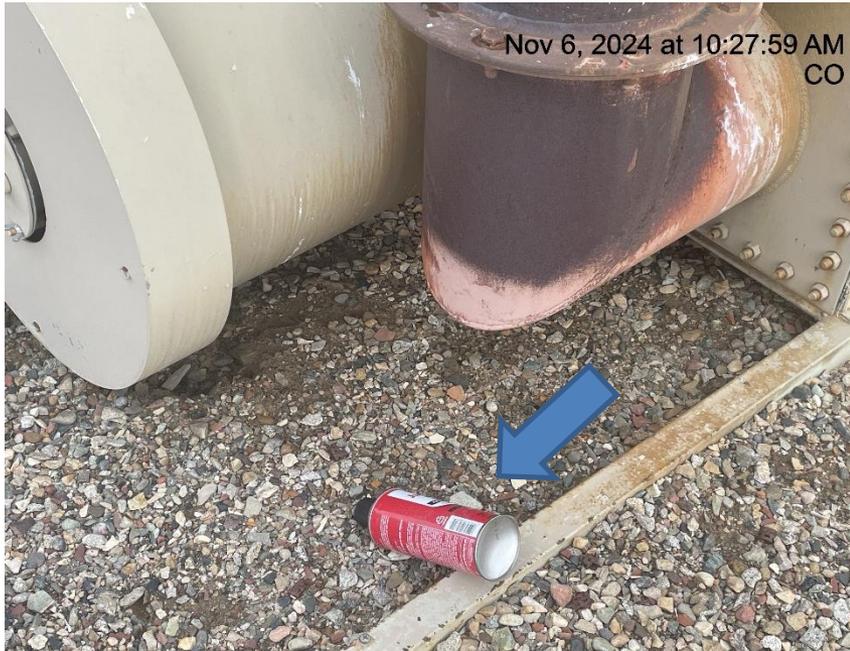
Photo # 9194 Debris
