Inspection Photos
Location: QB ENERGY Mesa/F26-697
Location ID: 448472
Date: 11/04/2024

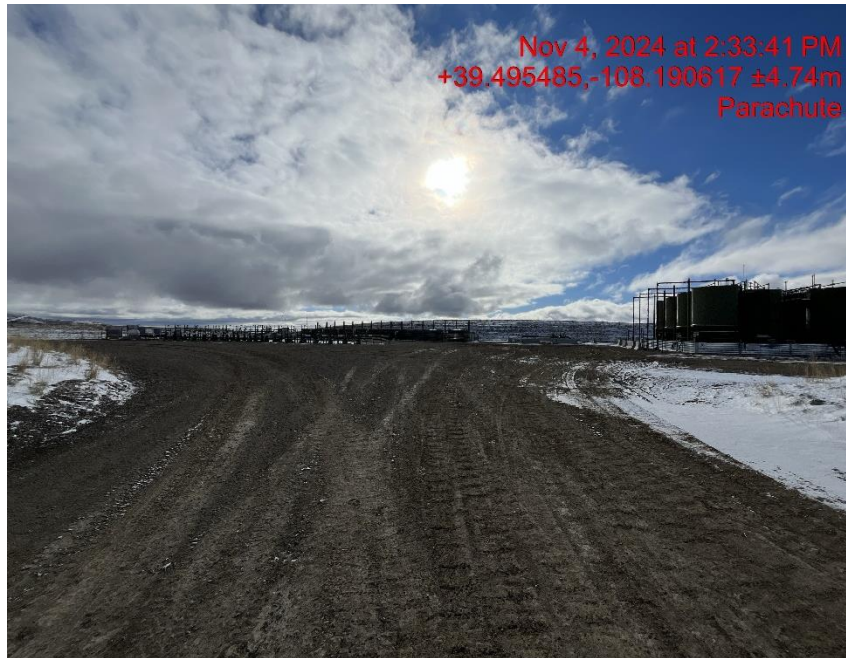
Photo # 8587 Entrance to location

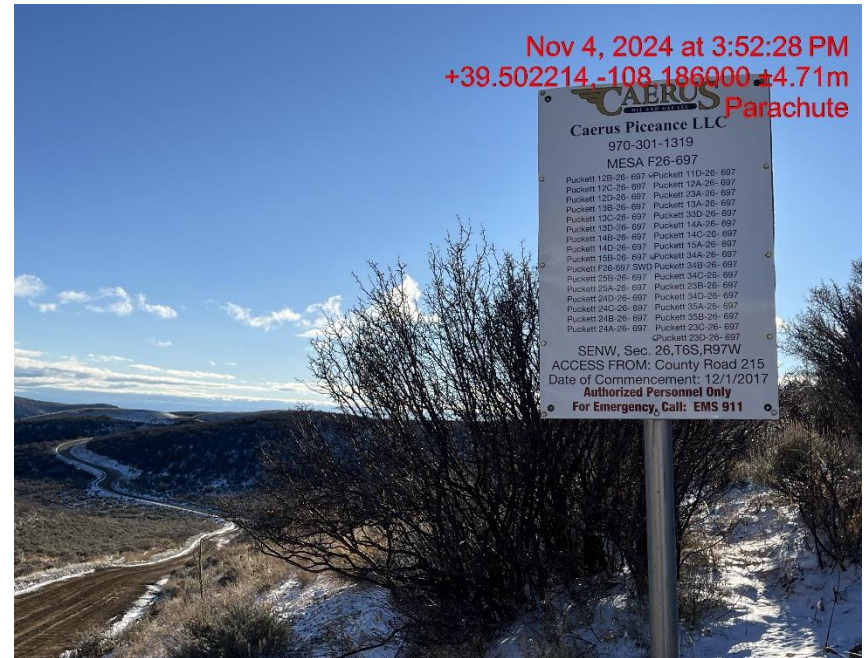
Photo # 8664 Location sign from lease road

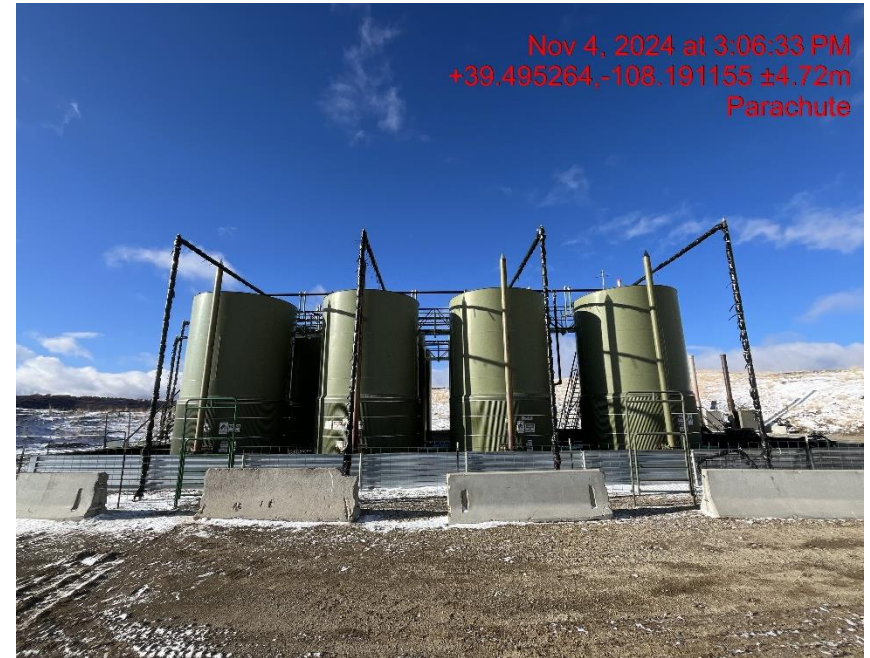
Photo # 8610 No tank battery sign

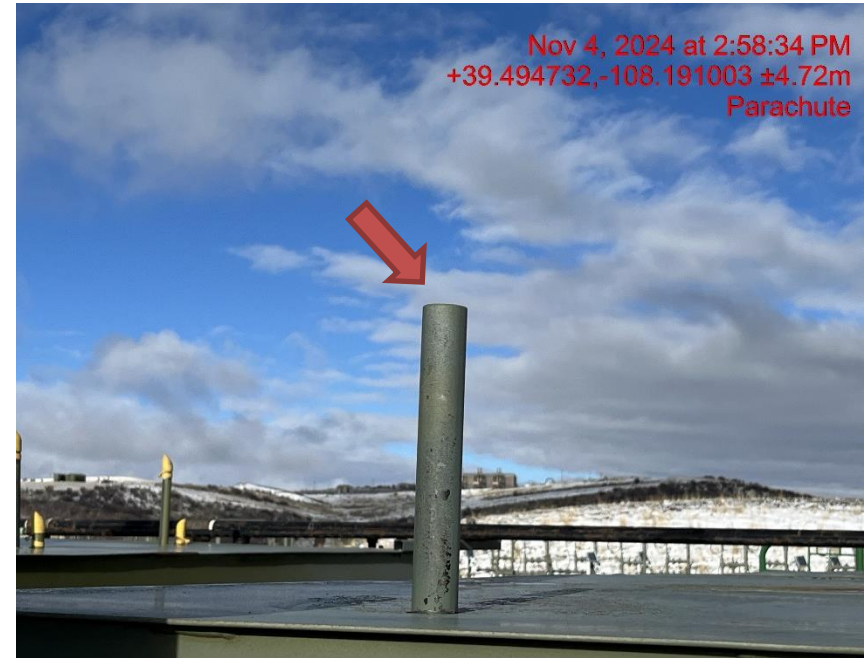
**Photo # 8603 PRV vent line does not comply with CECMC
pressure safety device rules**

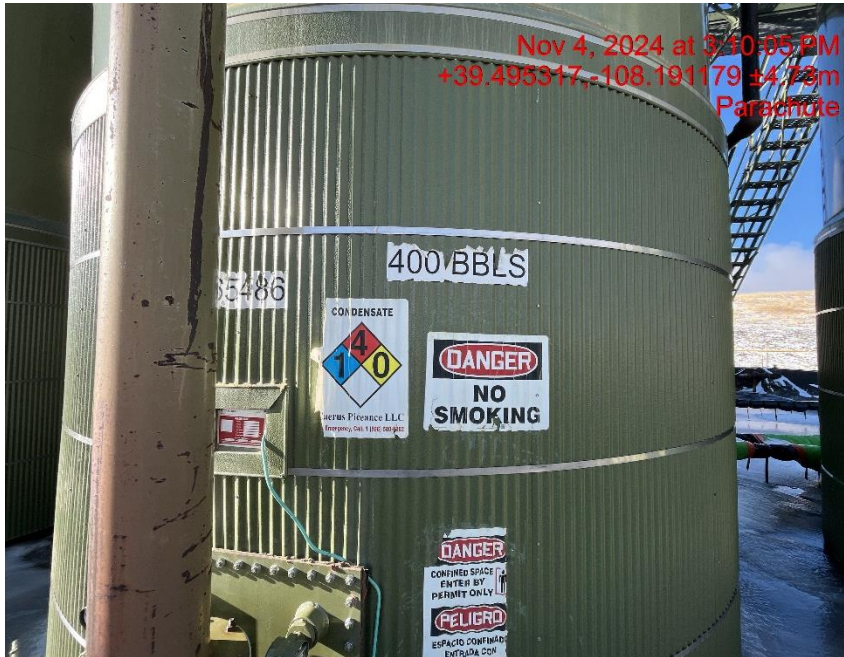
Photo # 8614 Tank labels damaged and illegible

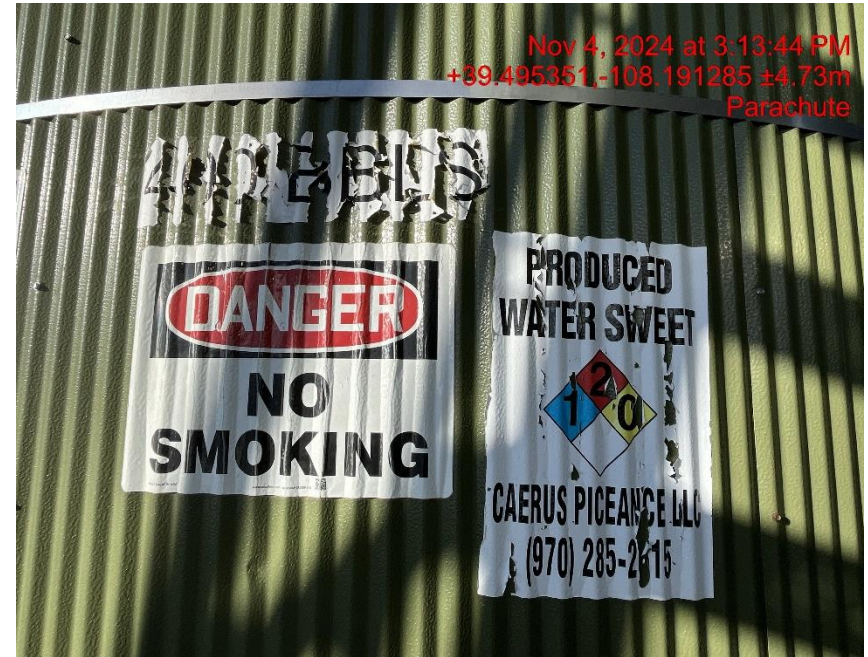
Photo # 8618 Tank labels damaged and illegible

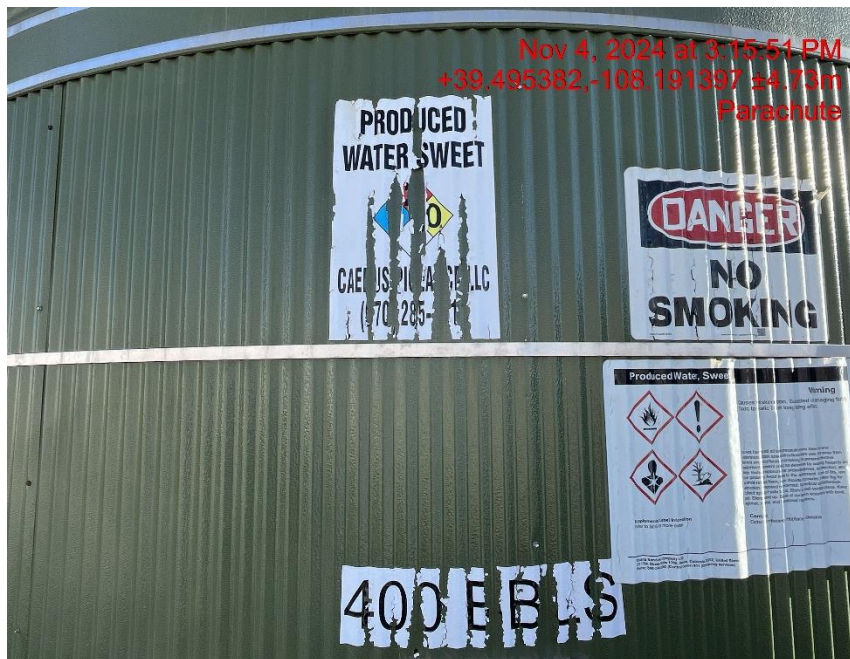
Photo # 8620 Tank labels damaged and illegible

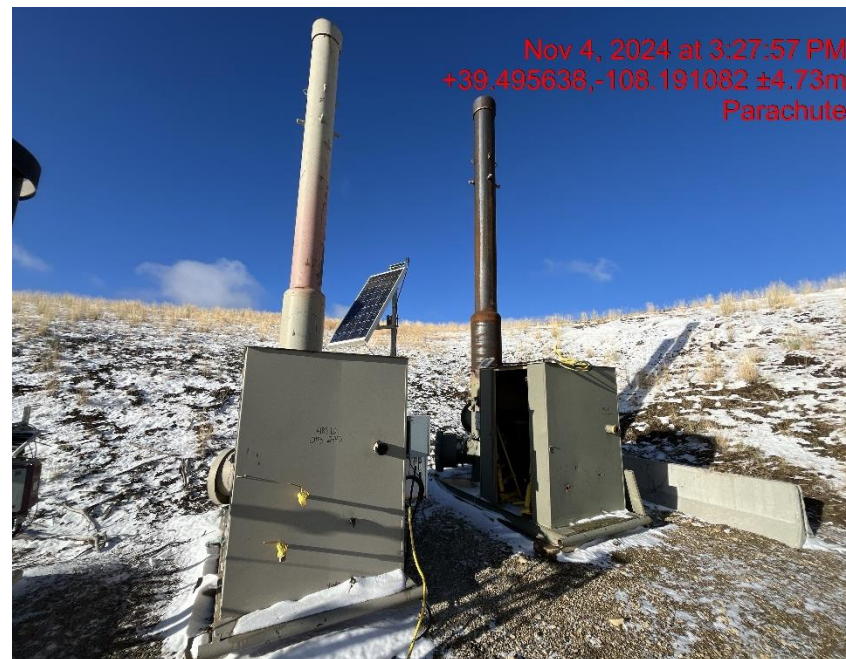
Photo # 8635 Unused equipment on location
