Inspection Photos  
Location: QB ENERGY Mesa/N23-697  
Location ID: 448427  
Date: 11/04/2024

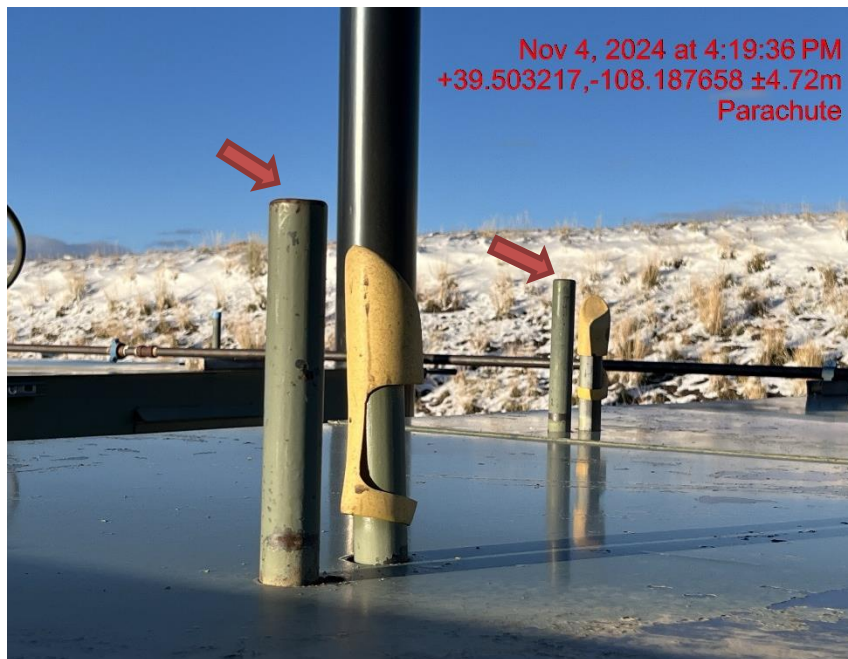
**Photo # 8680 Rupture disc vent lines do not comply with CECMC pressure safety**

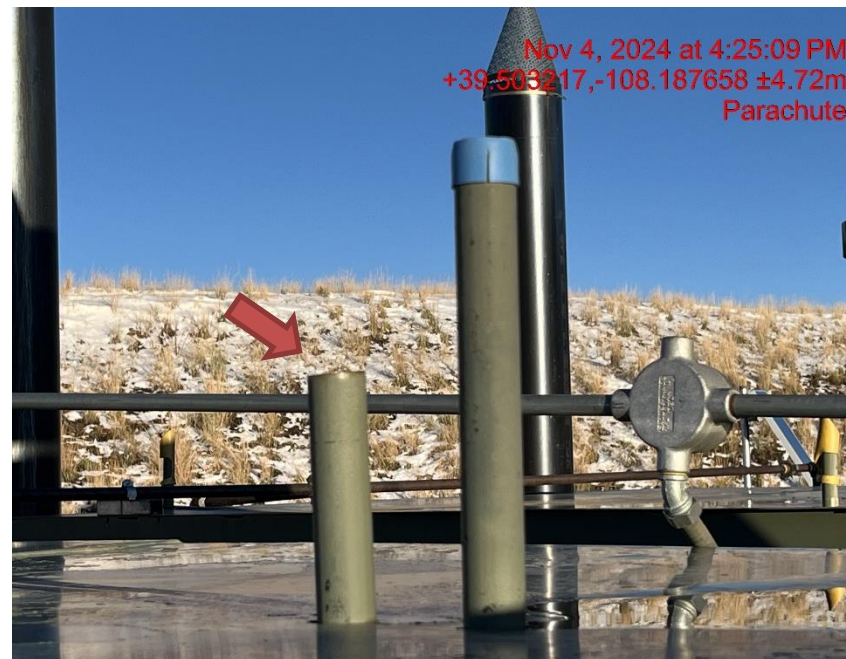
**Photo # 8688 PRV vent line does not comply with CECMC pressure safety device rules**

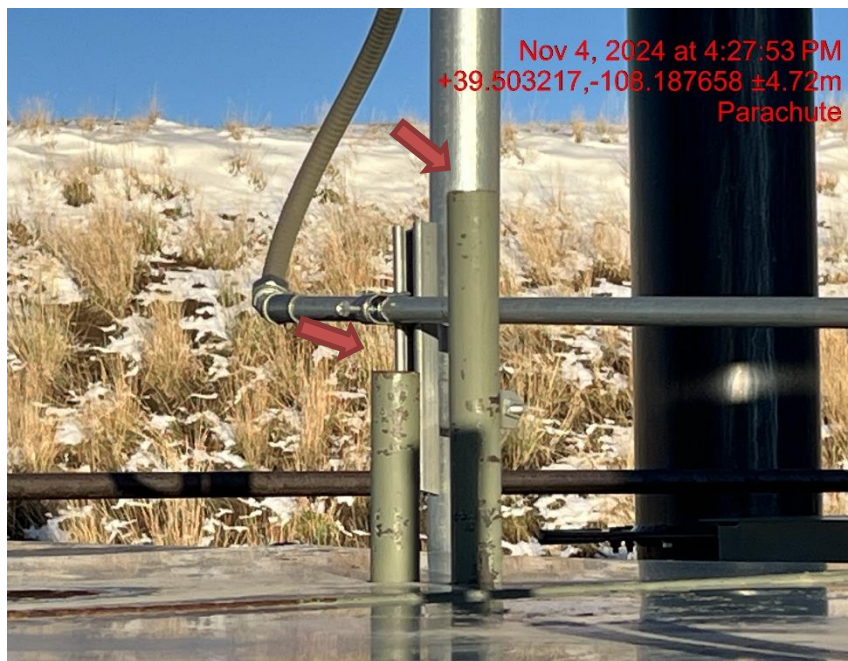
Photo # 8691 PRV & Rupture disc vent line do not comply with CECMC pressure safety device rules

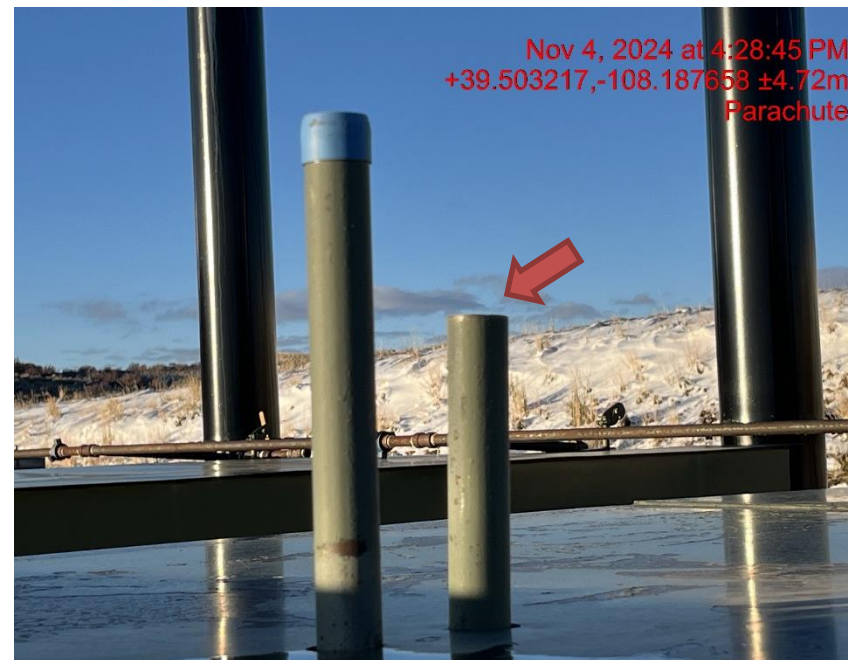
Photo # 8693 PRV vent line does not comply with CECMC pressure safety device rules

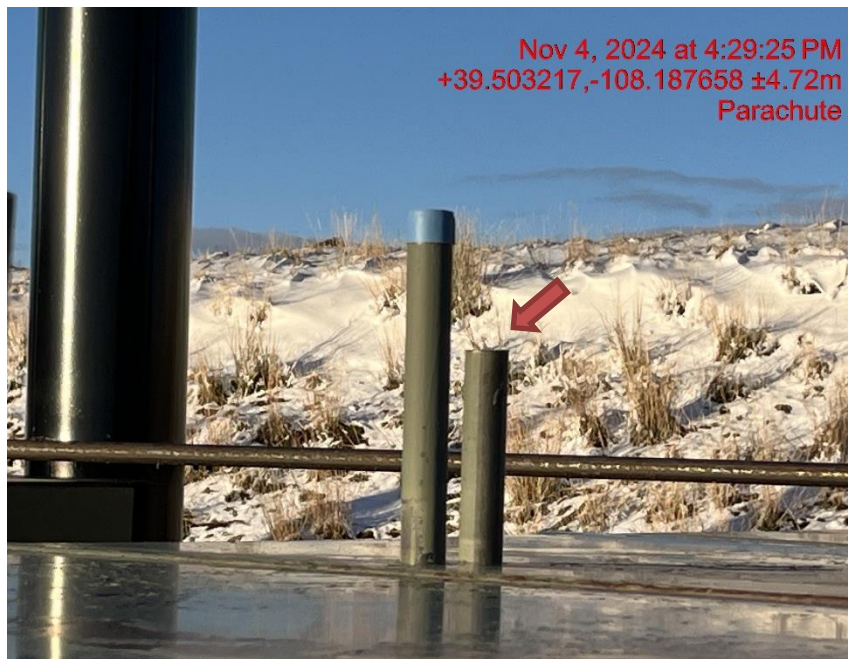
Photo # 8695 PRV vent line does not comply with CECMC pressure safety device rules

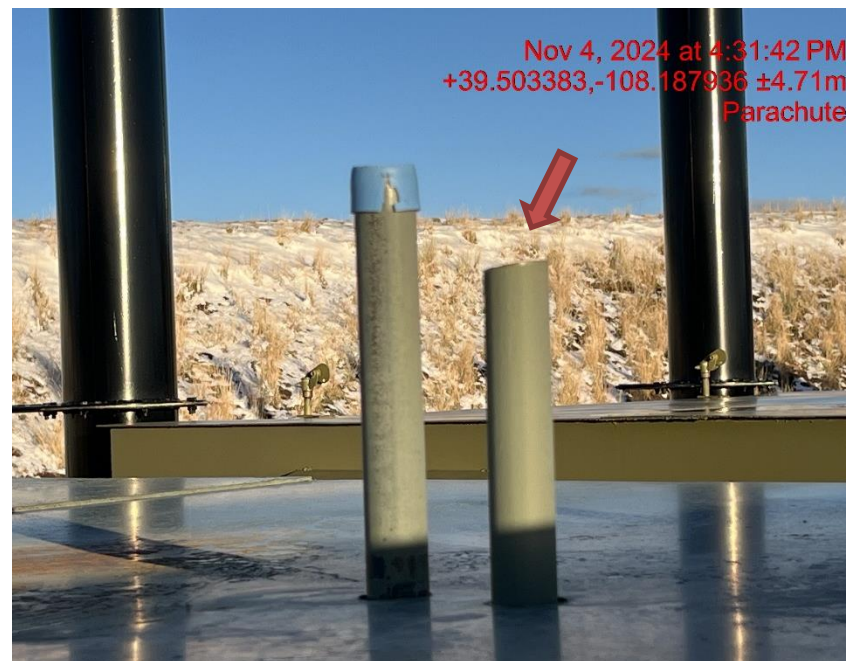
Photo # 8697 PRV vent line does not comply with CECMC pressure safety device rules

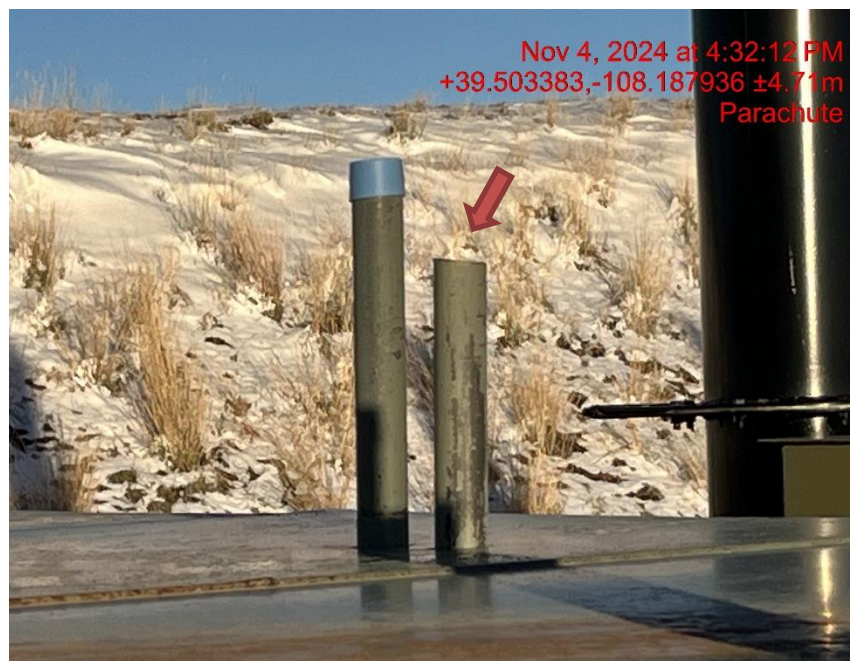
**Photo # 8699 PRV vent line does not comply with CECMC pressure safety device rules**

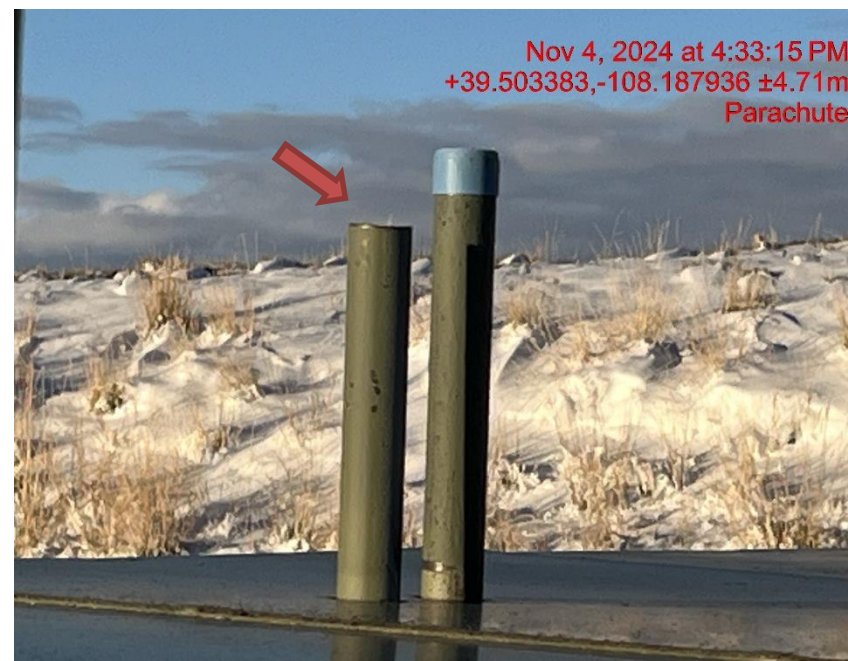
**Photo # 8701 PRV vent line does not comply with CECMC pressure safety device rules**

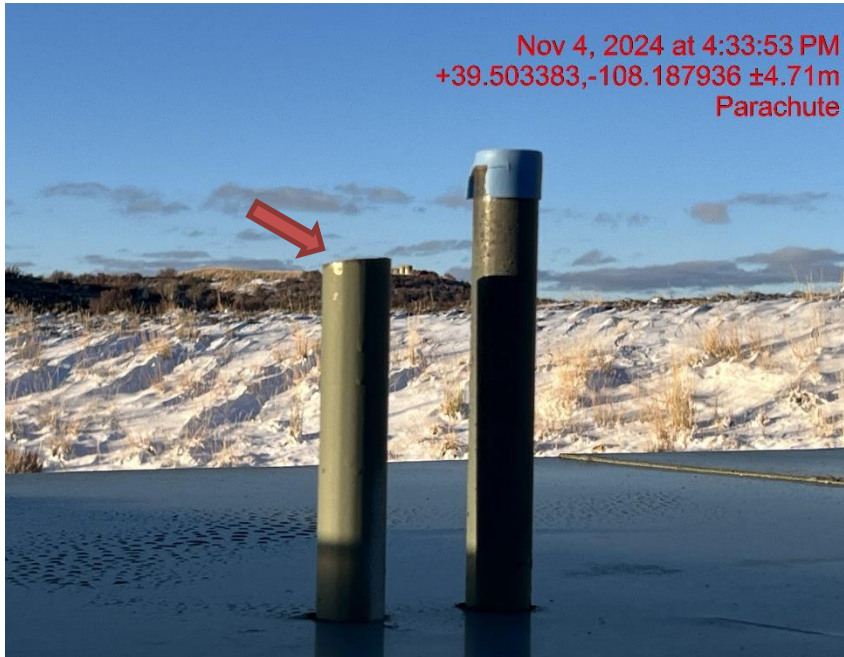
Photo # 8703 PRV vent line does not comply with CECMC pressure safety device rules

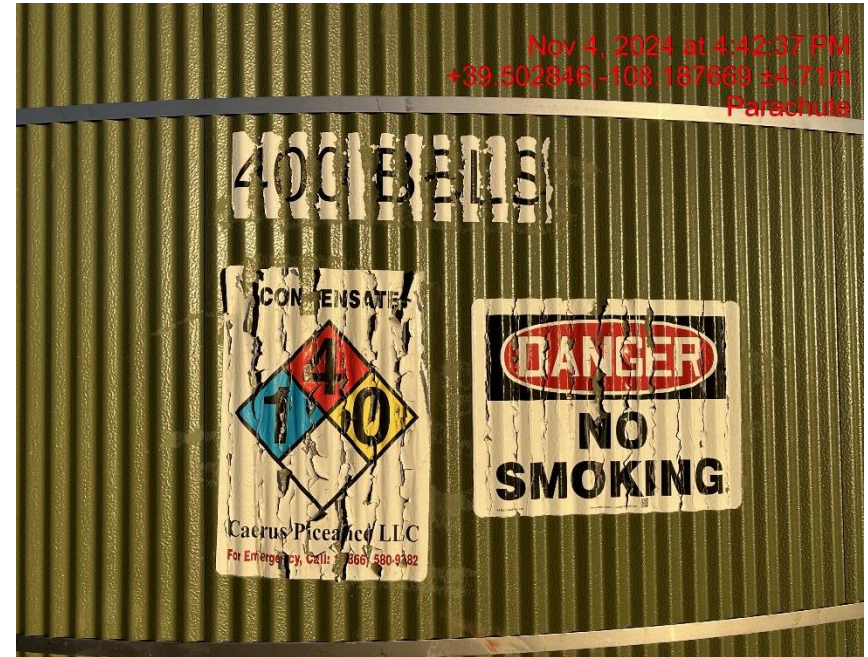
Photo # 8714 Tank labels damaged and illegible

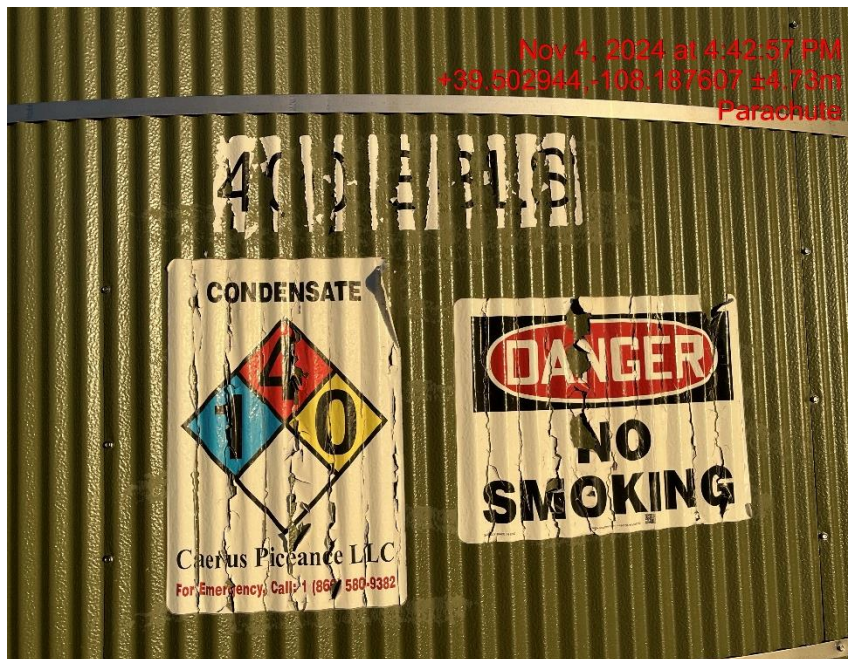
Photo # 8715 Tank labels damaged and illegible

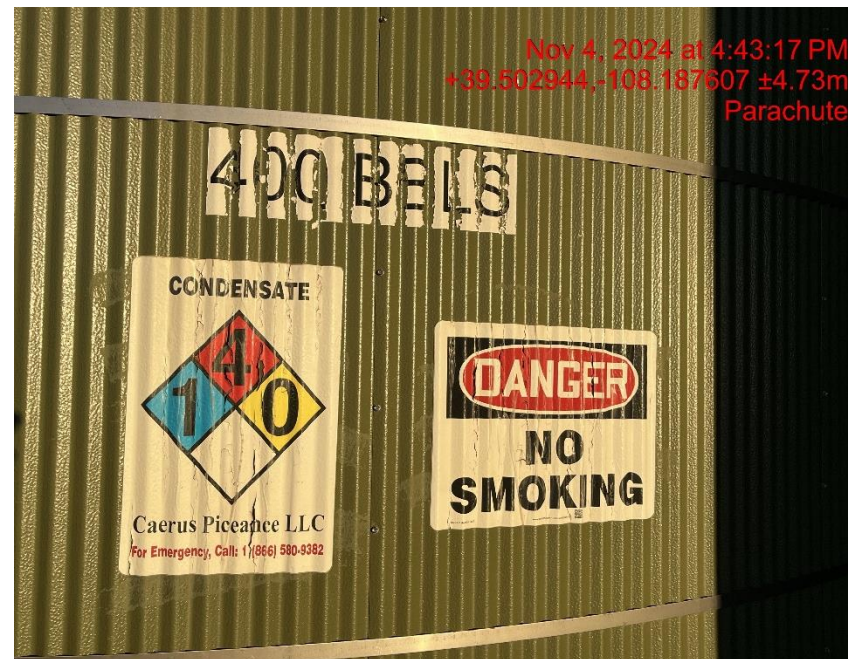
Photo # 8716 Tank labels damaged and illegible

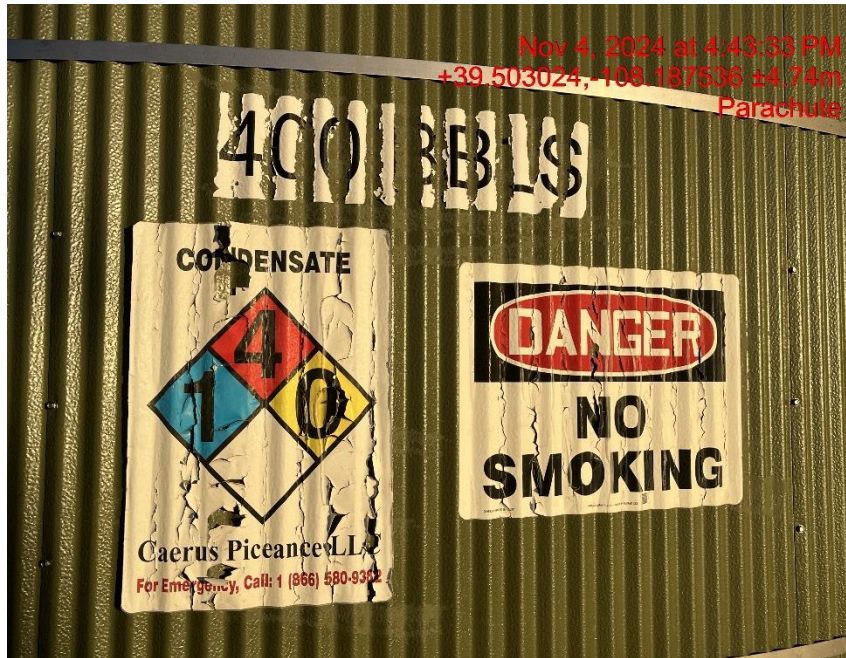
Photo # 8717 Tank labels damaged and illegible

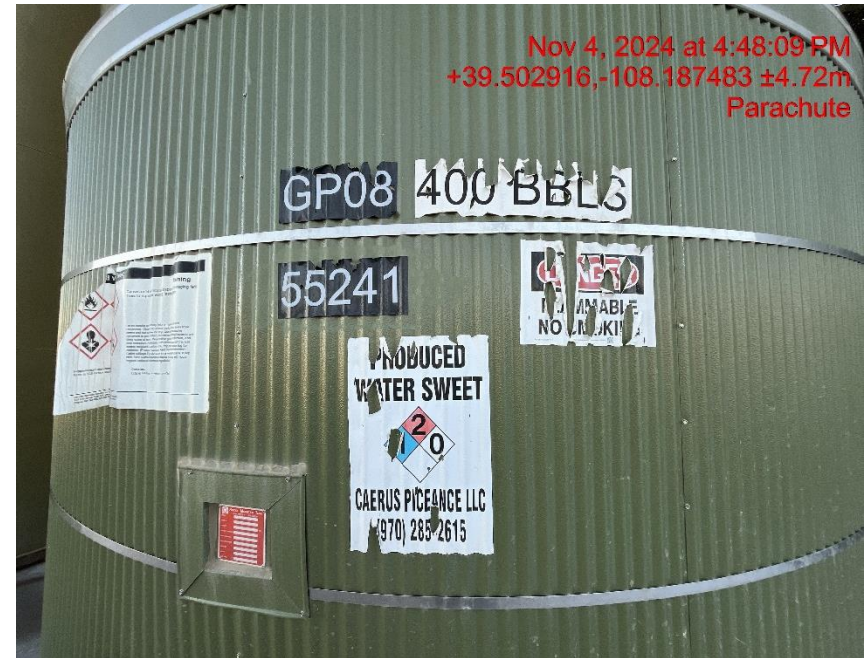
Photo # 8723 Tank labels damaged and illegible

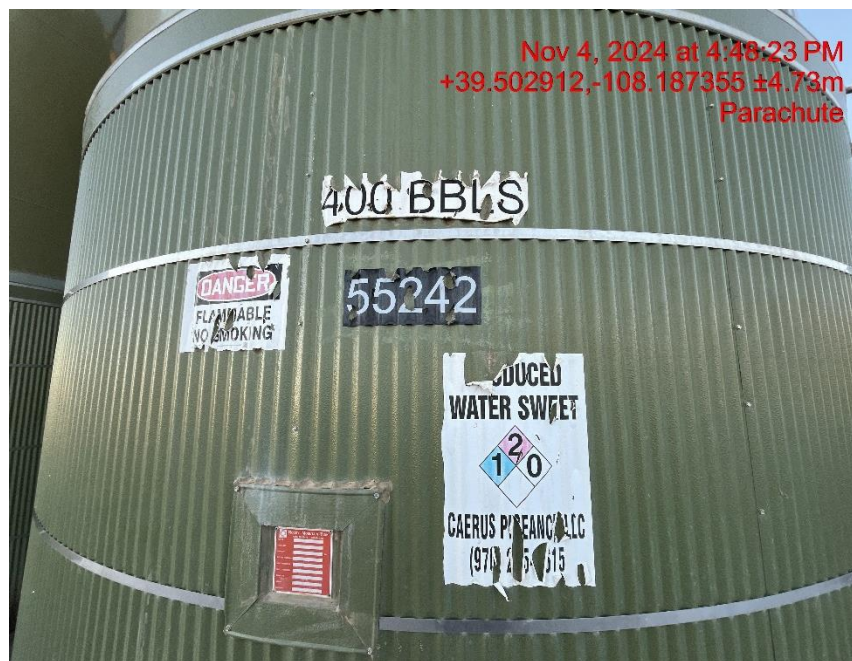
Photo # 8724 Tank labels damaged and illegible

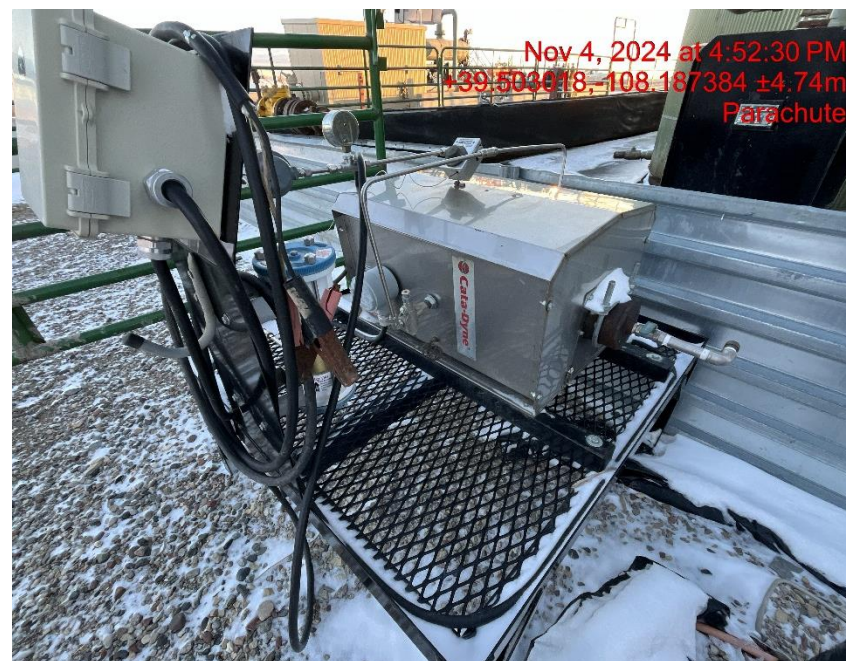
Photo # 8728 Unused equipment on location

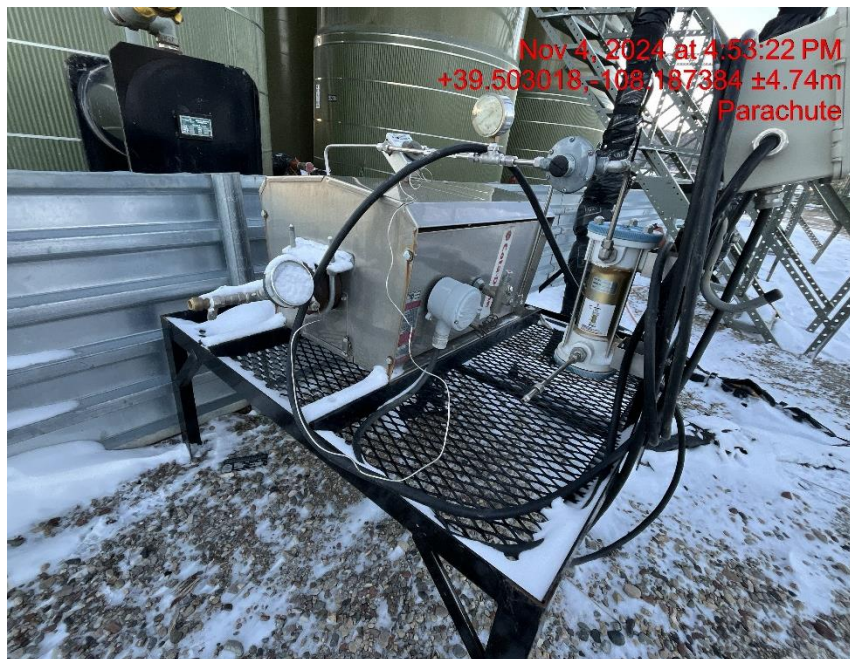
**Photo # 8729 Unused equipment on location**

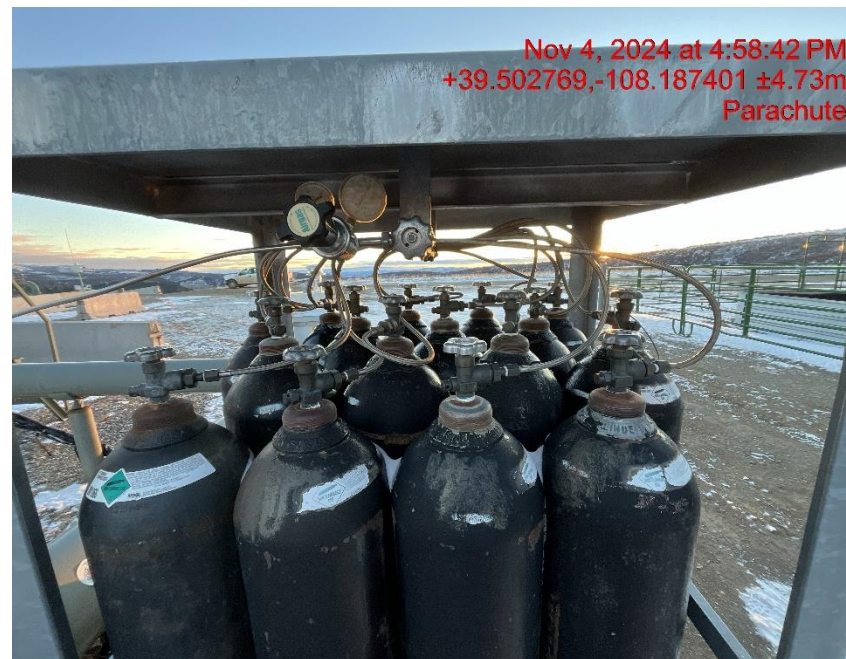
**Photo # 8738 Some labels are peeling and becoming illegible**

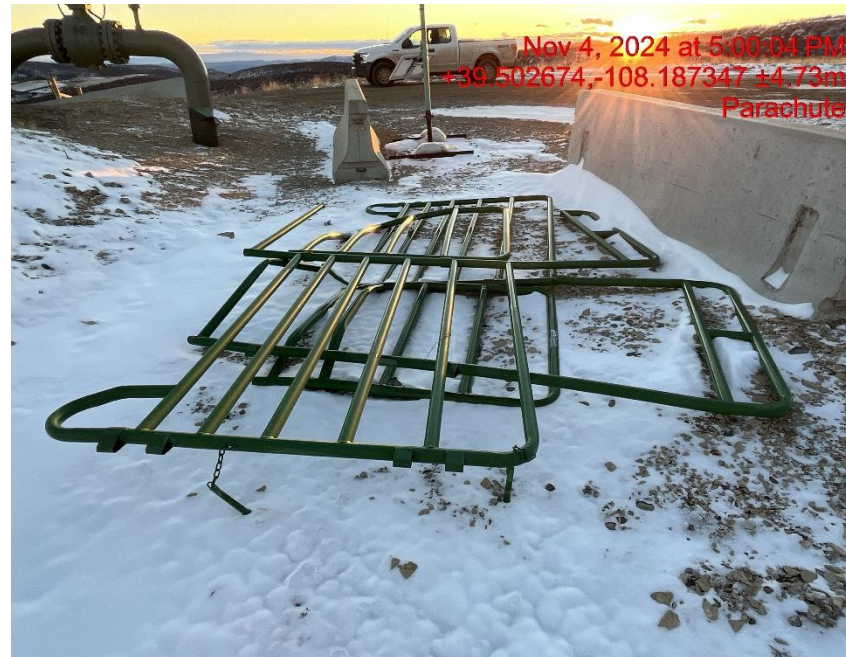
**Photo # 8739 Debris**
