Inspection Photos

Location Name: TEP ROCKY MOUNTAIN LLC HONEA 19-05 Pad

Location # 335038

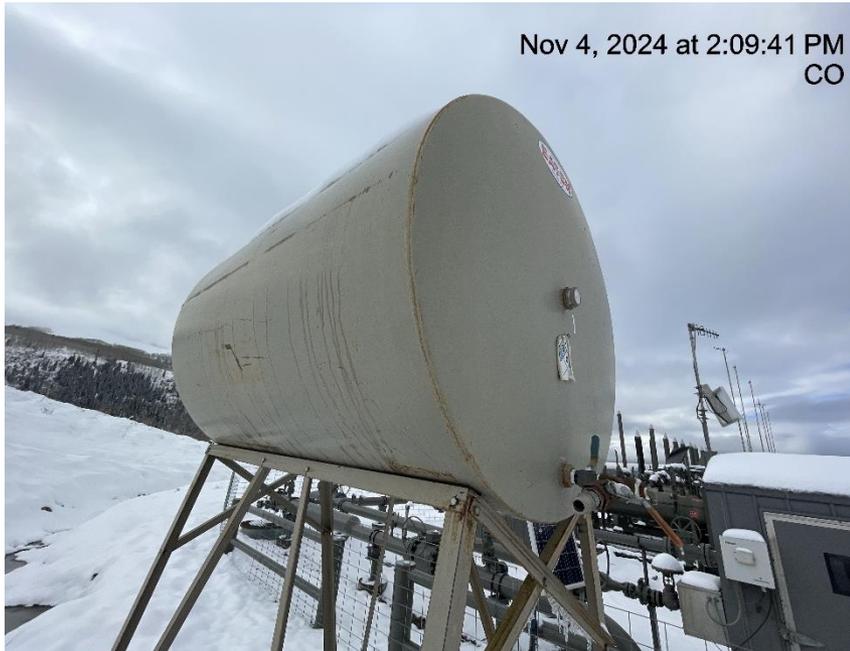
Photo # 8900 Methanol tank missing some required info /does not comply with CECMC labeling rules

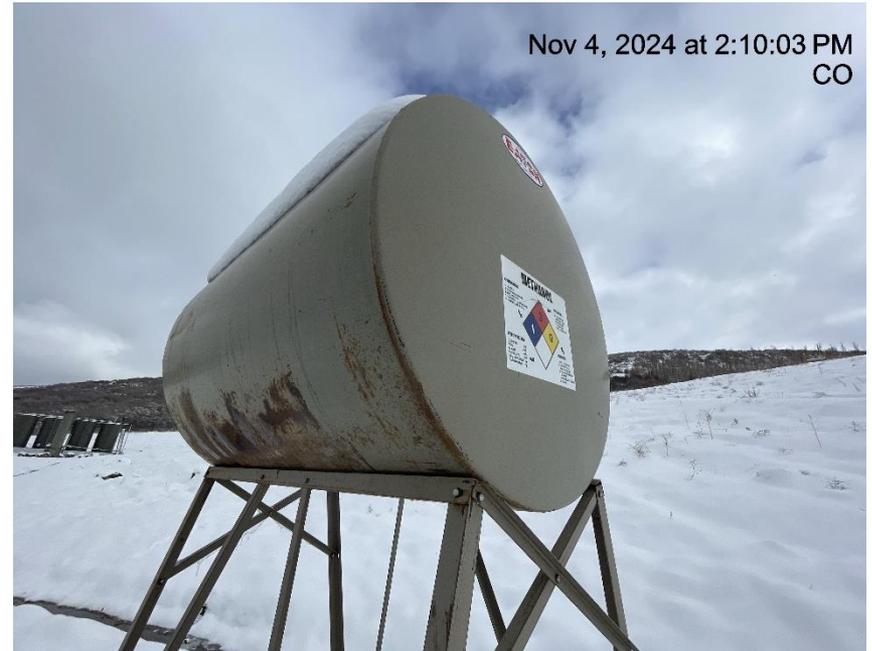
Photo # 8901 Methanol tank missing some required info /does not comply with CECMC labeling rules

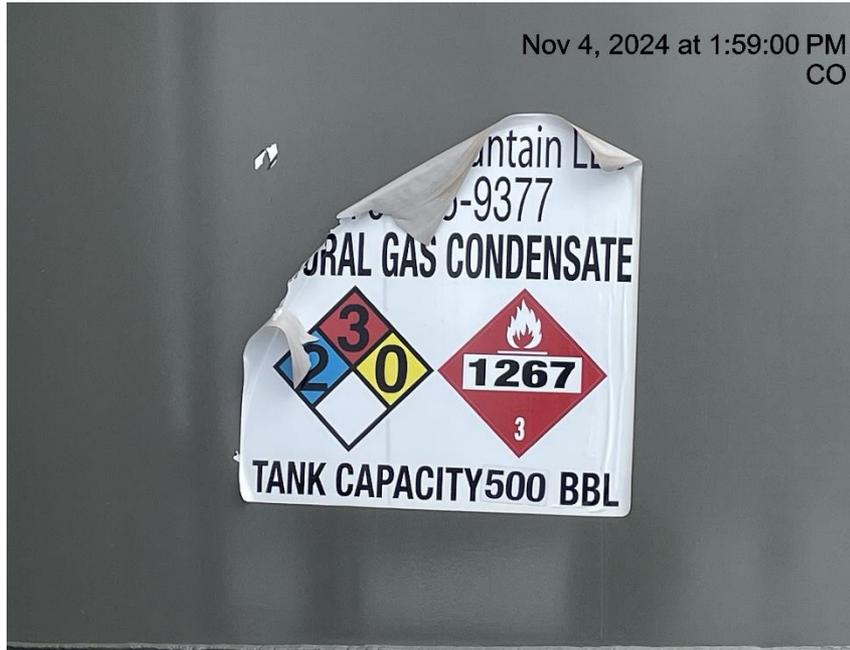
Photo # 8902 Tank label damaged & peeling/some required info is illegible

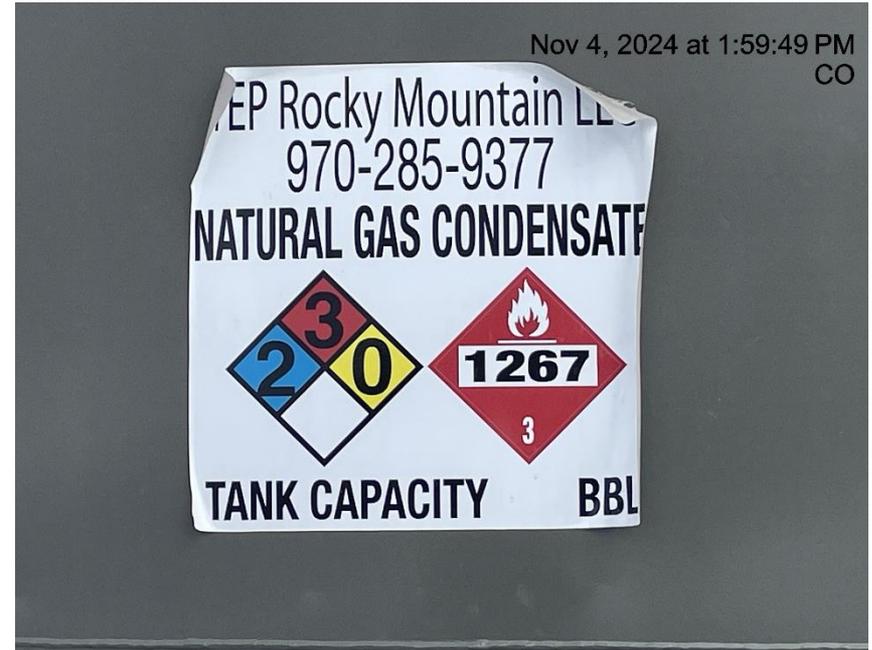
Photo # 8903 Tank label peeling/some required info is starting to become illegible

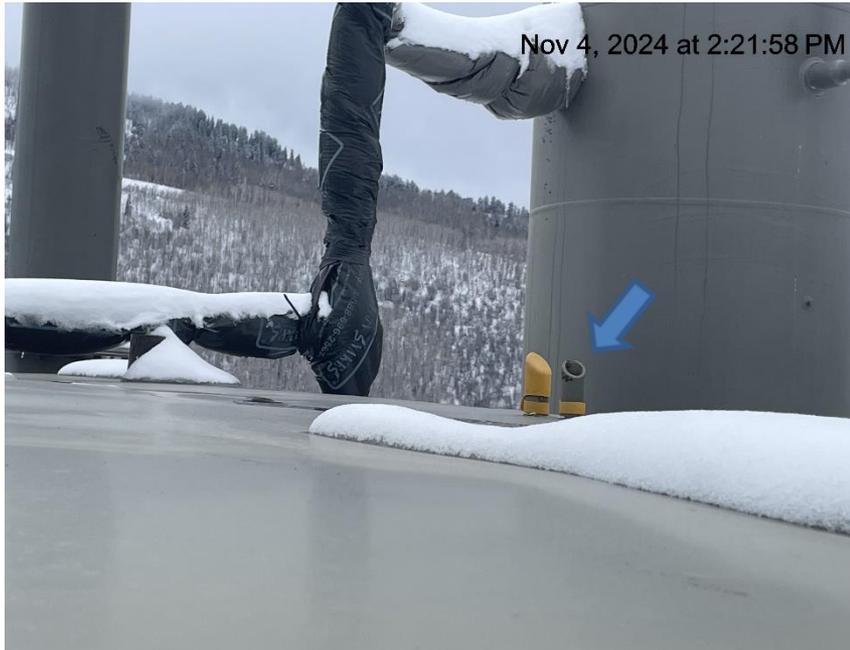
Photo # 8904 Rupture disc vent line does not comply with CECMC pressure safety device rules

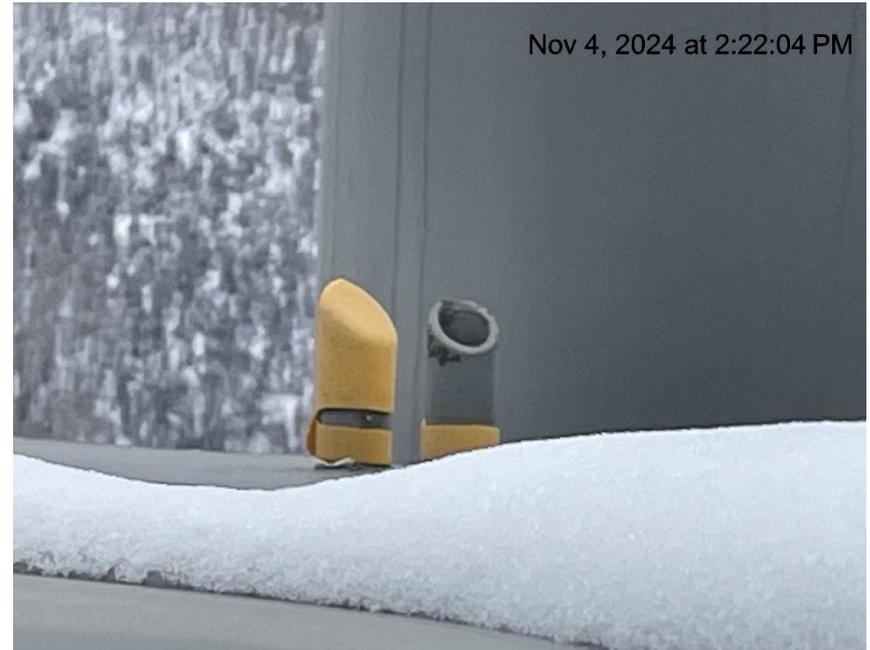
Photo # 8905 Rupture disc vent line does not comply with CECMC pressure safety device rules

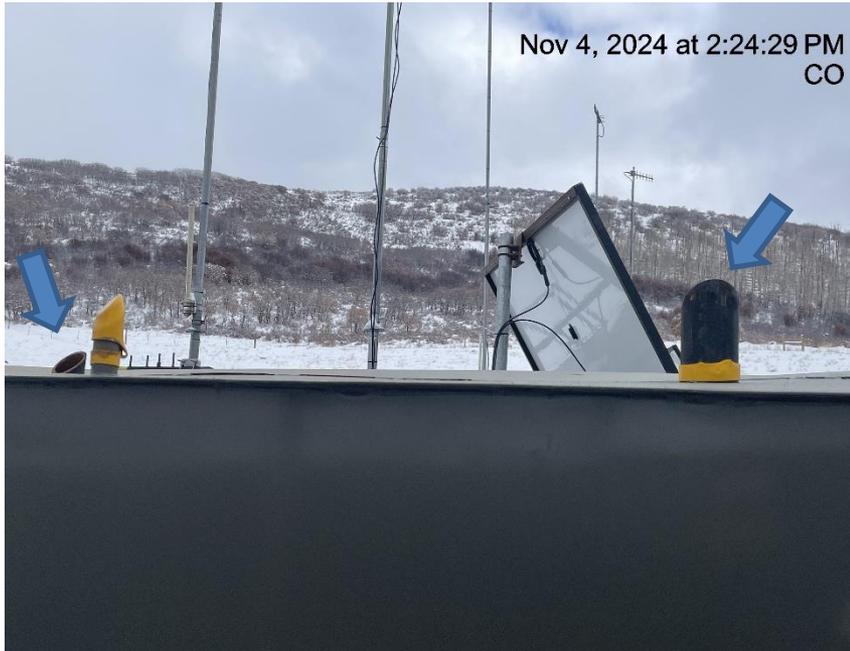
Photo # 8906 PRV vent lines do not comply with CECMC pressure safety device rules

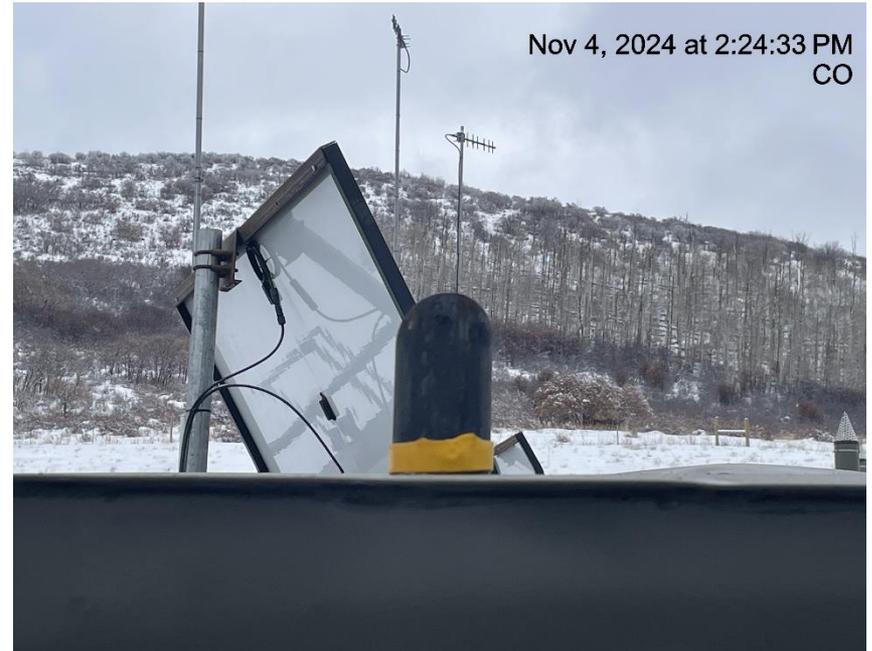
Photo # 8907 PRV vent line does not comply with CECMC pressure safety device rules

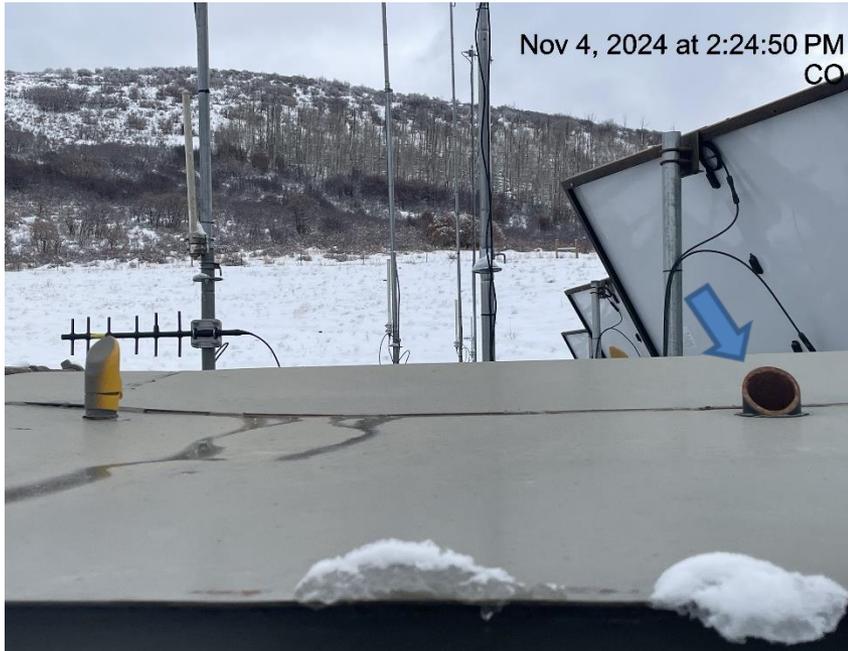
Photo # 8908 PRV vent line does not comply with CECMC pressure safety device rules

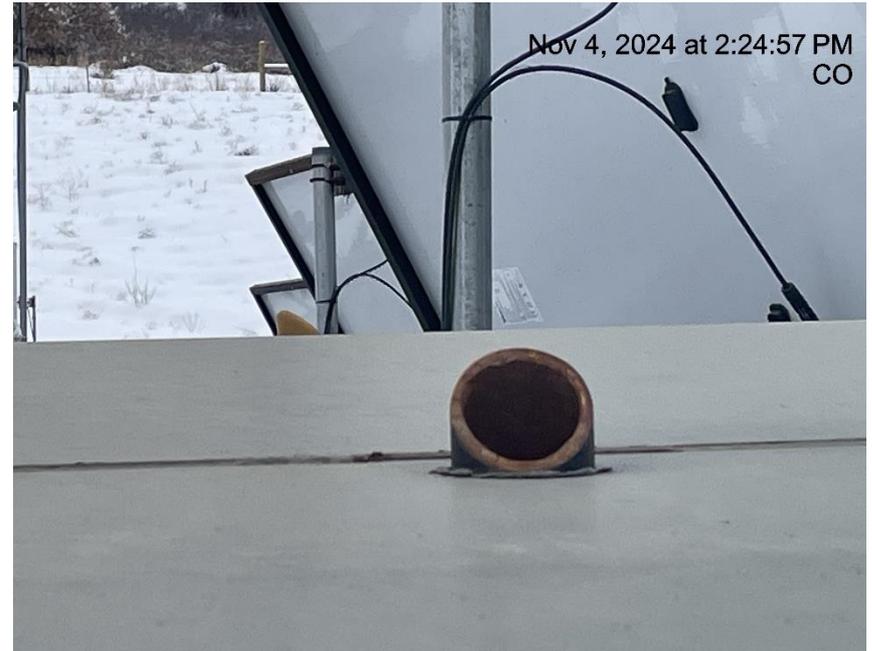
Photo # 8909 PRV vent line does not comply with CECMC pressure safety device rules

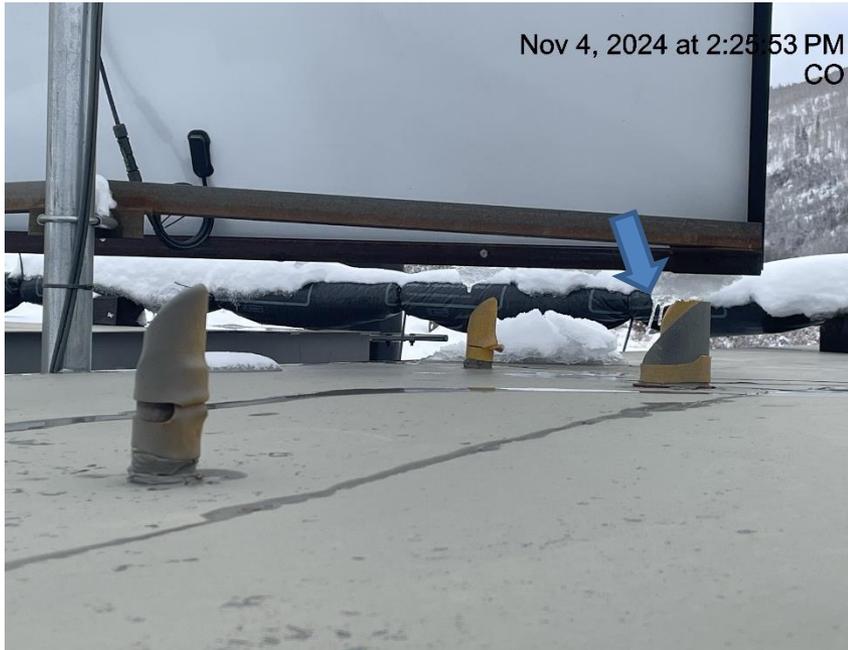
Photo # 8910 PRV vent line does not comply with CECMC pressure safety device rules

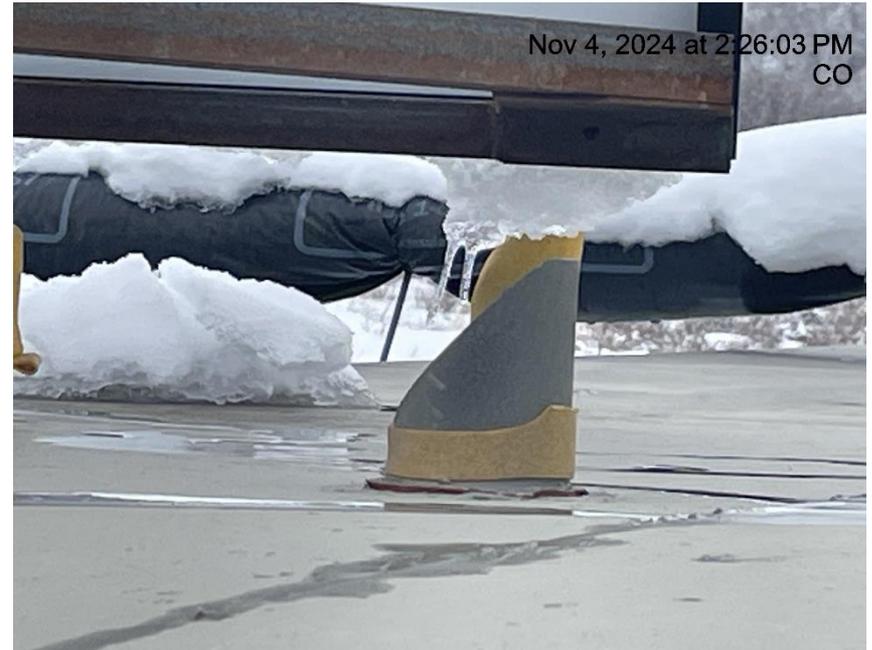
Photo # 8911 PRV vent line does not comply with CECMC pressure safety device rules

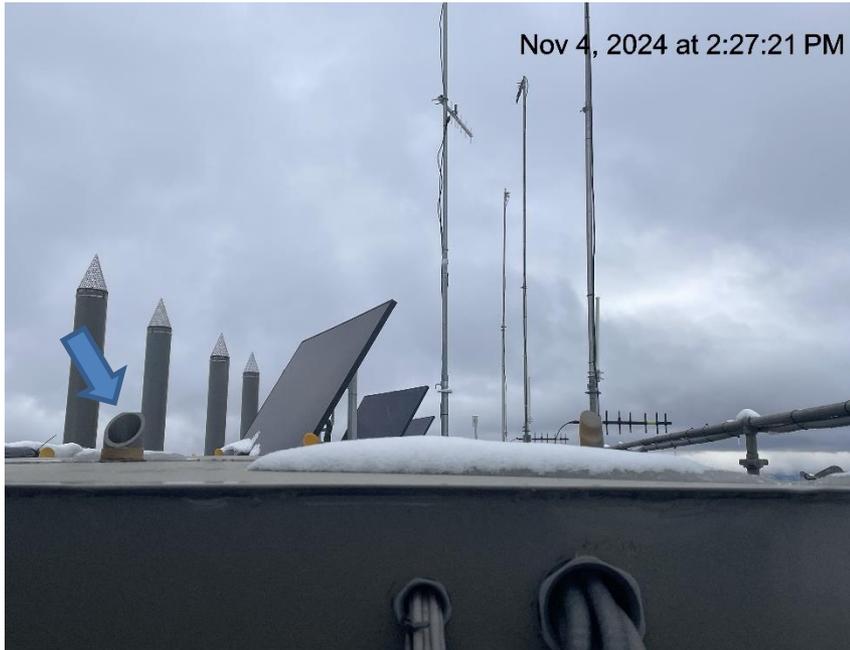
Photo # 8912 PRV vent line does not comply with CECMC pressure safety device rules

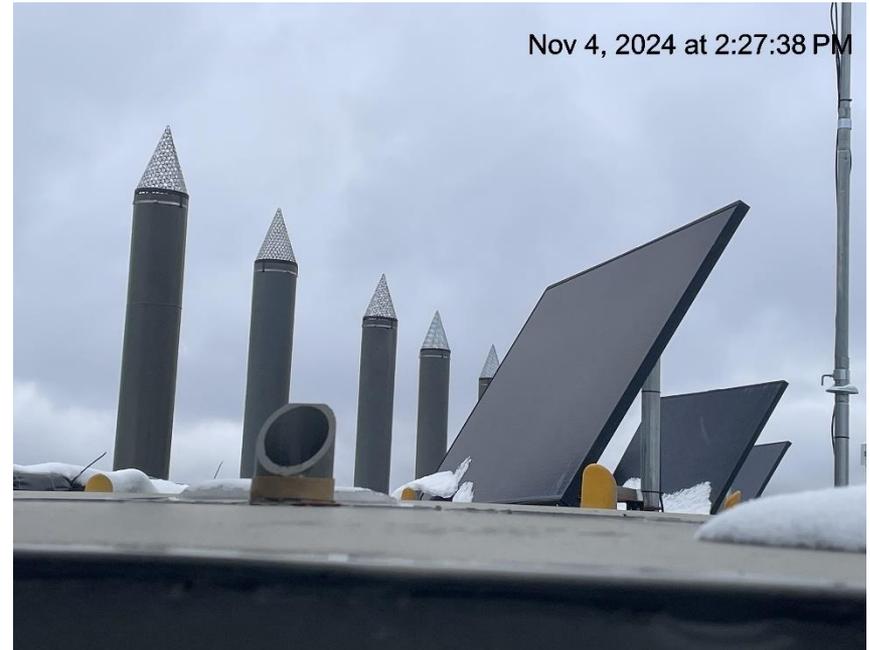
Photo # 8913 PRV vent line does not comply with CECMC pressure safety device rules

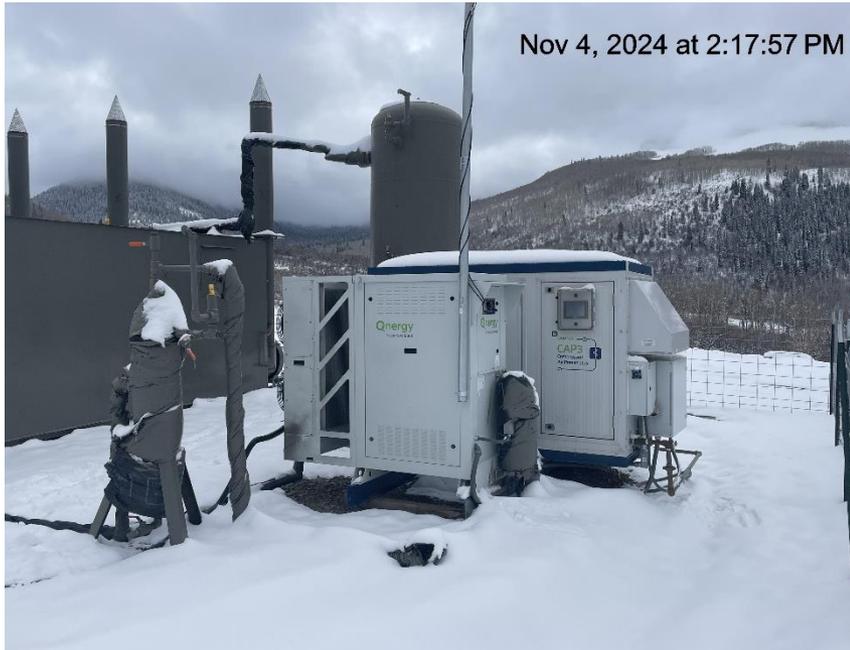
Photo # 8914 Natural gas generator & air compressor not listed in operators FORM 2A or in any FORM 4 SUNDRY /operator is not in compliance with CECMC rules

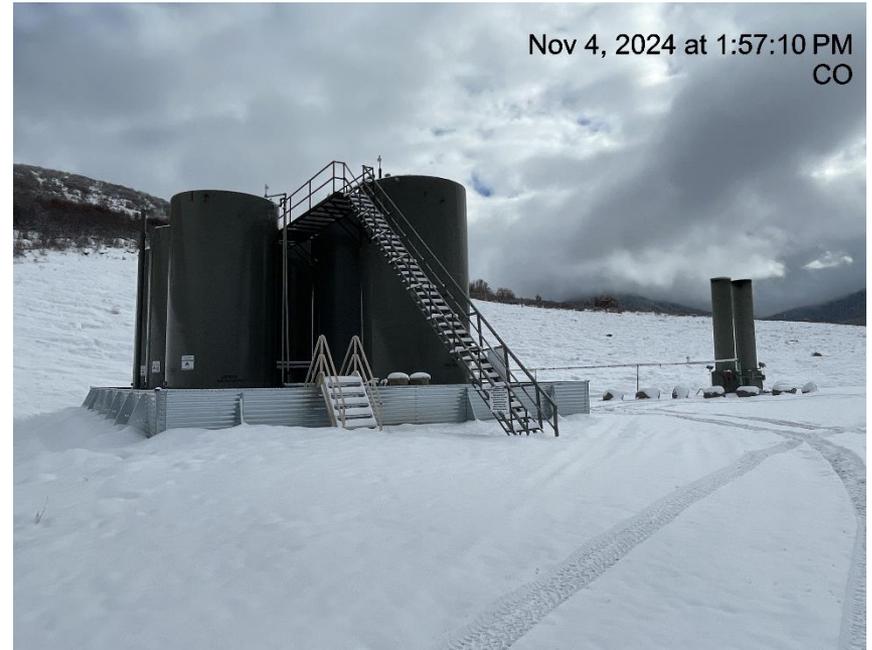
Photo # 8915 Total of seven 500 bbl tanks in battery on location – FORM 2A submitted by operator only lists 6 tanks/operator is out of compliance
