Inspection Photos

Location Name: TEP ROCKY MOUNTAIN LLC ROBINSON A Pad

Location #: 336015

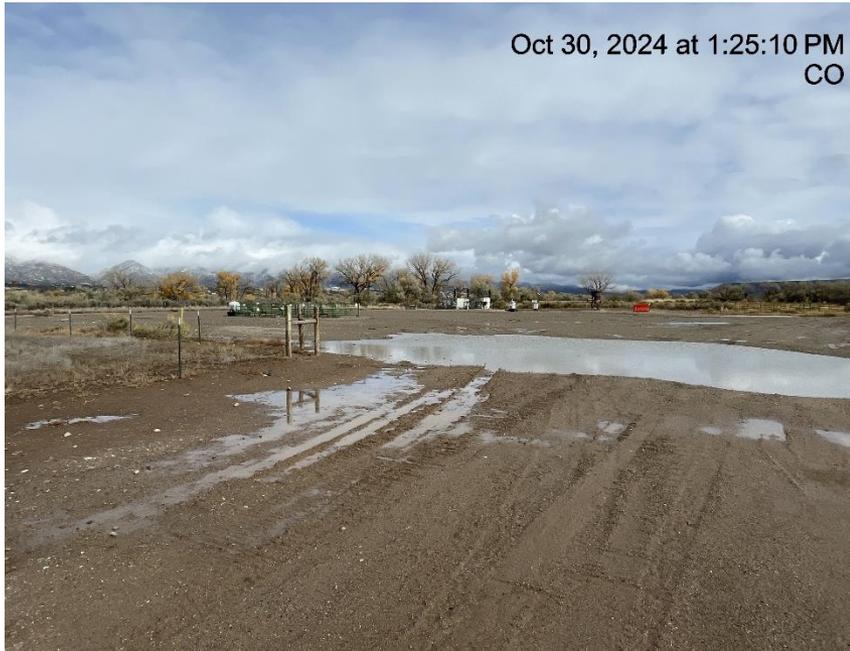
Photo # 8500 From entrance to location

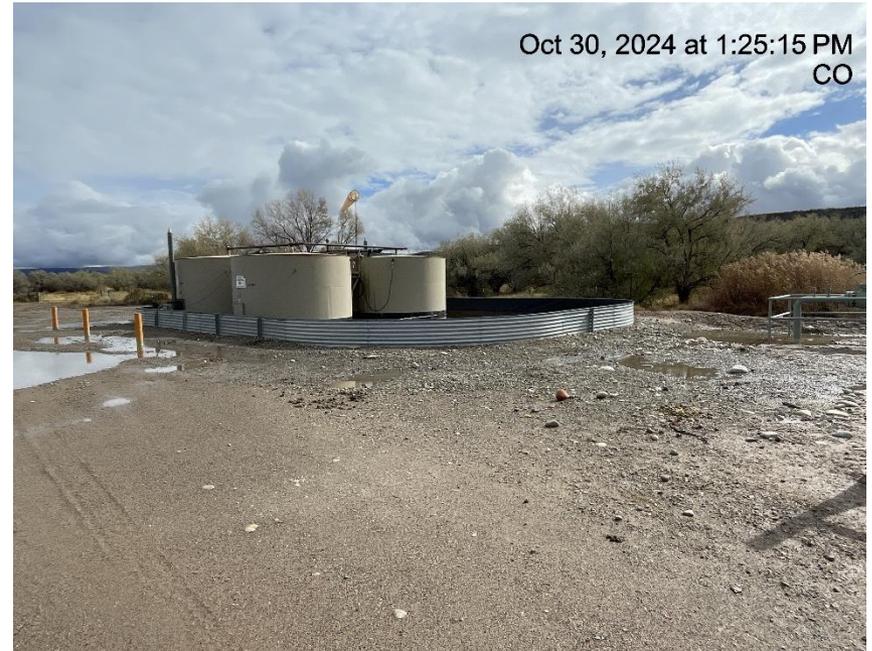
Photo # 8501 From entrance to location

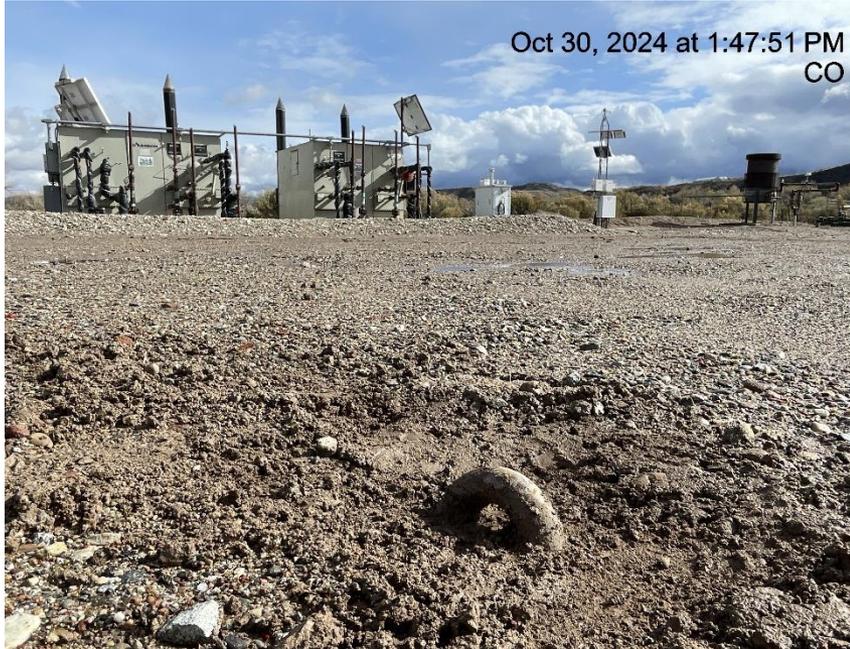
Photo # 8508 Unmarked deadman

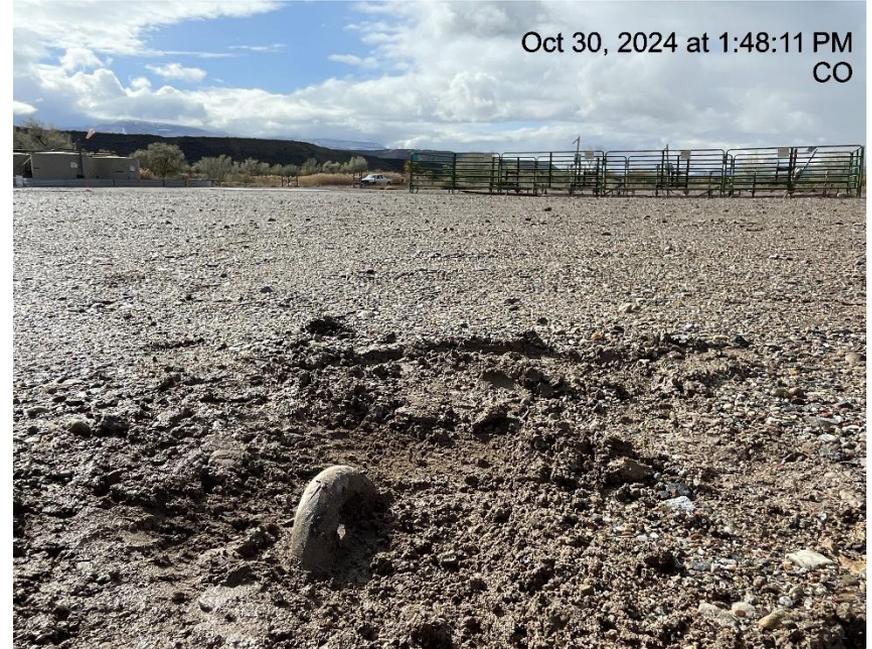
Photo # 8509 Same unmarked deadman

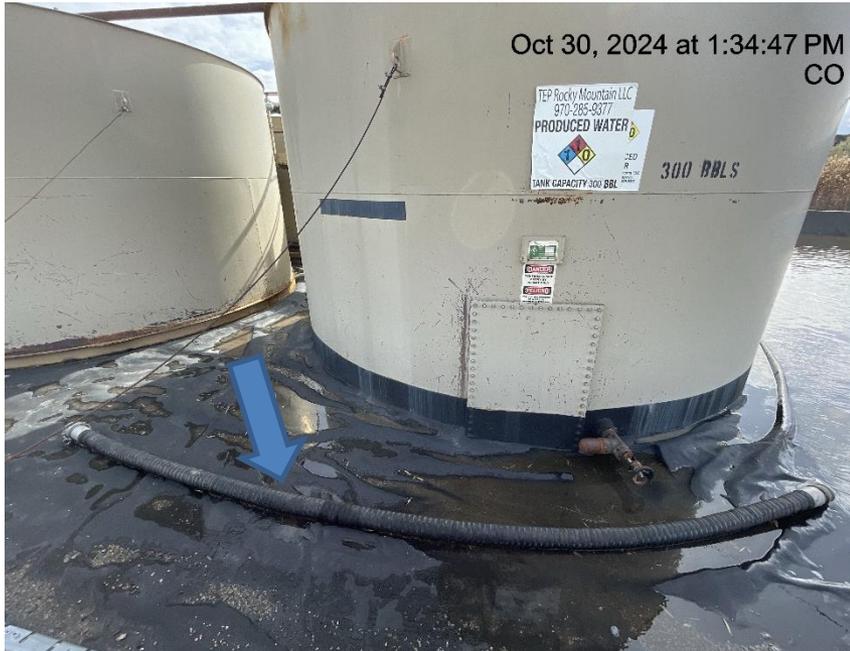
Photo # 8510 Unused equipment

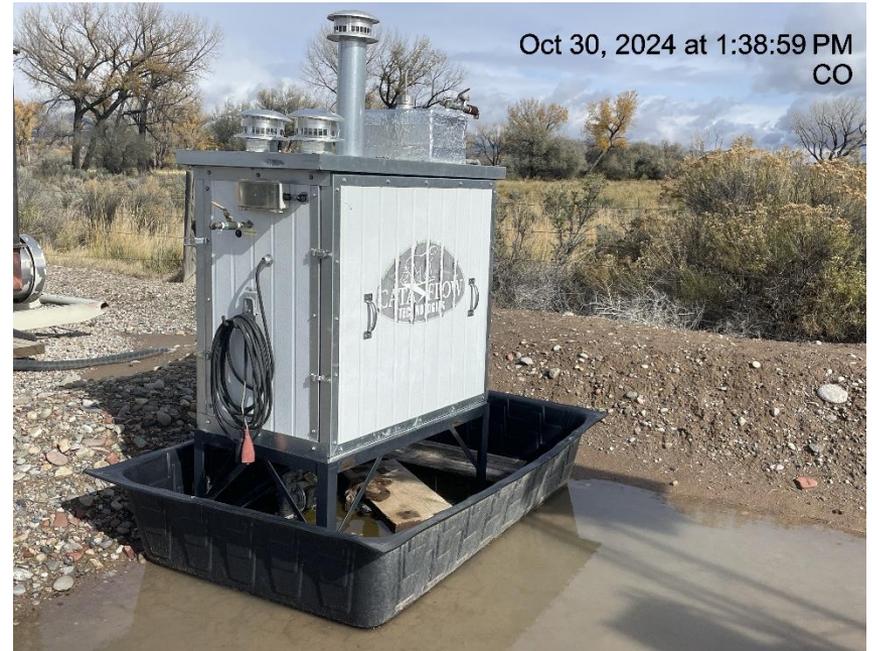
Photo # 8511 Unused equipment

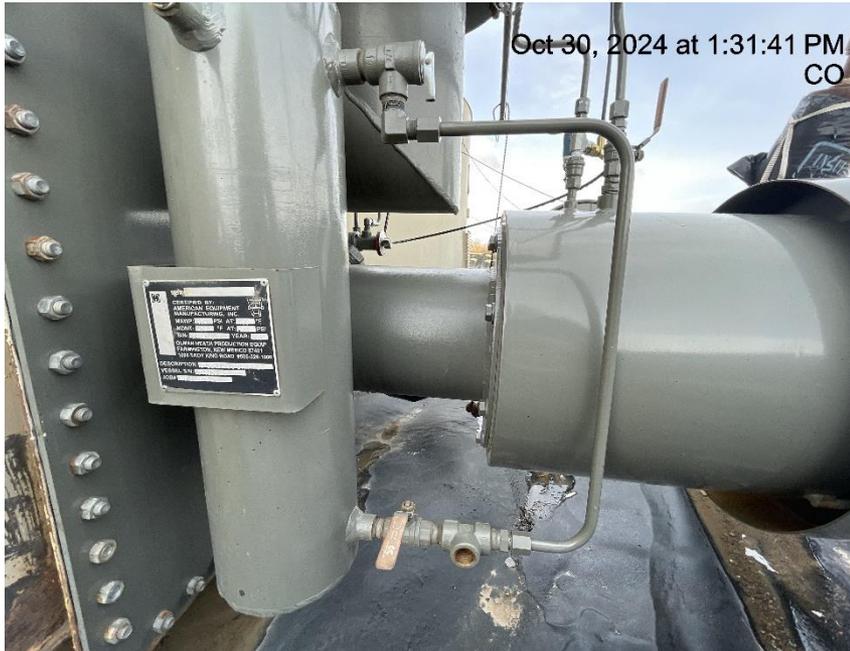
Photo # 8512 PRV vent line does not comply with CECCM pressure safety device rules

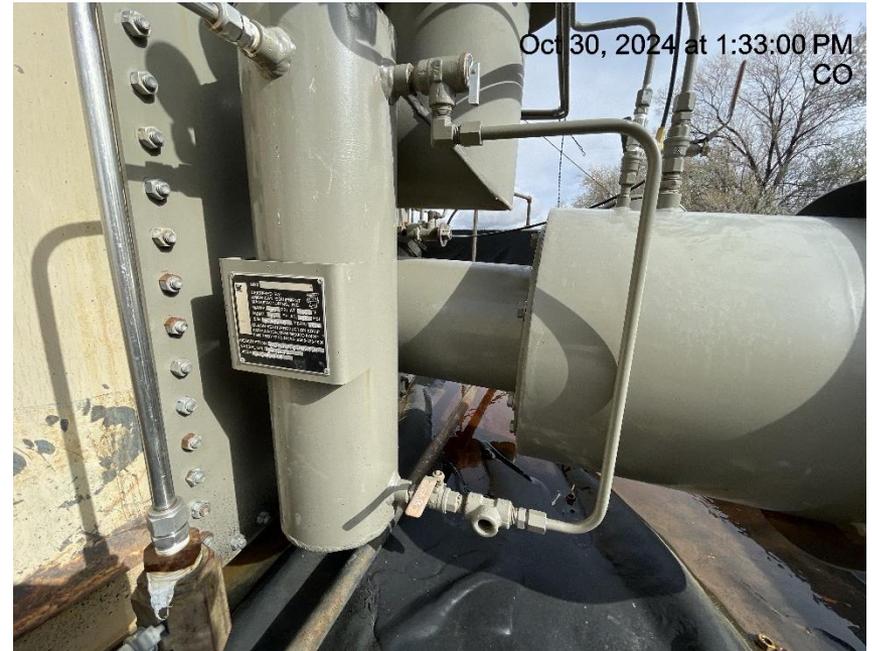
Photo # 8513 PRV vent line does not comply with CECCM pressure safety device rules
