# Site Specific Final Reclamation Completion Notice – Cropland Drone Imagery

## Permit Closure Report – Cropland

**Location Name:** DETTERER-66N67W/24NWSE

8/21/2024

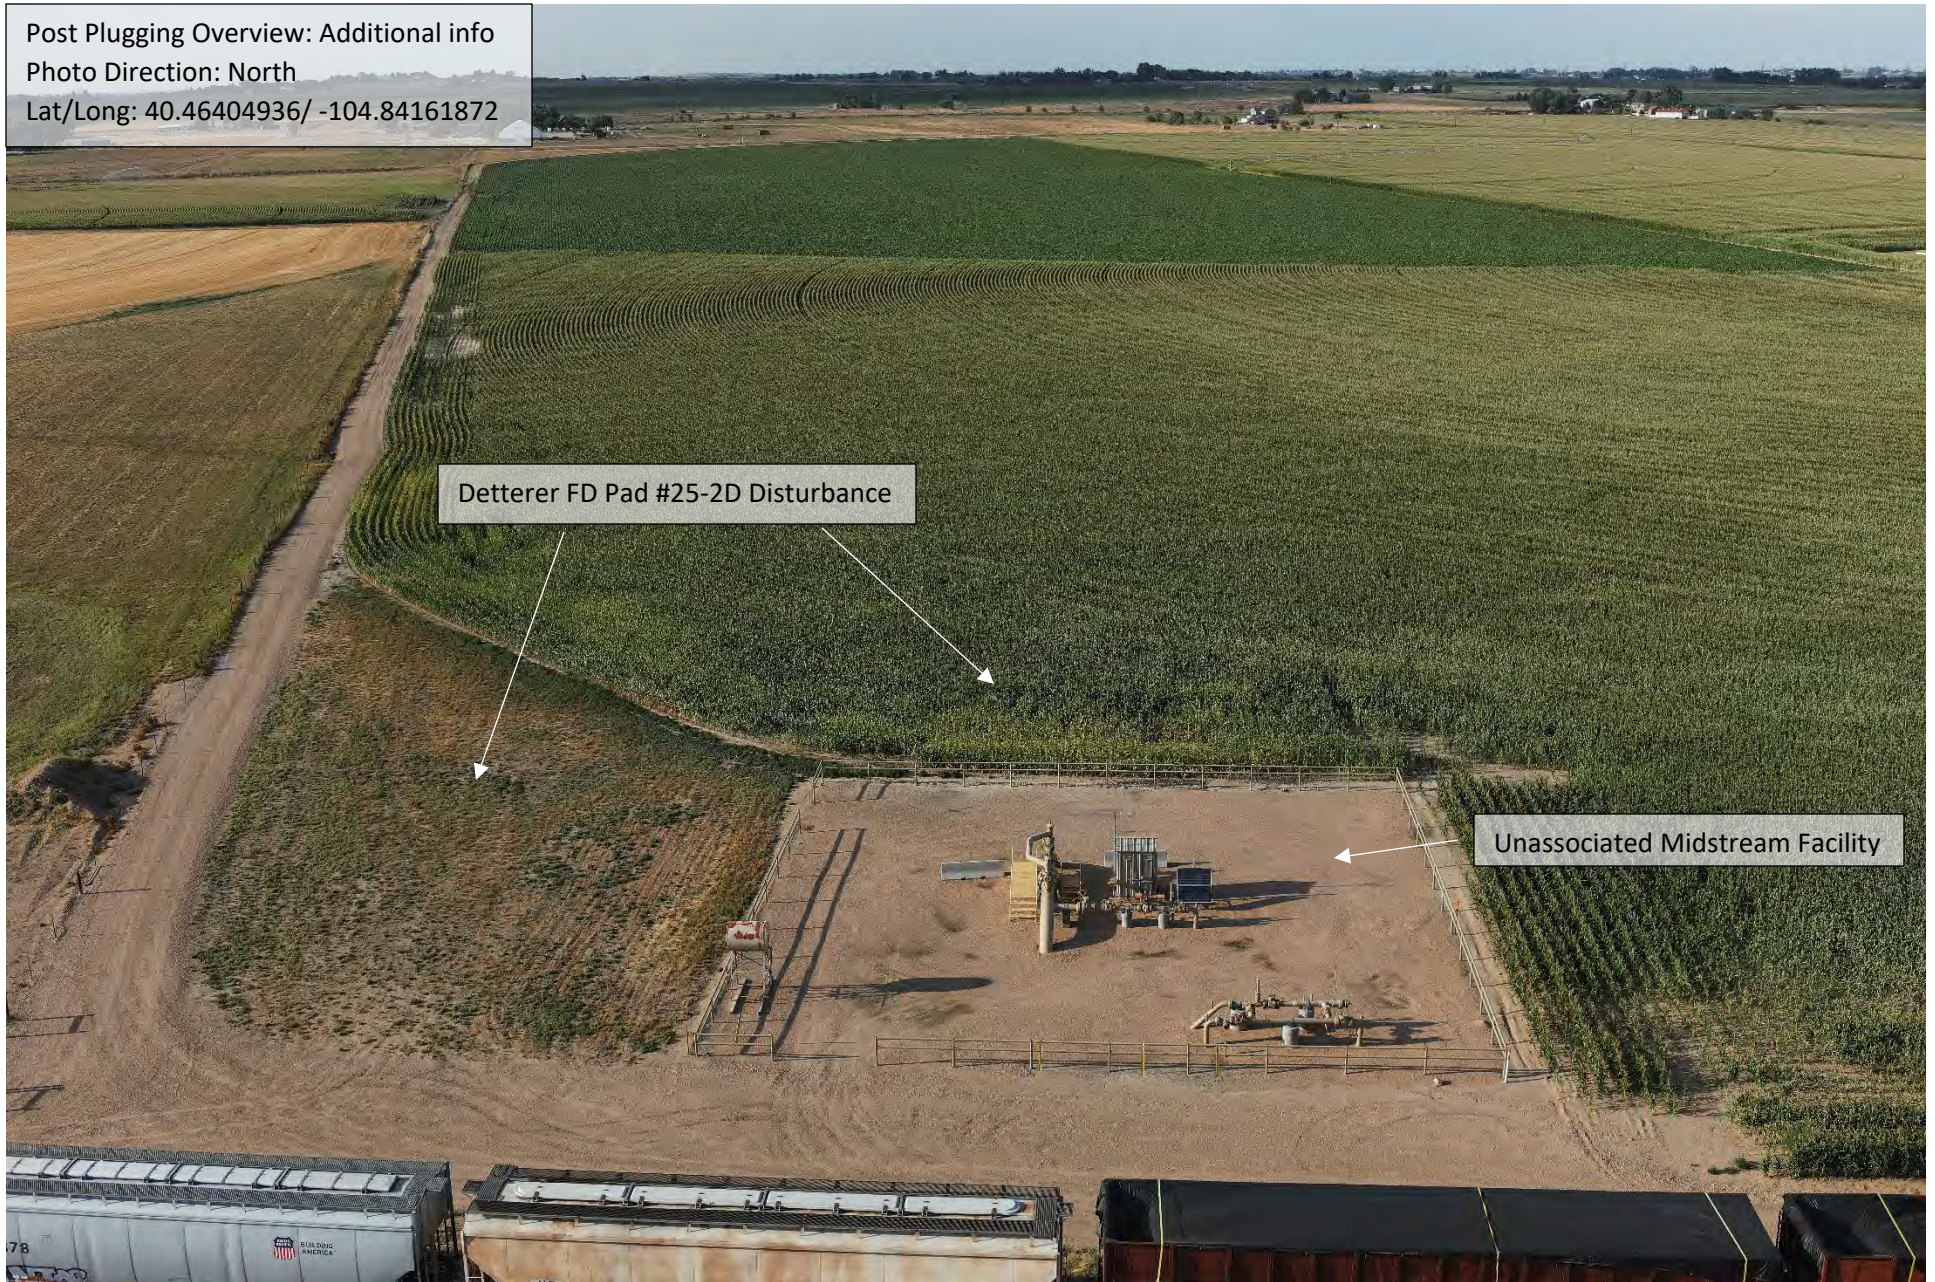
Post Plugging Overview: Additional info  
Photo Direction: North  
Lat/Long: 40.46404936/ -104.84161872

Detterer FD Pad #25-2D Disturbance

Unassociated Midstream Facility

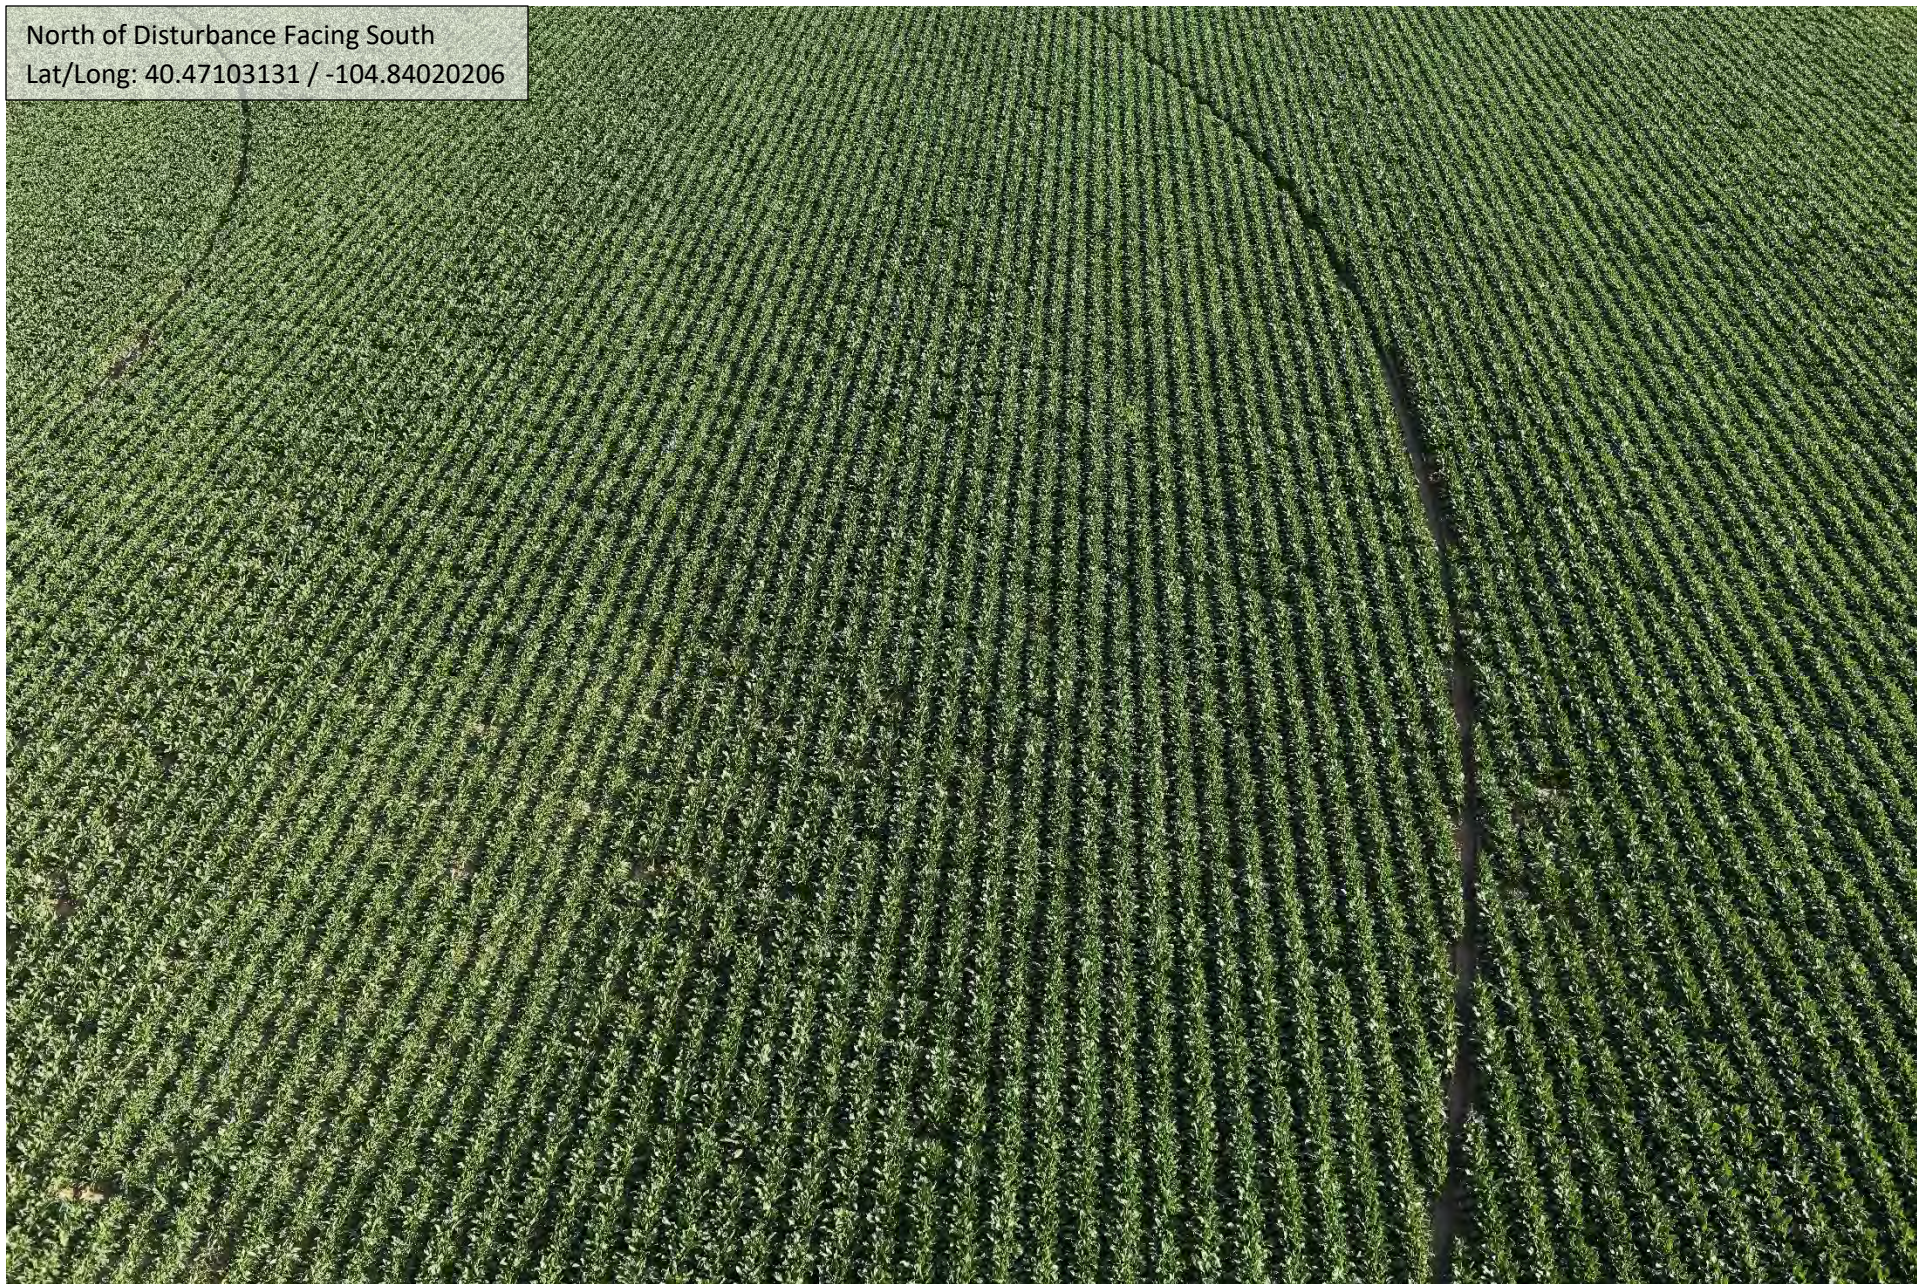
North of Disturbance Facing South  
Lat/Long: 40.47103131 / -104.84020206

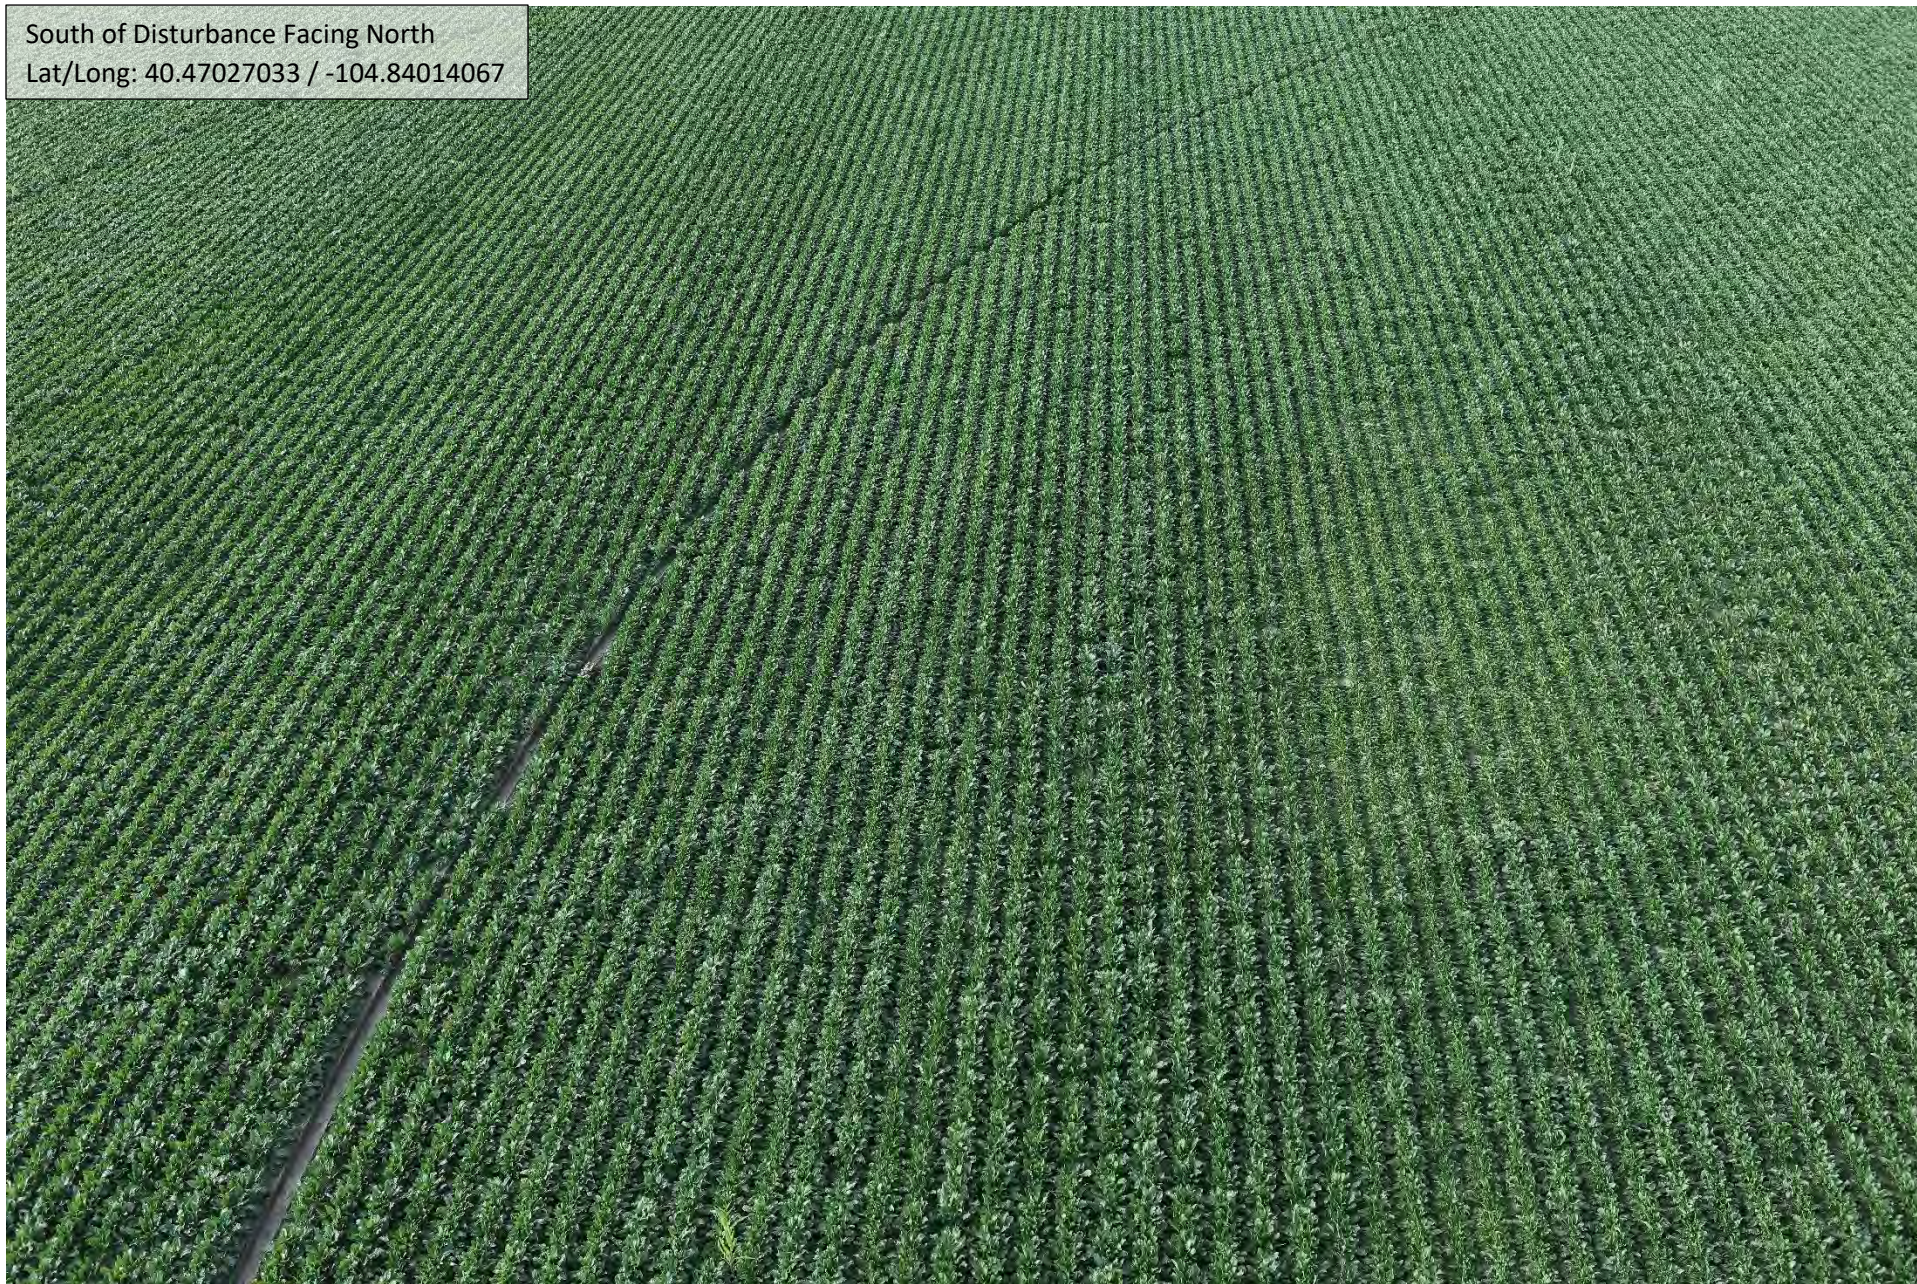
South of Disturbance Facing North  
Lat/Long: 40.47027033 / -104.84014067

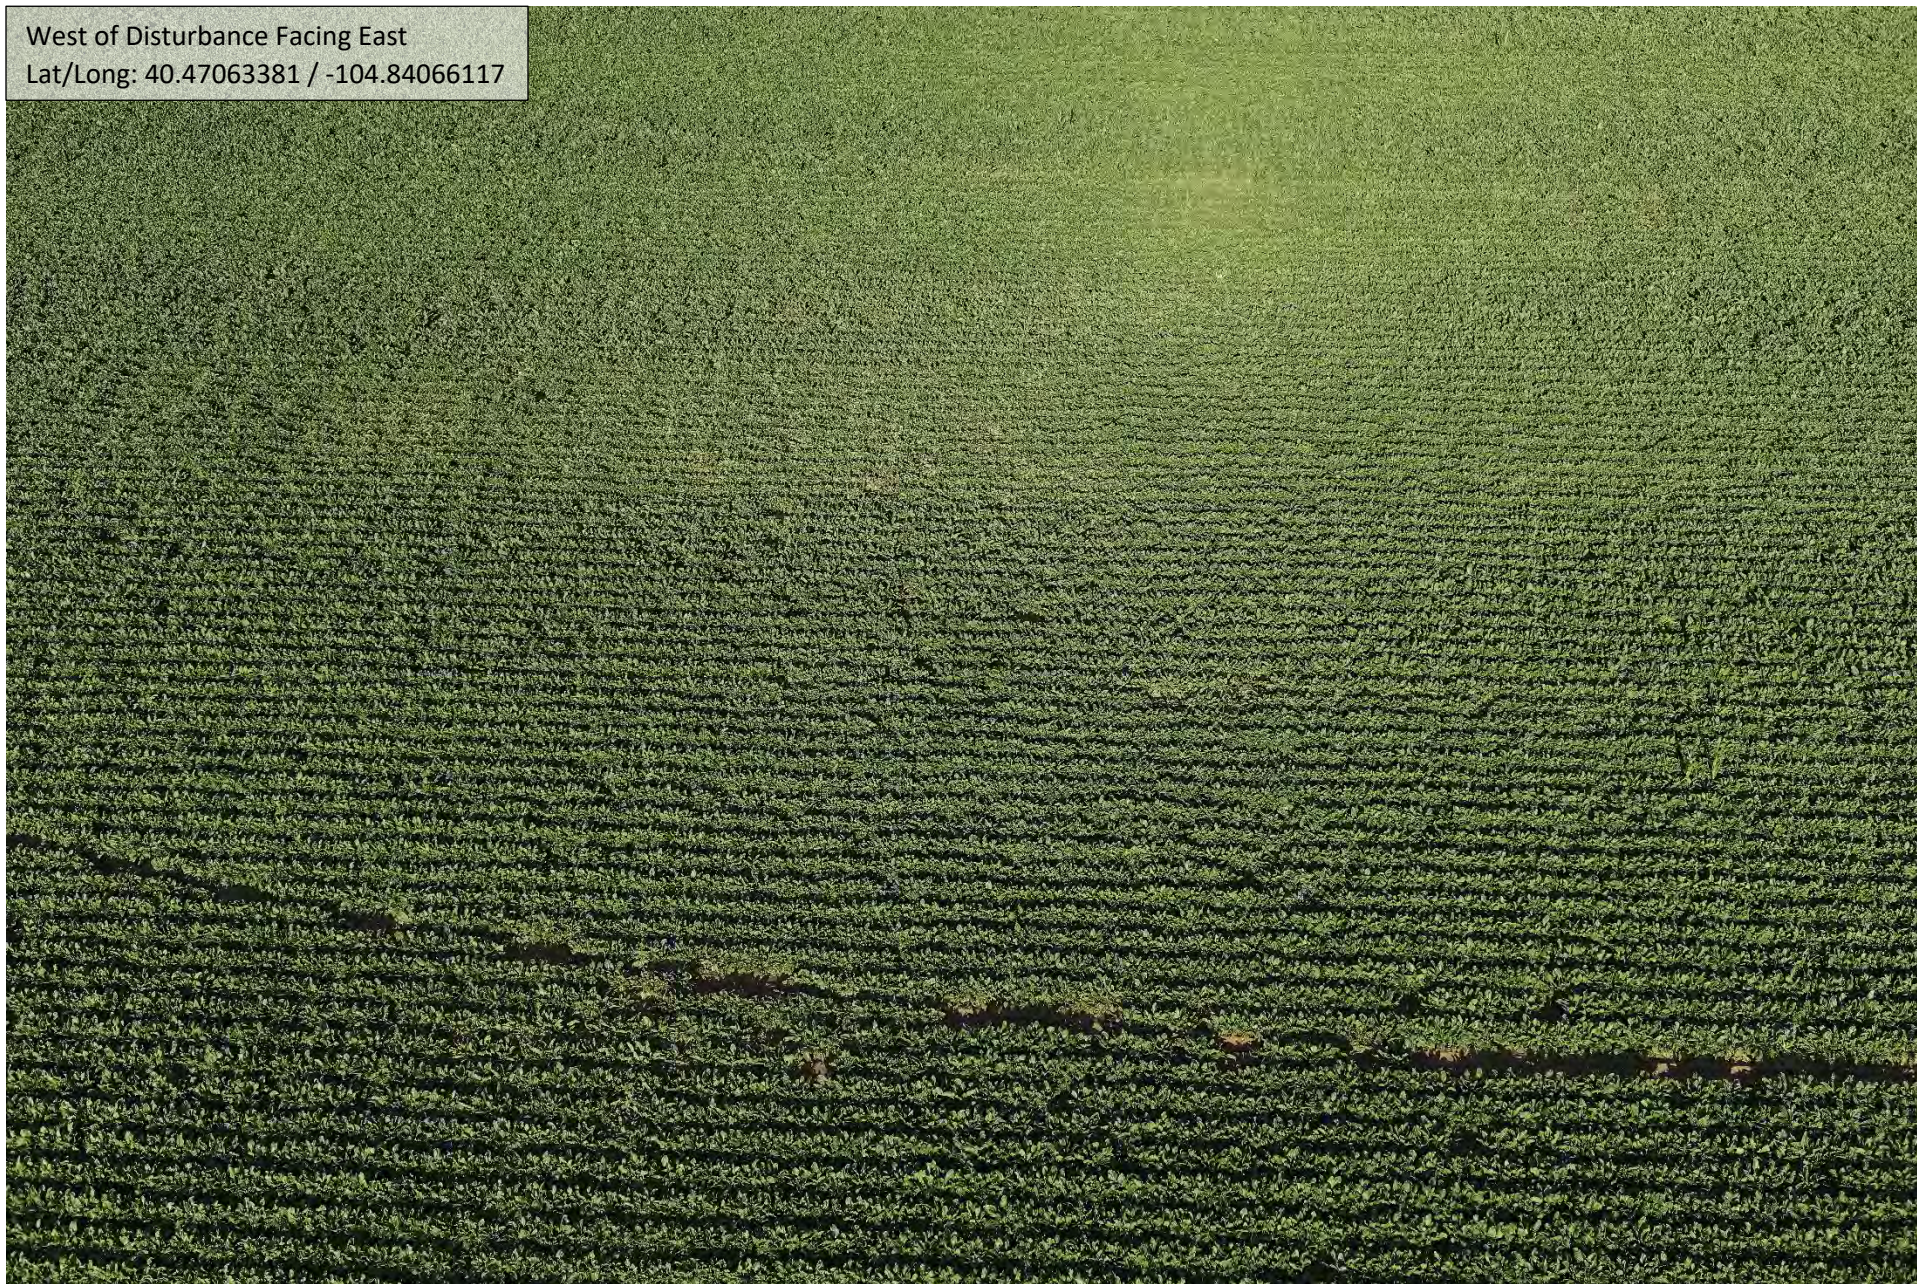
West of Disturbance Facing East  
Lat/Long: 40.47063381 / -104.84066117

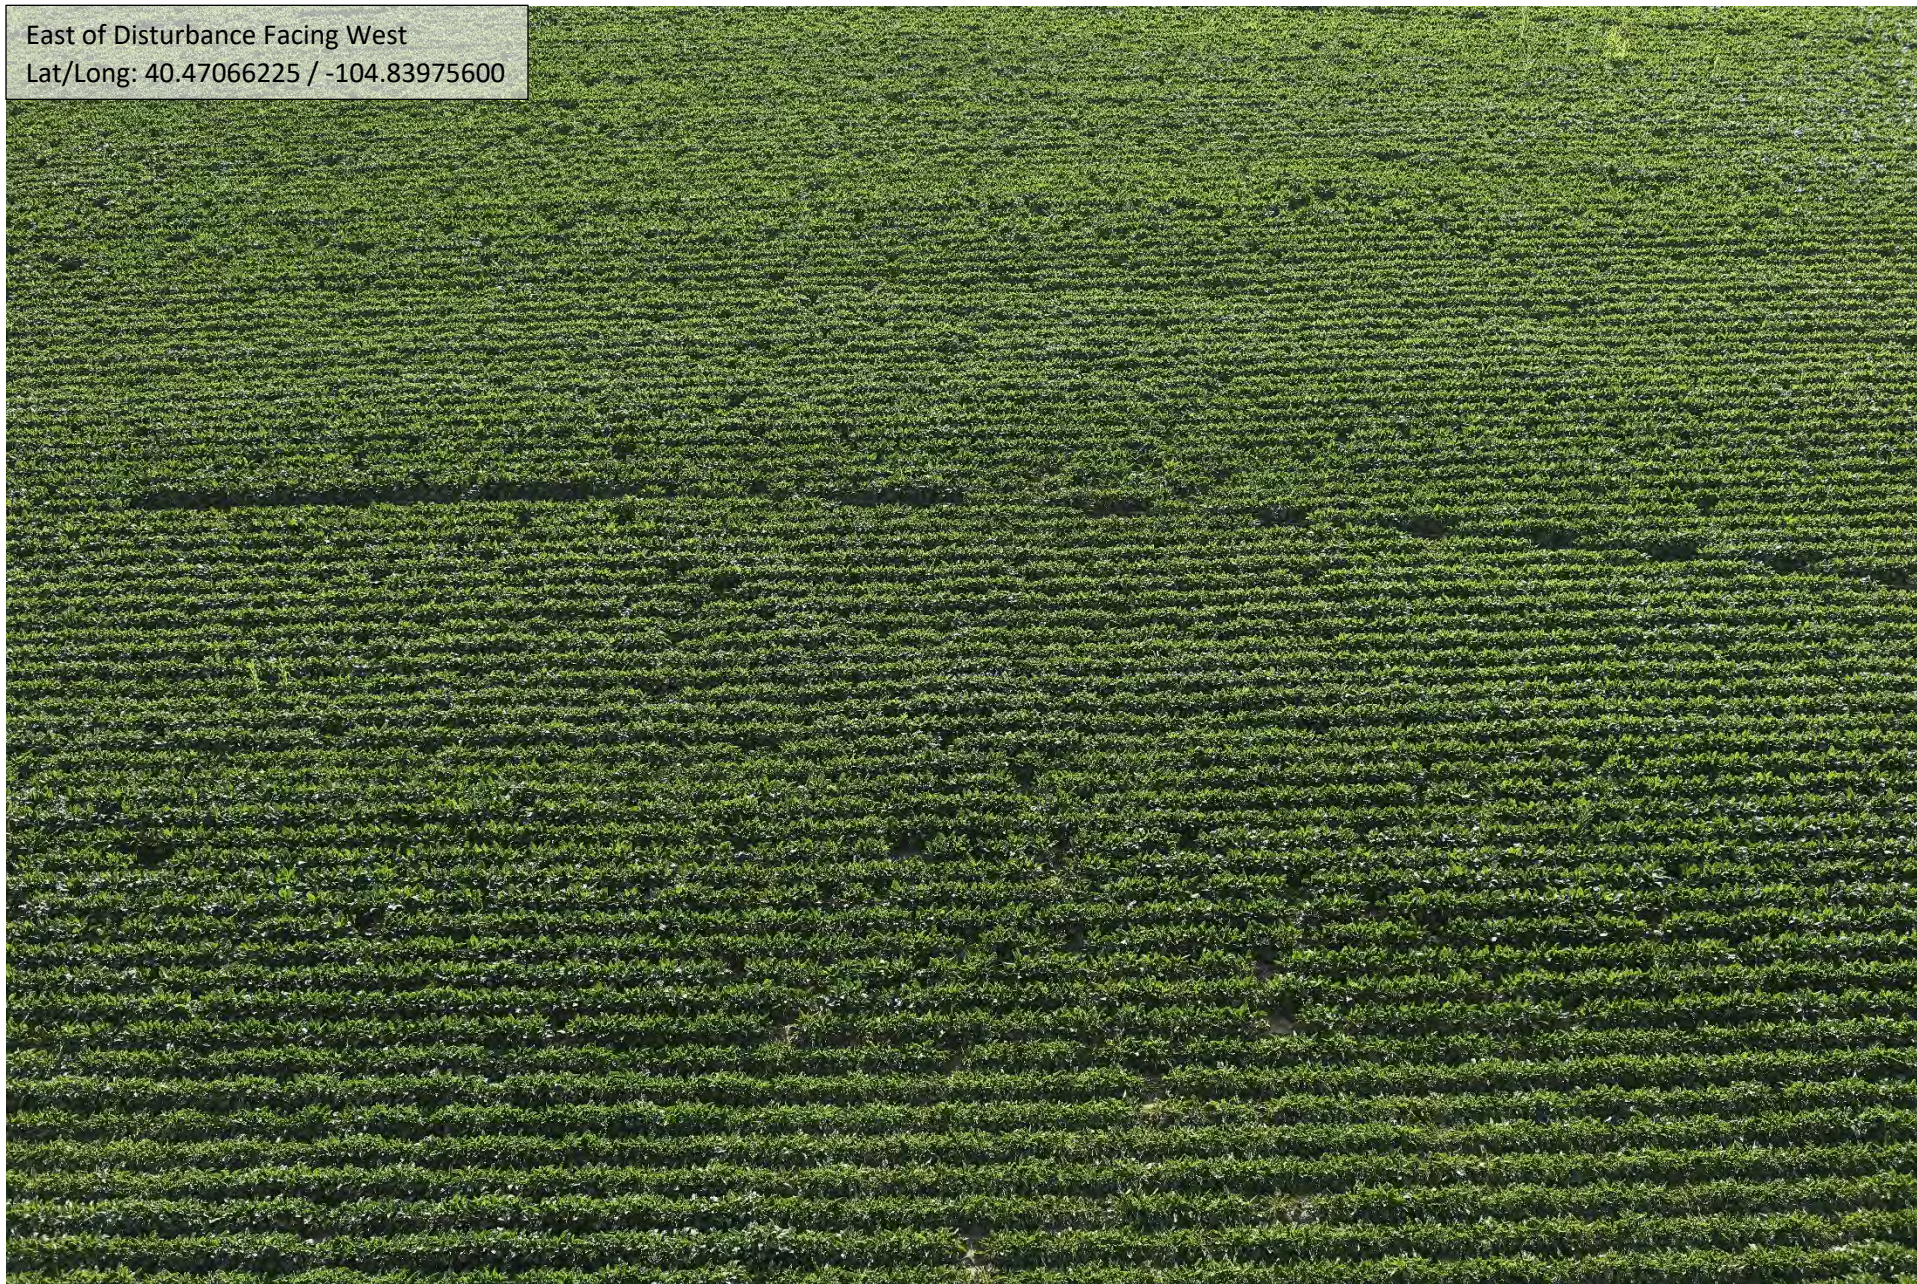
East of Disturbance Facing West  
Lat/Long: 40.47066225 / -104.83975600

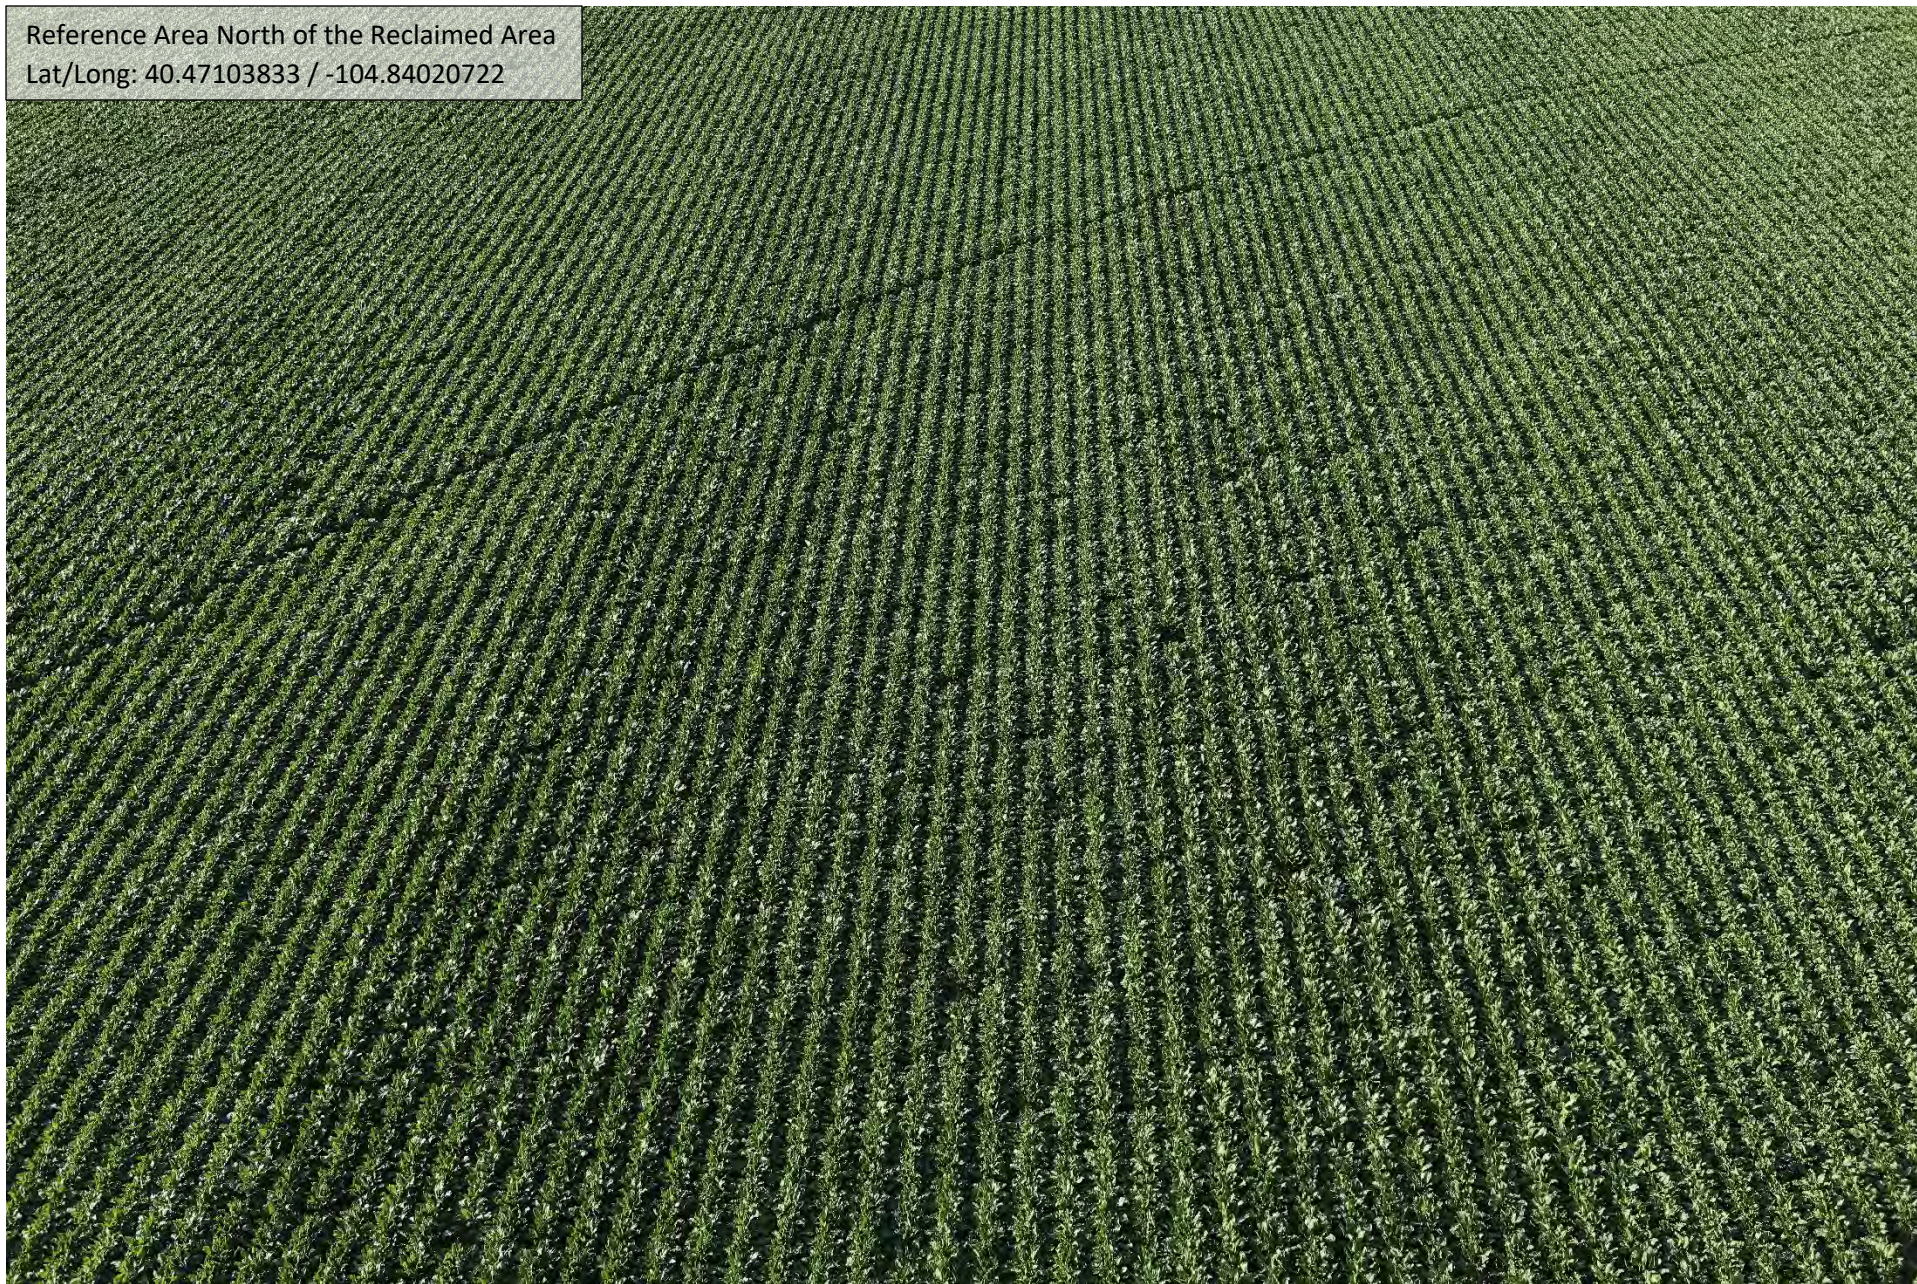
Reference Area North of the Reclaimed Area  
Lat/Long: 40.47103833 / -104.84020722

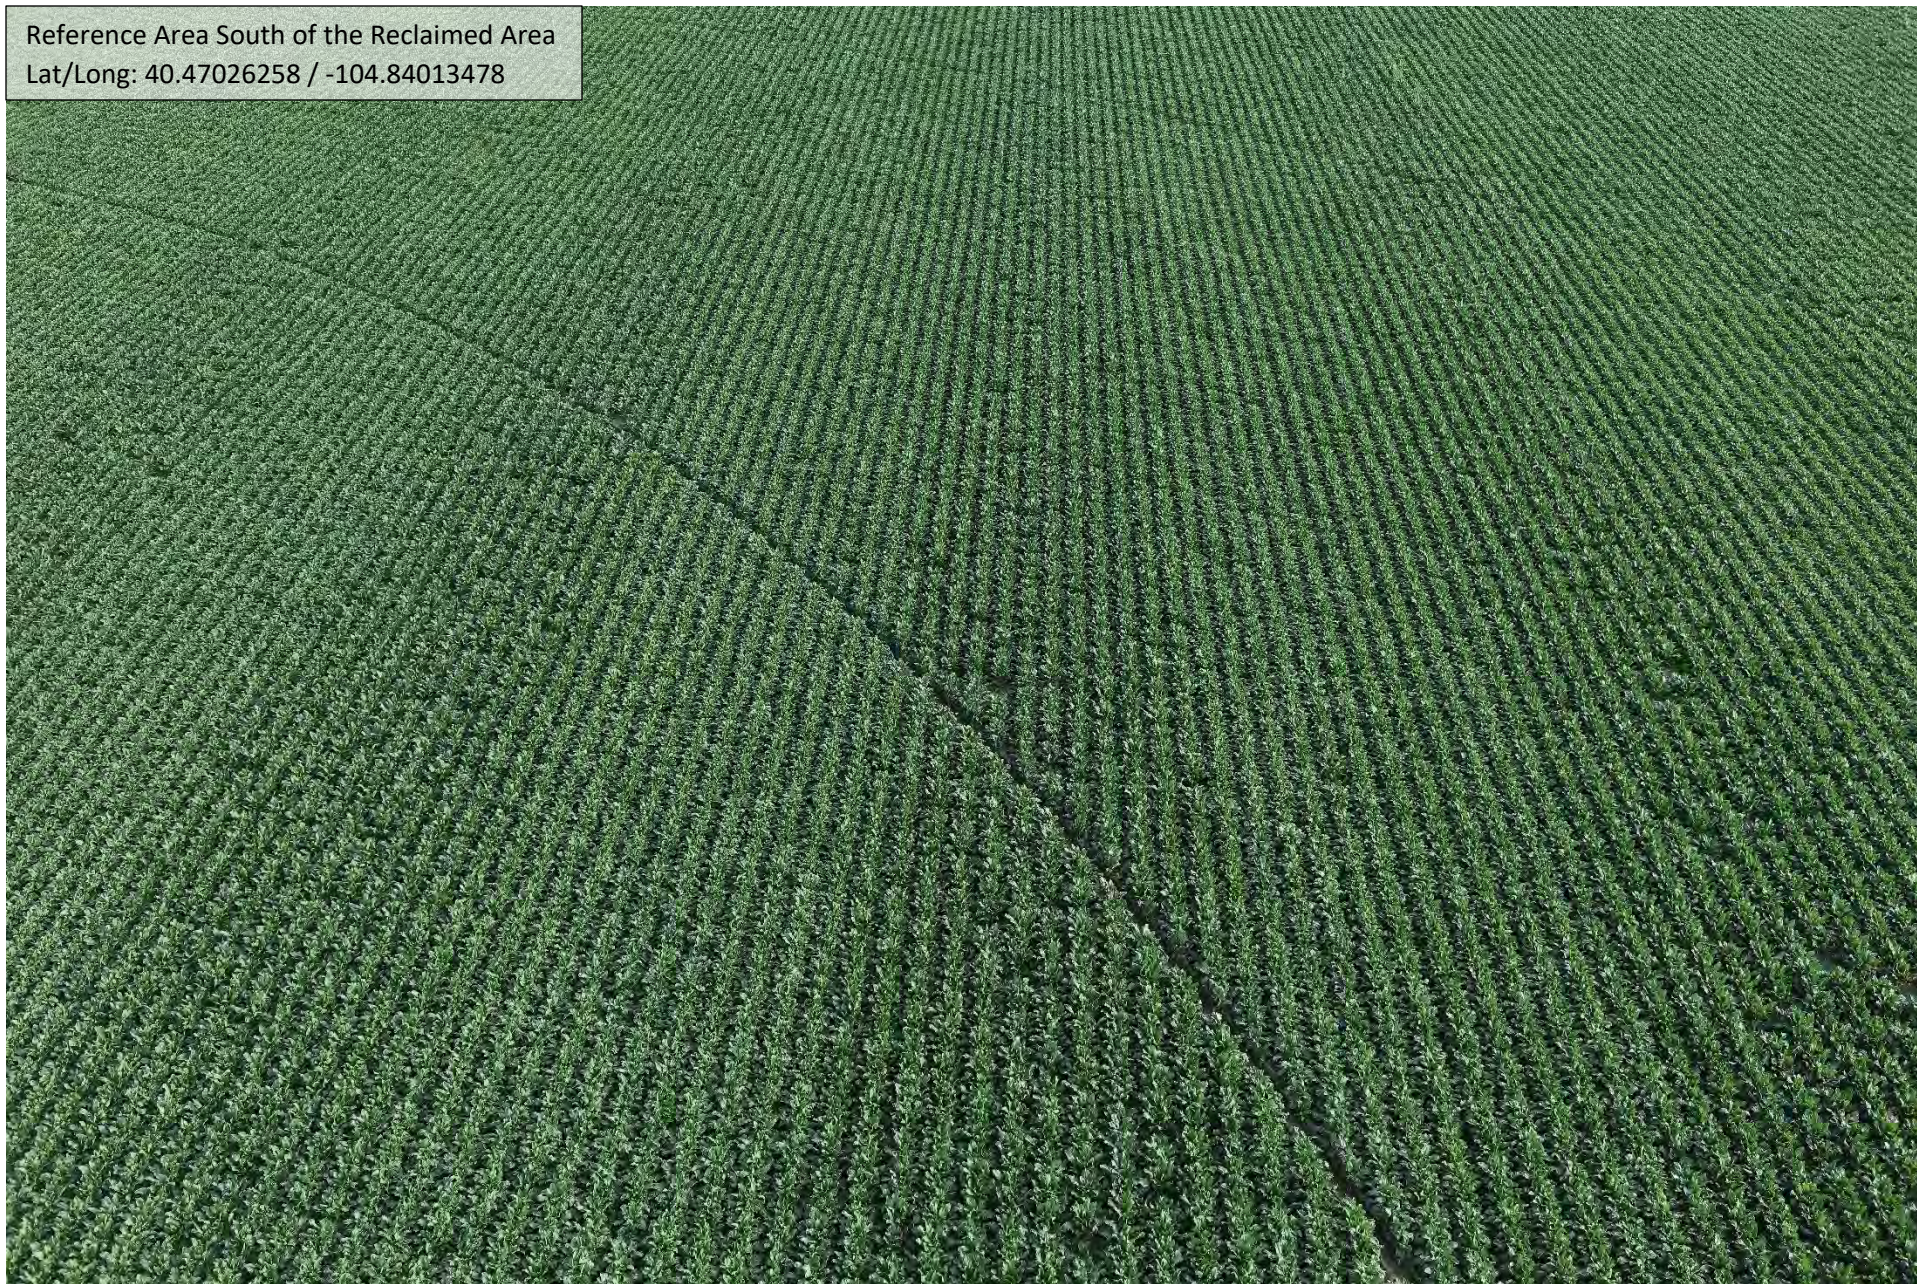
Reference Area South of the Reclaimed Area  
Lat/Long: 40.47026258 / -104.84013478

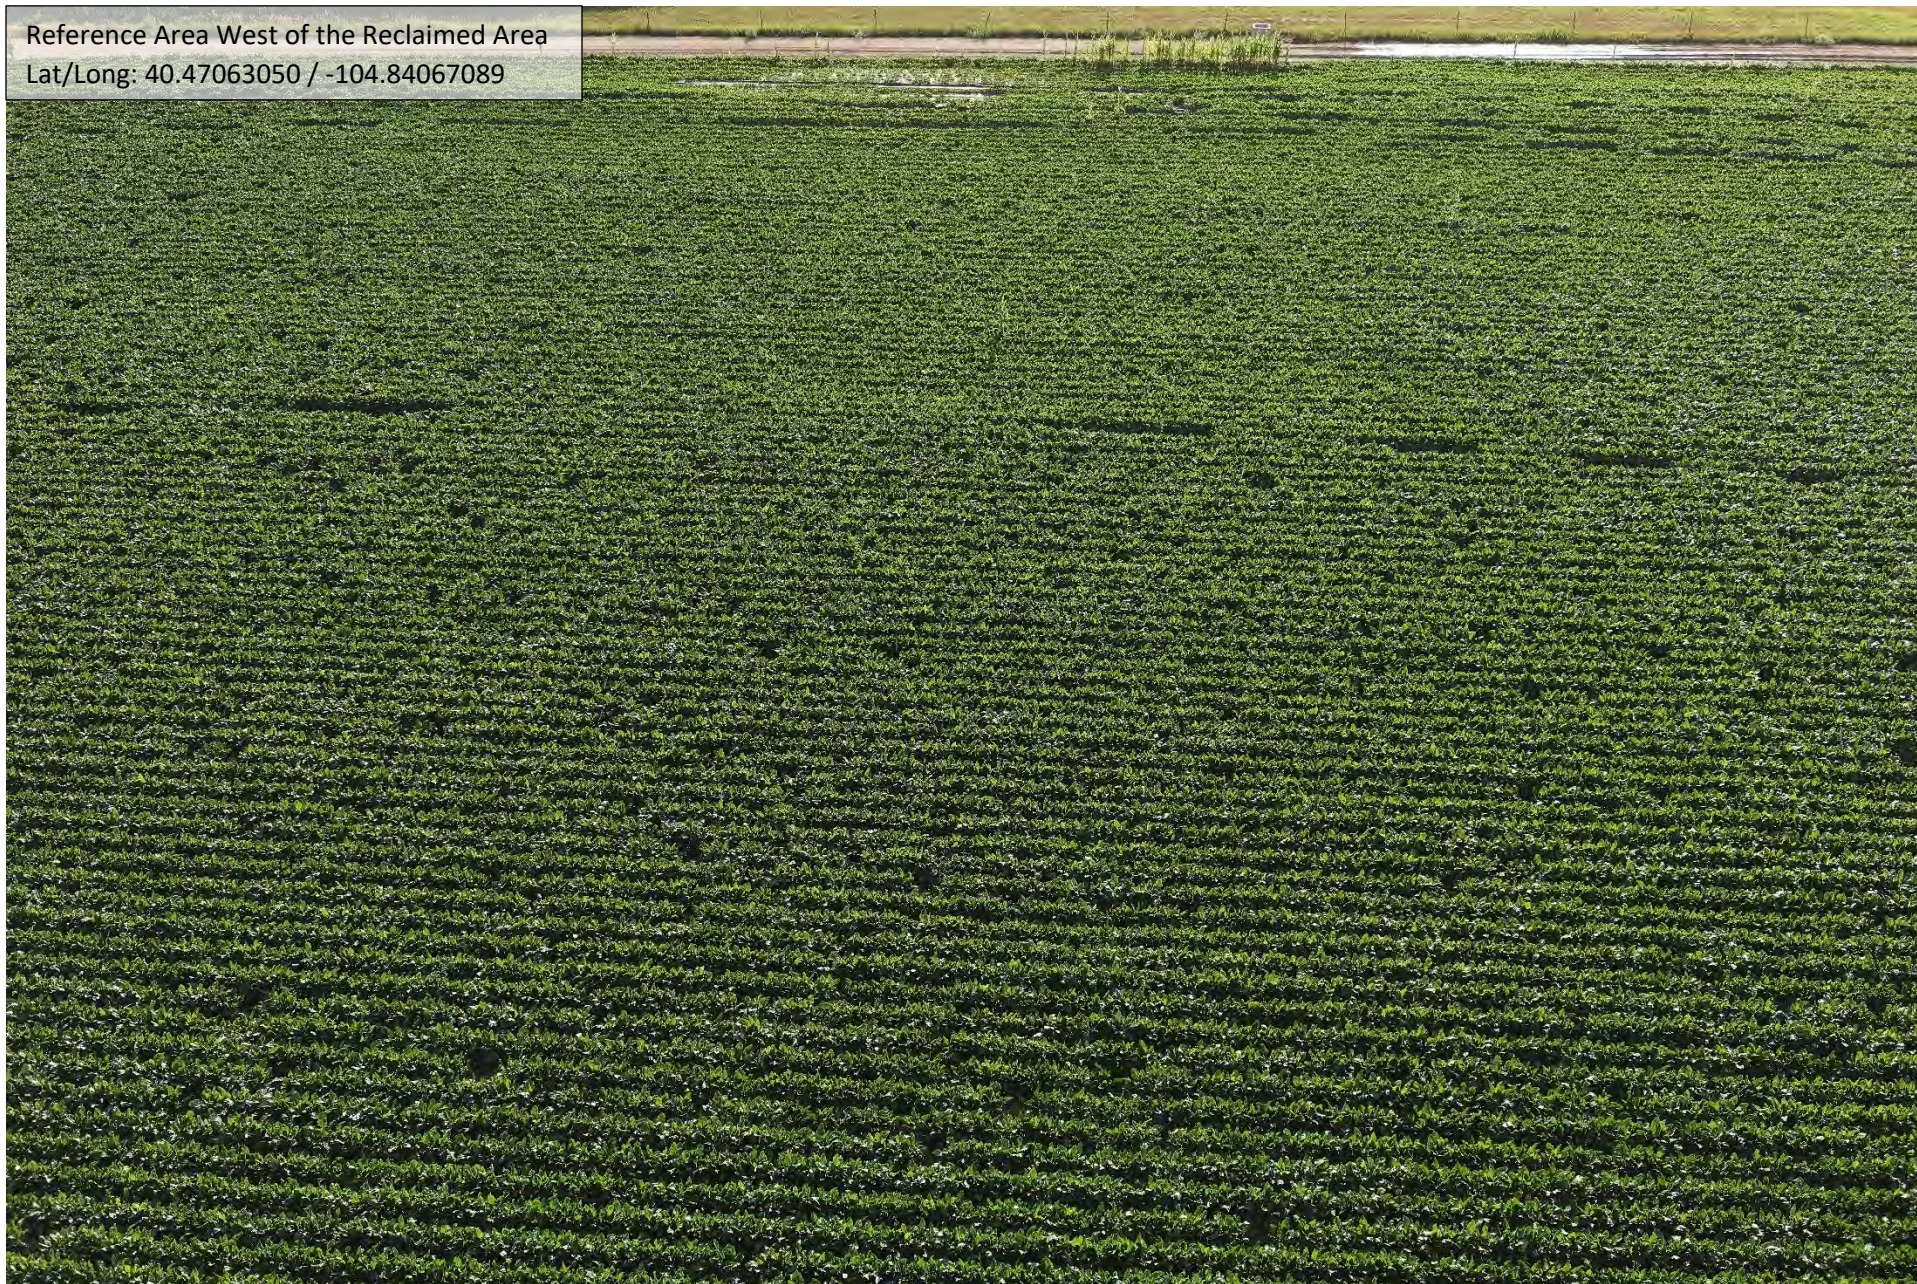
Reference Area West of the Reclaimed Area  
Lat/Long: 40.47063050 / -104.84067089

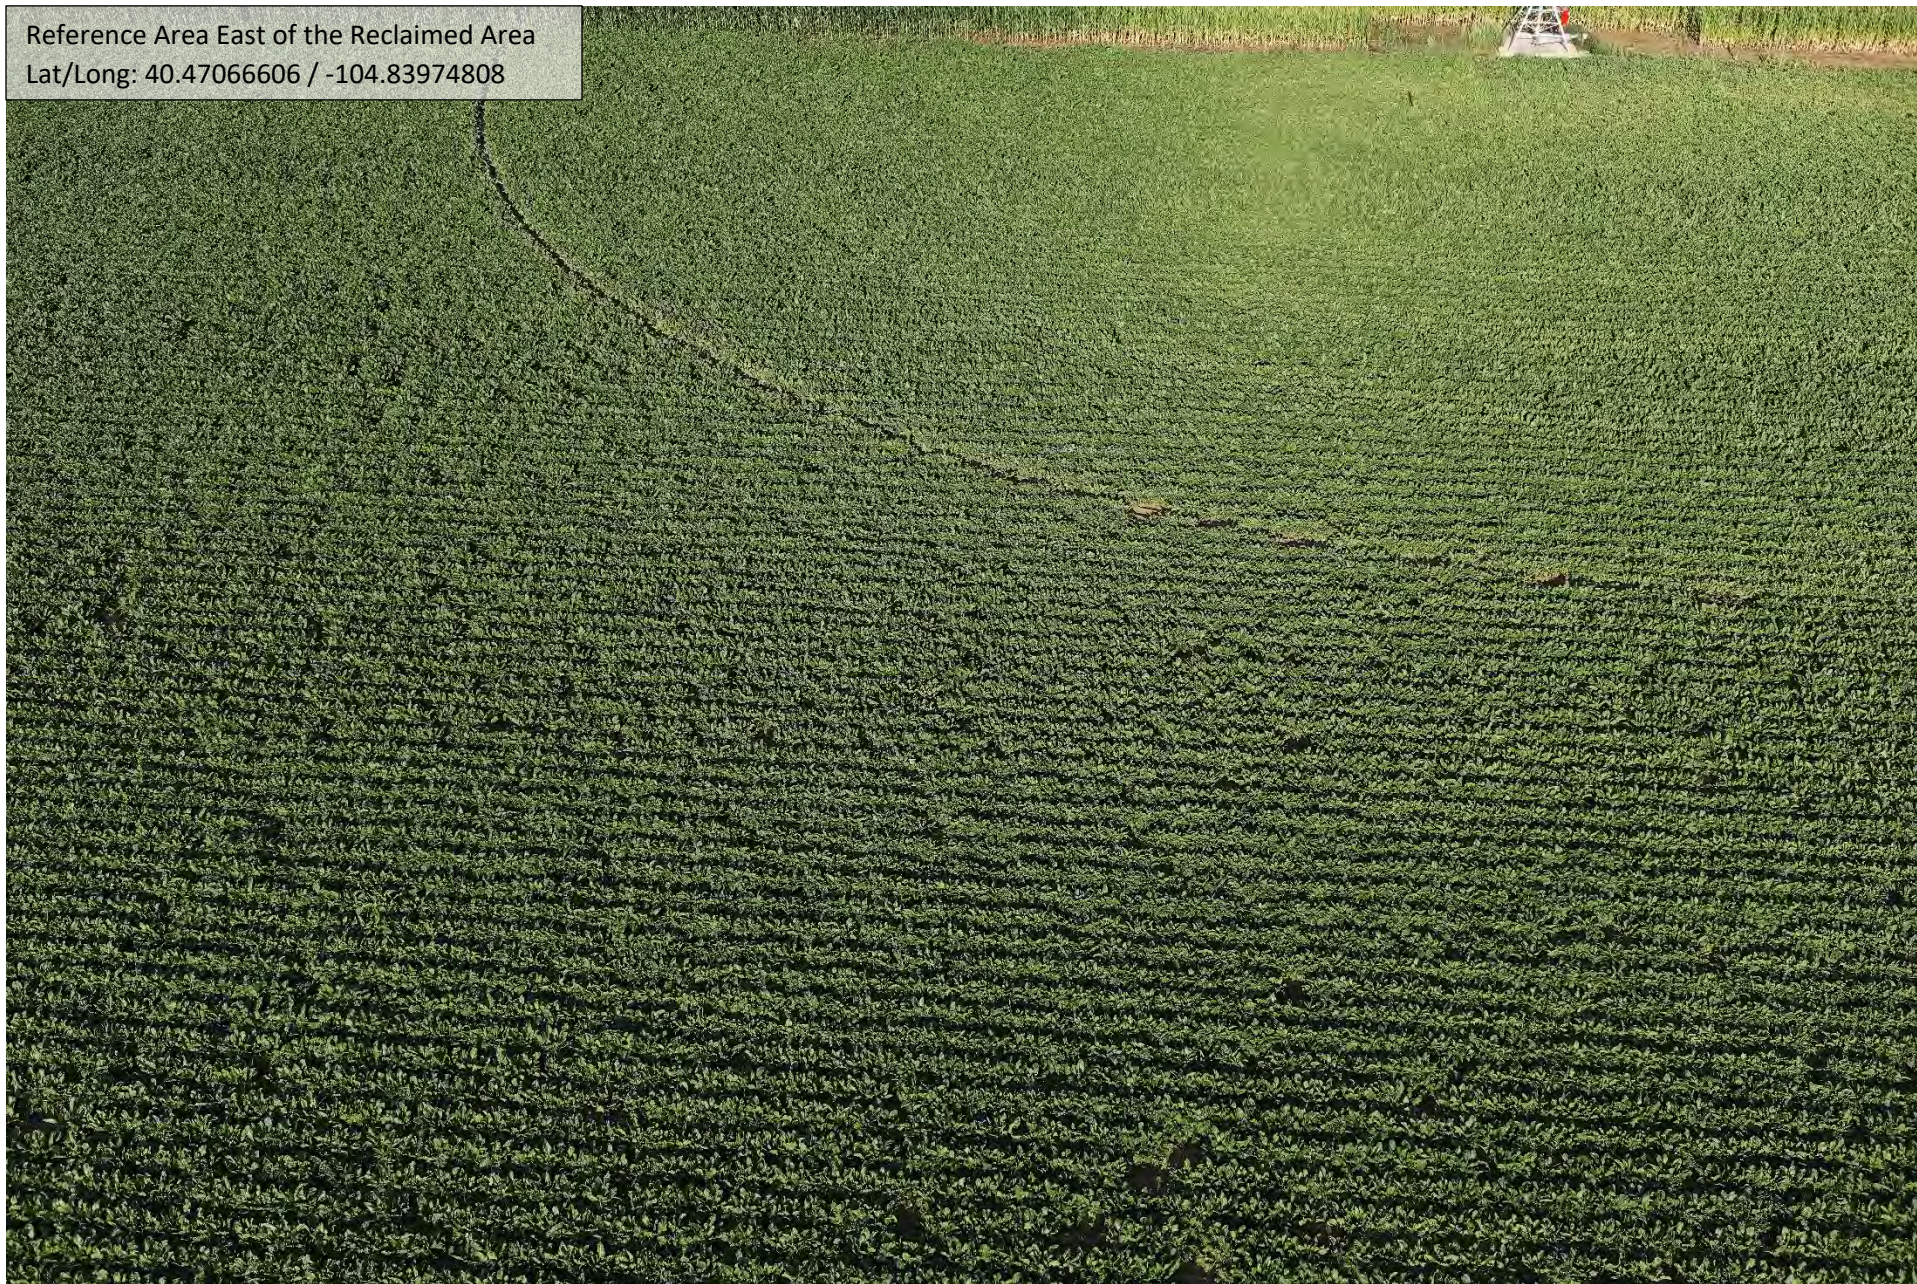
Reference Area East of the Reclaimed Area  
Lat/Long: 40.47066606 / -104.83974808
