# Site Specific Final Reclamation Completion Notice – Cropland Drone Imagery

## Permit Closure Report – Cropland

**Location Name:** DETTERER-66N67W/24NWSE

8/21/2024

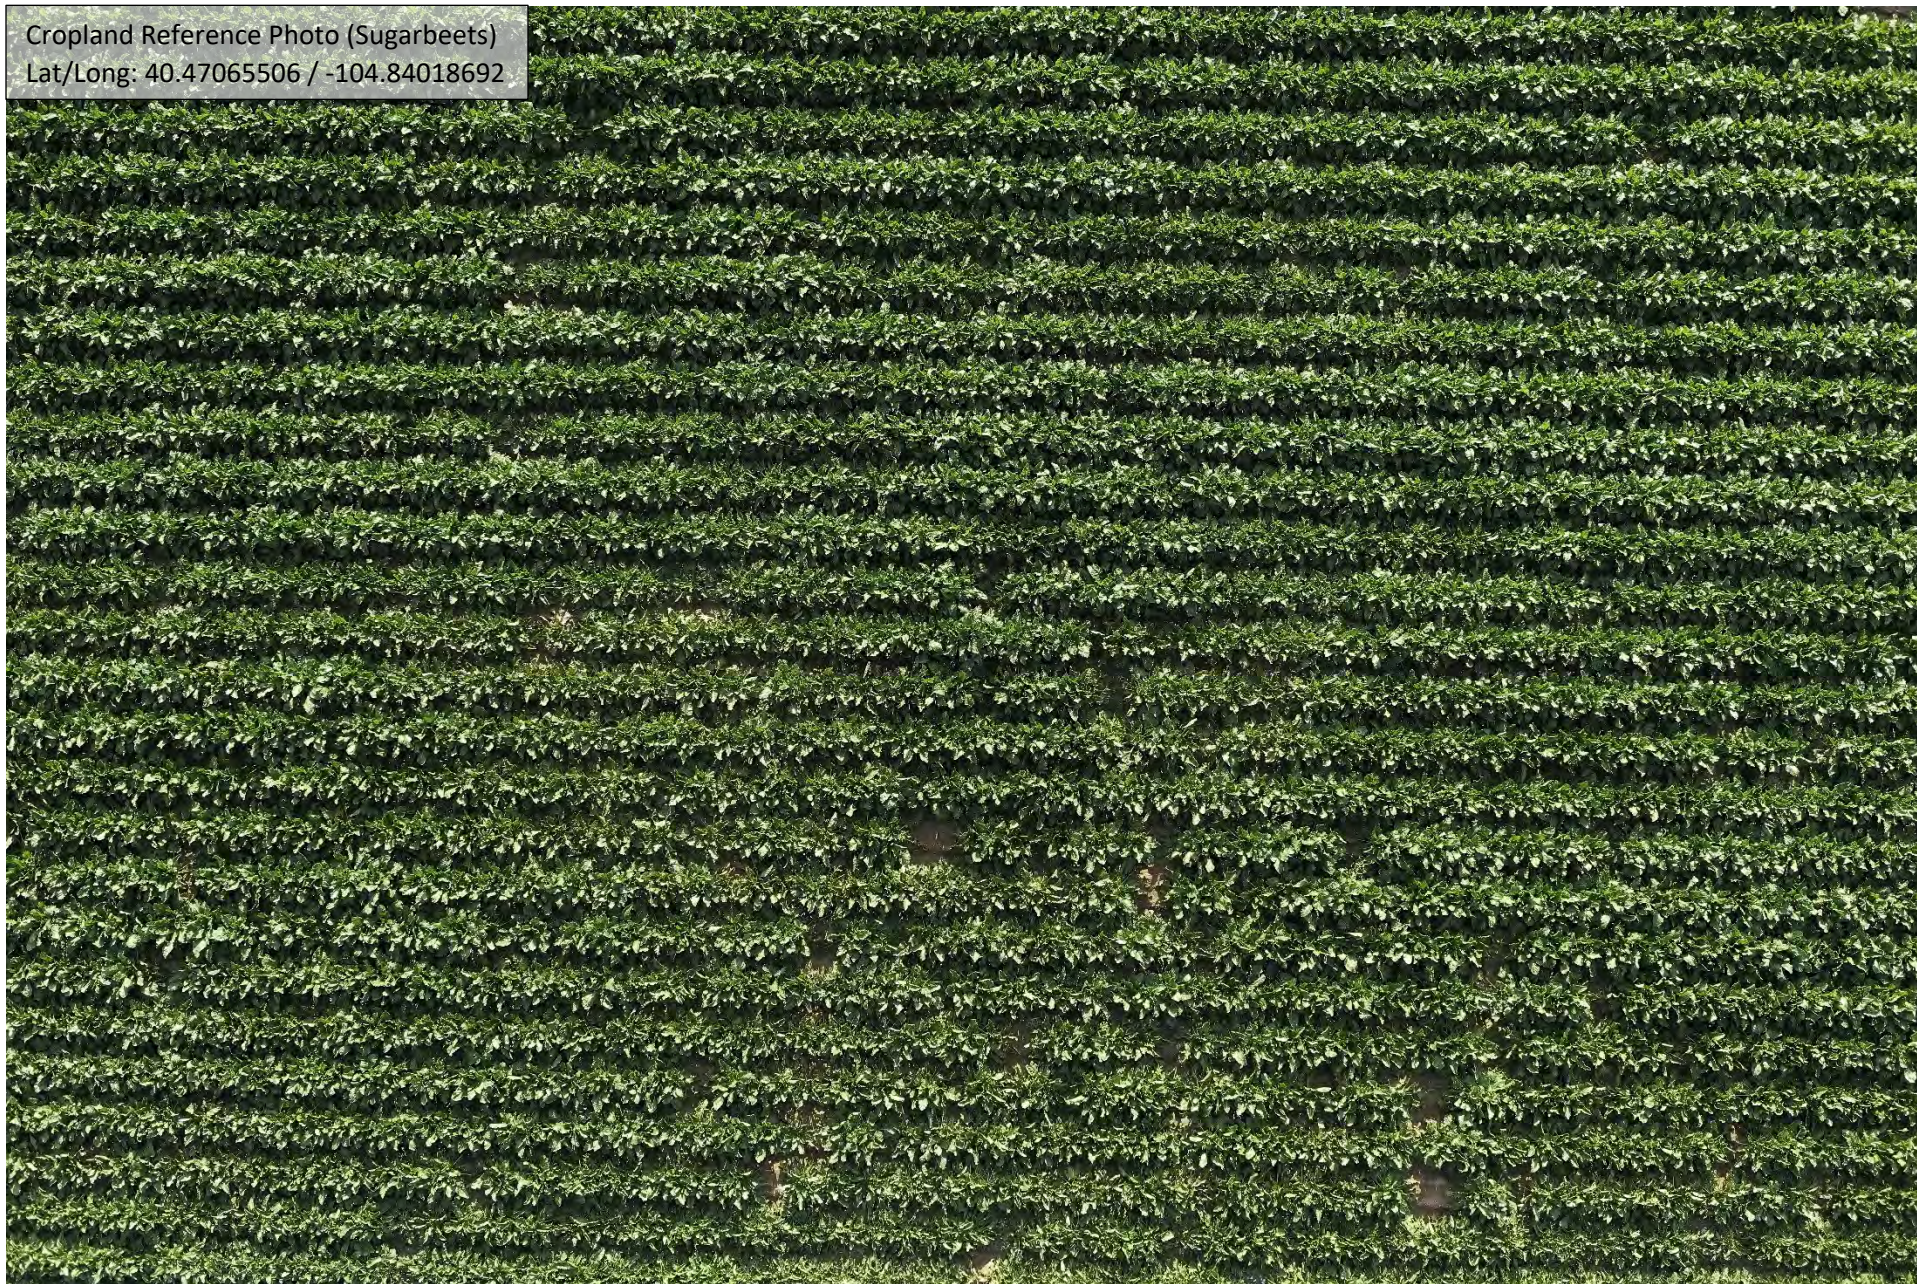
Cropland Reference Photo (Sugarbeets)  
Lat/Long: 40.47065506 / -104.84018692

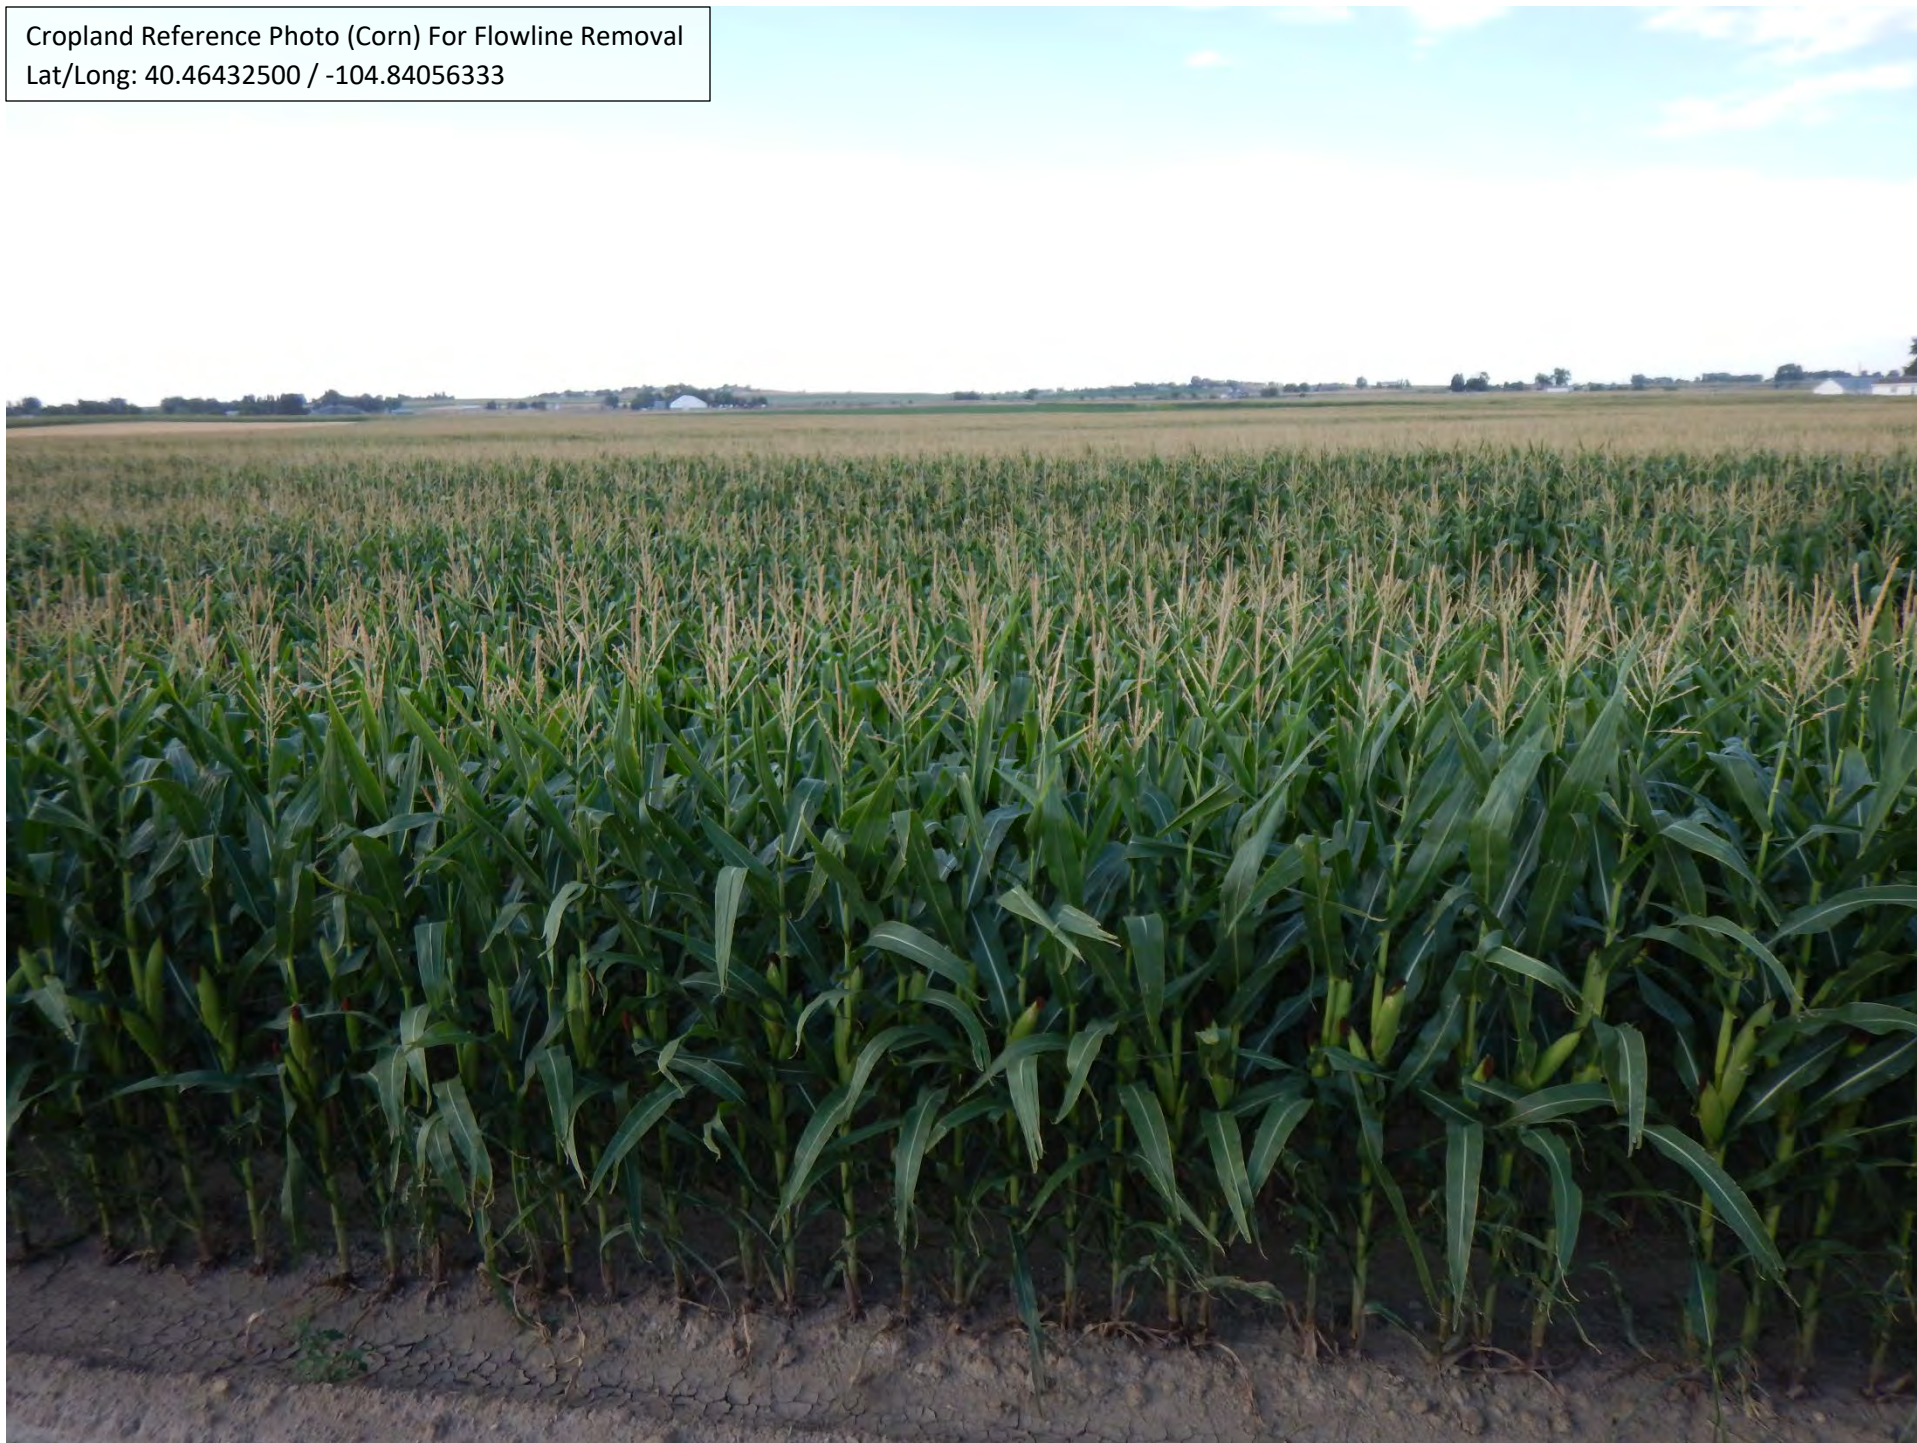
Cropland Reference Photo (Corn) For Flowline Removal  
Lat/Long: 40.46432500 / -104.84056333
