Inspection Photos

Location Name: TEP ROCKY MOUNTAIN LLC SOUTH LEVERICH 13-09 Pad

Location #: 335045

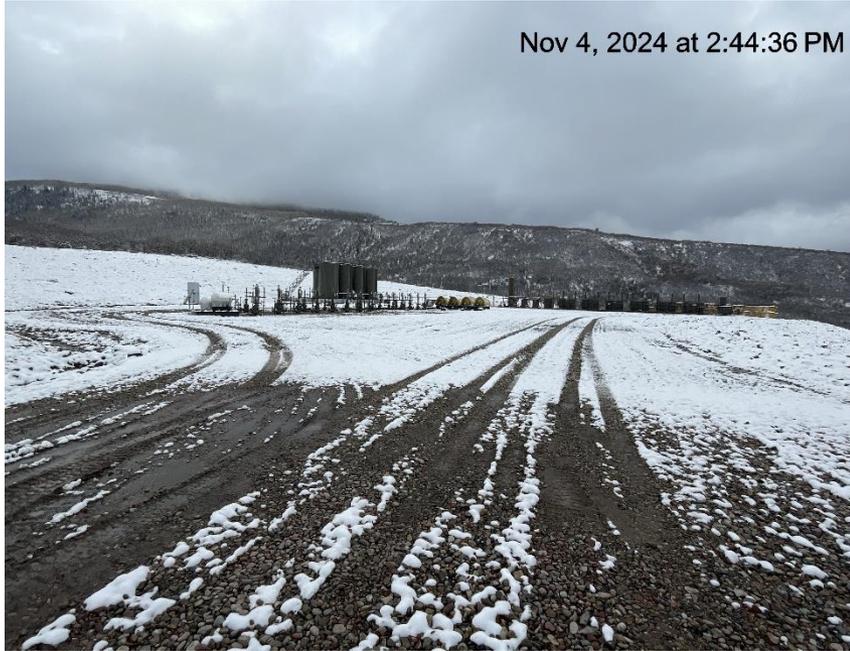
Photo # 8975 From entrance to location

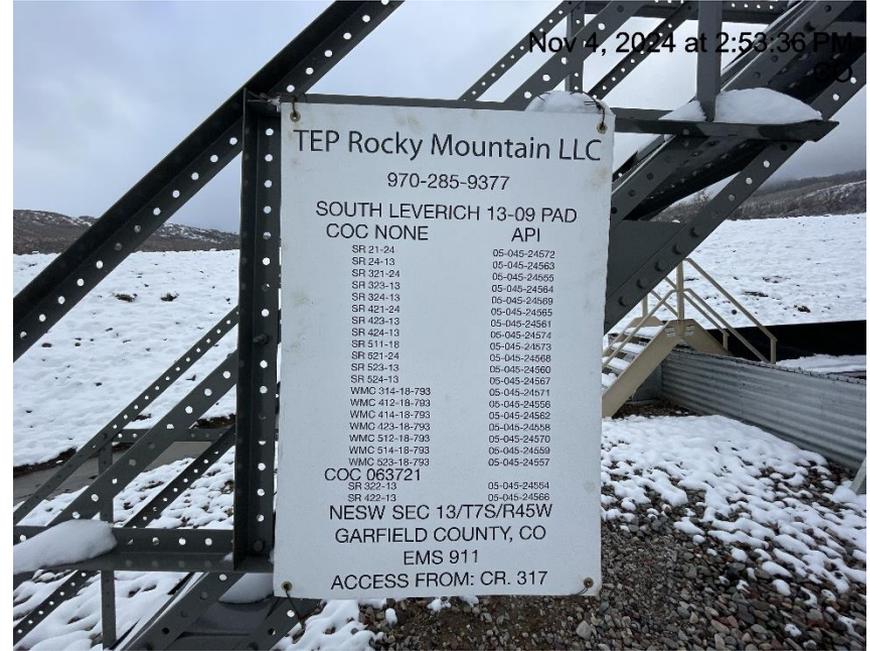
Photo # 8976 Location

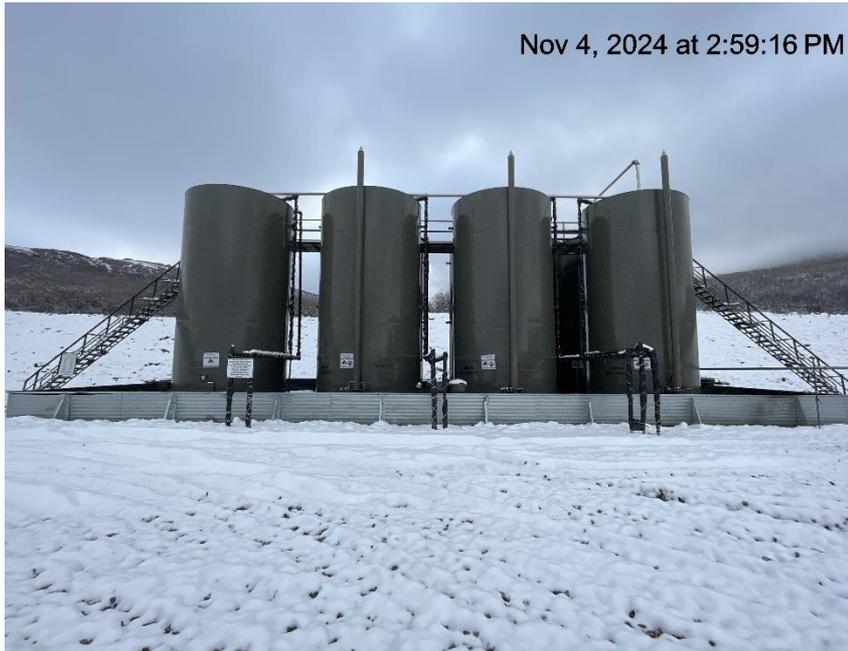
Photo # 8977 Location

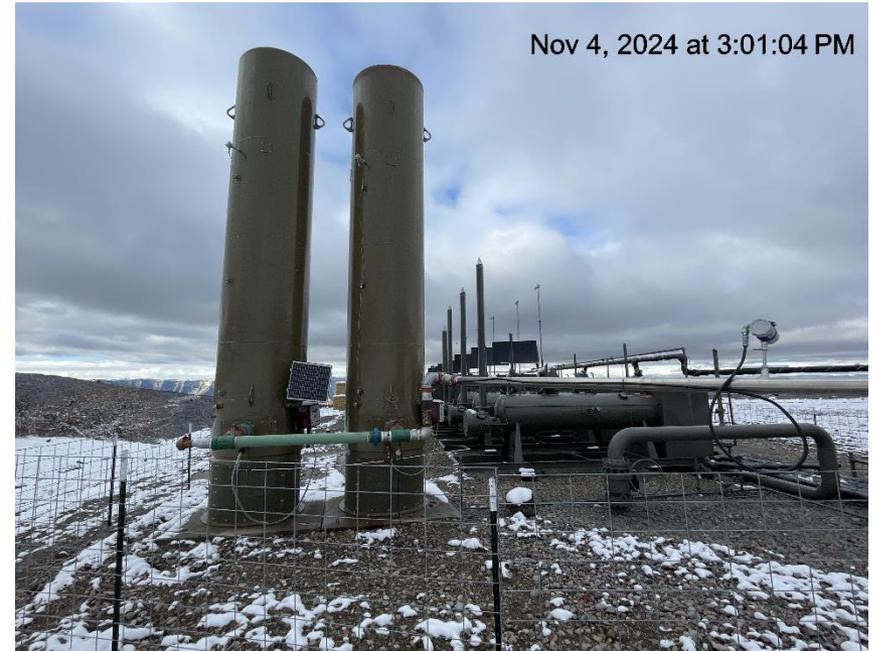
Photo # 8978 Location

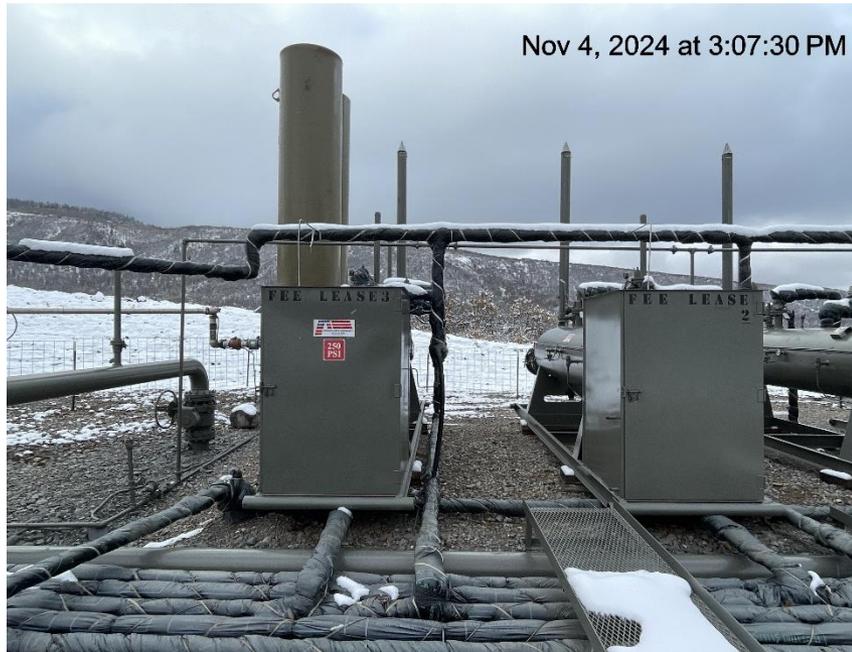
Photo # 8979 Location

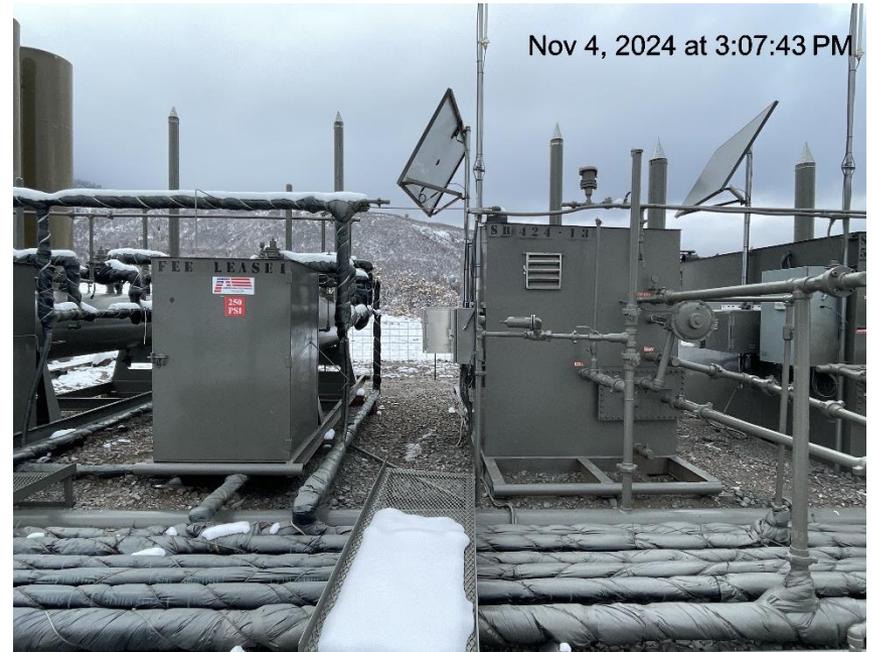
Photo # 8980 Location

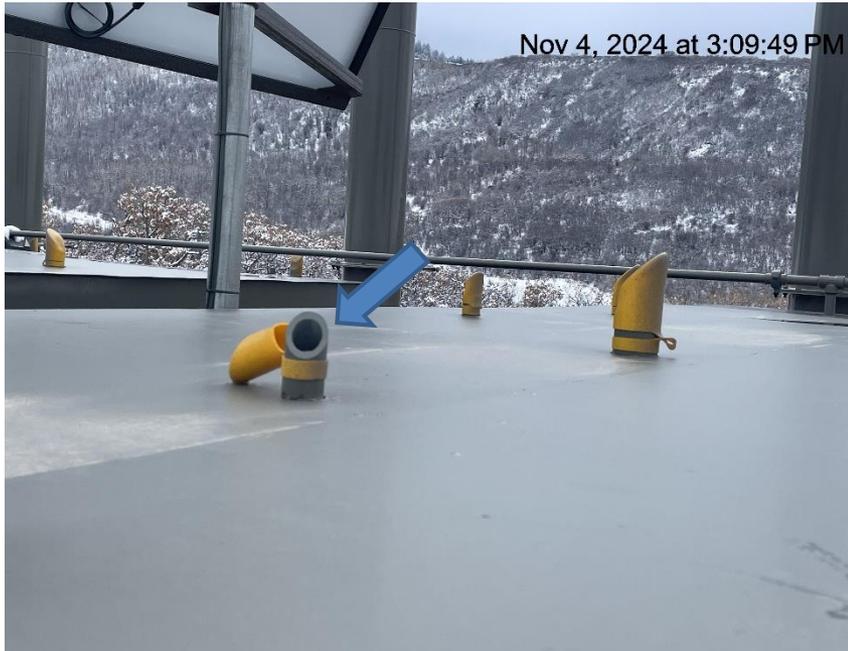
Photo # 8989 Rupture disc vent line does not comply with CECMC pressure safety device rules

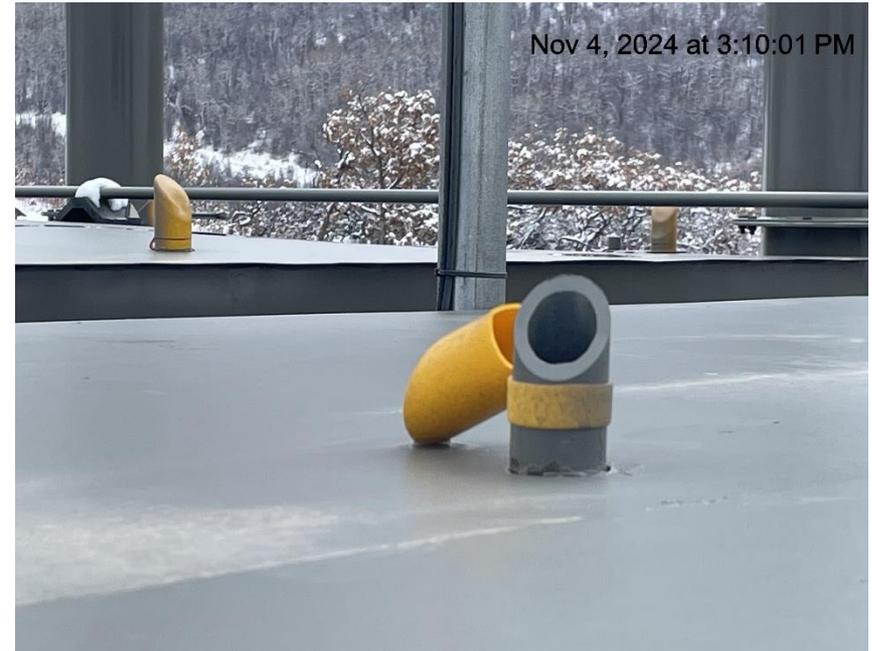
Photo # 8990 Rupture disc vent line does not comply with CECMC pressure safety device rules

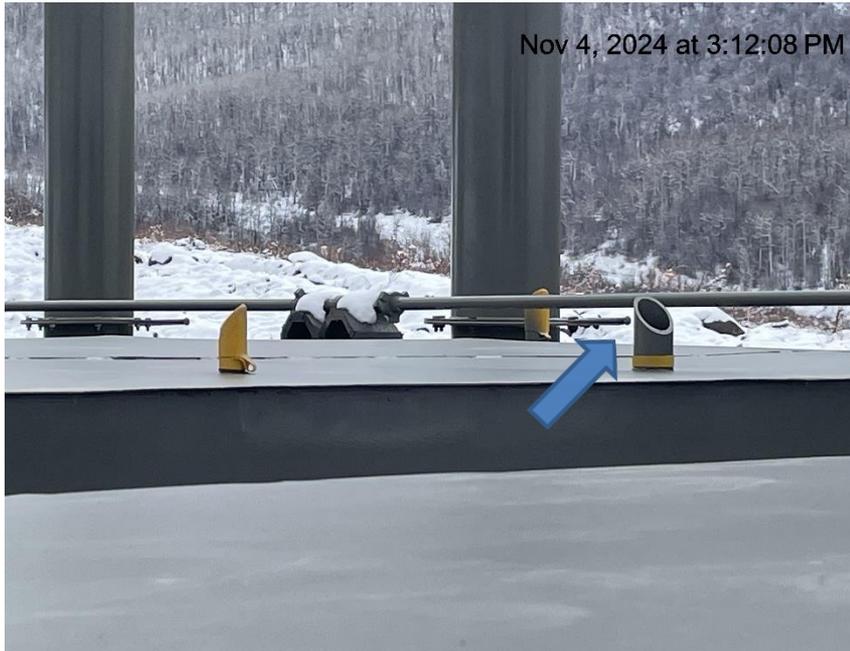
Photo # 8991 PRV vent line does not comply with CECMC pressure safety device rules

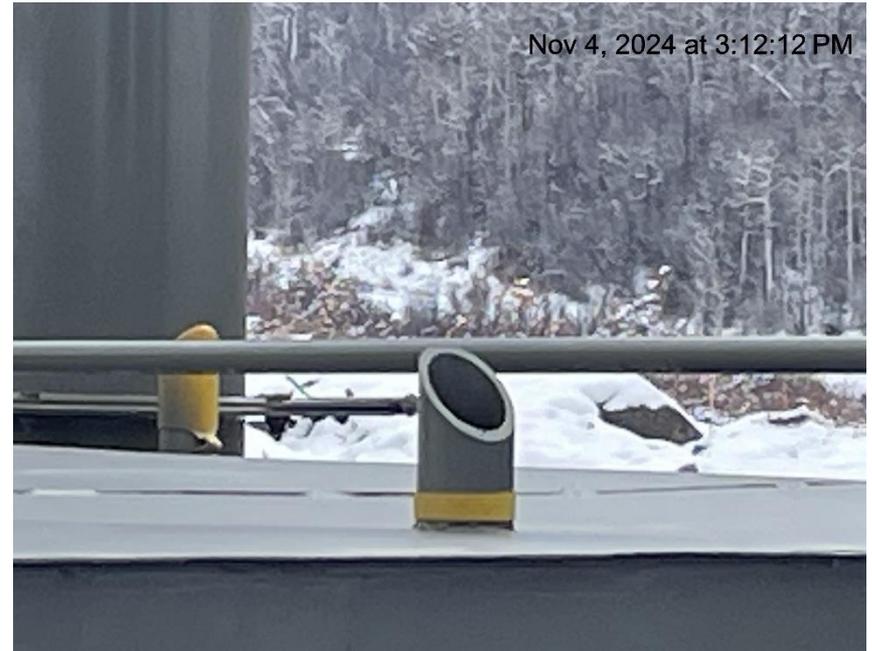
Photo # 8992 PRV vent line does not comply with CECMC pressure safety device rules

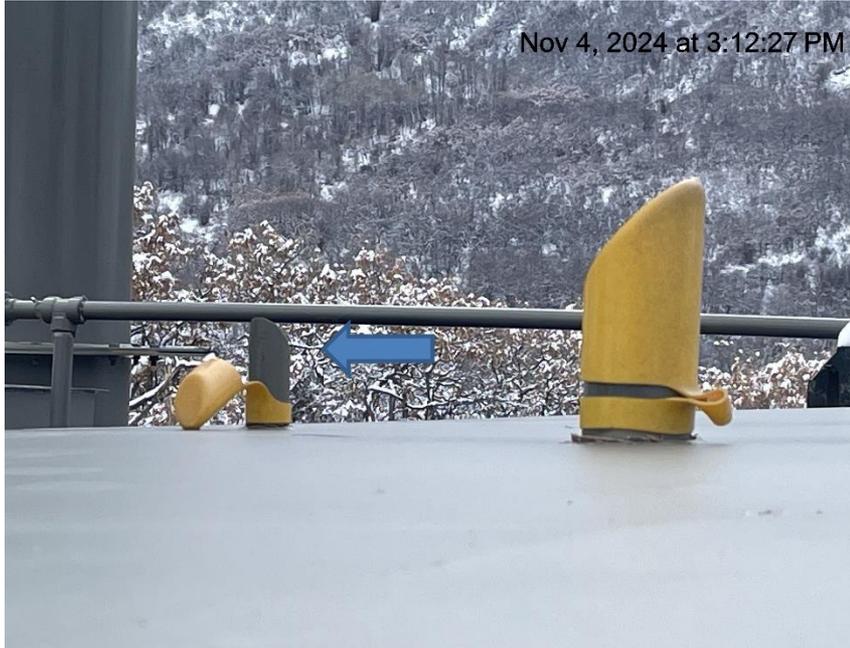
Photo # 8993 Rupture disc vent line does not comply with CECMC pressure safety device rules

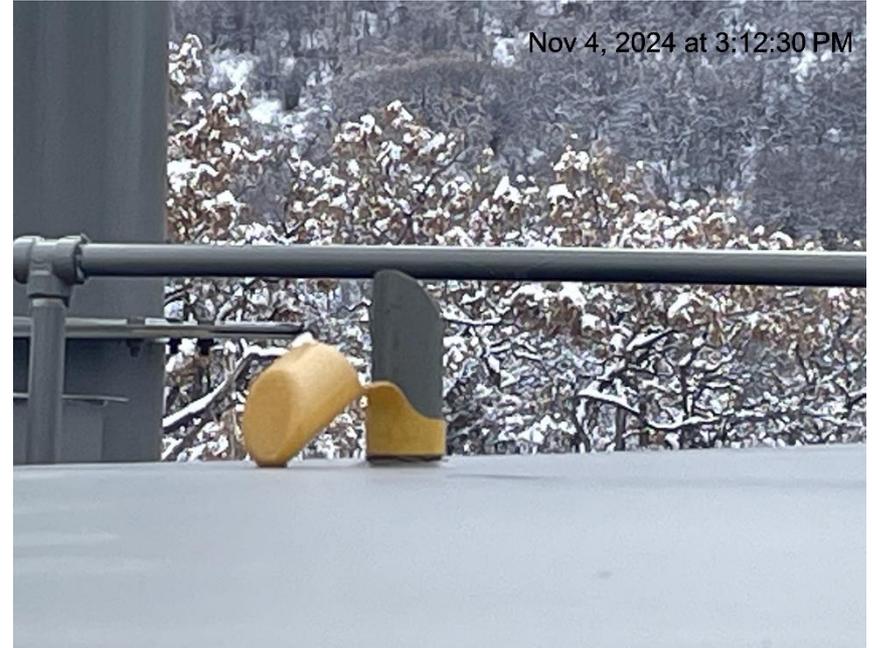
Photo # 8994 Rupture disc vent line does not comply with CECMC pressure safety device rules

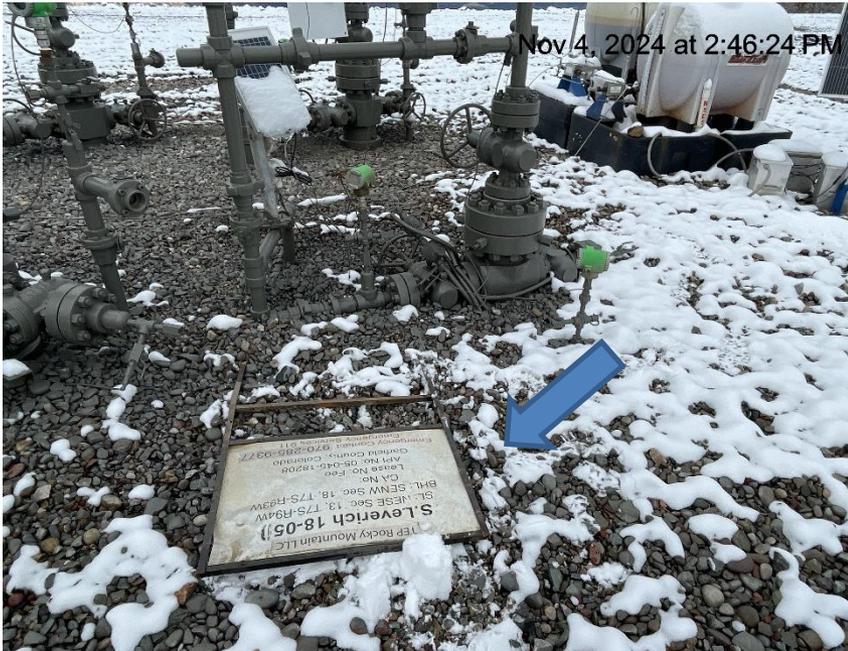
Photo # 8995 Wellhead sign laying on ground/not properly posted

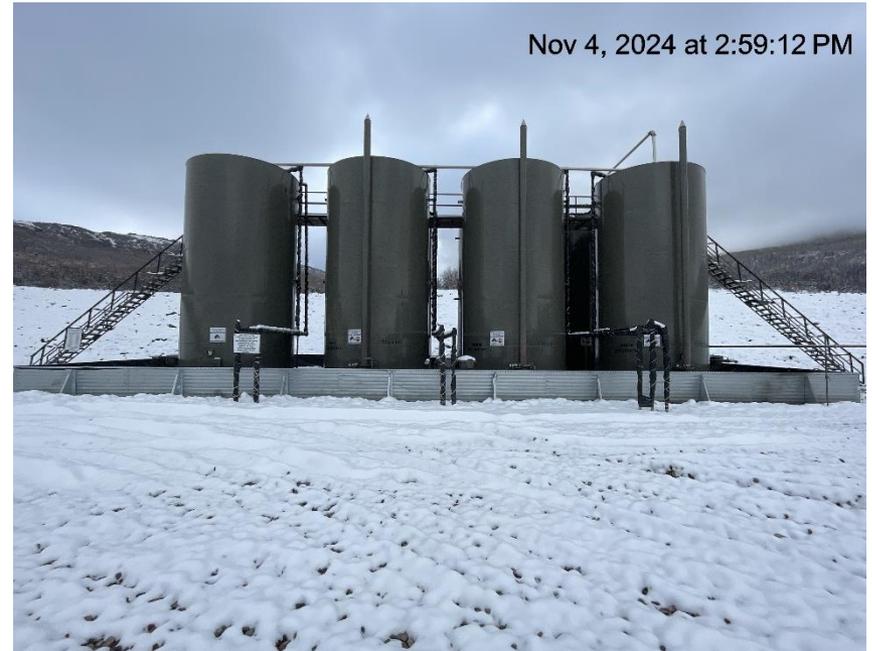
Photo # 8996 Tank battery contains seven 500 bbl tanks
FORM 2A submitted by operator only lists 6 tanks/operator
is not in compliance with CECMC rules

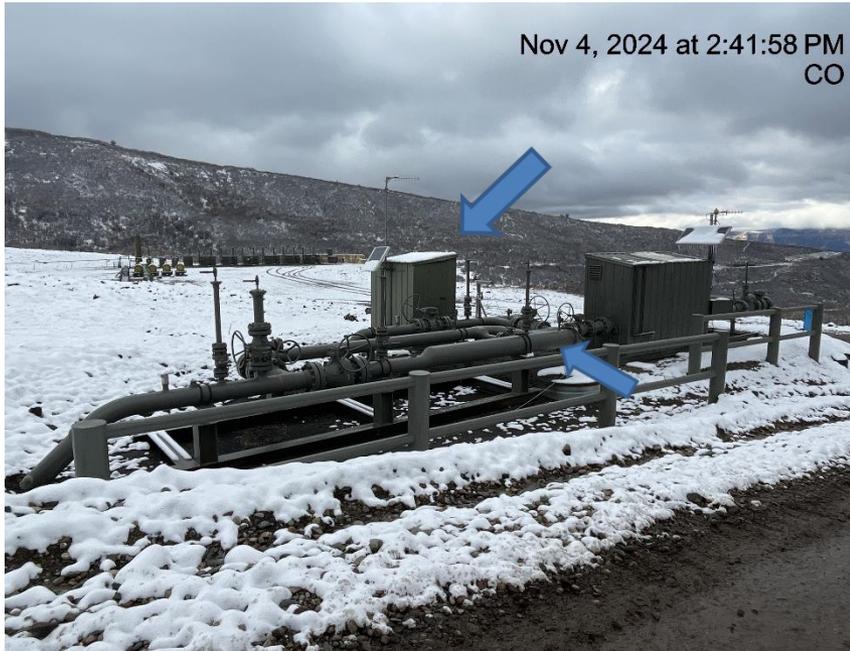
Photo # 8997 Pig station not listed is operators FORM 2A & Buy Back Meter listed in FORM 2A as Temporary Equipment/ operator is not in compliance with CECMC rules

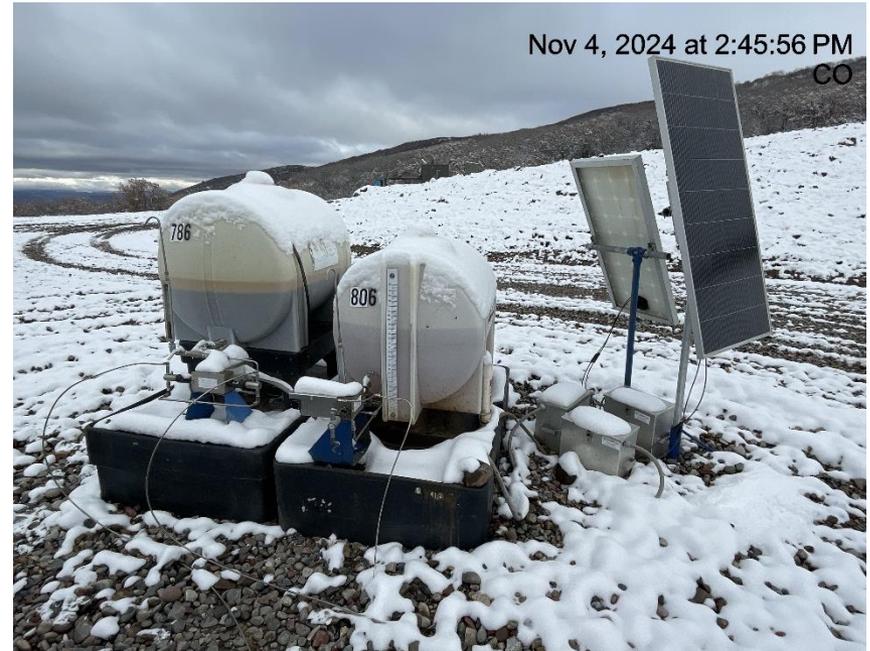
Photo # 8998 Two Chemical tanks not listed in FORM 2A/not in compliance with CECMC rules
