Operator: *BONANZA CREEK ENERGY OPERATING CO.*

Location Name: PRONGHORN-65N61W 17NWNW

Loc ID: 305141

Inspection: 708201748

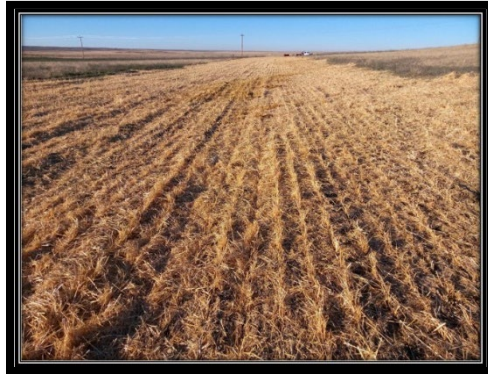
Exhibit A

CA: This location does not comply with Rule 1004. During this inspection, it was observed that the access road does not appear to have been recontoured/graded to reflect the adjacent topography. Additionally, the former well location has evidence of bare/exposed soils and road base debris. Other portions of the reclaimed areas appear to be progressing towards reclamation standards with desirable vegetation observed. Refer to attached inspection photos. Comply with Rule 1004. Reseed disturbance areas using a seed mixture requested by the surface owner, or a mixture prescribed by the local county NRCS. Establish vegetation with total perennial, non-invasive uniform plant cover of at least eighty (80) percent of reference area levels. Ensure erosion controls are implemented to stabilize the seeded soil. Operator shall continue to monitor and manage this site until the location meets Rule 1004 standards, including stormwater and weed management.

CA Resolution: Operator has addressed the CA issue, property has been contoured to match existing grade and re-seeded. as well in order to comply with Rule 606.
