Inspection Photos

Operator: Simcoe LLC - 10749

Location ID: 333907

Inspection Photos
Location Name: Barnes Leidy 2, 4
Location ID: 333907

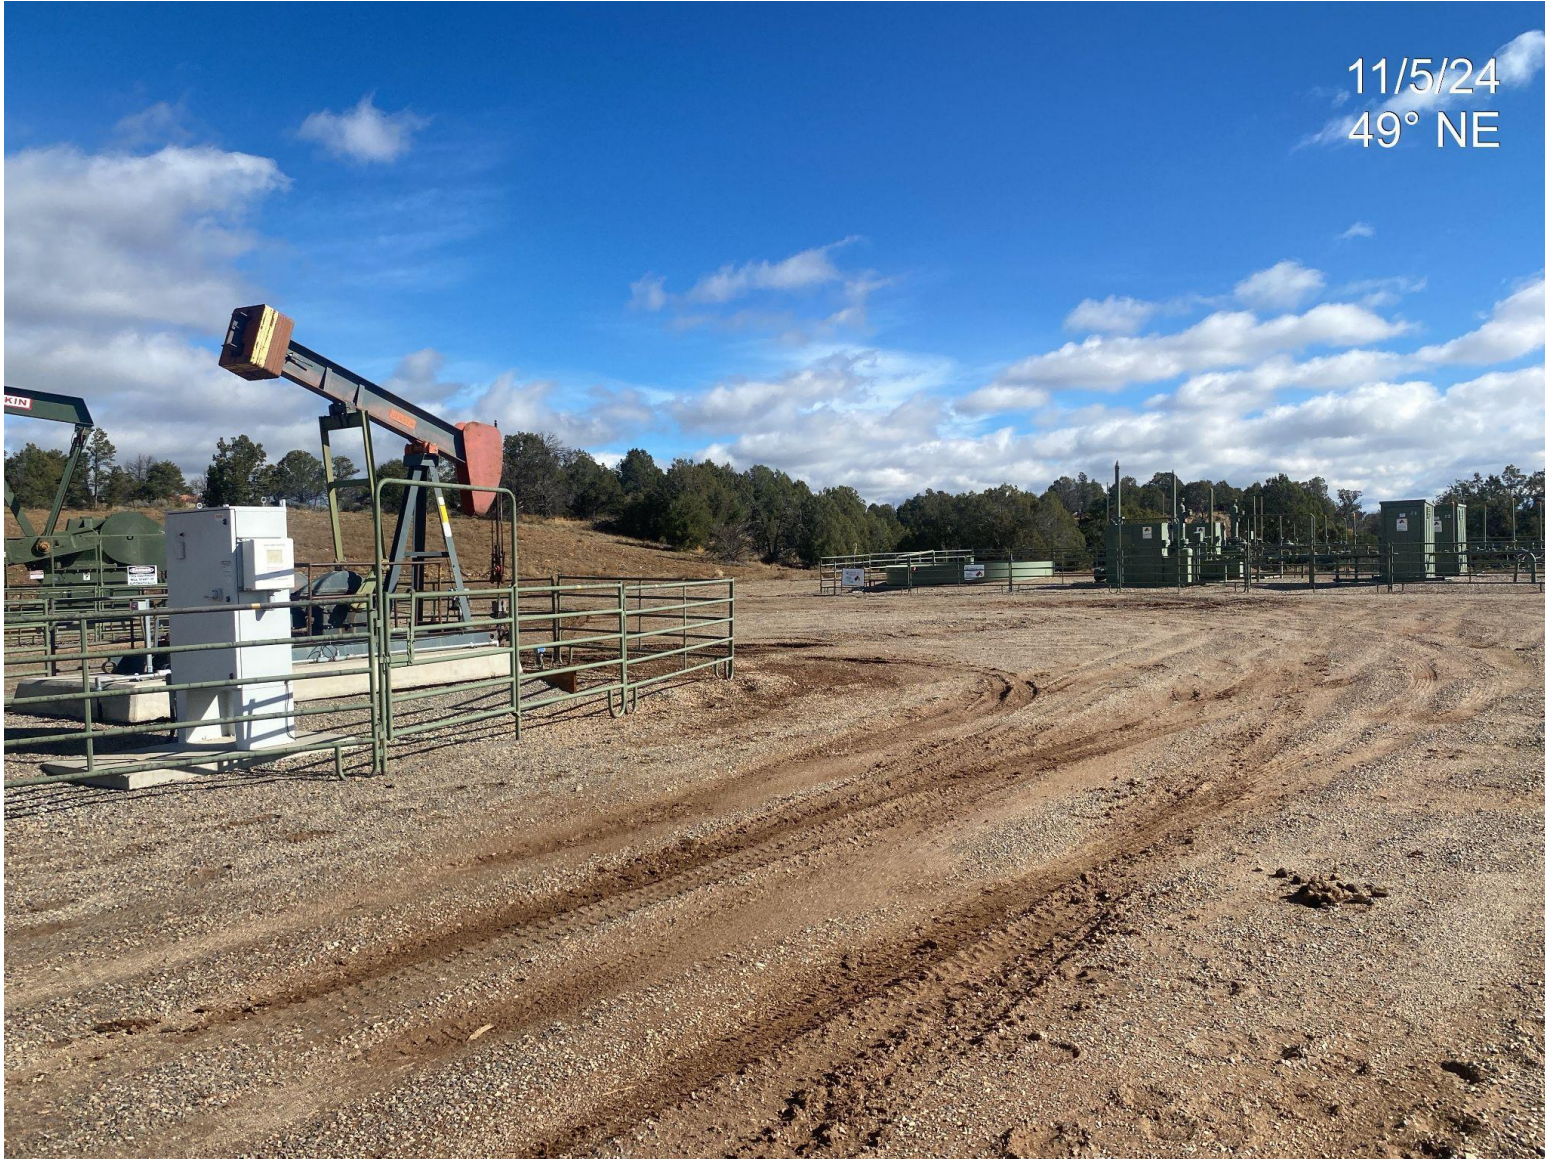
Photo 1. View of well disturbance taken from the access point facing center.

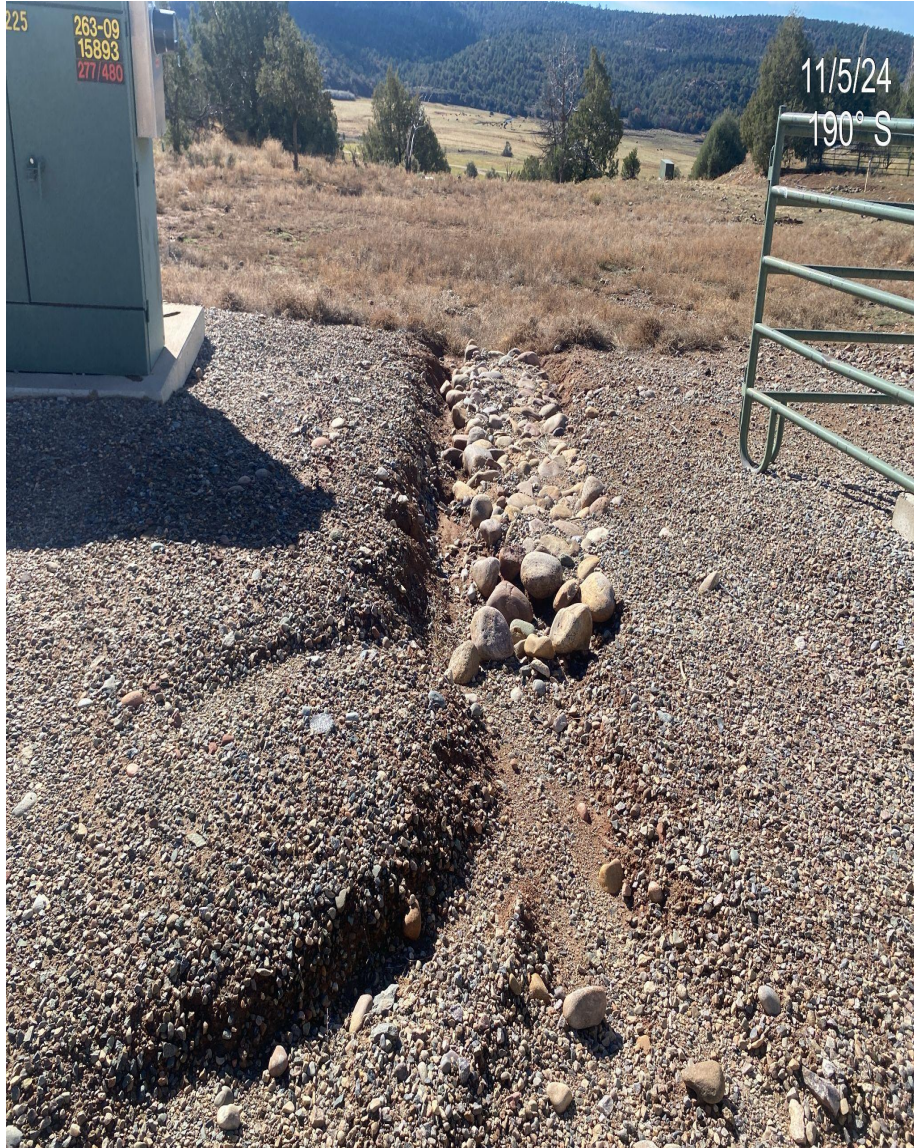
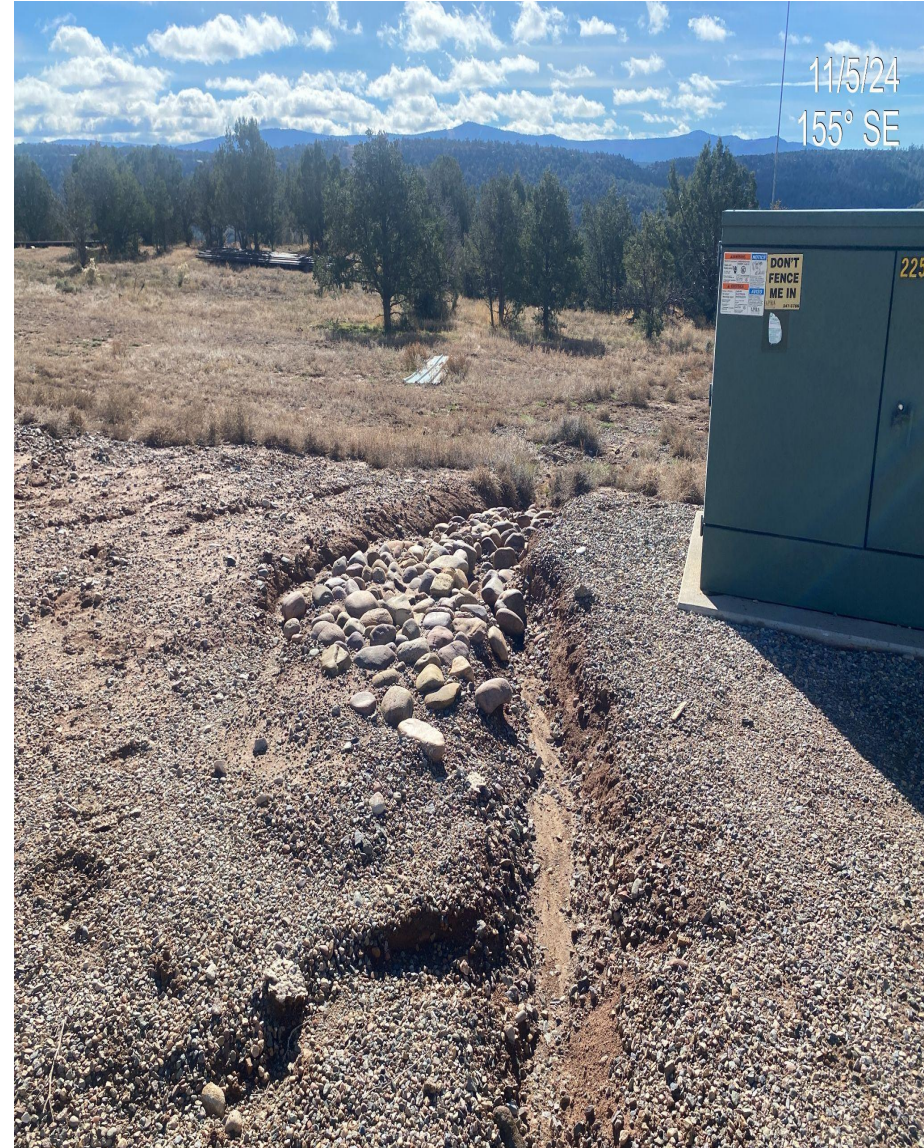
Photo 2. View of erosion forming along existing stormwater BMPs in the southern portion of the pad. Round river rock is likely contributing to formation of erosion.

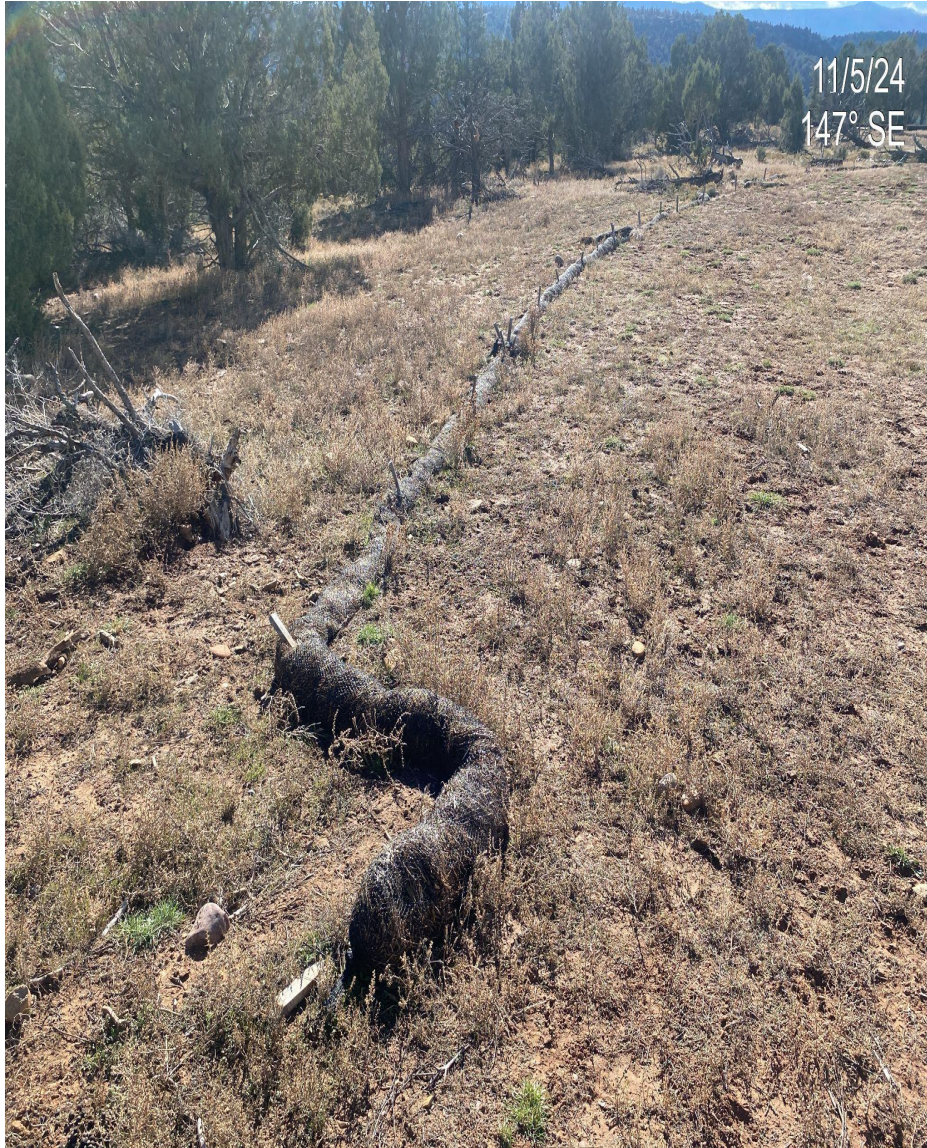
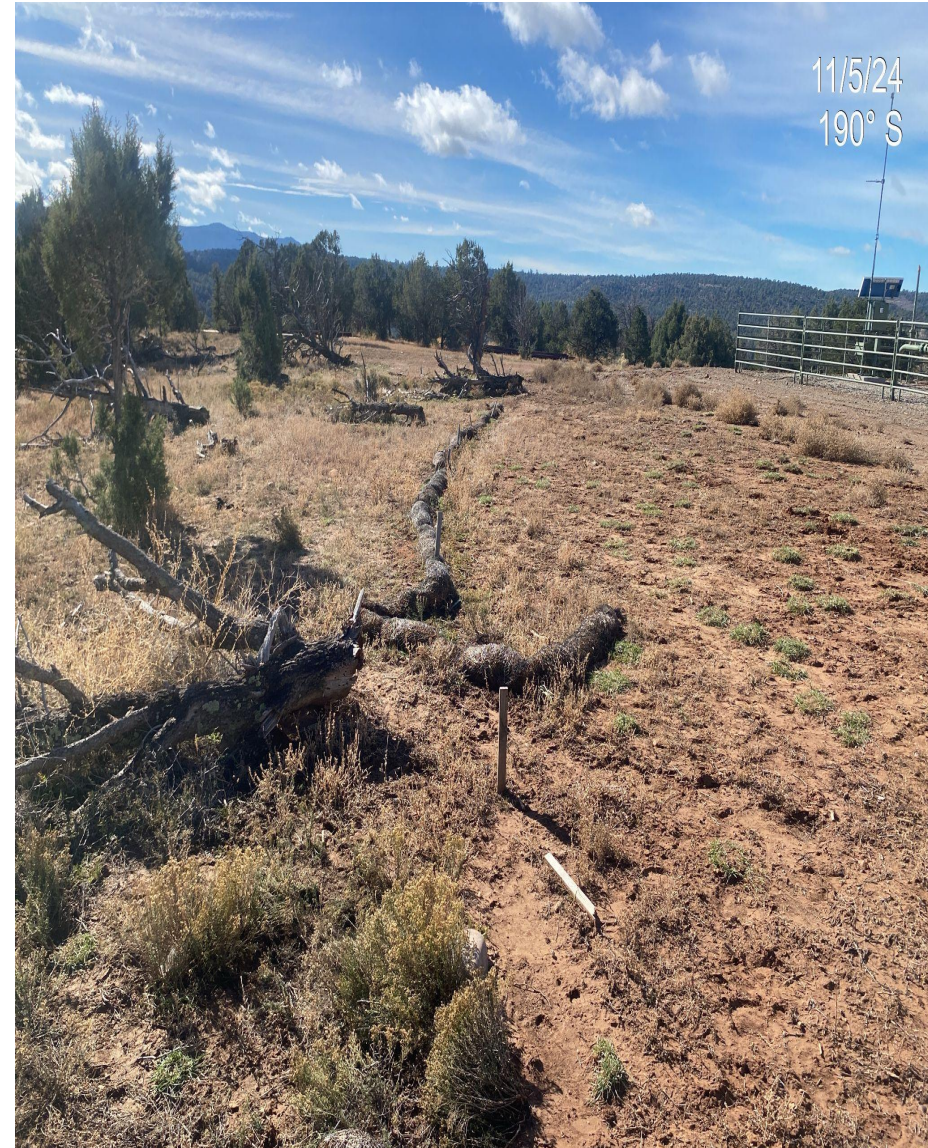
Photo 4. View of perimeter stormwater BMPs/wattles that are not installed correctly and no longer functioning. Determine if stormwater BMPs are needed if not wattles are considered debris and need to be removed.

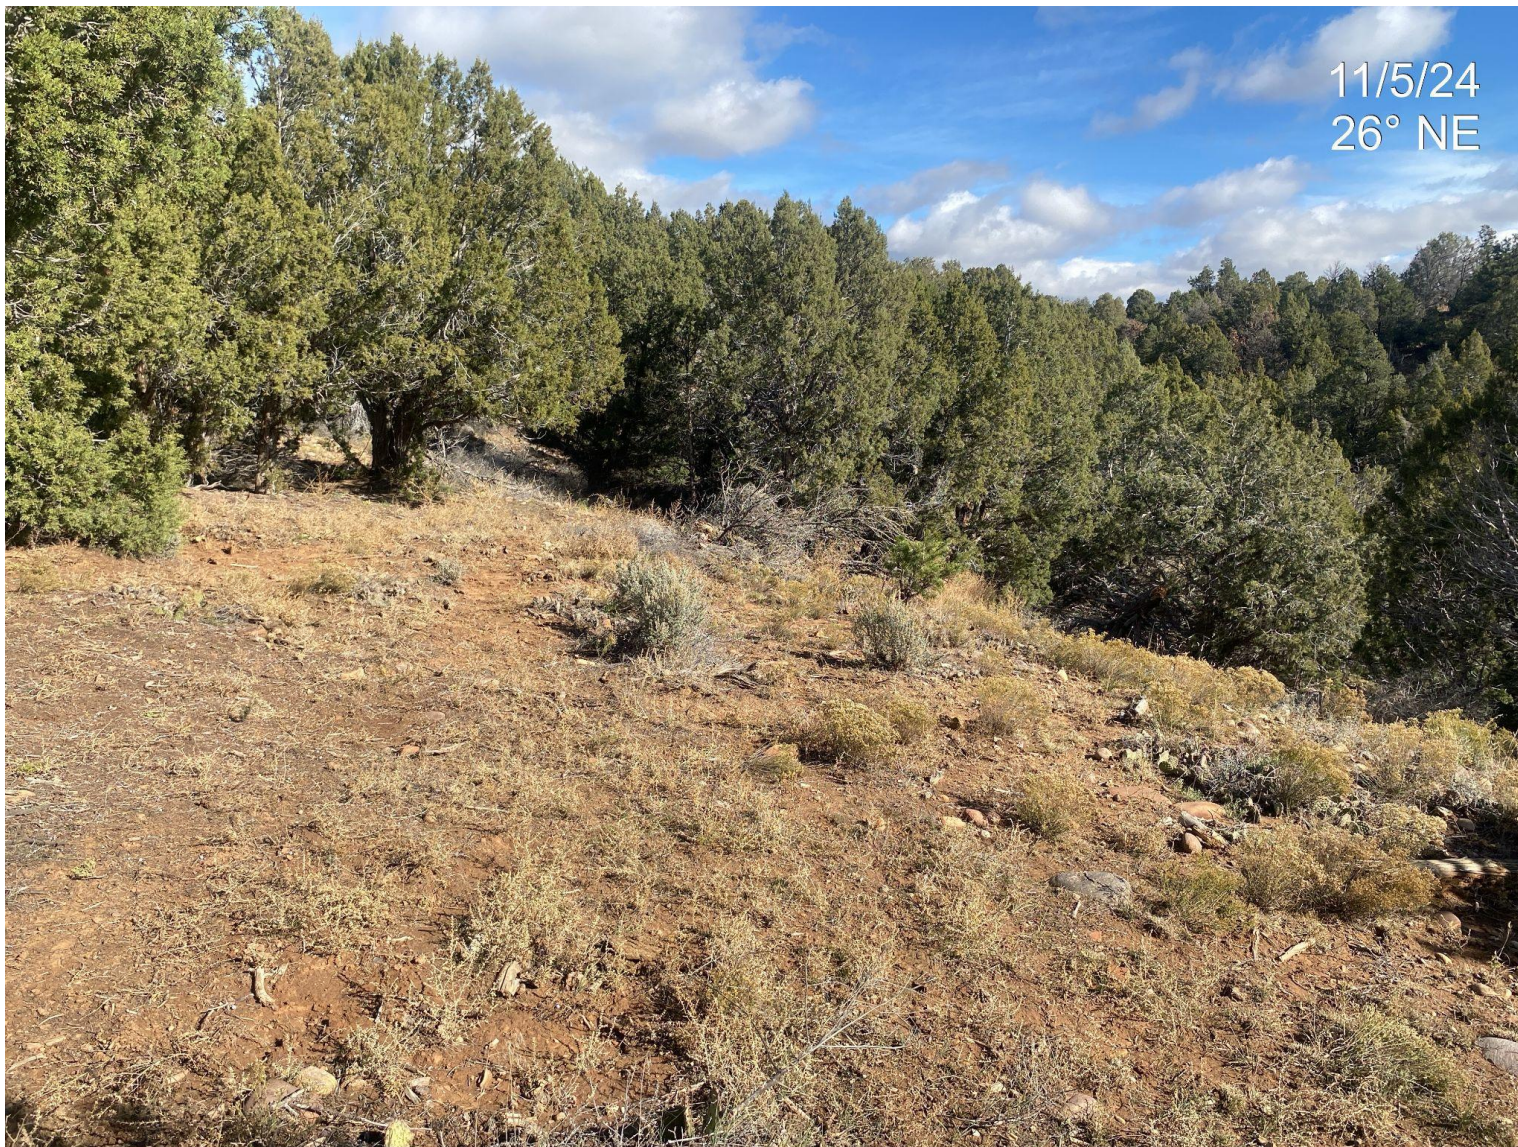
Photo 5. View of reference area composed of Sagebrush, Juniper, Broom Snakeweed and Indian Ricegrass.
