# Inspection Photos

Operator: Simcoe LLC - 10749

Inspection Document #: 714001456

Inspection Photos  
Location Name: Barnes A2  
Location ID: 312051

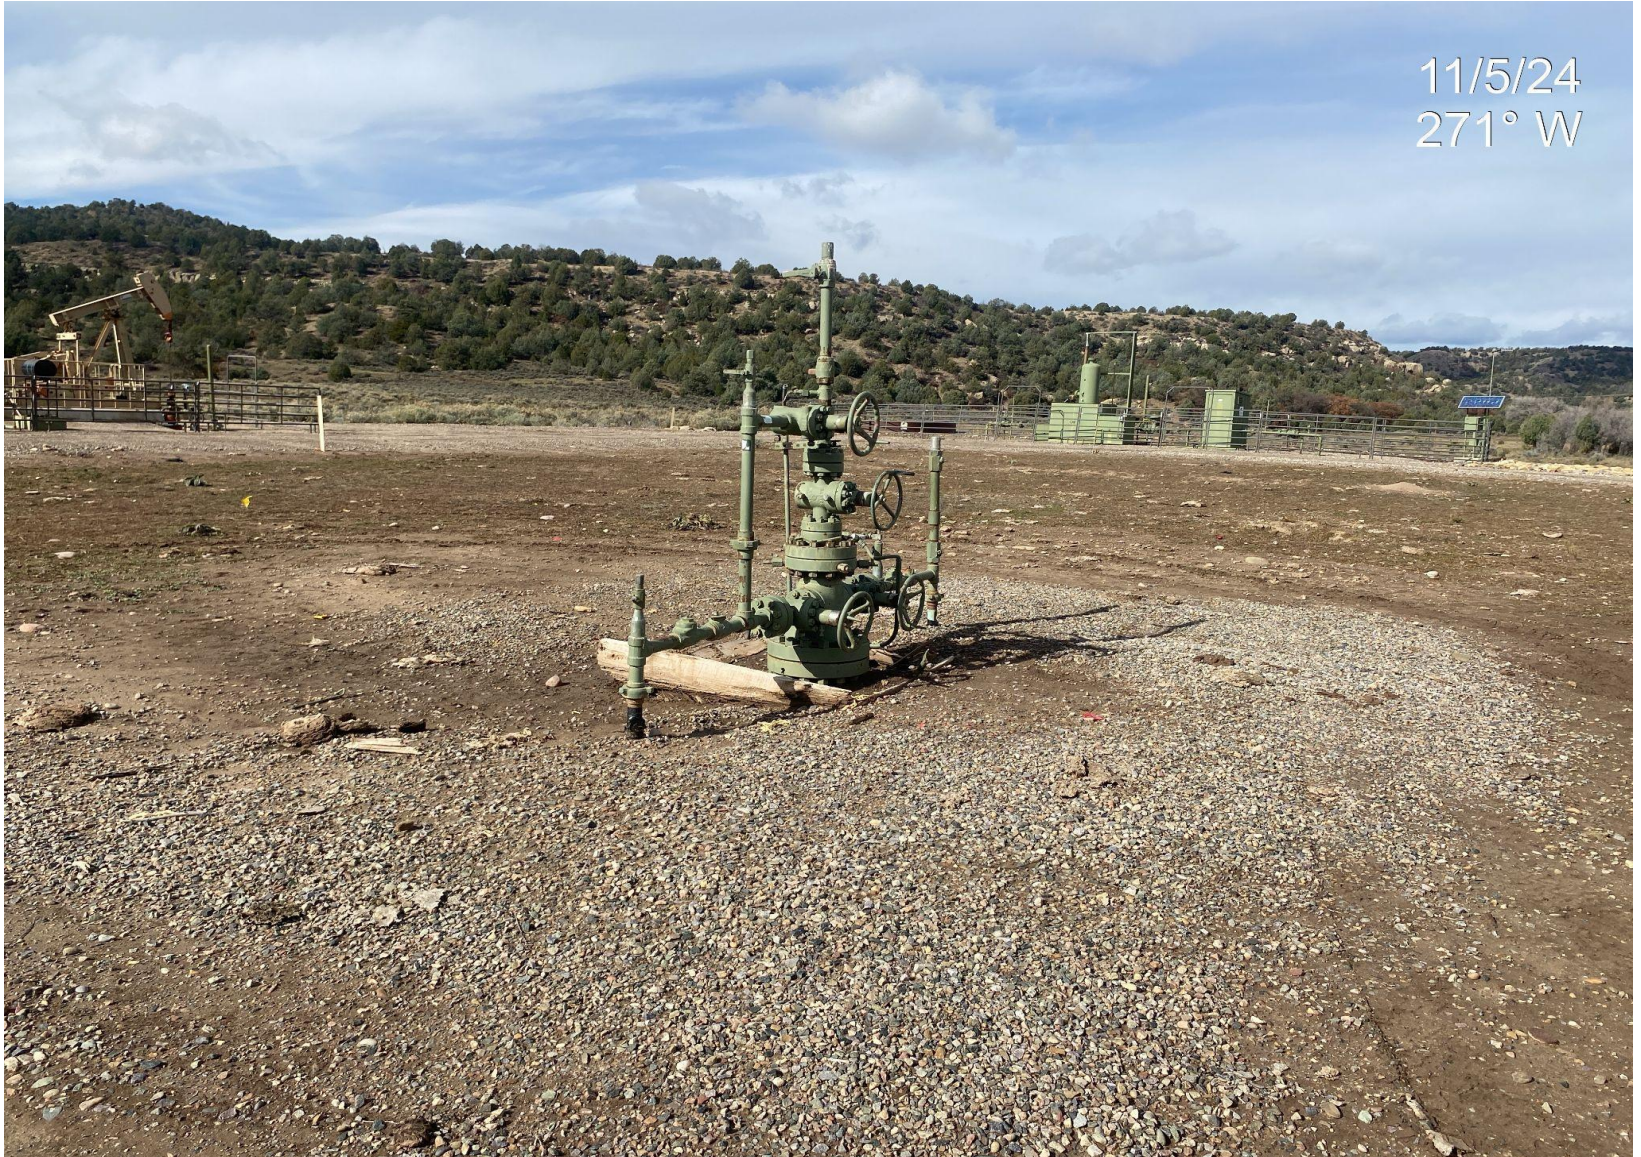
**Photo 1.** View of well disturbance taken from the access point facing center.

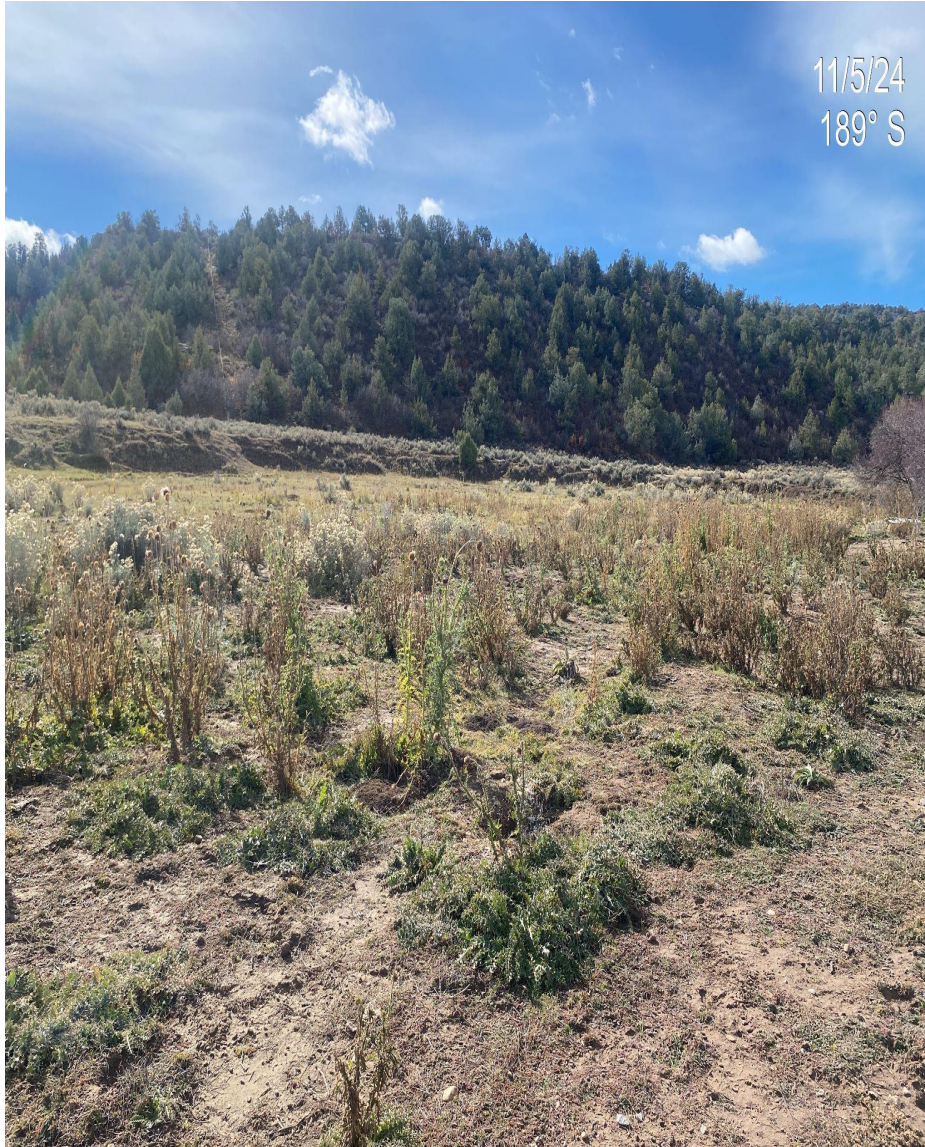
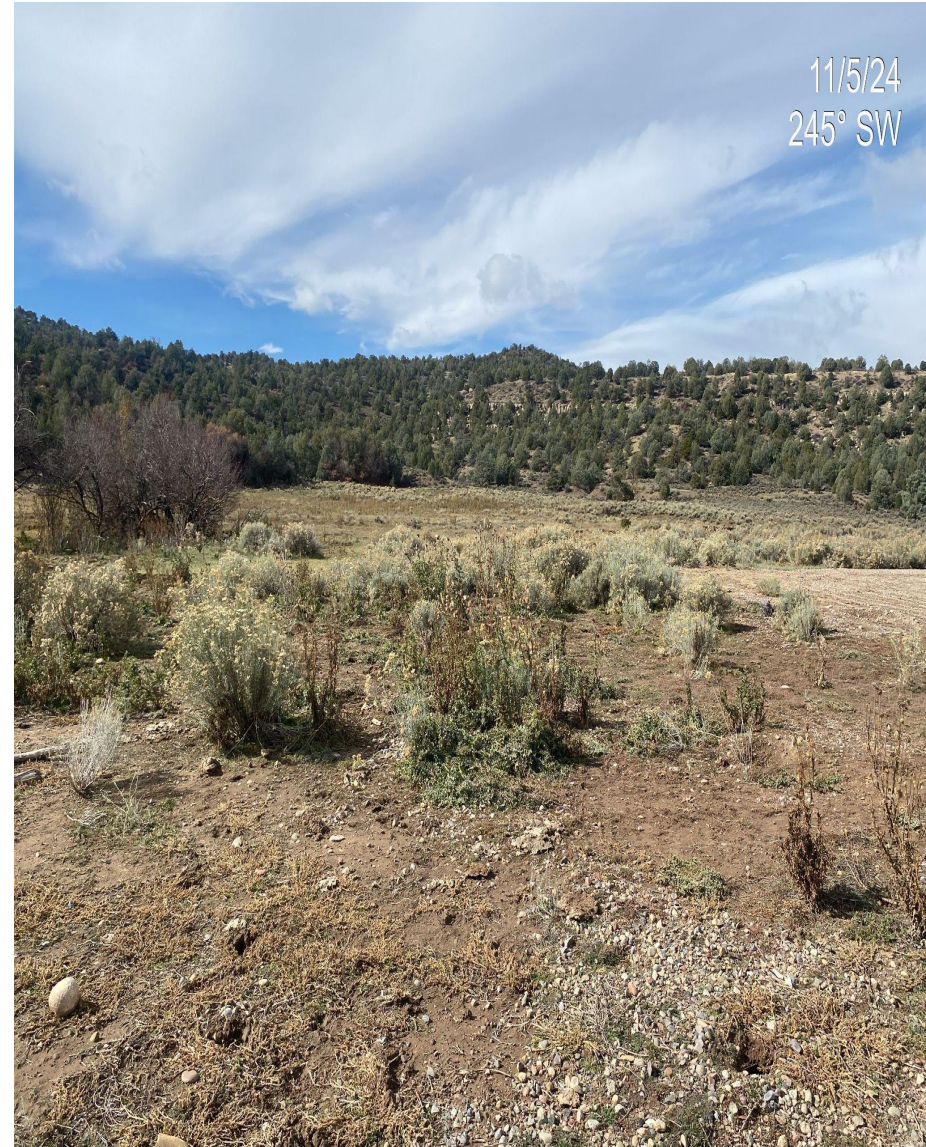
**Photo 2.** View of small Musk Thistle infestation observed in the eastern and southern portions of the disturbance.

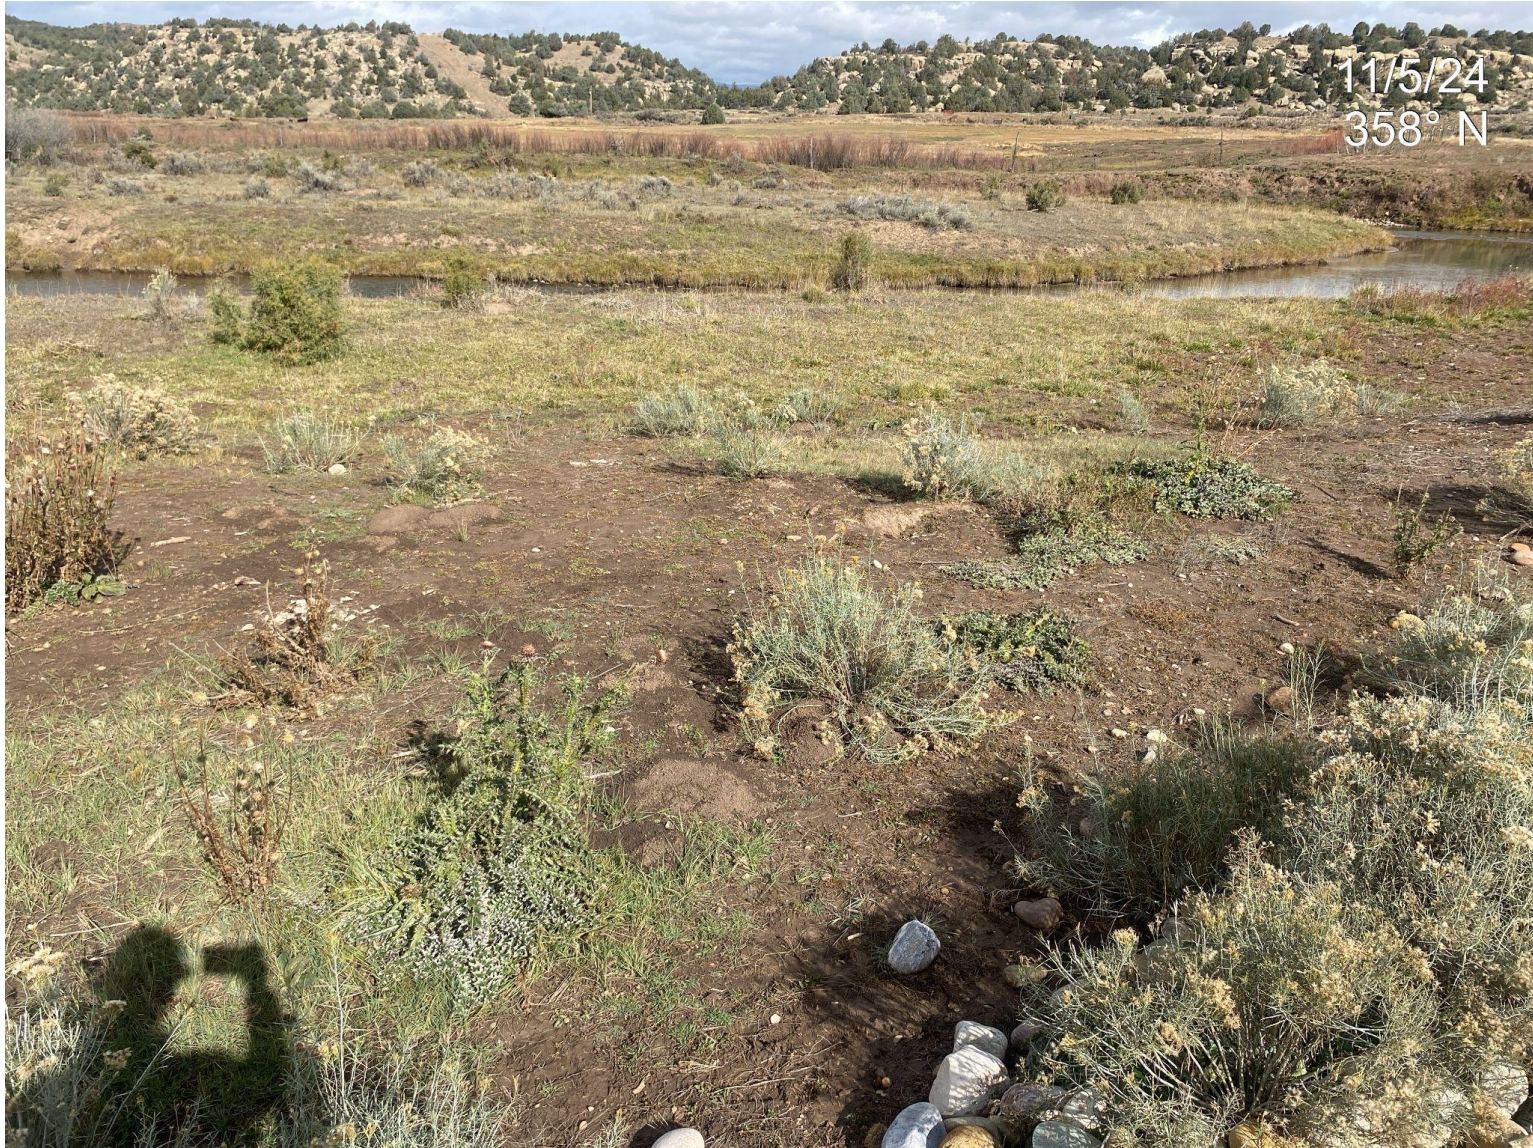
**Photo 3.** Musk Thistle observed in the western interim reclamation area.

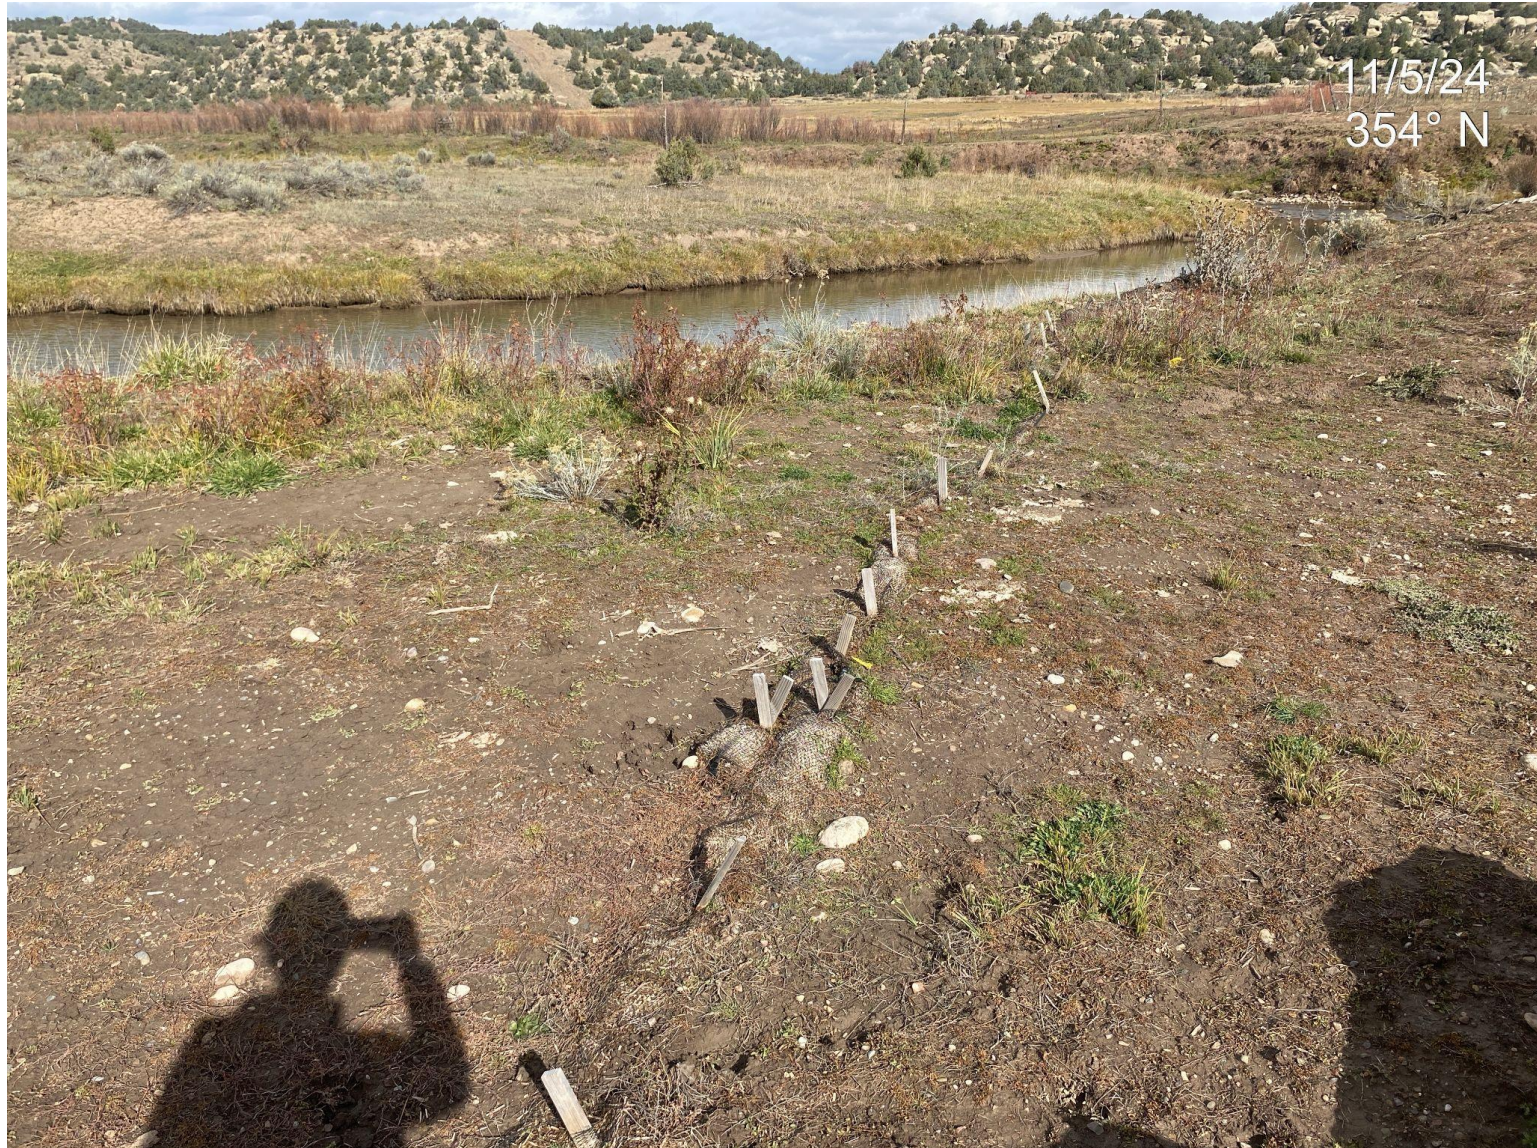
**Photo 4.** View of stormwater BMP wattles that are filled in with sediment and no longer functioning.

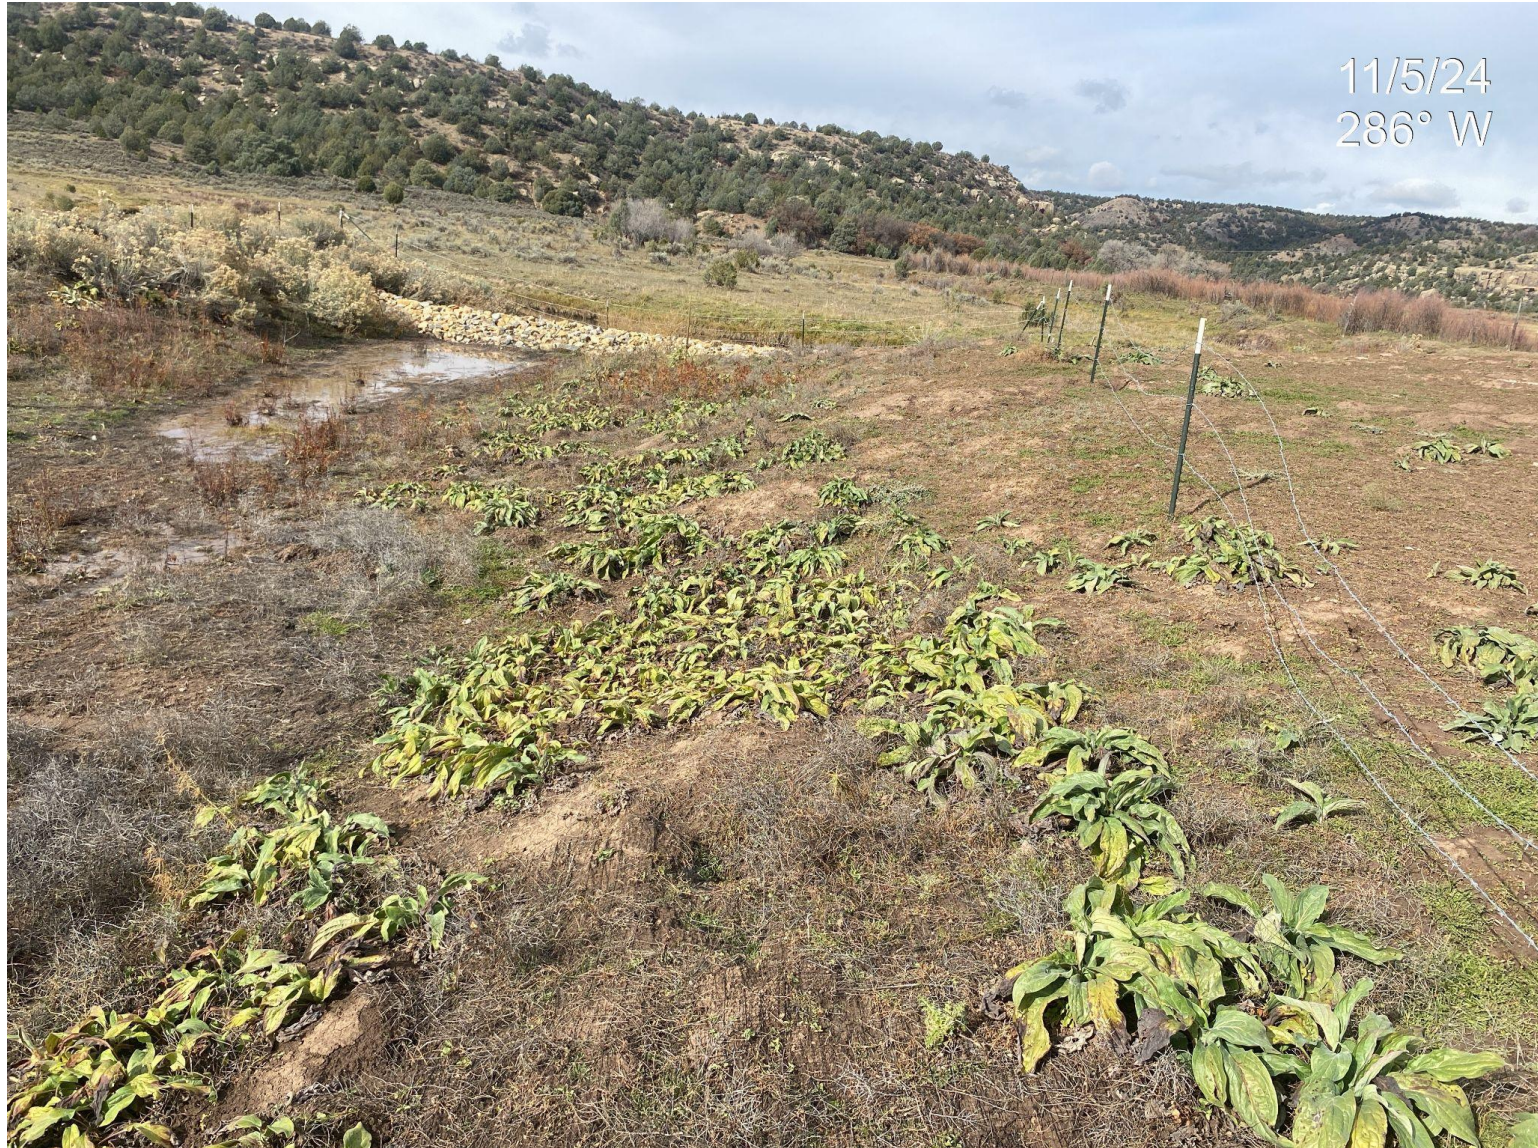
**Photo 5.** View of large patch of Houndstongue observed in the western portion of the disturbance.

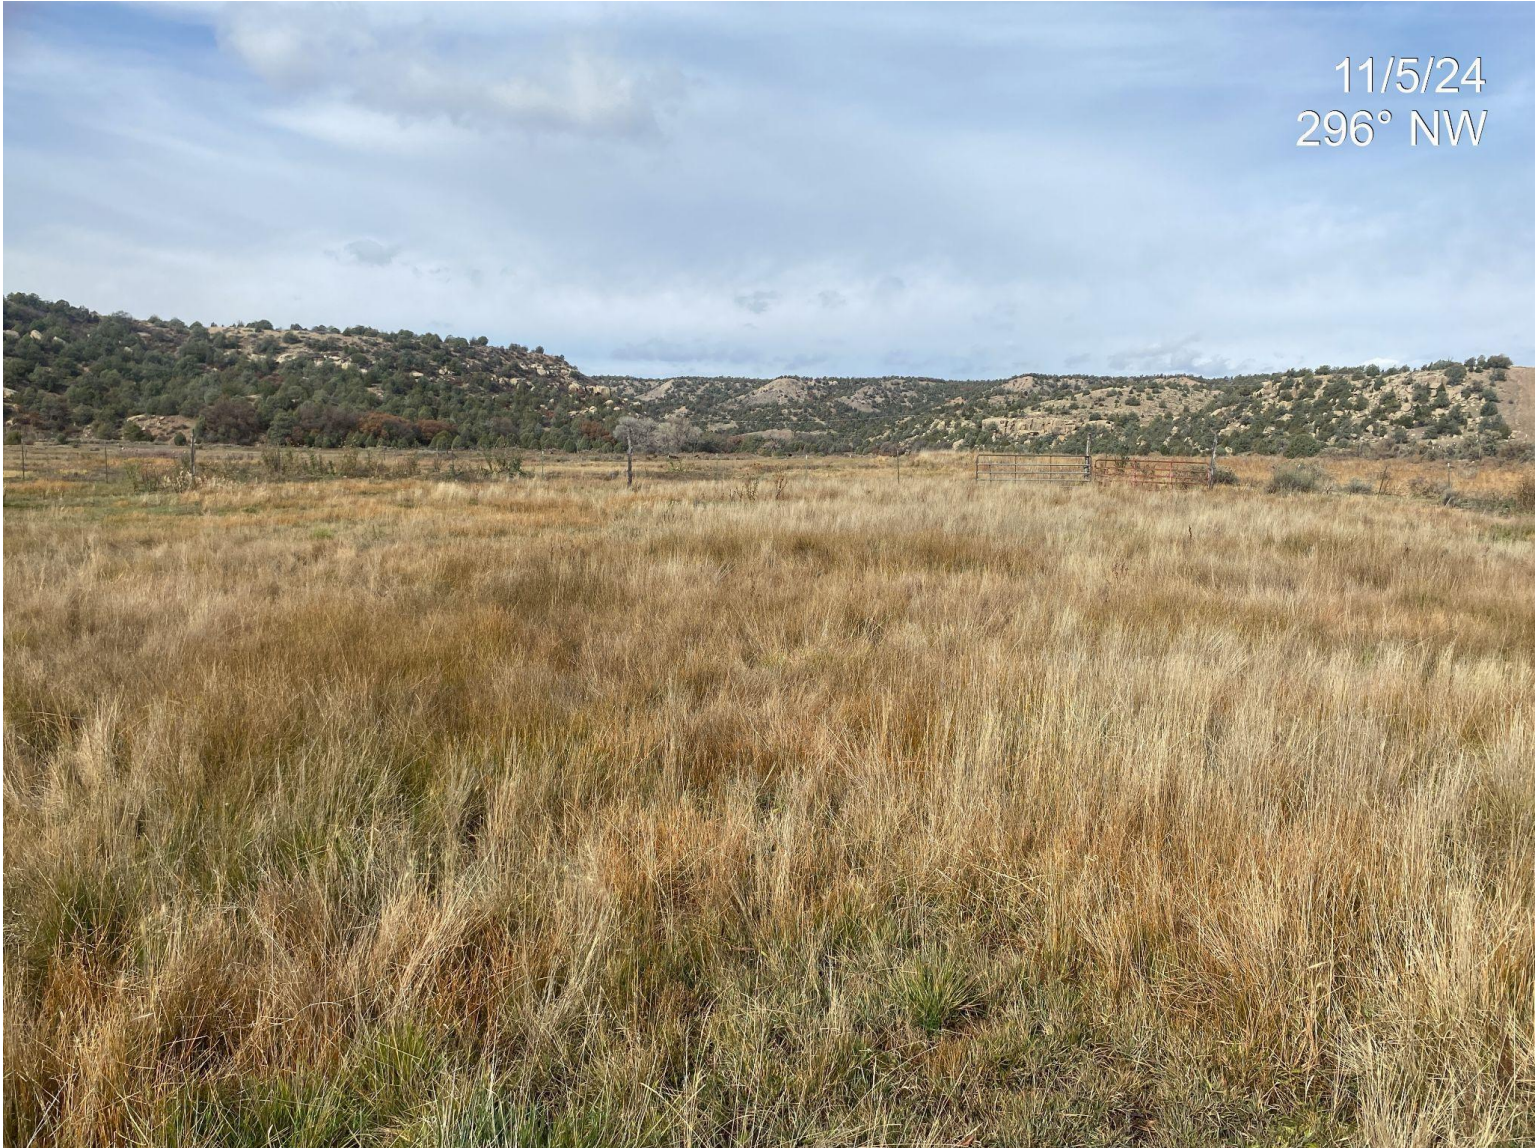
**Photo 6.** View of pasture reference area composed predominantly of Smooth Brome and Squirrel Tail.
