Inspection Photos
Location Name: Dorris Ackerson Unit 2
Location ID: 318223

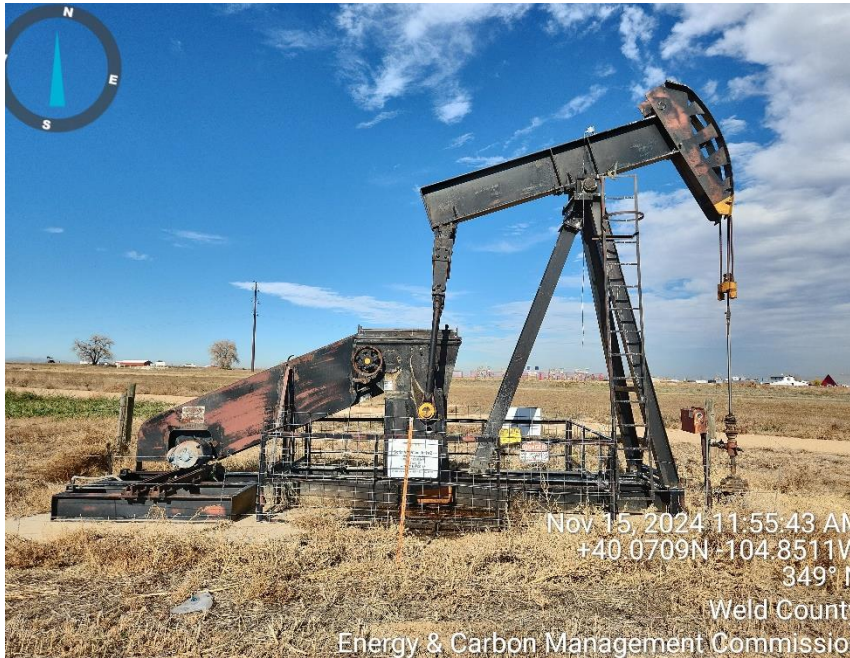
Photo 1 well head and equipment

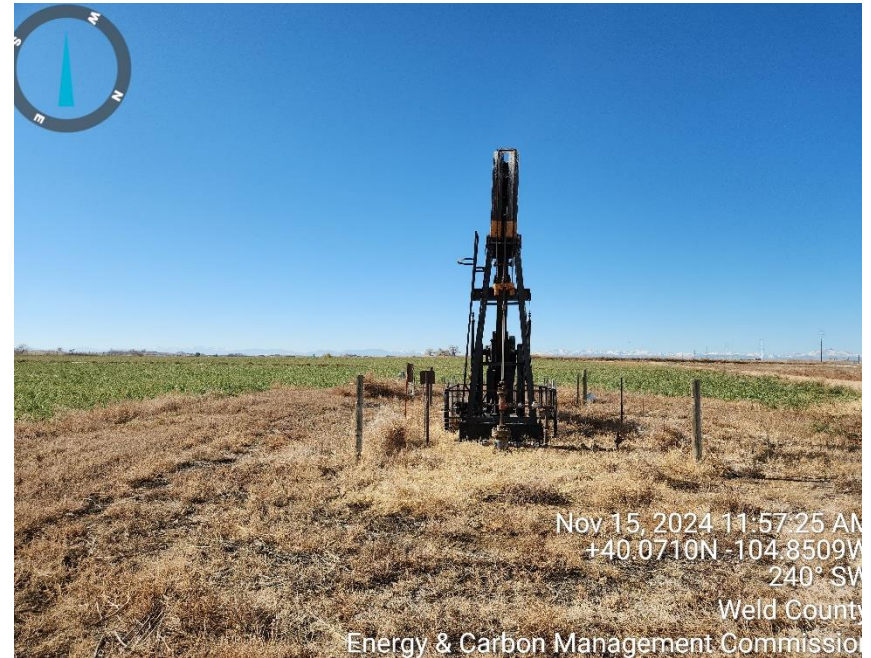
Photo 2 well head and equipment

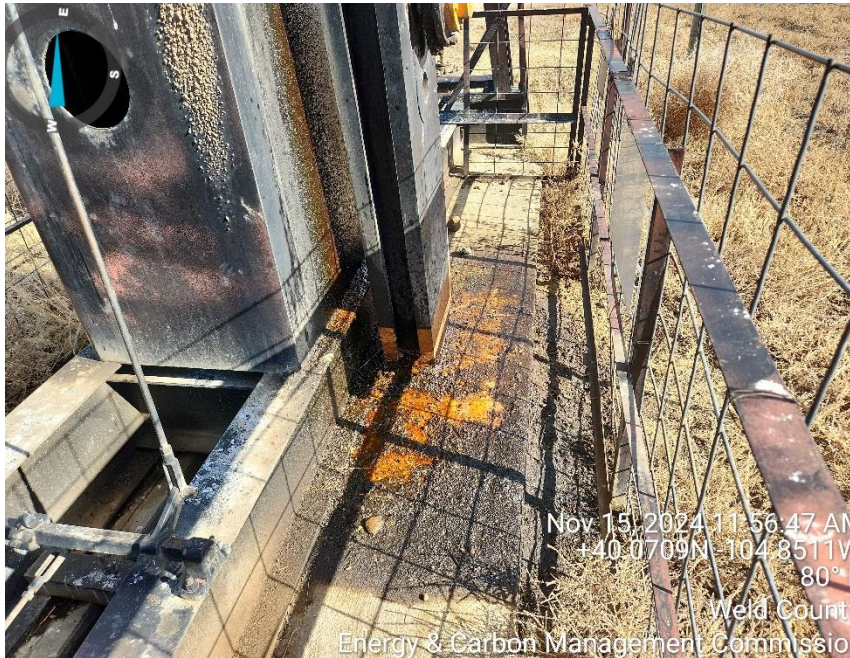
Photo 3 mech cond and stained soil

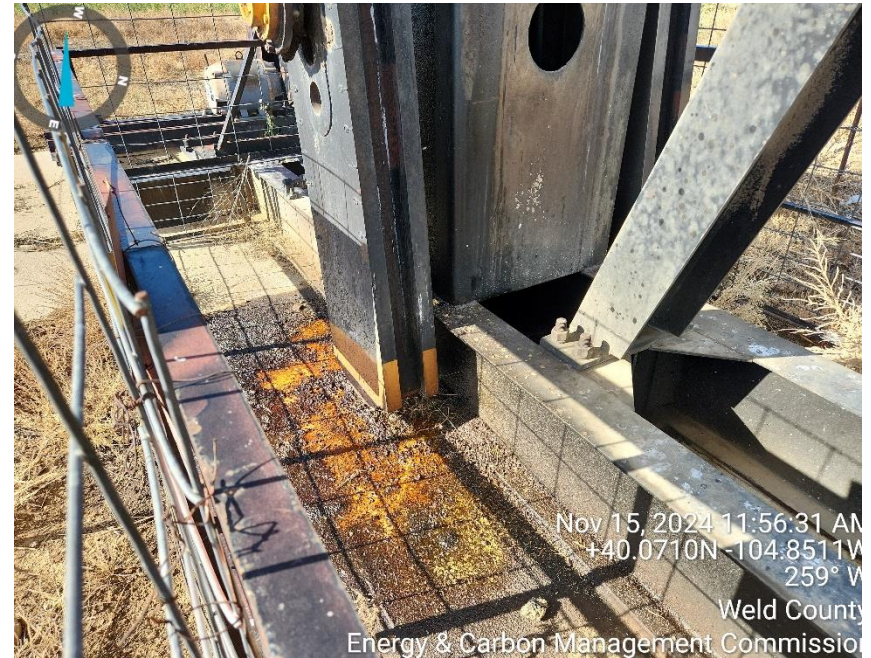
Photo 4 mech cond and stained soil
