Inspection Photos

API: 043-06219

Operator: AUSCO PETROLEUM INC

Inspection Date: 11/14/2024

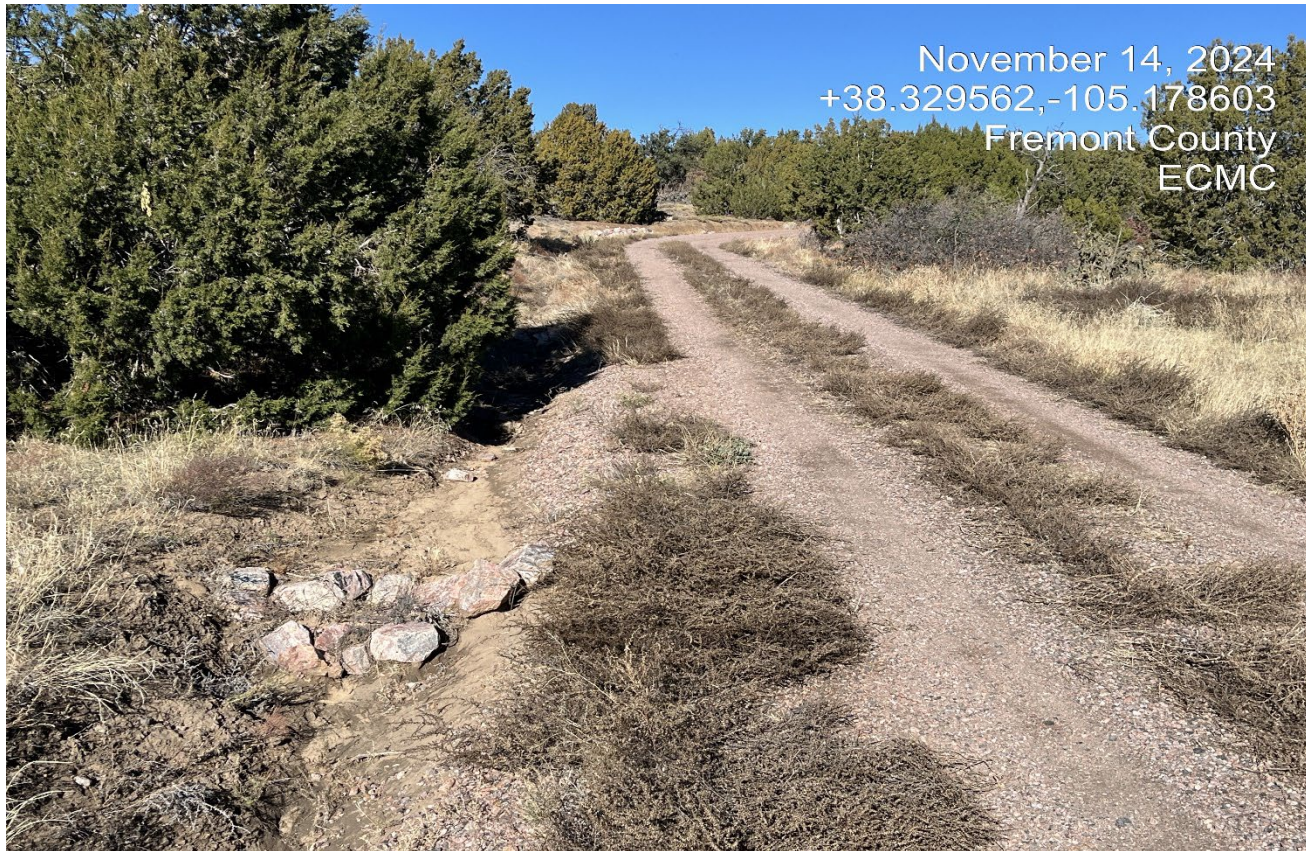
Photo 1. Facing northwest along the access road. There are check dams that are filled in and not maintained and erosion along the roadside.

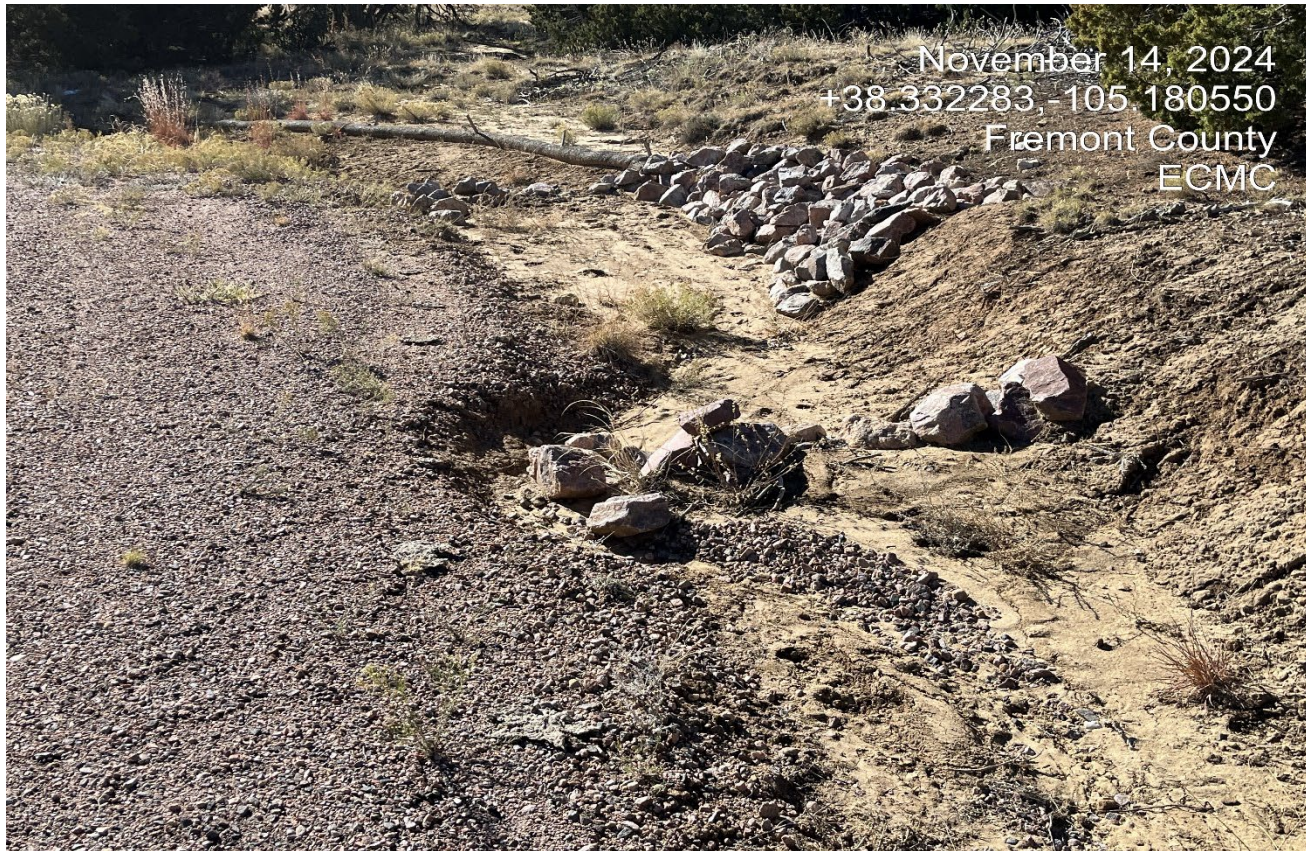
Photo 2. There are check dams where stormwater has eroded around the check dam. BMP maintenance is required.

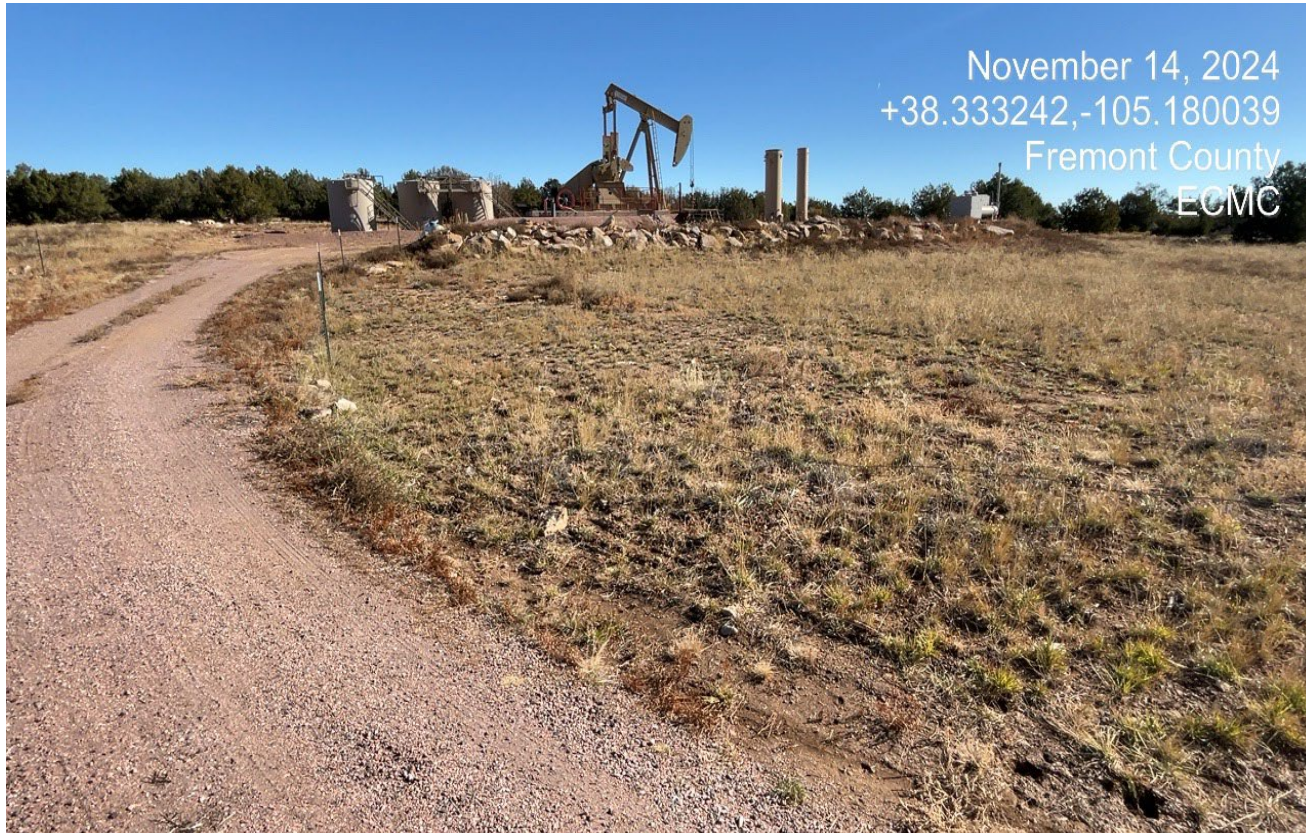
Photo 3. Facing north toward the location.

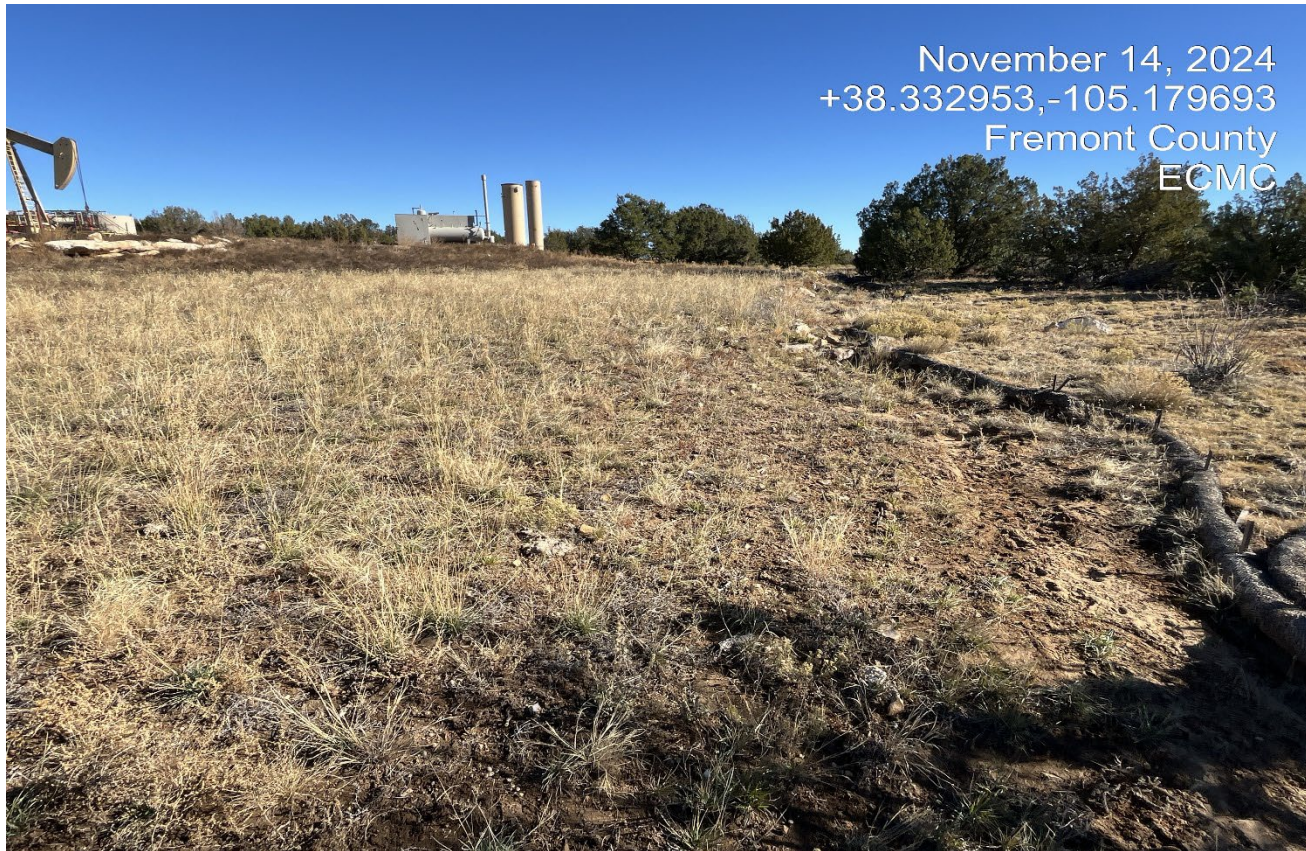
Photo 4. Perennial vegetation is progressing in the interim reclamation area.

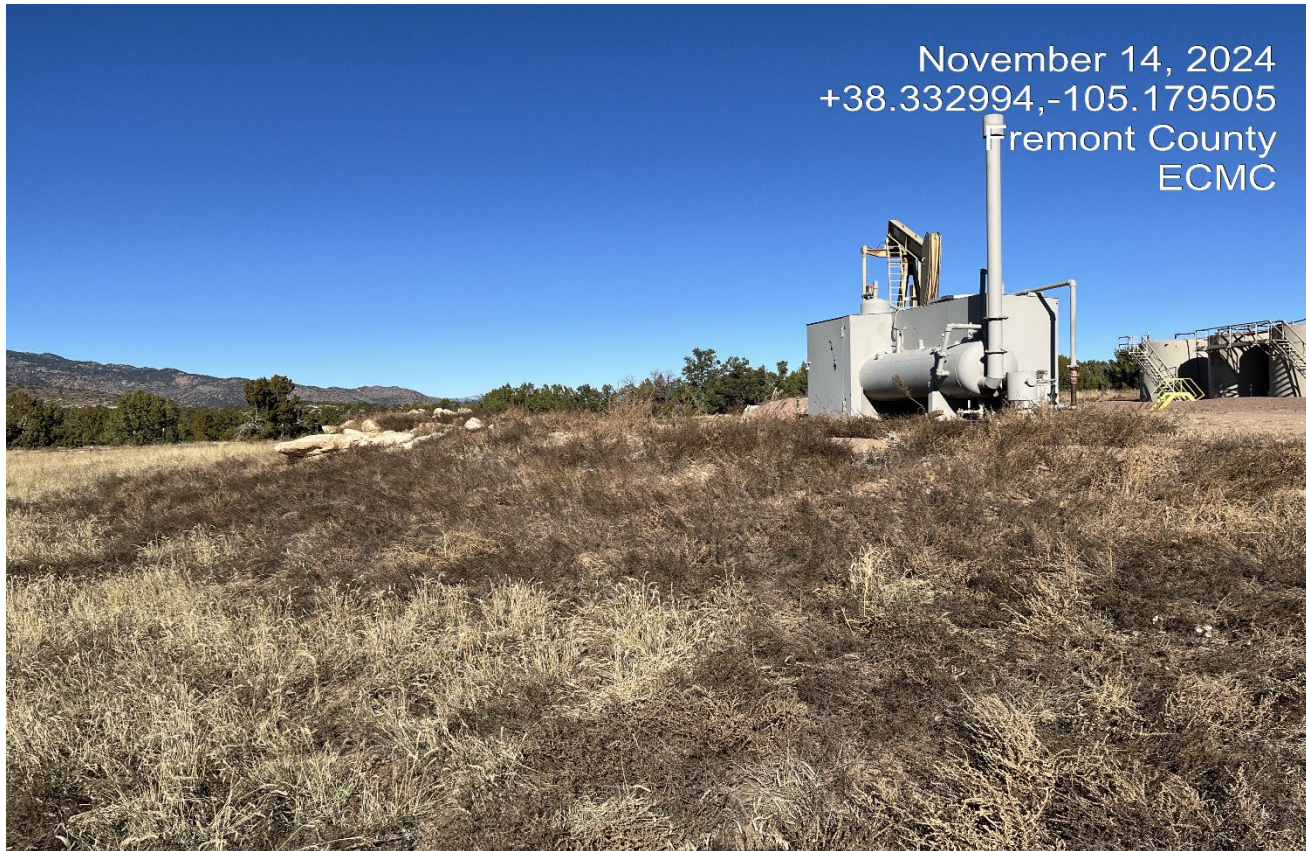
Photo 5. Facing west at the location. The dark brown vegetation is undesirable weeds that need to be controlled.

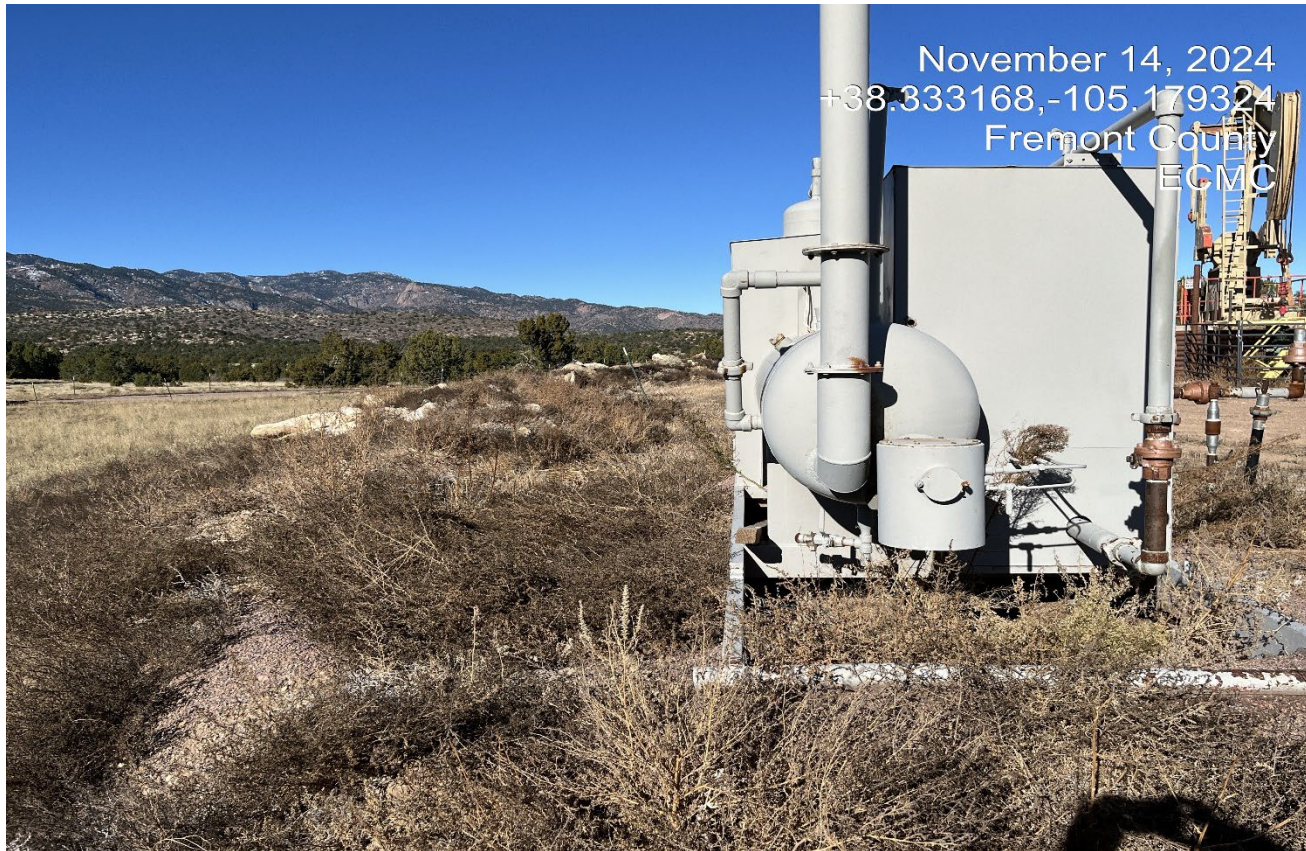
Photo 6. The weed debris around the equipment must be removed.

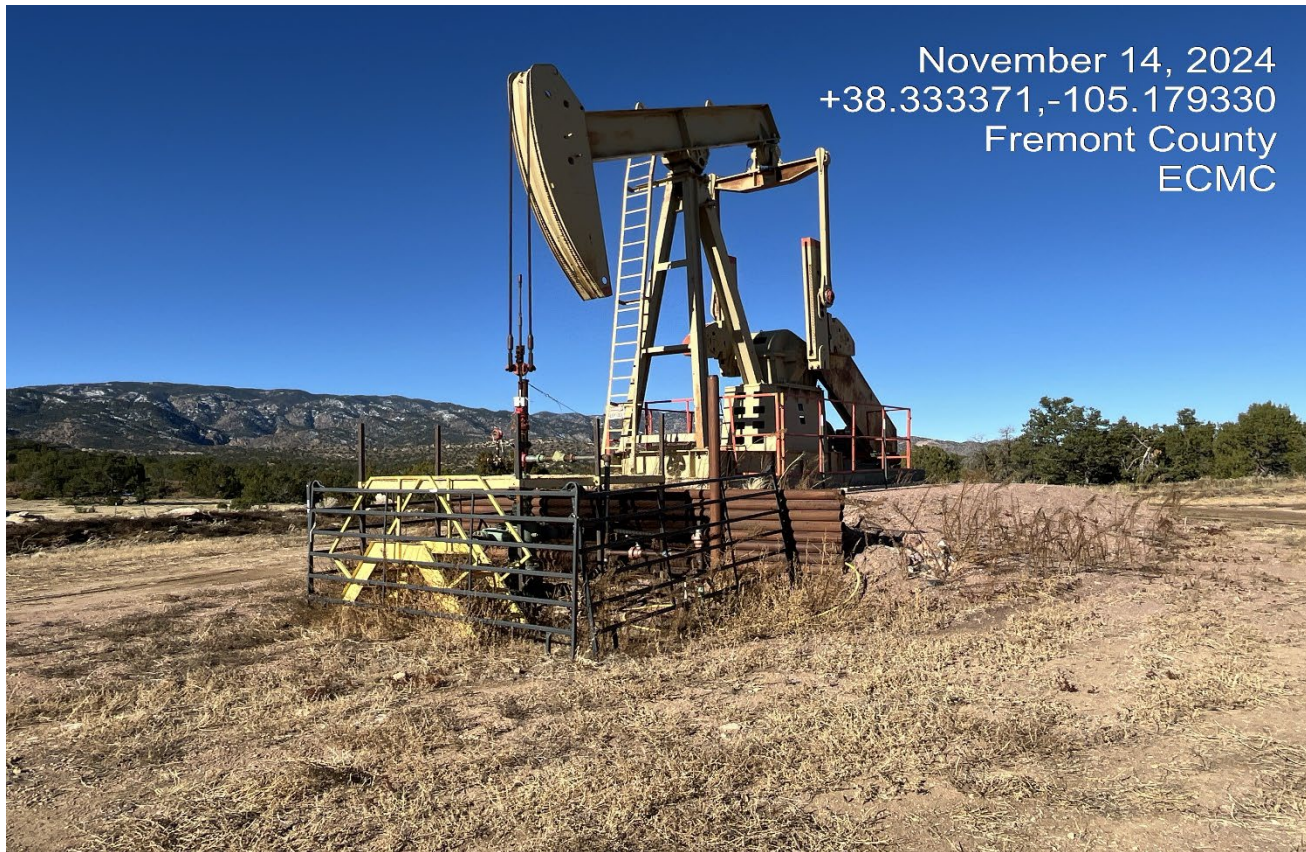
Photo 7. Facing toward the wellhead. The area around the equipment needs to be kept free of dry vegetation and debris.

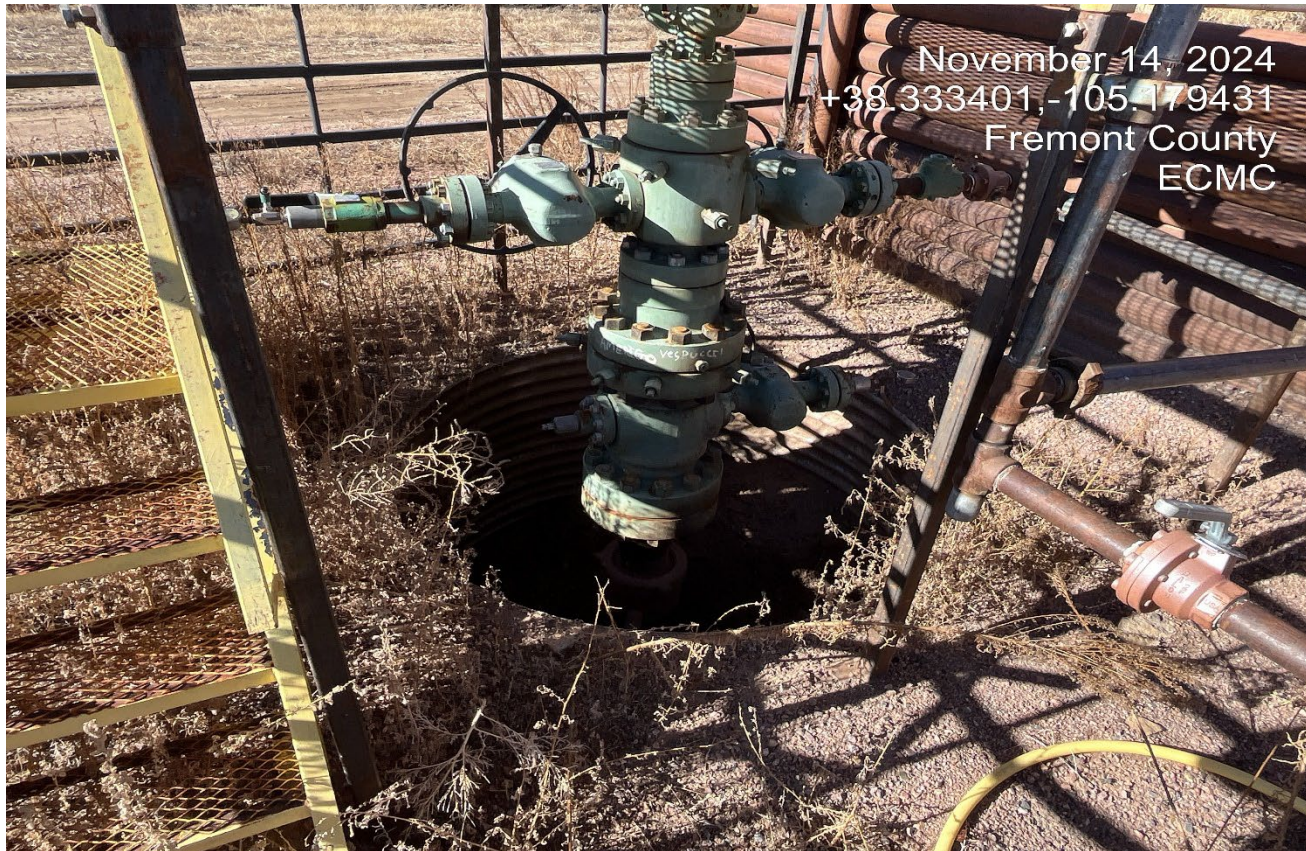
Photo 8. The open cellar at the wellhead needs to be covered or have an escape ramp for critters.

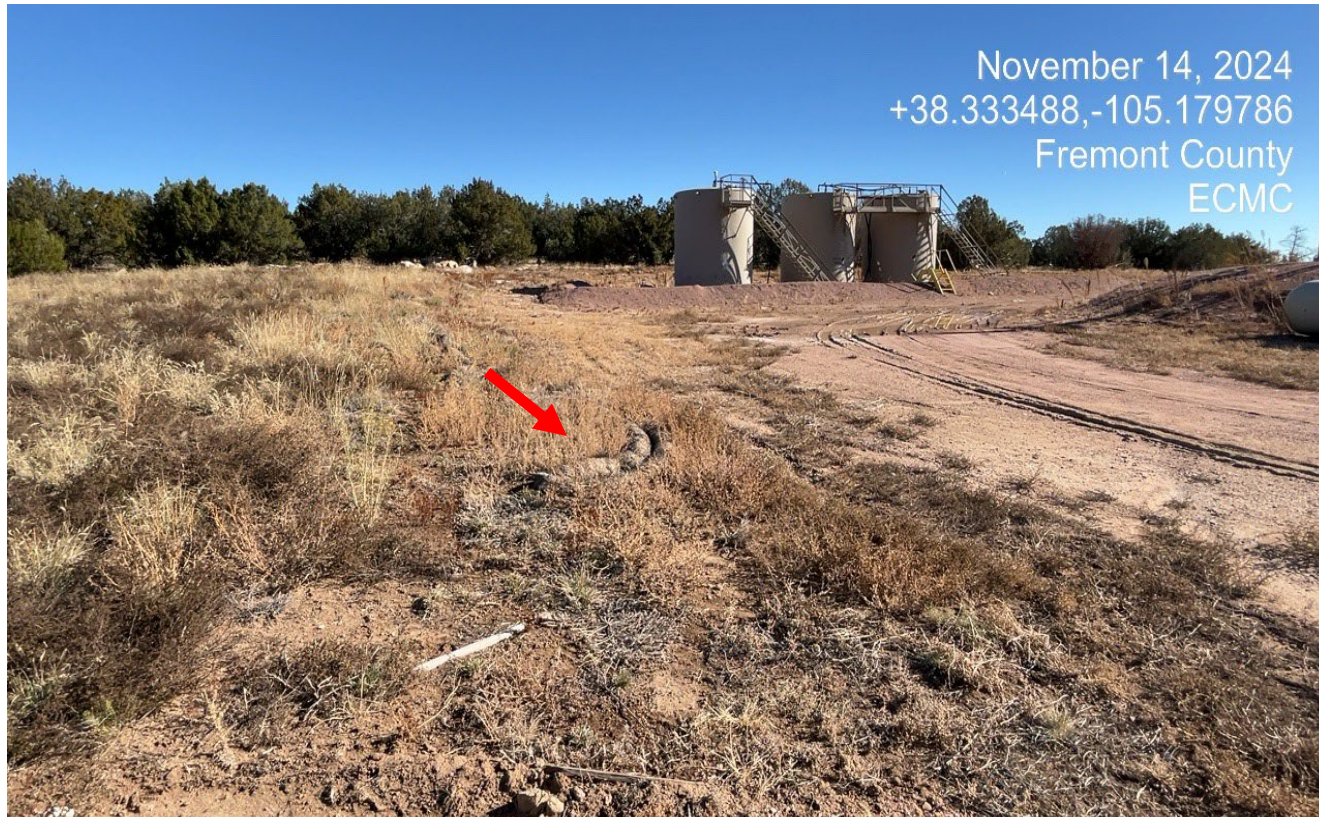
Photo 9. Facing north at the wellsite. The wattles at the red arrow are degraded and not maintained.
