# Inspection Photos

API: 043-06229

Operator: AUSCO PETROLEUM INC

Inspection Date: 11/14/2024

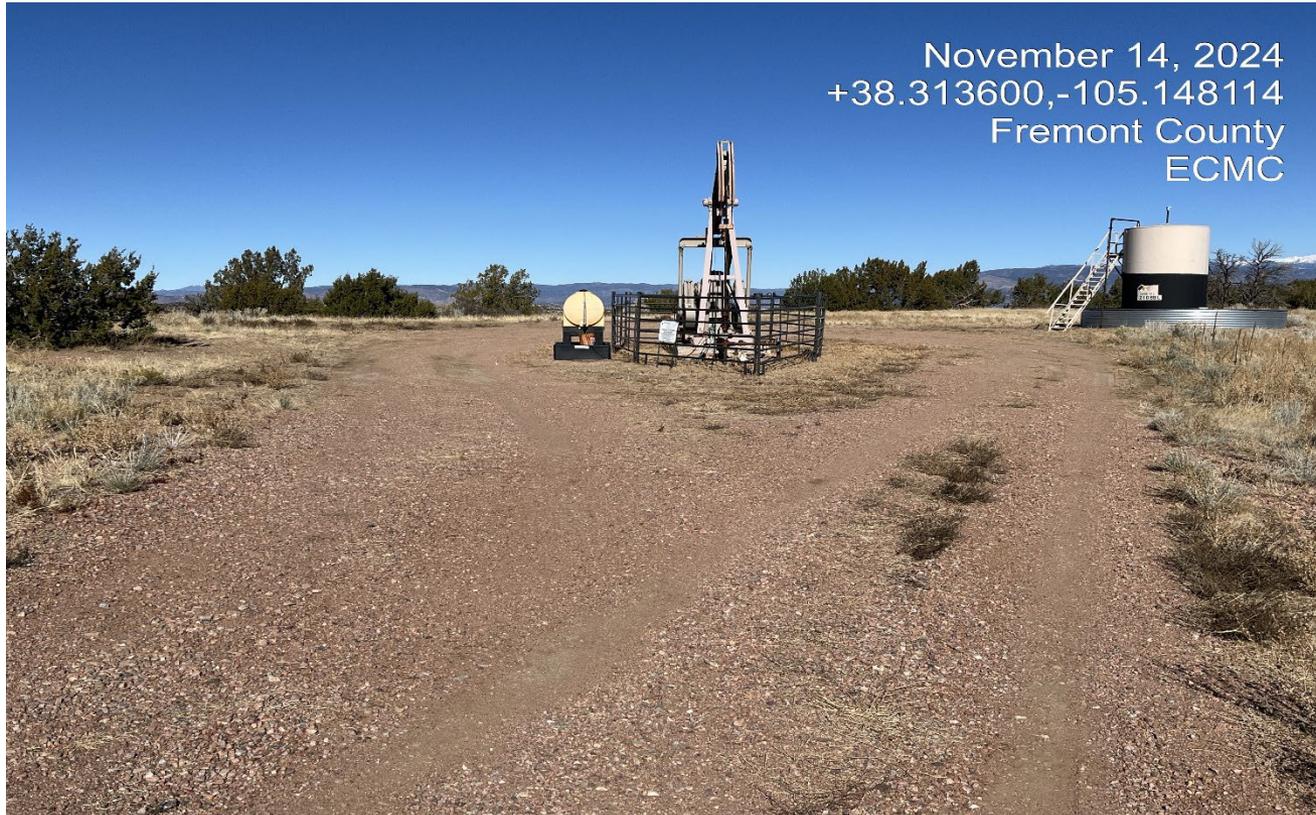
**Photo 1.** Facing northwest toward the location.

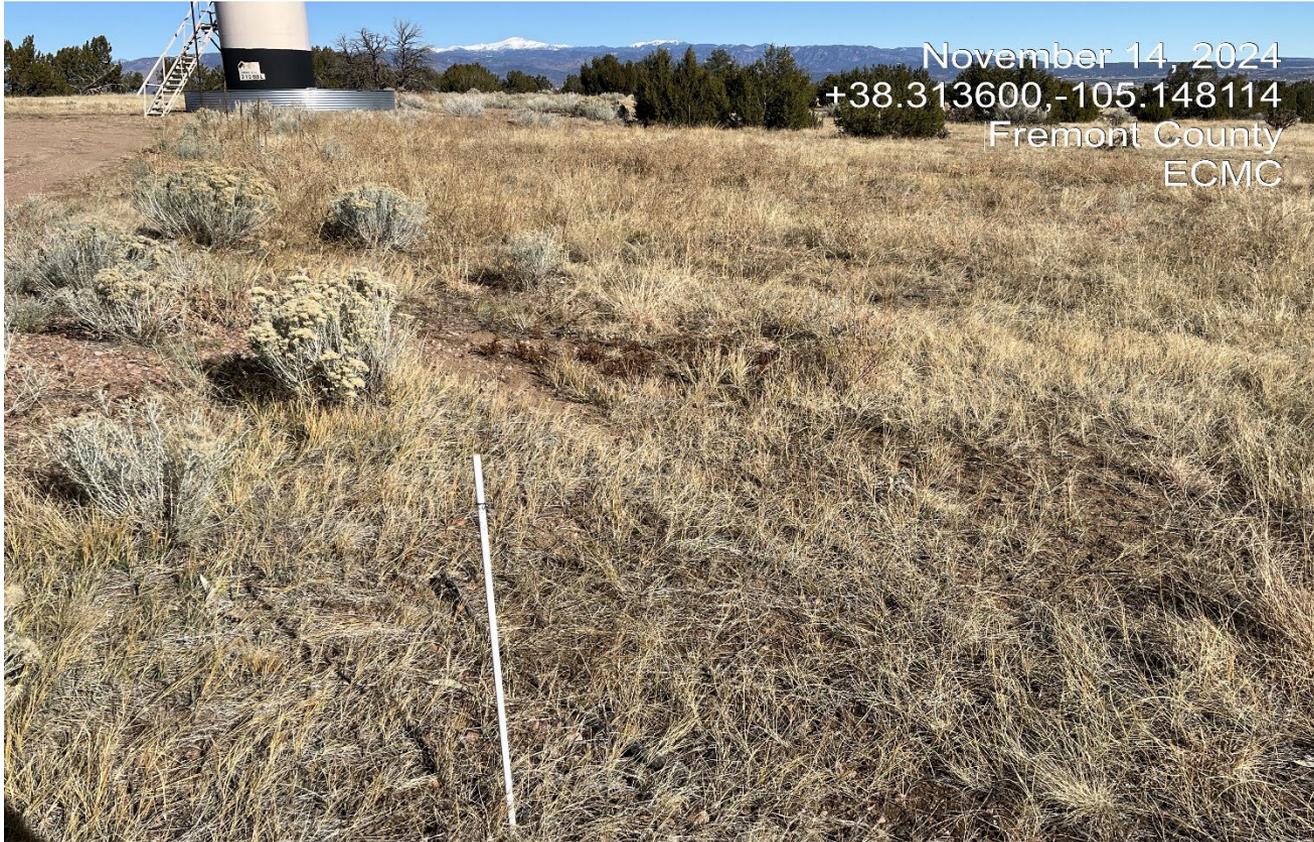
**Photo 2.** The perennial vegetation is progressing well in the interim reclamation area. The fence around this area was removed but the white poles still remain.

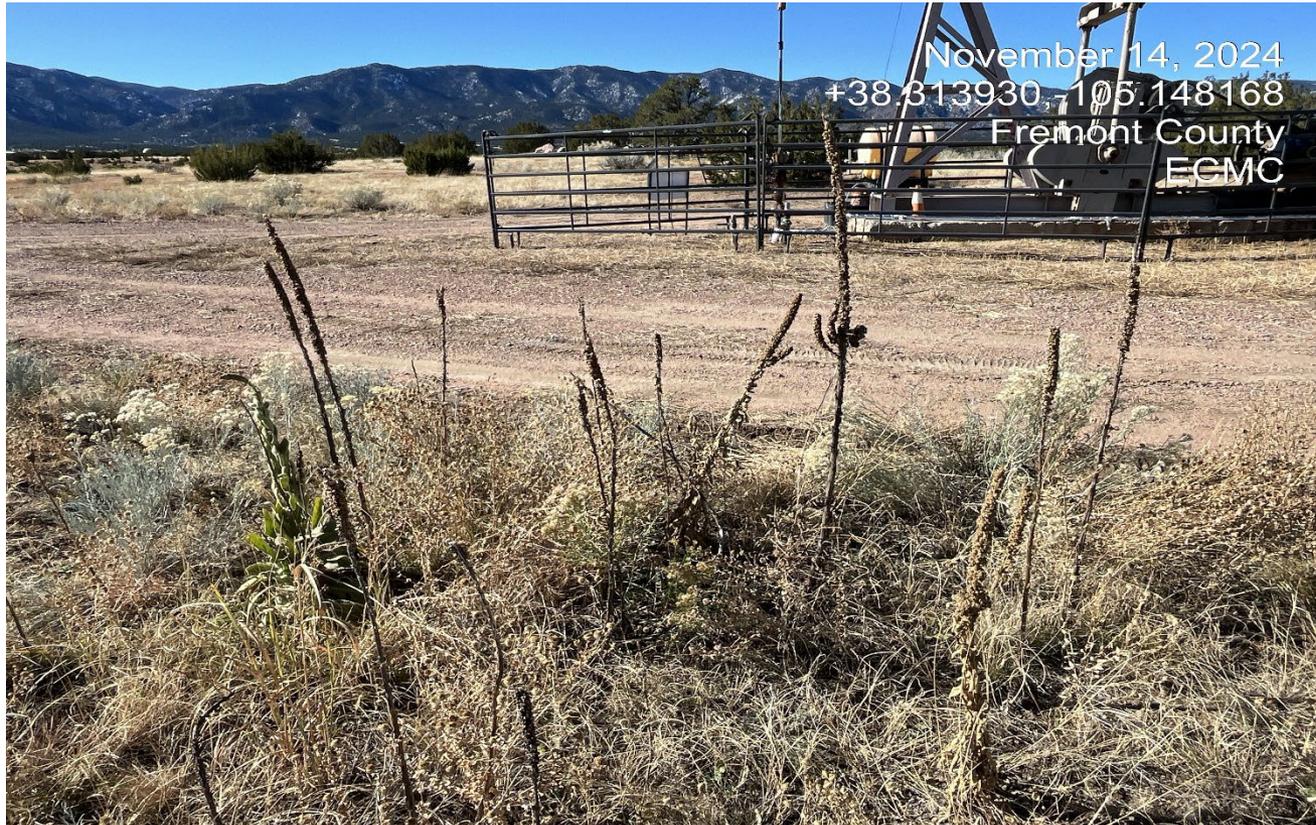
**Photo 3.** There are noxious weeds (Mullein) along the road near the well that will need to be controlled during the next growing season..

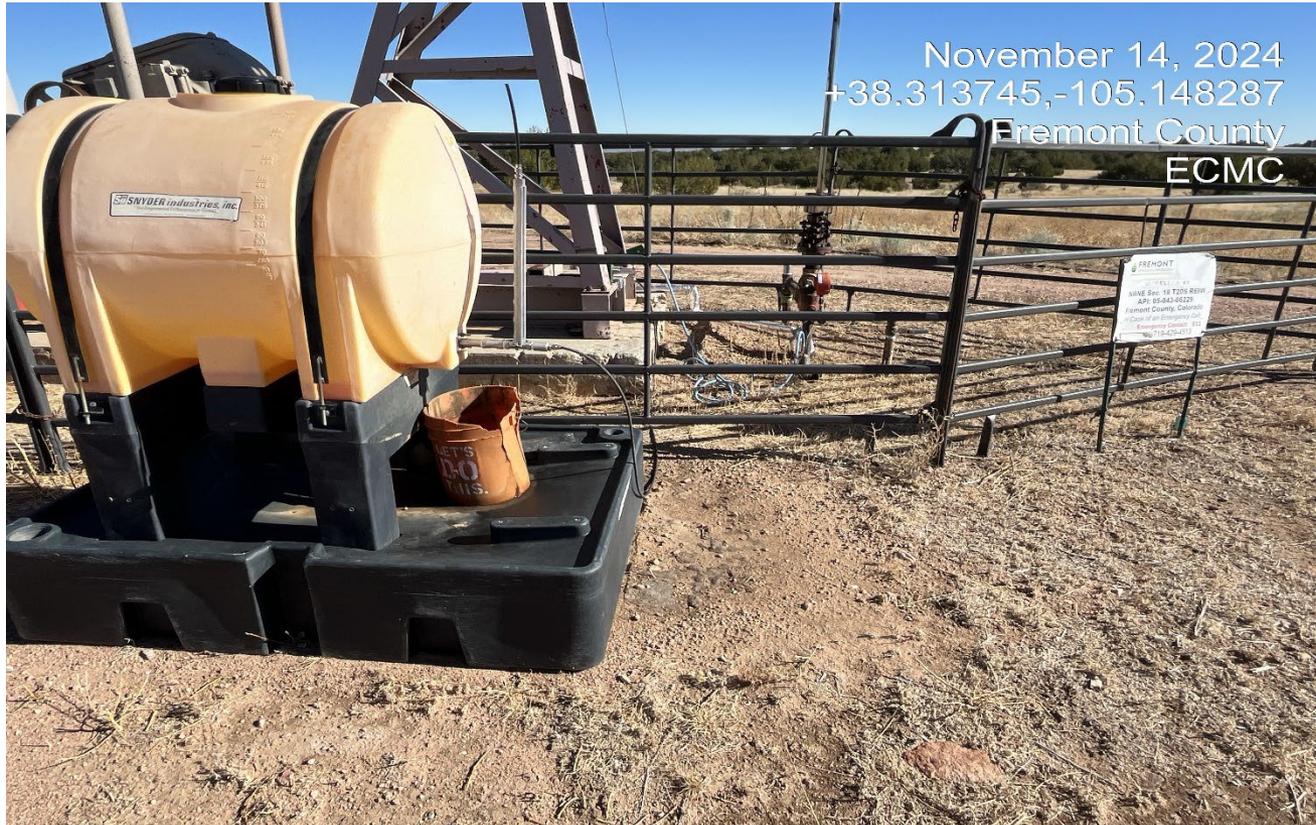
**Photo 4.** There is a orange bucket of oil that needs to be removed.
