Inspection Photos

Location: QB ENERGY BJU/B26-496 Pad
Location ID: 479149
Date: 11/14/2024

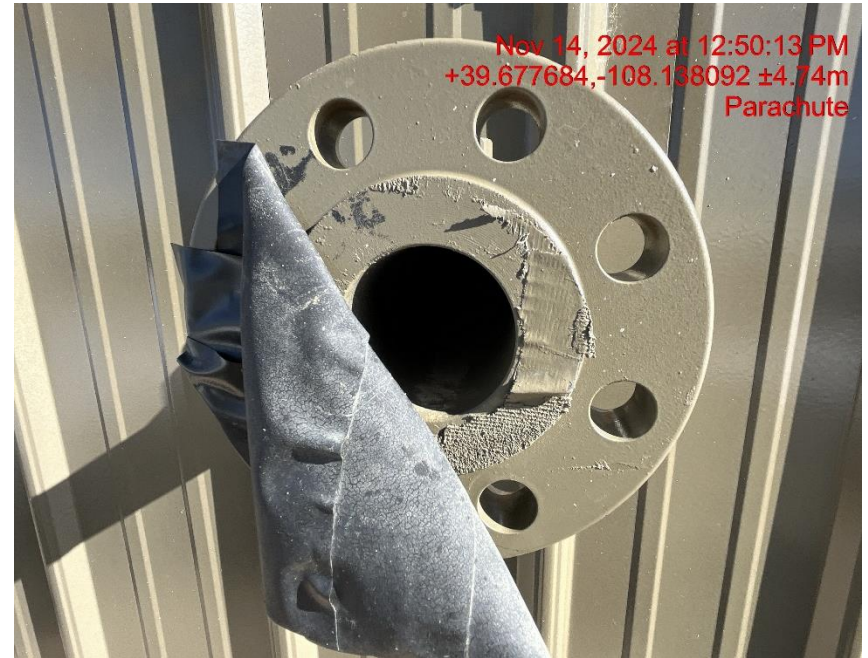
Photo # 9073 Open ended piping/wildlife hazard/ available for entry by wildlife

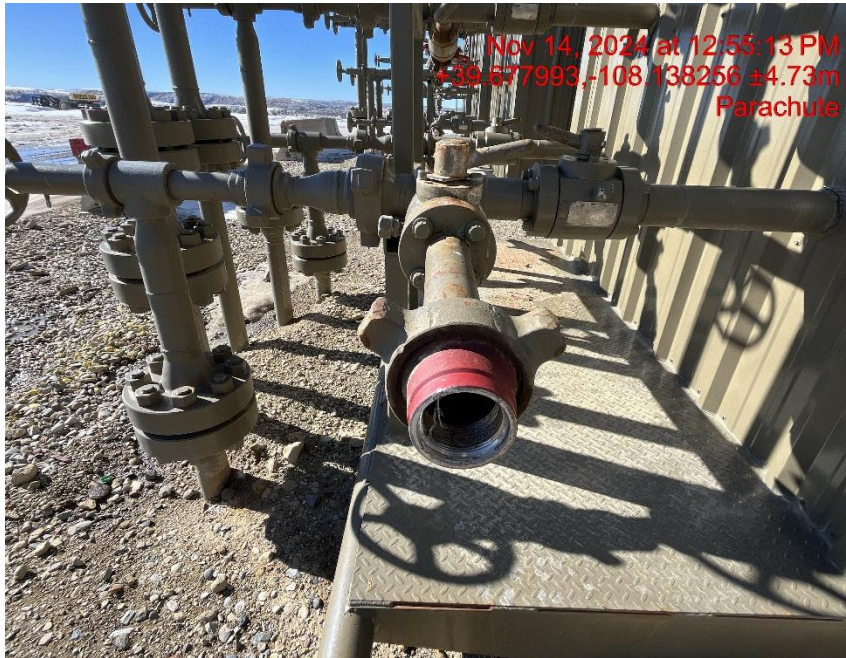
Photo # 9076 Open ended piping/wildlife hazard/ available for entry by wildlife

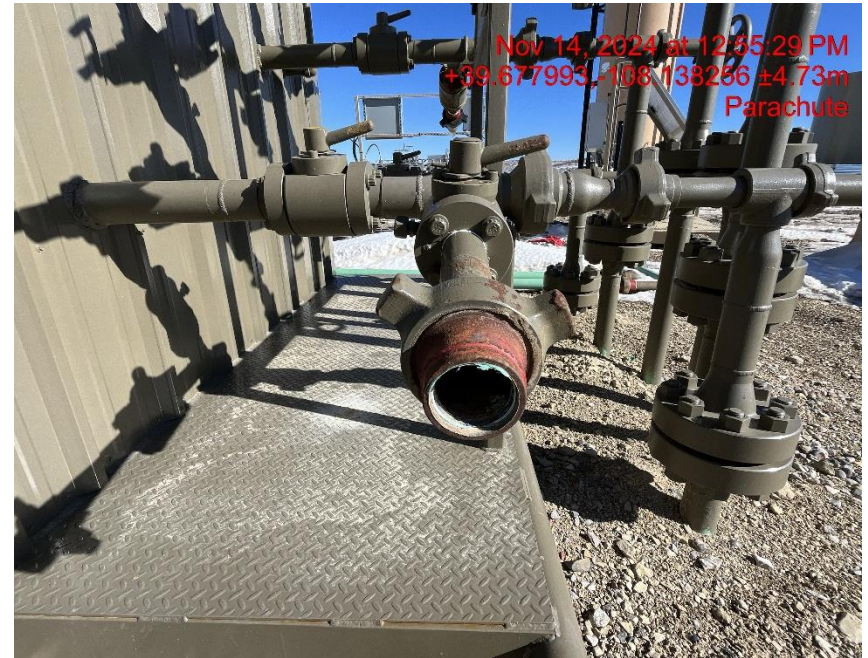
Photo # 9077 Open ended piping/wildlife hazard/ available for entry by wildlife

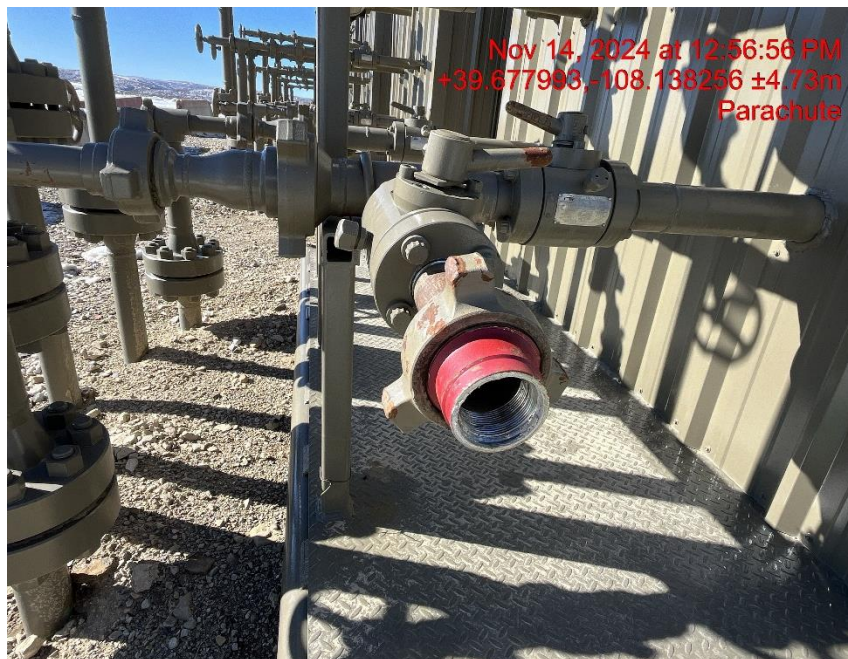
Photo # 9079 Open ended piping/wildlife hazard/ available for entry by wildlife

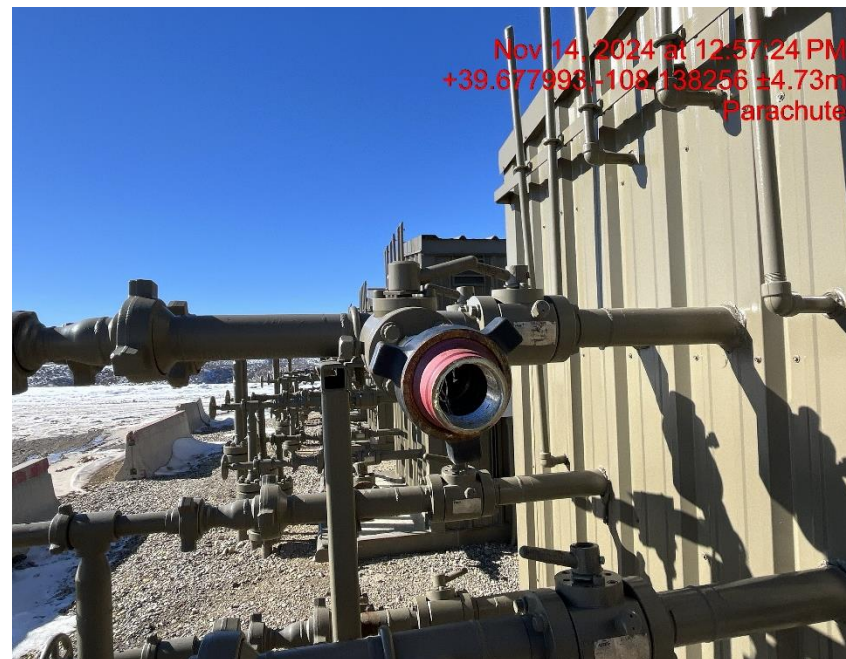
Photo # 9080 Open ended piping/wildlife hazard/ available for entry by wildlife

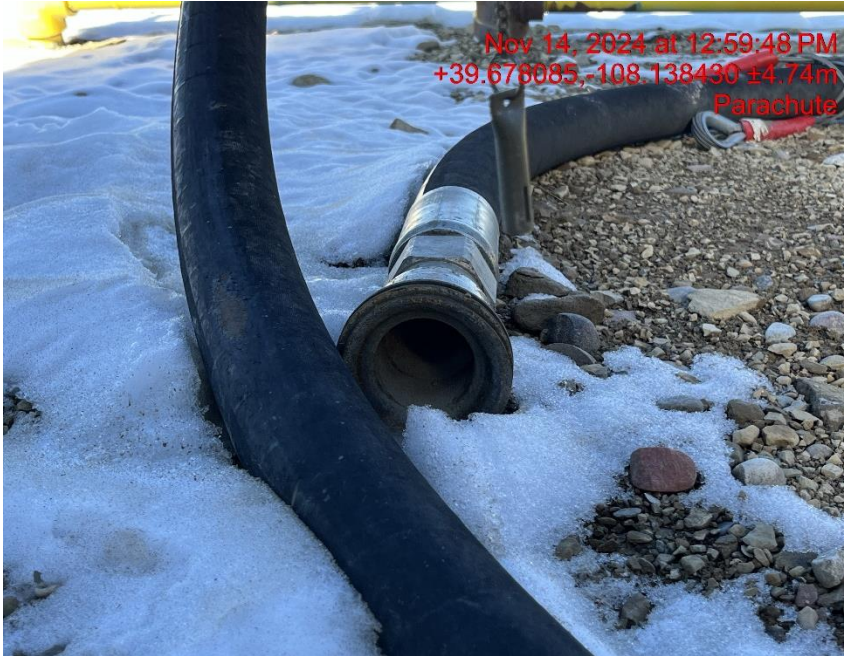
Photo # 9084 Open ended piping/wildlife hazard/ available for entry by wildlife

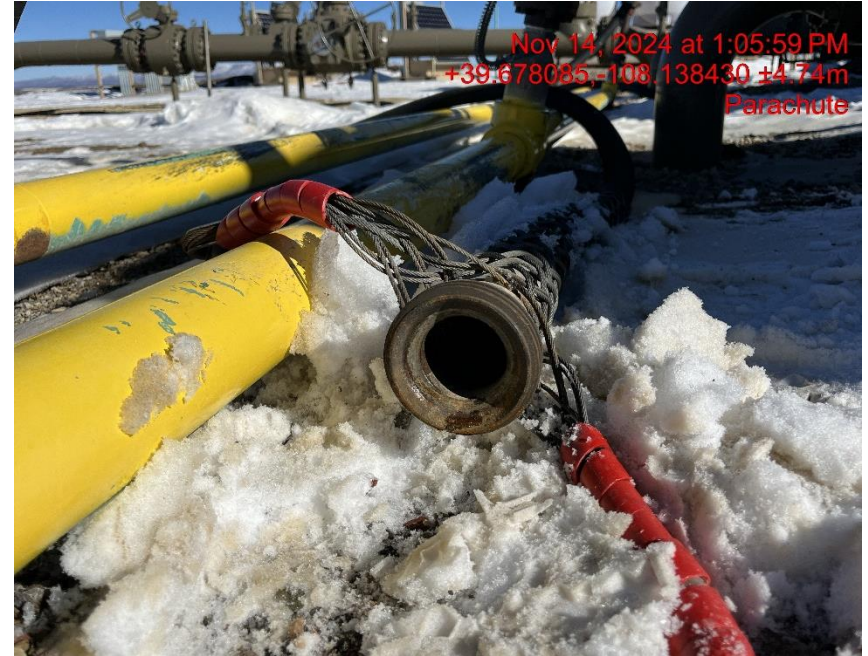
Photo # 9090 Open ended piping/wildlife hazard/ available for entry by wildlife

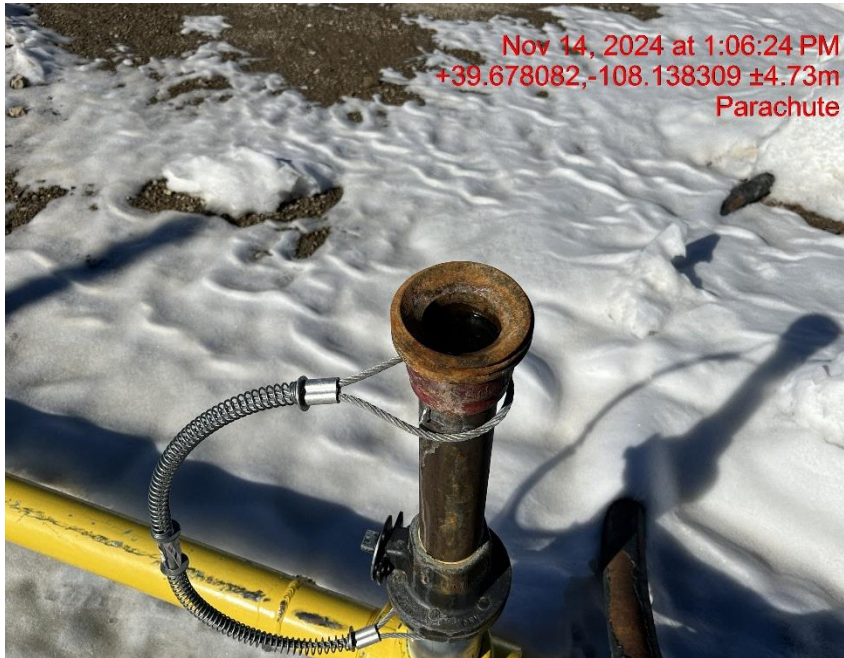
Photo # 9091 Open ended piping/wildlife hazard/ available for entry by wildlife

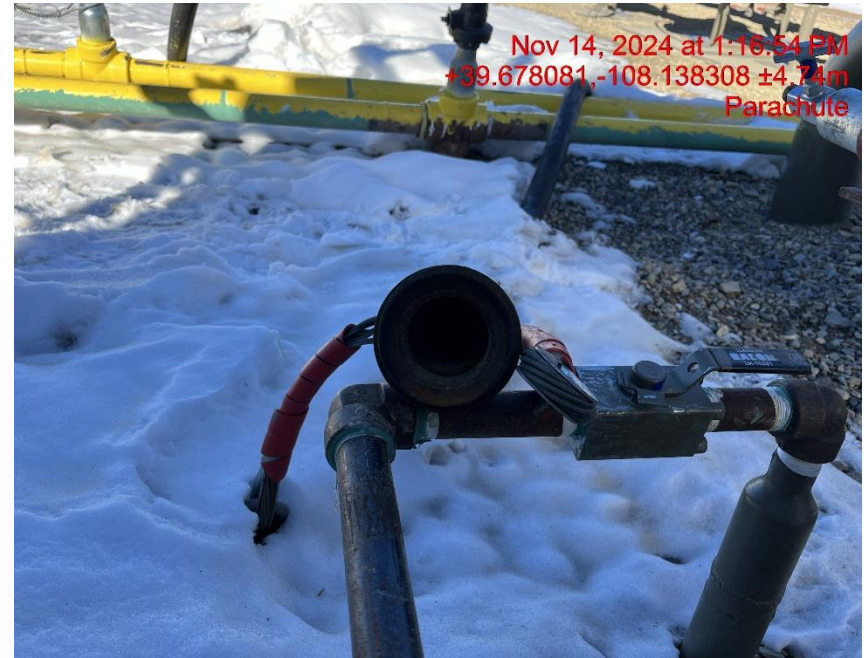
Photo # 9100 Open ended piping/wildlife hazard/ available for entry by wildlife

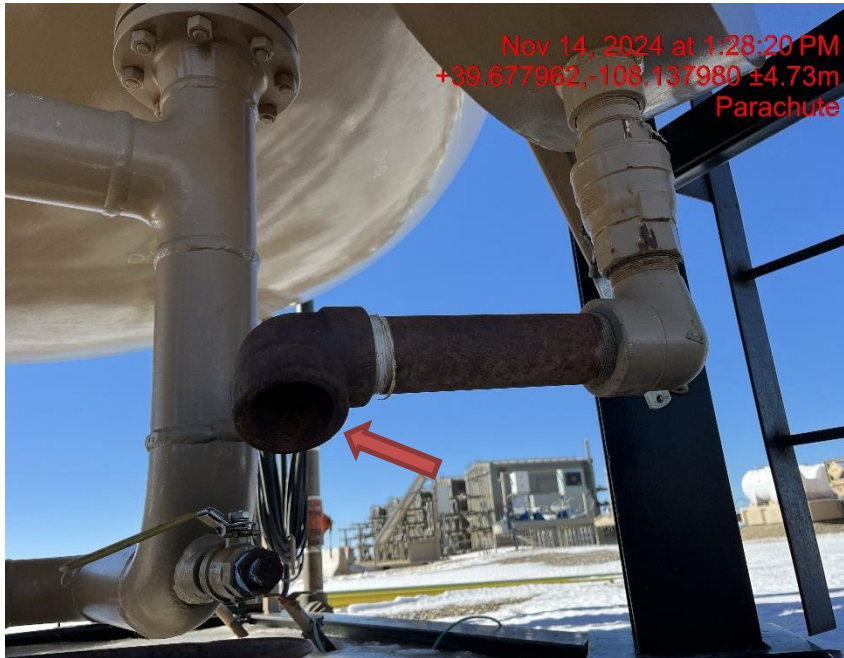
Photo # 9119 Open ended piping/wildlife hazard/ available for entry by wildlife

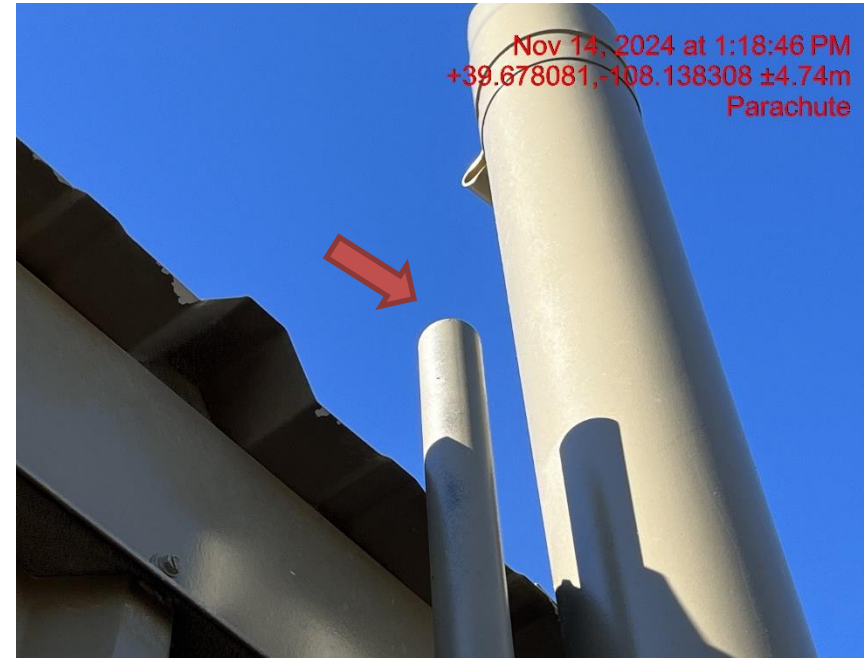
Photo # 9104 PRV vent line does not comply with CECMC pressure safety device rules

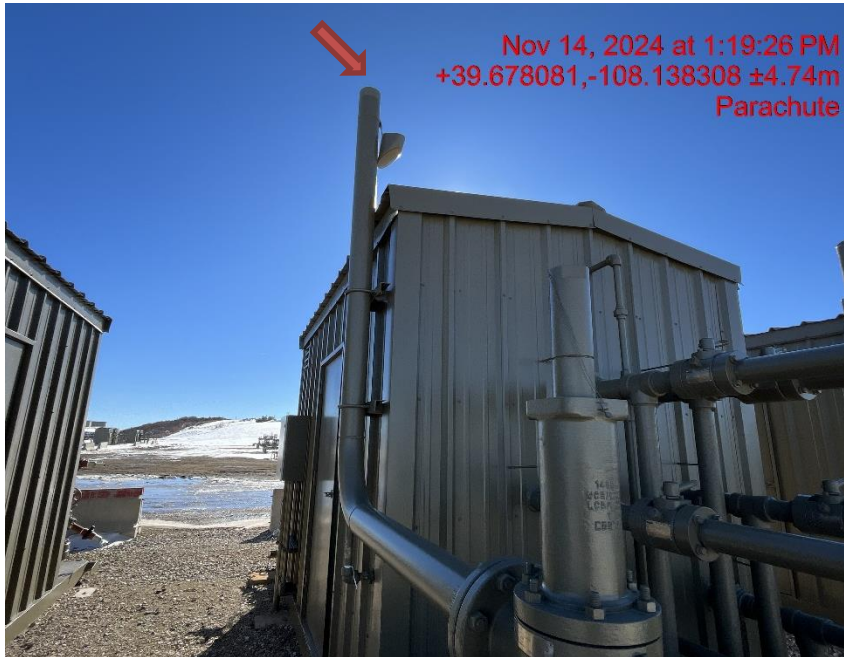
Photo # 9105 PRV vent line does not comply with CECMC pressure safety device rules

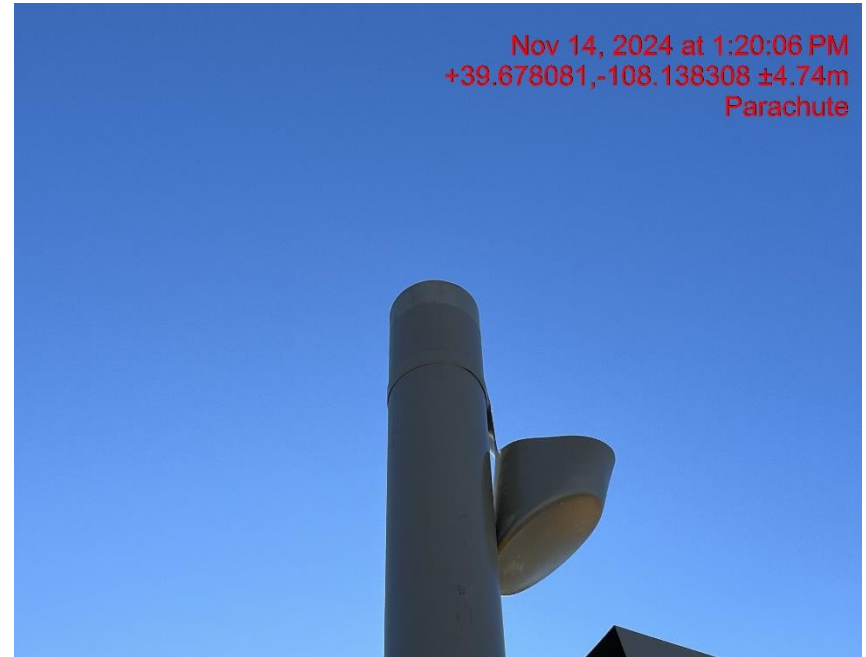
Photo # 9107 PRV vent line does not comply with CECMC pressure safety device rules

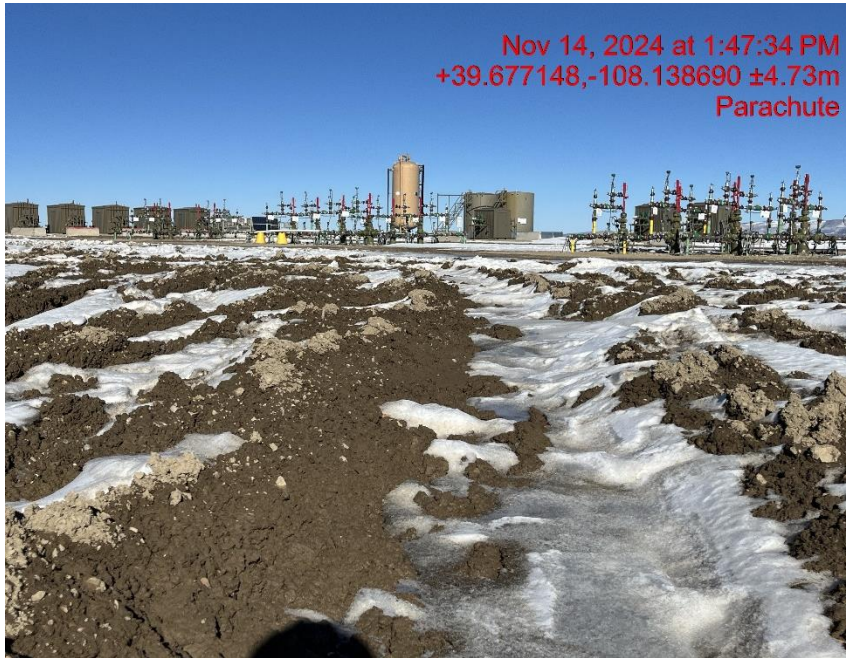
Photo # 9141 Lack of stabilization/compaction on location/insufficient BMP's

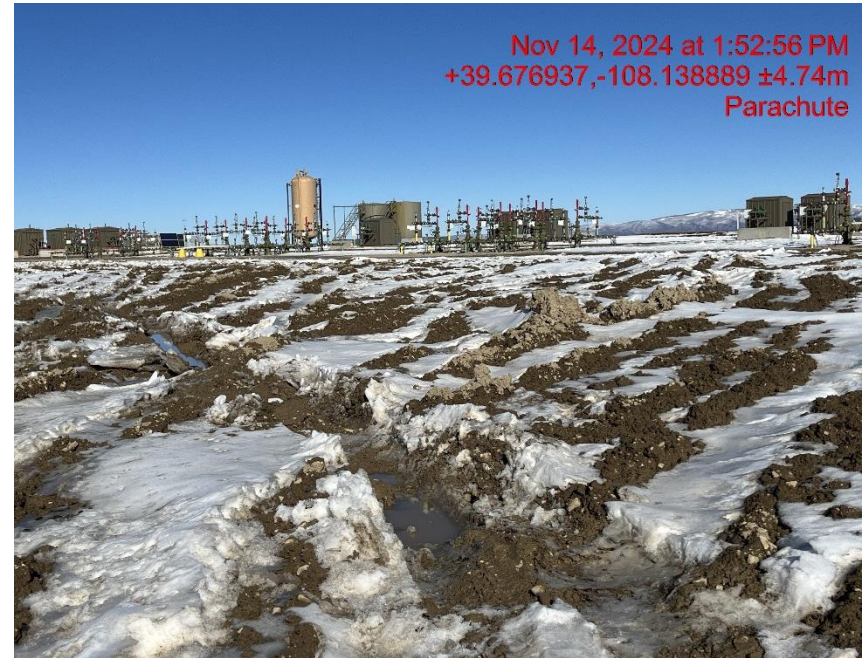
Photo # 9148 Lack of stabilization/compaction on location/insufficient BMP's

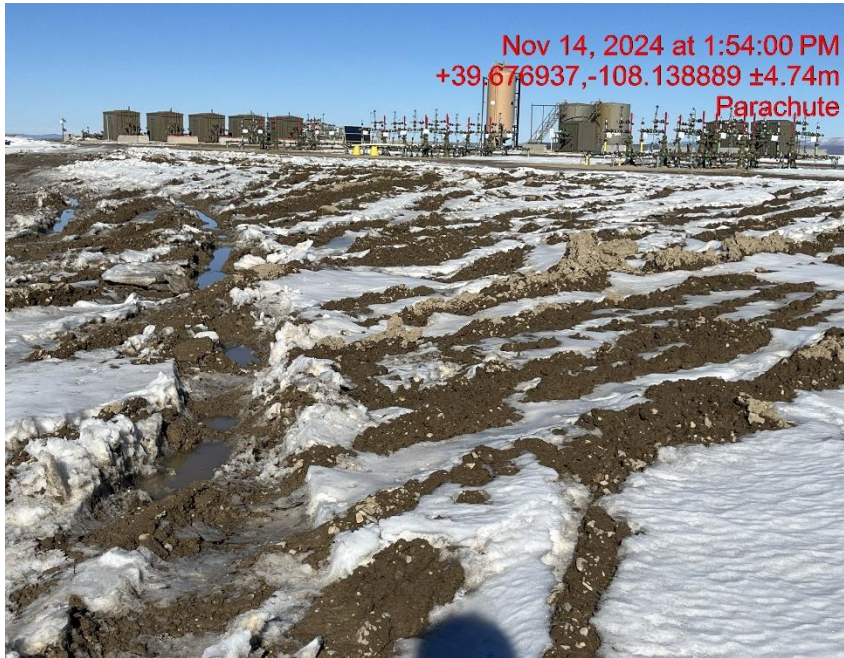
Photo # 9150 Lack of stabilization/compaction on location/insufficient BMP's

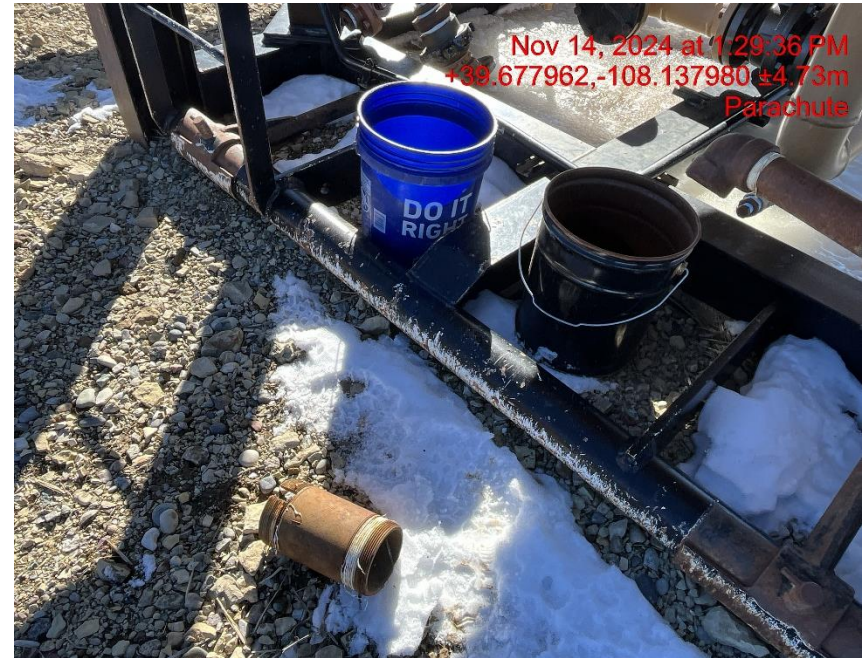
Photo # 9120 Debris

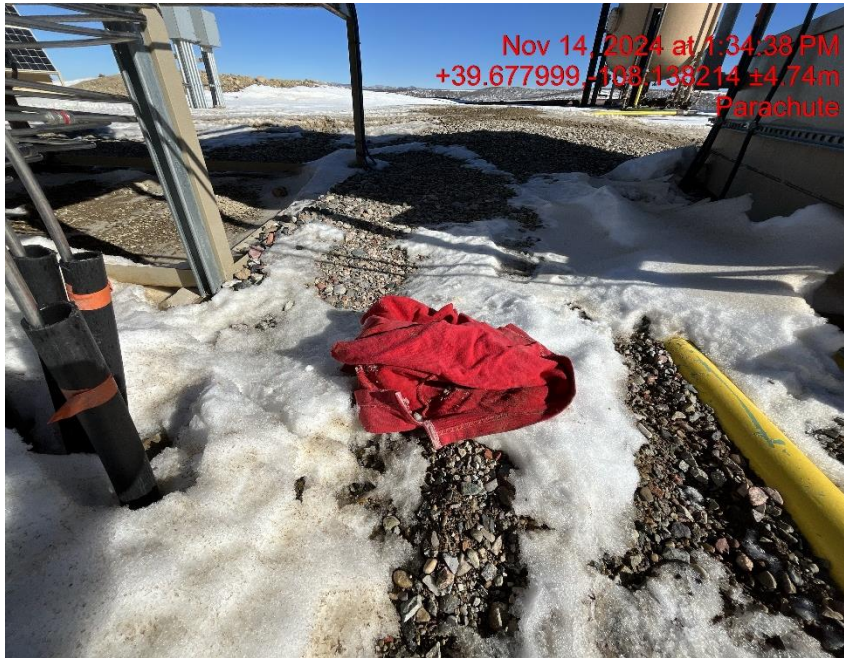
Photo # 9128 Debris

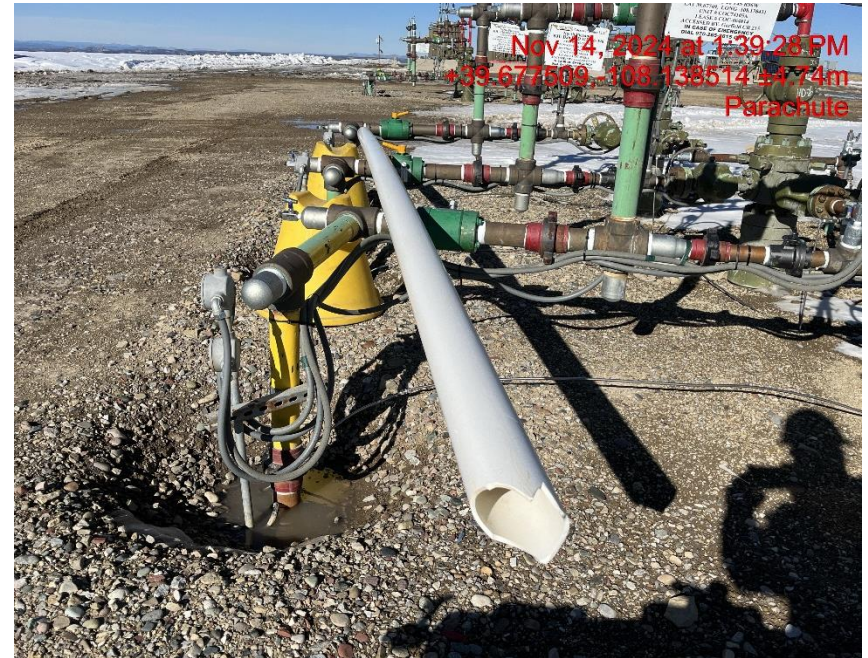
Photo # 9132 Debris
