Taproot – Big Mountain Viper Pad – Produced Water Release

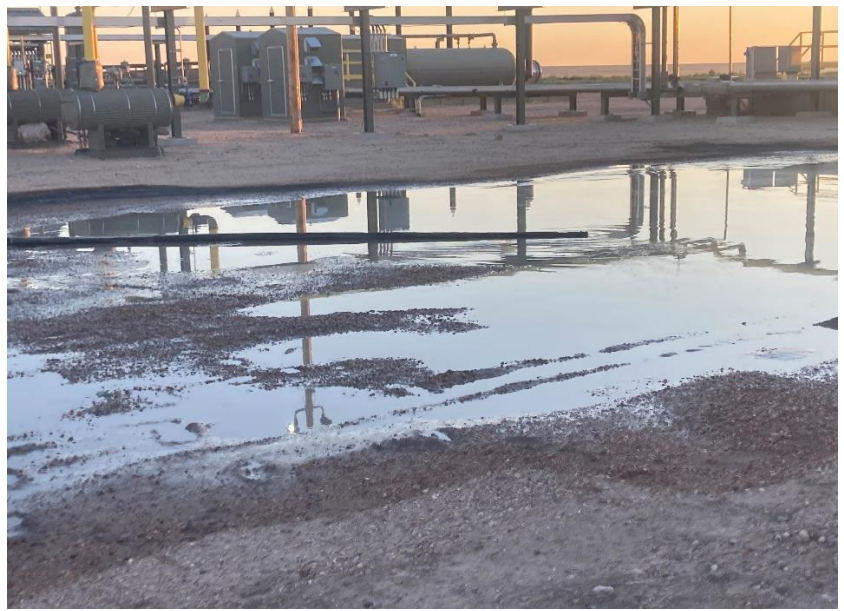
Photo: 1

Initial site conditions on 9/5 looking east.

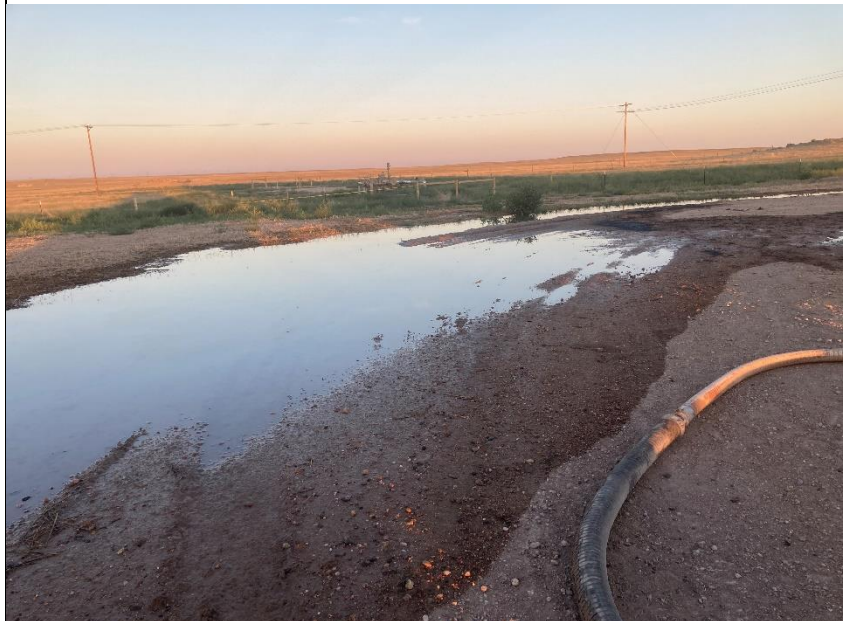
Photo: 2

Initial site conditions looking southwest.

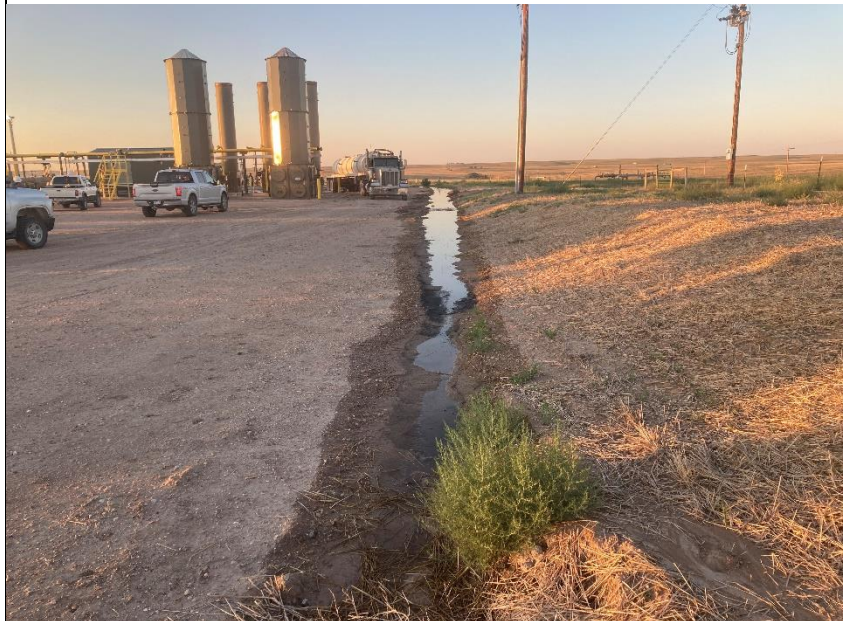
Photo: 3

Initial site conditions looking south.

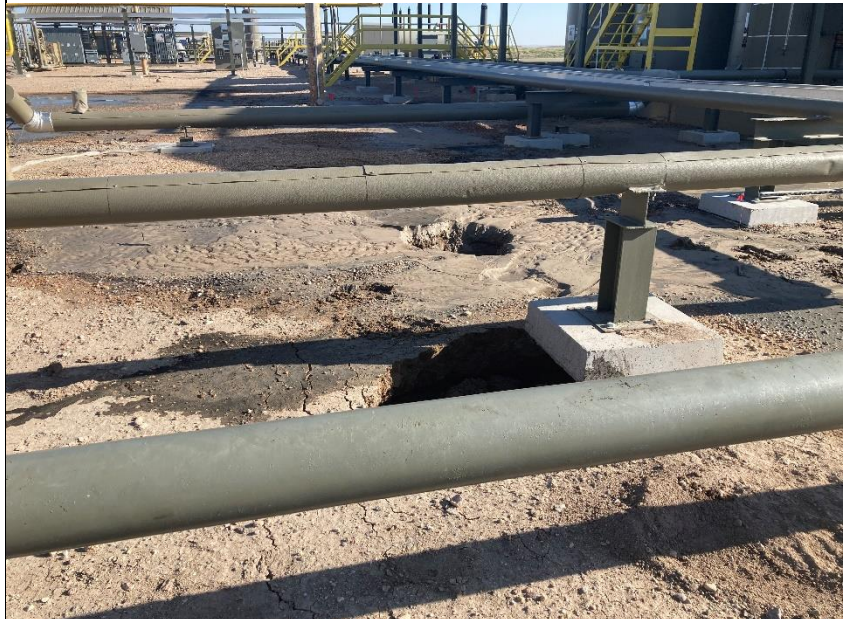
Photo: 4

Release location.

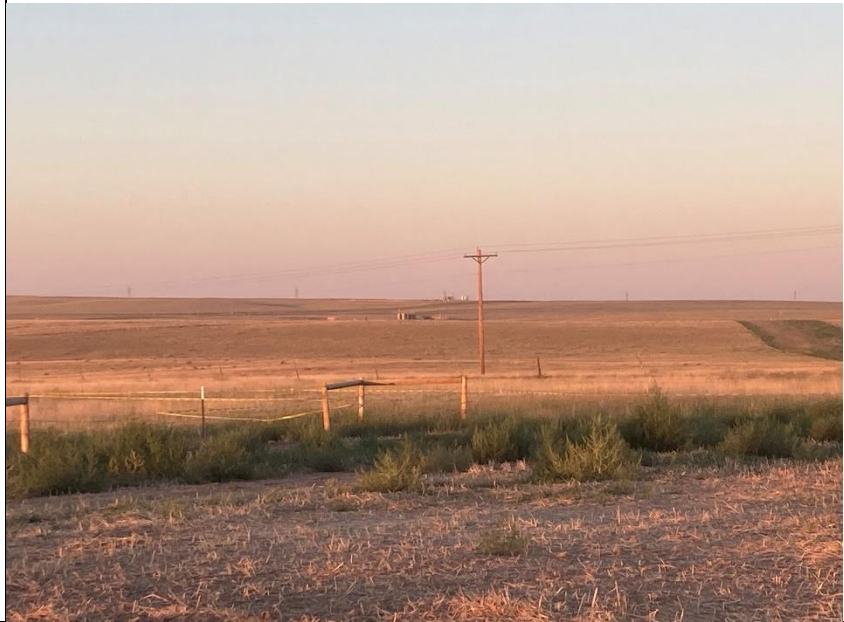
Photo: 5

The outlined impacted area of the adjacent property to the southwest.

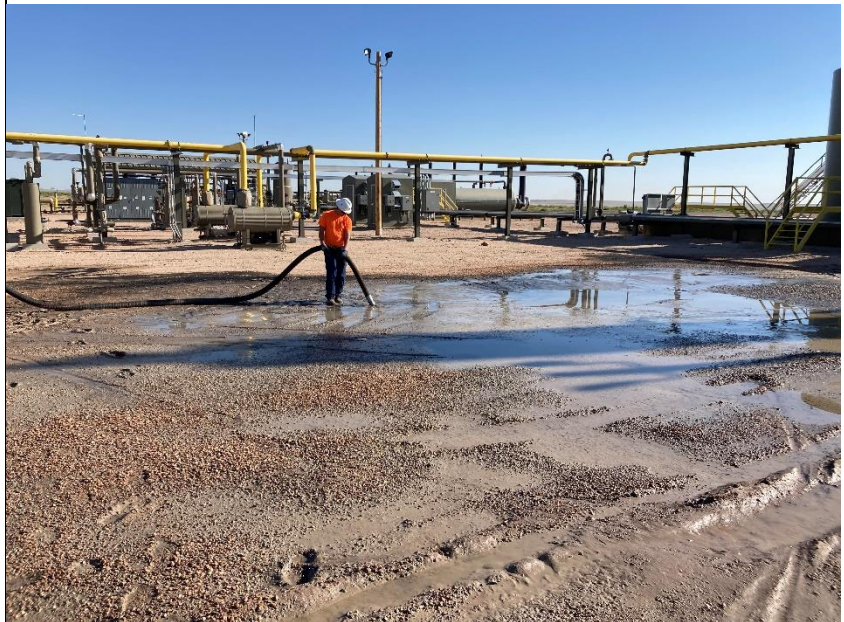
Photo: 6

Liquid Vac Truck Operator working to remove free liquids.

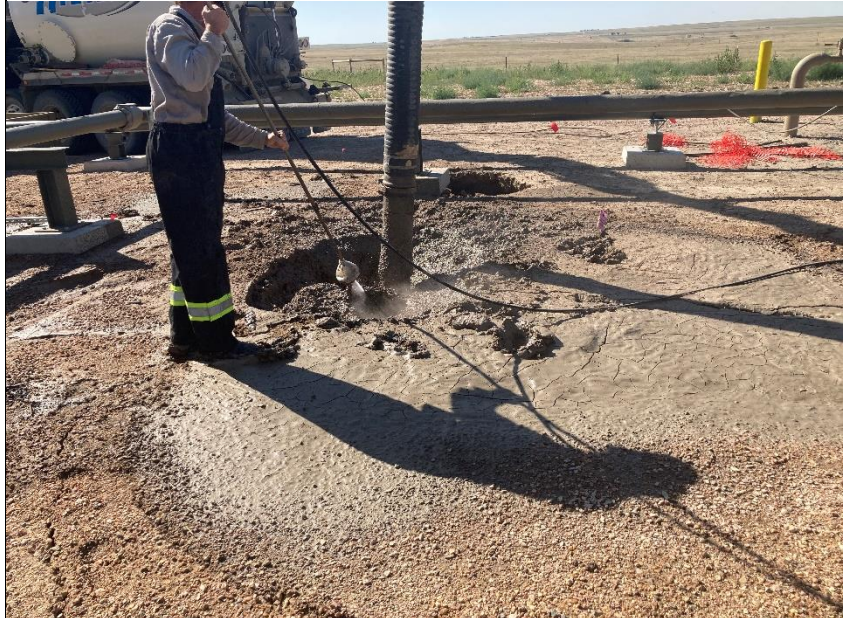
Photo: 7

Hydro excavator working in the primary excavation area to locate the pipeline failure.

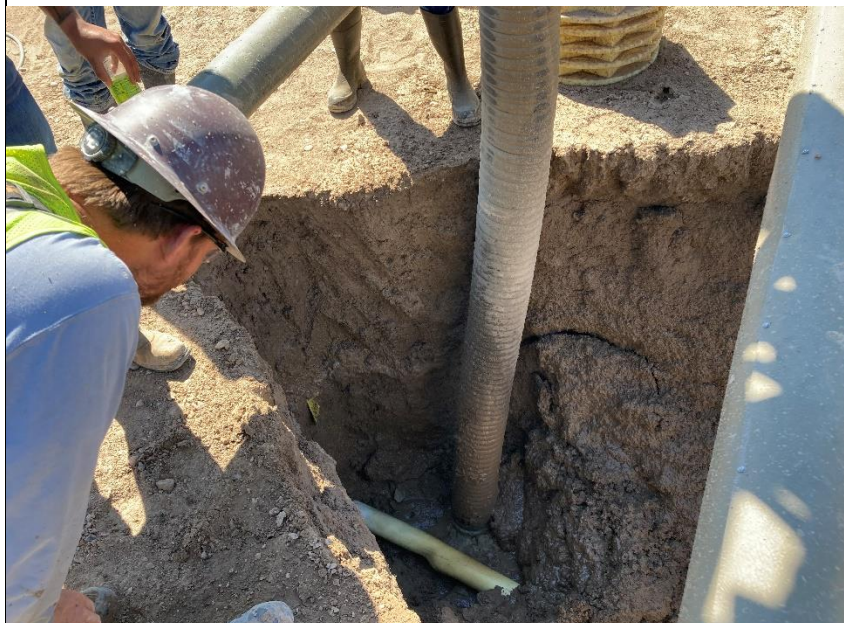
Photo: 8

Locating the failure in the pipeline.

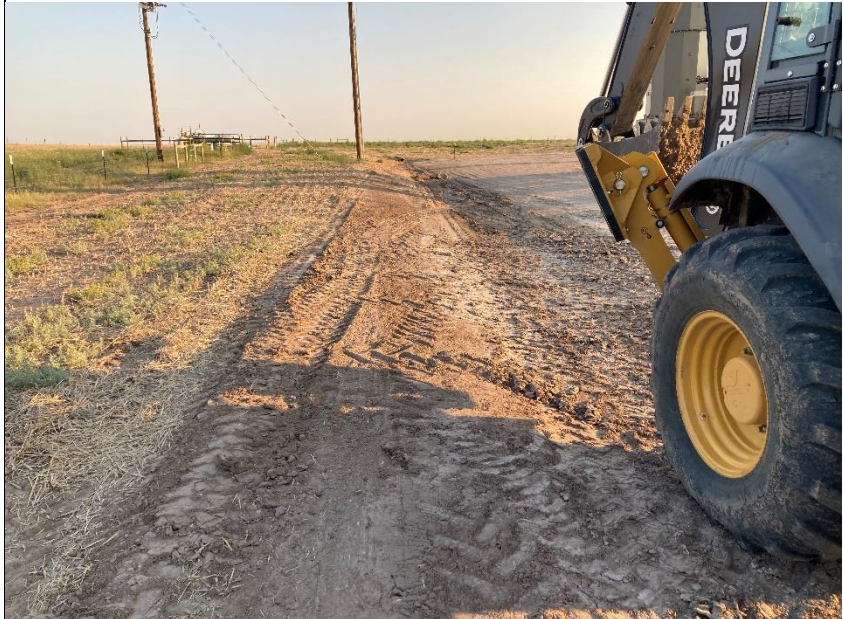
Photo: 11

Surface scrapping of impacted area to remove visible wet soil.

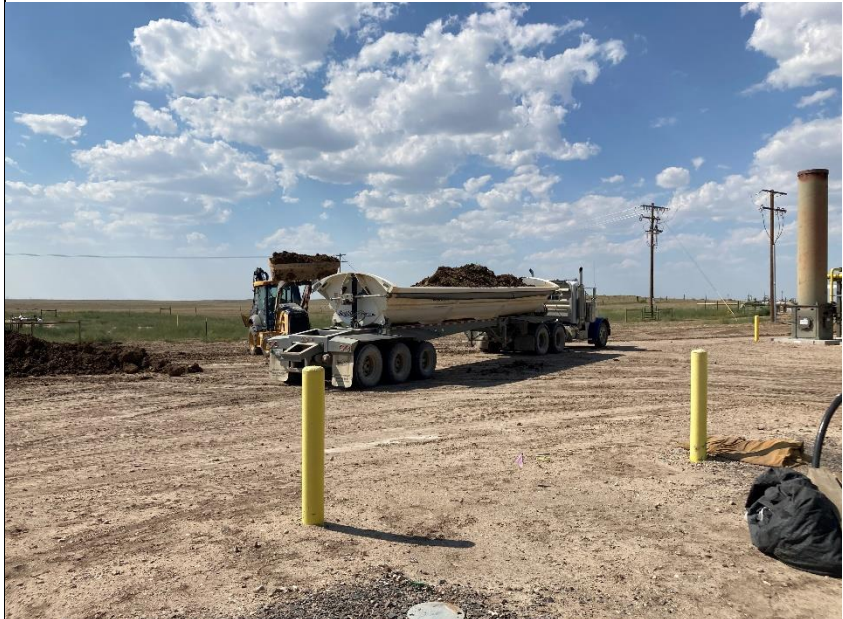
Photo: 12

Loading impacted soil for disposal.

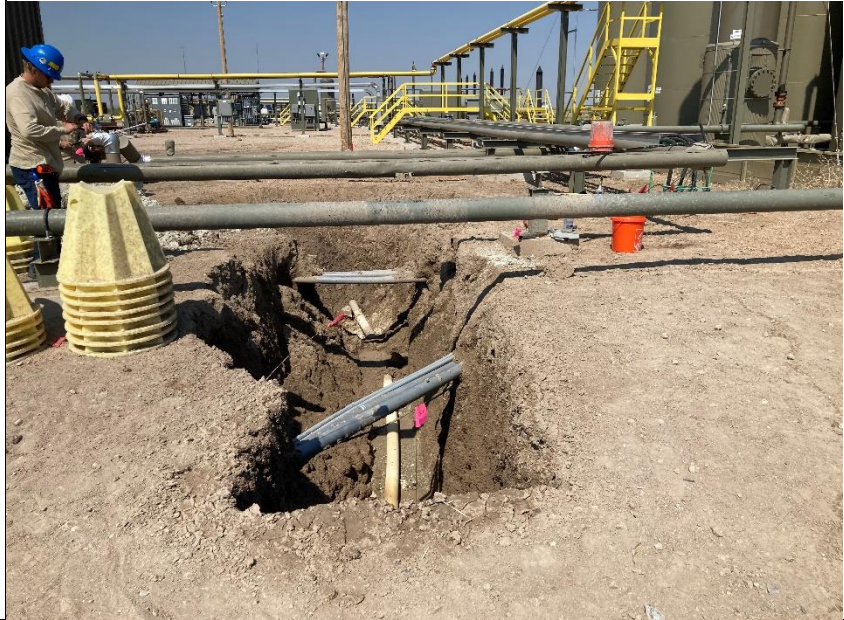
Photo: 13

Primary excavation area after exposing failed pipeline. View looking north.

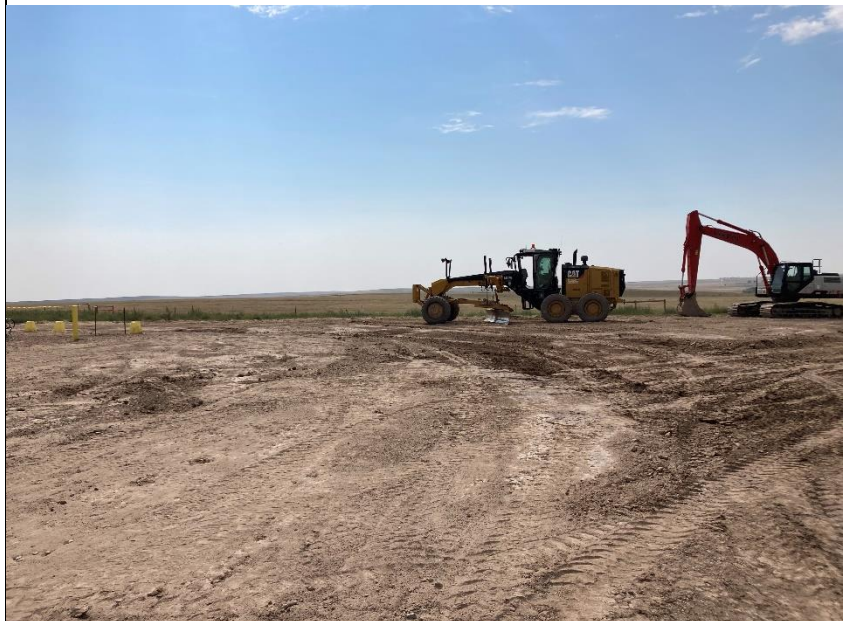
Photo: 14

Secondary excavation area after surface scrape looking west.

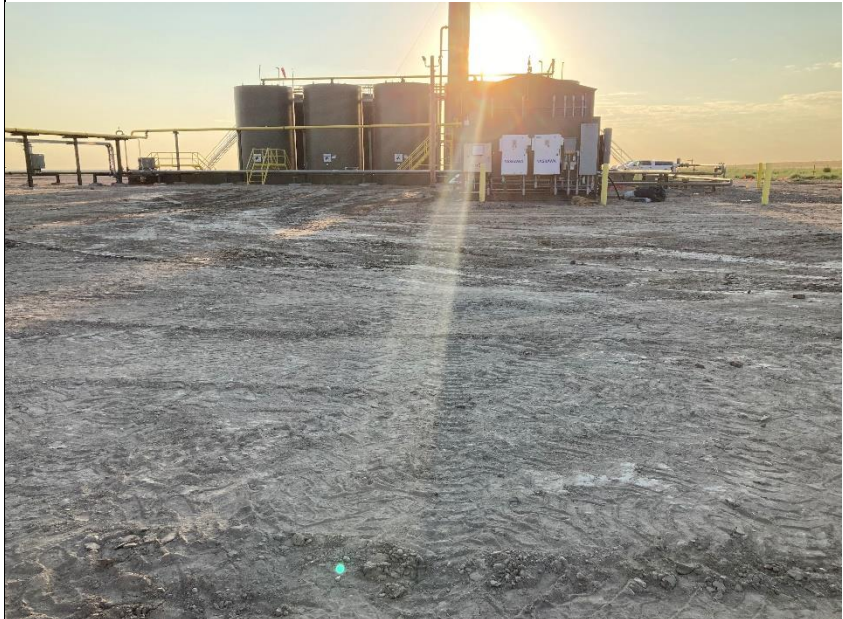
Photo: 15

Secondary excavation area after surface scrape, looking east.

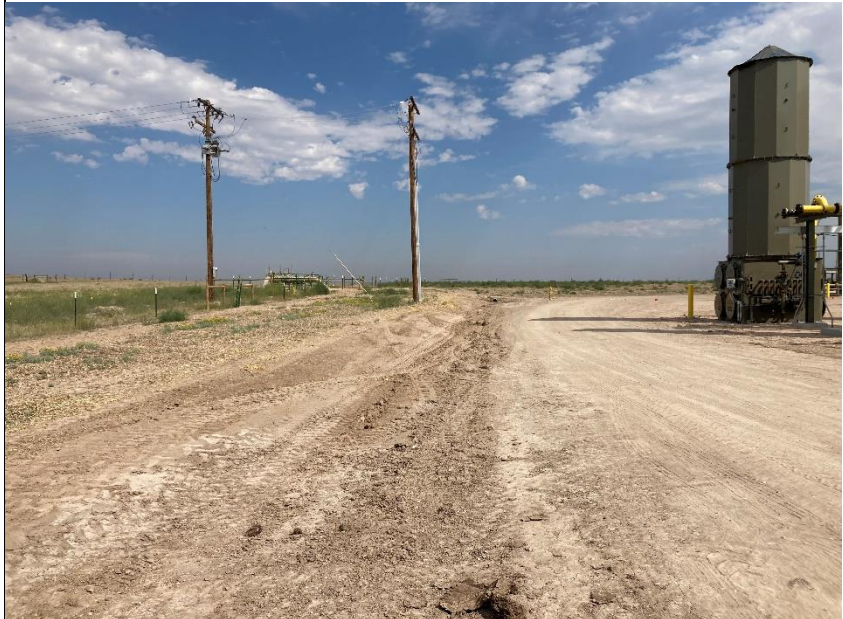
Photo: 16

Secondary excavation area after surface scrape looking north.

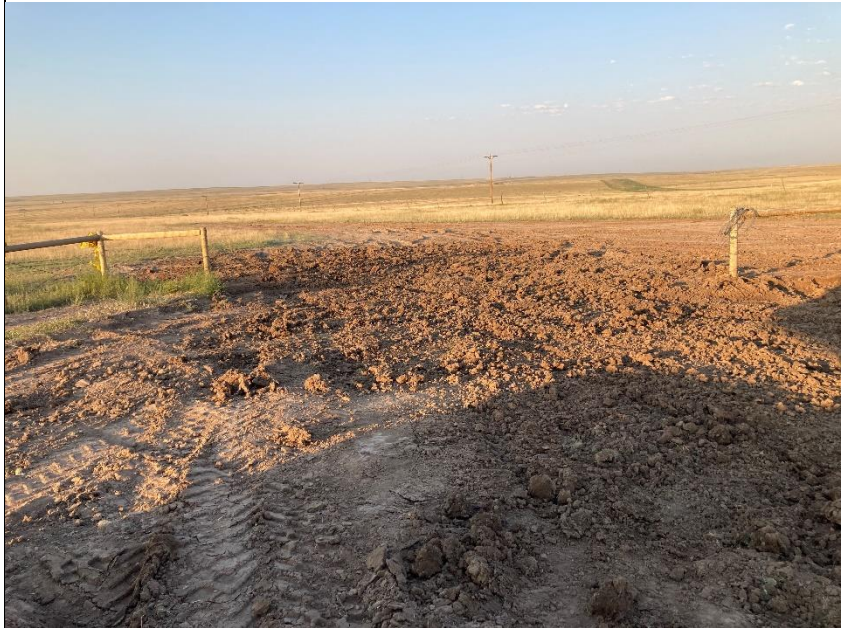
Photo: 17

Adjacent property after surface scrape.

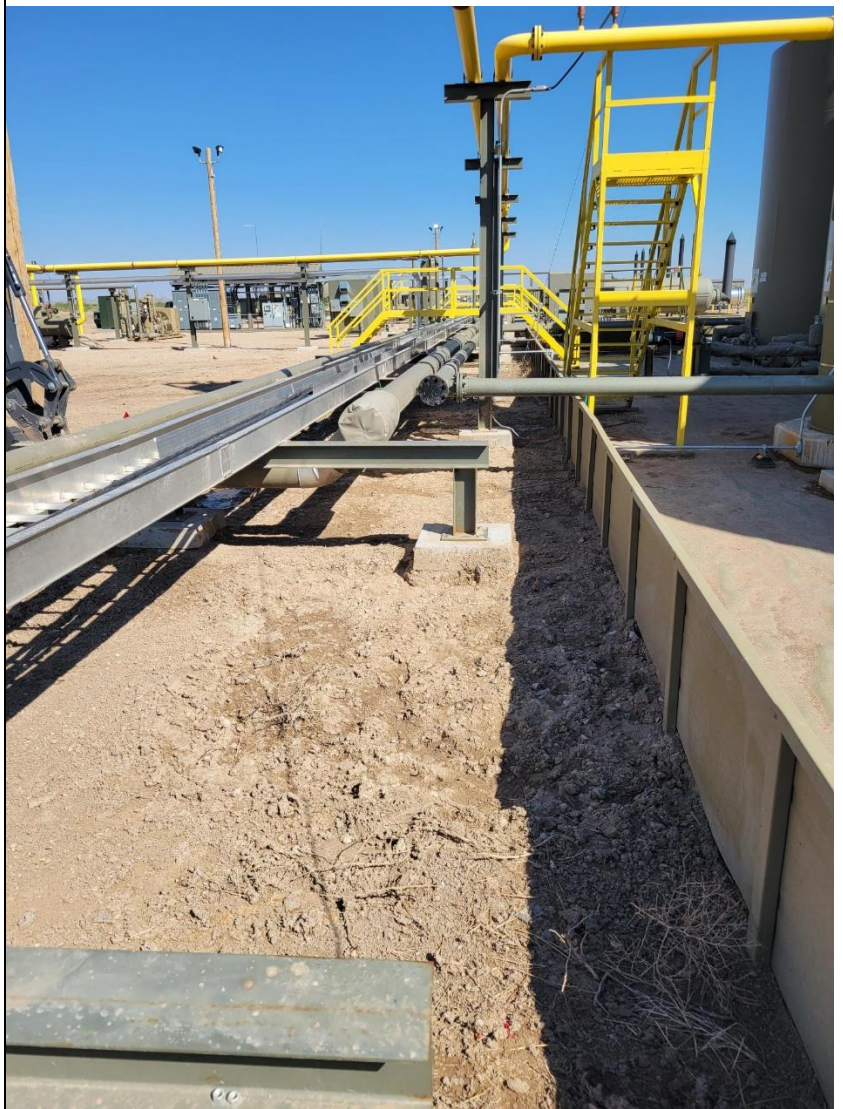
Photo: 19

Area of surface impacts to the east of the primary excavation. Hand digging and hydroexcavation performed until no observed impacts. View looking north.

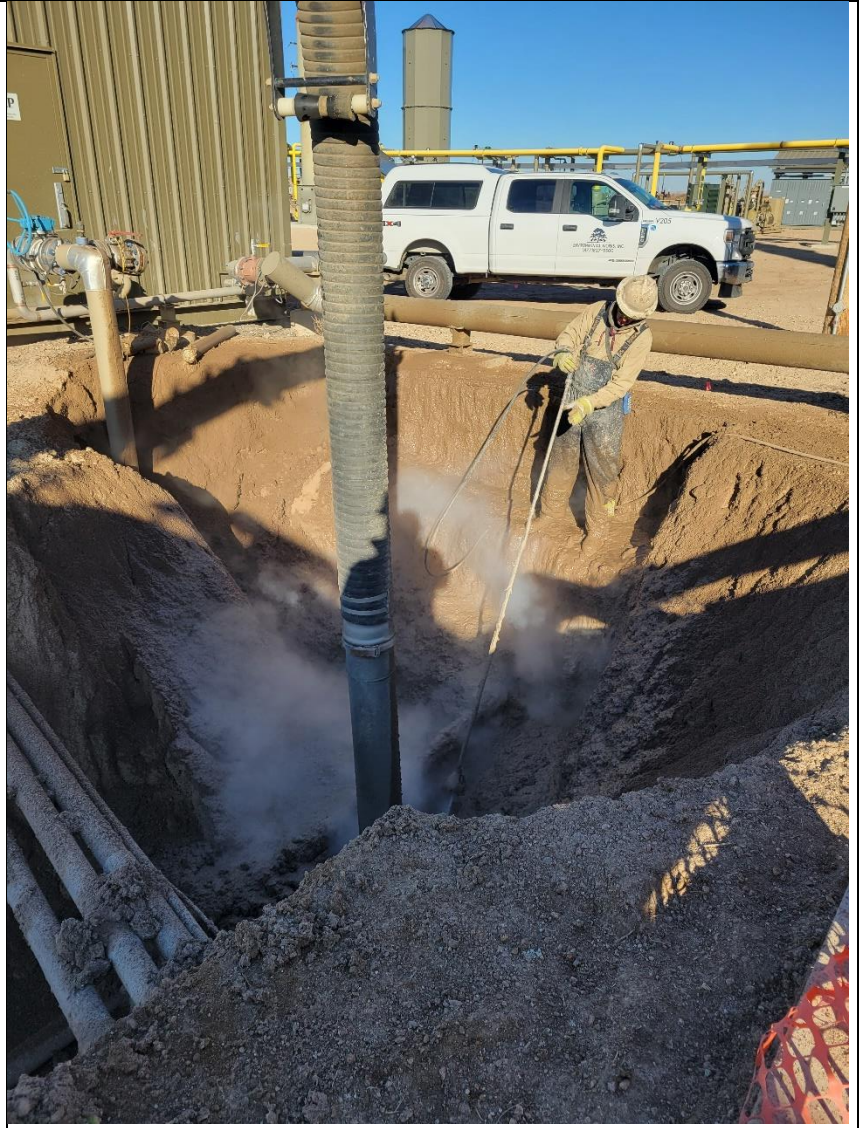
Photo: 20

Widening of primary excavation completed on 11/10/22 and 11/11/22. Secondary sidewall samples collected.

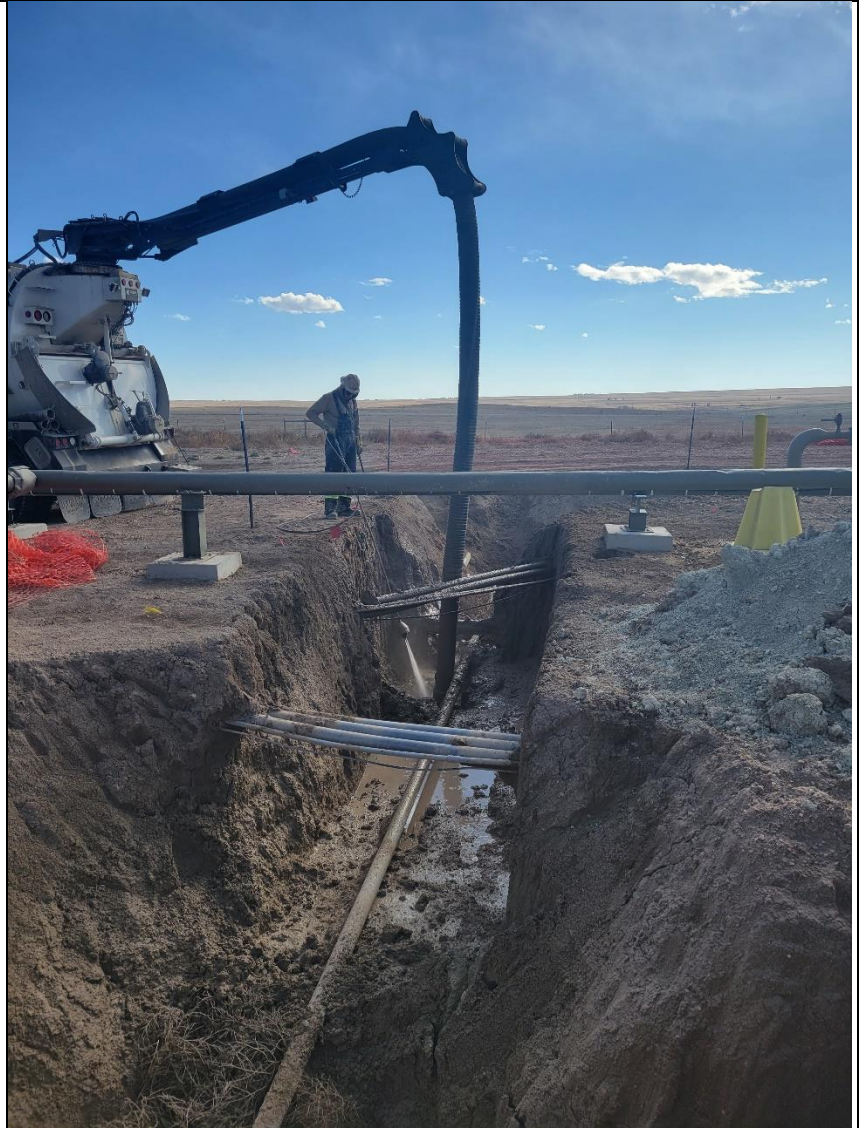
Photo: 21

Widening of primary excavation completed on 11/10/22 and 11/11/22. Existing infrastructure hindering further excavation.

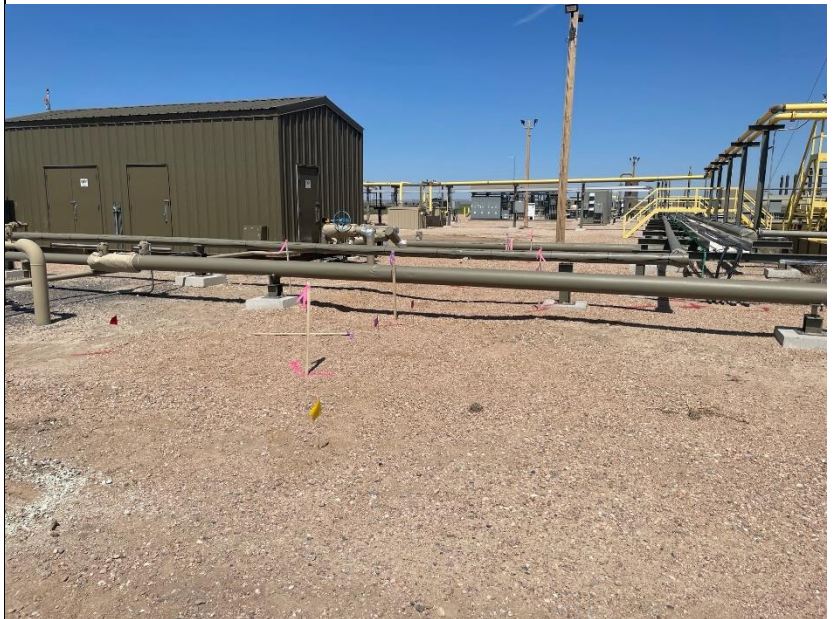
Photo: 22

Current site conditions August 2024, with locate flags and proposed soil boring location stakes.

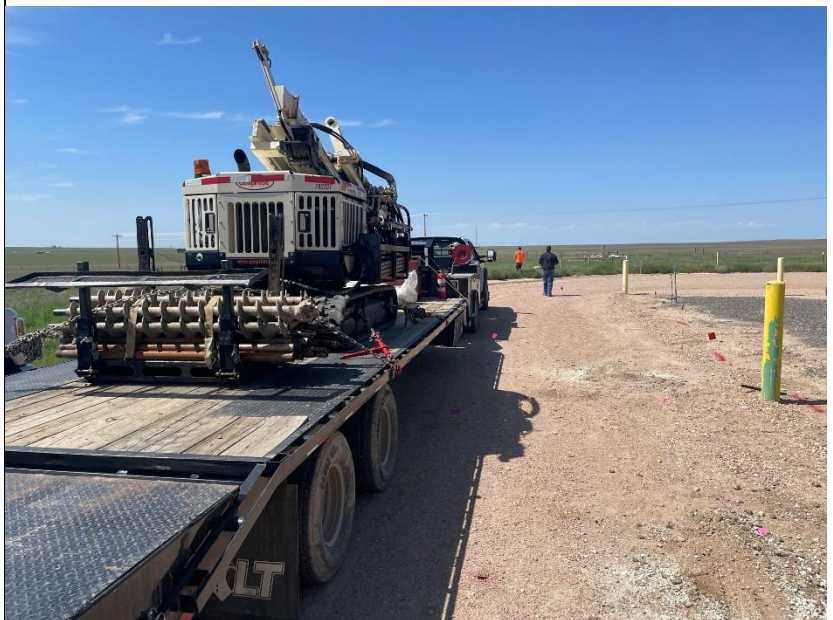
Photo: 23

EWI's Direct Push (DPT) rig arriving onsite.

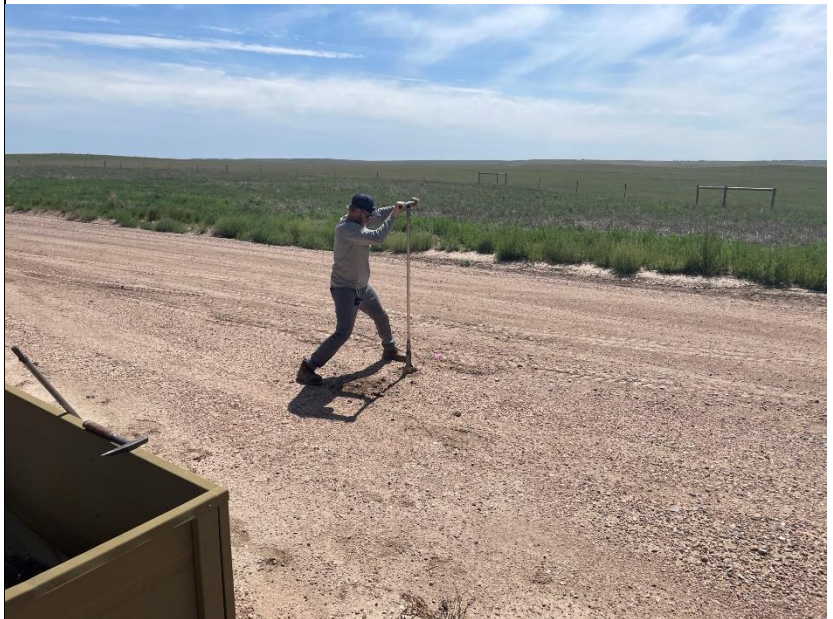
Photo: 24

EWI personnel hand auguring SB7 for spatial delineation of limited inorganic exceedances.

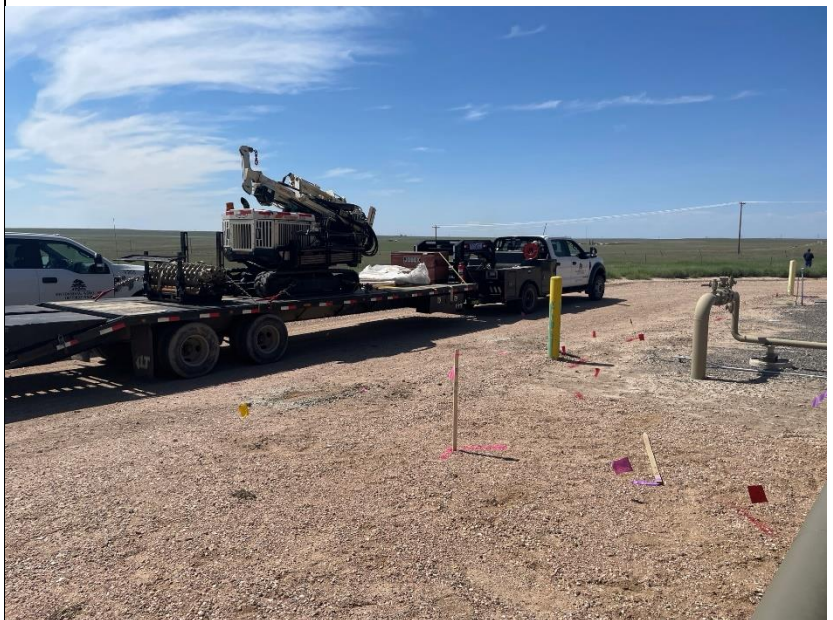
Photo: 25

EWI's DPT rig preparing to mobilize offsite.

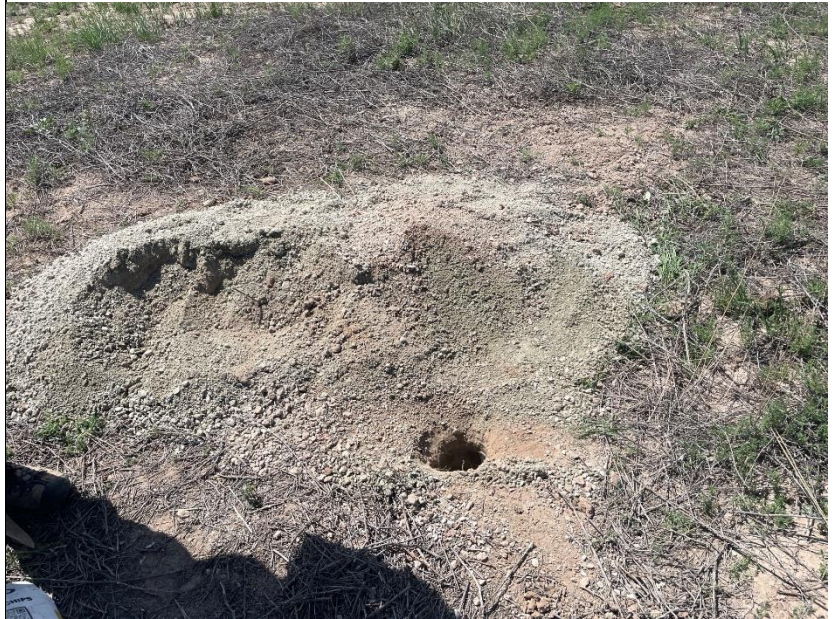
Photo: 26

Test Well (TW1) bore hole drilled to 50' with 1" PVC well material set. Well was dry after 4 hours. Auger cuttings were dry, fine grained silt and clay. Water or evidence for water within 50' depth was not observed.

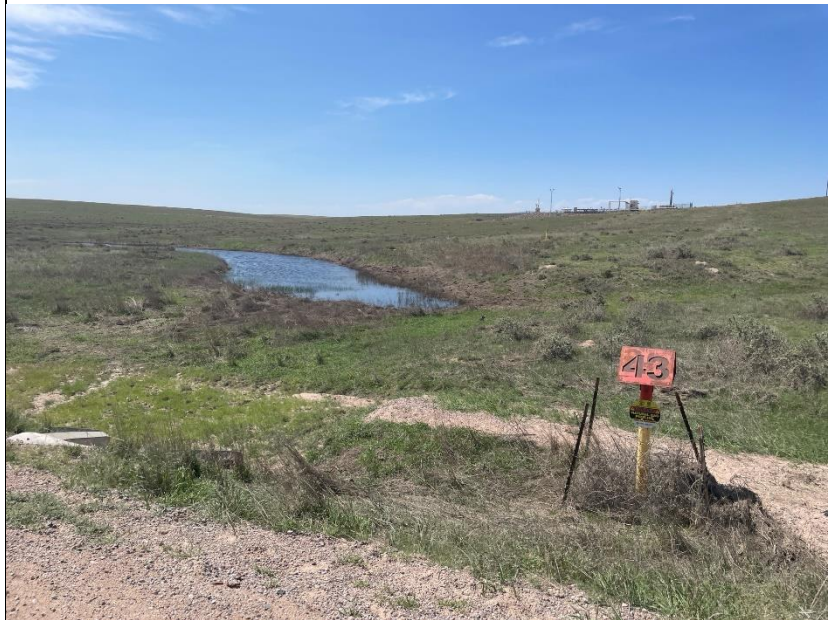
Photo: 27

Surface water located southeast of the Site from a temporary flooded water regime in a notable drainage located ~80' lower in elevation from the release location. The water table is typically located much lower than the surface in temporarily flooded water regimes.
