Inspection Photos

Location: QB ENERGY SGU-64S96W/23SWSW (M23-496)

Location ID: 335680

Date: 11/14/2024

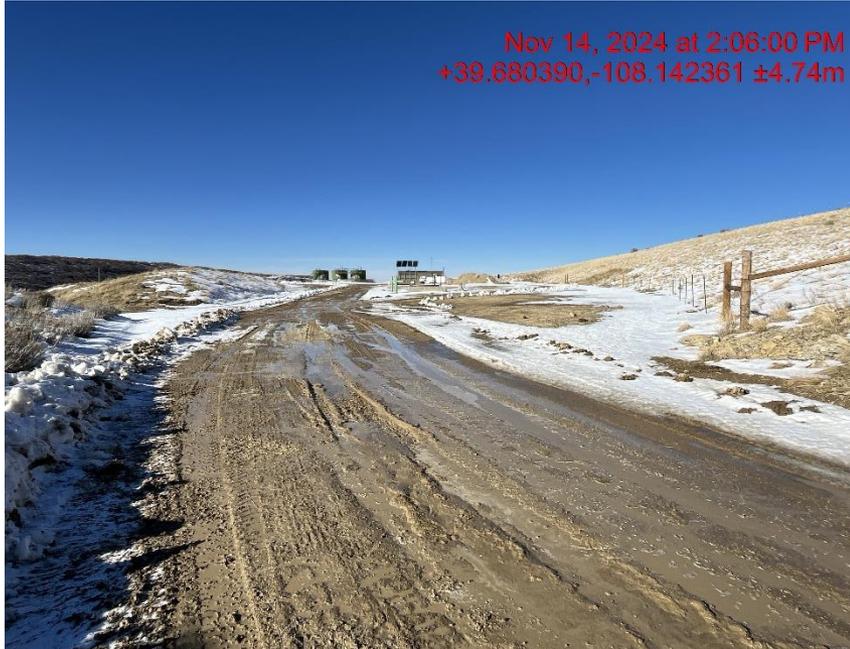
Photo # 9155 Entrance to location

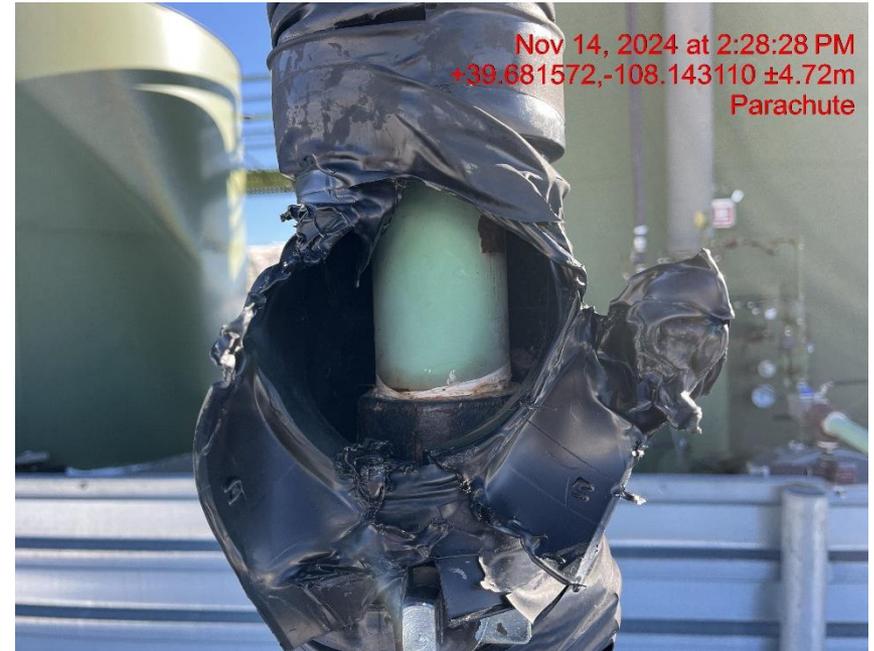
Photo # 9182 Flow line heating insulation open ended/wildlife hazard available for entry by wildlife

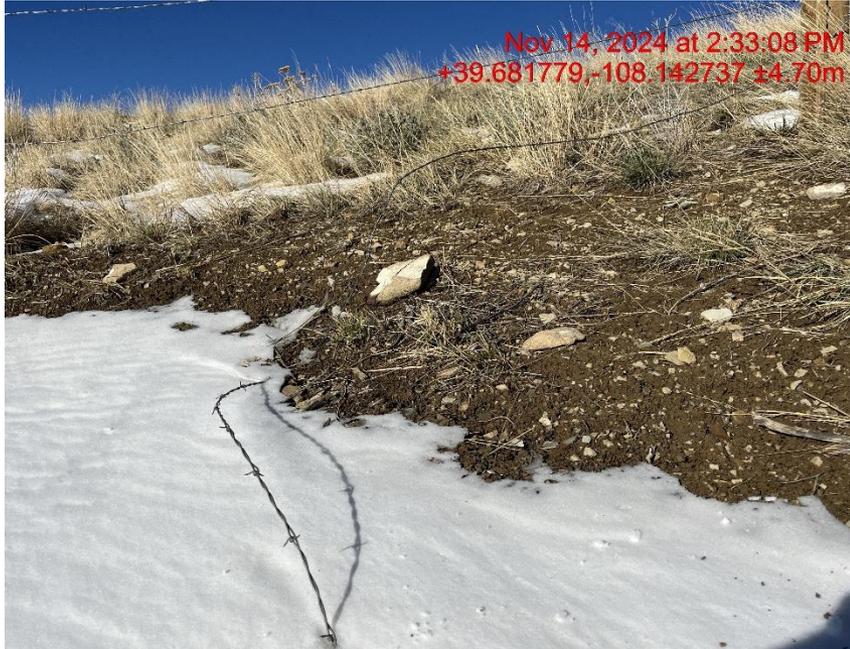
Photo # 9186 Loose barbed wire fencing/wildlife hazard

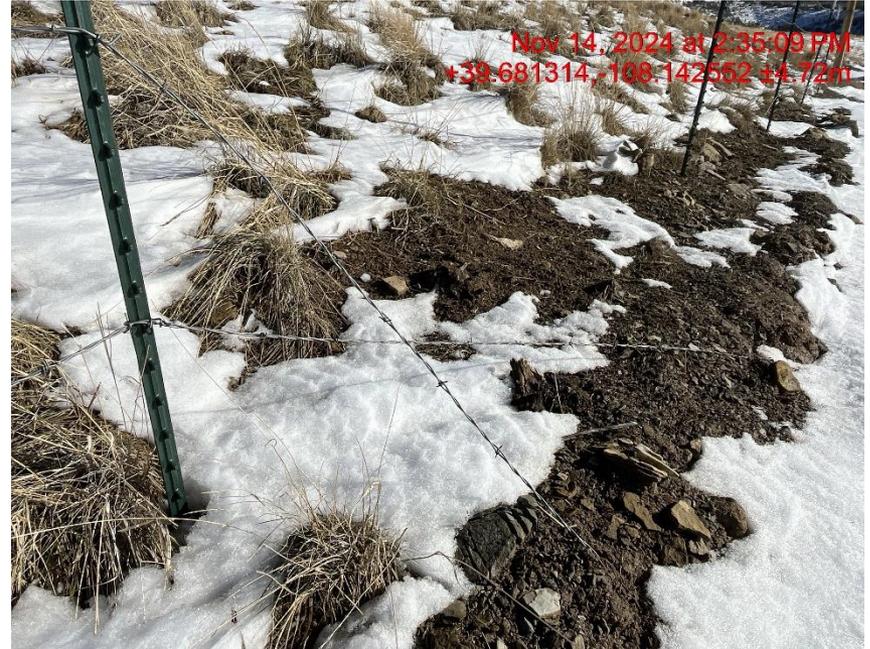
Photo # 9190 Loose barbed wire fencing/wildlife hazard

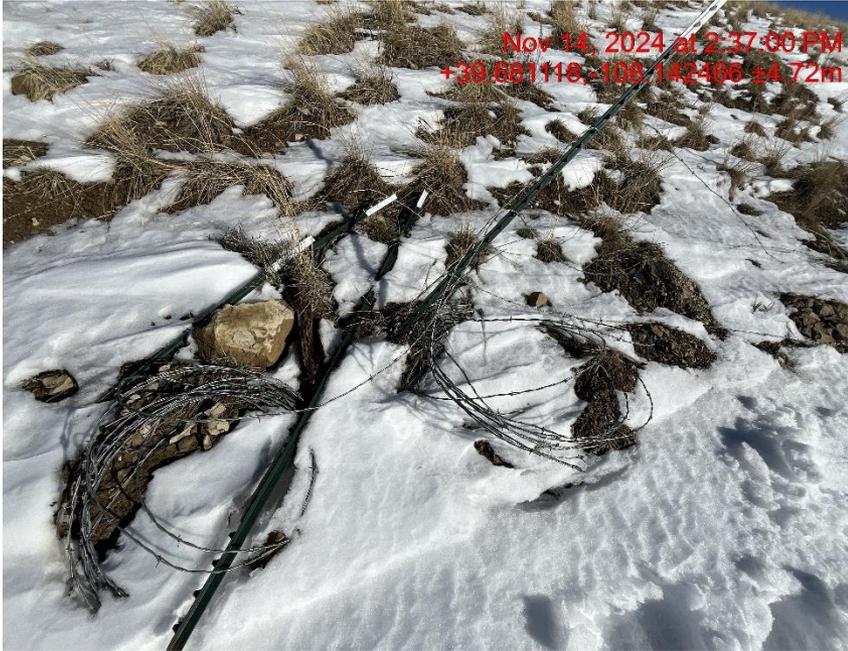
Photo # 9194 Loose barbed wire fencing/wildlife hazard

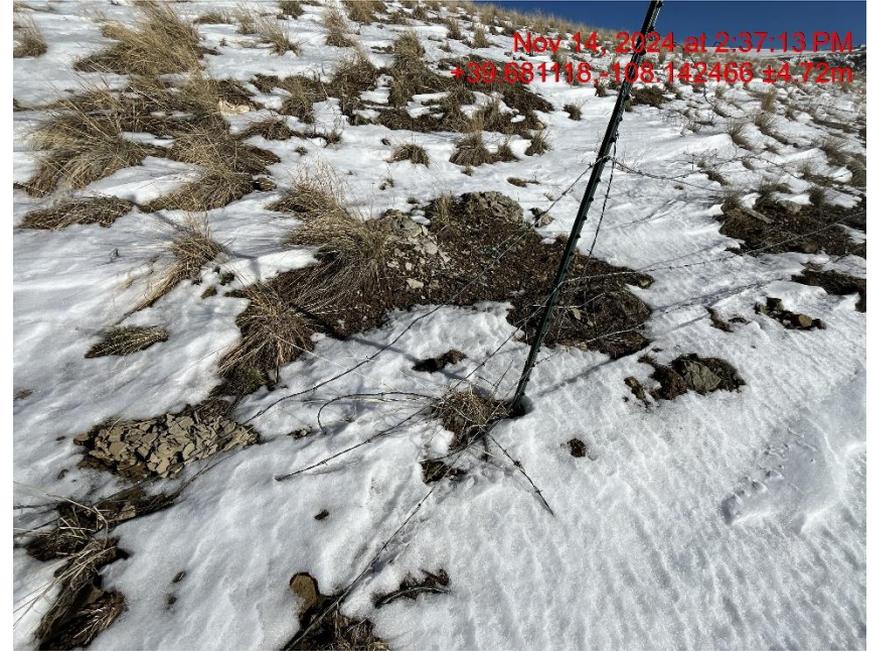
Photo # 9195 Loose barbed wire fencing/wildlife hazard
