TABLE 2
SUMMARY OF VOLATILE ORGANIC SOIL CHEMISTRY DATA
NOBLE 100322
OSCAR SEPARATOR, WELD COUNTY, COLORADO
REM #

OSCAR FACILITY

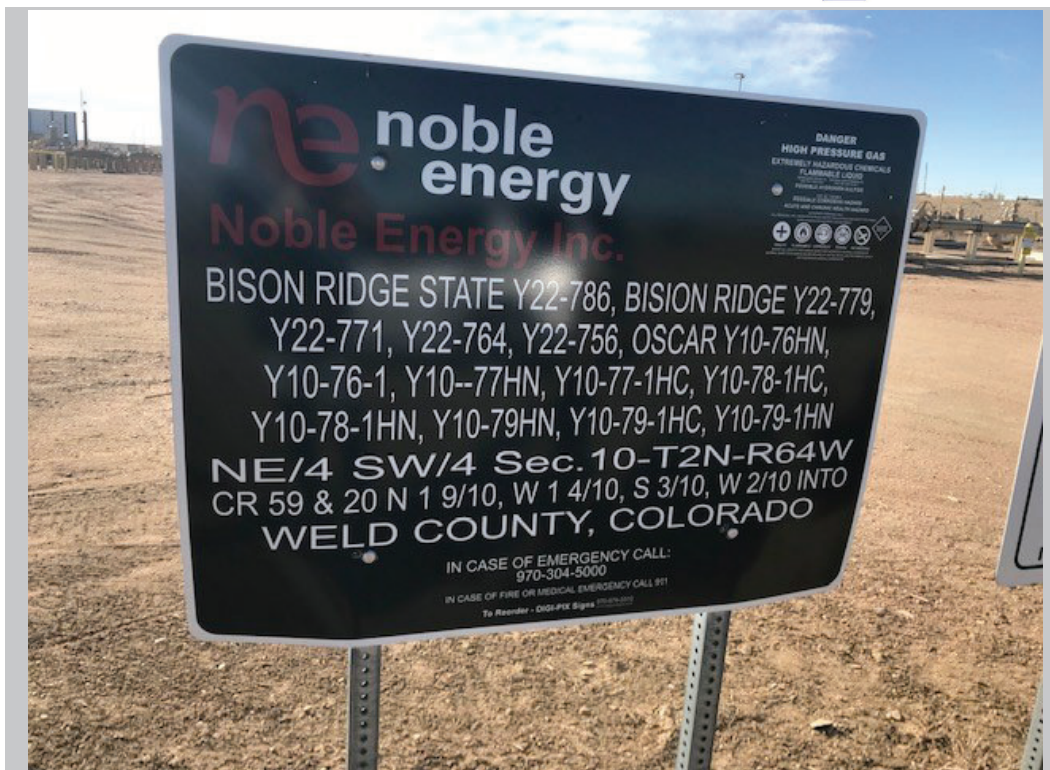
#1 - Oscar Facility

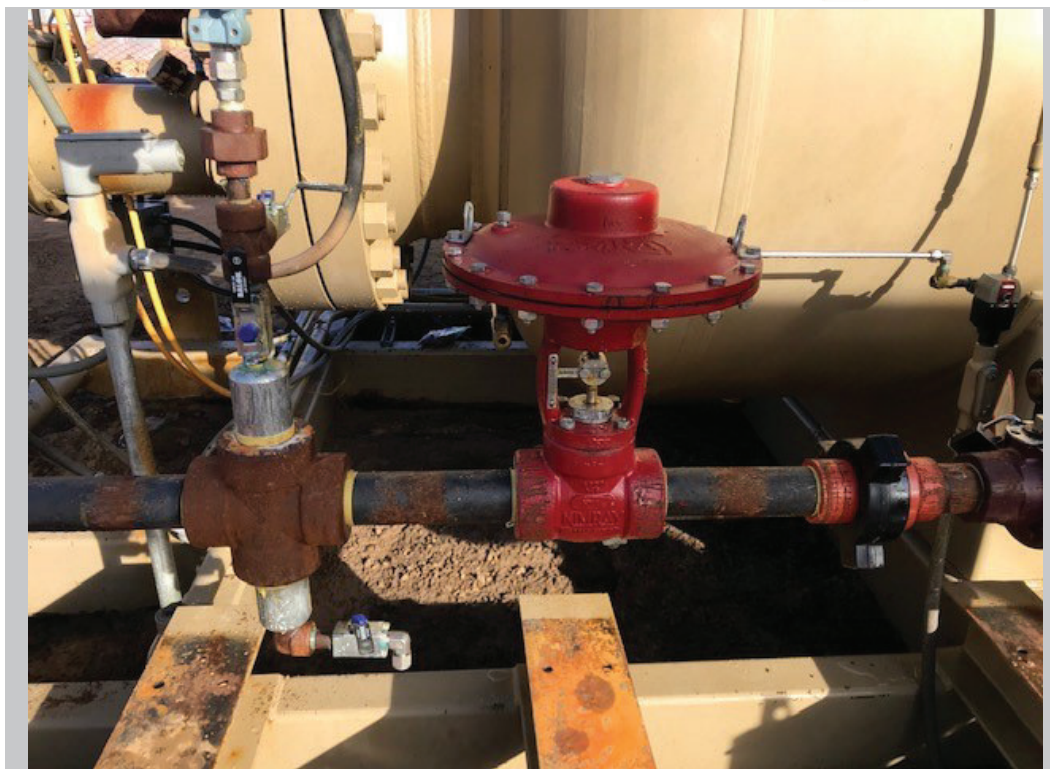
#2 - Kimray valve failed in the bottom

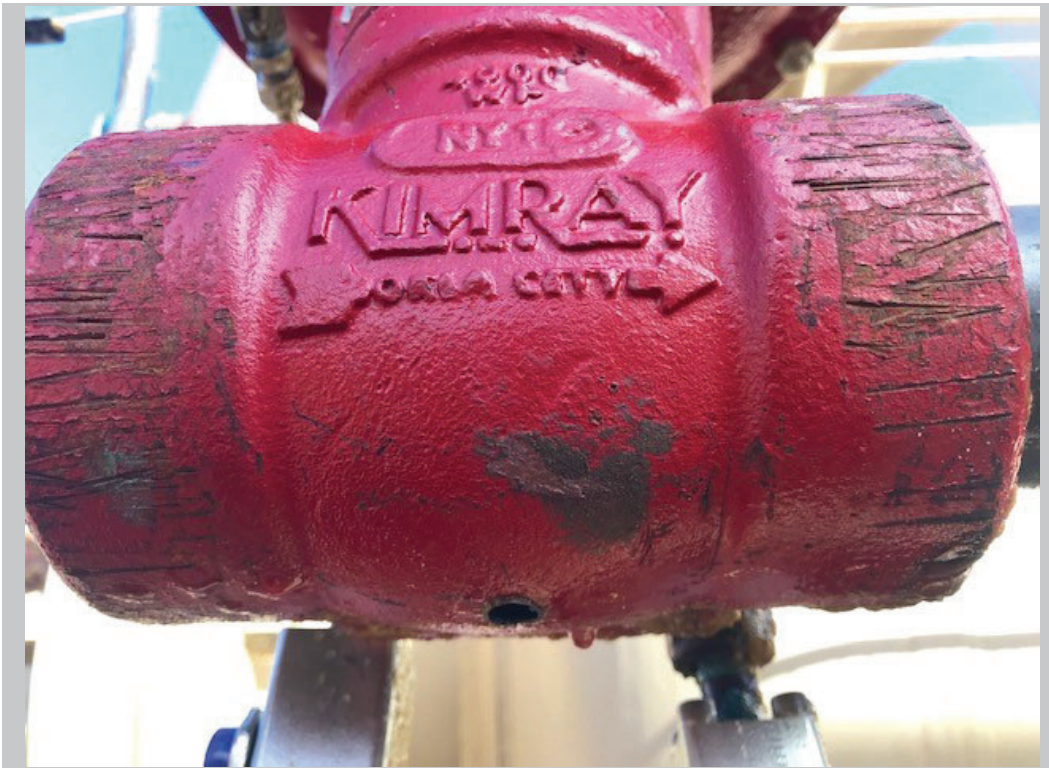
#3 - Bottom of Kimray valve with washout shown

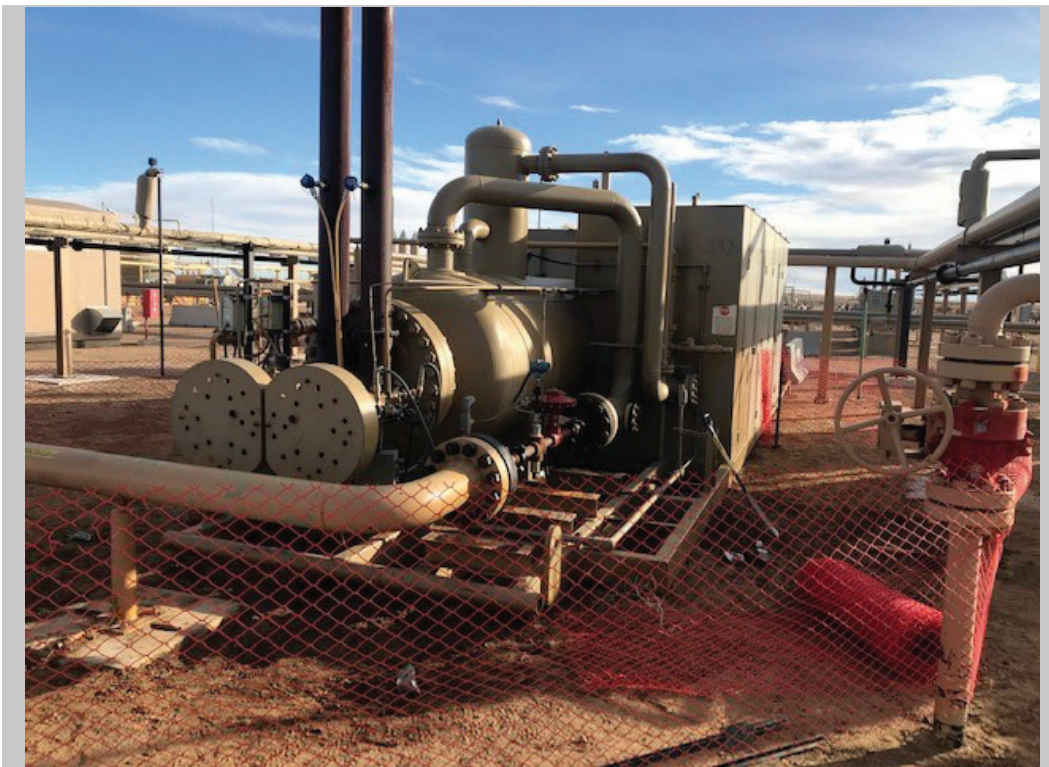
#4 - Looking east at impacted surface area

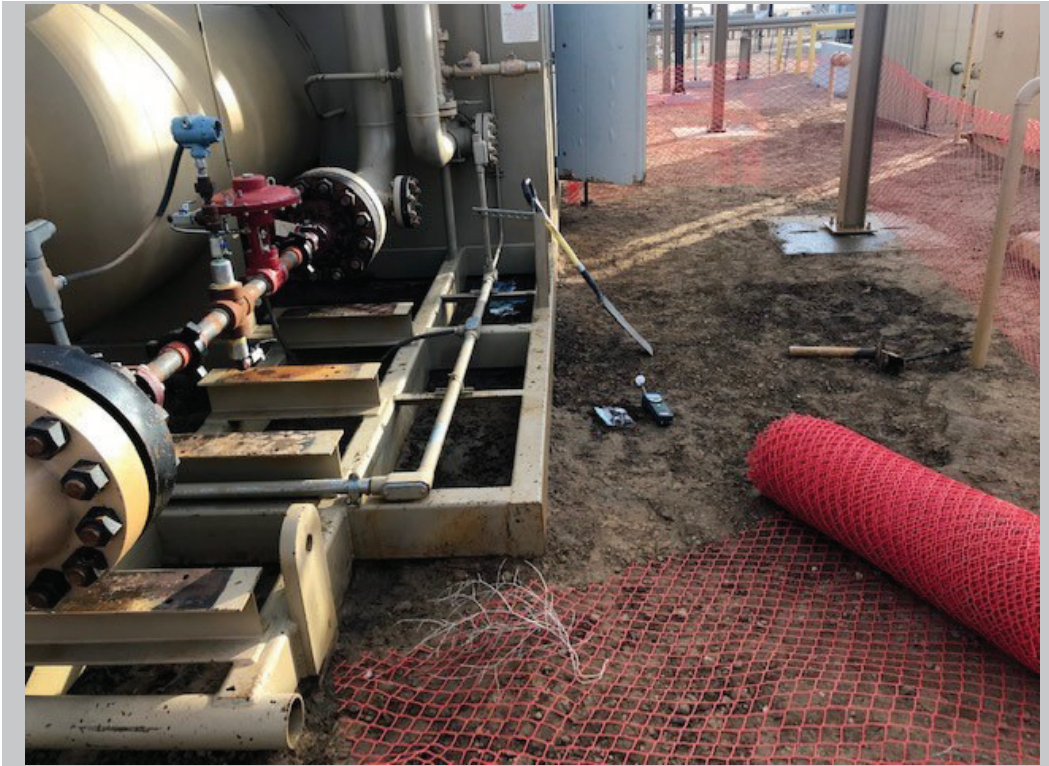
#5 - Looking east at impacted soil on south side of separator. Note Kimray valve on left side of photo.

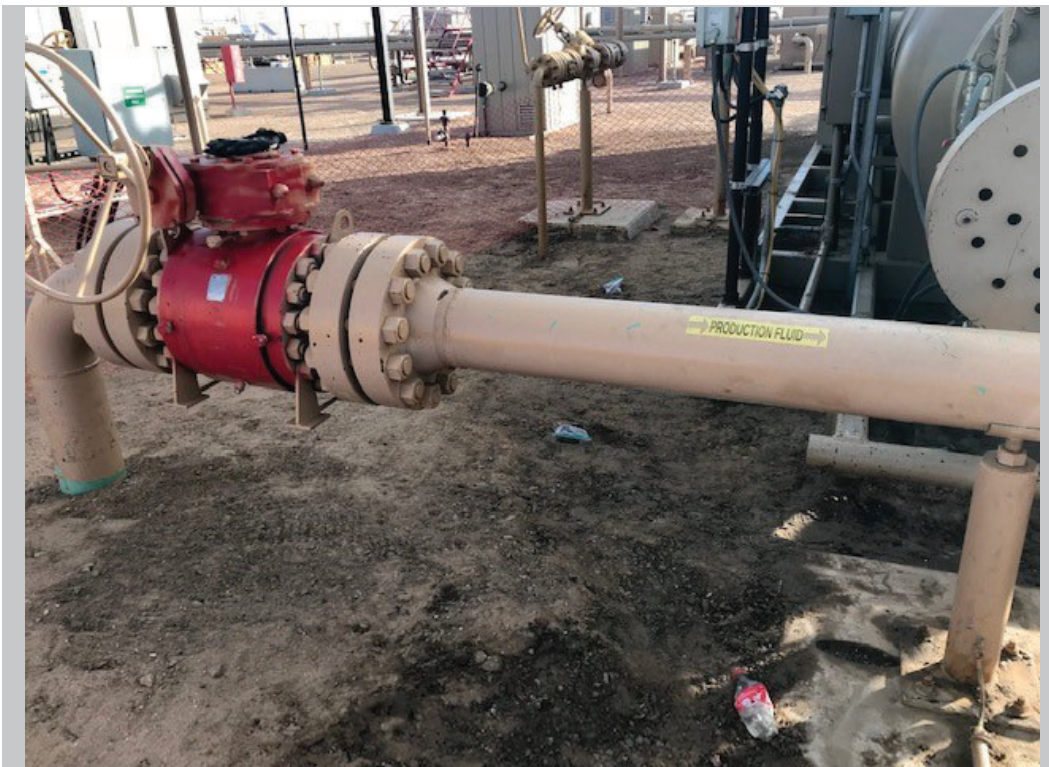
#6 - Looking east at north side of separator

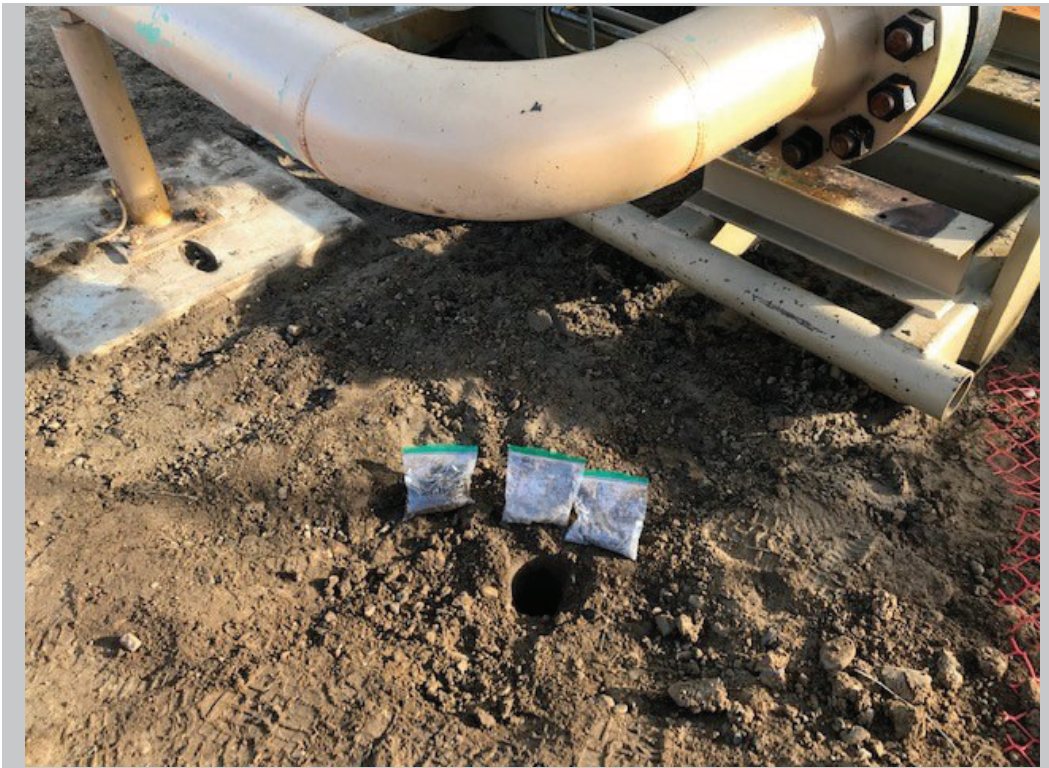
#7 - Looking northeast at separator skid. The southwest corner was the most impacted area with elevated PID concentrations to 1.5 ft.

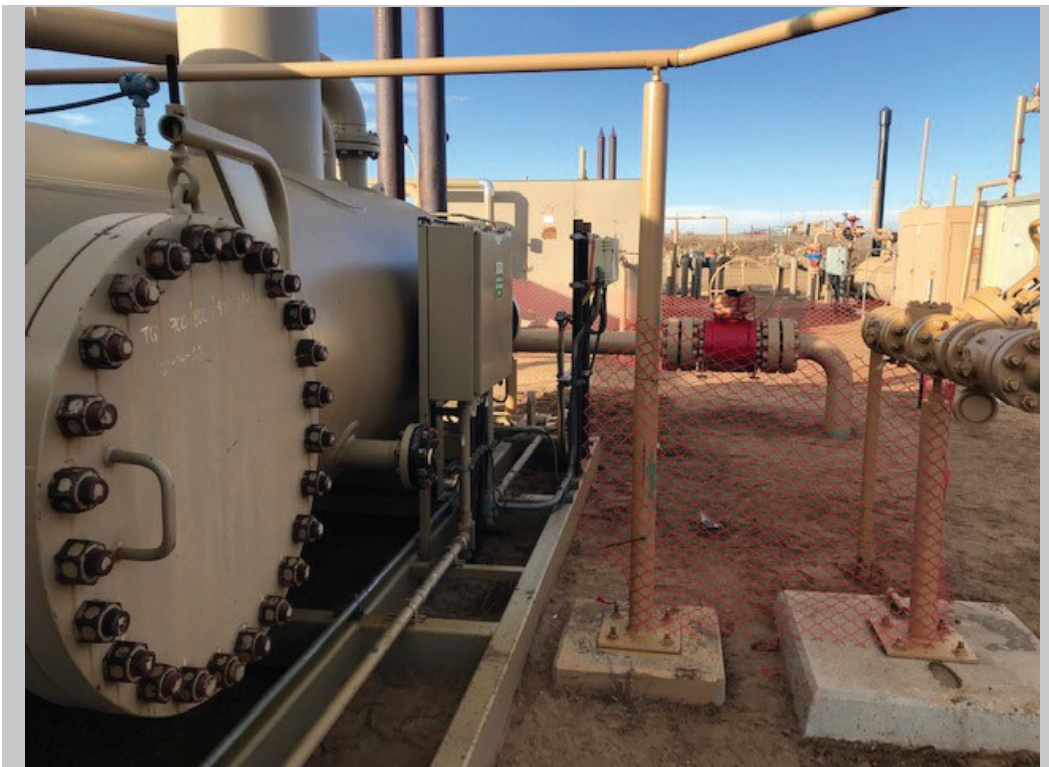
#8 - Looking west at north side of separator skid.
