Inspection Photos

Location Name: TEP ROCKY MOUNTAIN LLC RWF 23-25 Booster Station

Facility ID: 488423

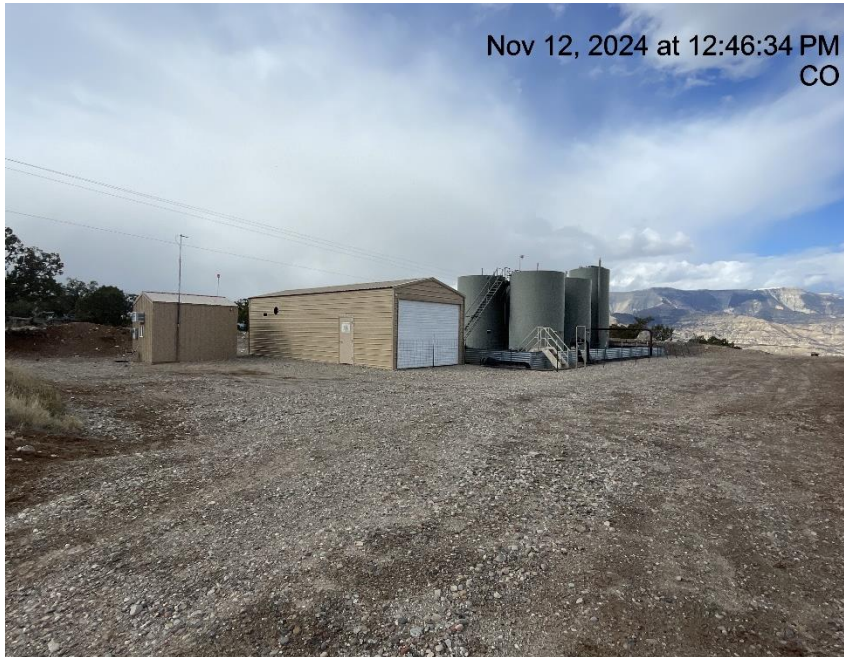
Photo # 9883 From entrance to location

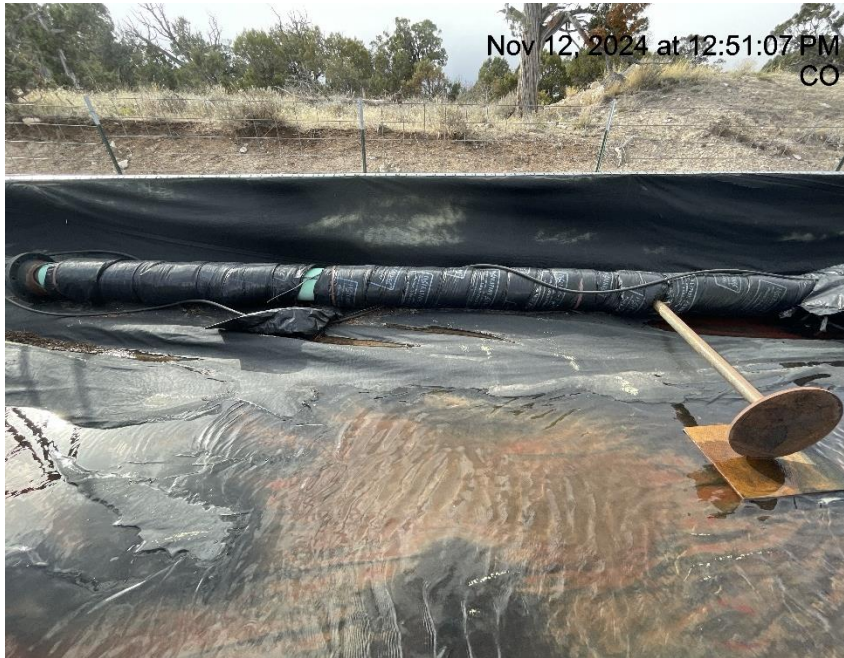
Photo # 9893 Debris

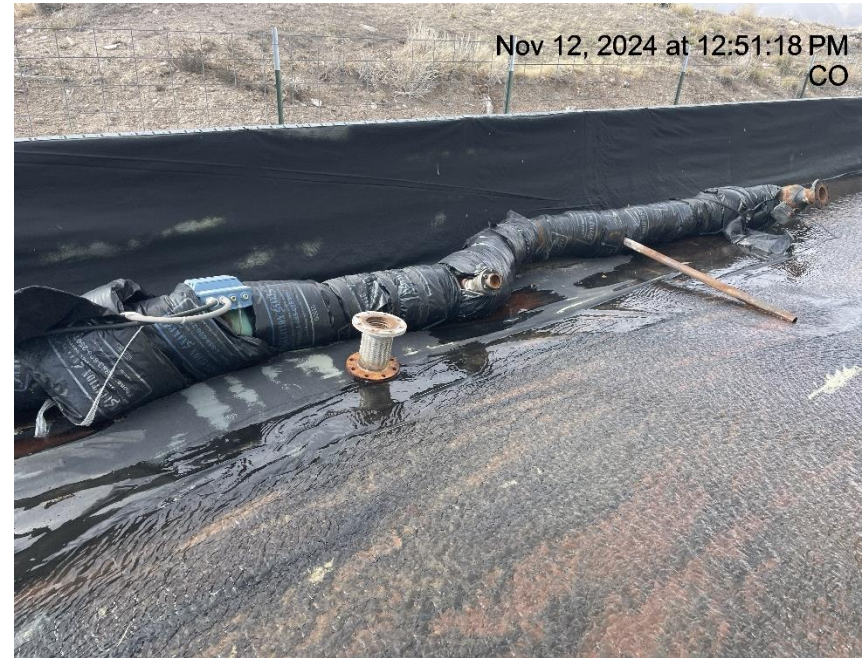
Photo # 9894 Debris

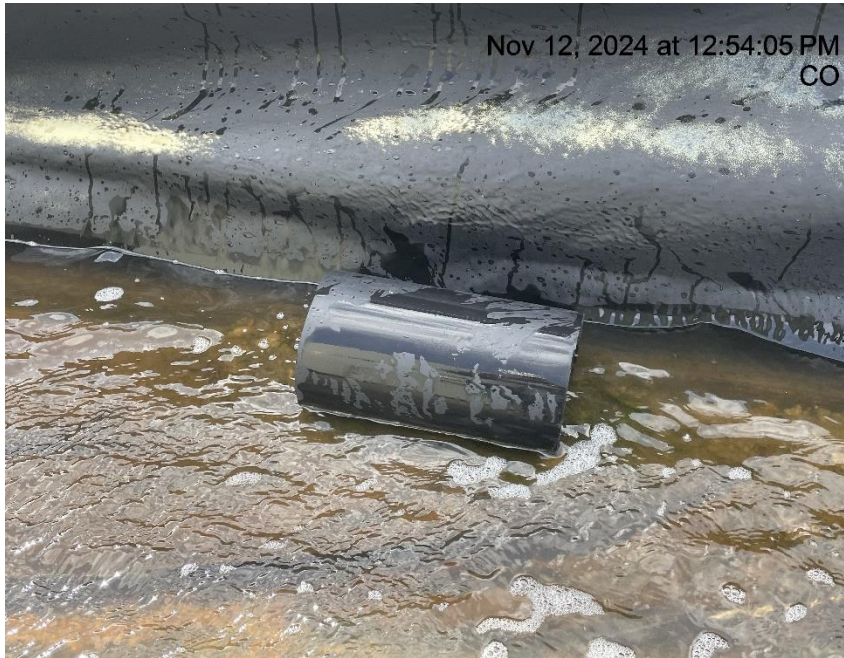
Photo # 9895 Debris

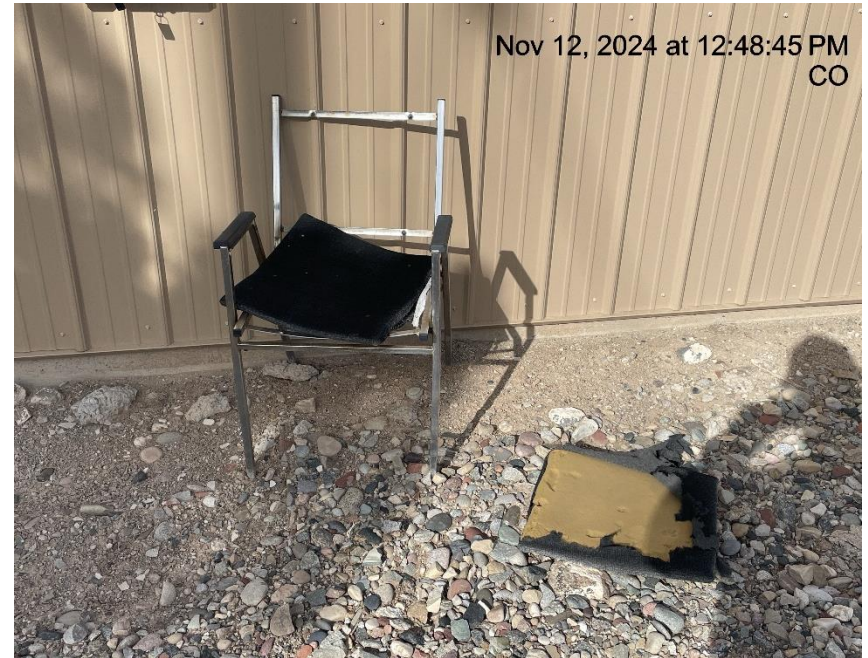
Photo # 9896 Debris

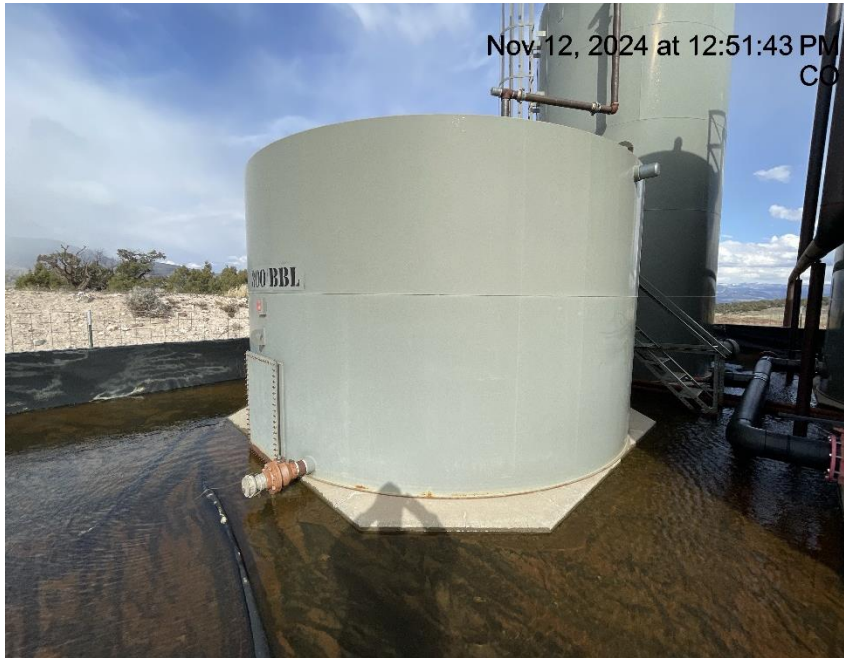
Photo # 9897 Tank lacks required labeling

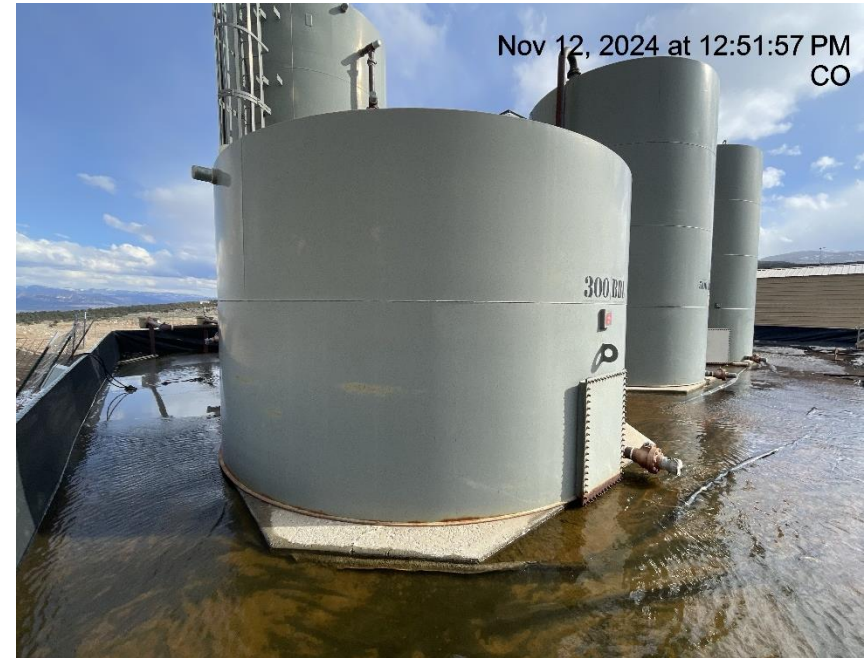
Photo # 9898 Tank lacks required labeling

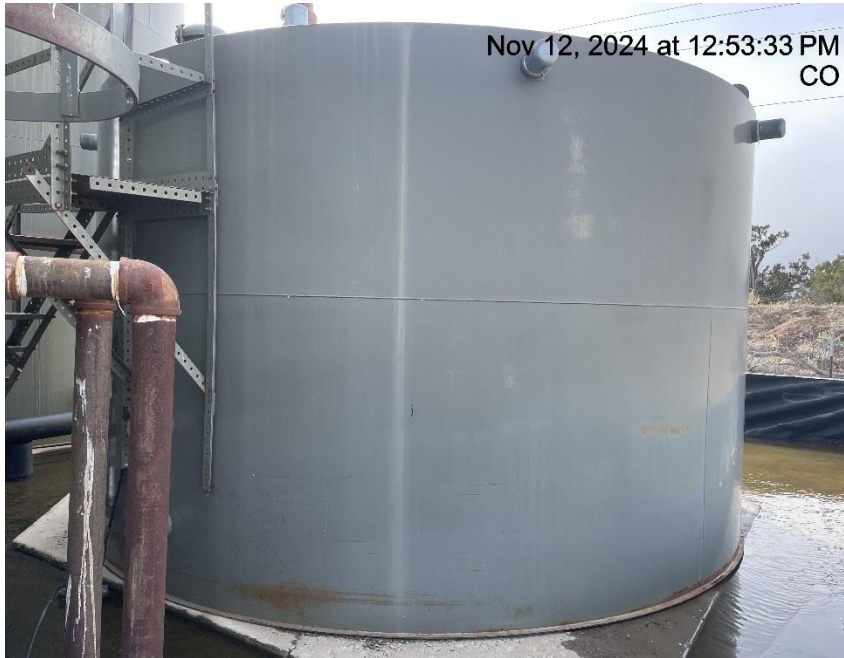
Photo # 9899 Tank lacks required labeling

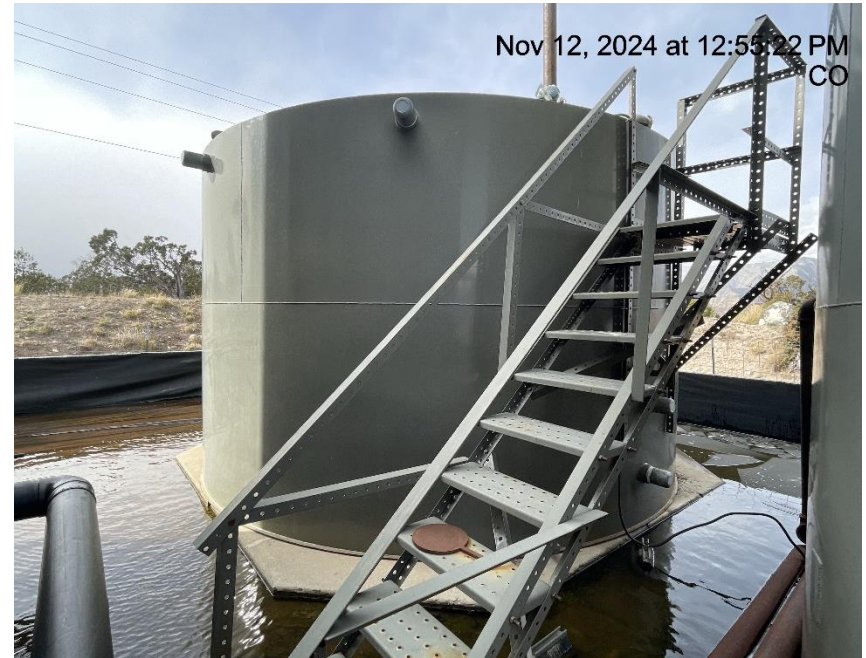
Photo # 9900 Tank lacks required labeling

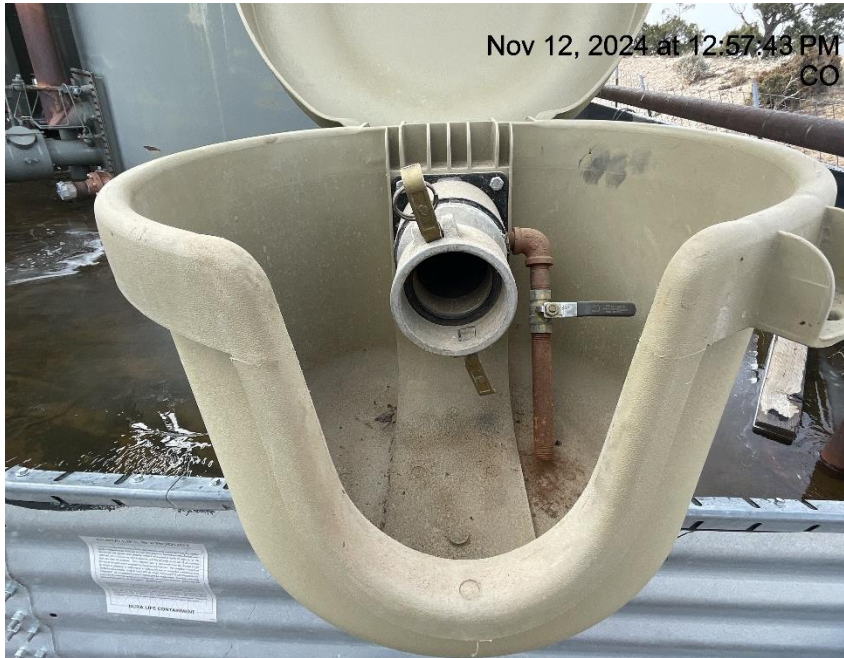
Photo # 9901 Open ended load line

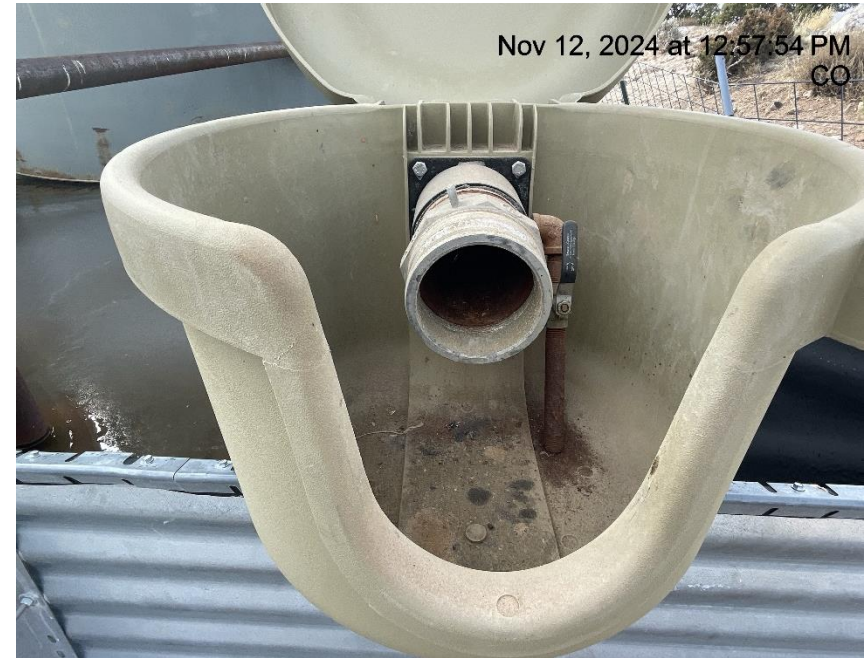
Photo # 9902 Open ended load line

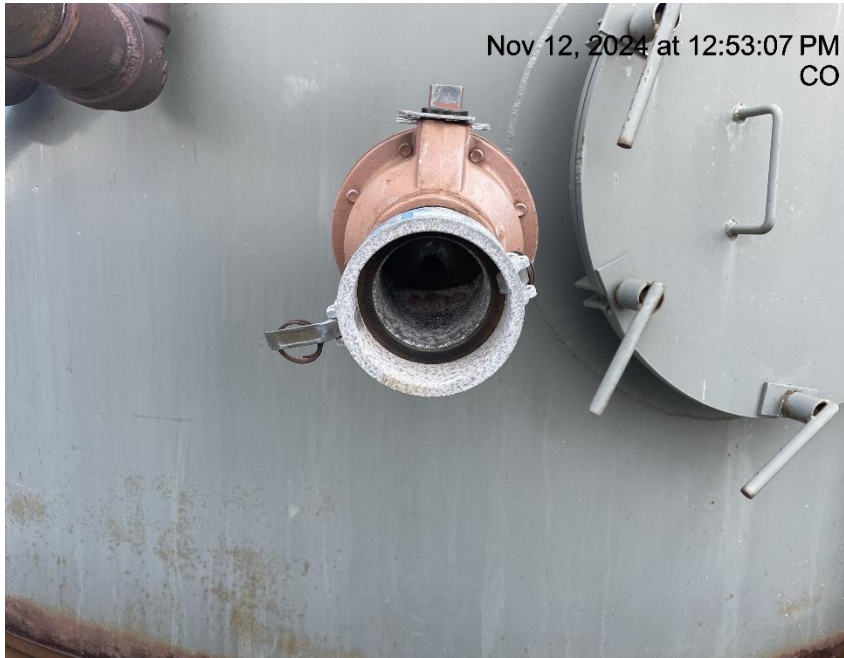
Photo # 9903 Open ended load line

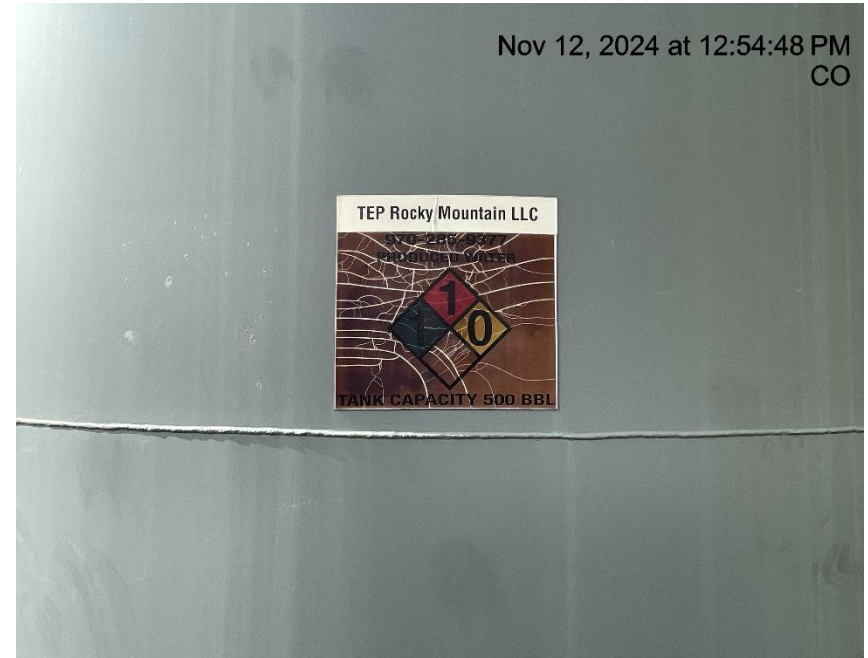
Photo # 9904 Tank label weathered & some required information is illegible

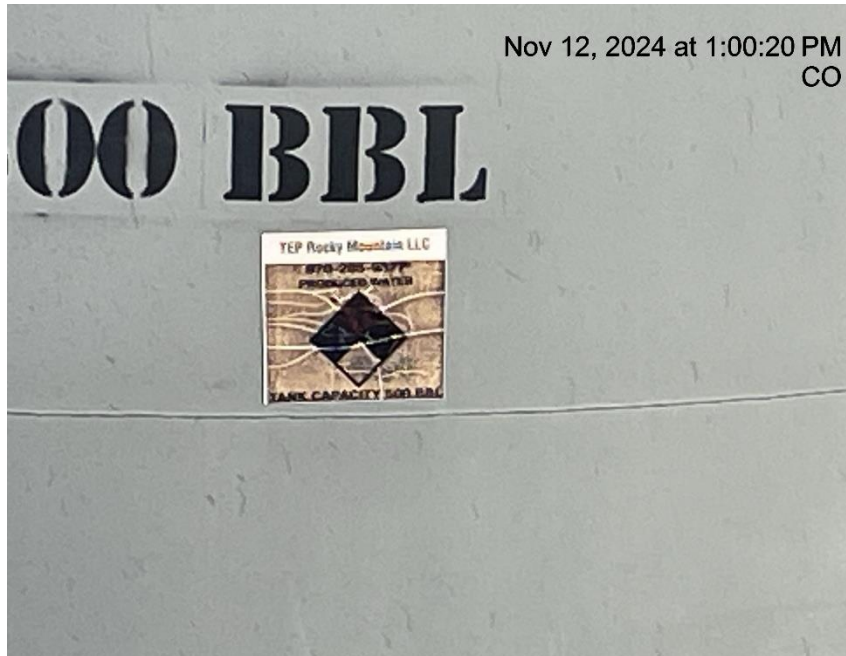
Photo # 9905 Tank label weathered & some required information is starting to become illegible

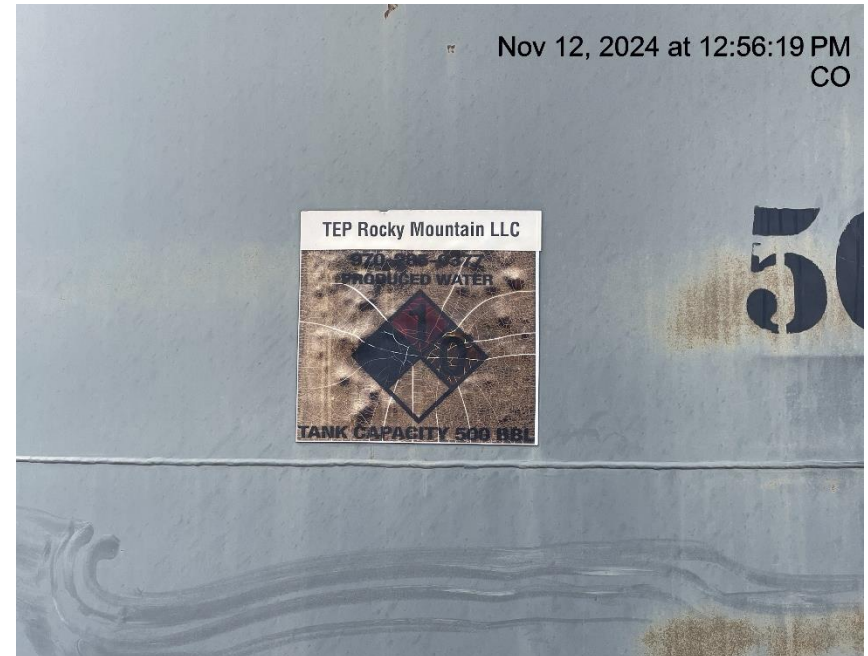
Photo # 9906 Tank label weathered & some required information is starting to become illegible

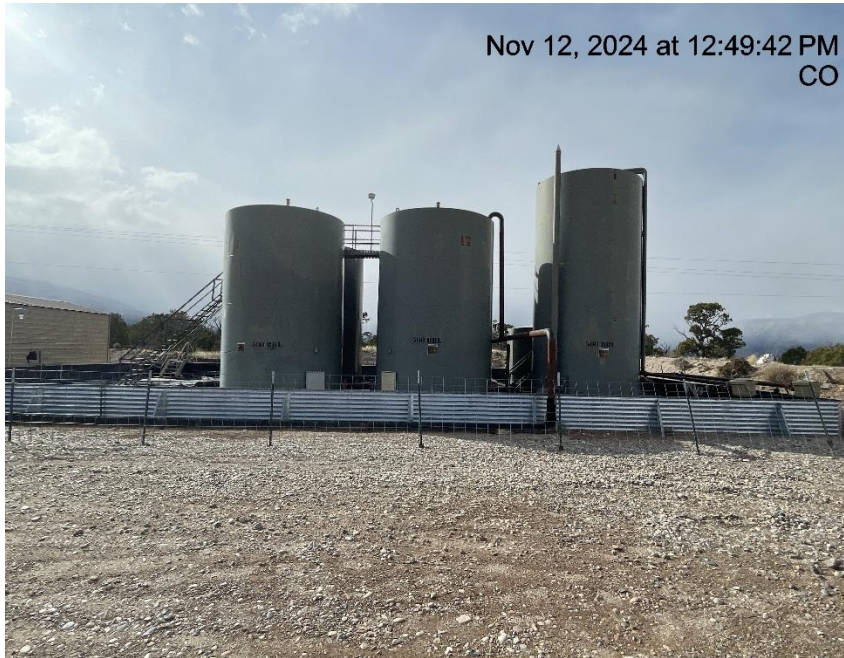
Photo # 9907 Tank battery lacks required signage

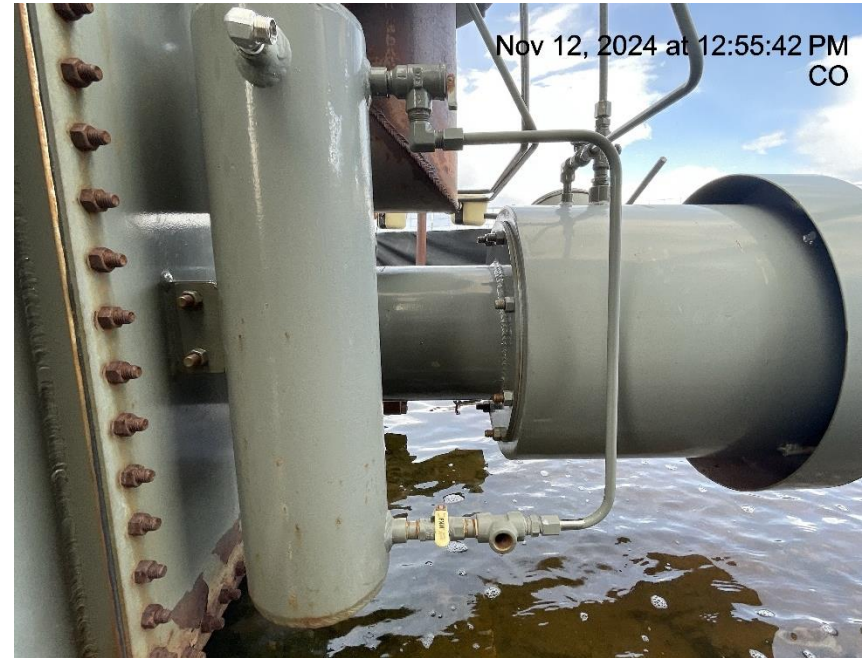
Photo # 9908 PRV vent line does not comply with CECMC pressure safety device rules
