Inspection Photos

API: 061-06713

Operator: THOMAS L SPRING LLC

Inspection Date: 11/20/2024

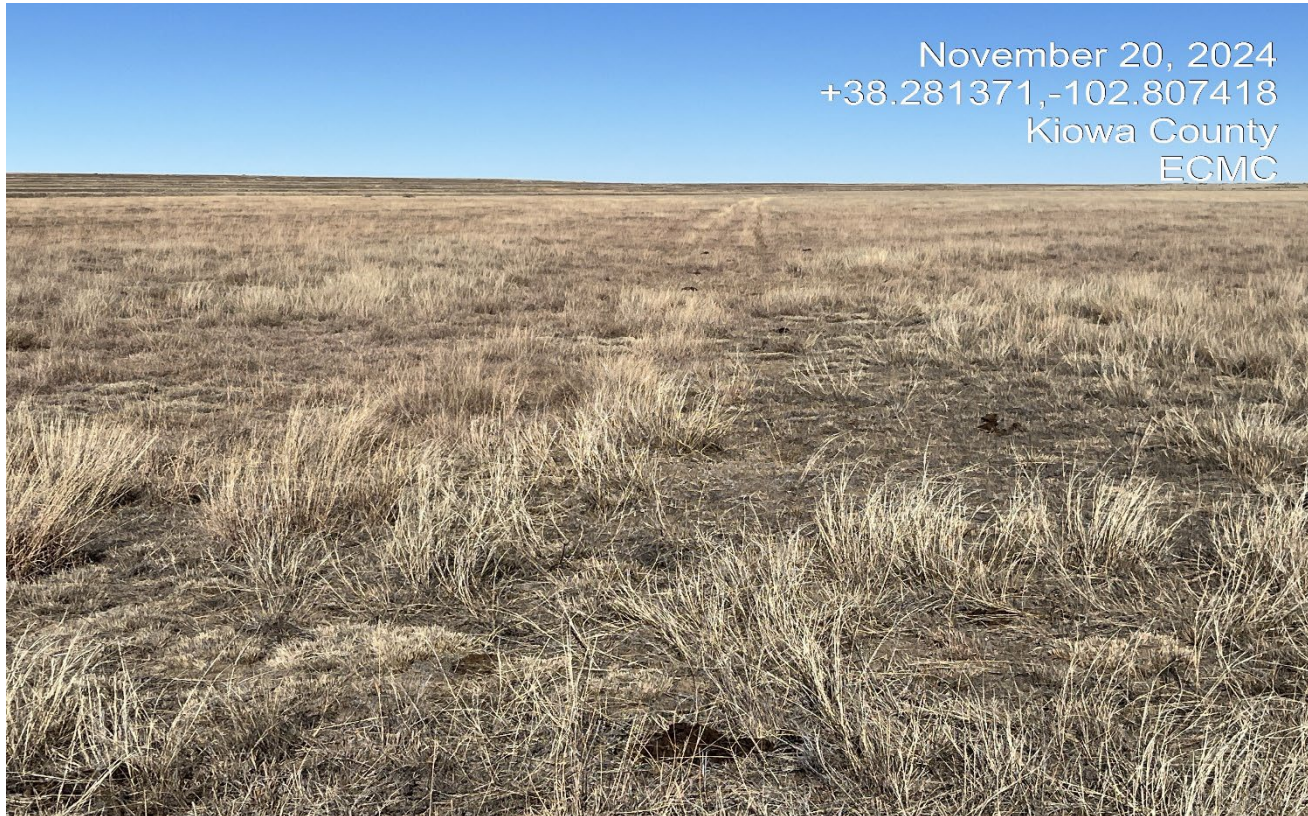
Photo 1. Facing north toward the former access road which has established perennial vegetation.

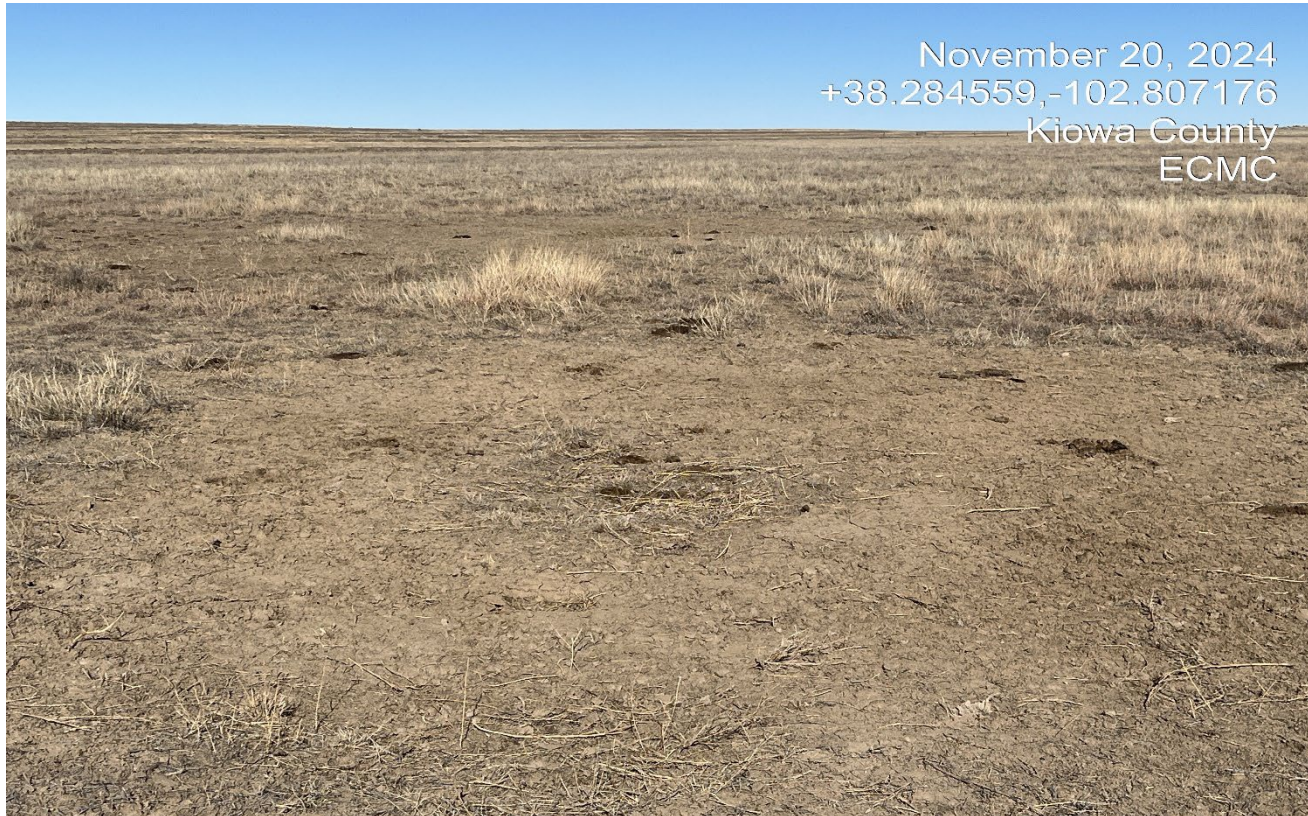
Photo 2. South side of the location facing north. There are areas of the location that have not established perennial vegetation.

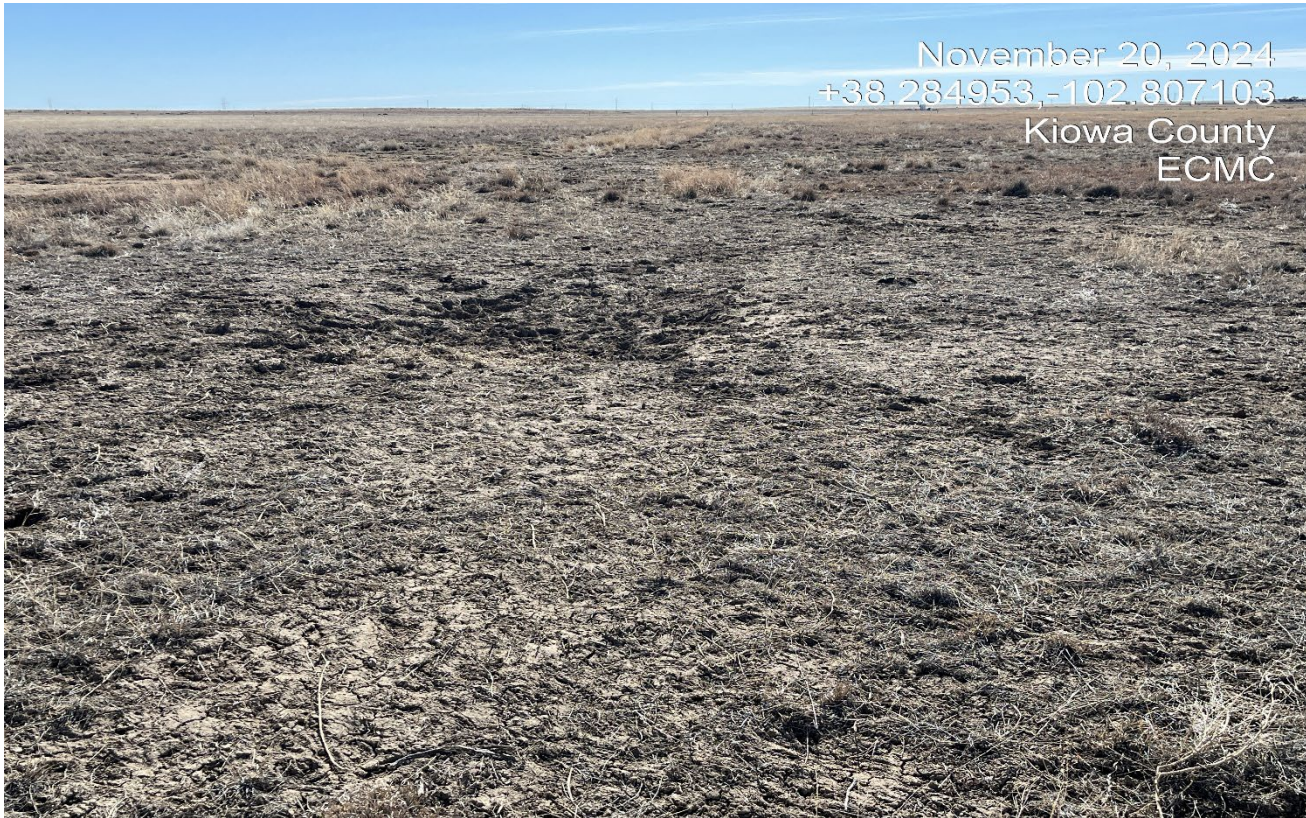
Photo 3. North side of the location facing south. There are areas of the location that have not established perennial vegetation.

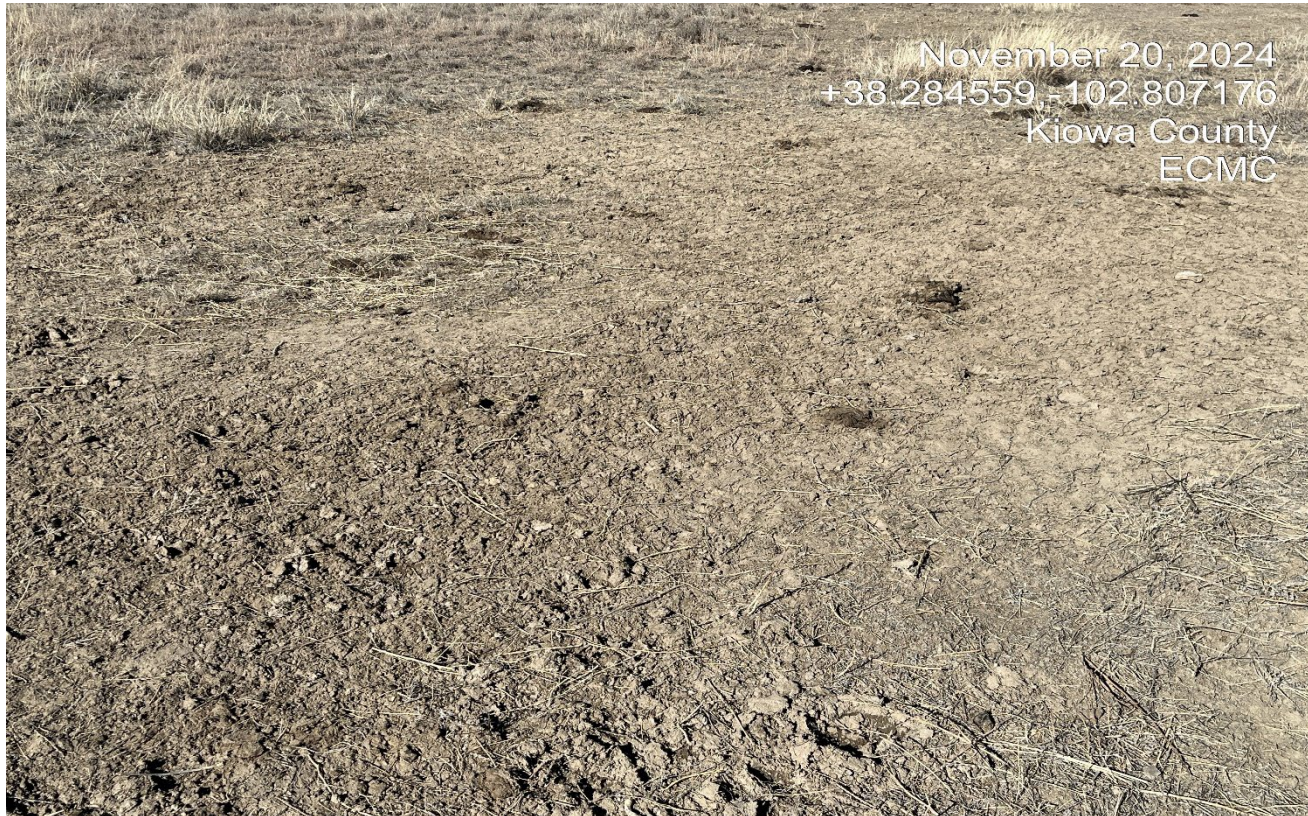
Photo 4. View of ground cover shows bare soil in areas of the location.

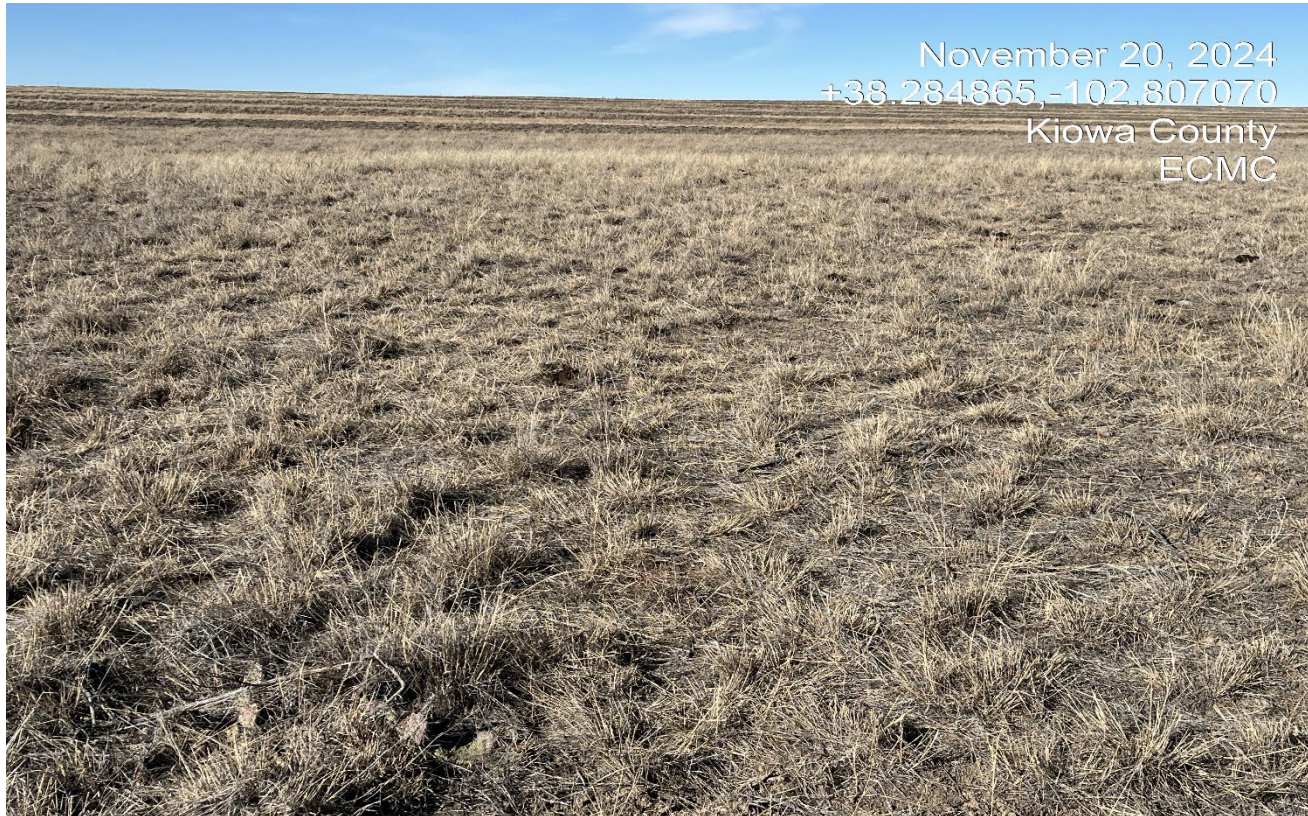
Photo 5. Facing northwest toward the surrounding reference area.
