Inspection Photos

API: 061-06765

Operator: THOMAS L SPRING LLC

Inspection Date: 11/20/2024

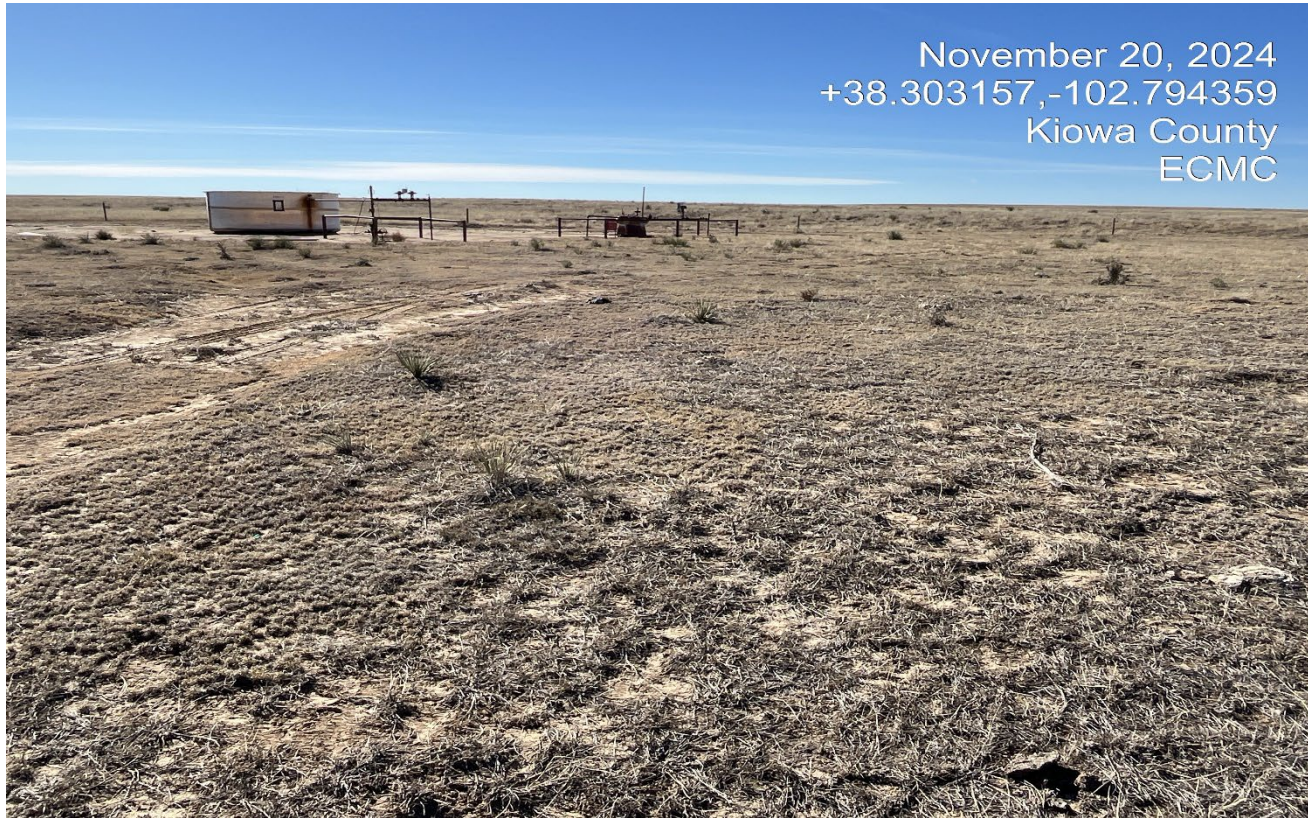
Photo 1. Facing southwest toward the location which is stabilized with perennial native vegetation.

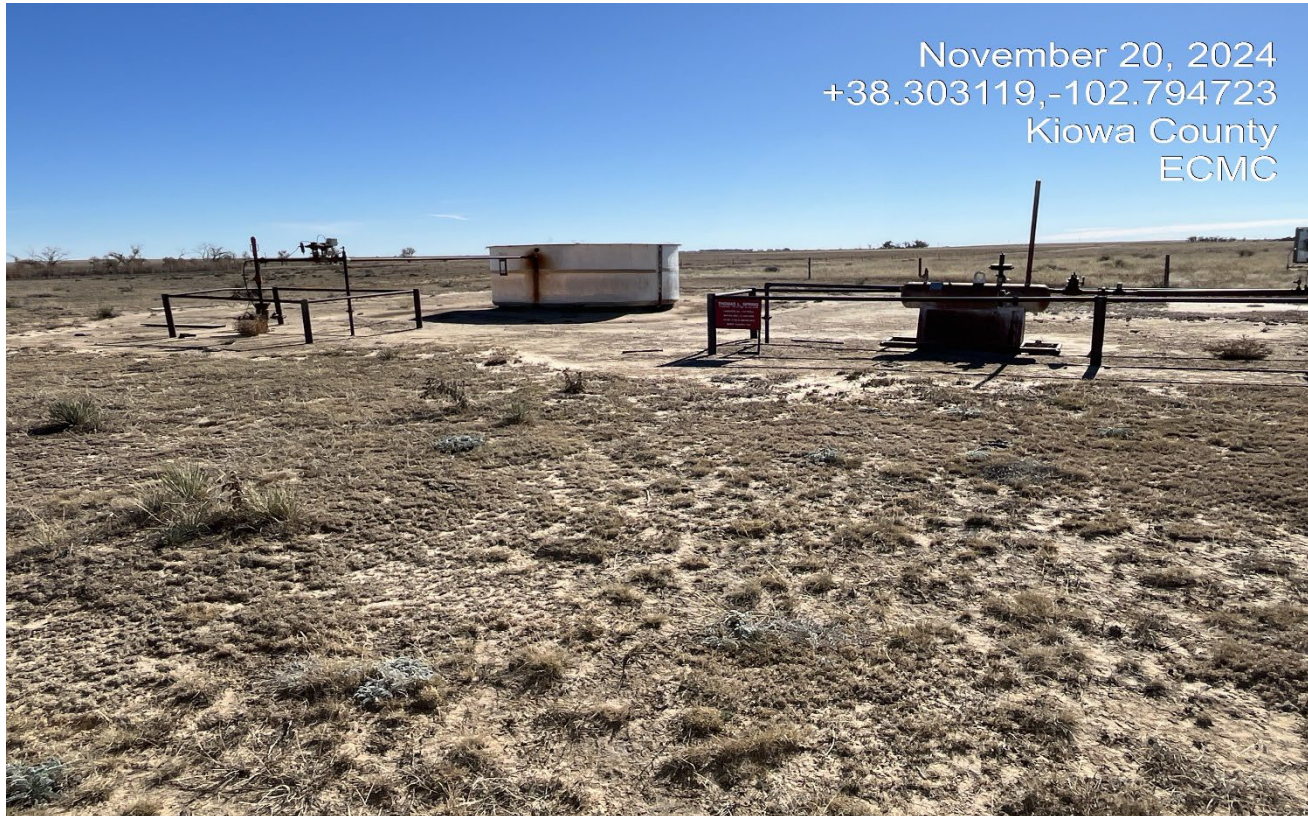
Photo 2. Facing southeast toward the wellsite.

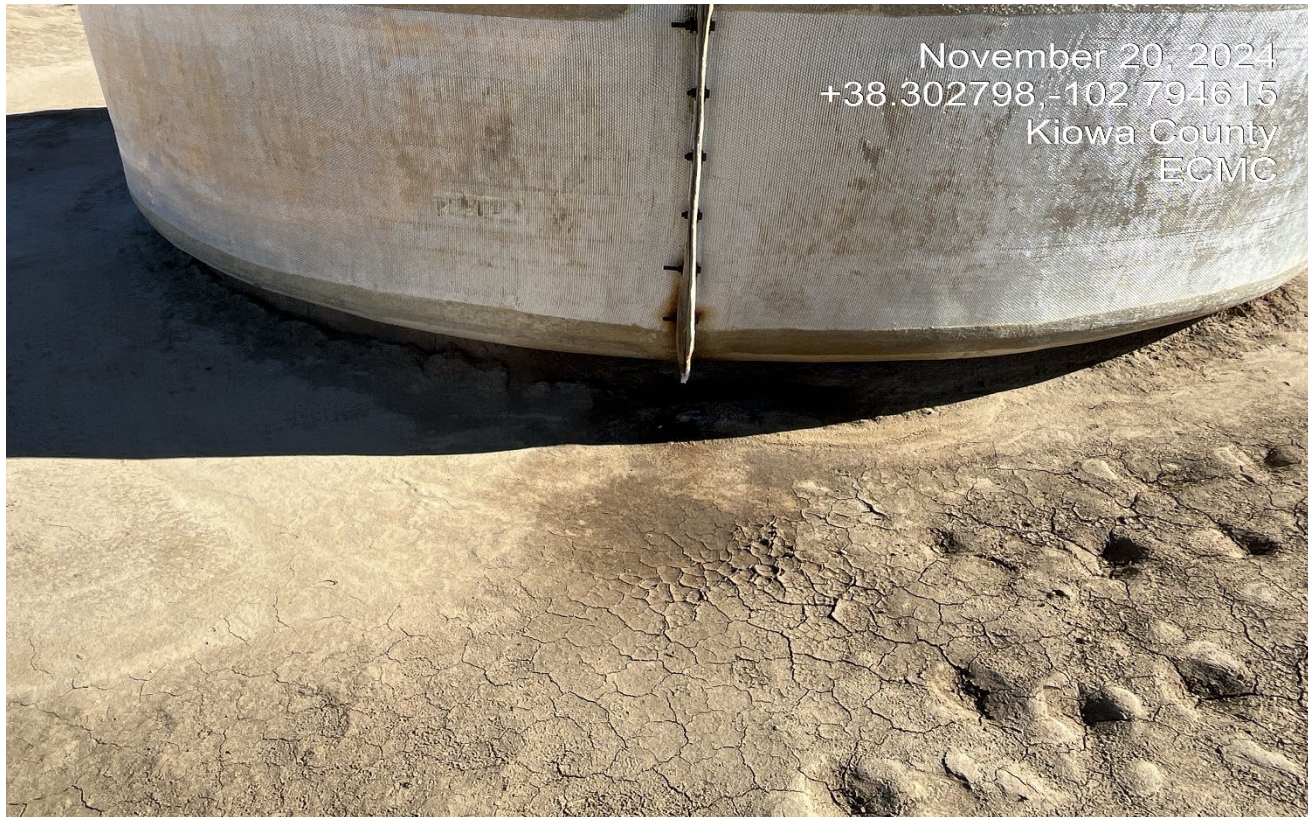
Photo 3. There is a slight leak at the tank seam.

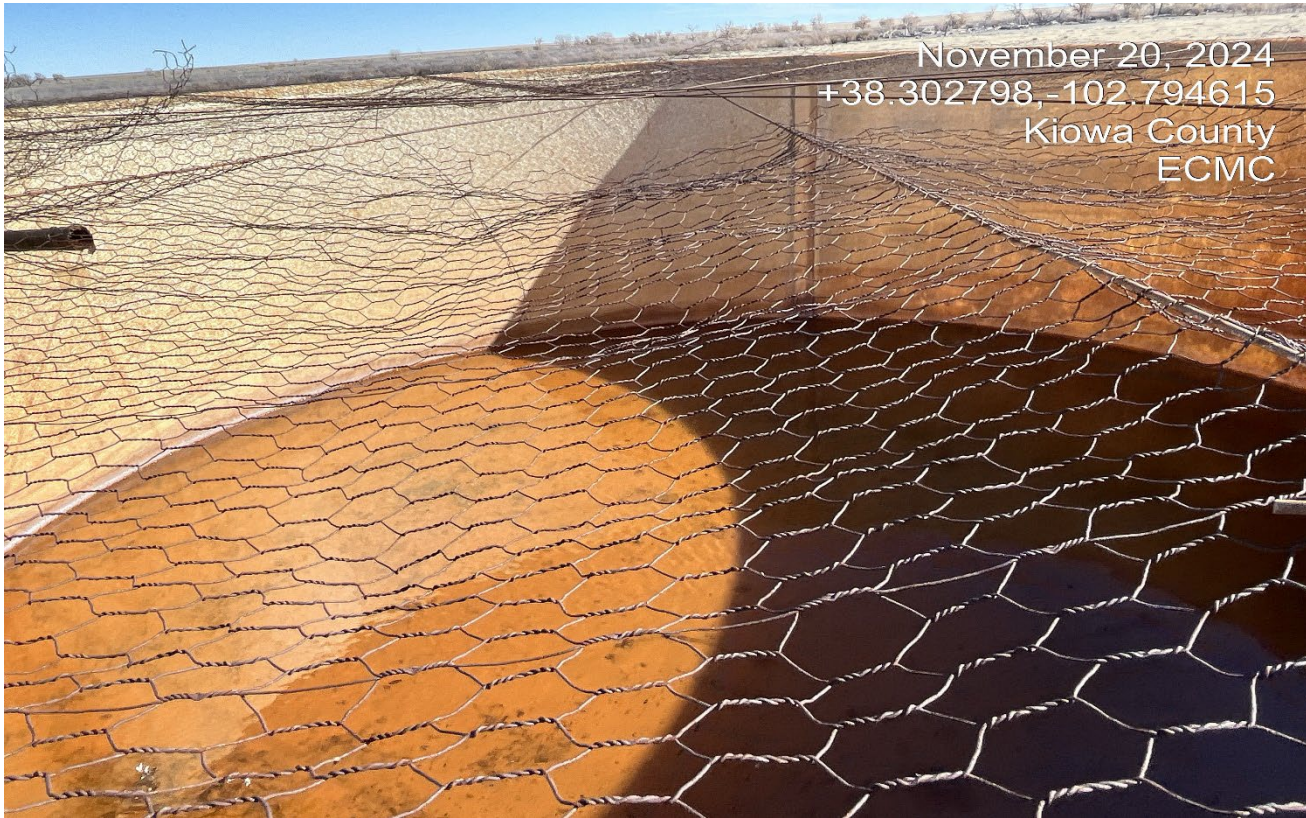
Photo 4. There are some gaps in the wire mesh that need to be repaired to prevent entry.
