WELL NAME: AC 12-03, API #: 071-08296, INSP. # 716300261

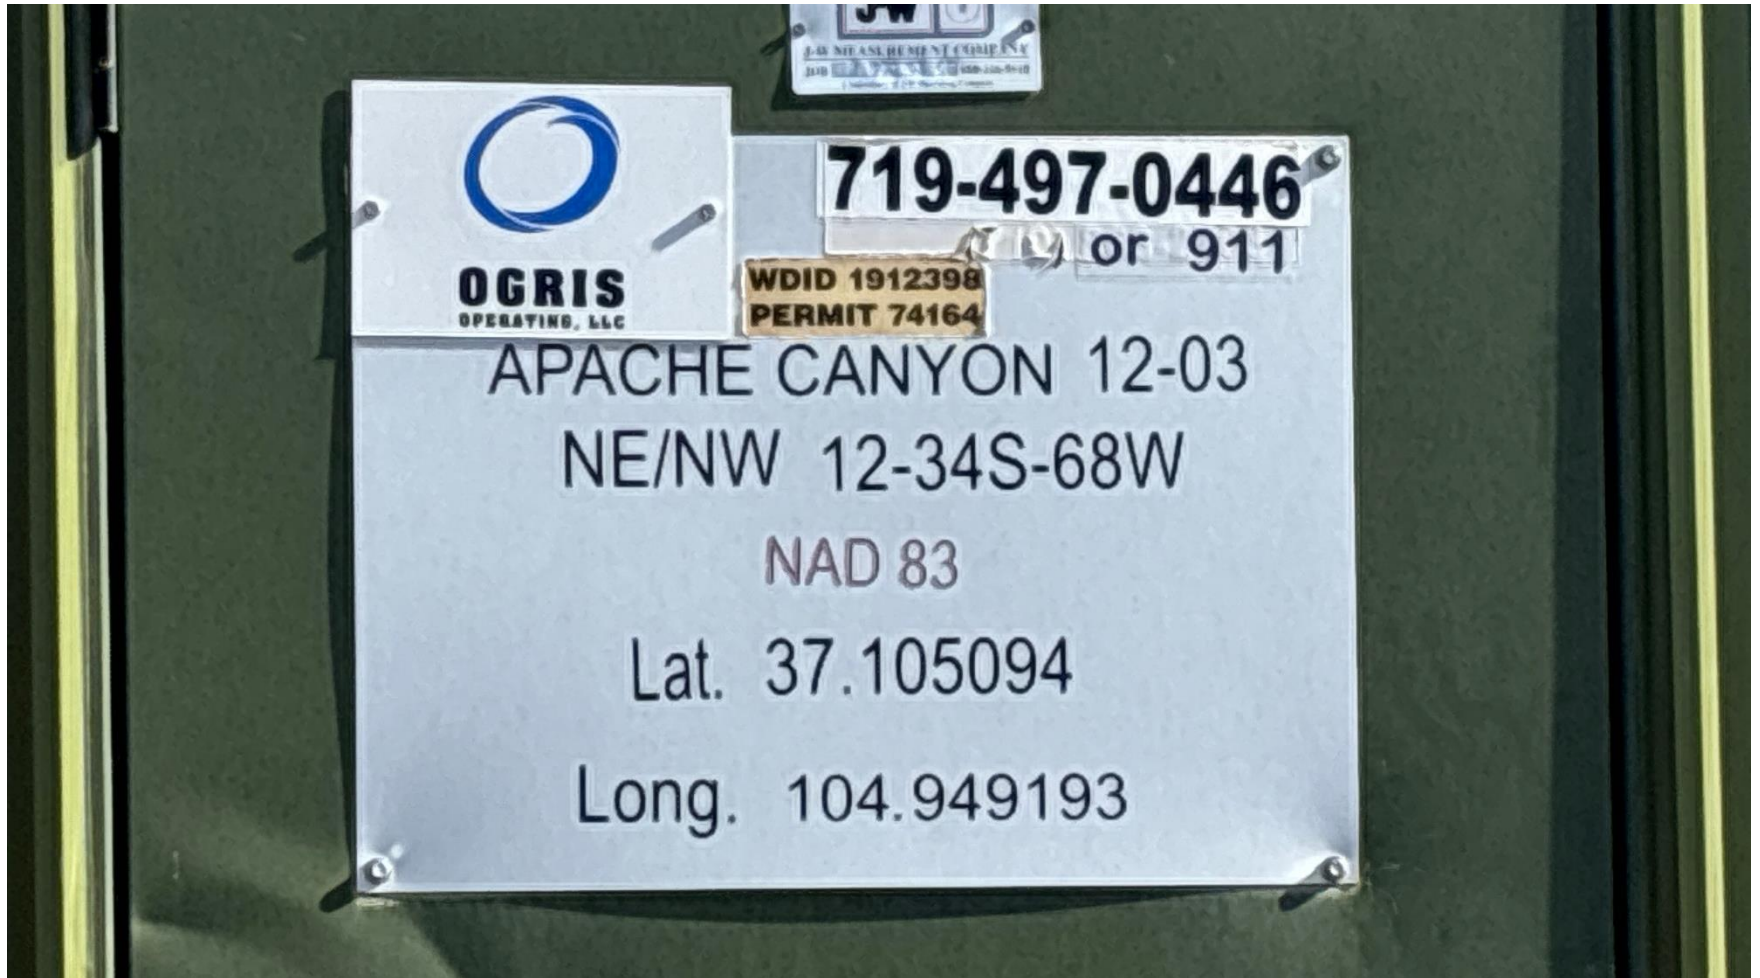
PHOTO 1: WELL SIGN

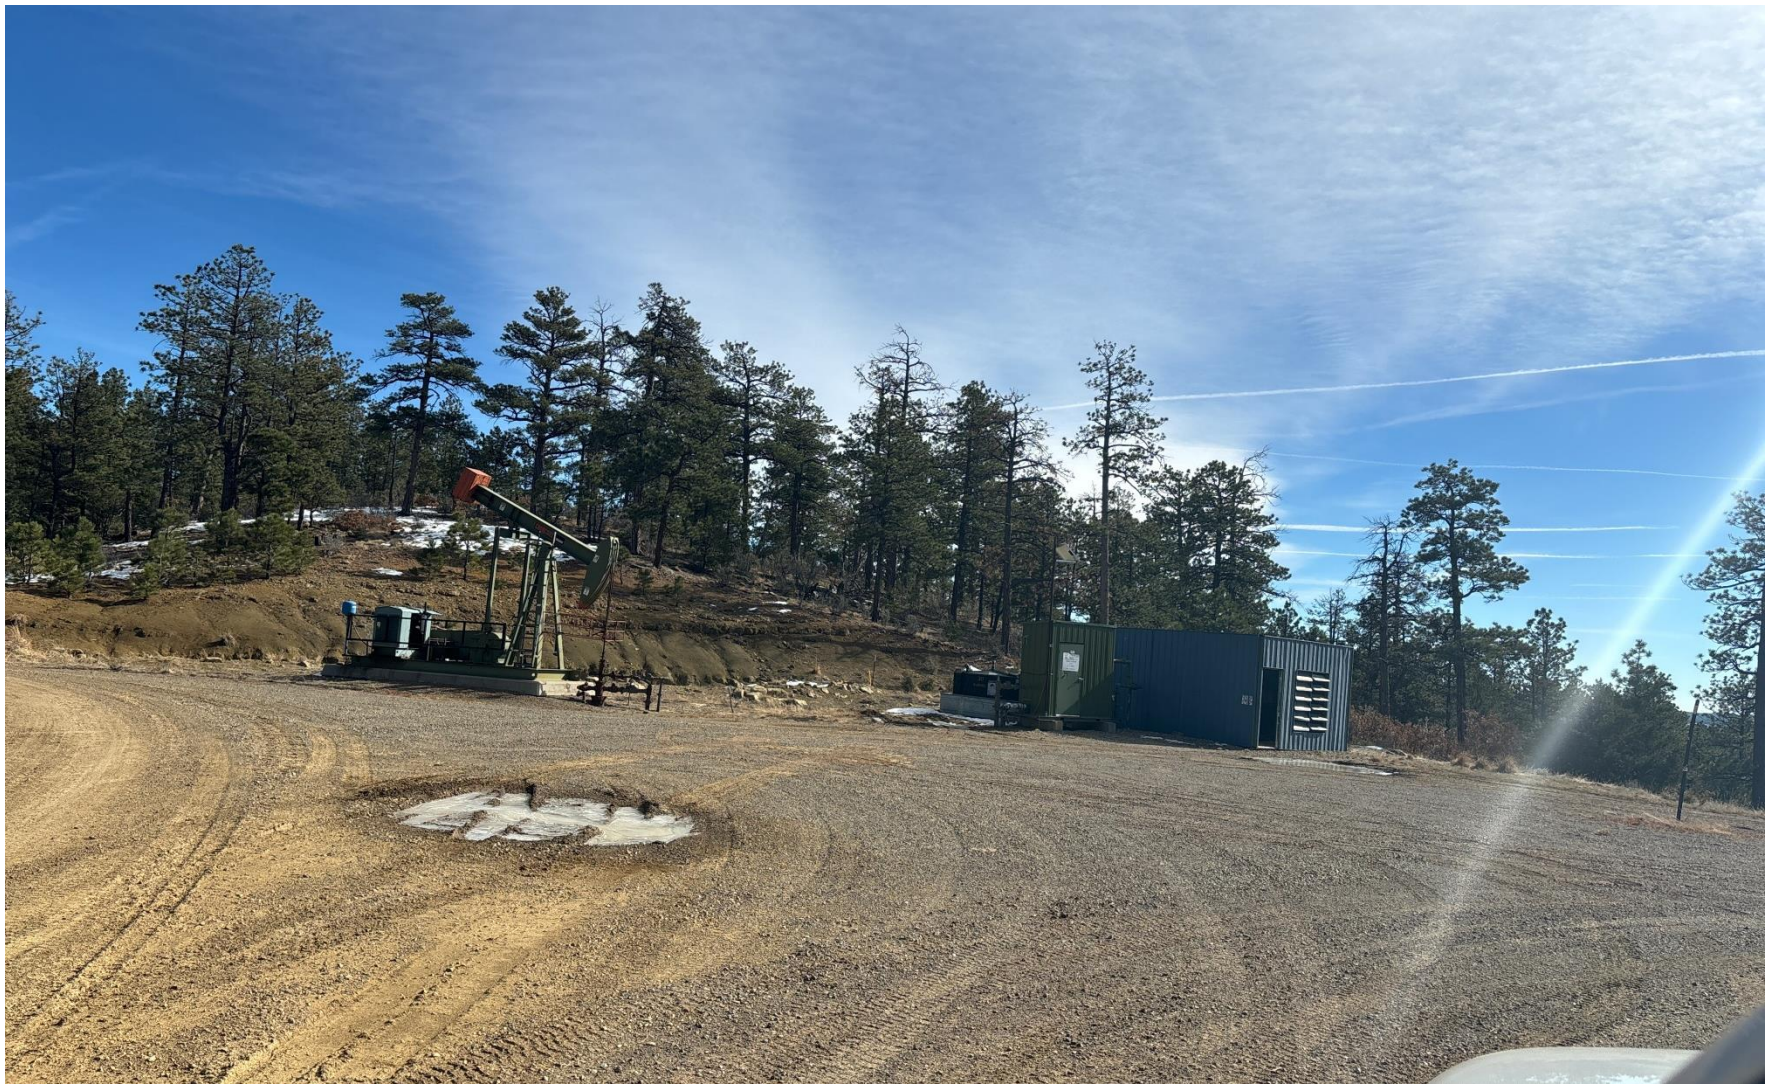
PHOTO 2: LOCATION.

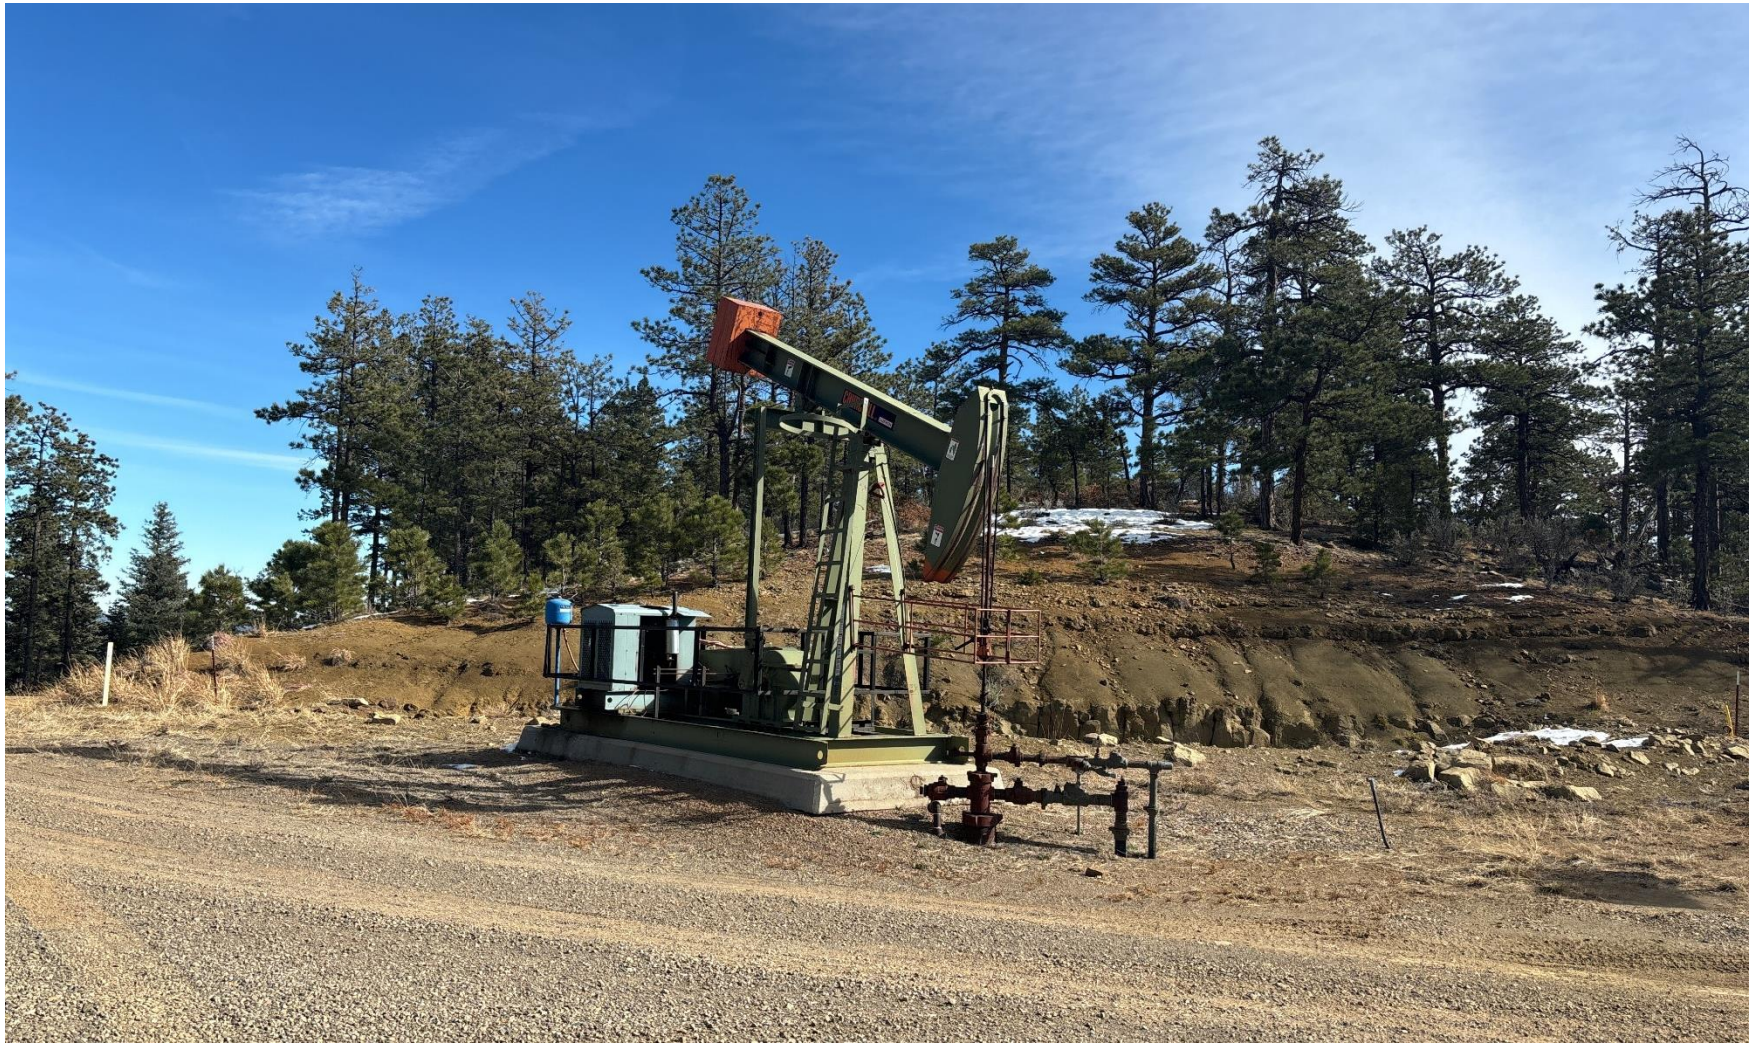
PHOTO 3: WELLHEAD AND EQUIPMENT.

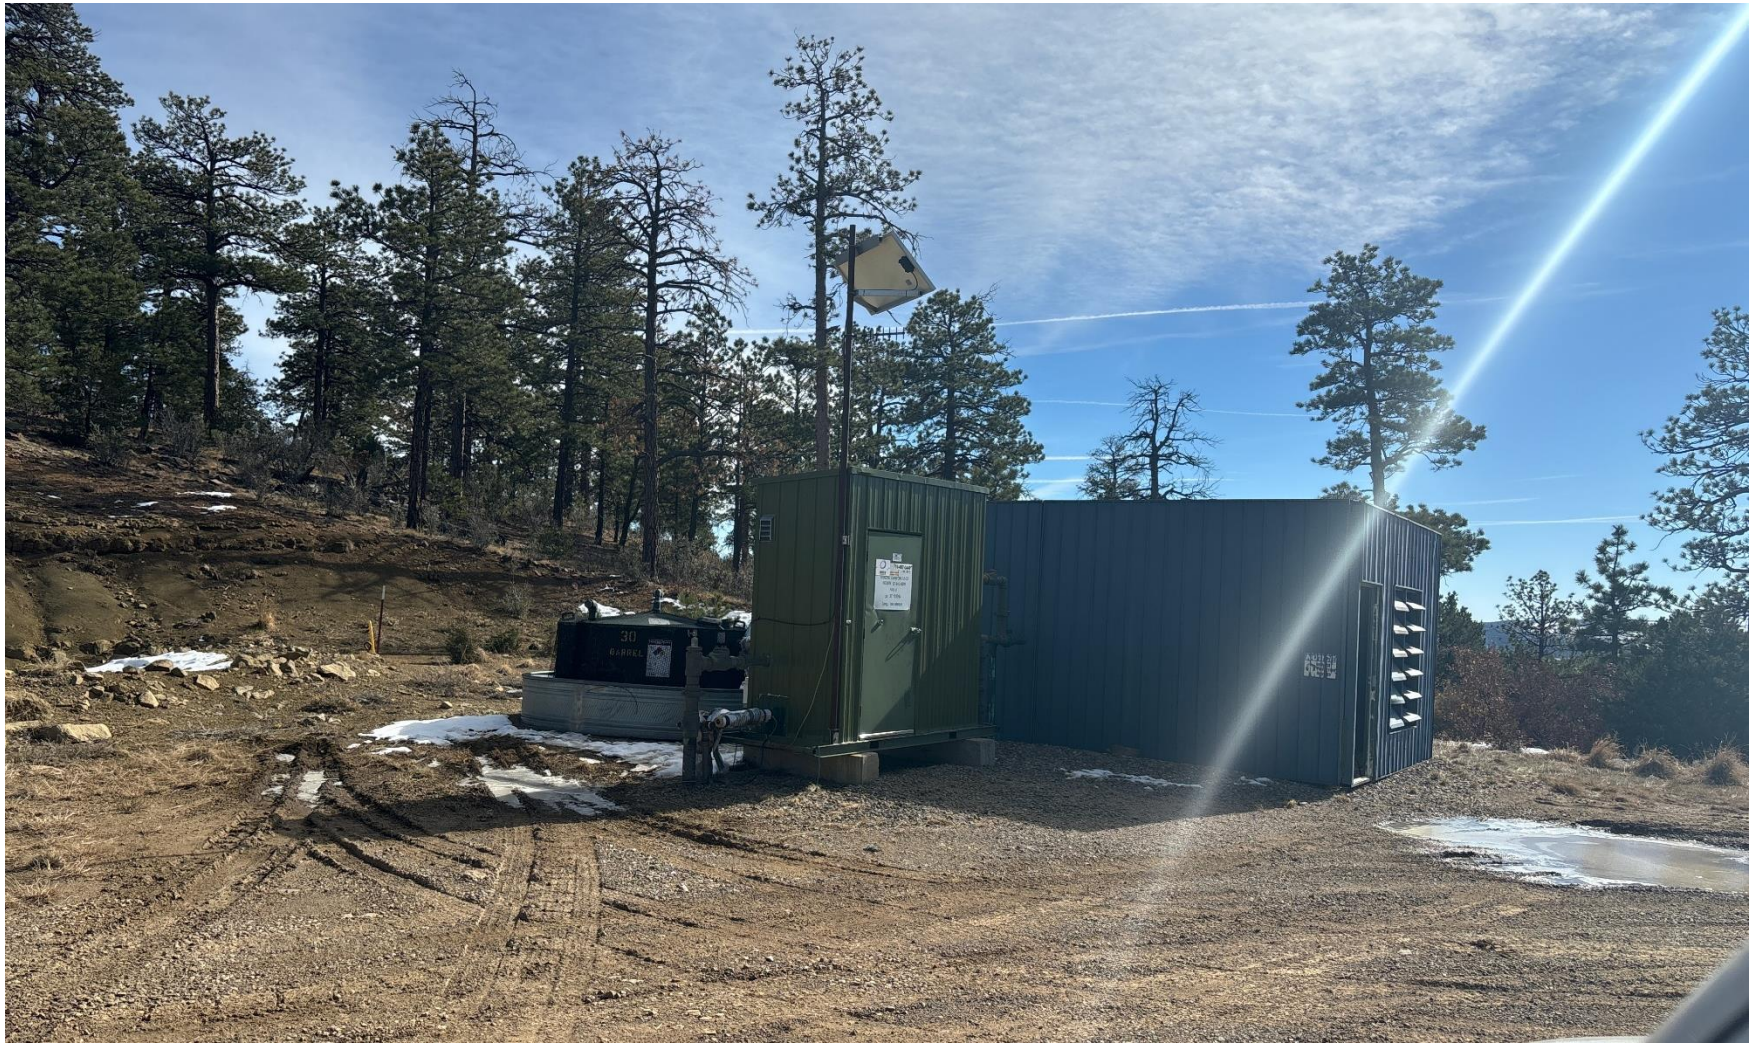
PHOTO 4: WELL EQUIPMENT.

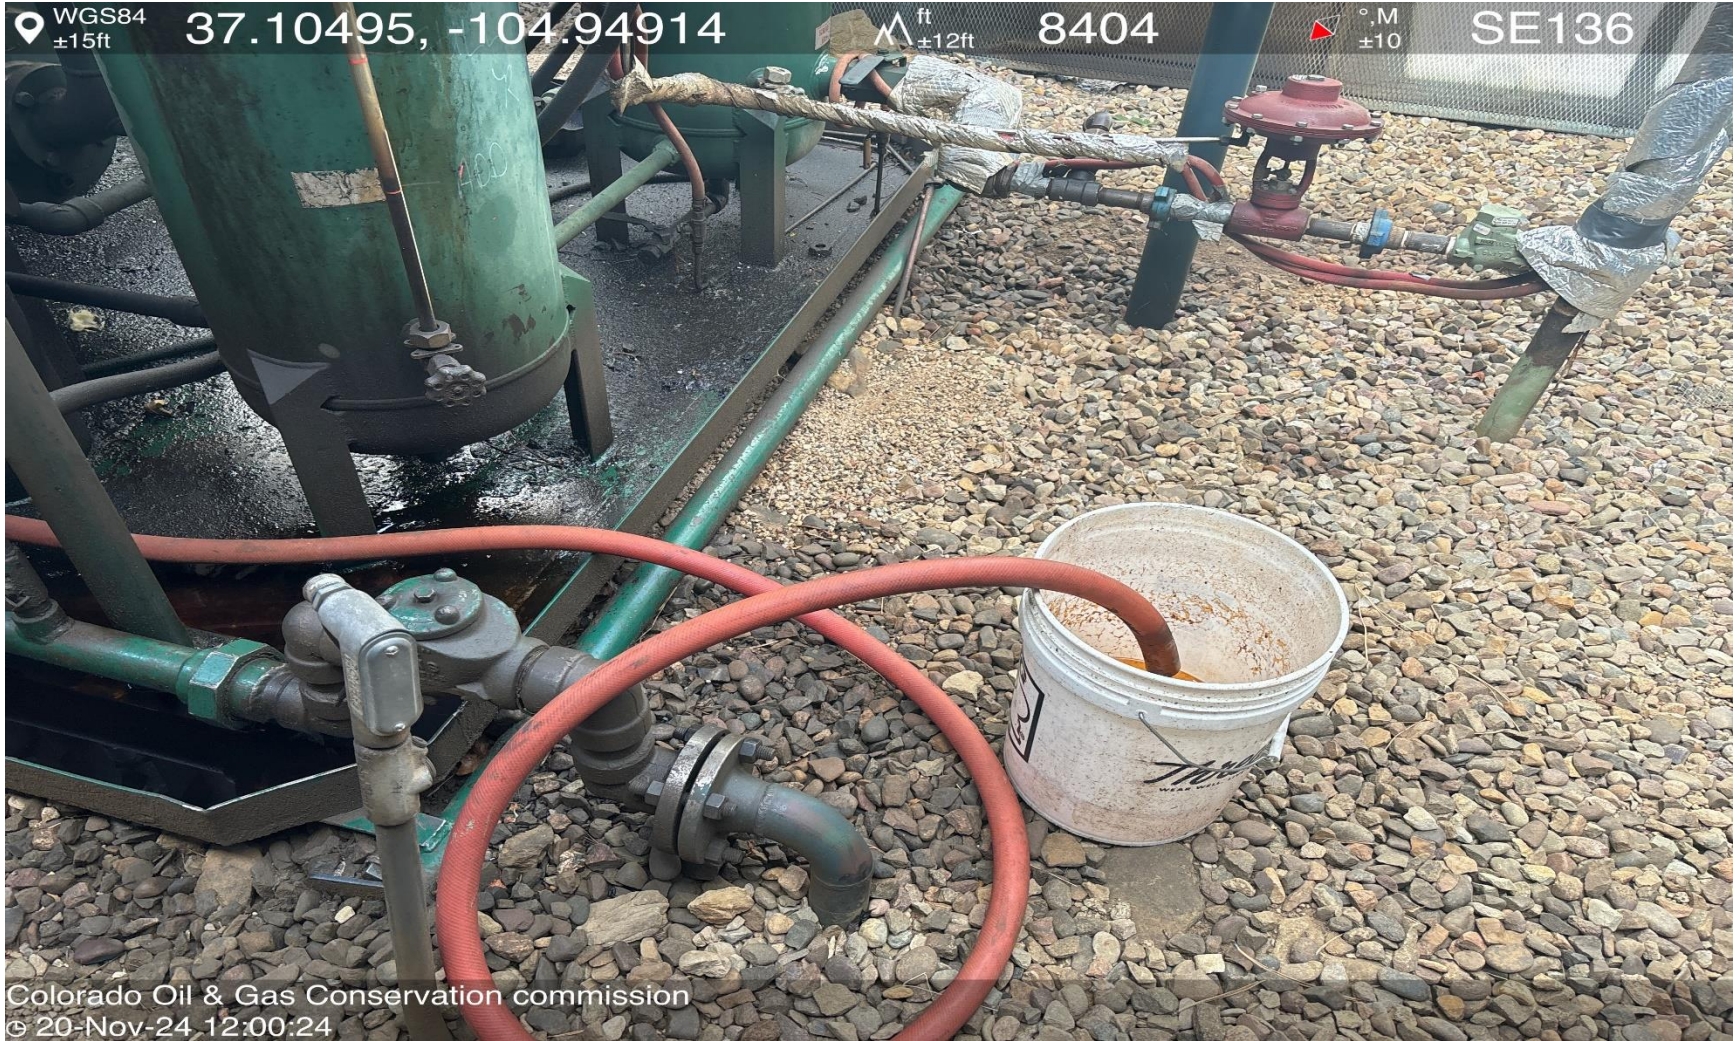
PHOTO 5: AREA OF IMPACTED SOIL NEAR COMPRESSOR. Conduct maintenance on equipment, cleanup stained material and review self inspection processes. COMPLY WITH RULE 1002,(2).D. CA DATE 11/30/2024.

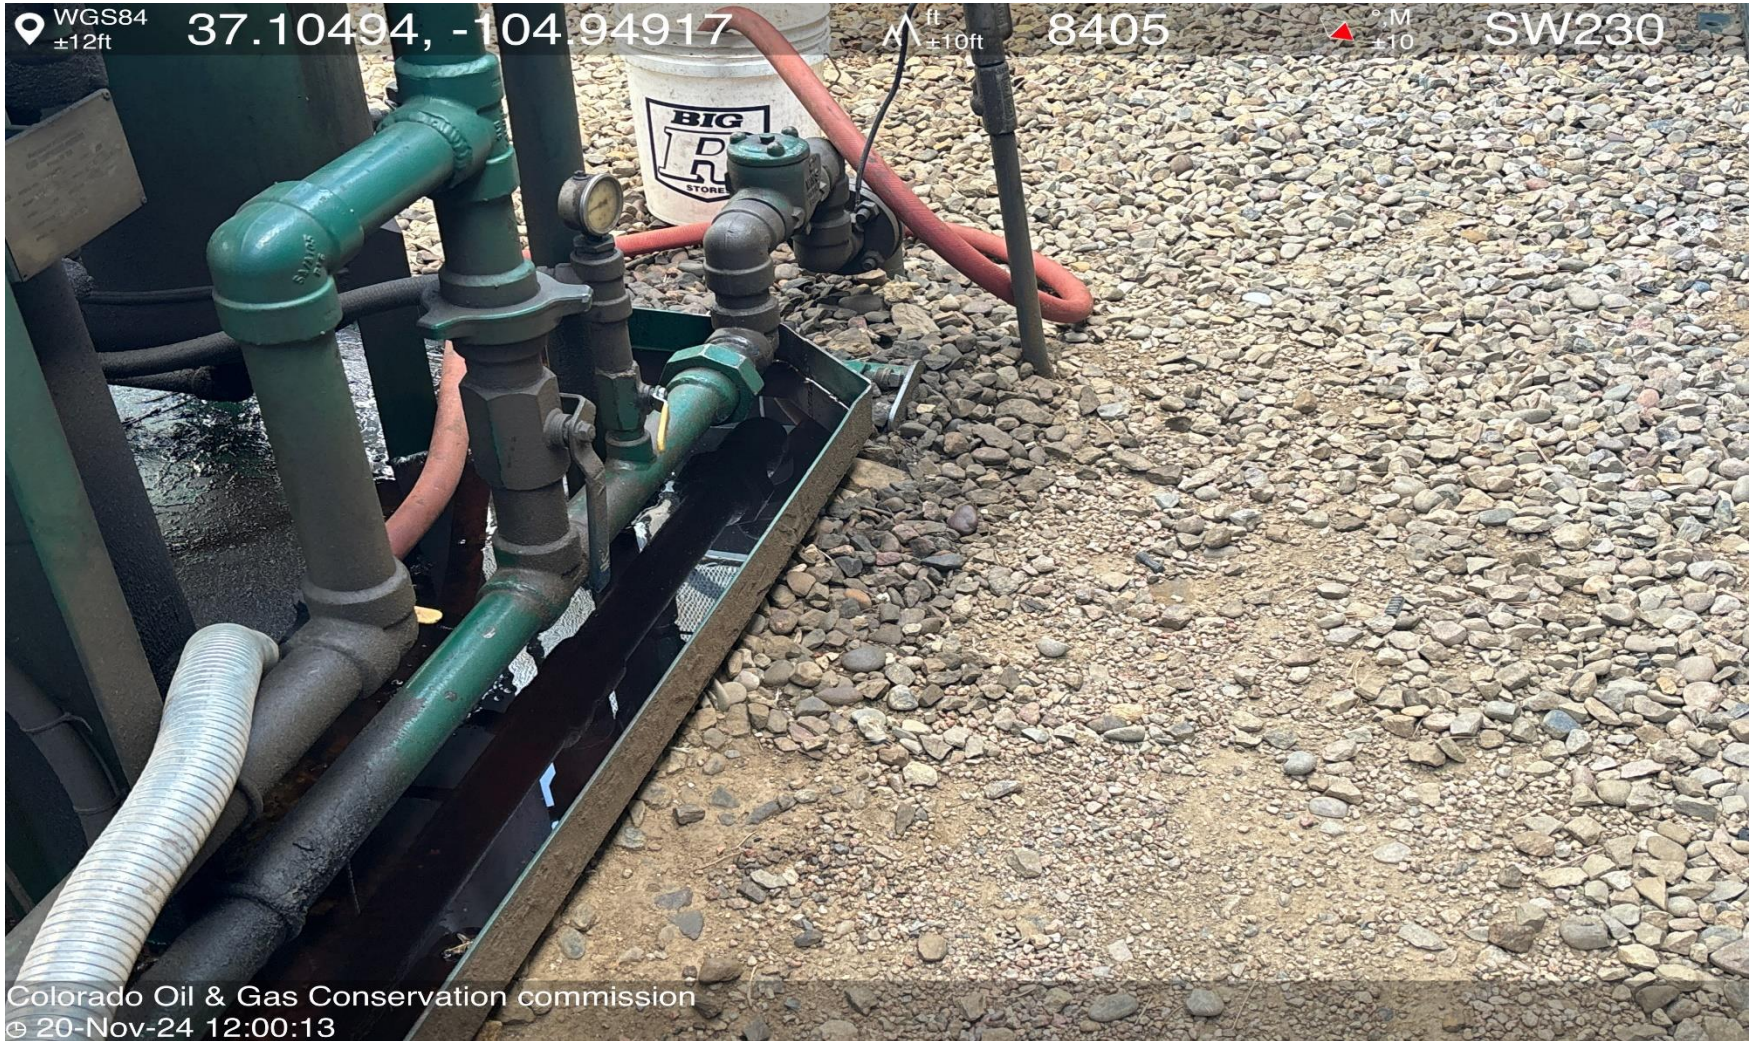
PHOTO 6: AREA OF IMPACTED SOIL NEAR COMPRESSOR. Conduct maintenance on equipment, cleanup stained material and review self inspection processes. COMPLY WITH RULE 1002,(2).D. CA DATE 11/30/2024.

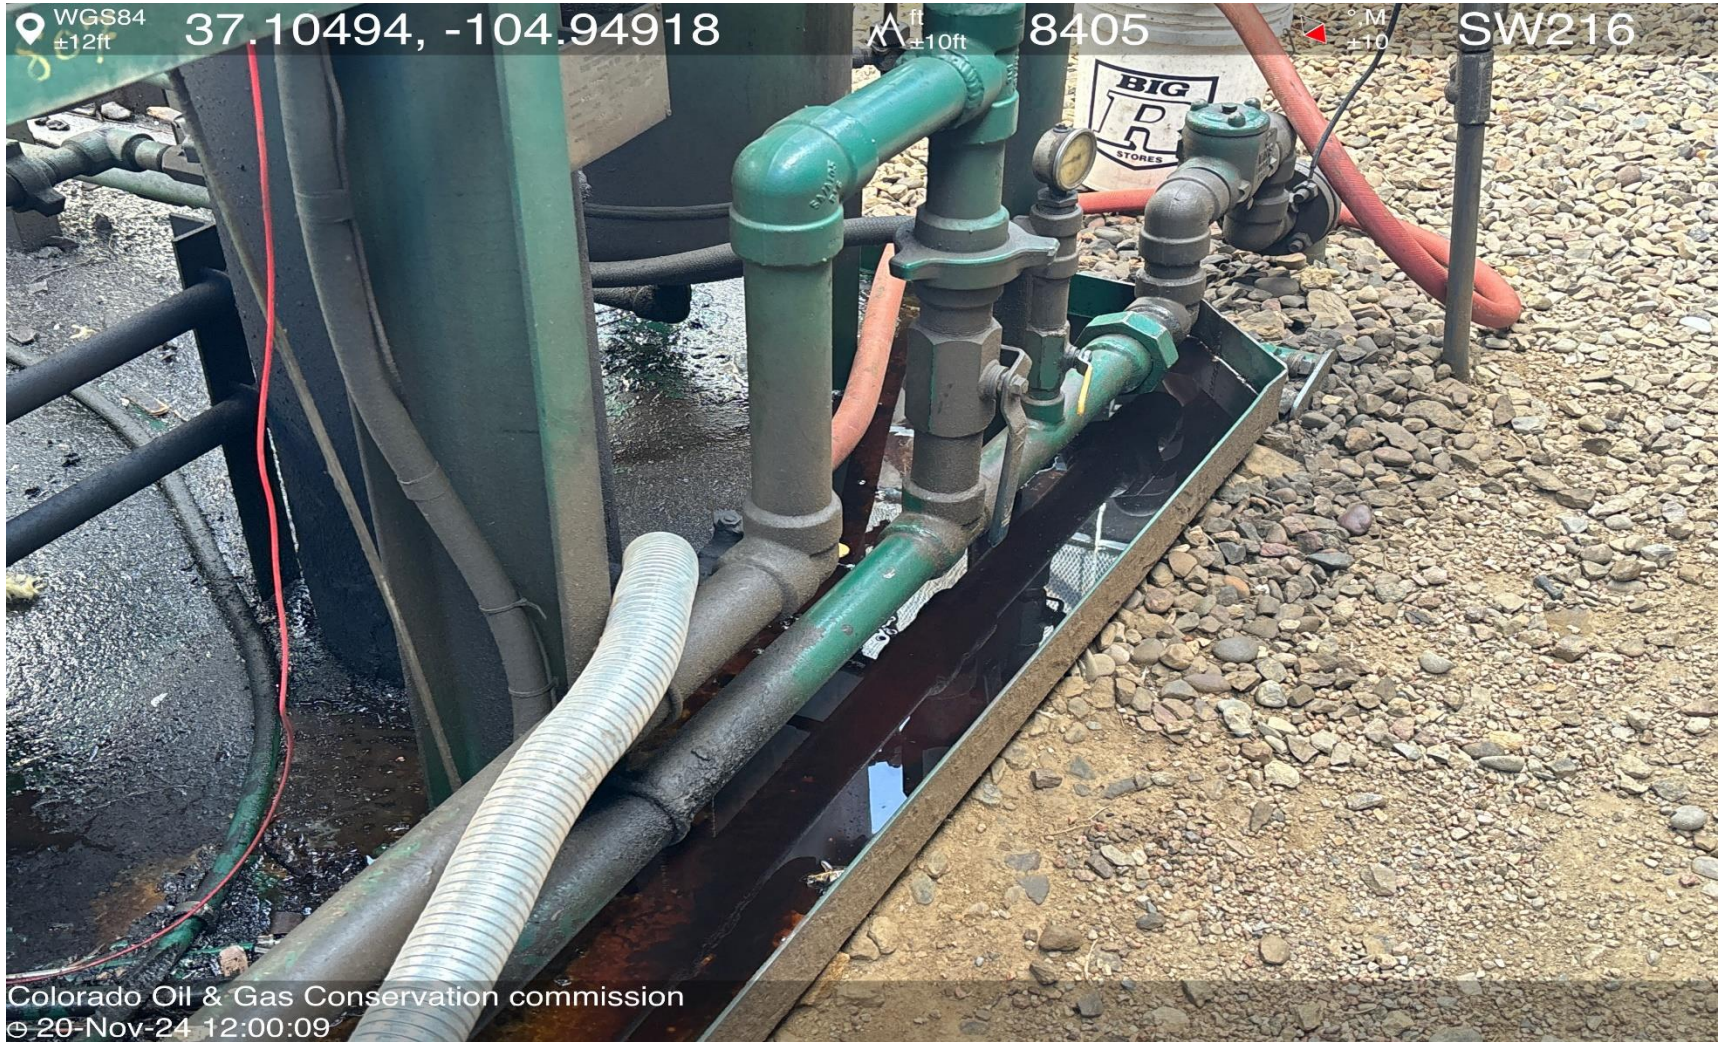
PHOTO 7: OILY WASTE FROM LEAK IN HYDRAULIC MOTOR HAS FILLED SKID AND HAS SPILLED OVER CAUSING IMPACT SOIL SURROUNDING SKID. DRAIN OILY WASTE REPAIR ALL LEAKS AND REMOVE OR TREAT IMPACTED SOIL PER RULE 1002..(2).D & 1002.f.(2)B, Comply with general provisions of the oil and gas act for wildlife protection AND SB-181. 11/21/2024.
