Interim Reclamation and Stormwater Inspection

October 17, 2024

Location ID: 436485

Inspection Document #: 712300102

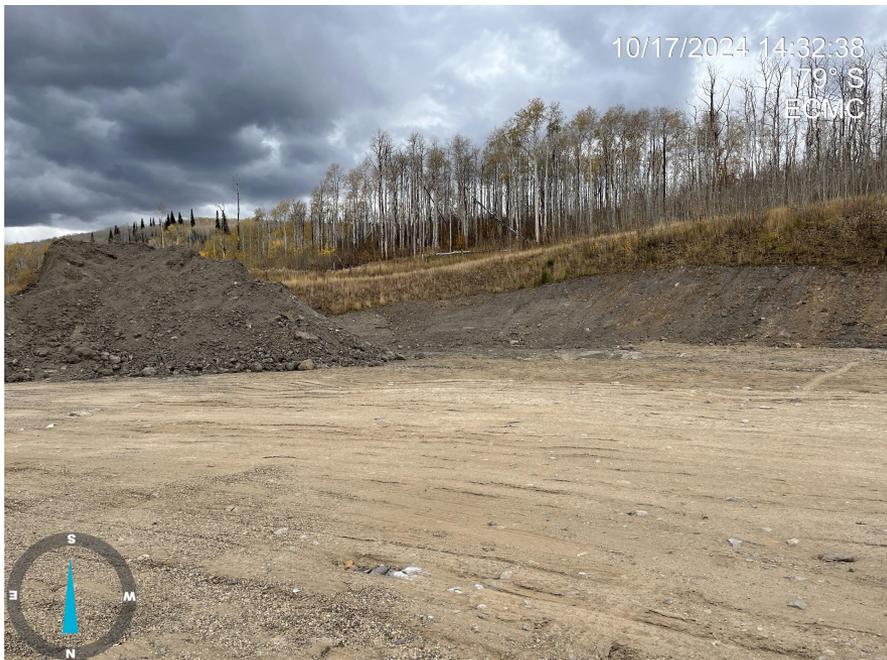
Photo 1. Photo taken from western portion of Location, facing south. Photo illustrates that the cuttings pile is missing containment measures. At the time of inspection, cuttings were in process of being removed from the Location.

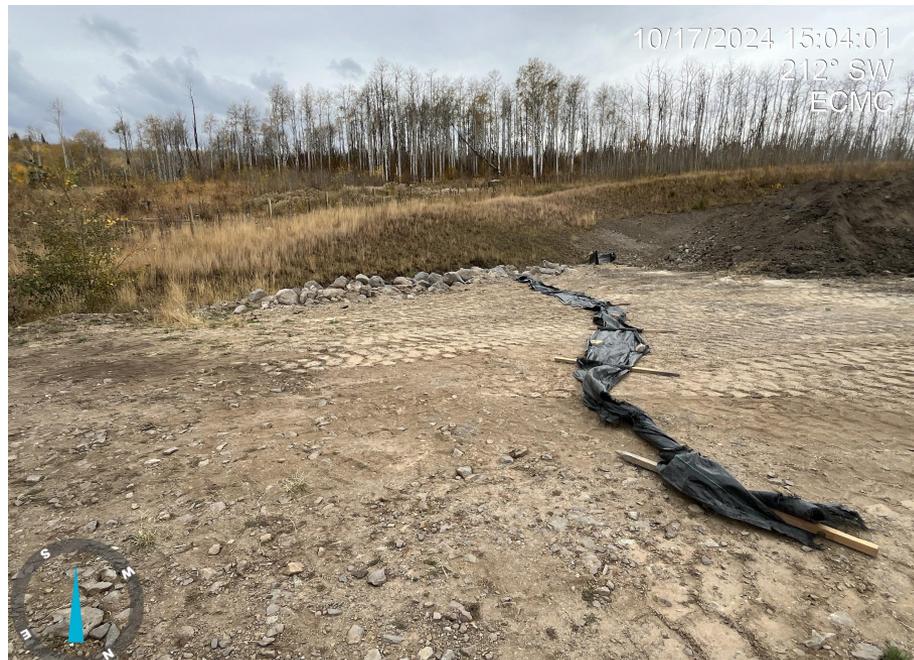
Photo 2. Photo taken from southern portion of Location, facing southwest. Operator previously implemented silt fence to protect offsite movement of E&P waste. BMP was not properly maintained and inadequate in containing E&P waste. Operator indicated that they removed silt fence 10/18/2024.

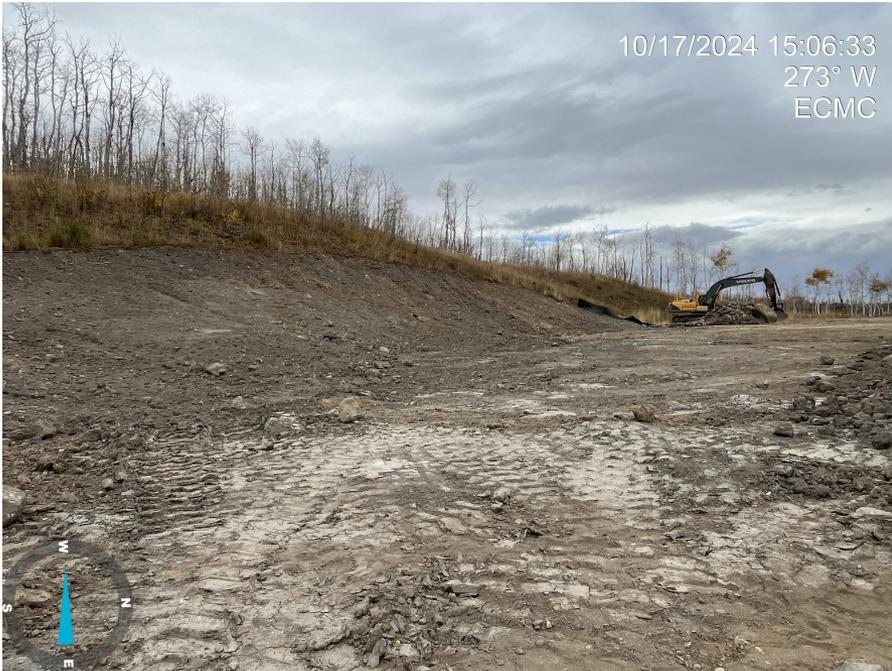
Photo 3. Photo taken from southern portion of working pad surface, facing west. Photo illustrates inadequate/missing secondary containment measures around cuttings pile.

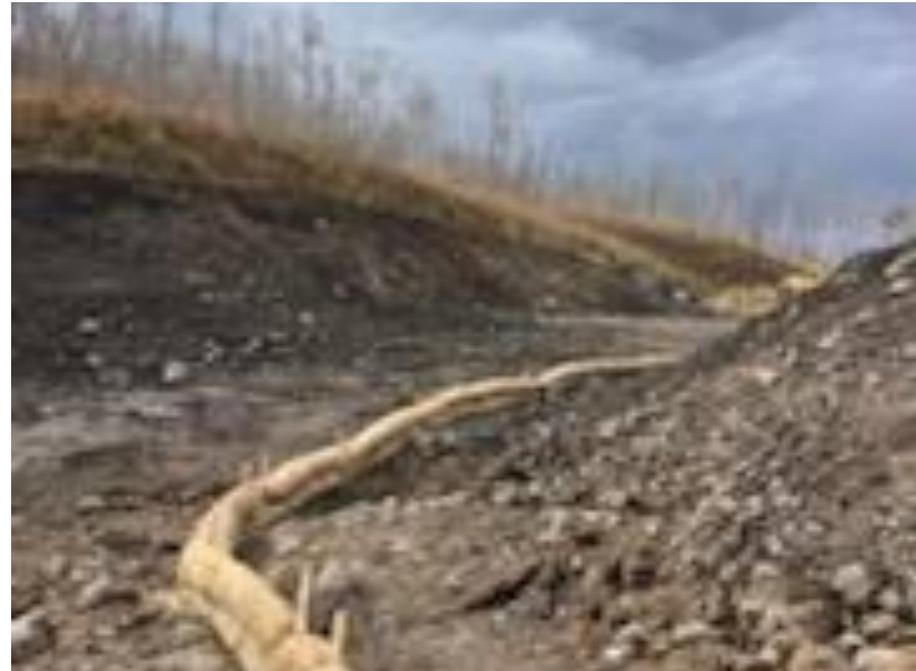
Photo 4. On 10/18/2024, photo submitted by Operator. Photo illustrates adequate containment measures implemented around the cuttings pile 10/18/24.

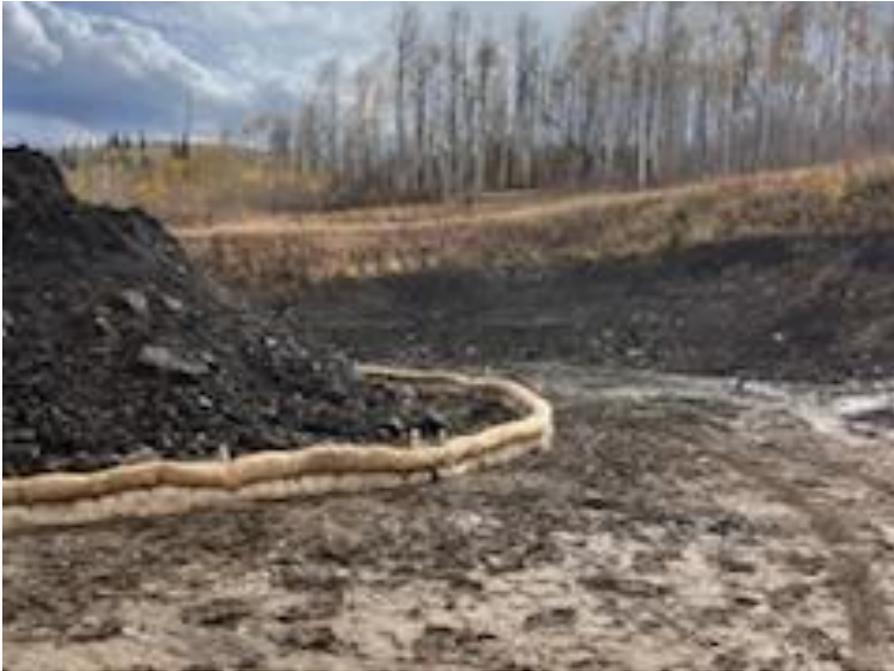
Photo 5. On 10/18/2024, photo submitted by Operator. Photo illustrates adequate containment measures implemented 10/18/24. Adequate containment measures implemented 10/18/24.

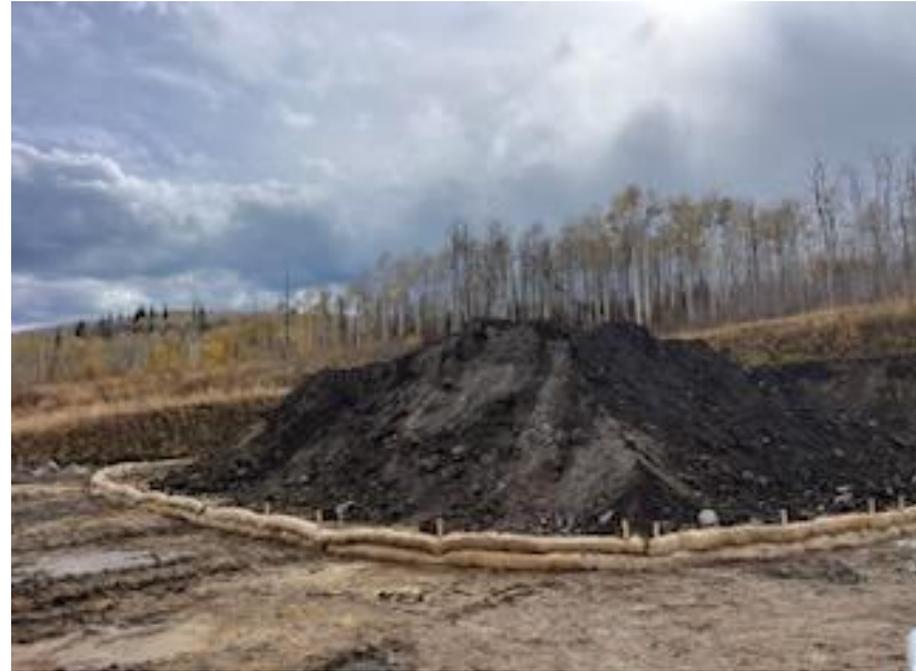
Photo 6. On 10/18/2024, photo submitted by Operator. Photo illustrates adequate containment measures implemented 10/18/24. Adequate containment measures implemented 10/18/24.

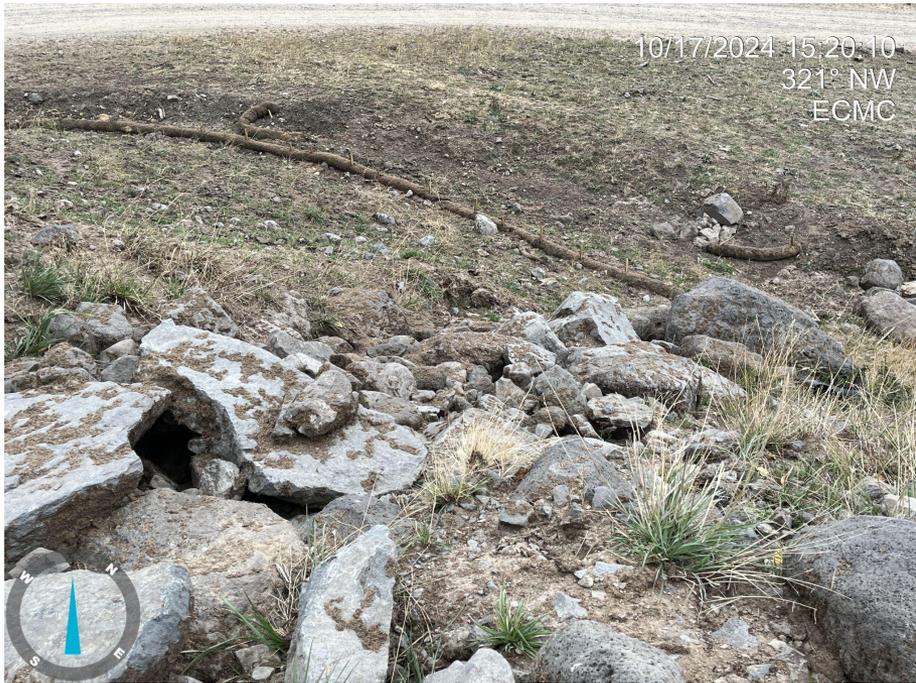
Photo 7. Photo taken of northern fill slope, illustrating the stormwater outlet. Geotextile lining in conjunction with multiangular rip-rap material has been implemented at the outlet on the north end of the Location.

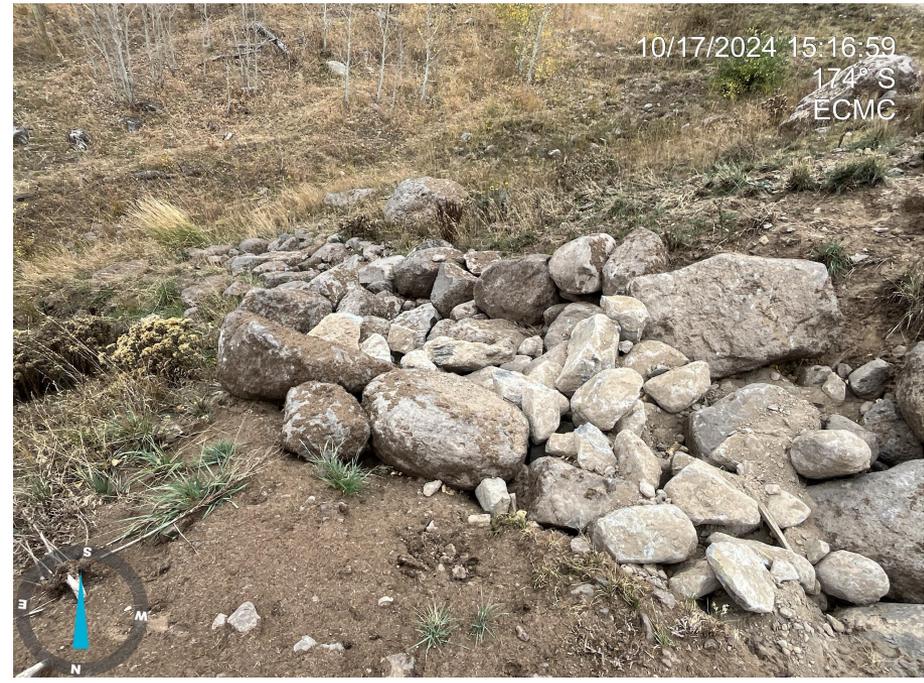
Photo 8. Photo taken on eastern edge of Location, illustrating the stormwater outlet has been lined with a geotextile material in conjunction with multiangular rip-rap.

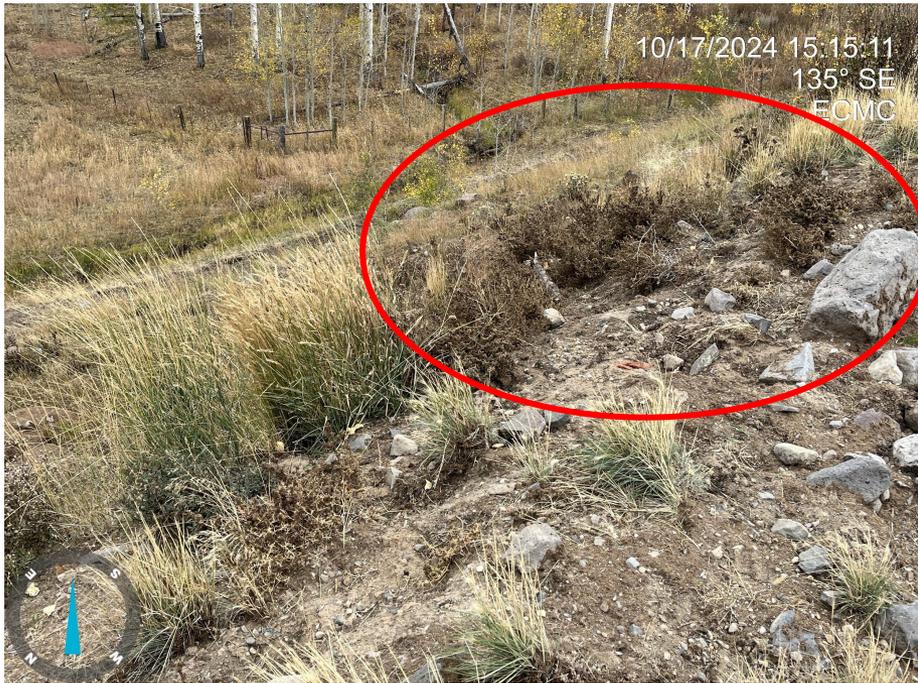
Photo 9. Photo taken on northern edge of location, facing north, illustrating the fill slopes. Undesirable weed species observed in the red circles (Canada Thistle had already seeded at this time). Weeds observed on the cut and fill slopes.

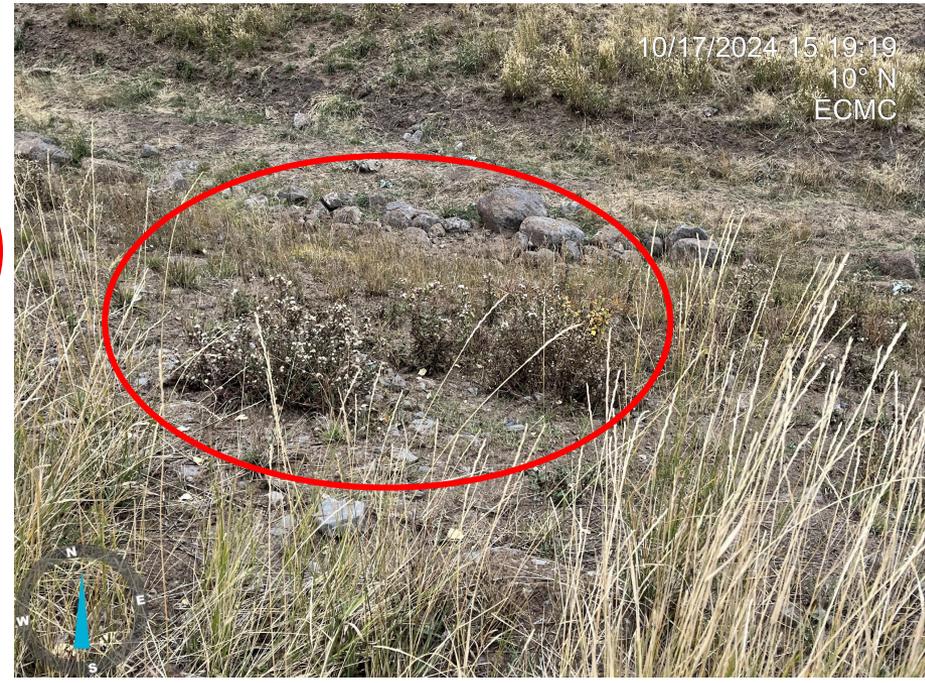
Photo 10. Photo taken on northern edge of location, facing north, illustrating the fill slopes. Undesirable weed species observed in the red circles (Canada Thistle had already seeded at this time).

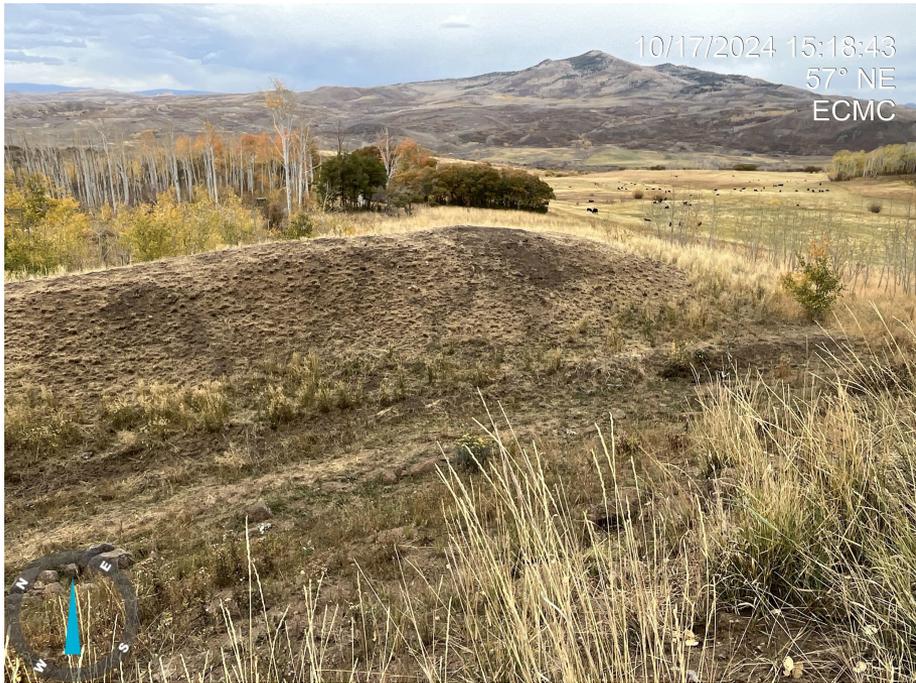
Photo 11. Photo taken of the topsoil stockpile. BMPs (hydromulch) have been implemented to reduce slope erosion and degradation.

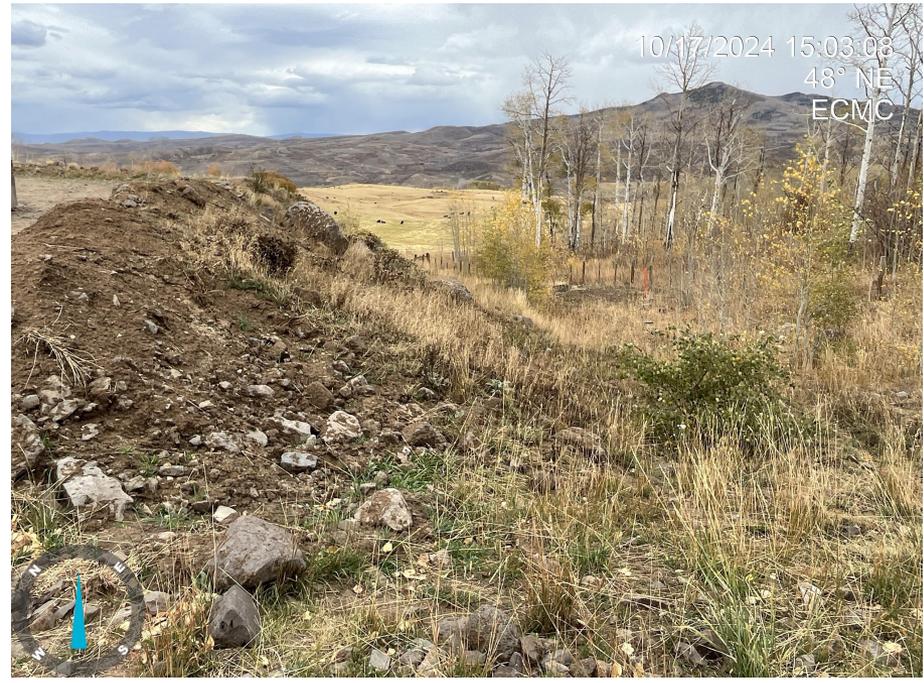
Photo 12. Photo taken of eastern fill slope area, facing northeast. BMPs (hydromulch) have been implemented to reduce slope erosion and degradation.

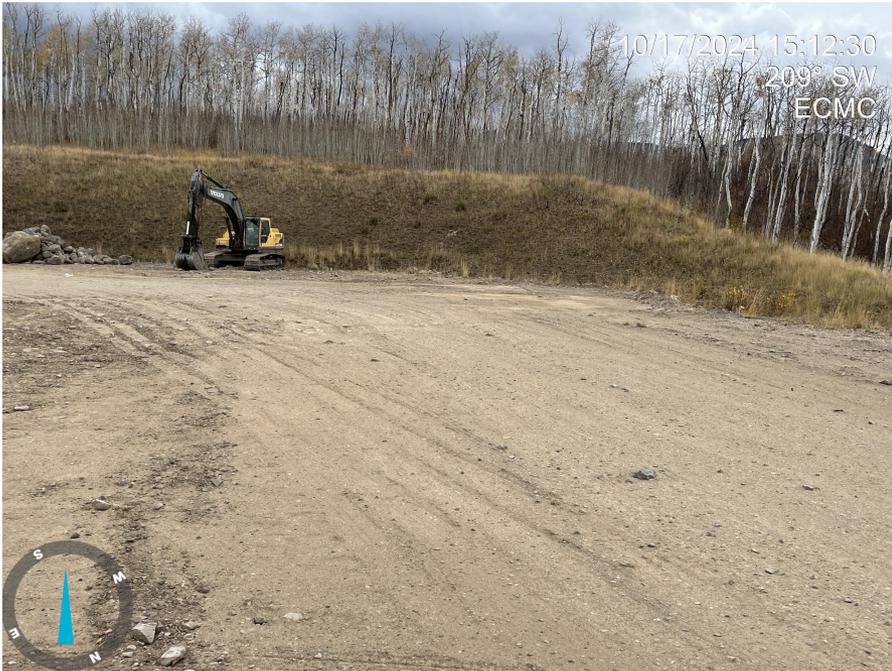
Photo 13. Photo taken from western portion of Location, facing southwest. Photo illustrates that all risers and flowline equipment have been removed.

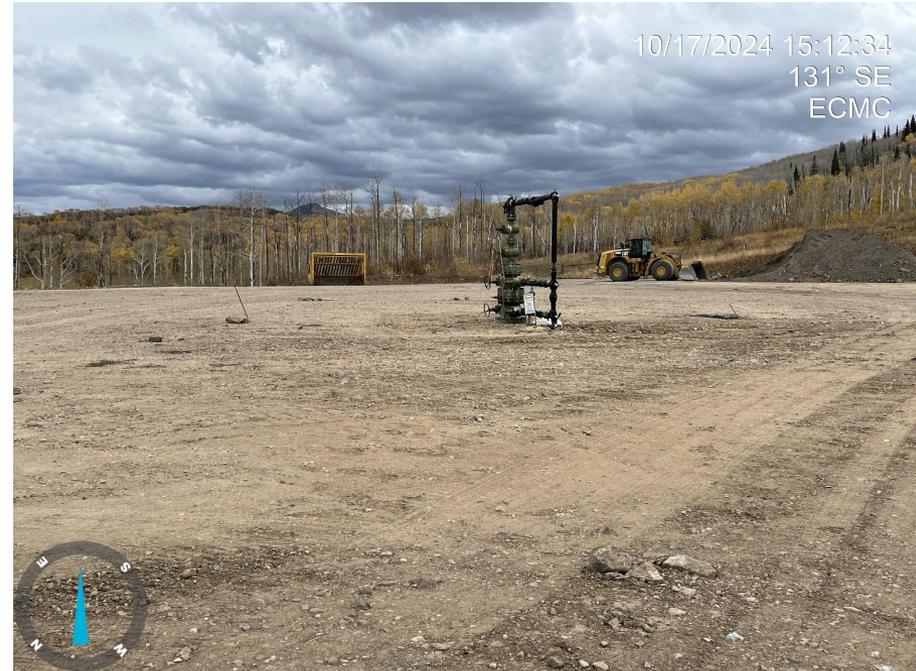
Photo 14. Photo taken from western edge of Location, facing southeast. Photo illustrates that all risers and flowline equipment have been removed.
