Inspection Photos

Location Name: TEP ROCKY MOUNTAIN LLC CLOUGH RMV 66-20 Pad

Location ID: 335272

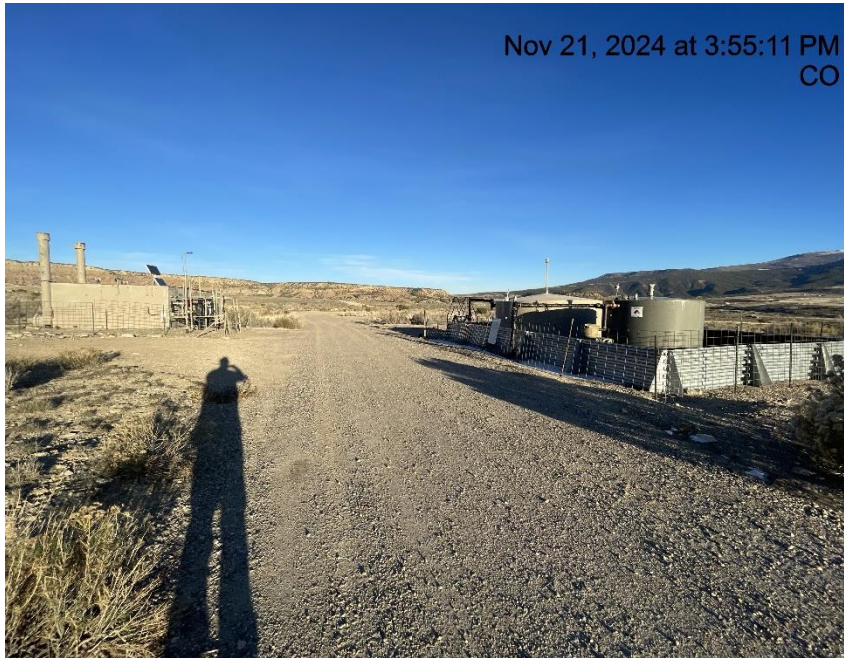
Photo # 1045 From entrance to location

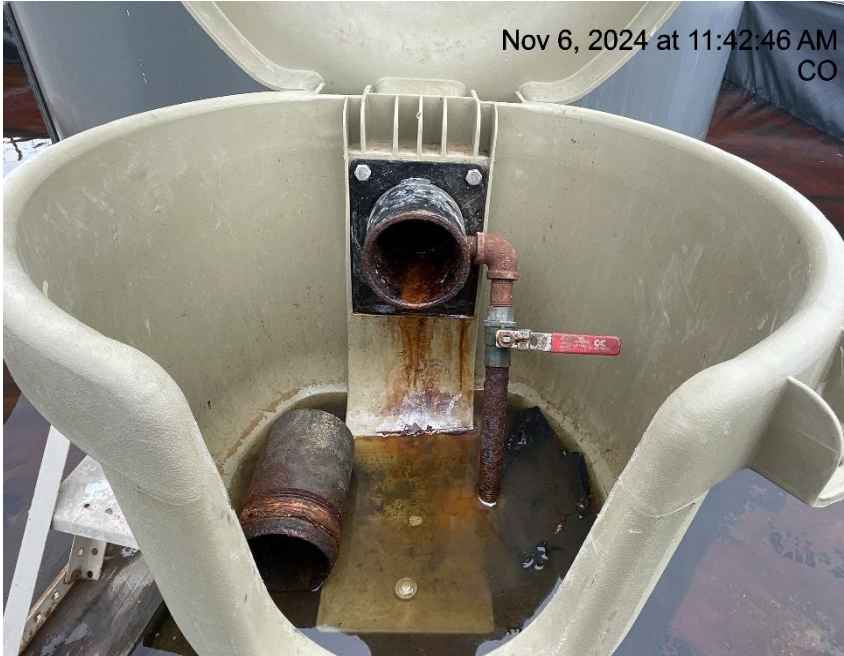
Nov 6, 2024 at 11:42:46 AM
CO

Photo # 9420 From inspection 708904982 conducted on
11/06/2024 - Open ended load line

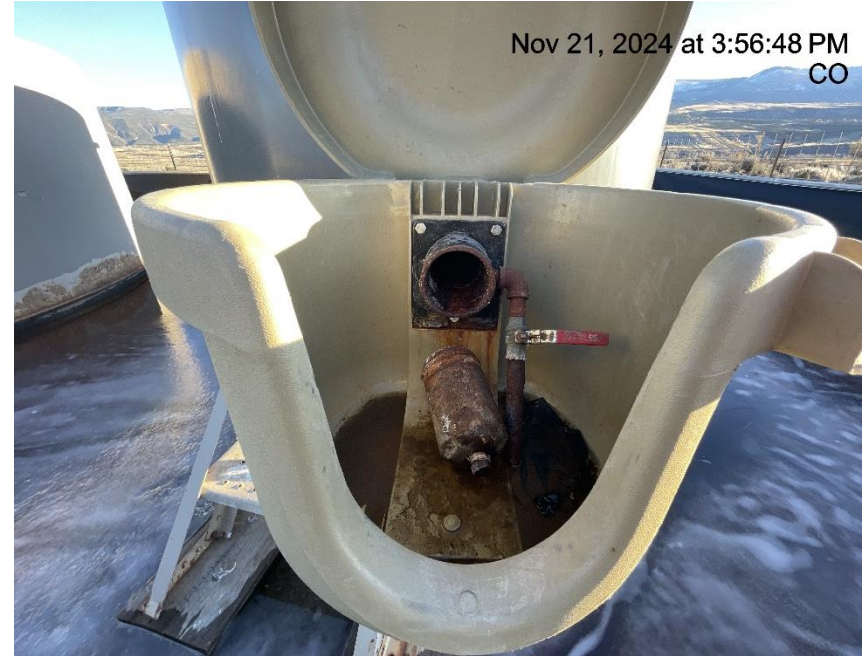
Nov 21, 2024 at 3:56:48 PM
CO

Photo # 1051 Open ended load line
