Inspection Photos  
Location Name: Federal 3-11  
Location ID: 322429  
Inspection Date: 11/14/2024

**COLORADO**  
Energy & Carbon Management  
Commission  
Department of Natural Resources

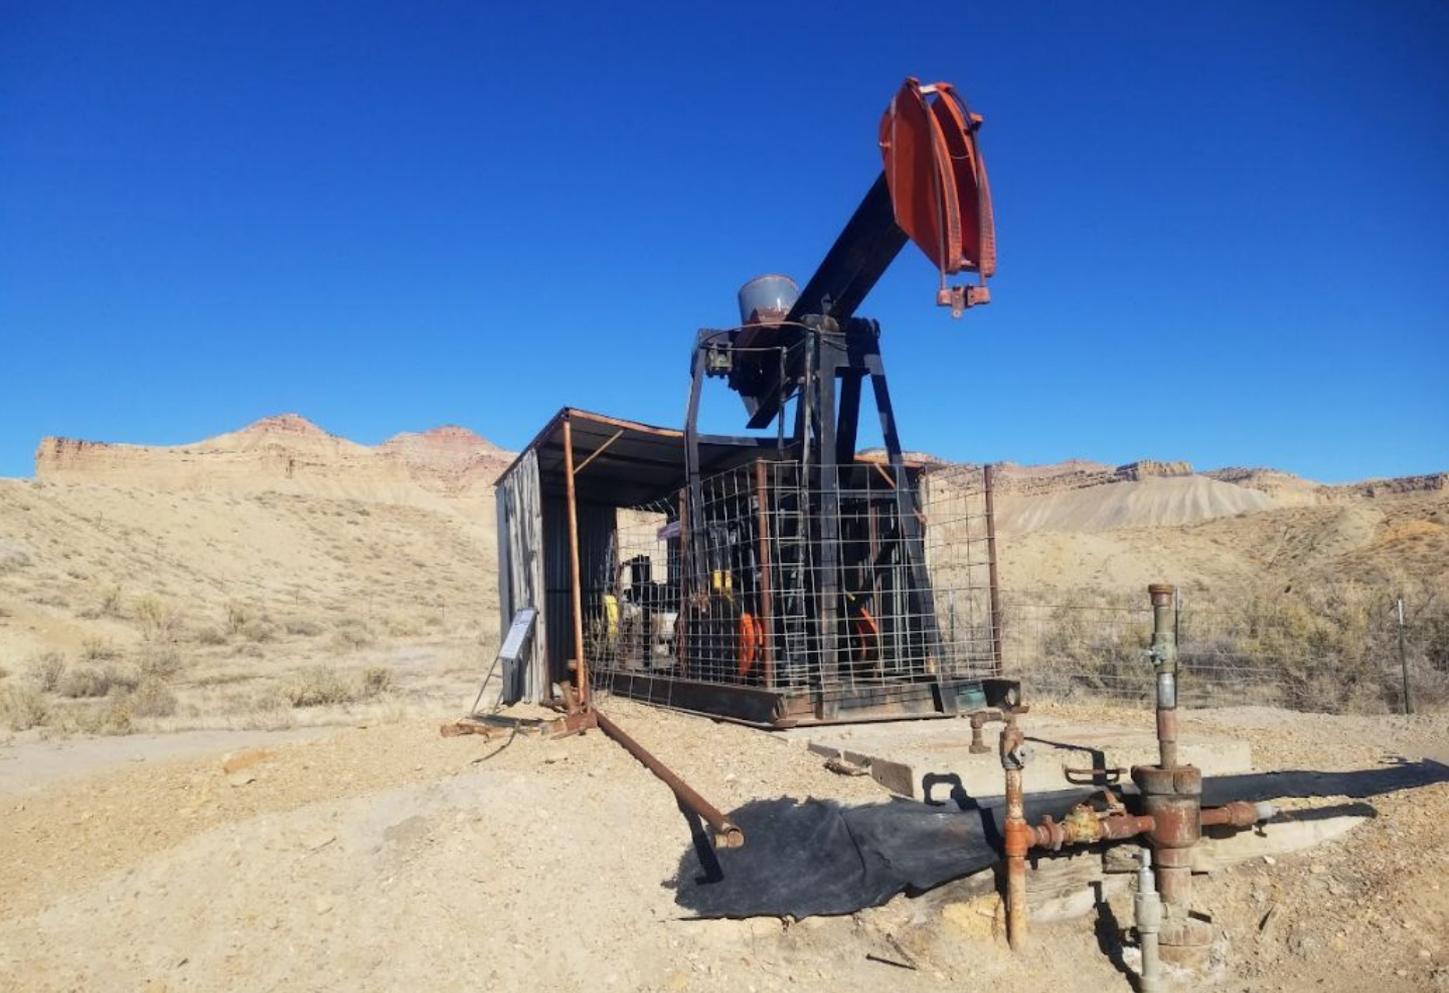
Wellhead and pump jack.

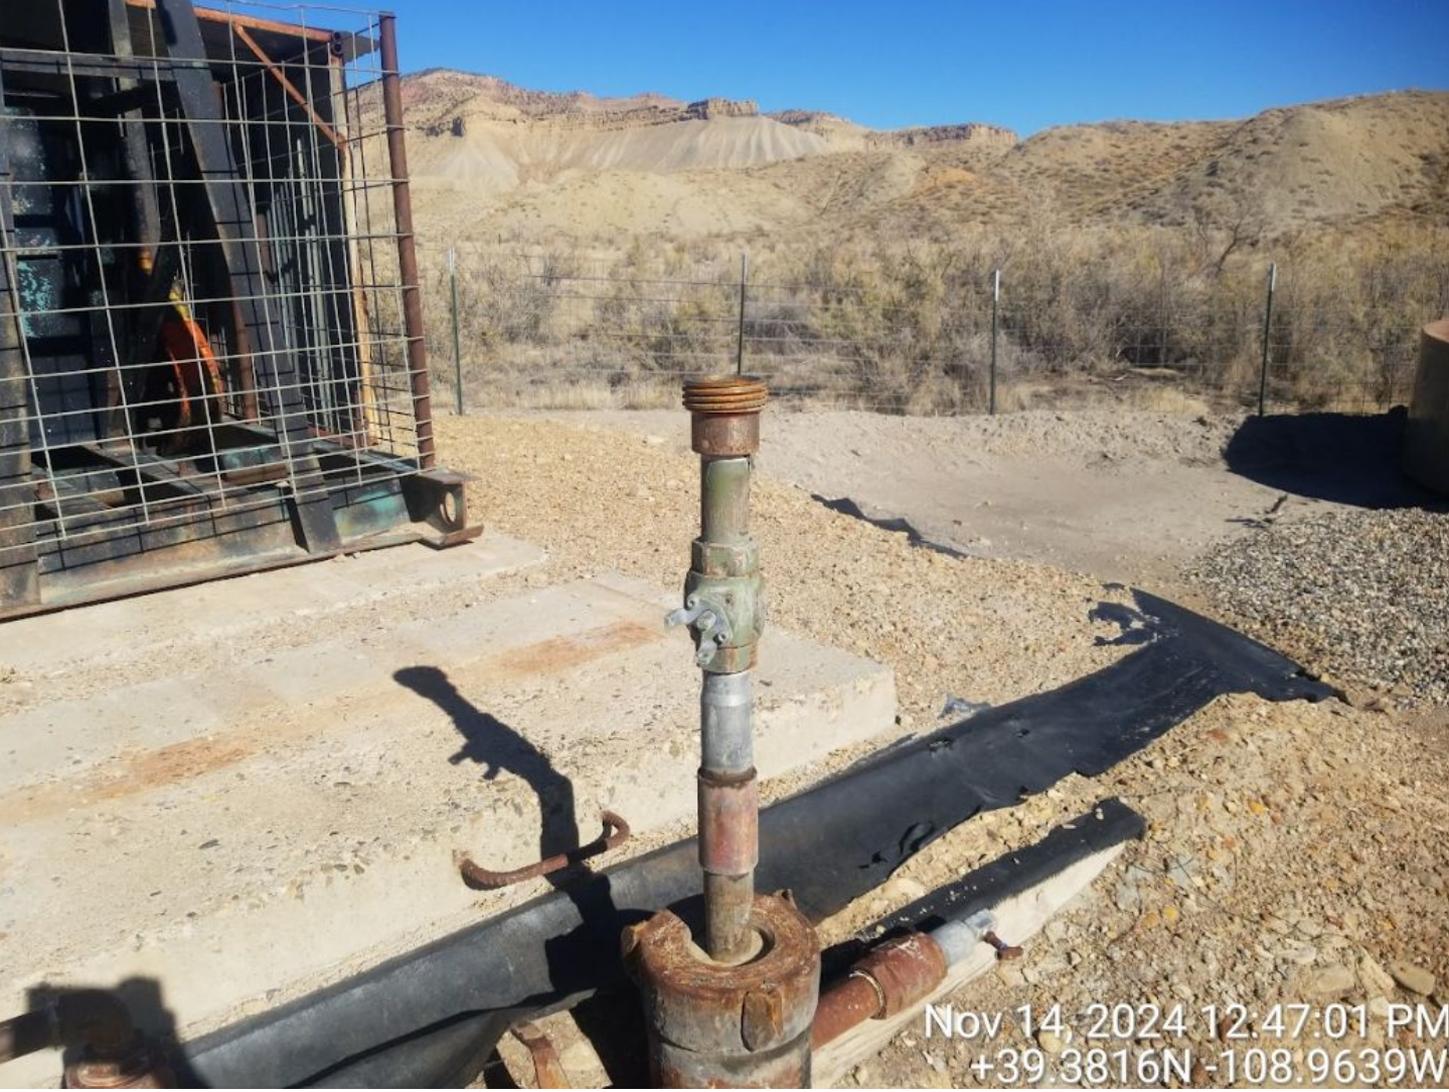
Location of the active gas leak originating from the wellhead.

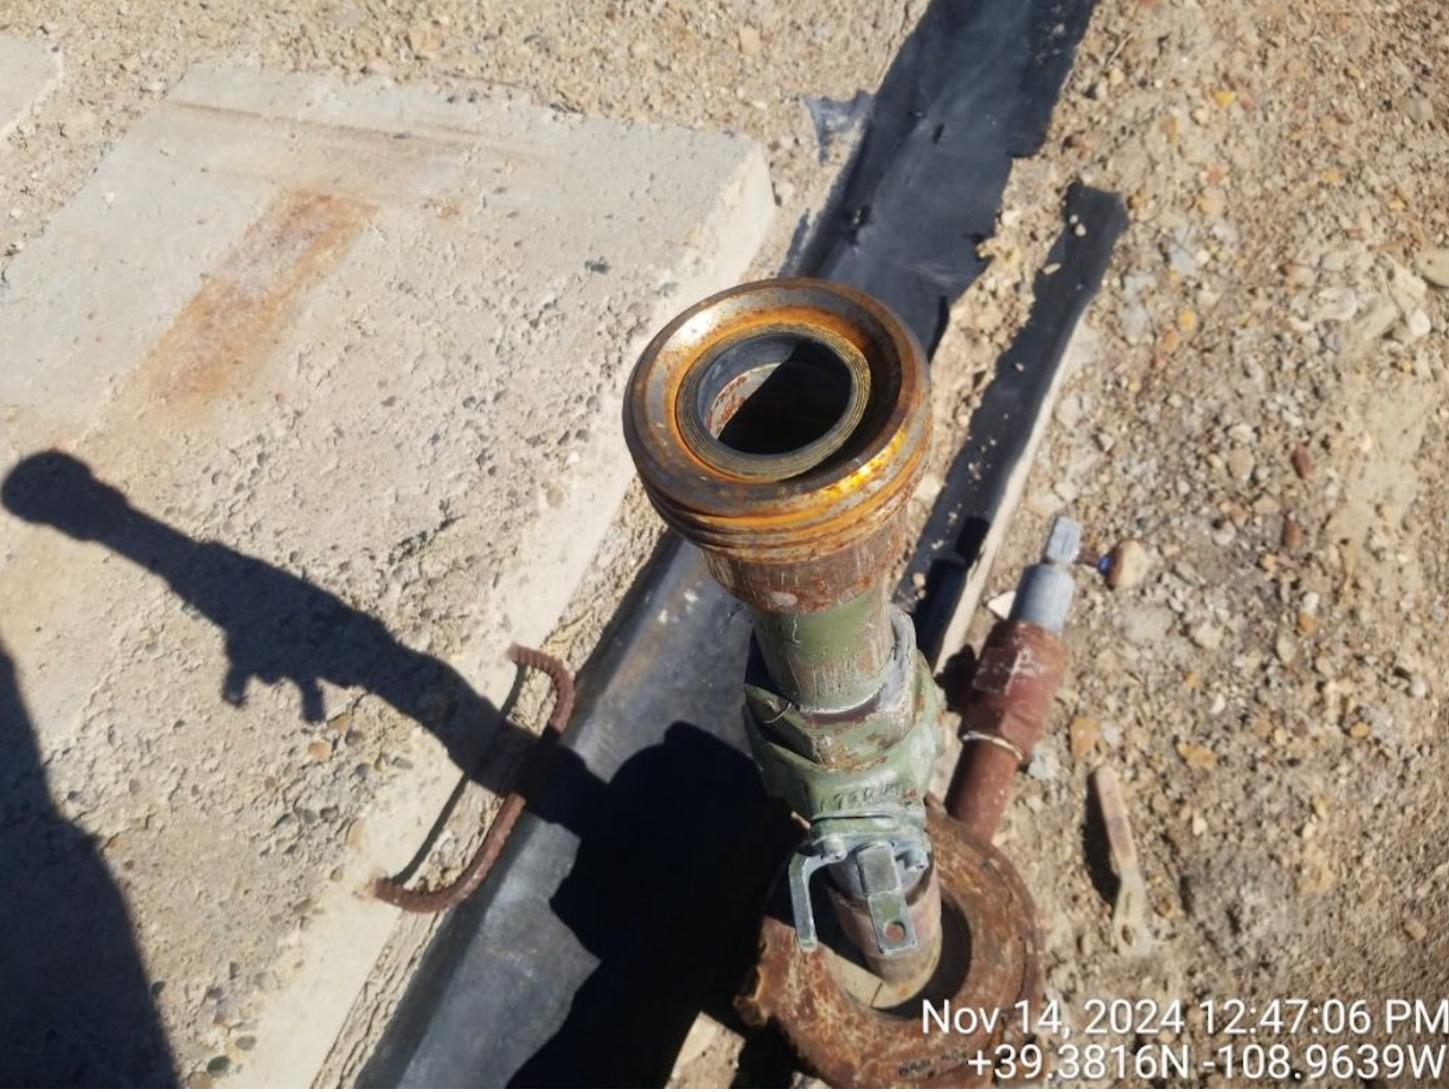
Location of the active gas leak originating from the wellhead.

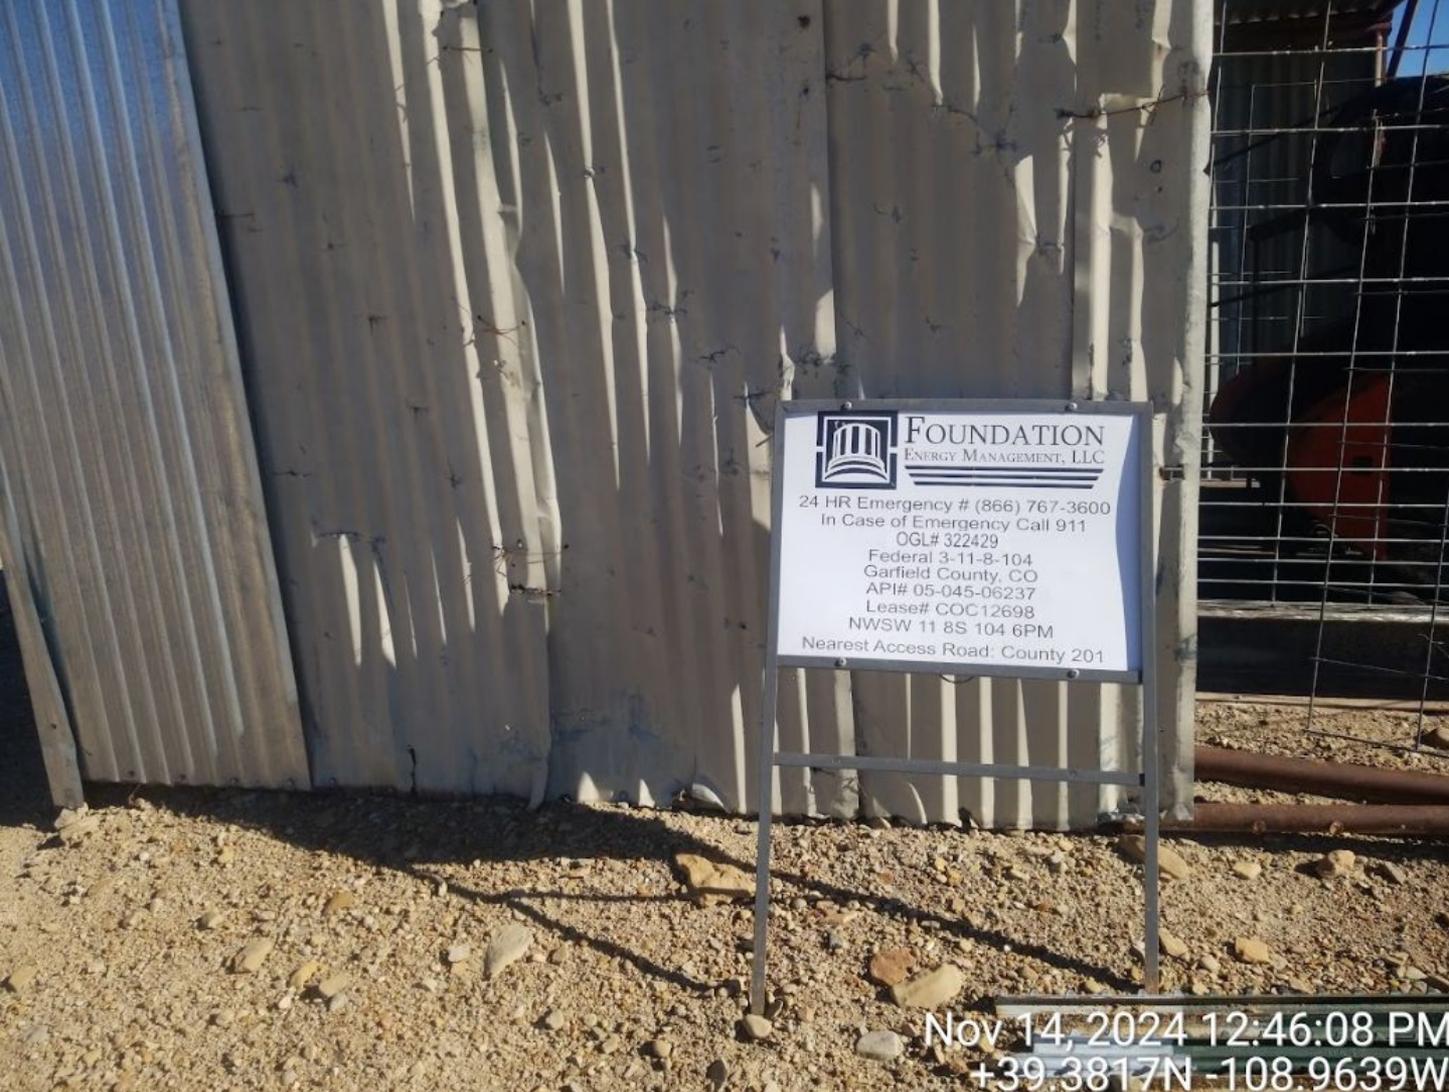
Wellhead sign.

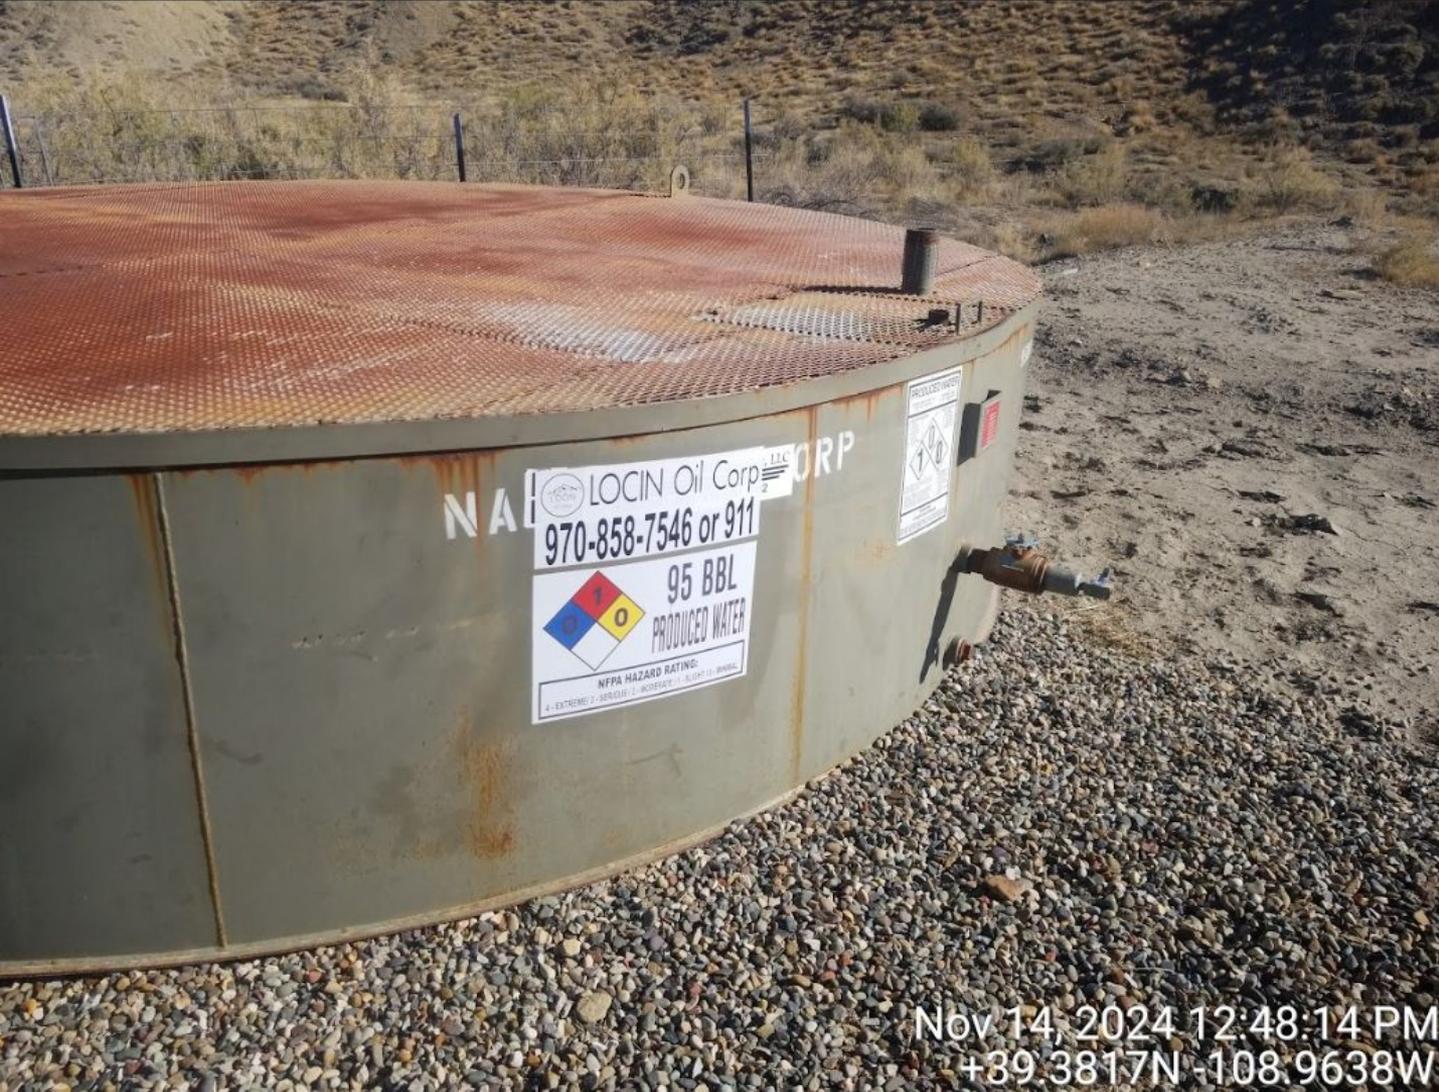
95 bbl produced water  
steel AST.

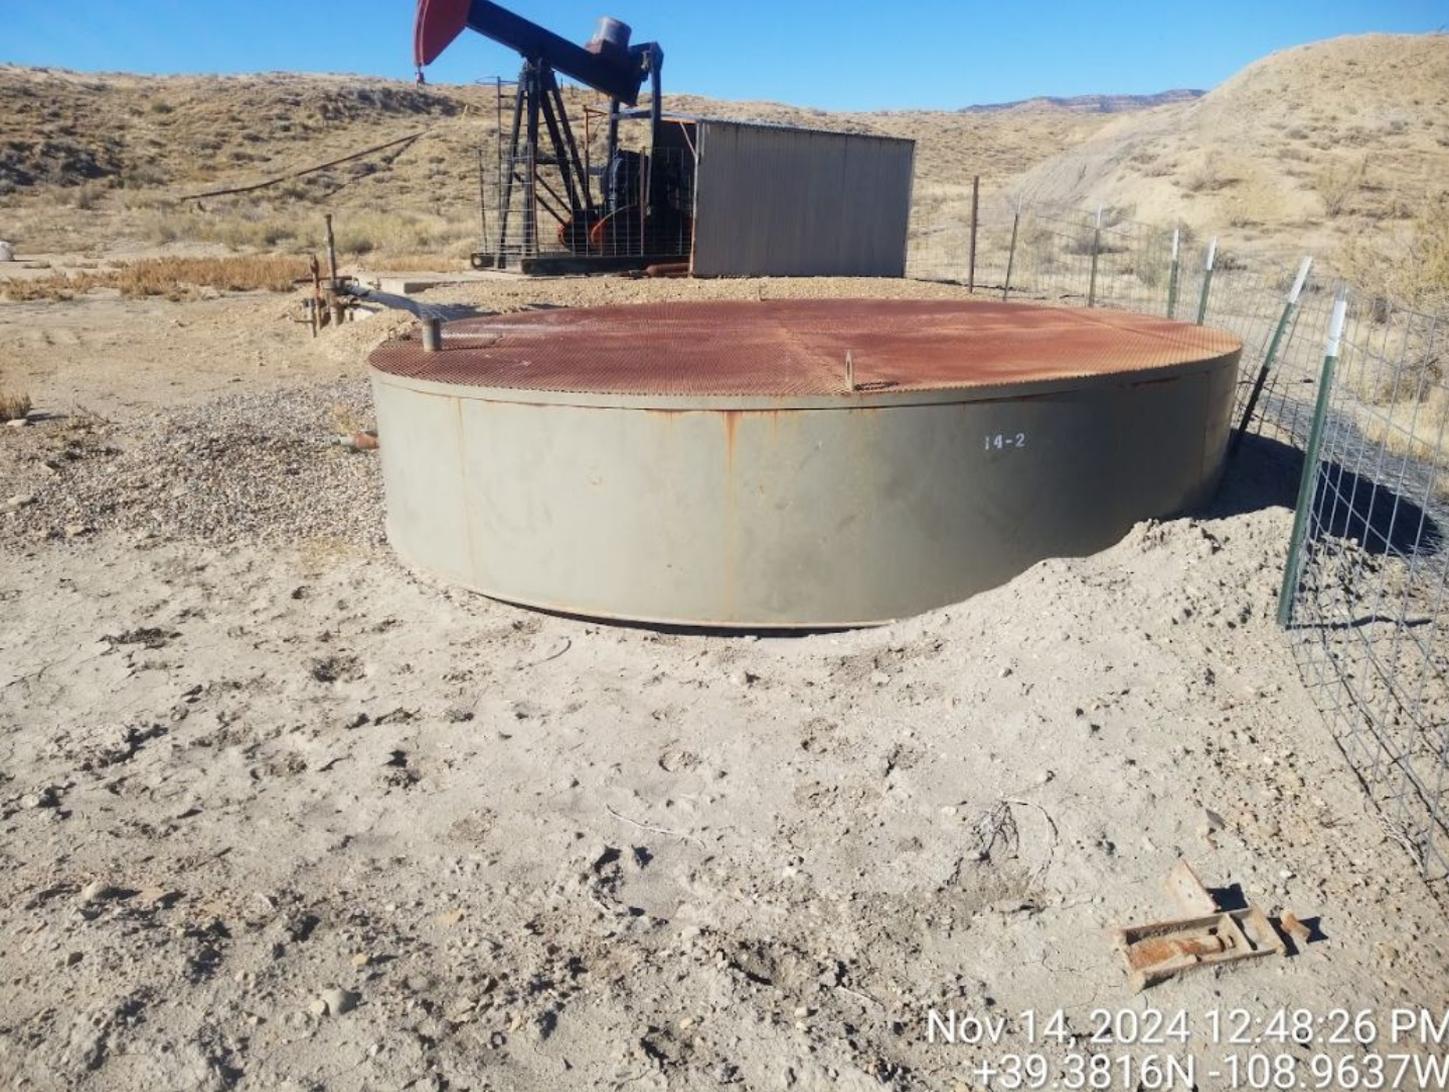
95 bbl produced water  
steel AST, inadequate  
secondary containment  
structure.

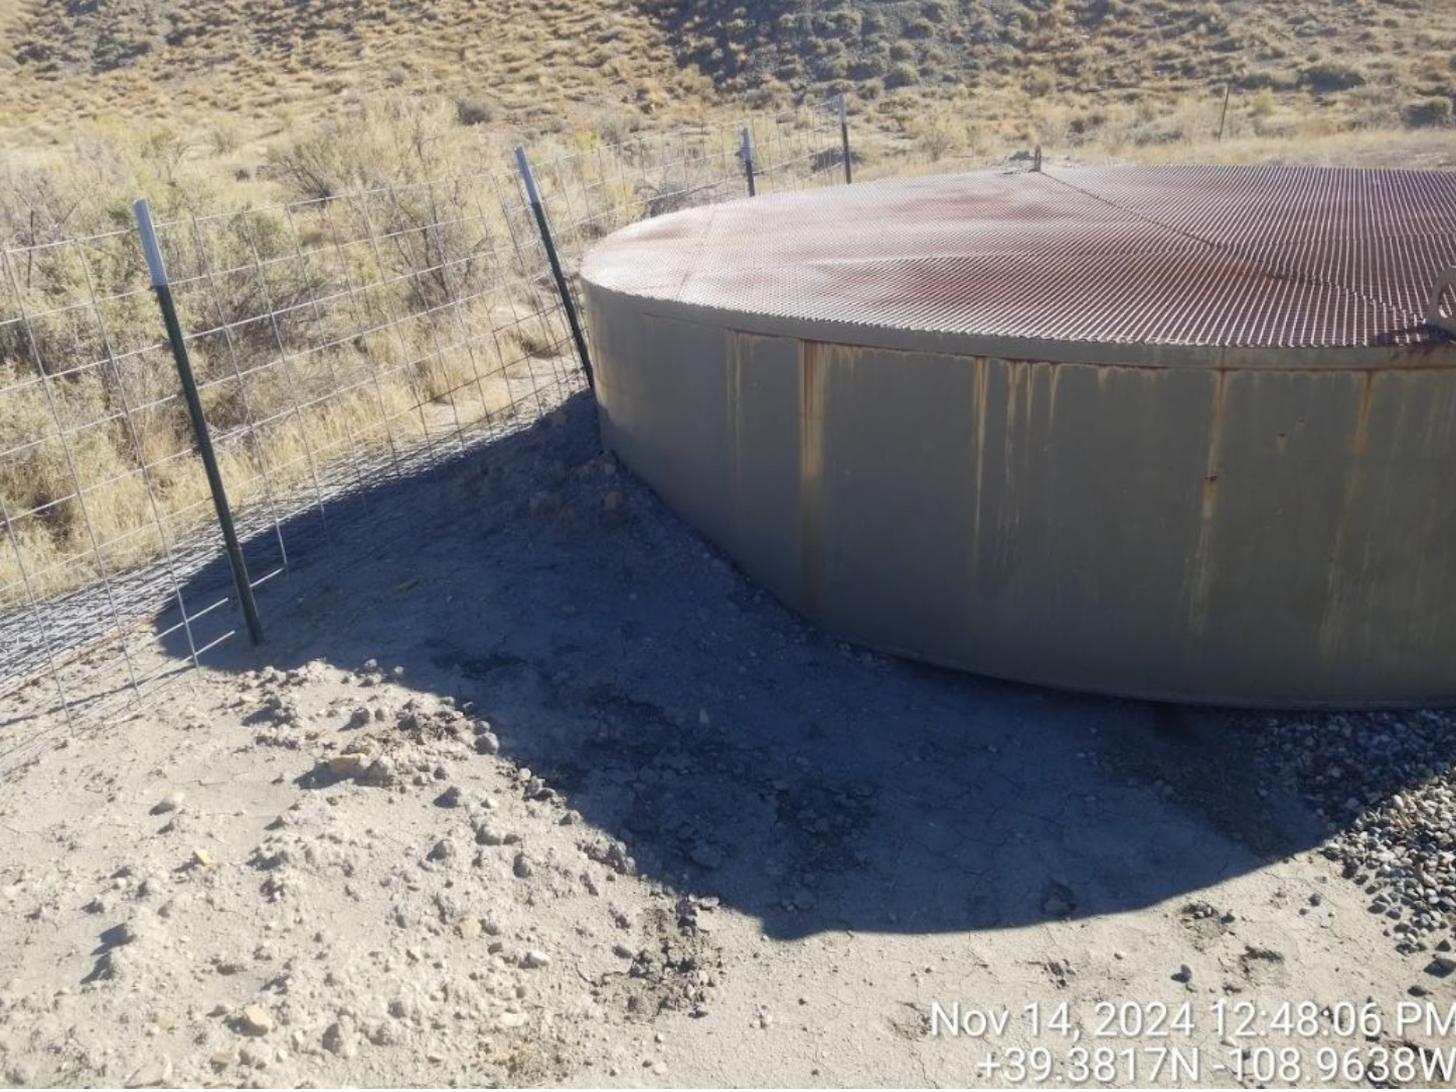
95 bbl produced water  
steel AST, inadequate  
secondary containment  
structure.

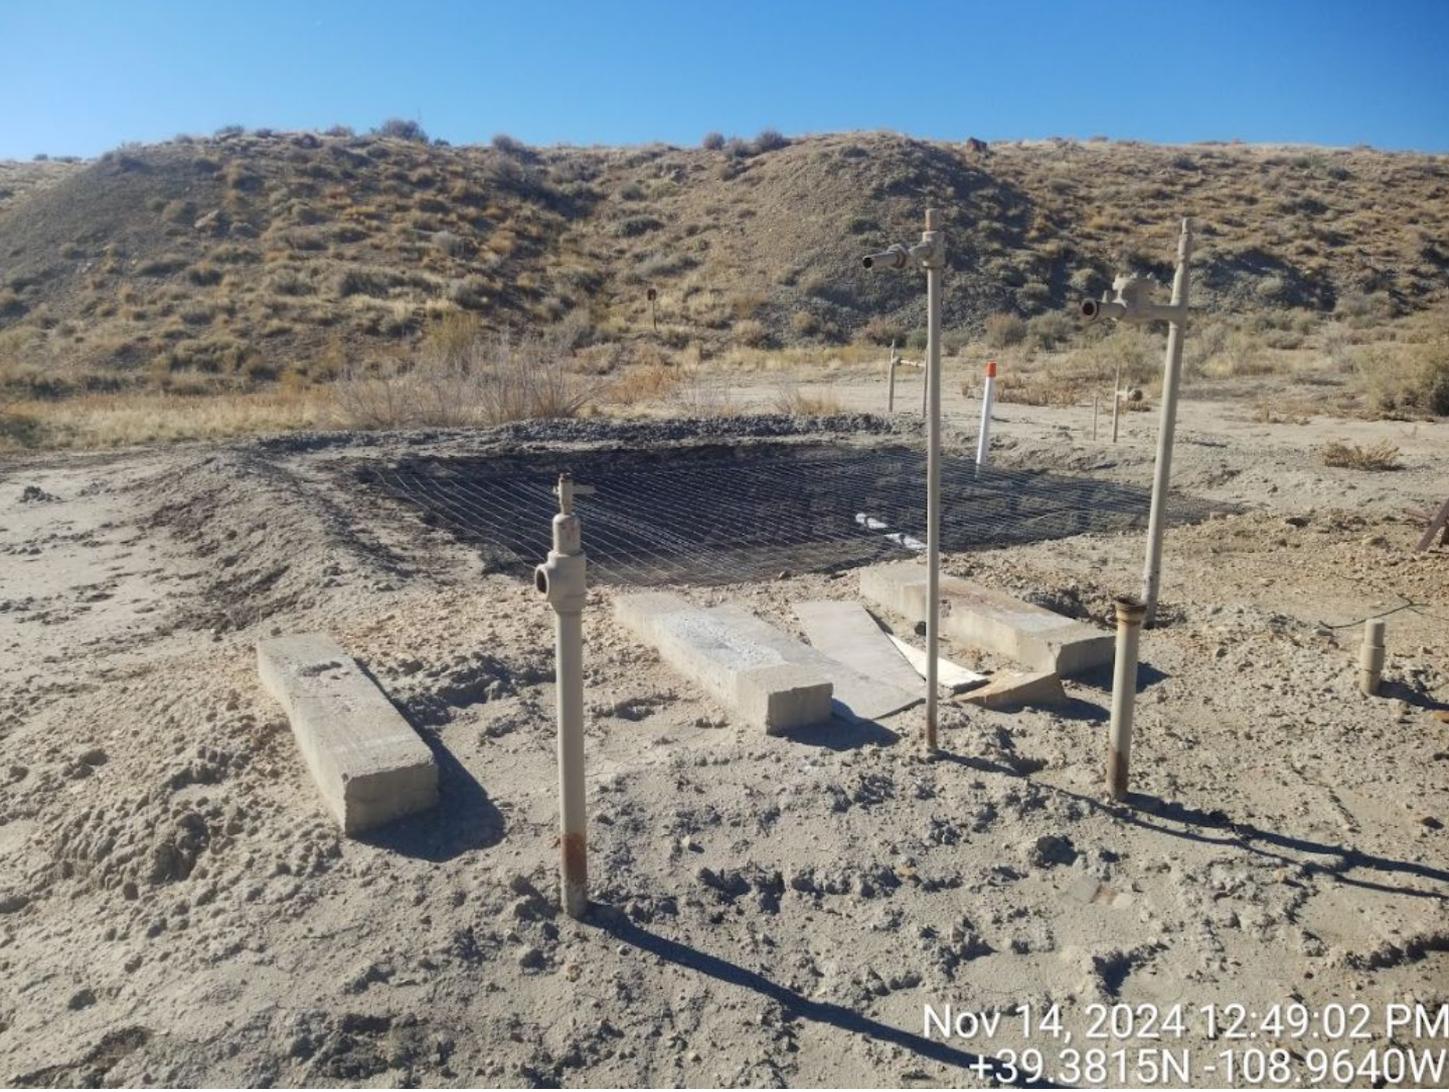
Flowlines or crude oil transfer lines not maintained to prevent failures. Valves not locked and tagged out.

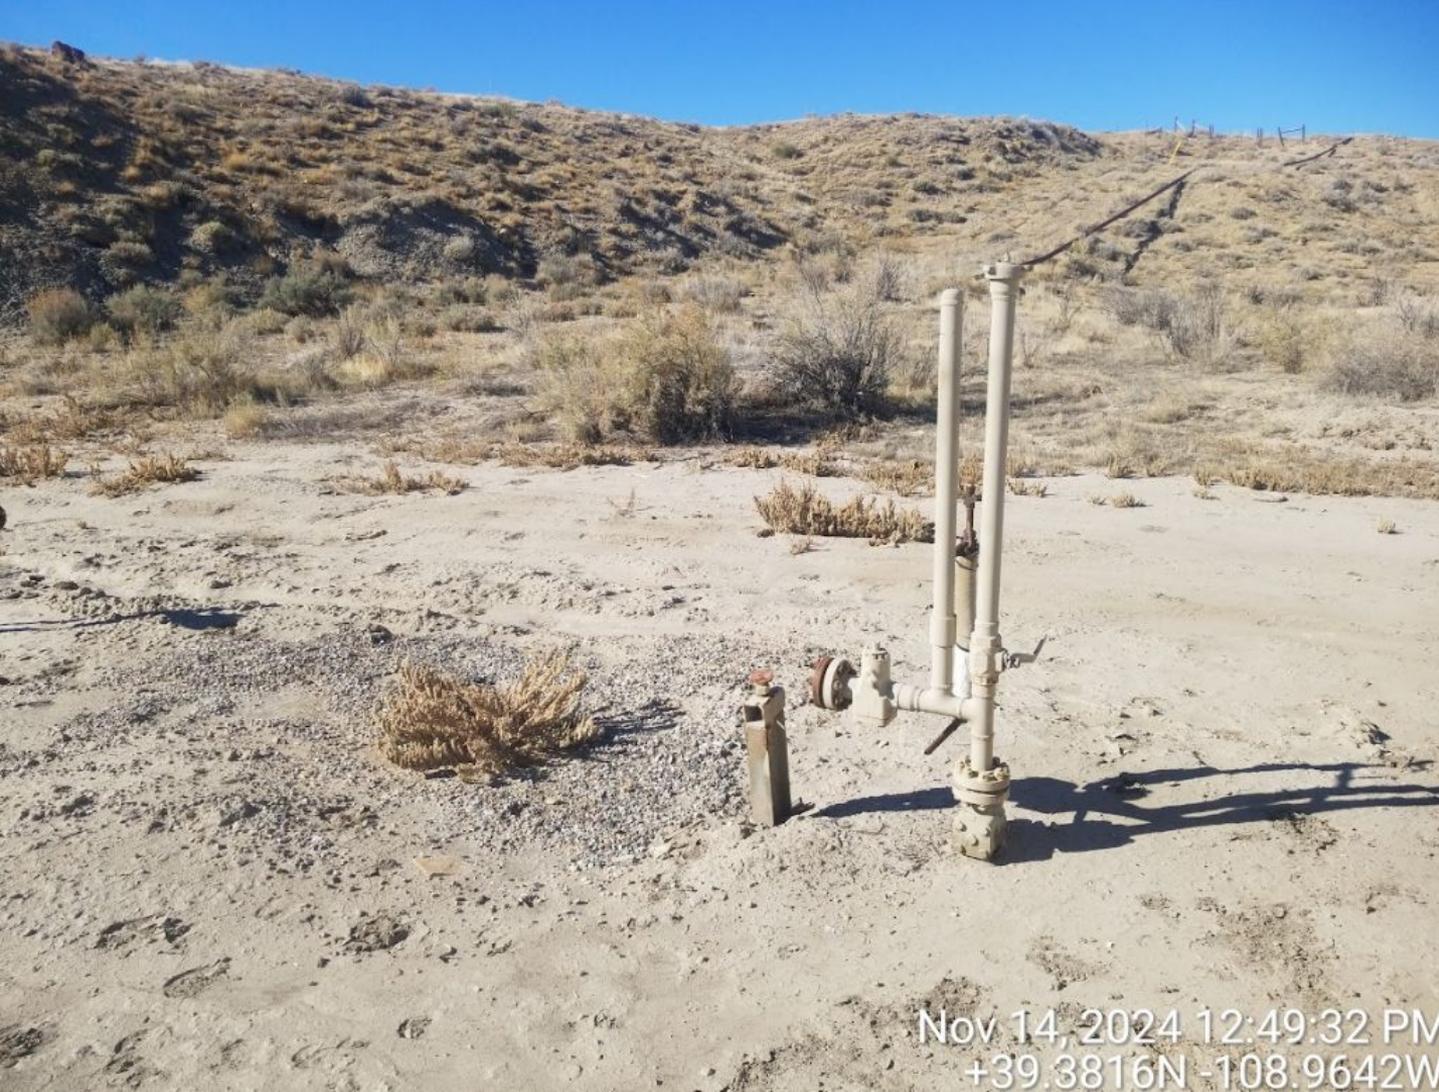
Flowlines or crude oil transfer lines not maintained to prevent failures. Valves not locked and tagged out.

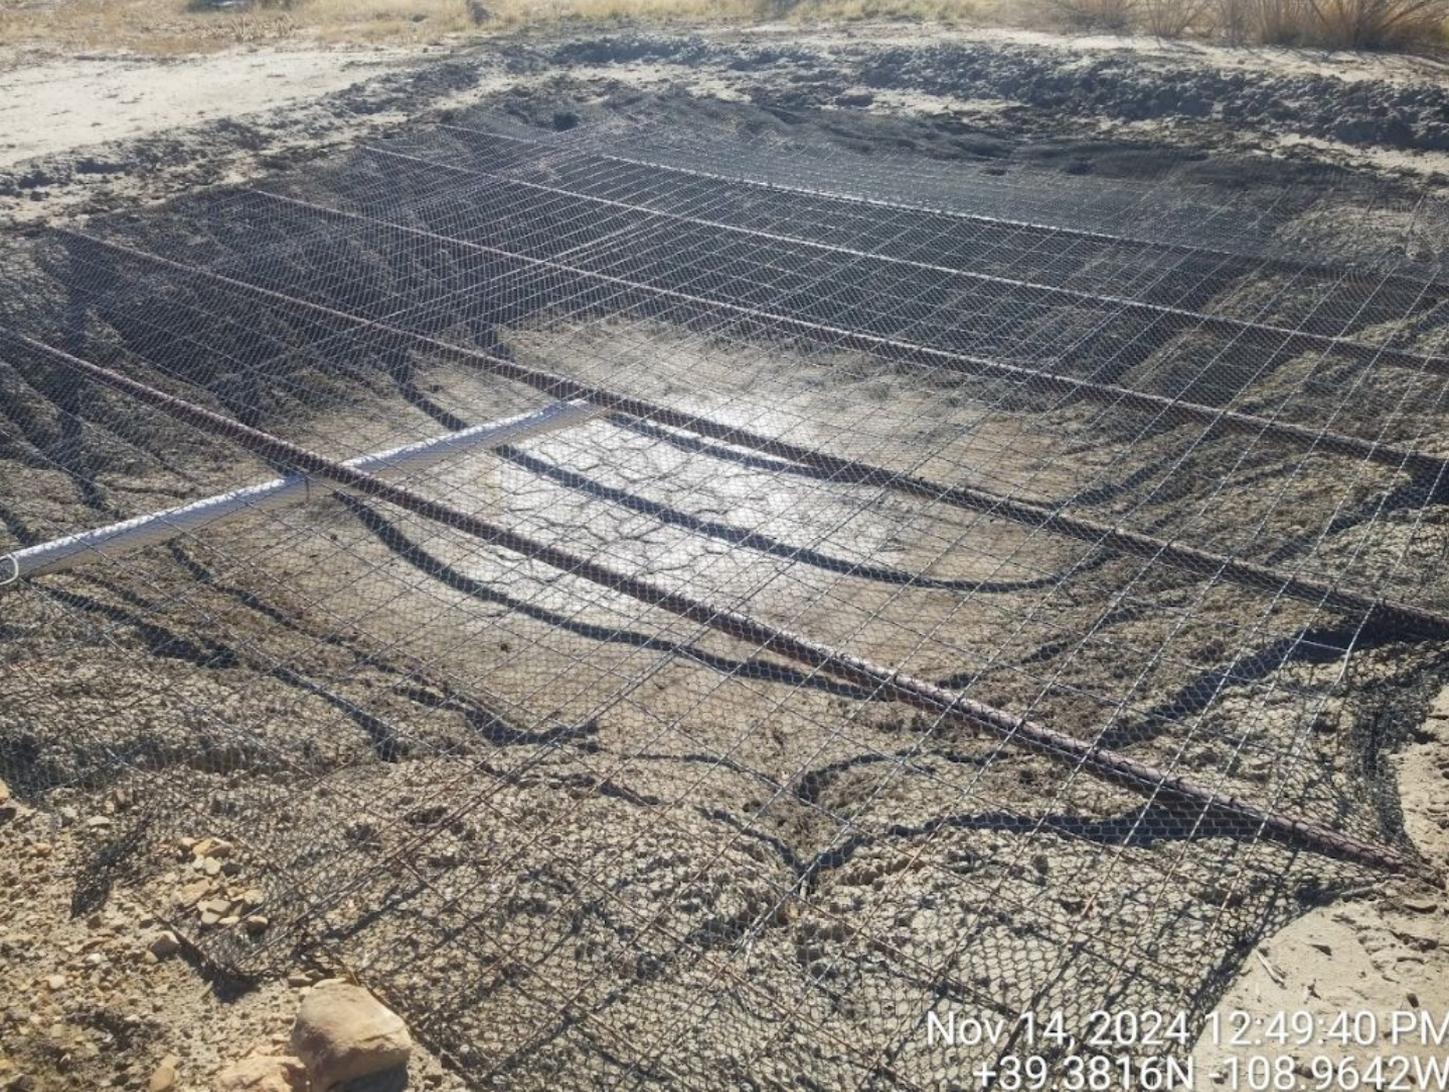
Earthen produced water  
pit.
