Inspection Photos

Operator: Petrox Resources Inc. - 69805

Location ID: 378718

Inspection Photos
Location Name: Wright 33-5 16-1
Location ID: 378718

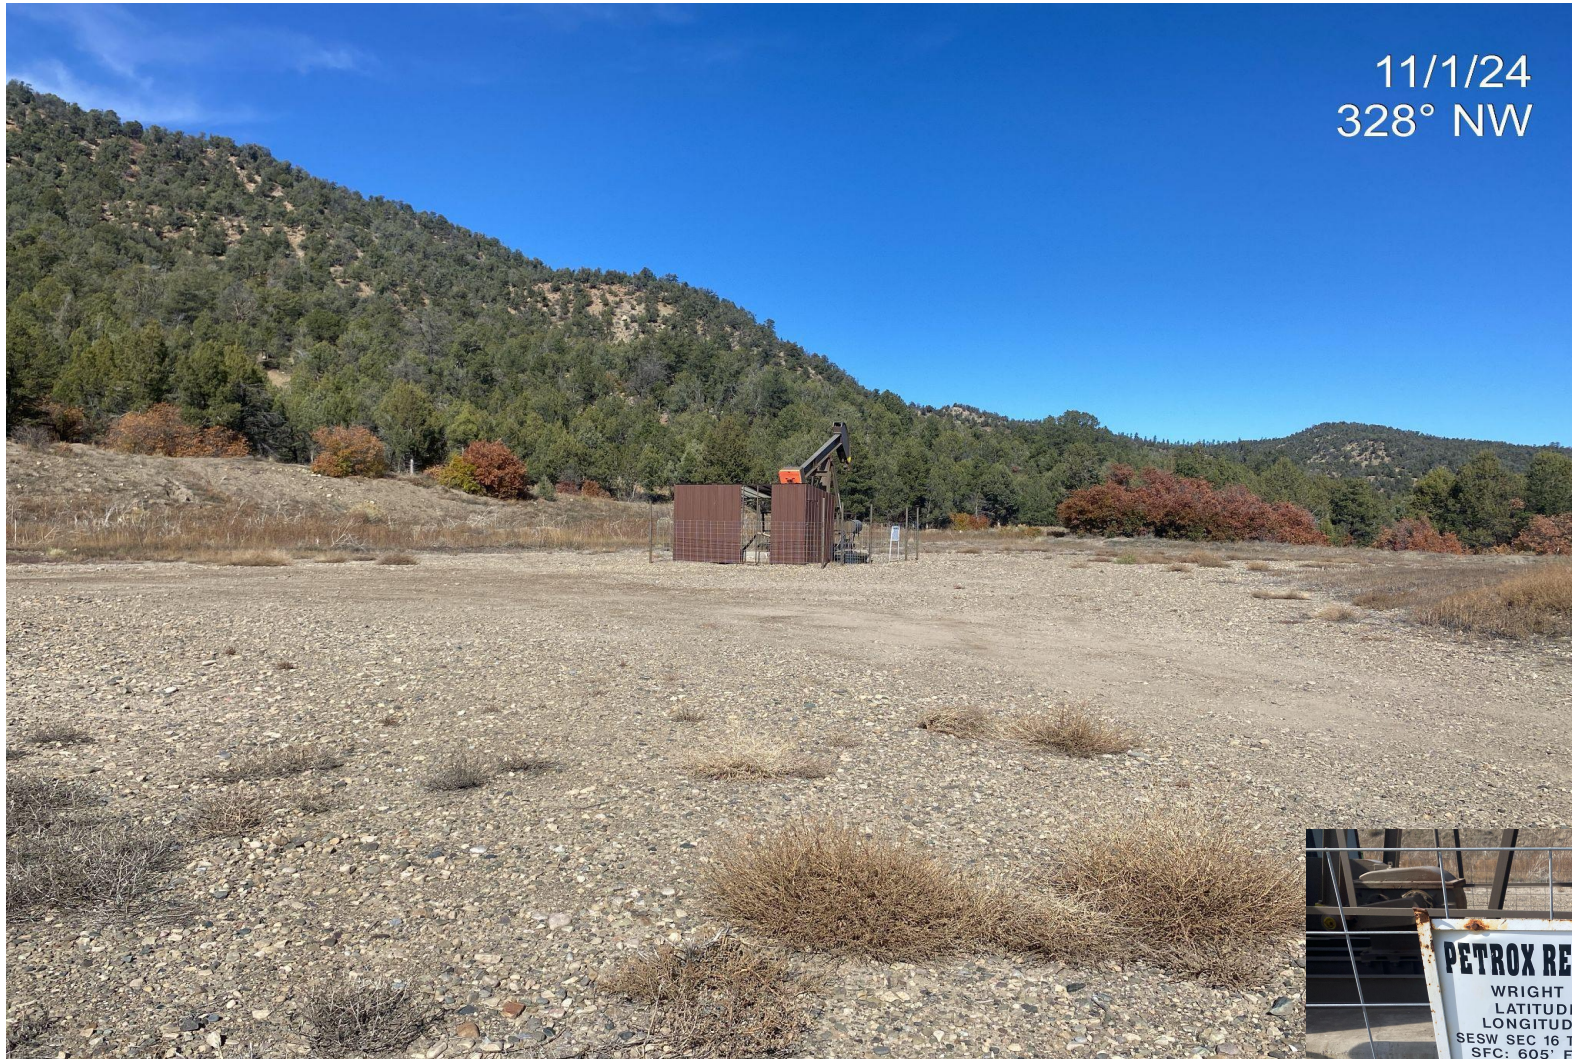
Photo 1. View of the well disturbance taken from the access point facing center. Local emergency # missing from well signage.

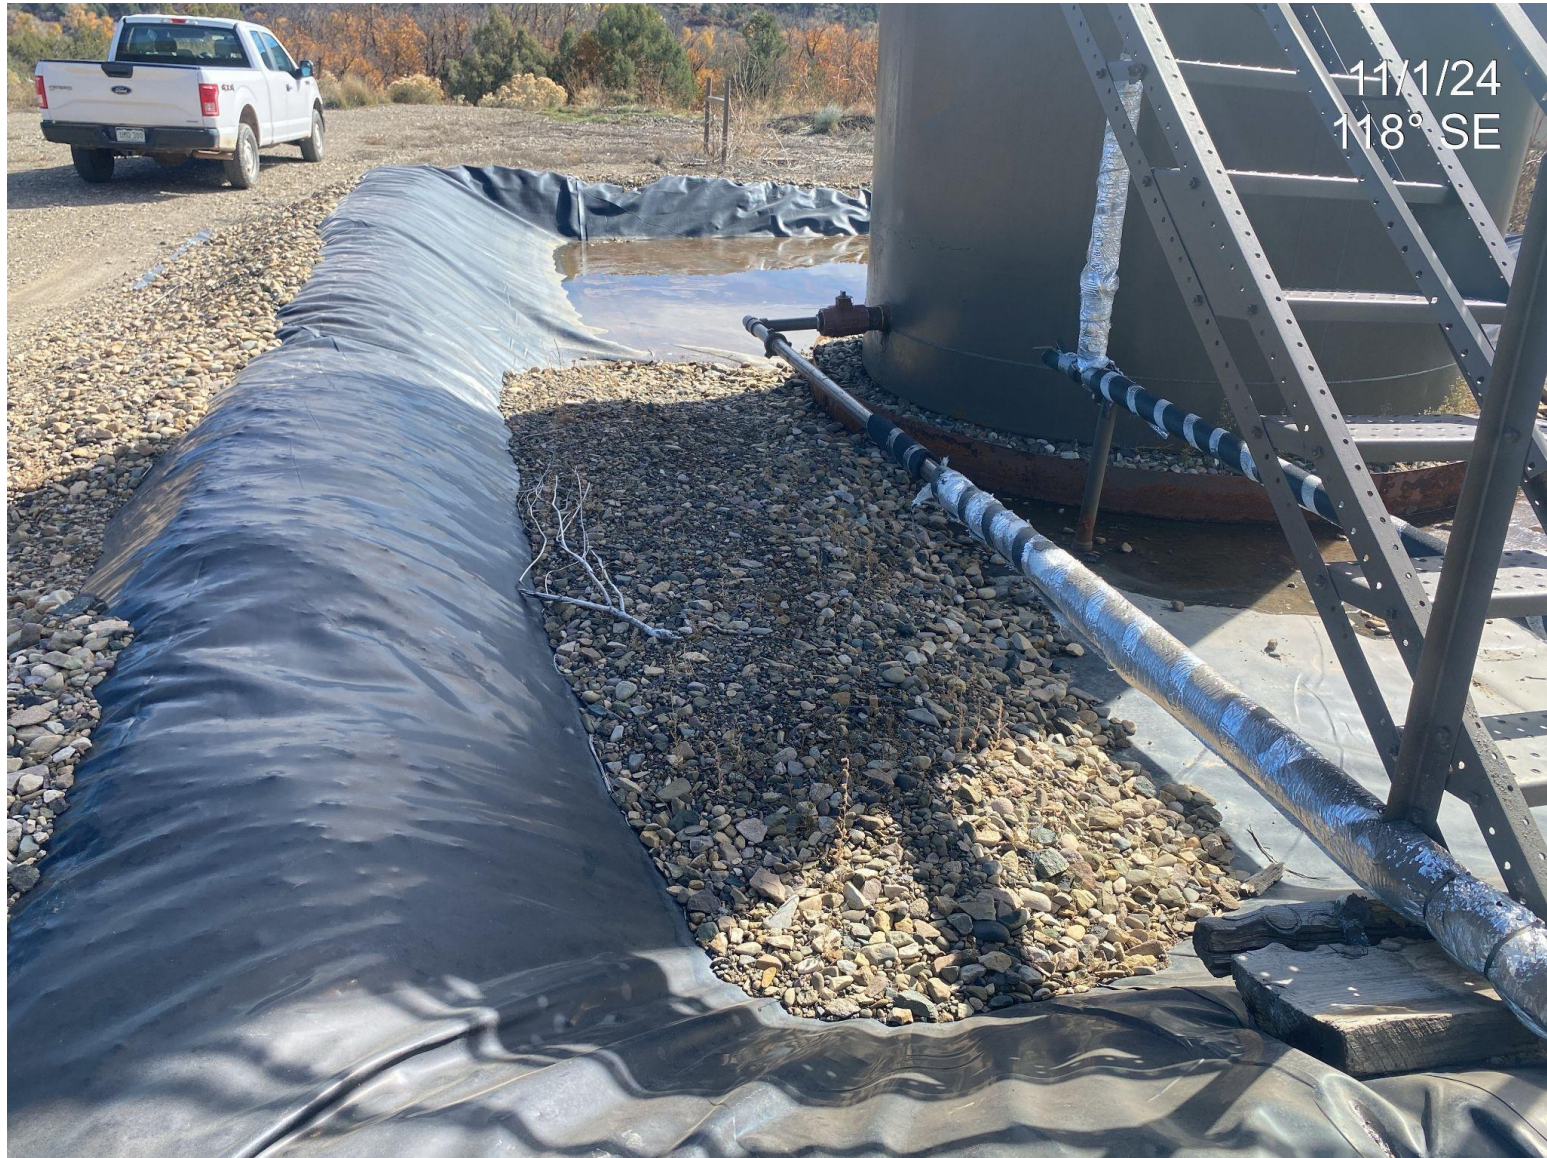
Photo 2. Gravel in produced water tank secondary containment which is affecting overall capacity/volume.

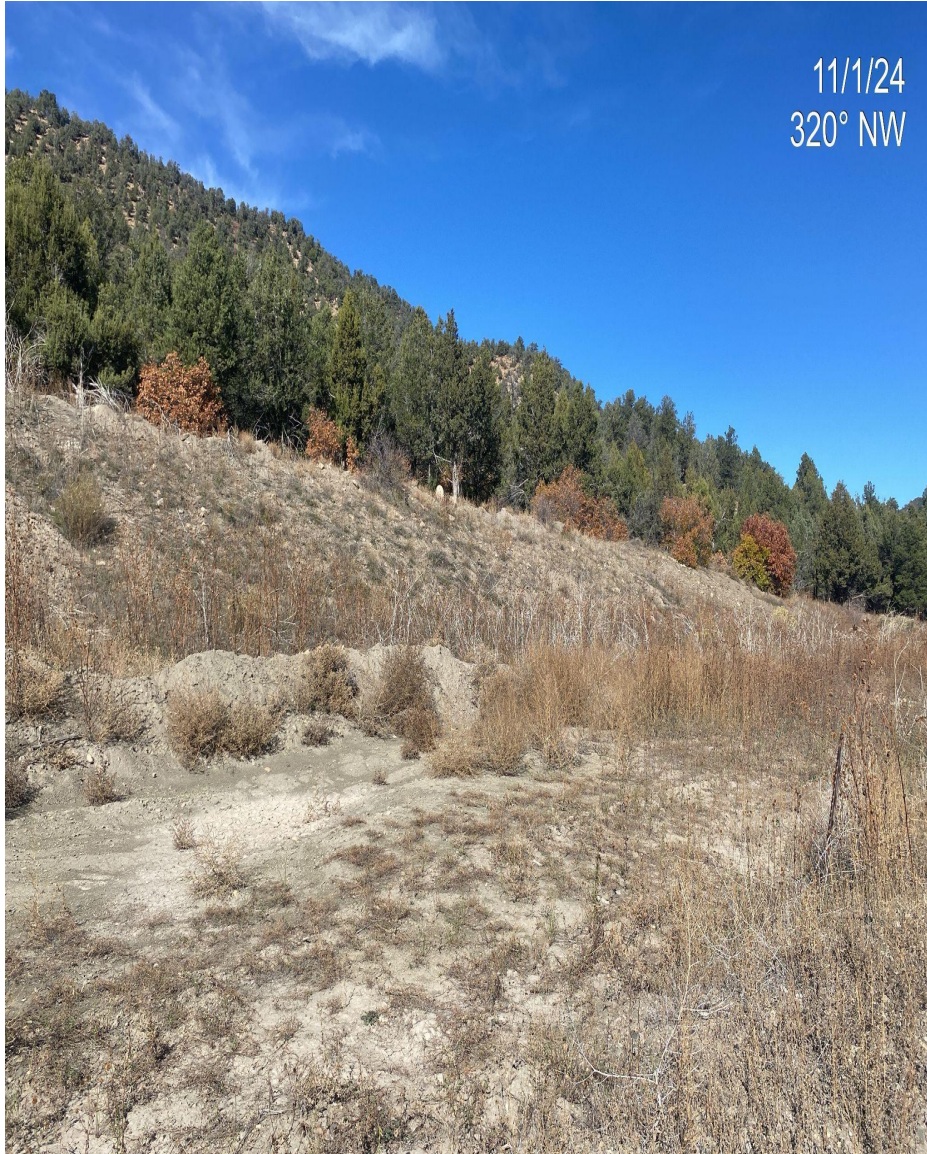
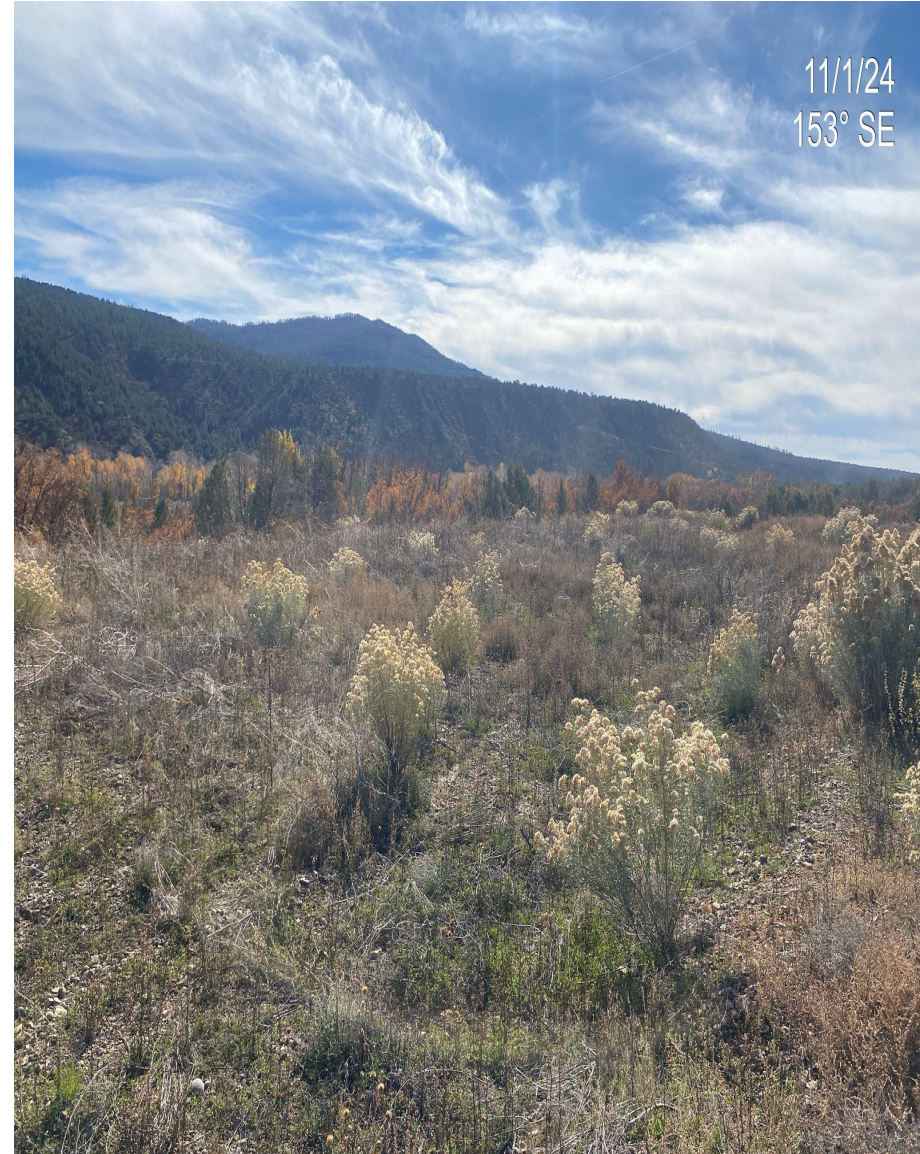
Photo 3. View of western and eastern portions of the pad which have not been interim reclaimed to 1003 standards/requirements.

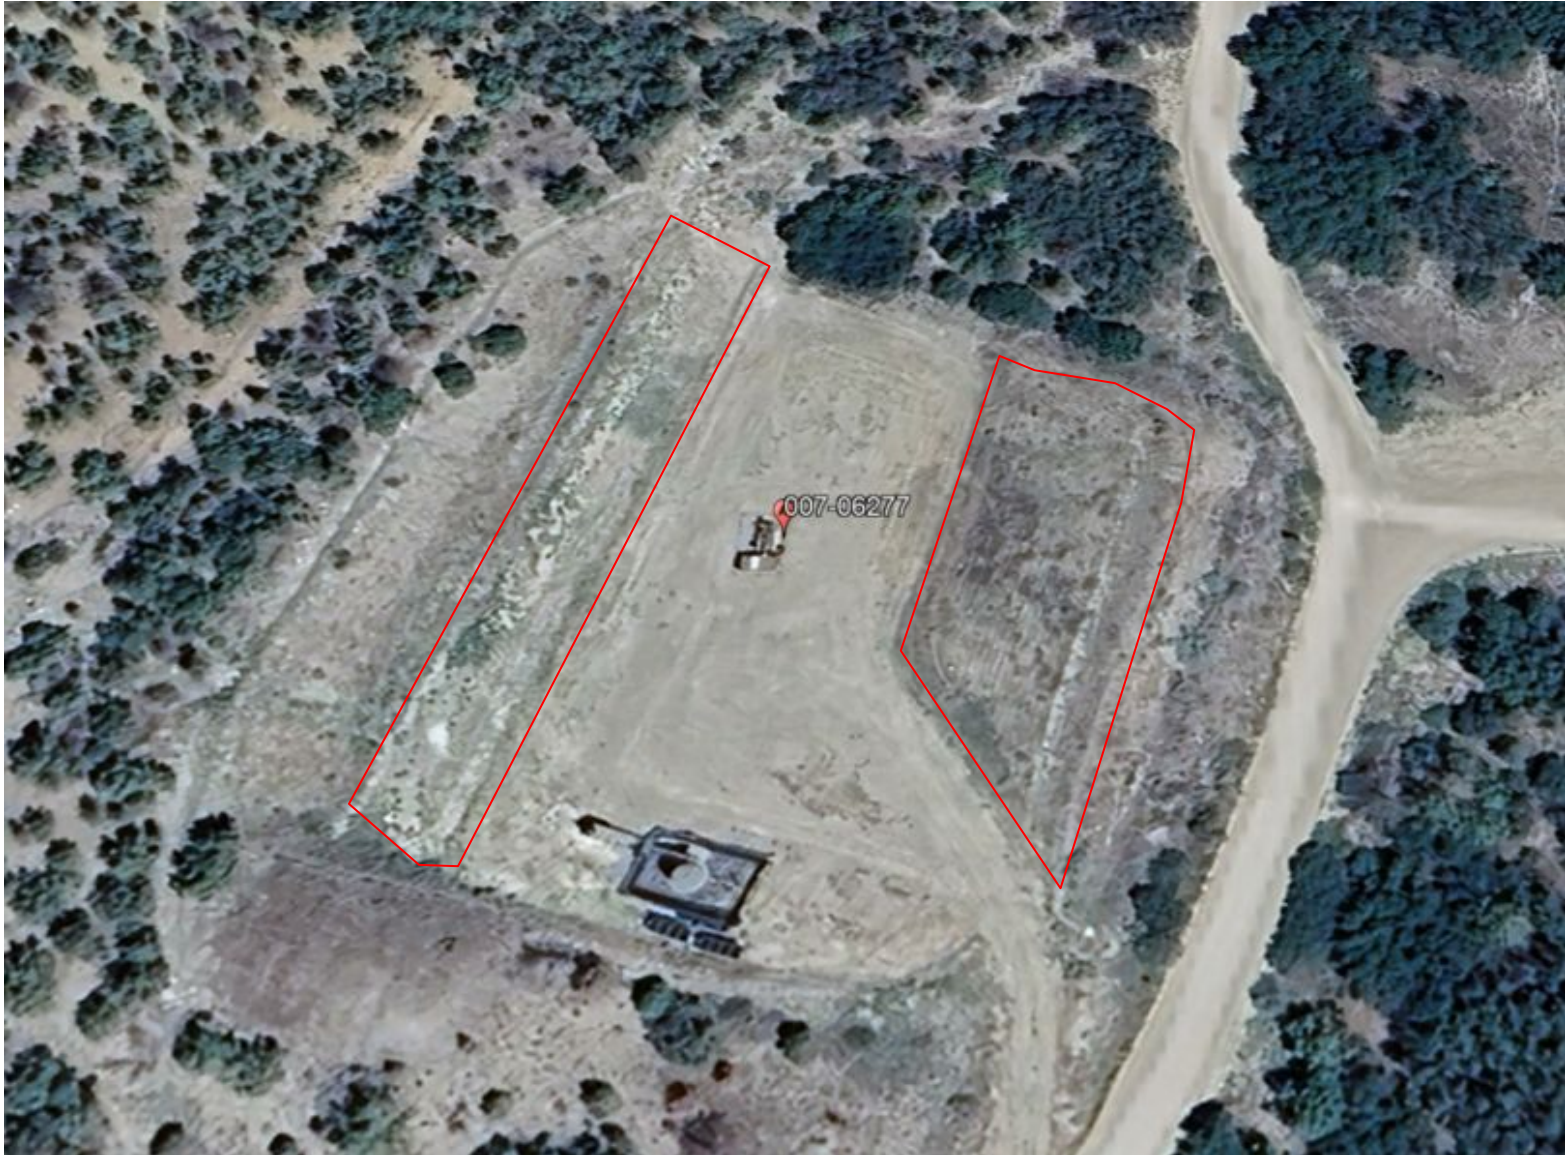
Photo 4. 2024 aerial imagery of areas on well pad which have not been reclaimed per 1003 requirements/standards.

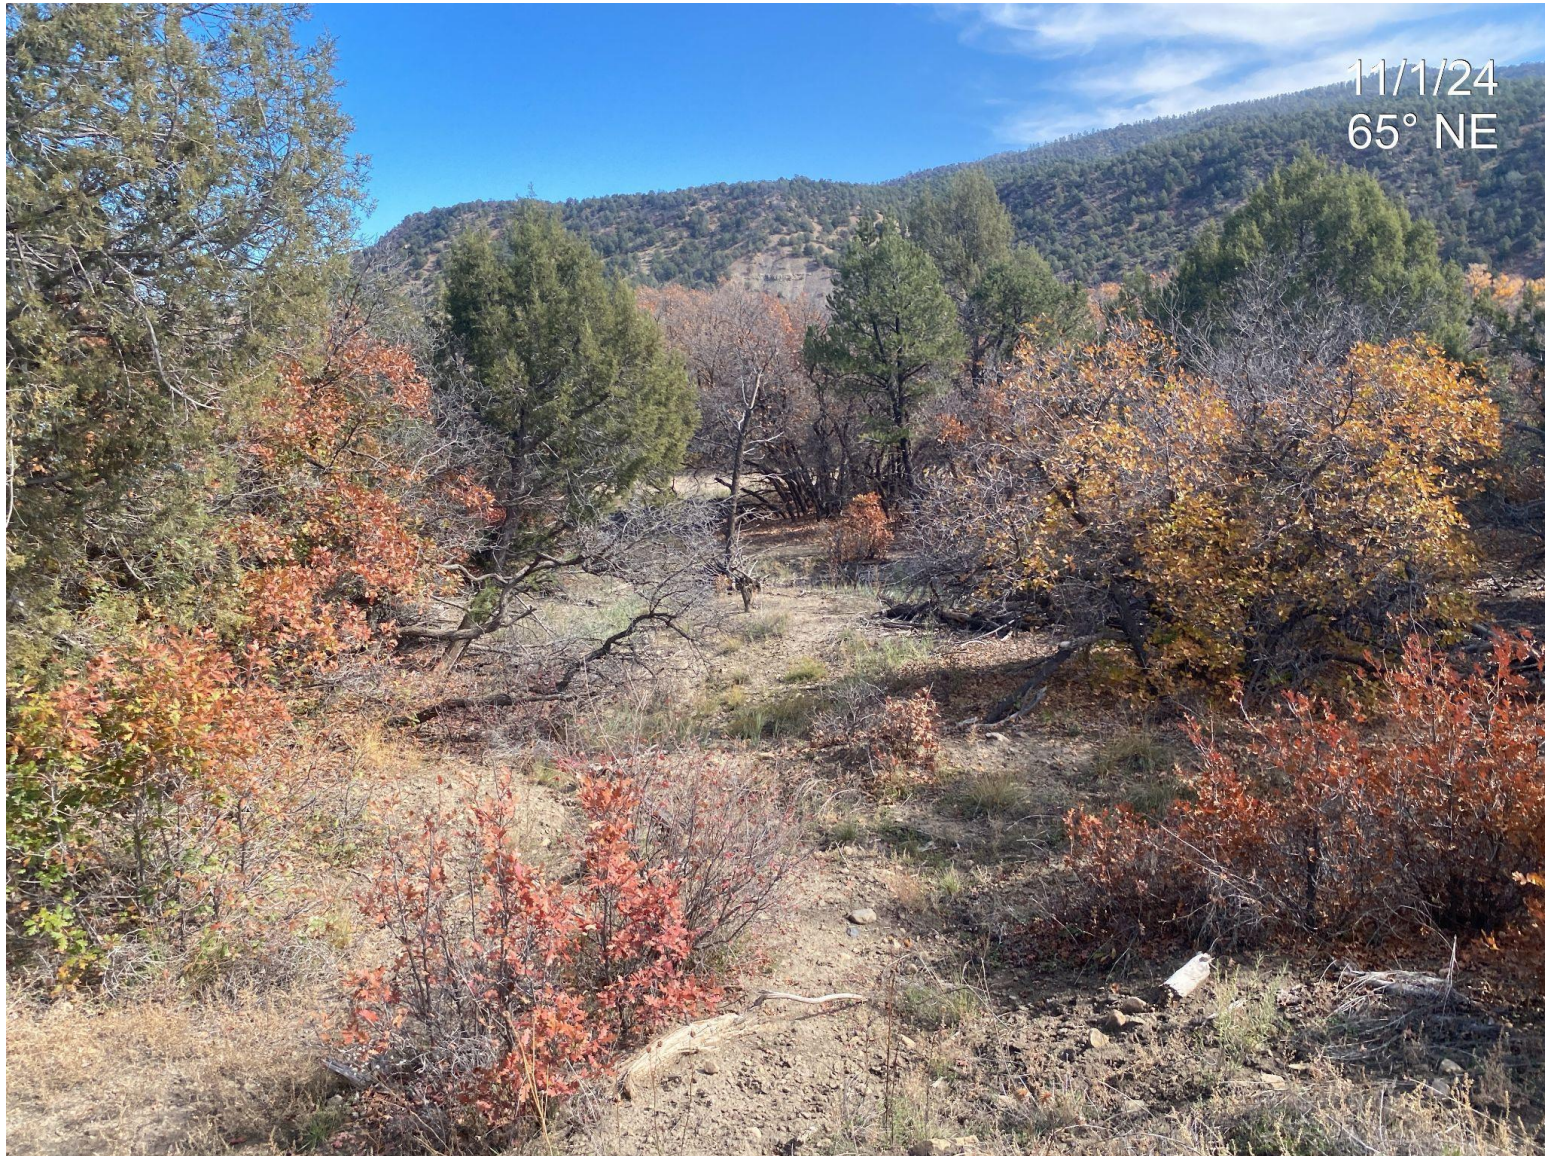
Photo 5. Reference area composed of Juniper, Gambel Oak and Indian Ricegrass.
