# Inspection Photos

Operator: Hilcorp Energy Company - 10133

Location ID: 443138

Inspection Photos  
Location Name: Anderson 3-5H  
Location ID: 443138

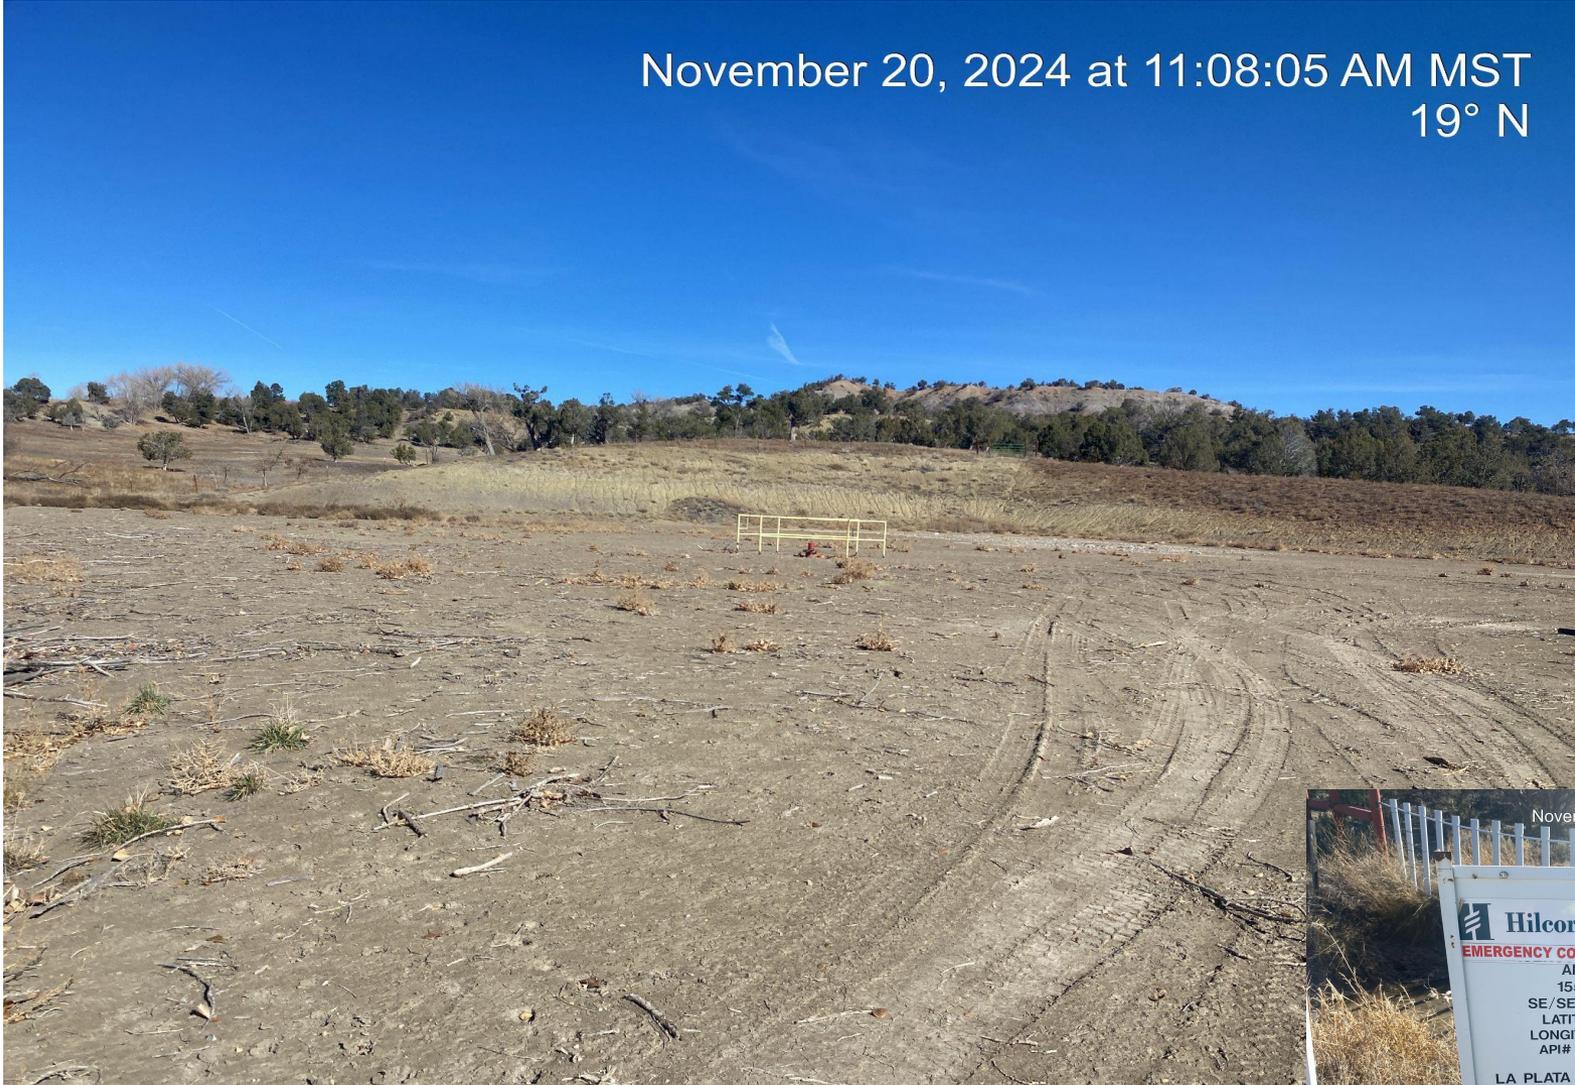
**Photo 1.** View of the well disturbance taken from the access point facing center.

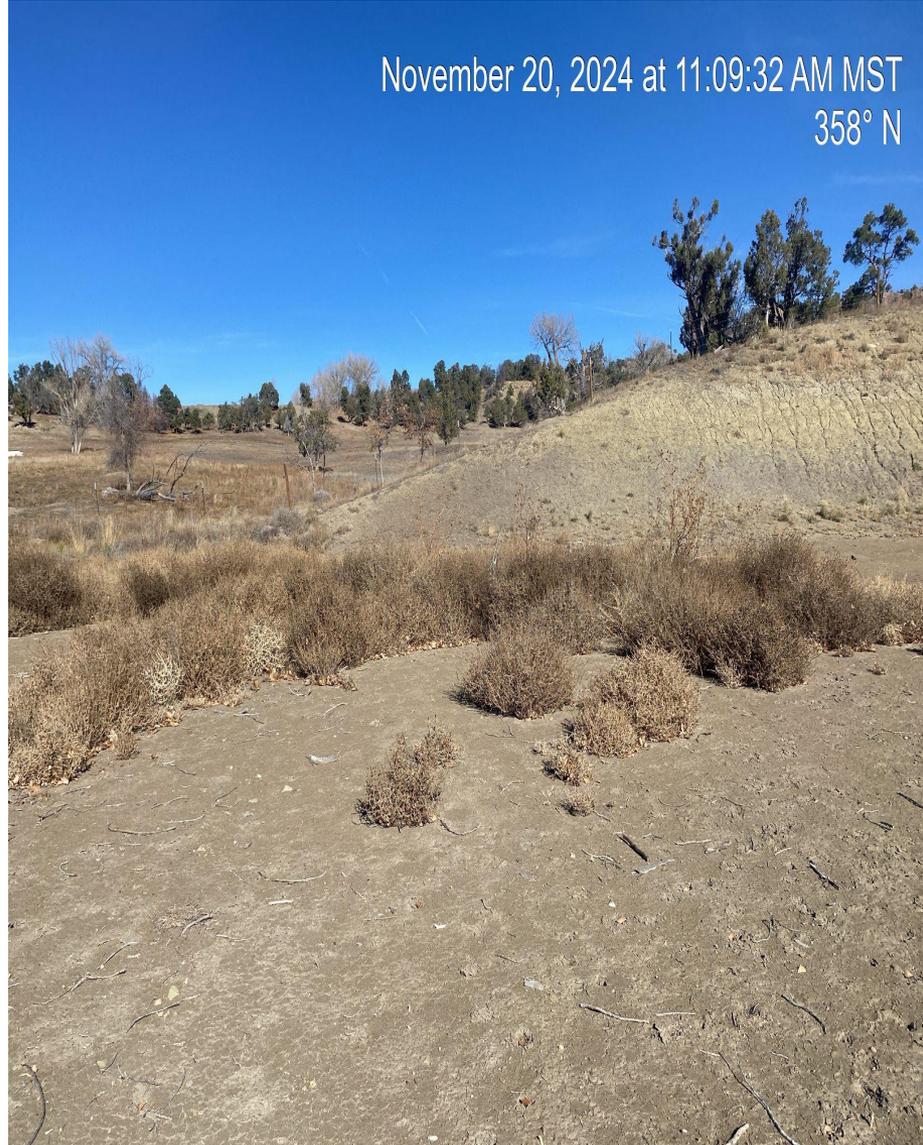
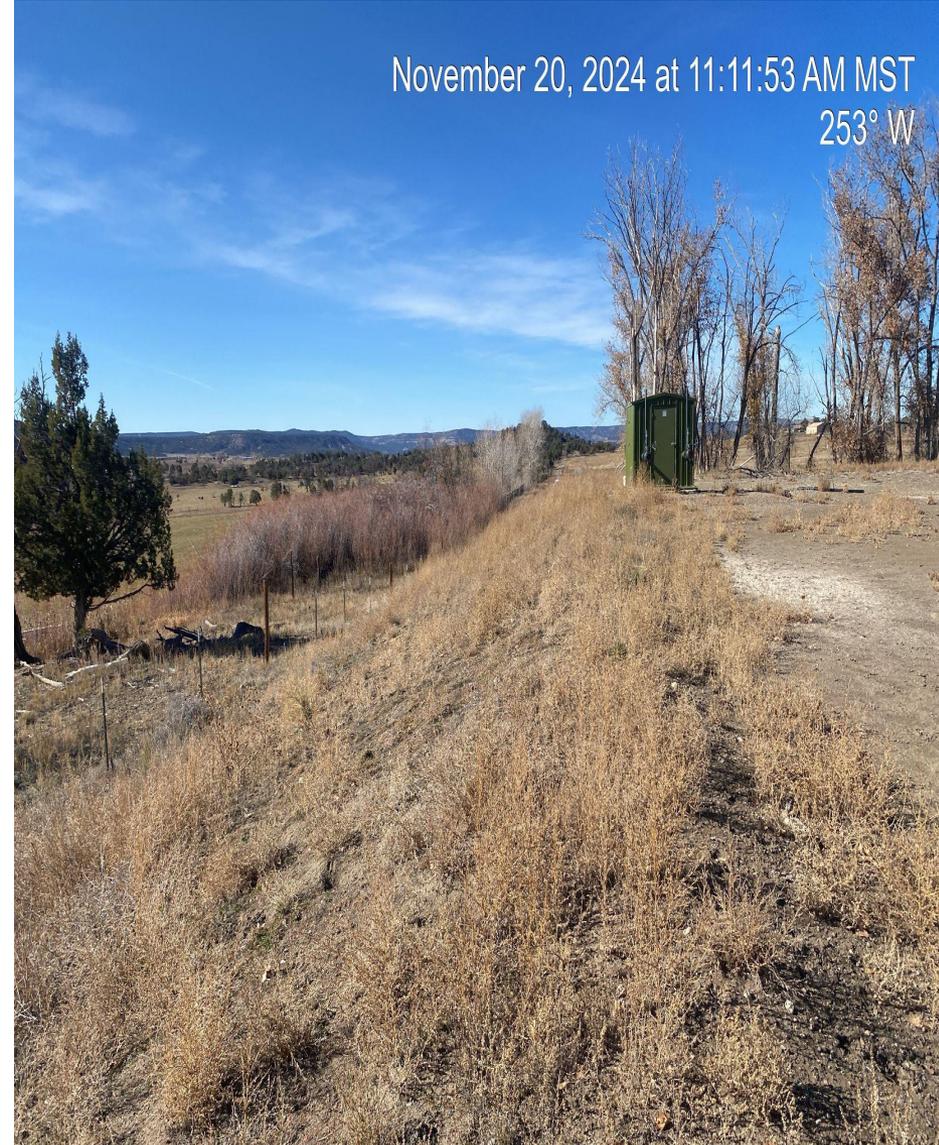
**Photo 2.** View of weedy Russian Thistle Debris and Kochia observed on the active pad and within southern fill slope area.

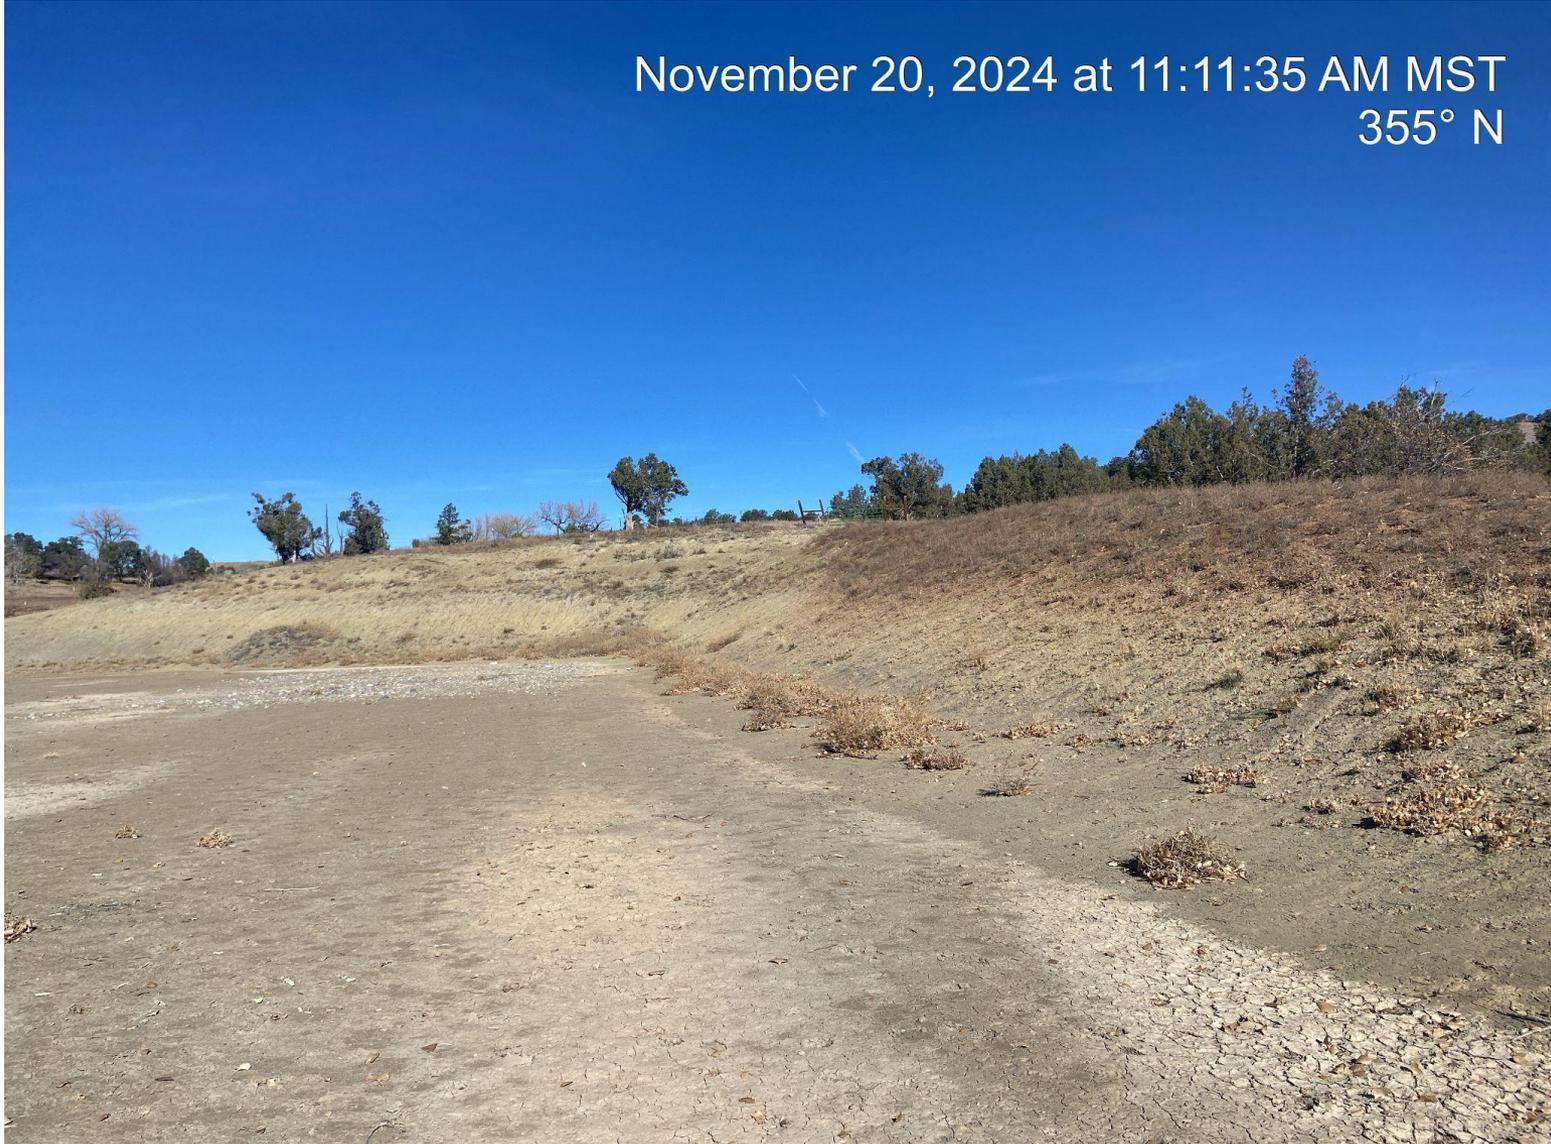
**Photo 3.** View of northern fill slope that remains with mostly bare soils and minimal vegetation.

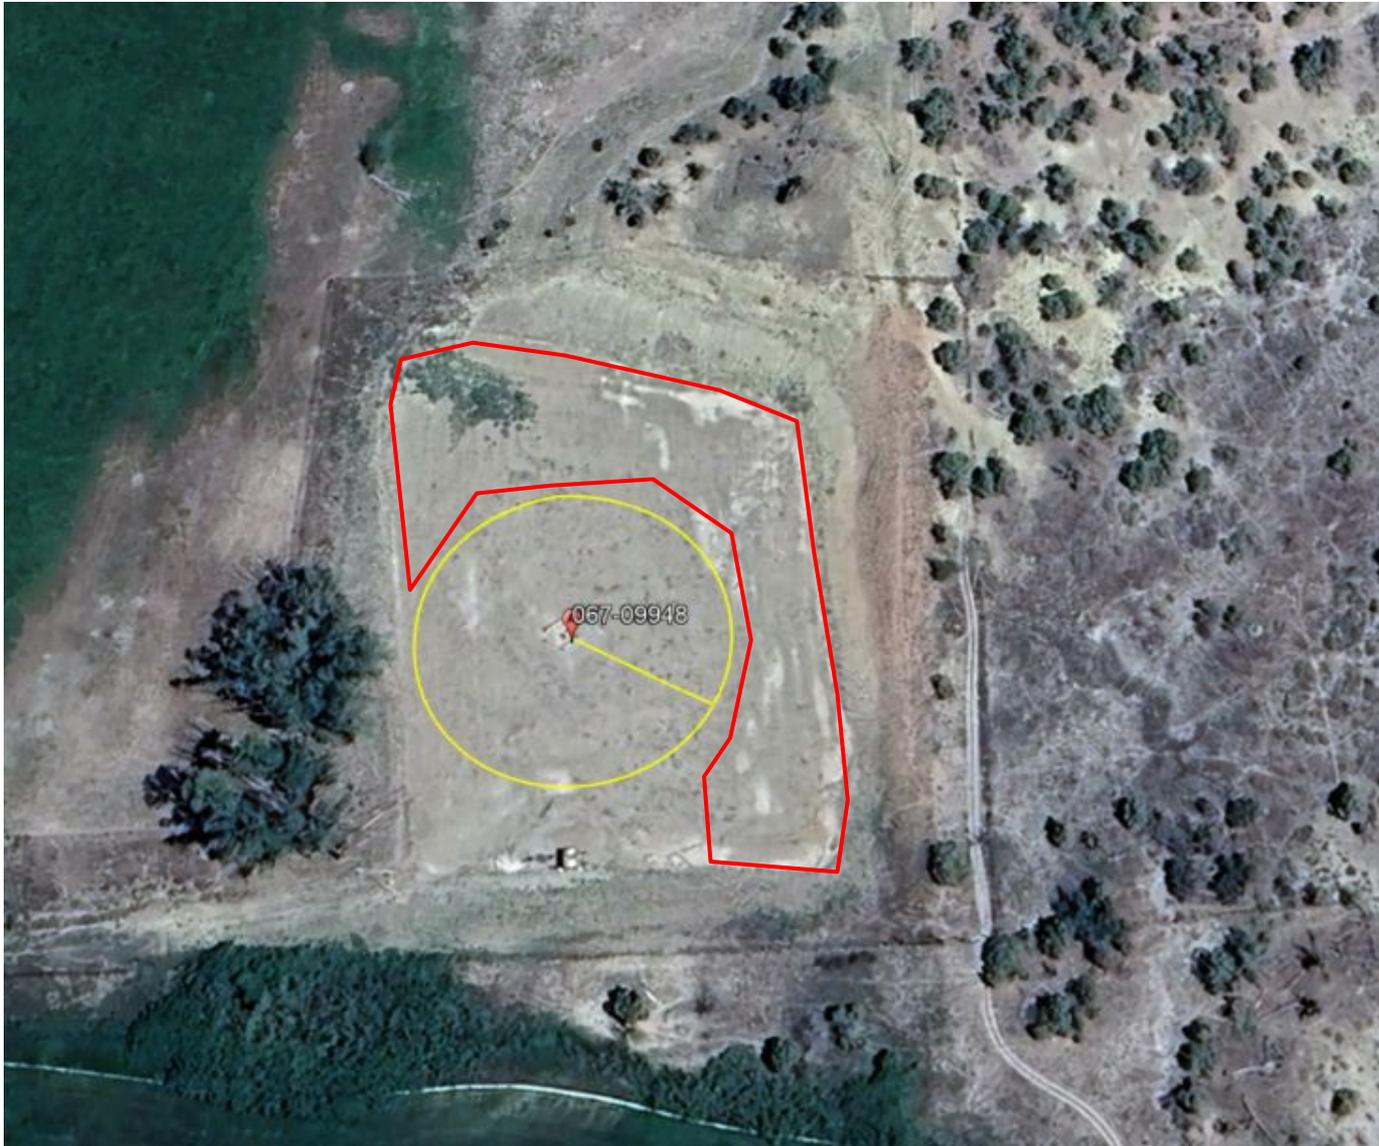
**Photo 4.** 2024 aerial imagery of areas on well pad which have not been reclaimed per 1003 requirements/standards. Areas no longer needed for operations highlighted in red have not been interim reclaimed.

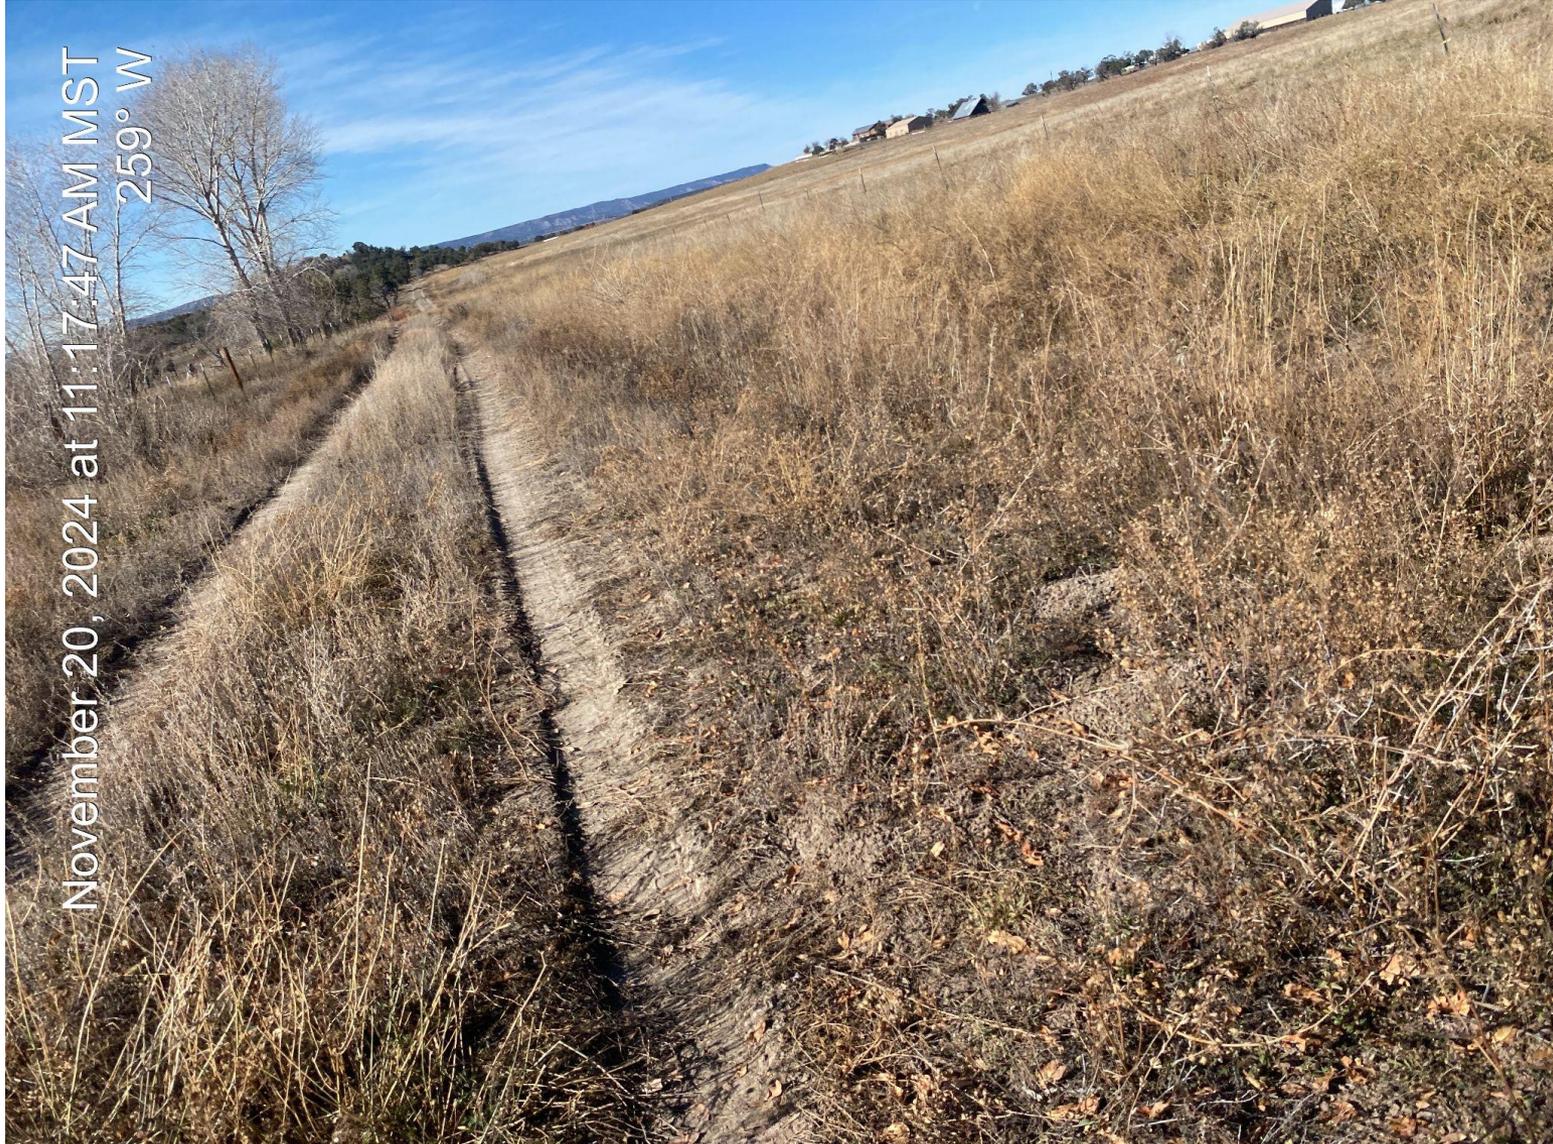
**Photo 5.** Weedy Russian Thistle and Kochia debris observed dominating the access road.

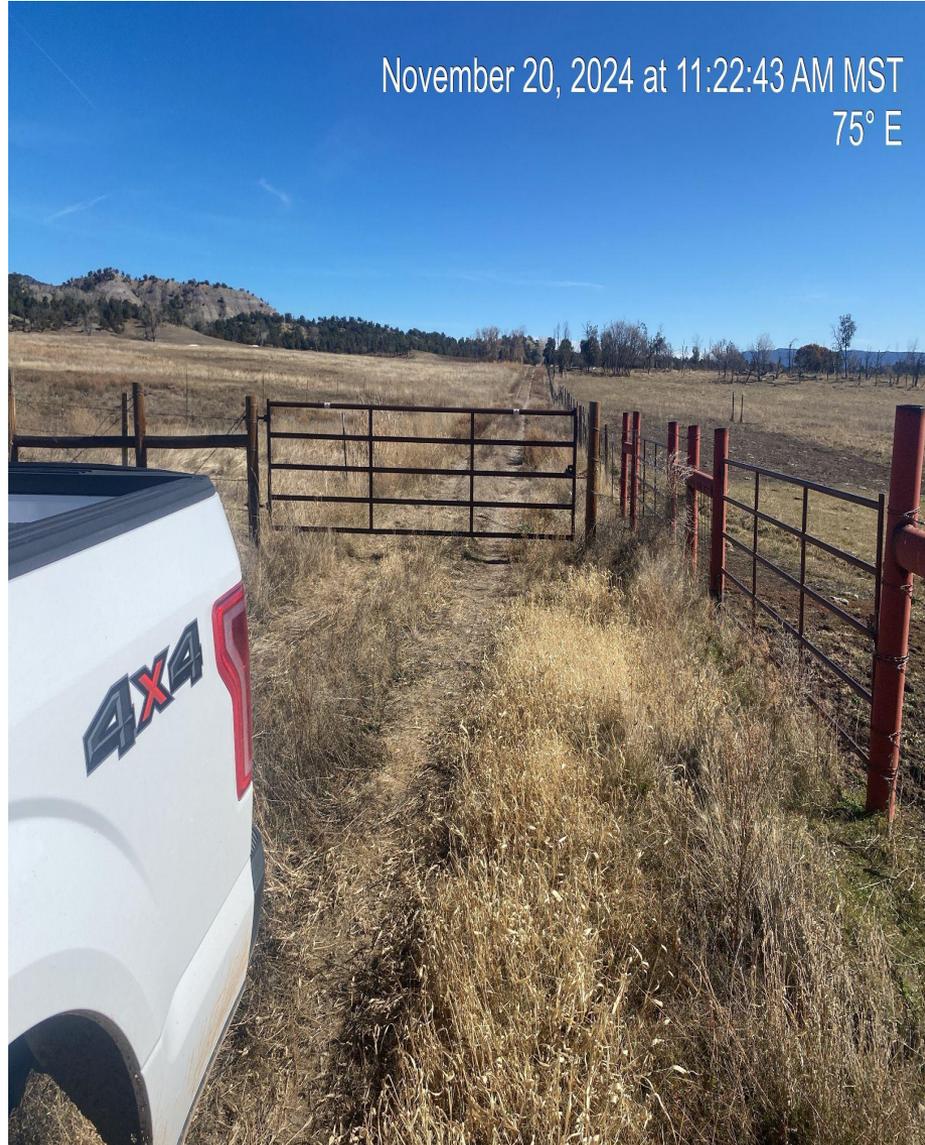
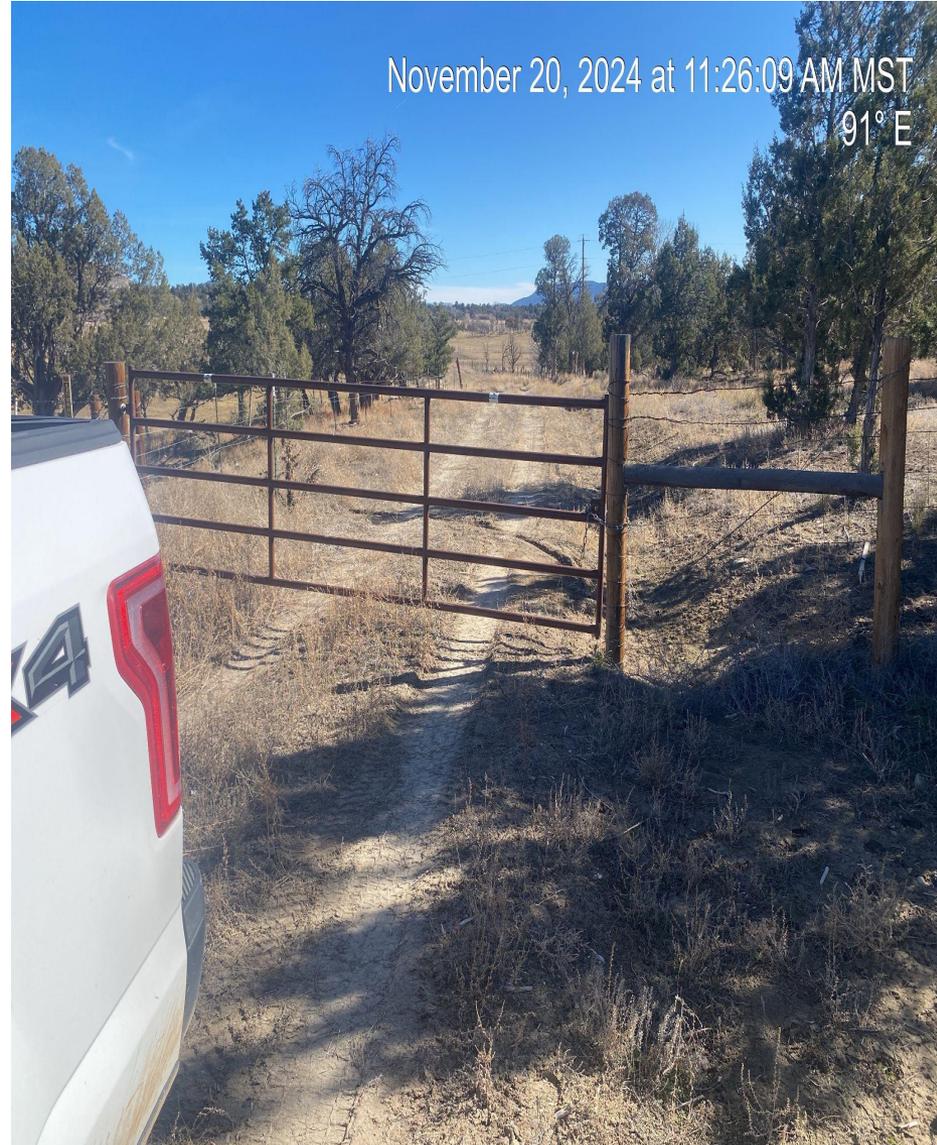
Photo 6. View of closed gates leaving location.

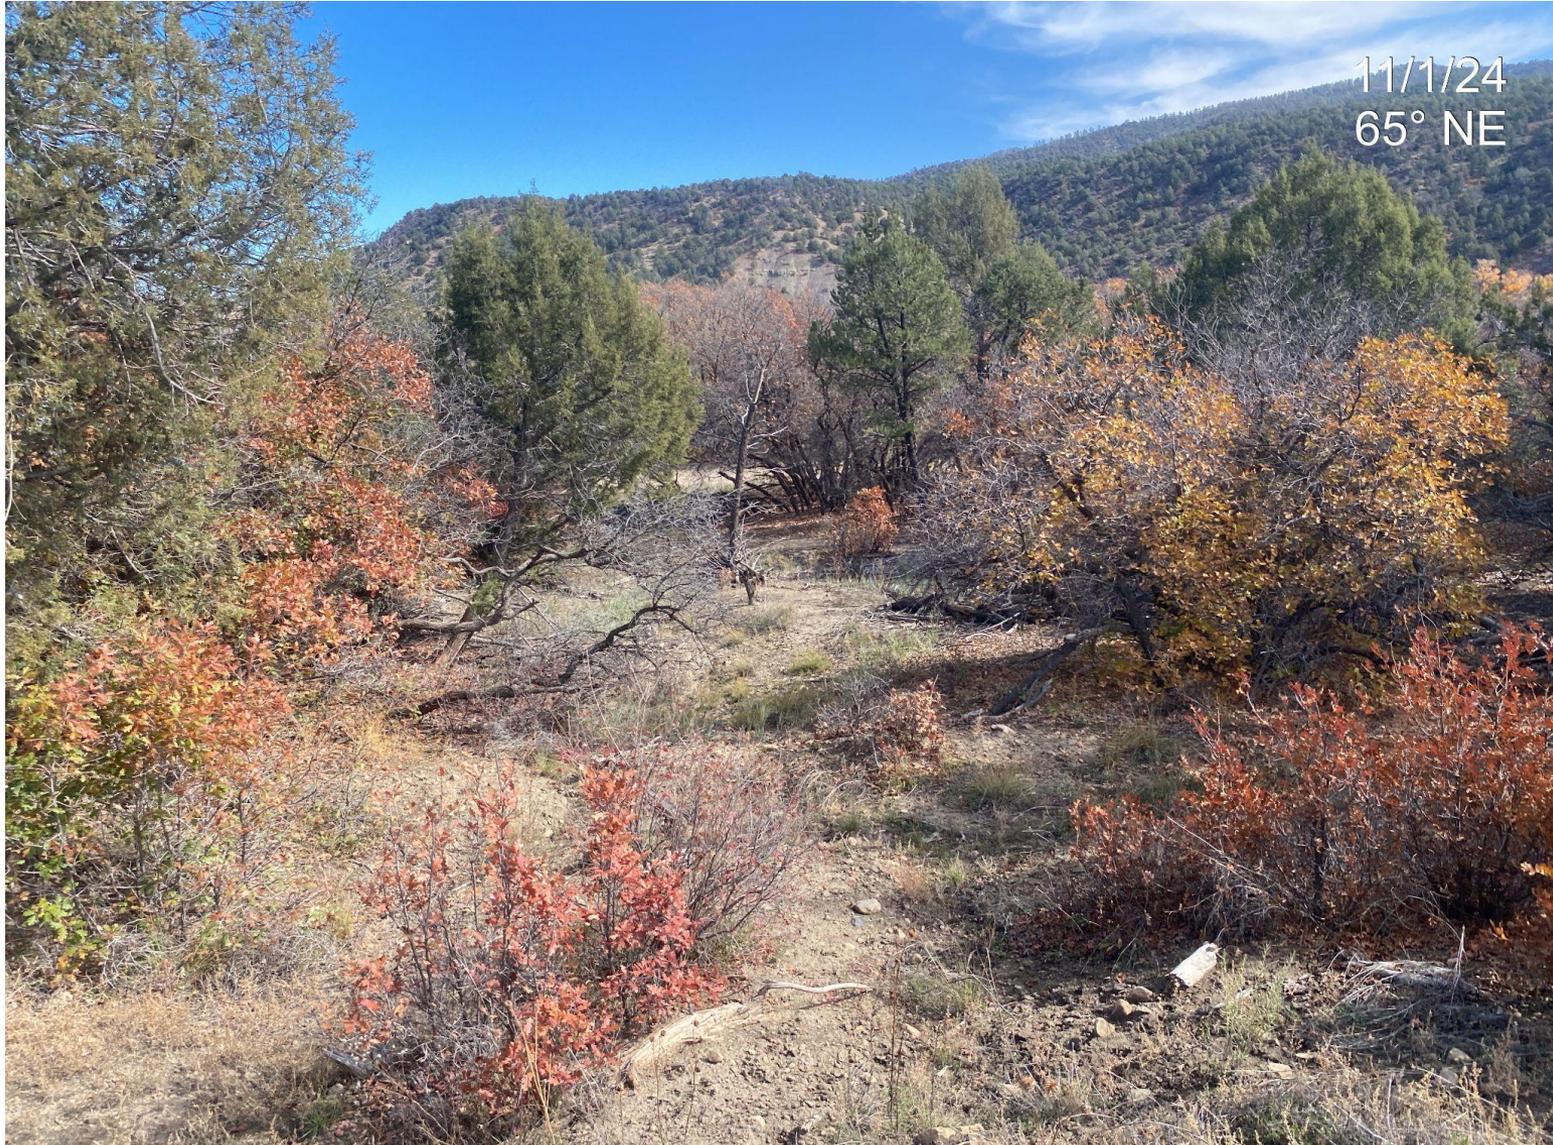
**Photo 5** Reference area composed of Juniper, Gambel Oak and Indian Ricegrass.
