Caerus  
School House Point OM L15  
Location ID: 335979

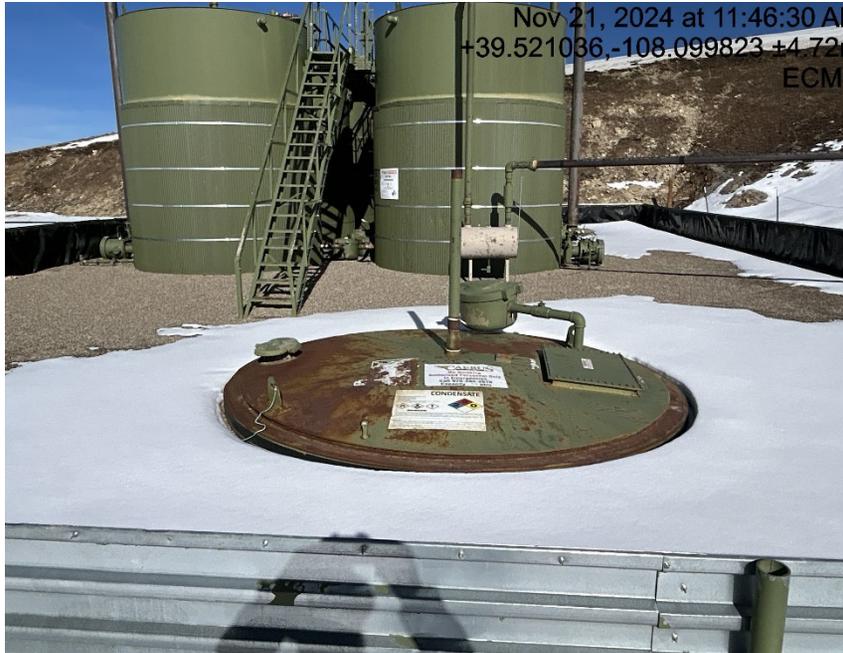
Condensate tank venting

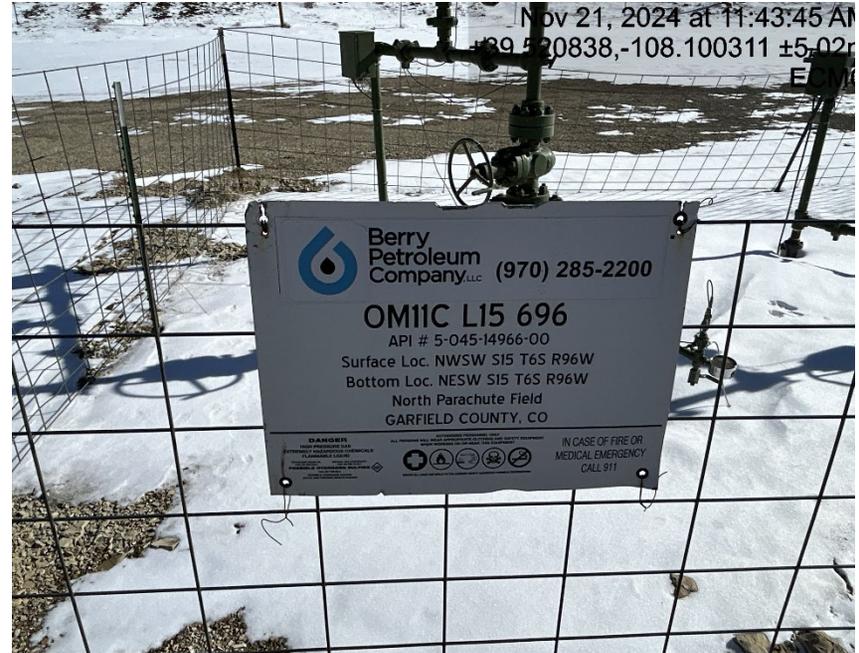
Well signage needs maintained

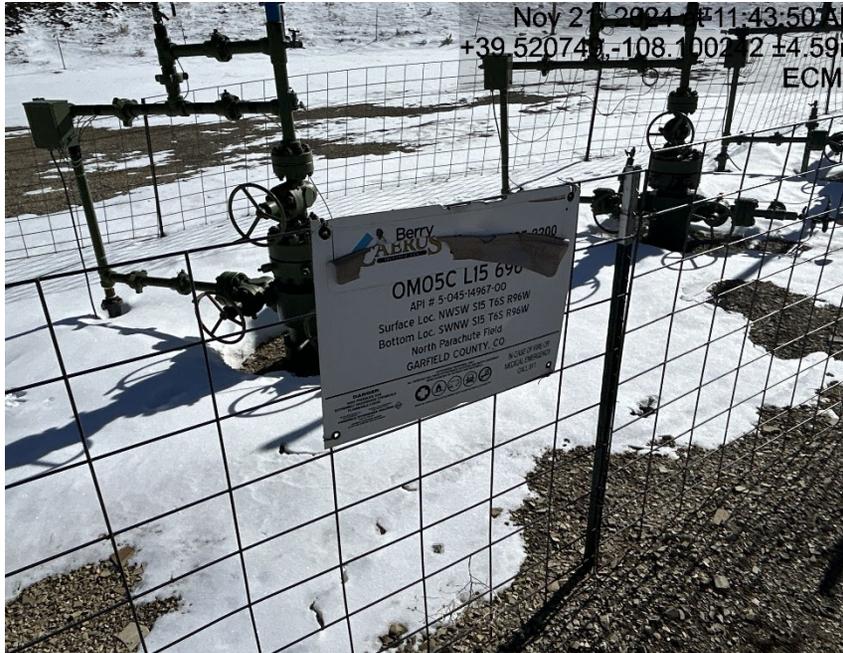
Well signage needs maintained

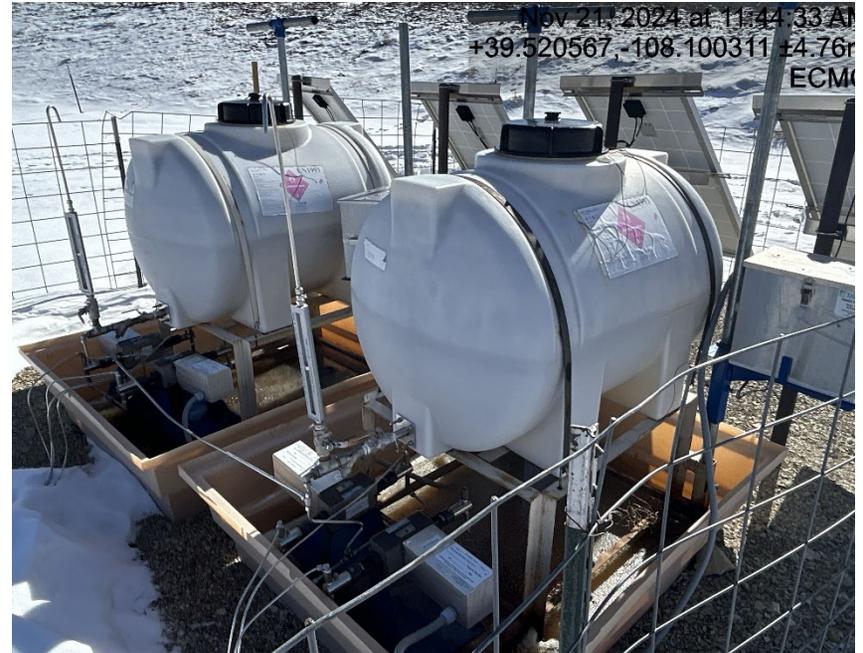
Signage is beginning to become illegible

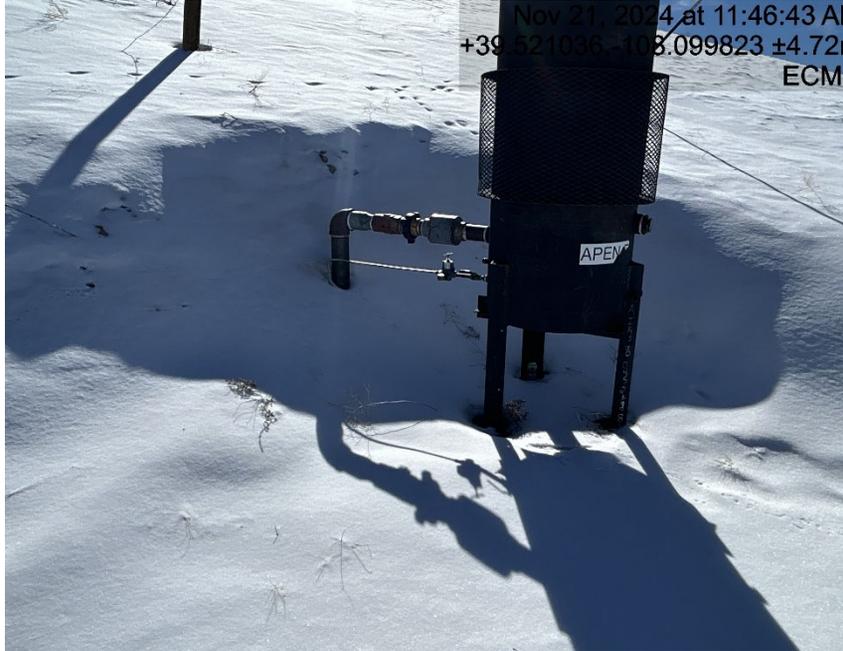
No meter noticed

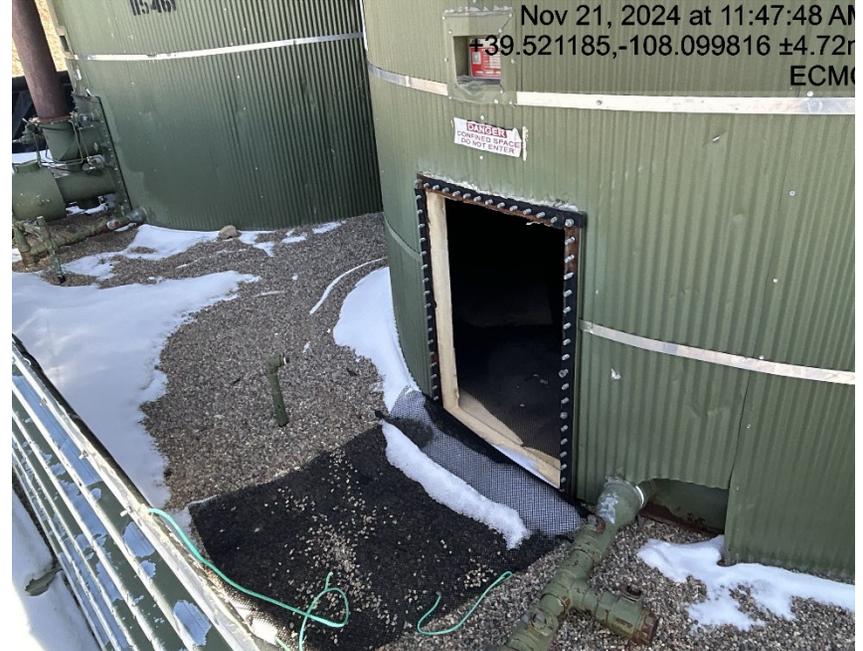
Open manway on tank

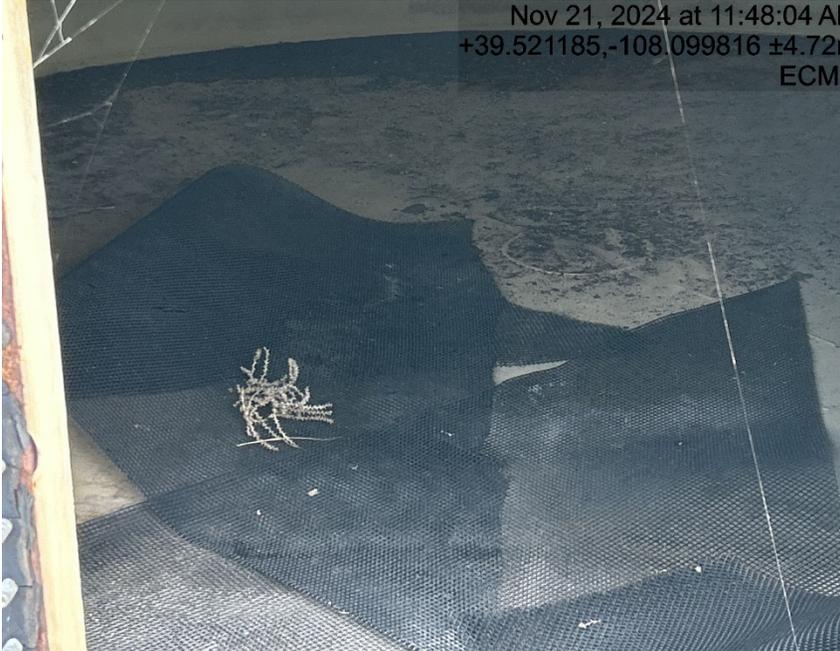
Open manway on tank

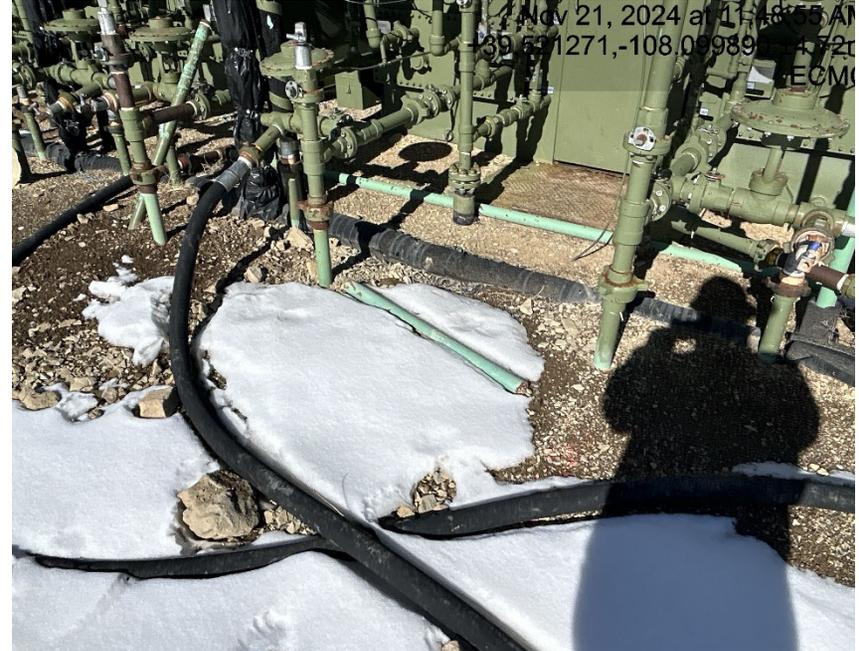
Debris

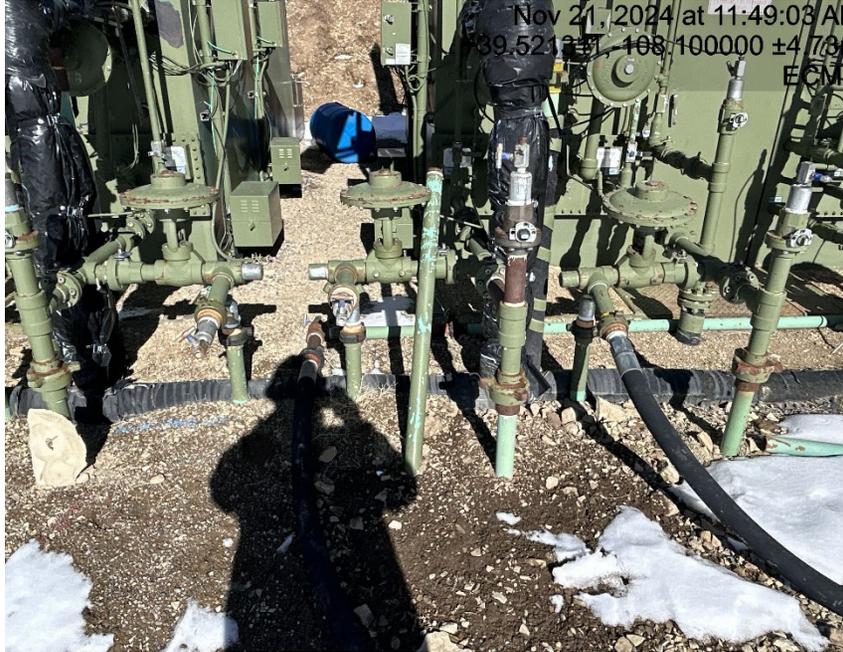
Debris

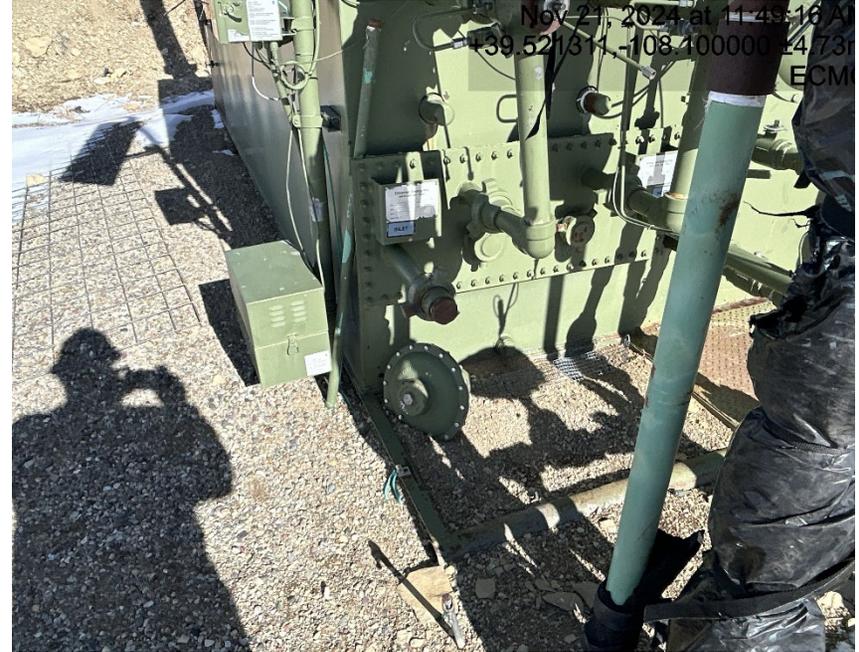
Debris

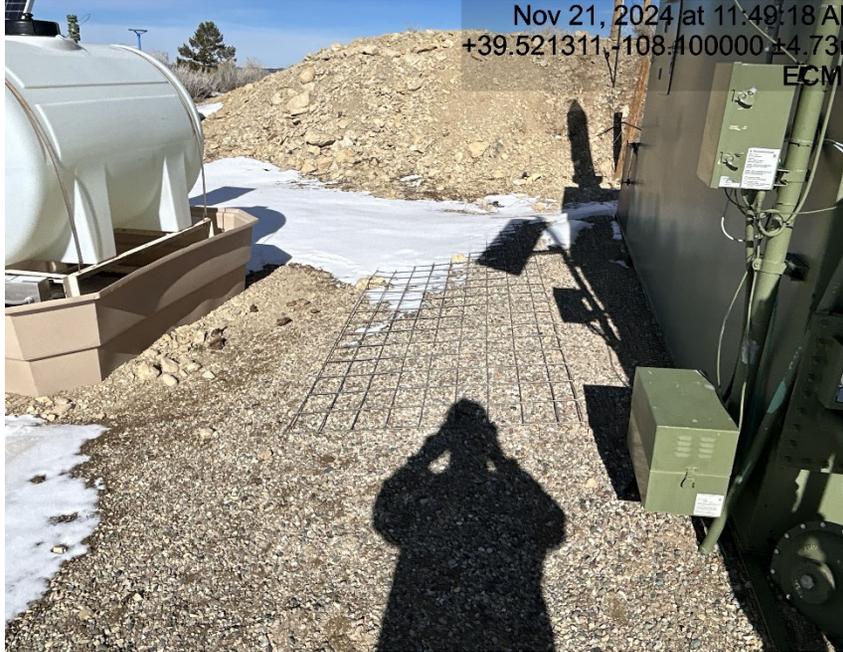
Debris

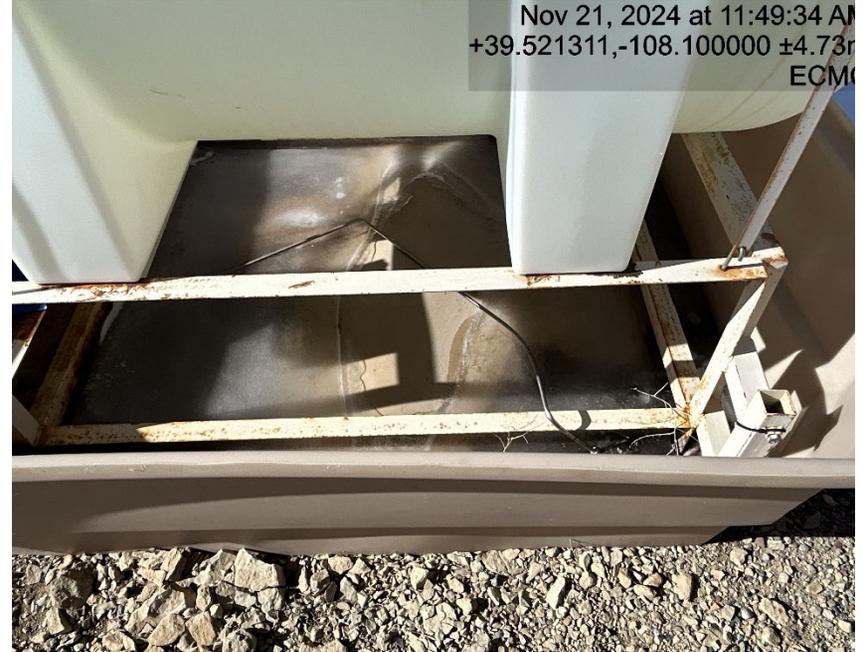
Debris

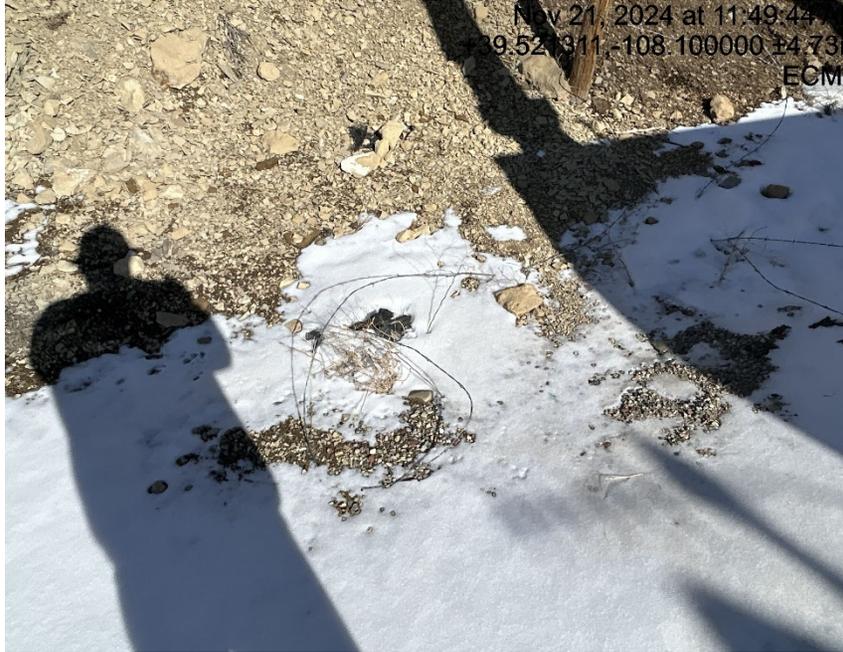
**Barbed wire is debris and a wild life hazard**

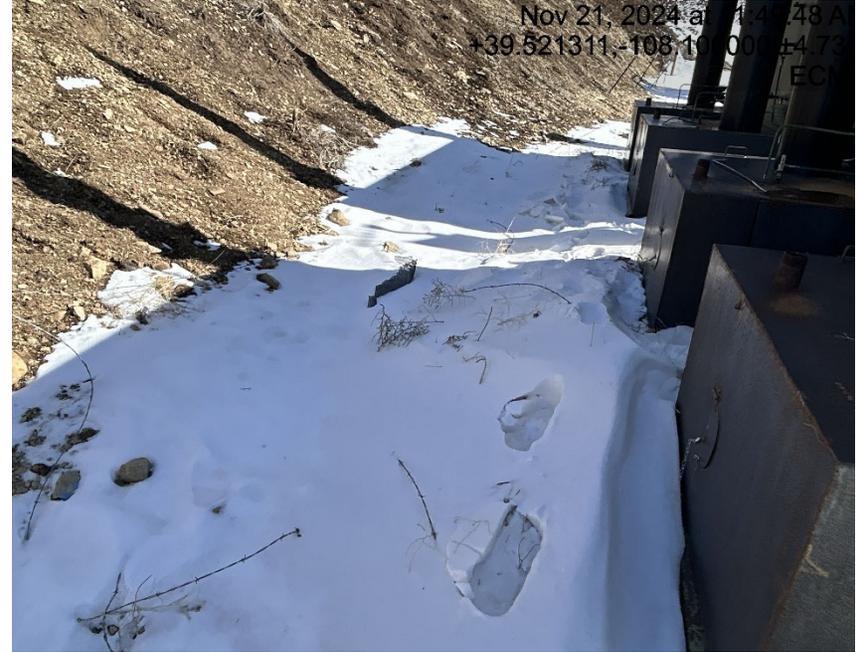
**Barbed wire is debris and a wild life hazard**

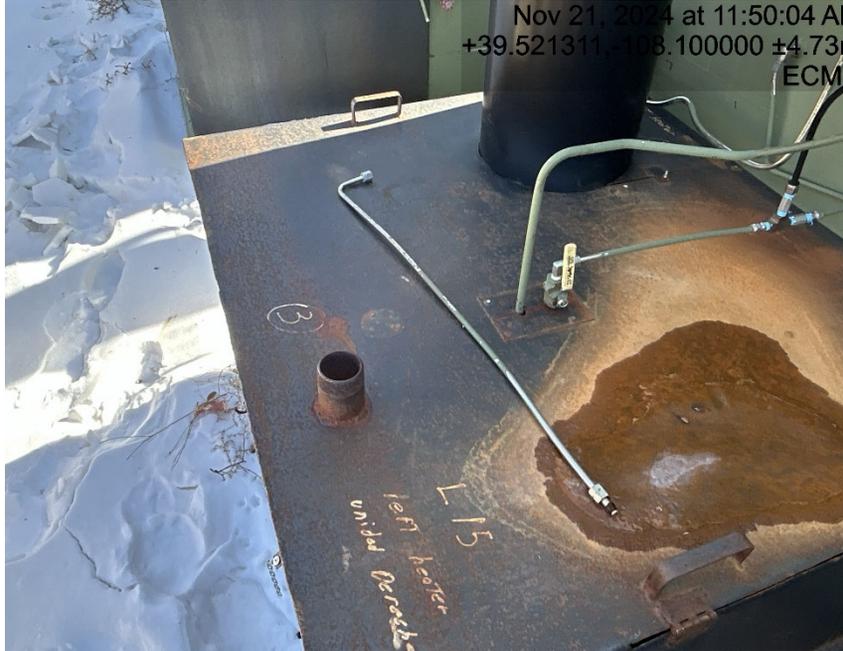
Debris

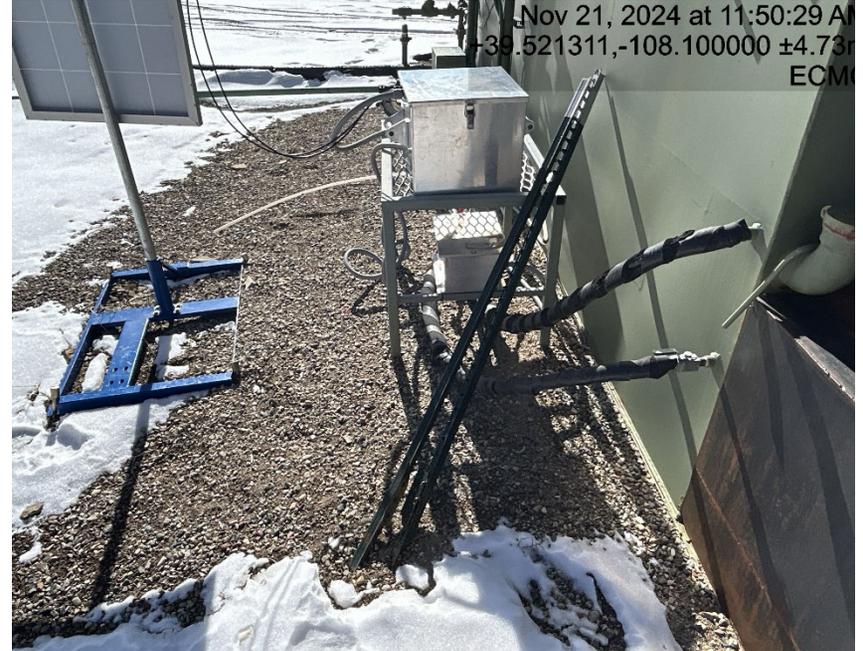
Debris

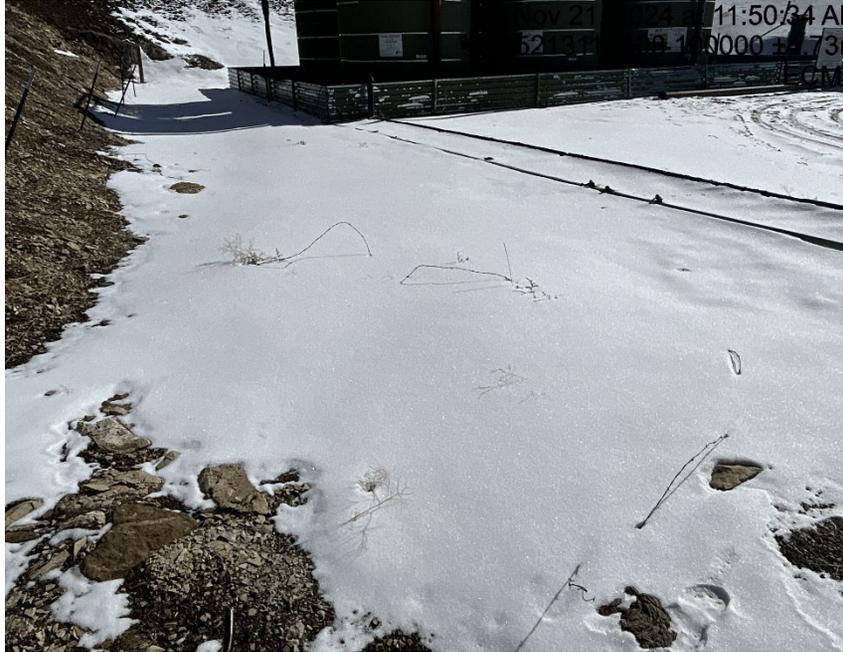
Barbed wire is debris and a wild life hazard

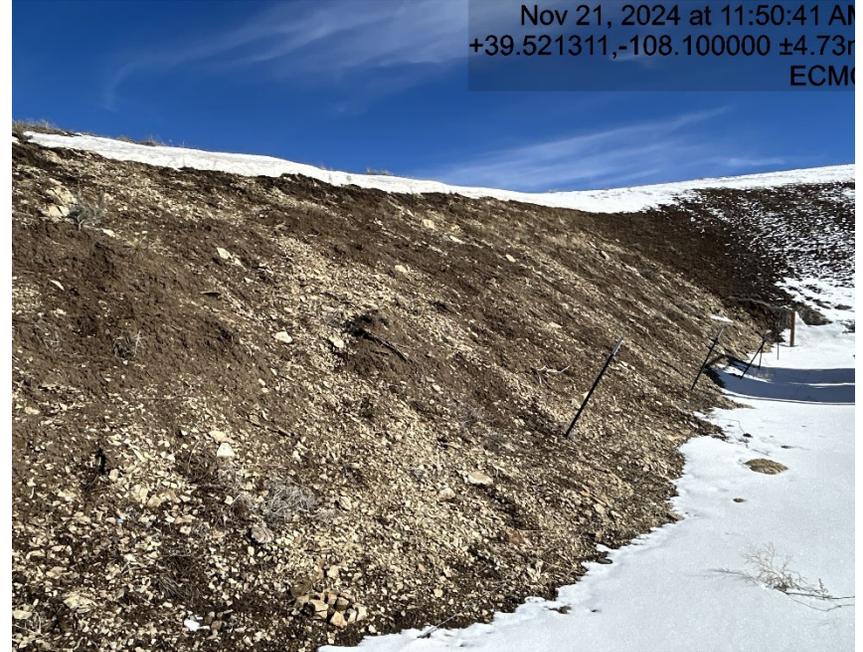
Cut slope shows some signs of lack of stablization
