Inspection Photos

Loc: 324494

Operator: **OXY USA INC**

Inspection Date: 11/25/2024

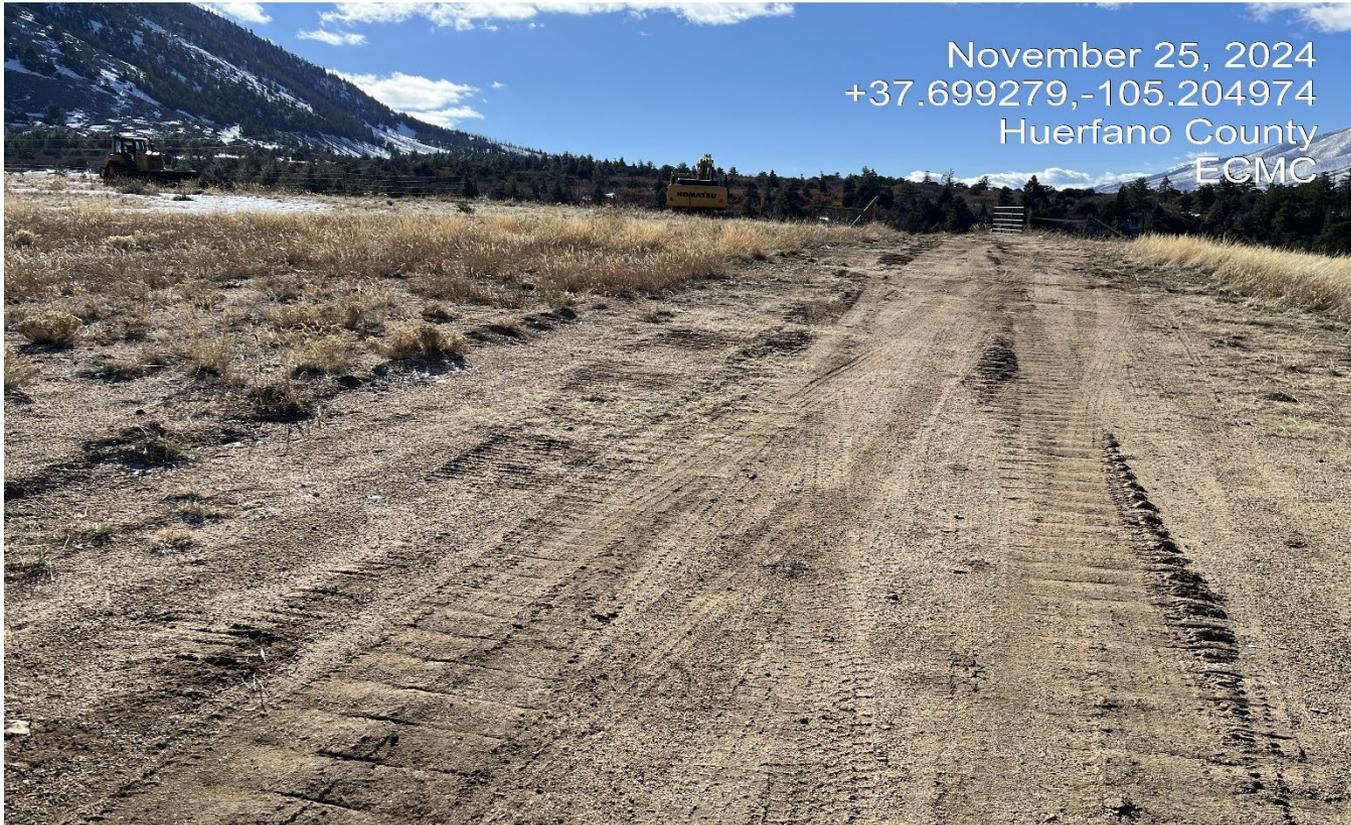
Photo 1. Facing south toward the access road.. The access road will need to be decompacted and reclaimed.

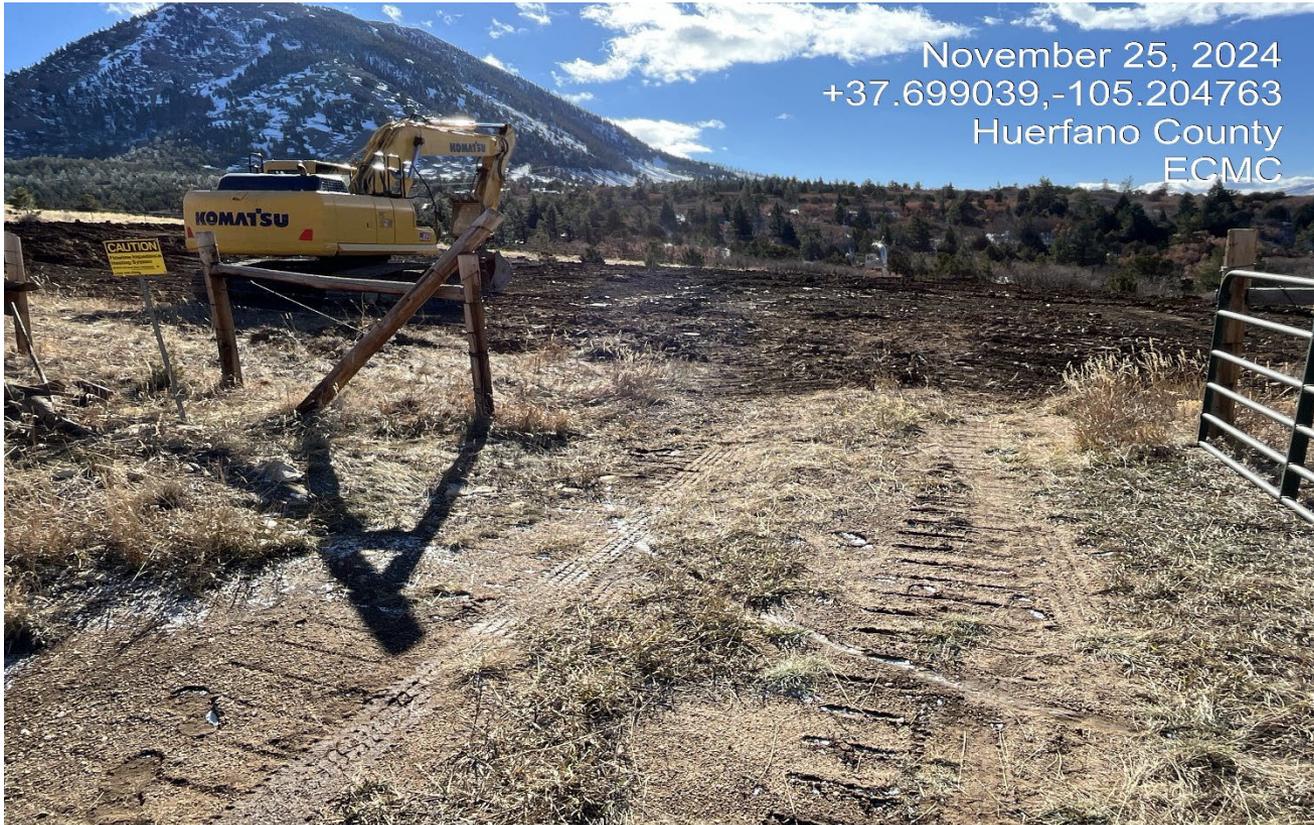
Photo 2. Facing south toward the location. The location is currently being recontoured.

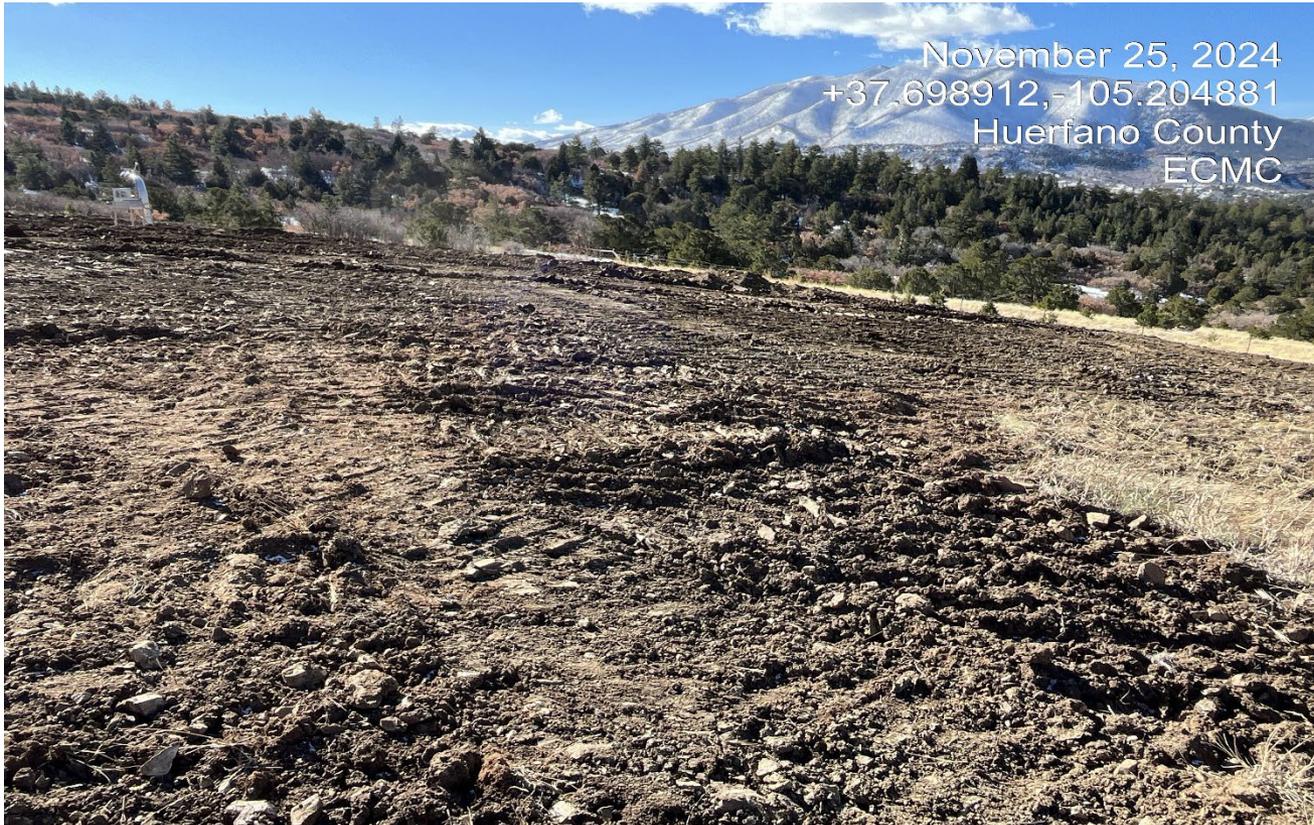
Photo 3. Facing southwest at the location. There appears to be more material in this area that needs to be pushed up toward the cu slope.

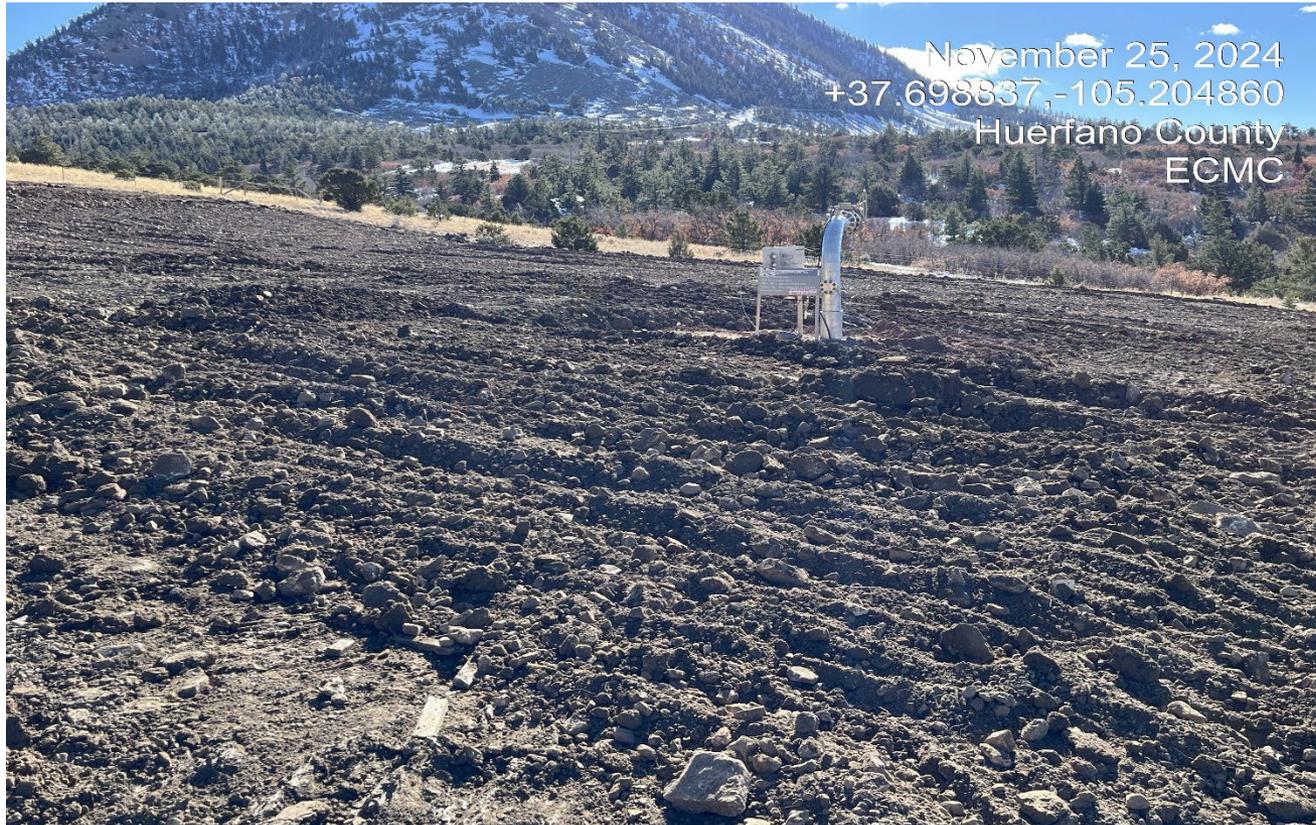
Photo 4. There is still a pipeline riser that remains at enter of the location that needs to be removed per the Rules.

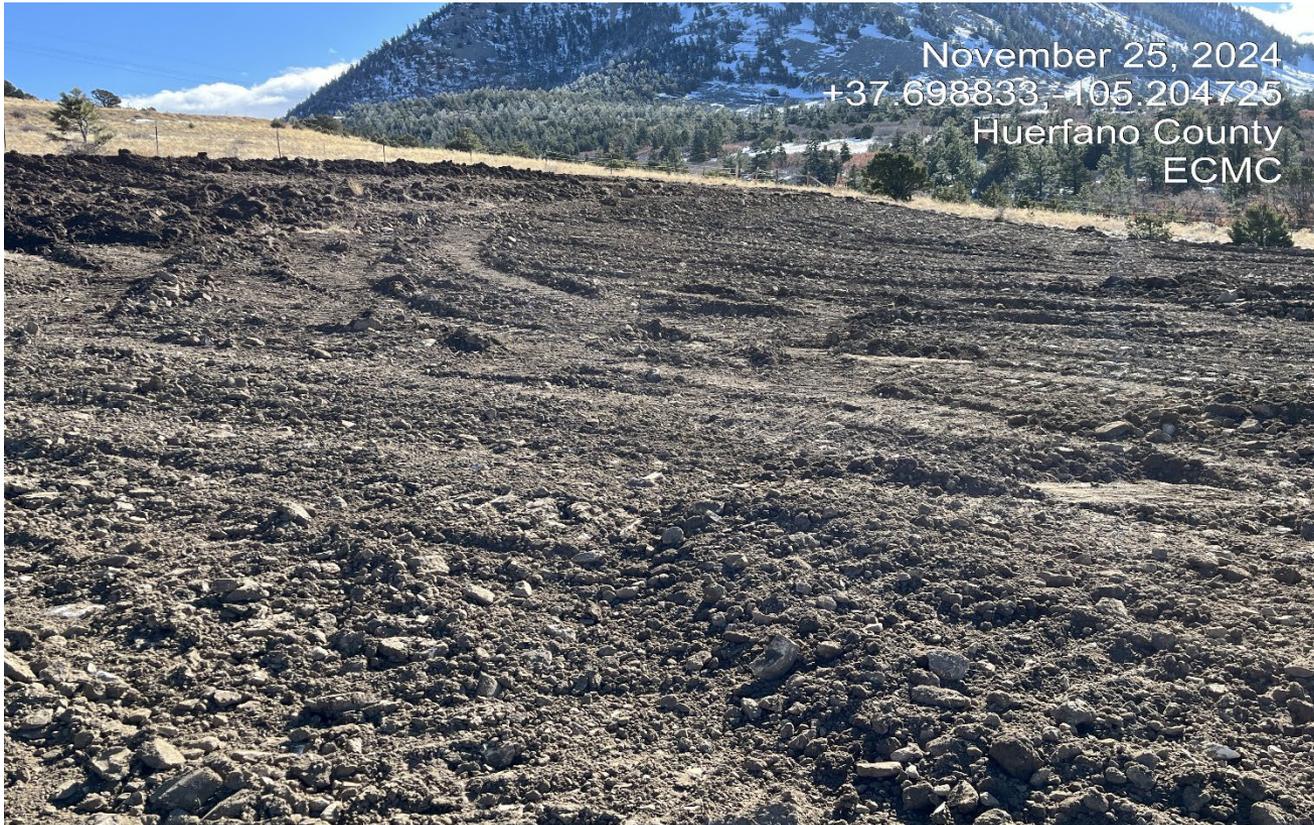
Photo 5. Facing southeast at the location. This area appears to need more material to match surrounding contours. Recontouring is still in process.

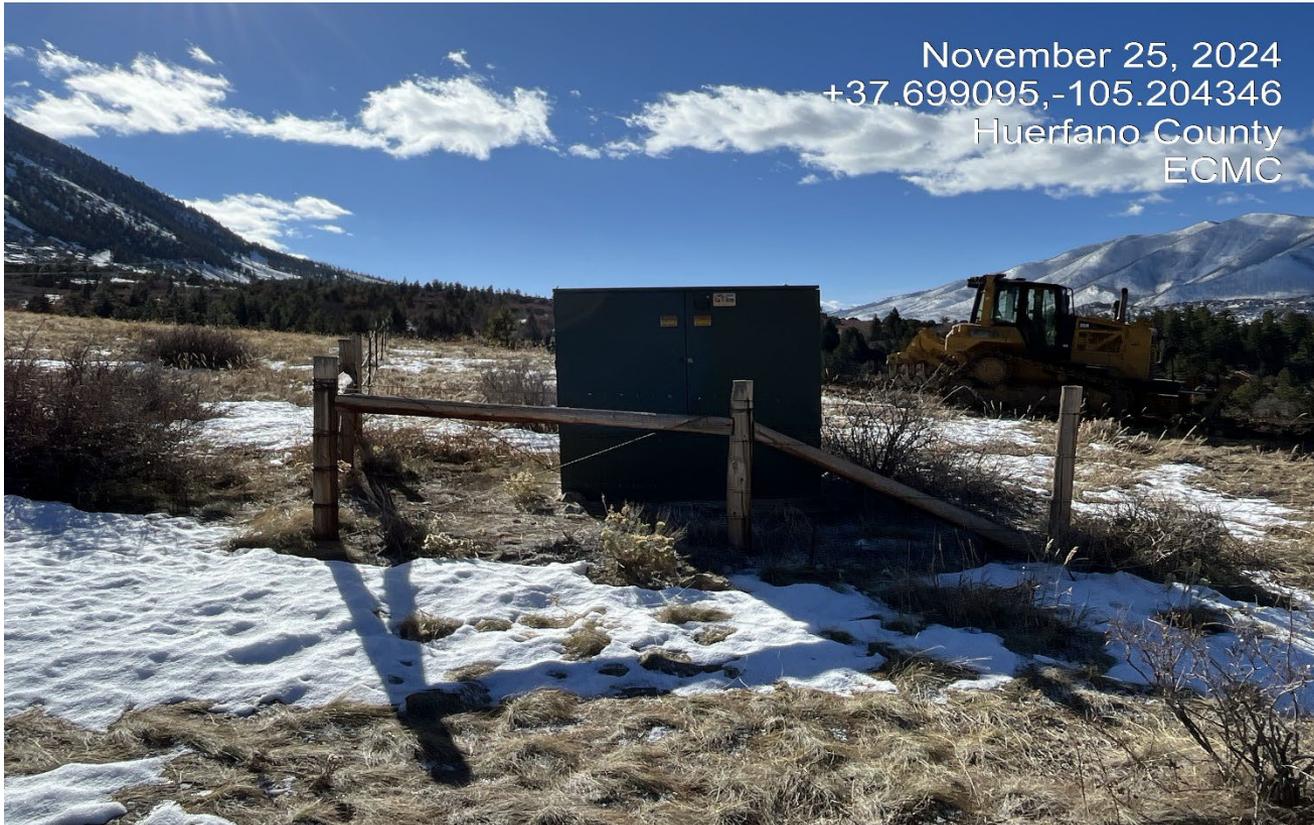
Photo 6. There is an electrical box at the northeast corner of the location that must be removed.
