Inspection Photos

Location: LARAMIE ENERGY LLC Ed Koch/7-9 Pad

Location ID: 312638

Date: 11/21/2024

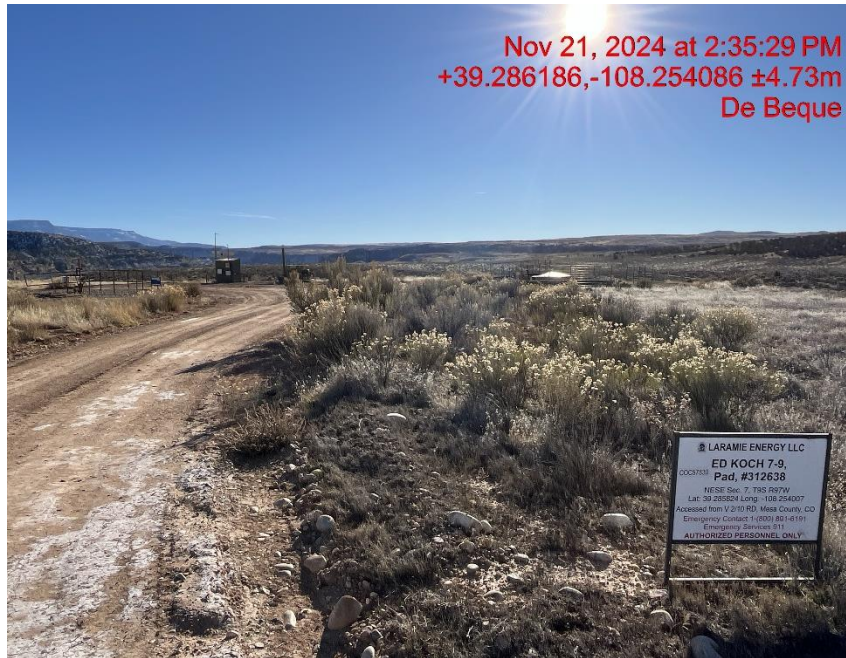
Photo # 9673 Entrance to location

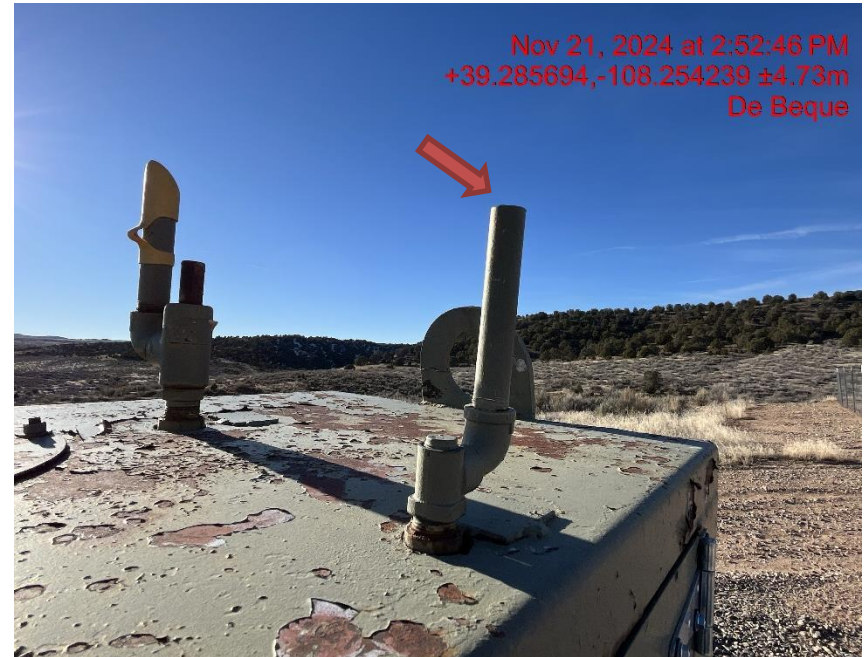
Photo # 9698 PRV vent line does not comply with CECMC pressure safety device rules

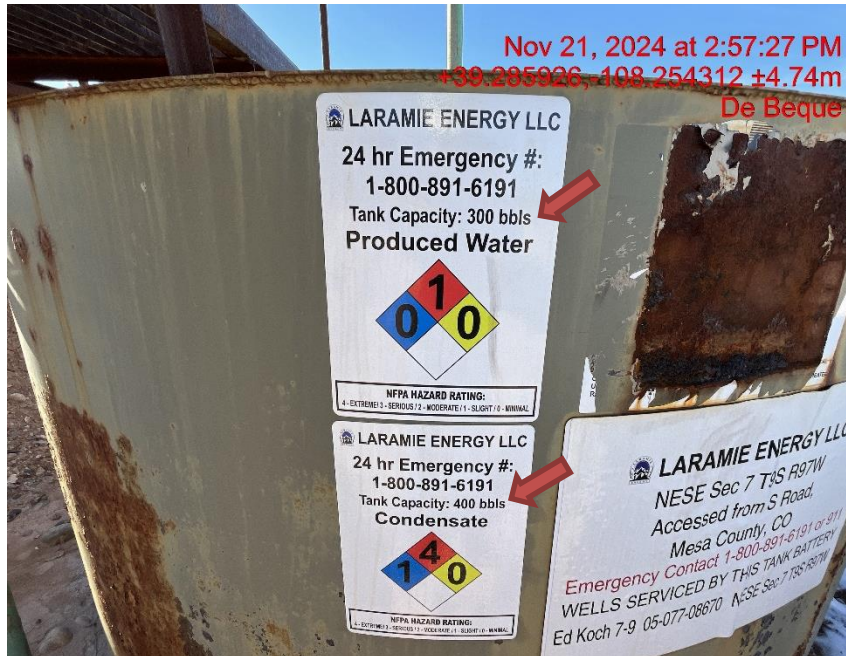
Photo # 9704 Tank labels have conflicting capacity information

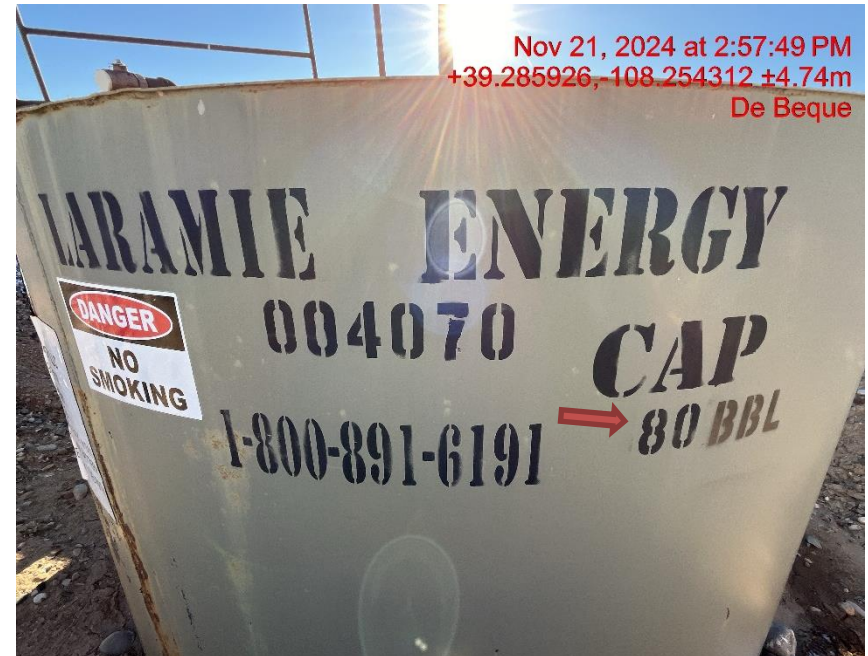
Photo # 9705 Tank labels have conflicting capacity information

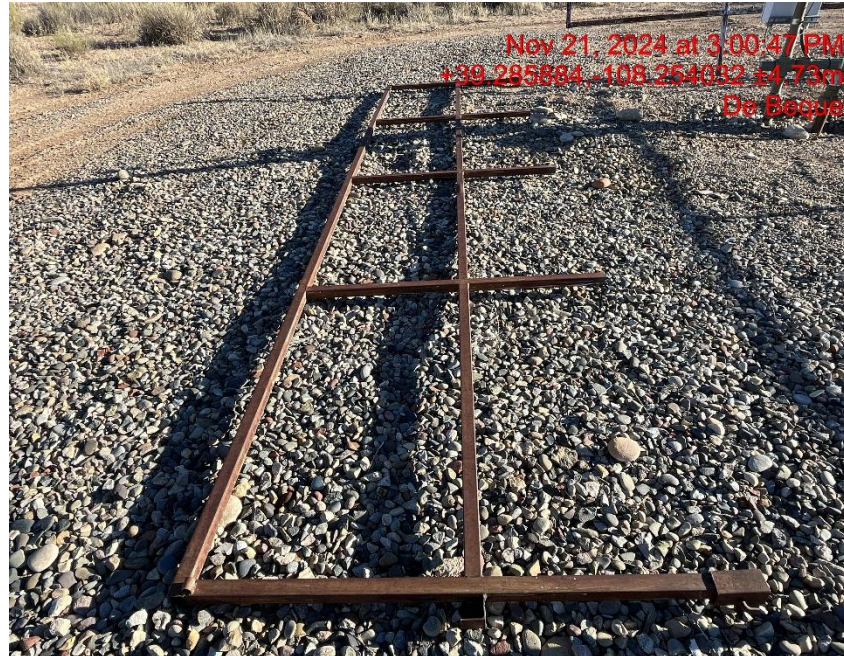
Photo # 9709 Debris
