Inspection Photos

Location Name: TEP ROCKY MOUNTAIN LLC FEDERAL RMV 33-20 Pad

Location ID: 335136

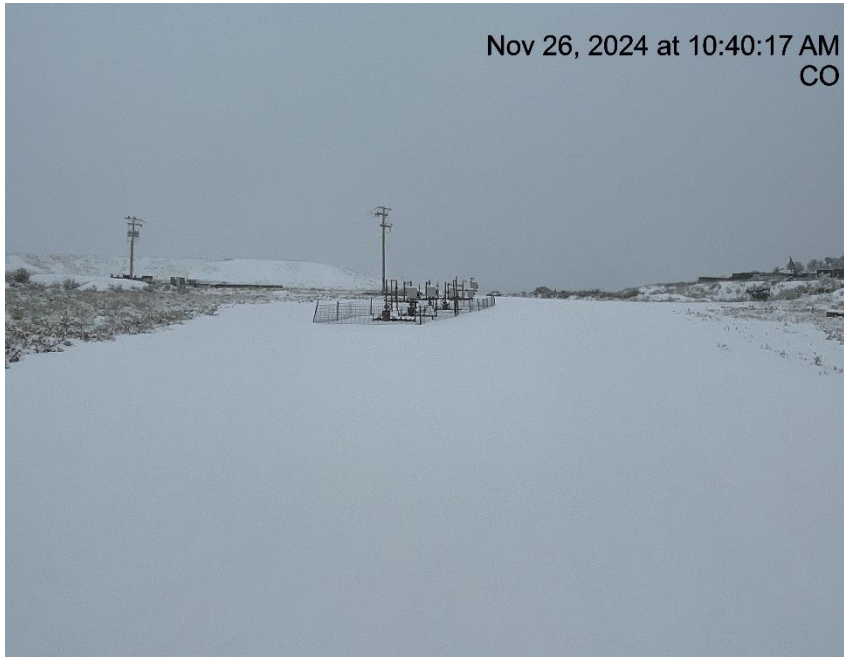
Photo # 1345 From entrance to location

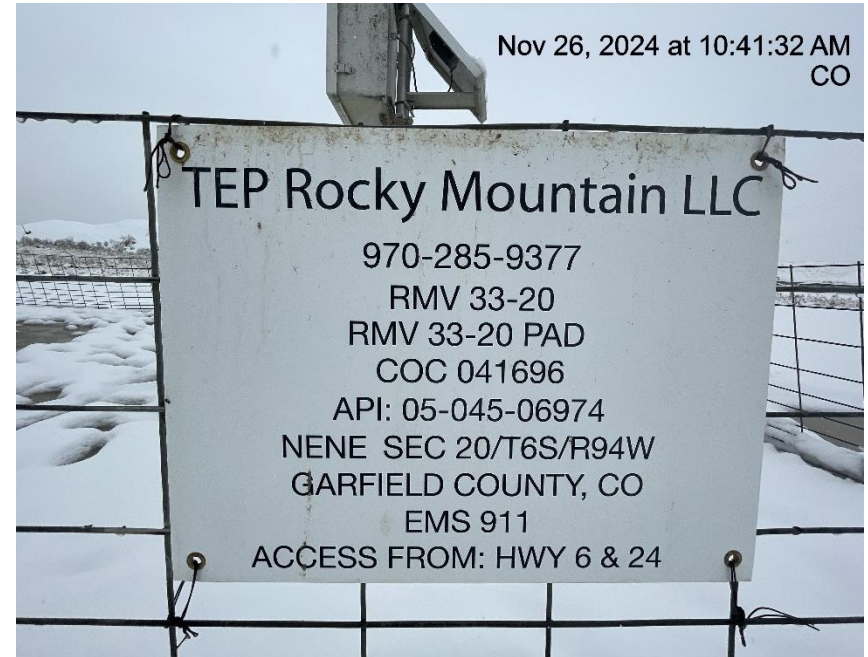
Photo # 1346 Location

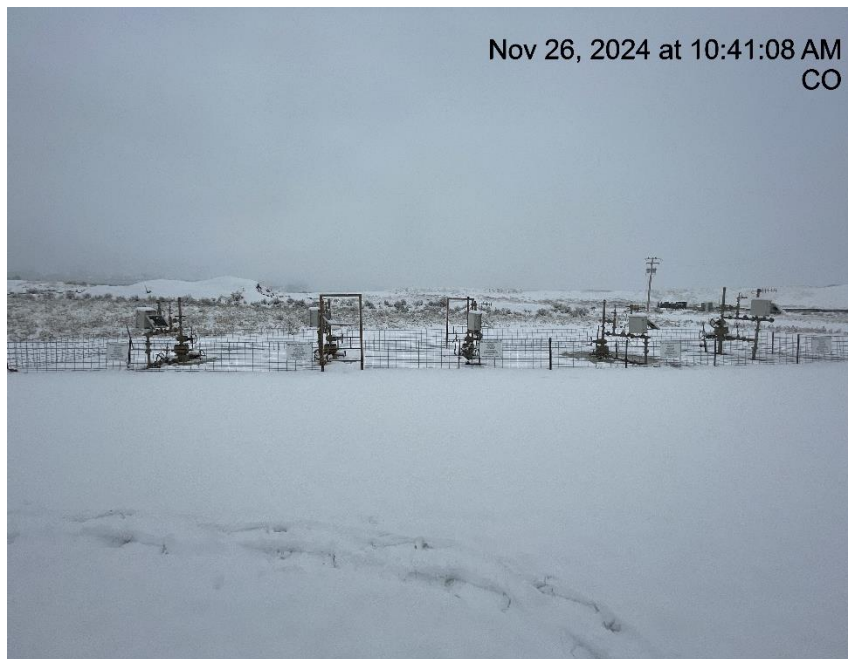
Photo # 1347 Location

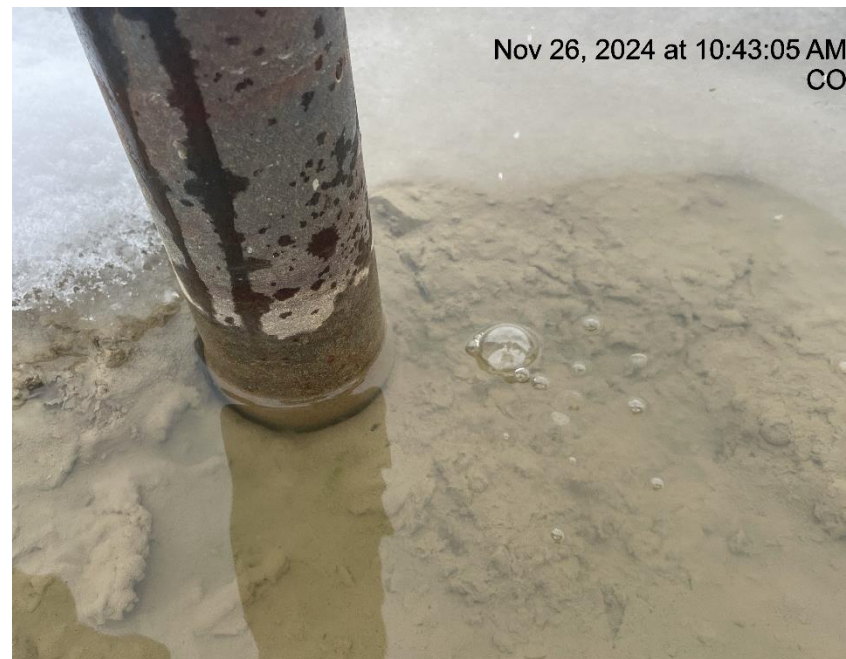
Photo # 1348 Mechanical Condition - possible bradenhead leak on the RMV 33-20 well

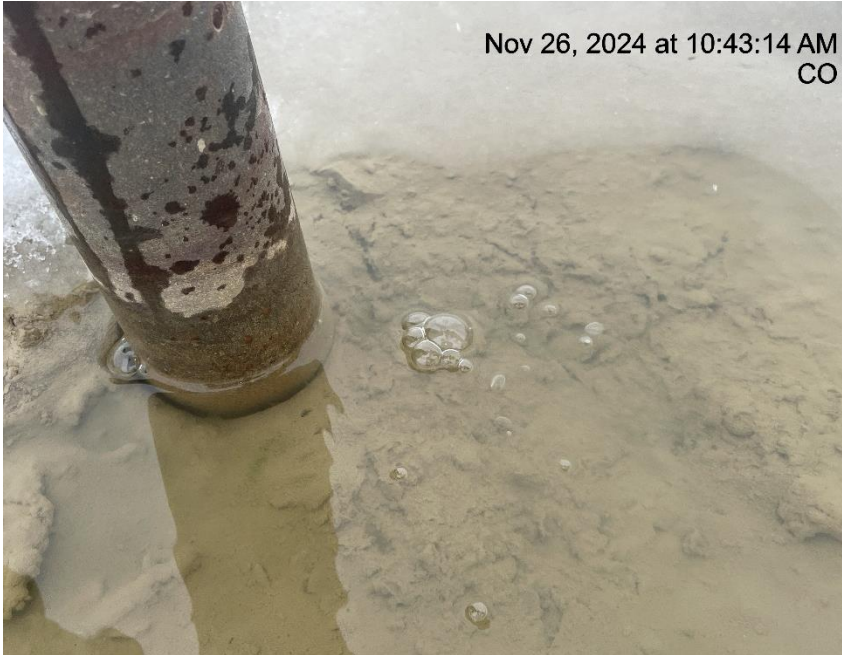
Photo # 1349 Mechanical Condition - possible bradenhead leak on the RMV 33-20 well

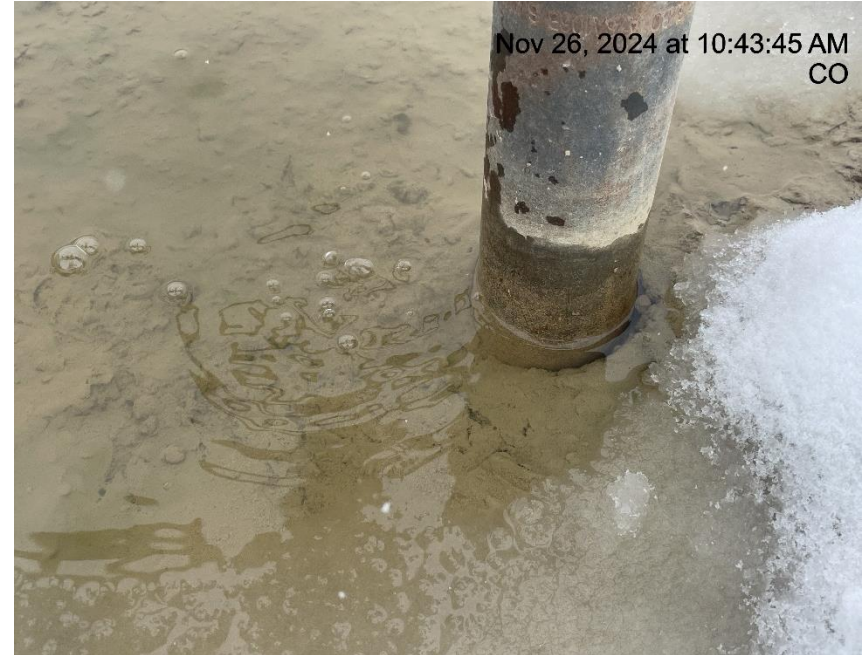
Photo # 1350 Mechanical Condition - possible bradenhead leak on the RMV 33-20 well

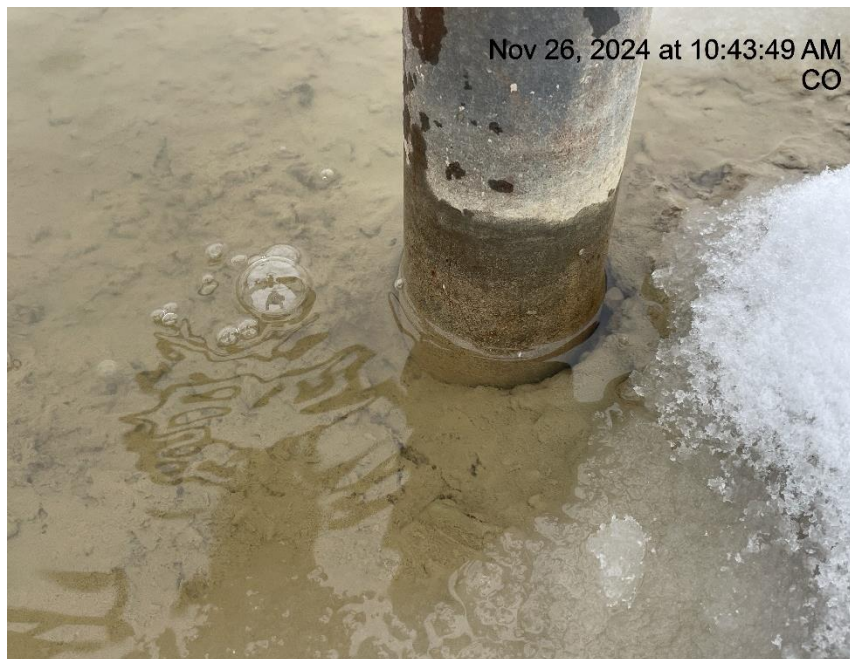
Photo # 1351 Mechanical Condition - possible bradenhead leak on the RMV 33-20 well
