Western Operating Propst B #2 NESE Sec 27 11 N 53W Photo Log

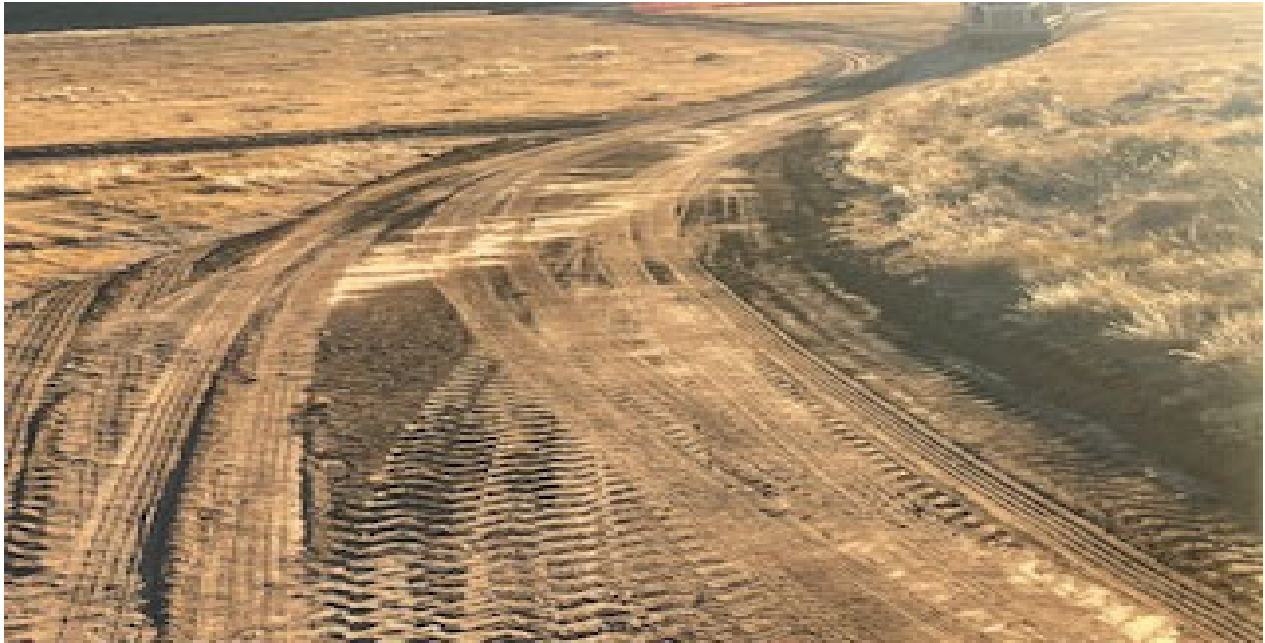
Access Road Graded fixed storm water erosion

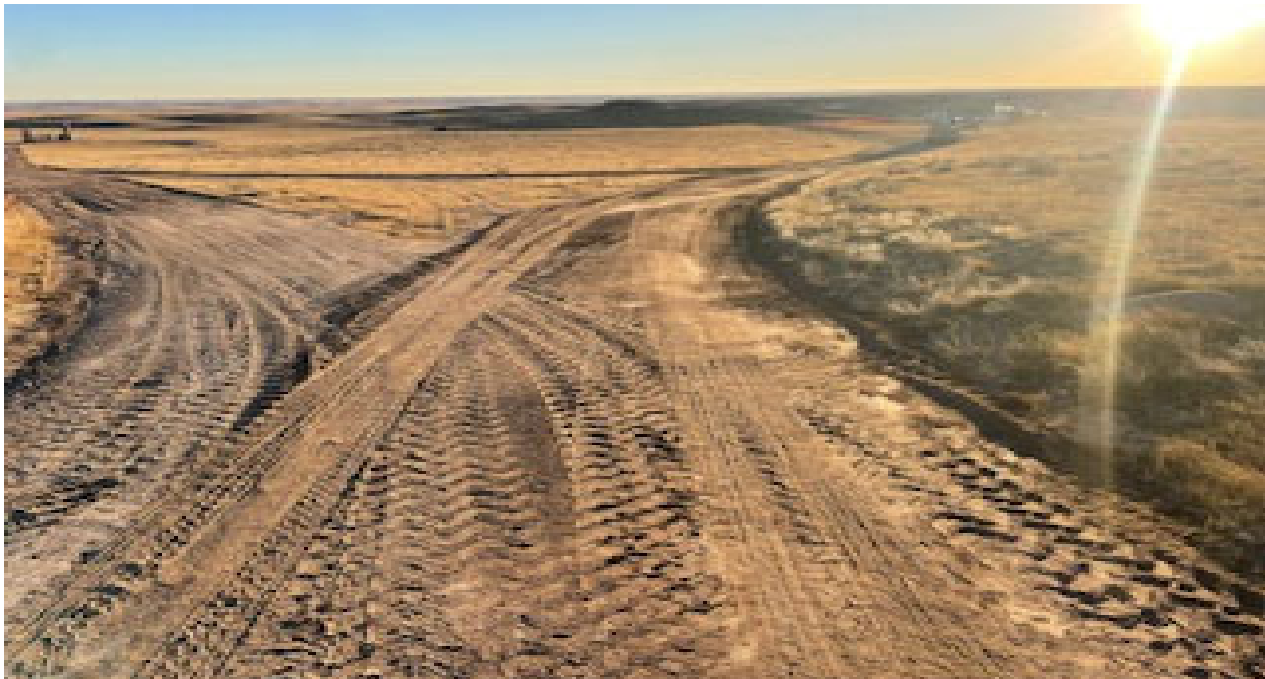
Access Road Graded looking from Gate towards Propst B – 2 Well

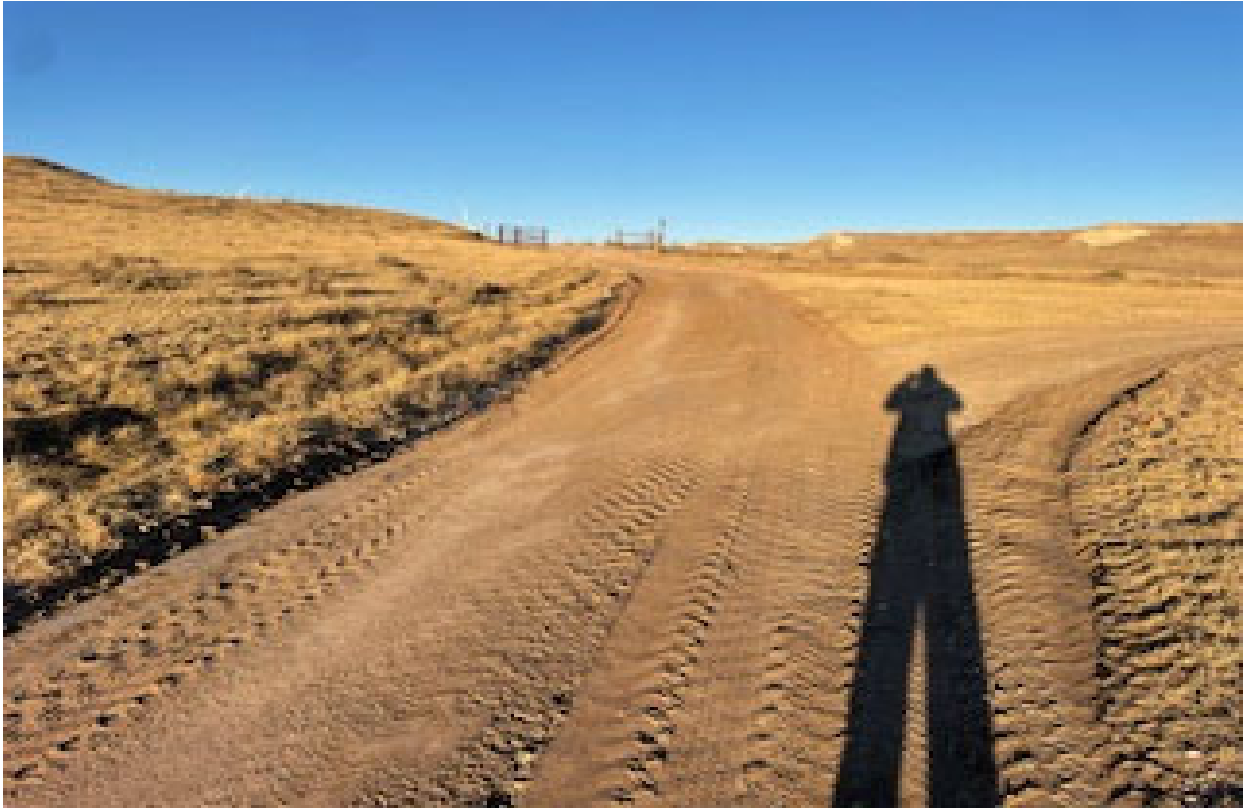
Access Road Graded looking towards entrance gate

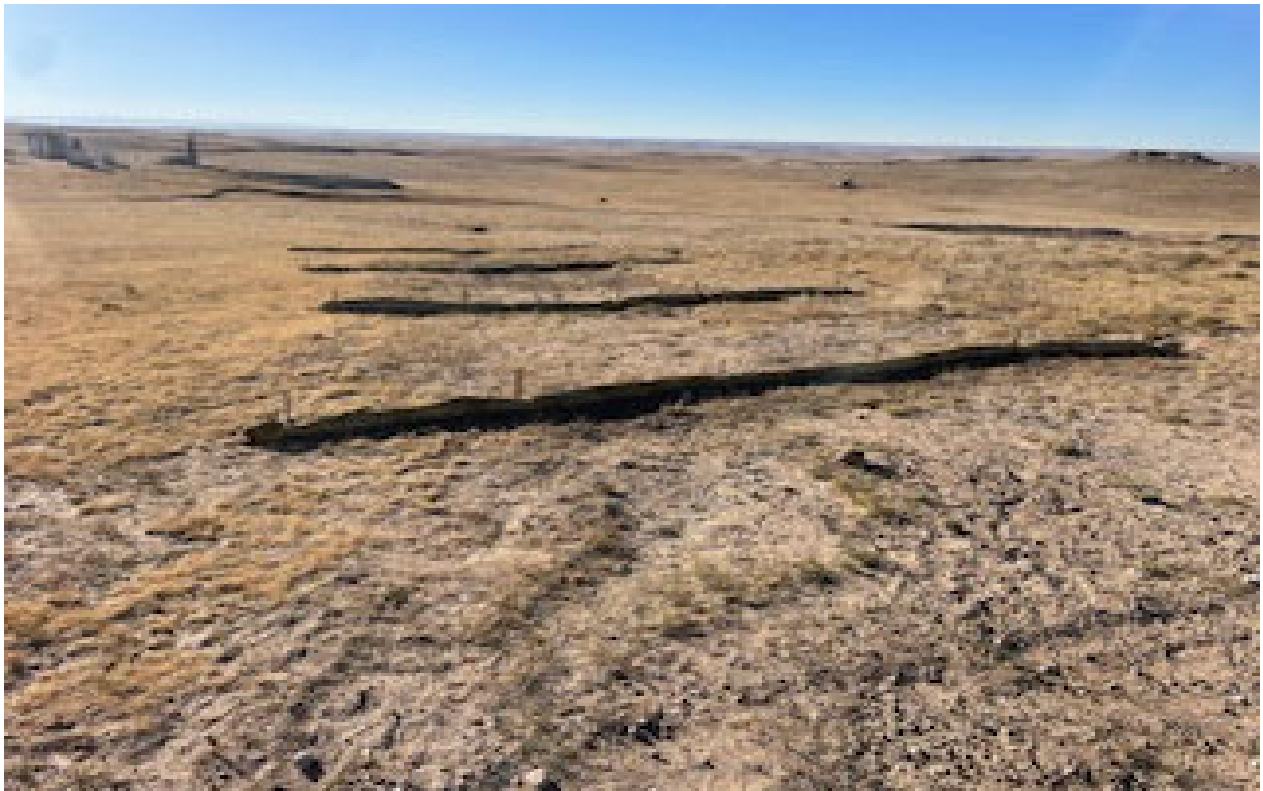
Straw Wattles re-installed South of old Separator Area, trenched and backfilled

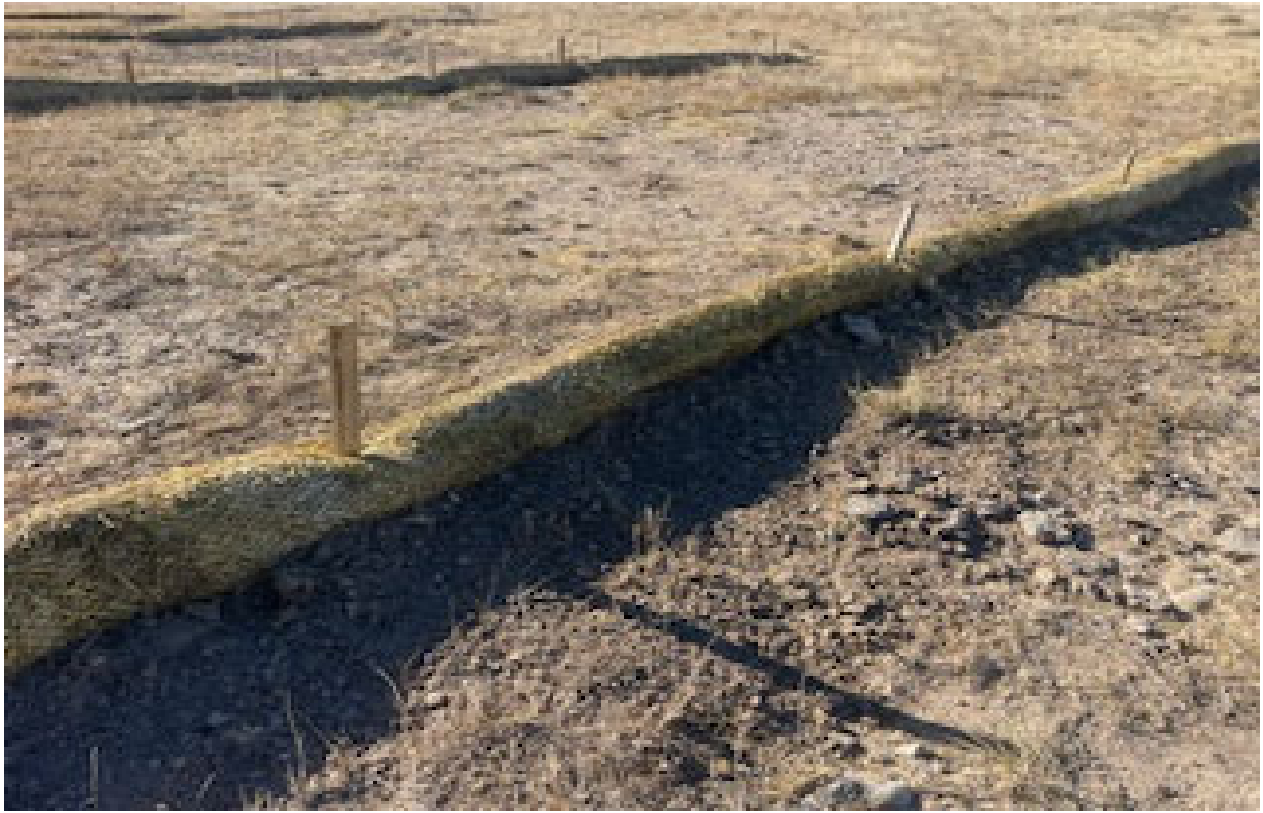
Straw Wattles South of old Separator Area, trenched and backfilled

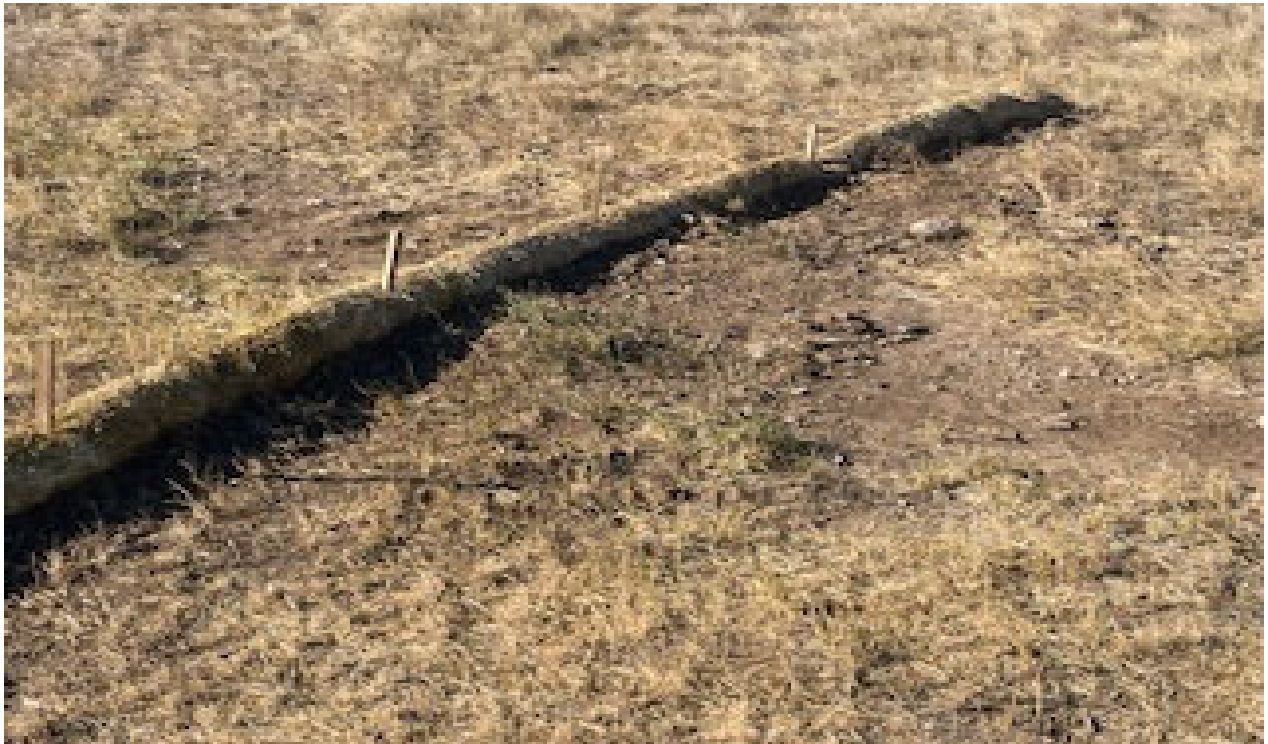
Straw Wattles South of old Separator Area, trenched and backfilled

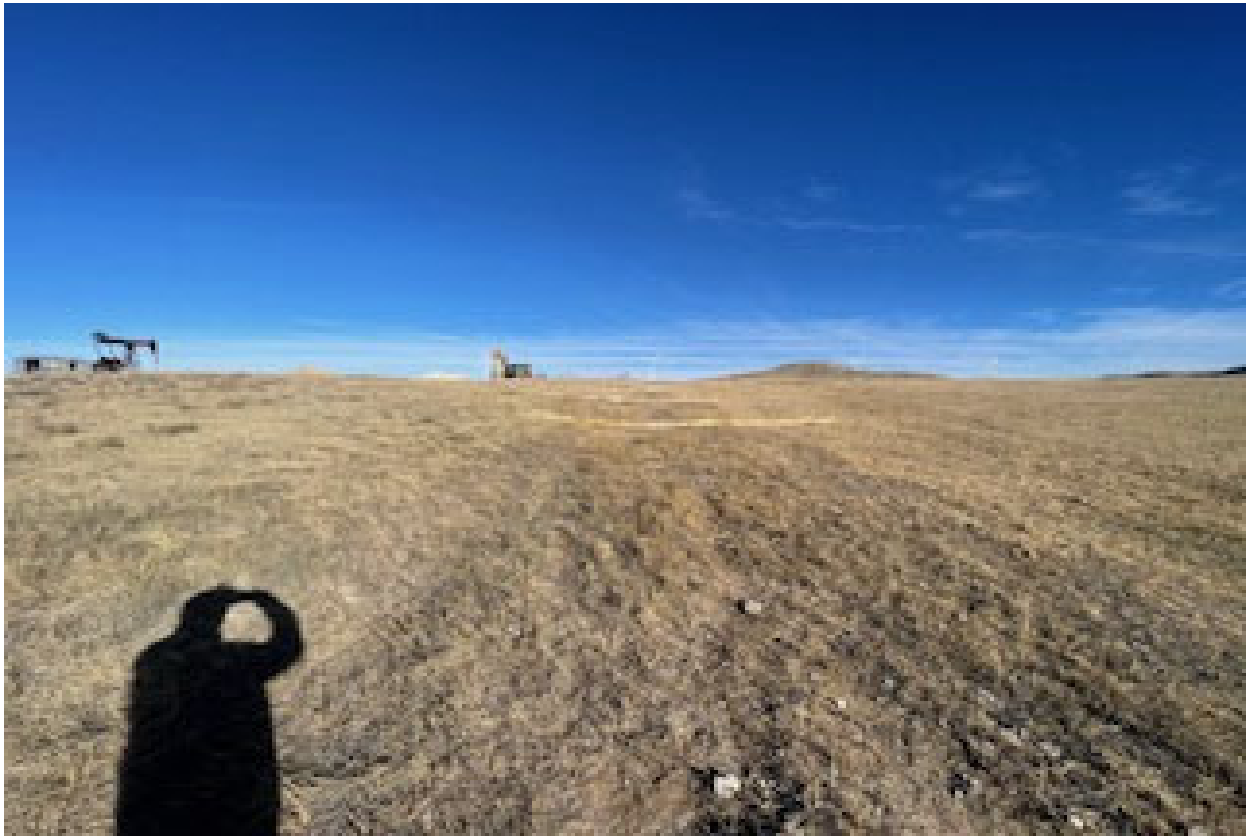
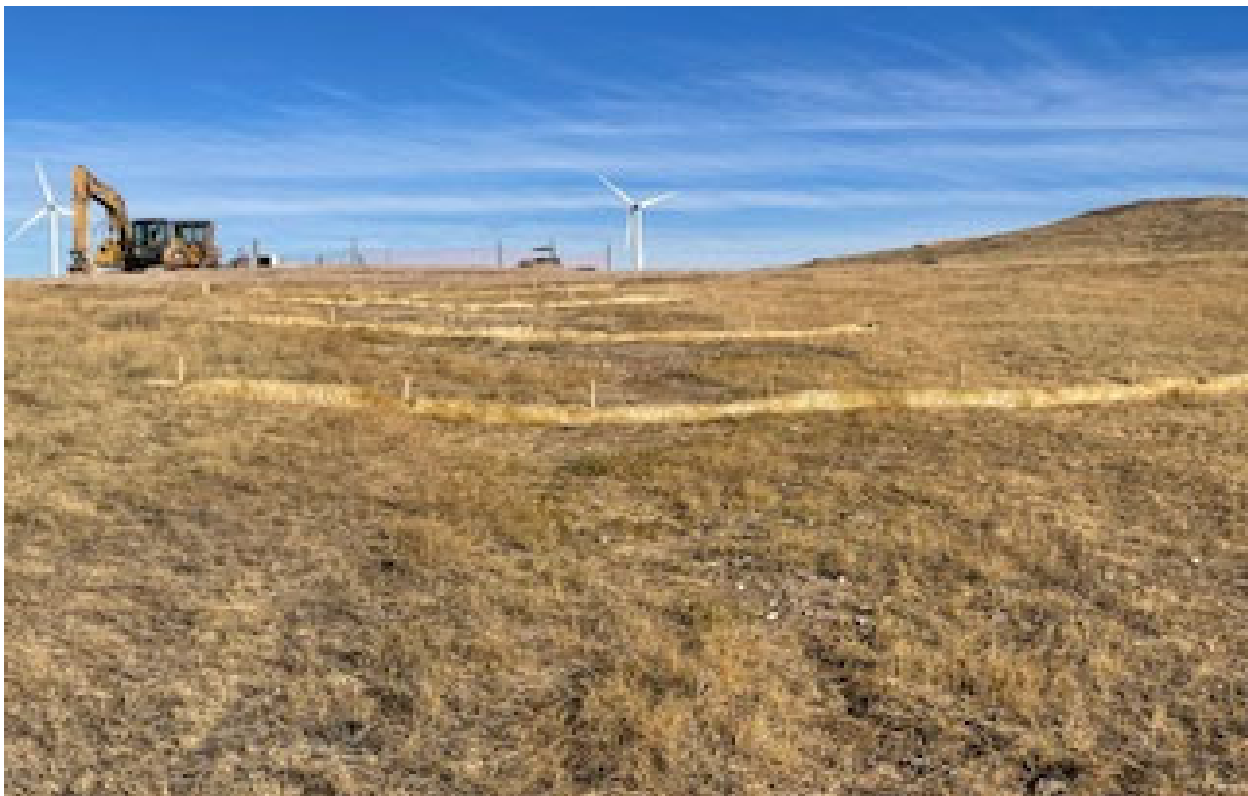
Straw Wattles installed South of old Separator Area, Standing South of wattles looking North

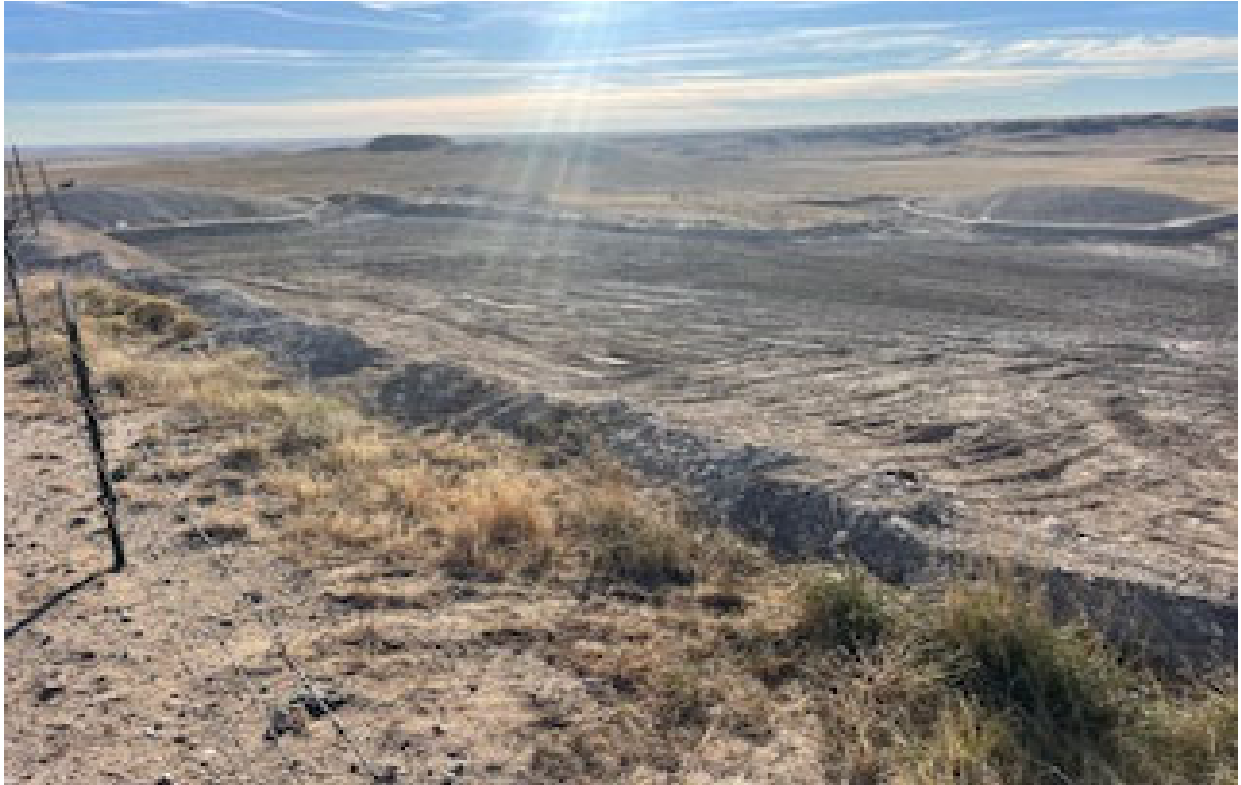
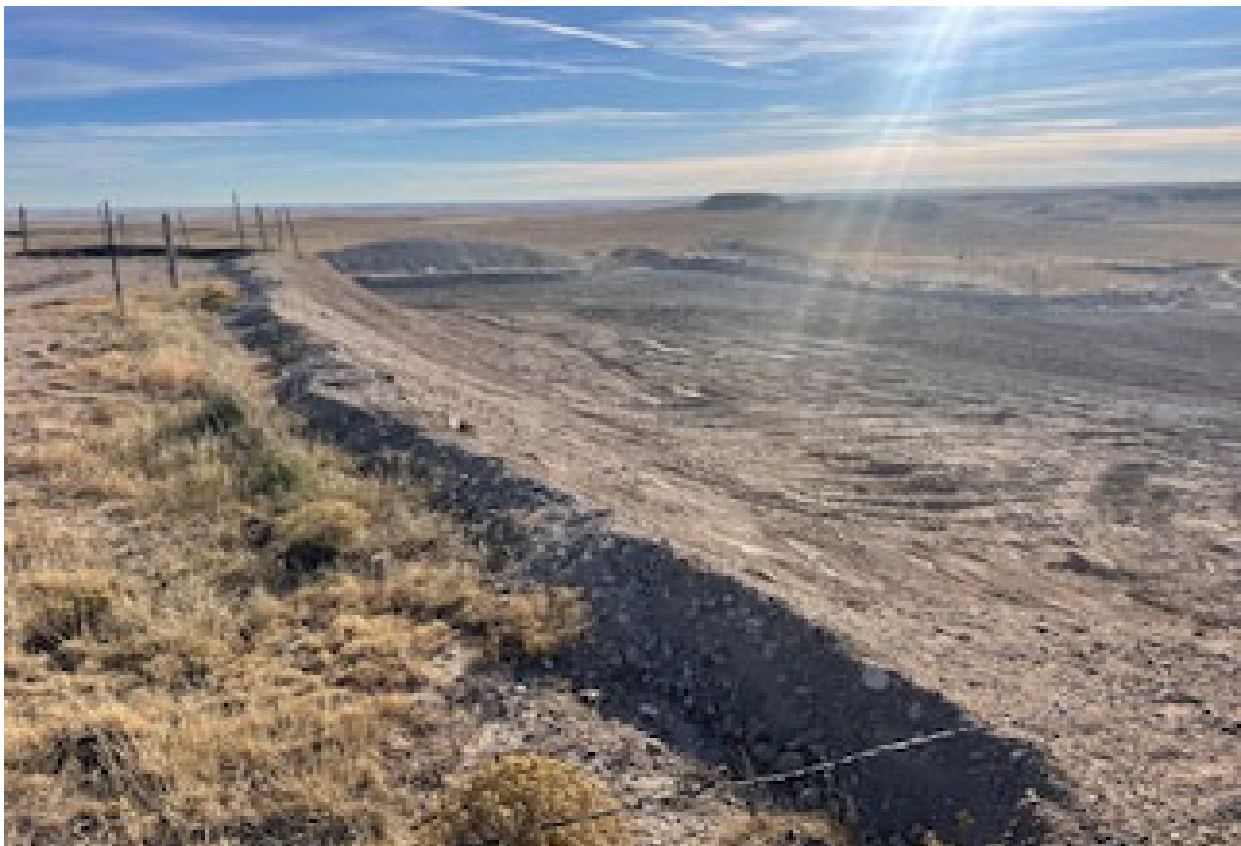
Noxious Weeds removed from excavation area and ripped for storm water erosion

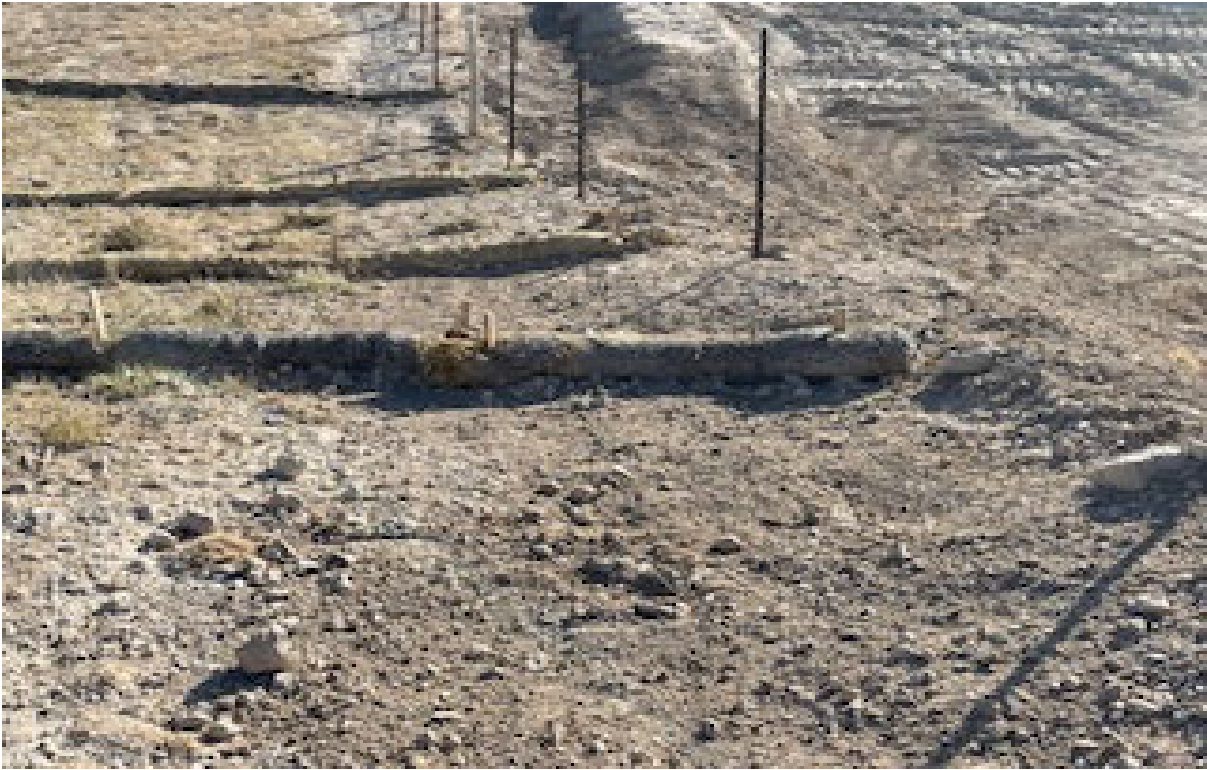
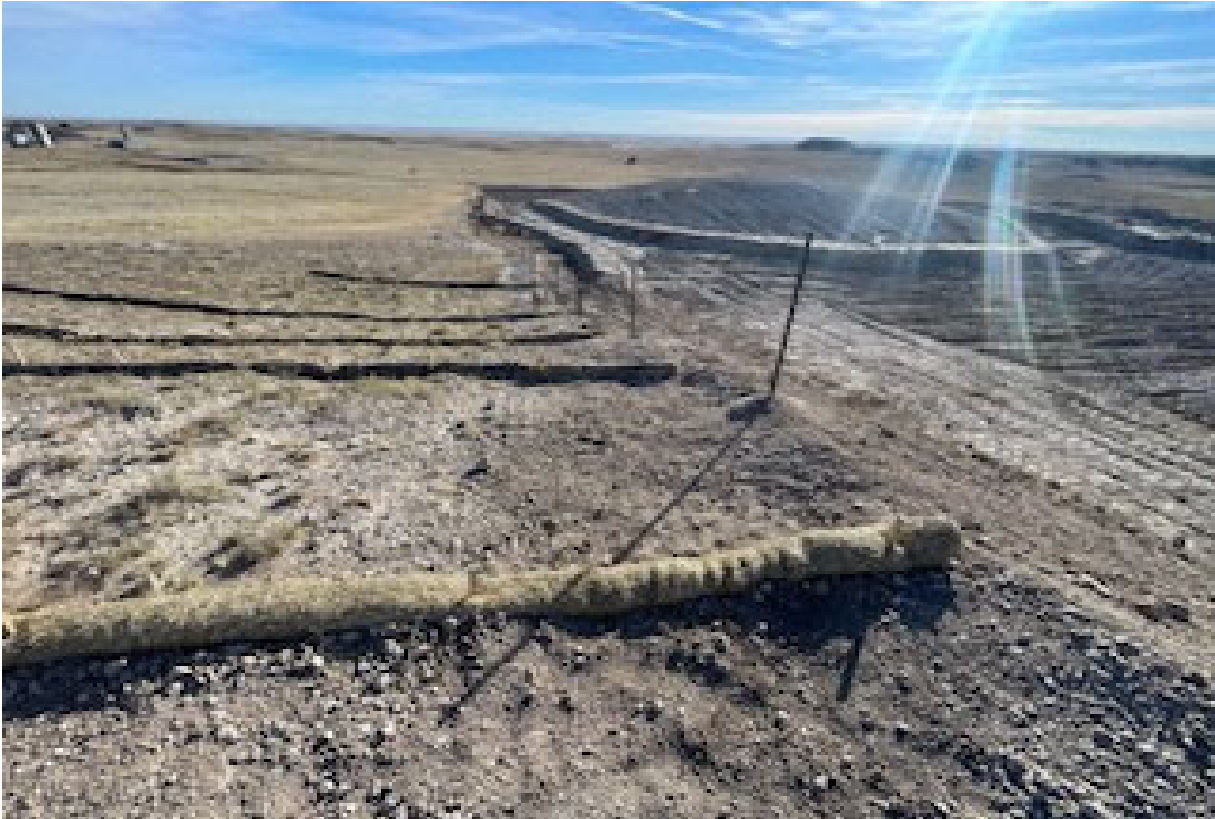
Area South of Pumping jack, Storm water erosion fixed and Straw Wattles installed, trenched and backfilled

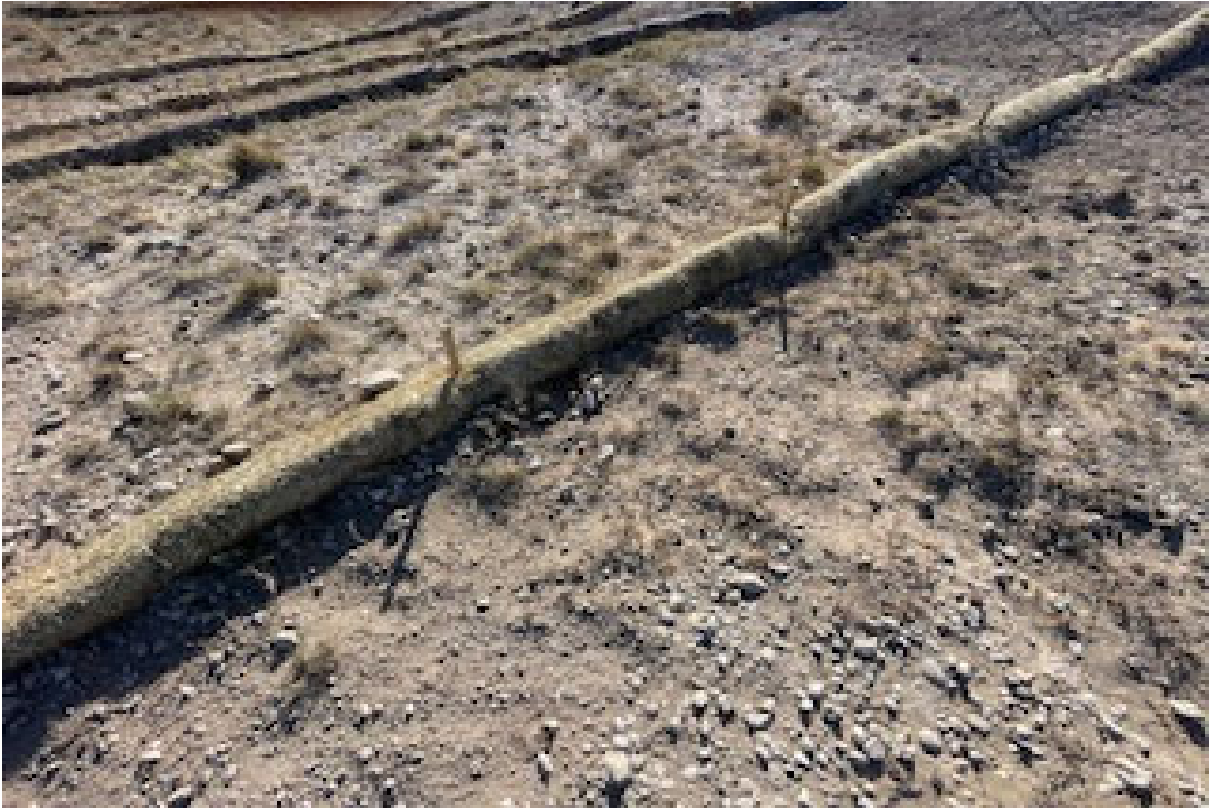
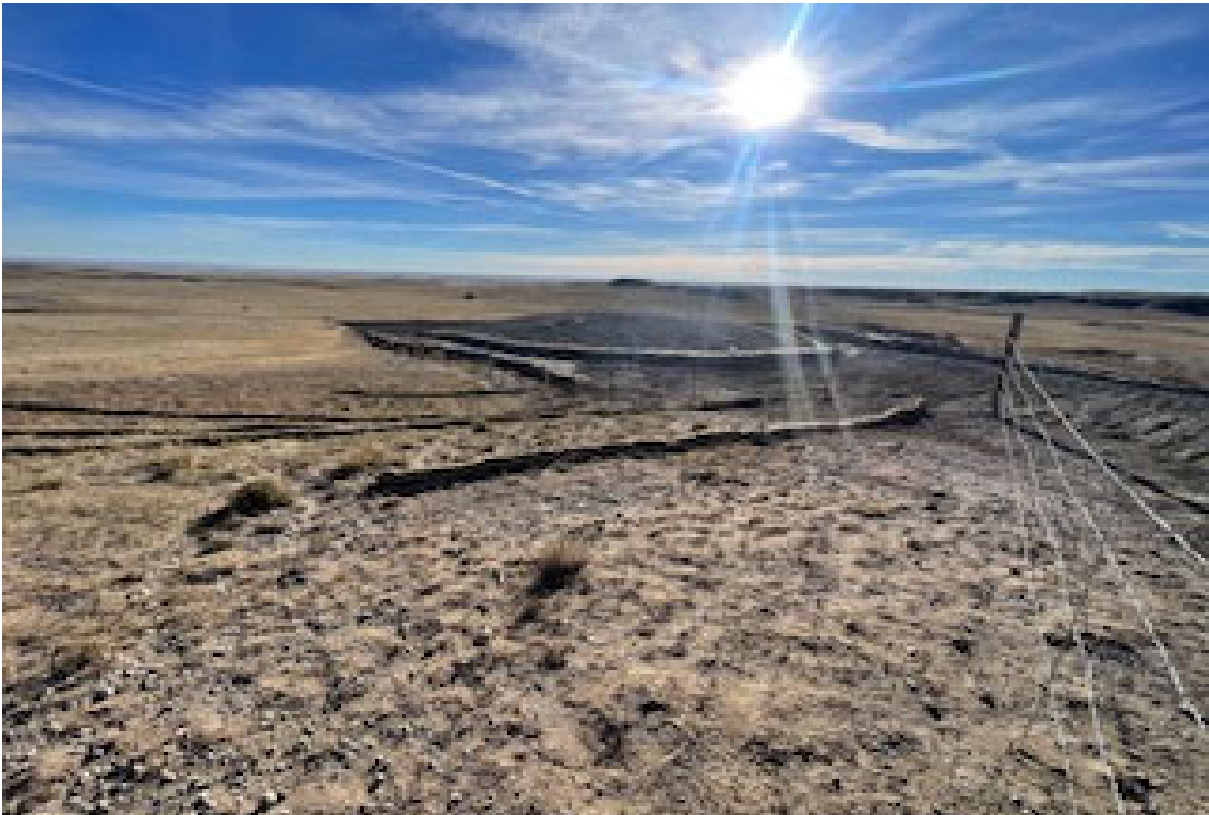
Straw Wattles installed South of Pump Jack, trenched and backfilled

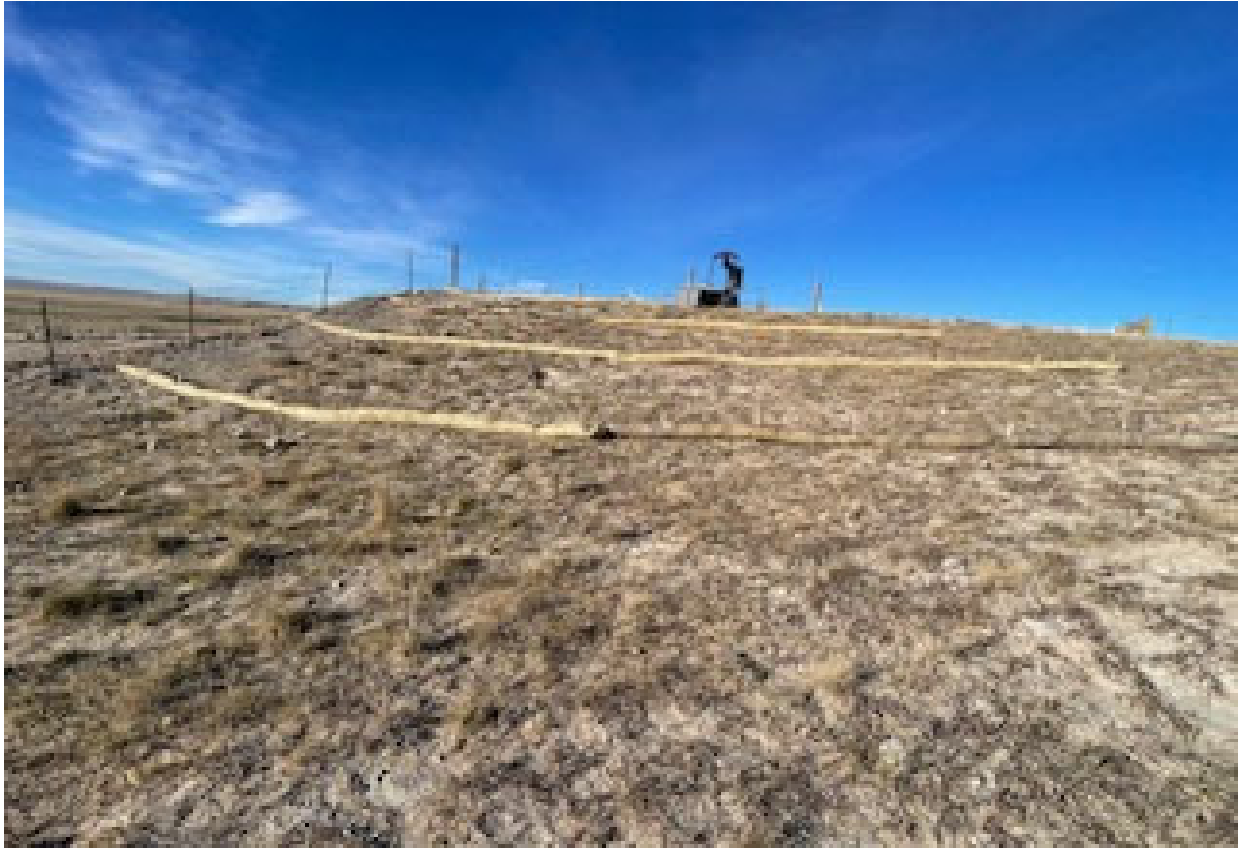
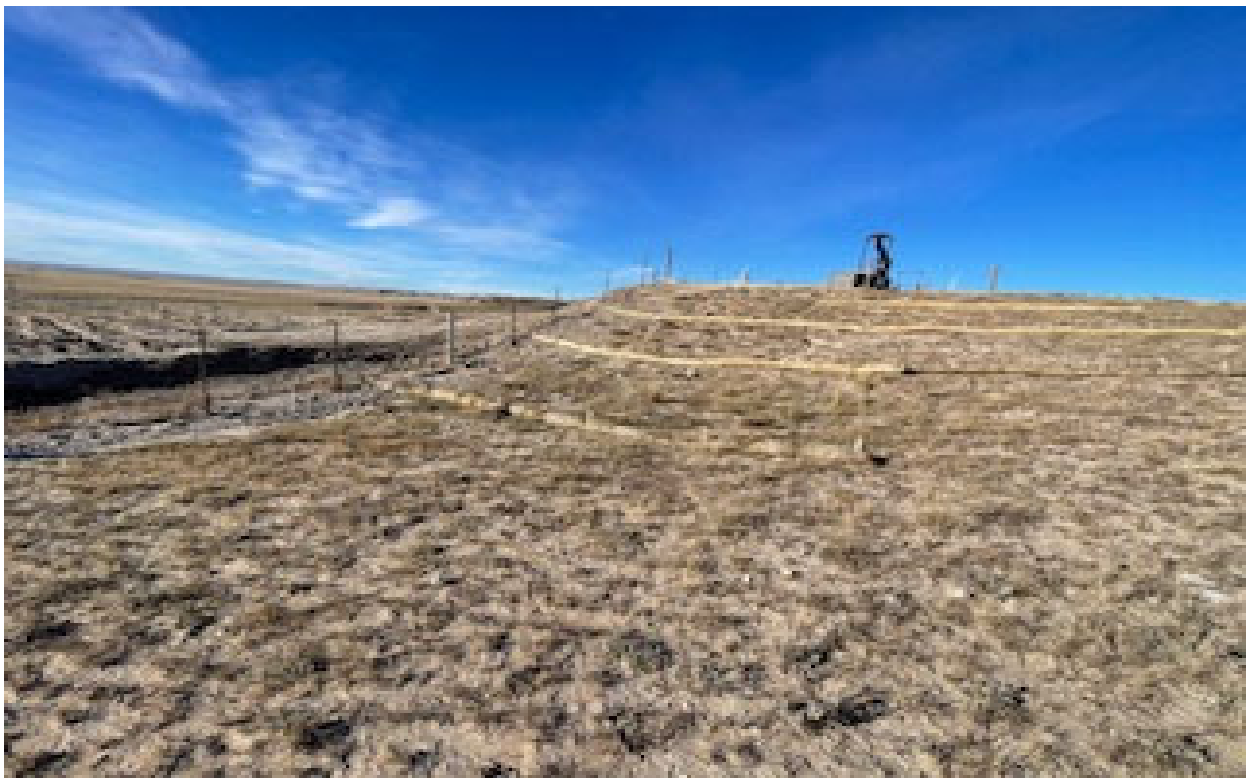
Straw Wattles installed South of Pump Jack looking from the South to the North

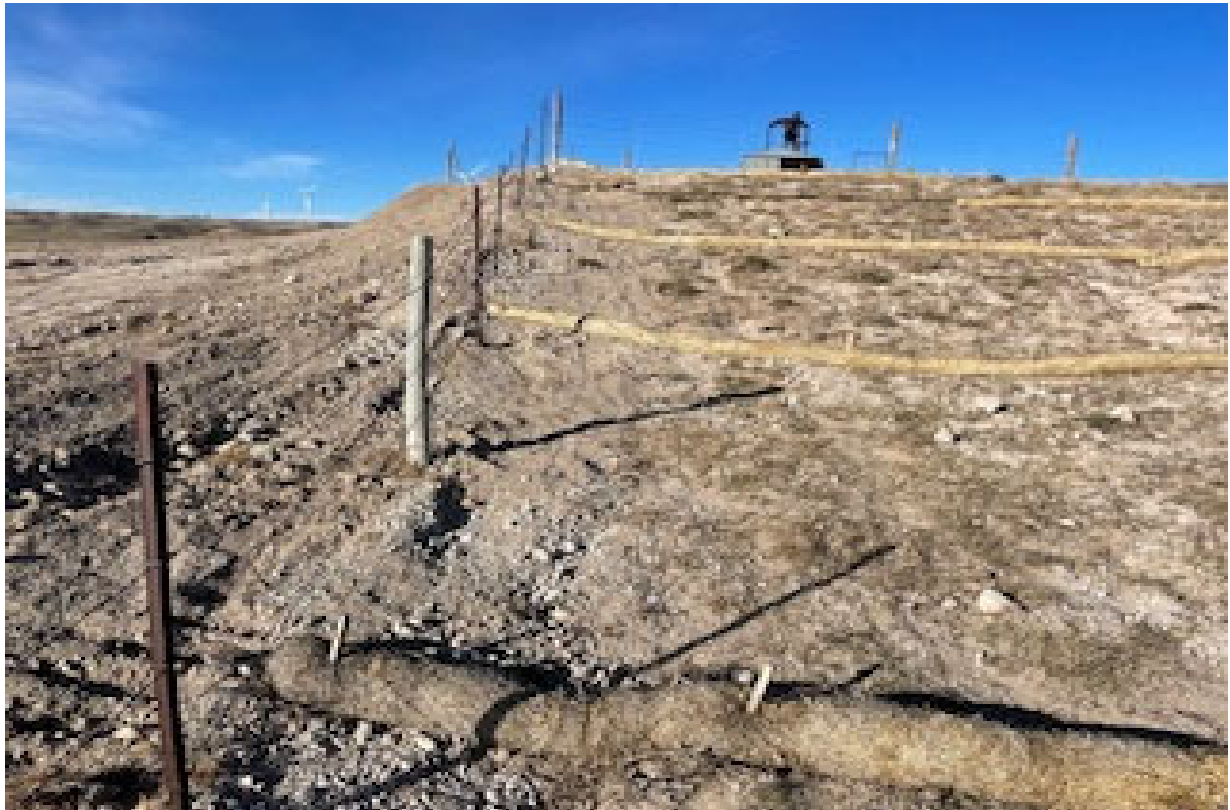
Straw Wattles installed and Storm water erosion fixed

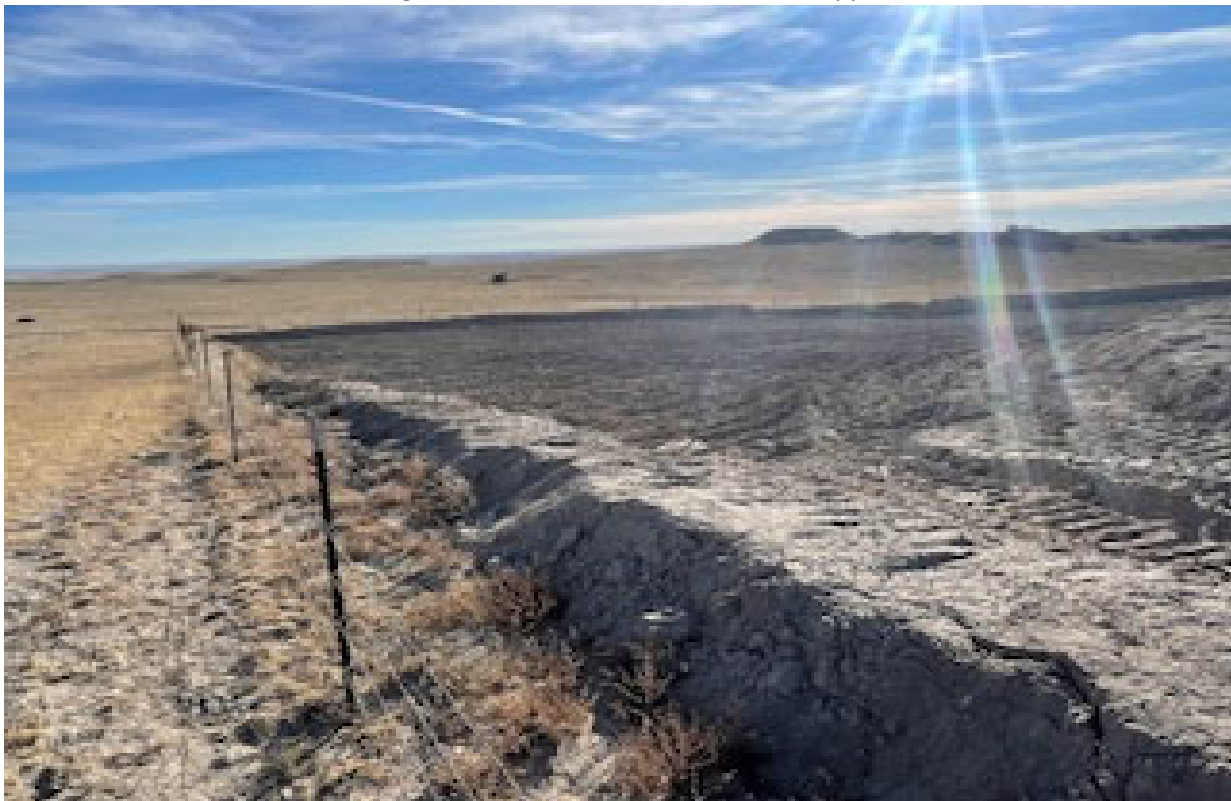
East side of excavation looking South, Weeds removed and area ripped for storm water erosion

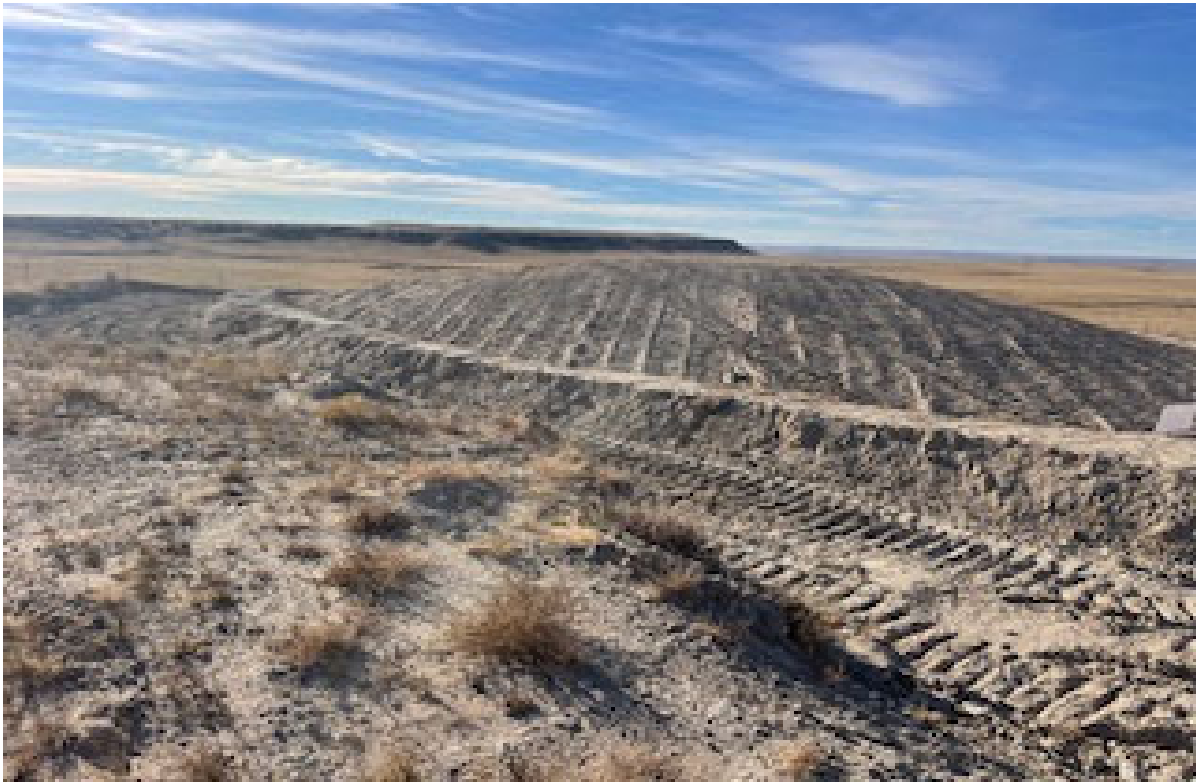
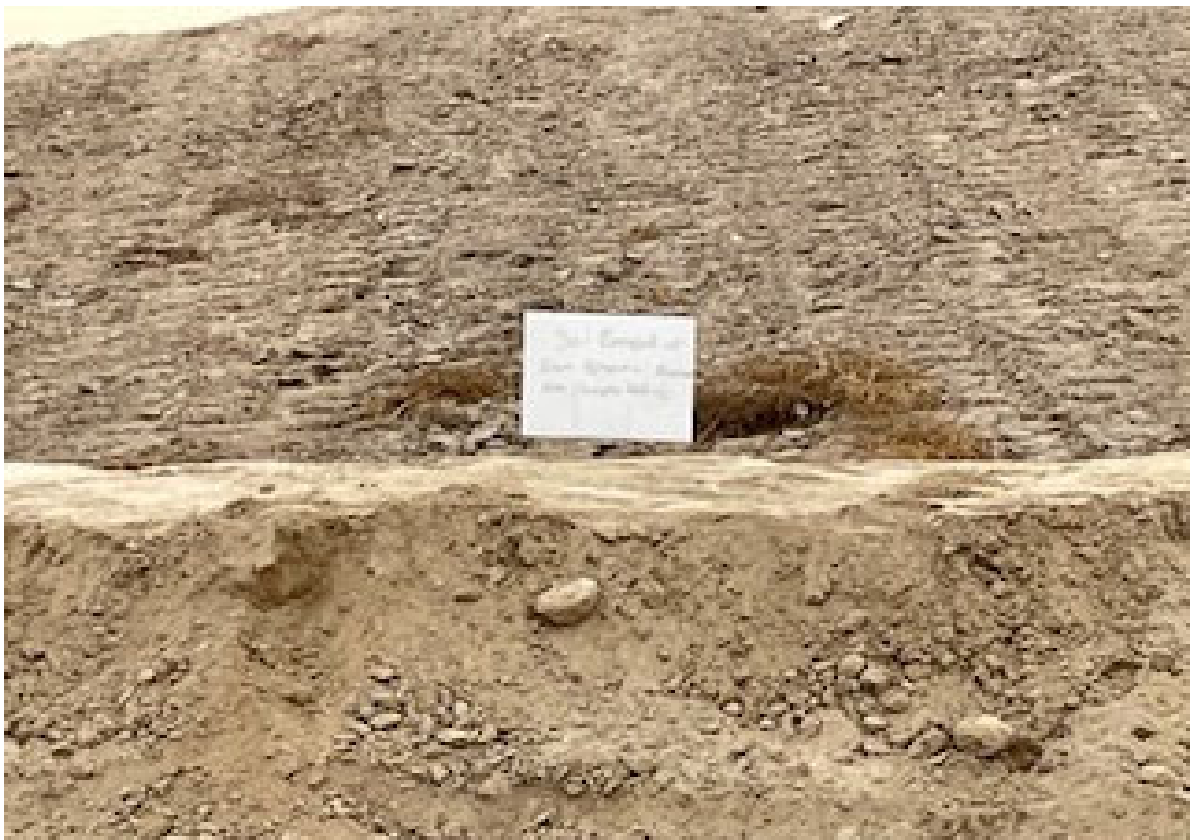
Scraped up soil from potential impacted area West of the excavation with a berm and signage

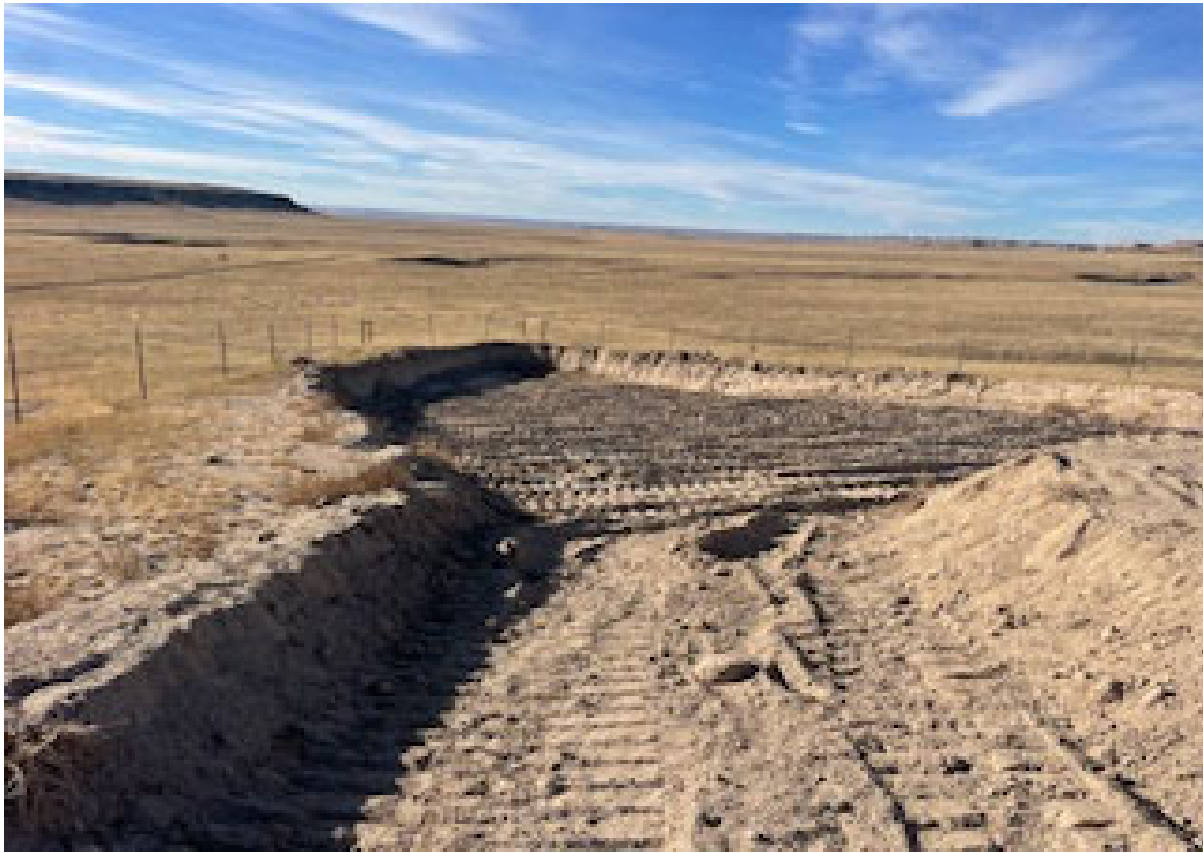
West end of excavation, weeds removed and ripped for storm water erosion

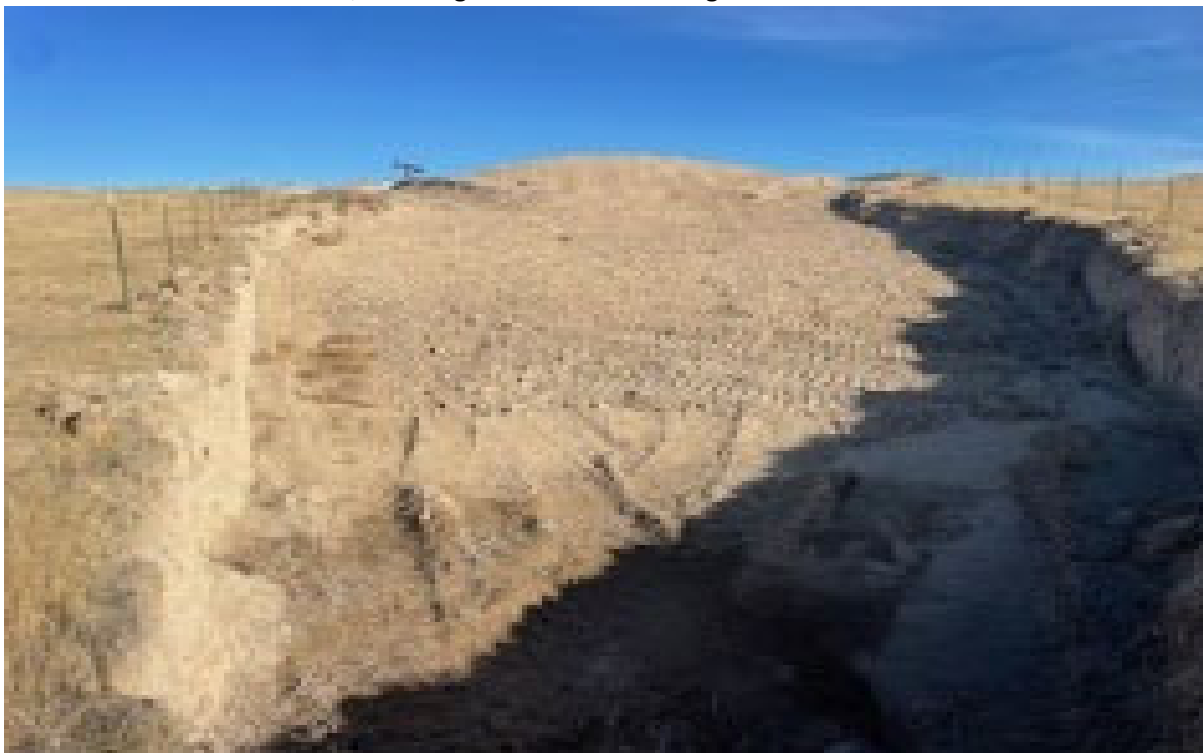
West end of excavation, standing on West end looking East. All trash and debris removed
