Western Operating Propst B #2 NESE Sec 27 11 N 53W Photo Log

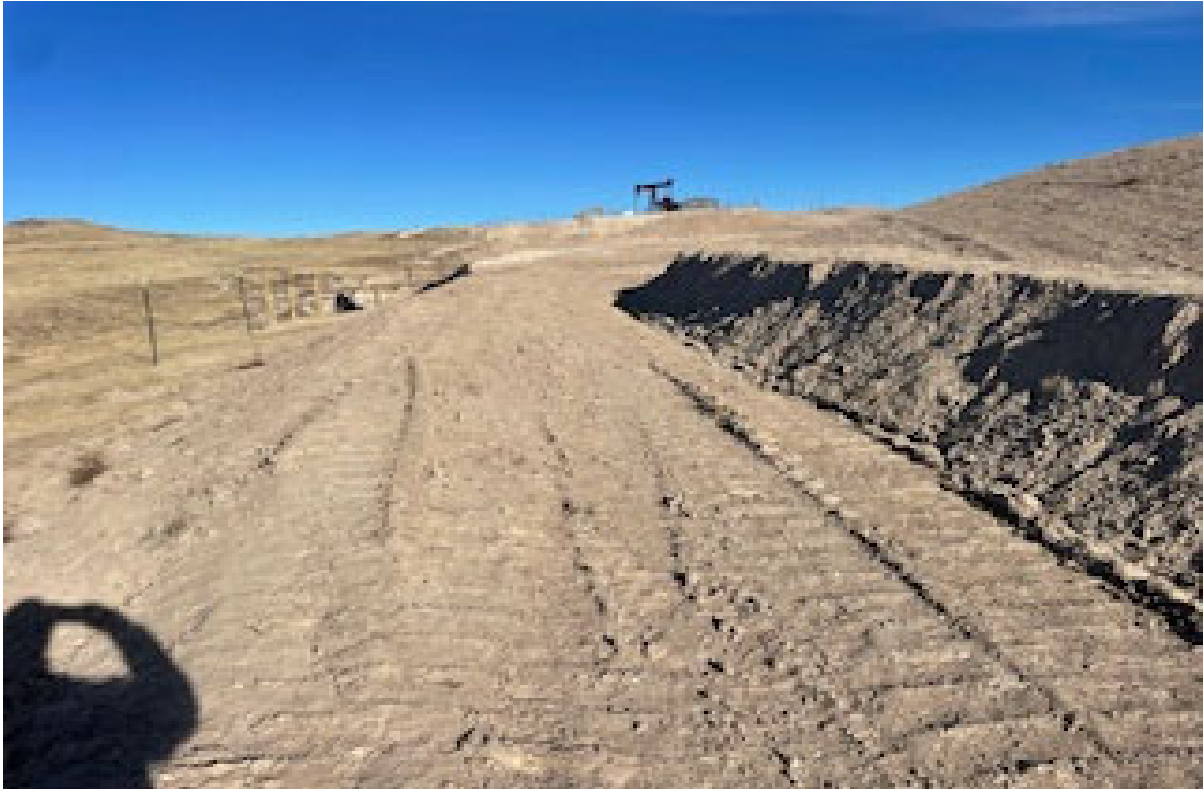
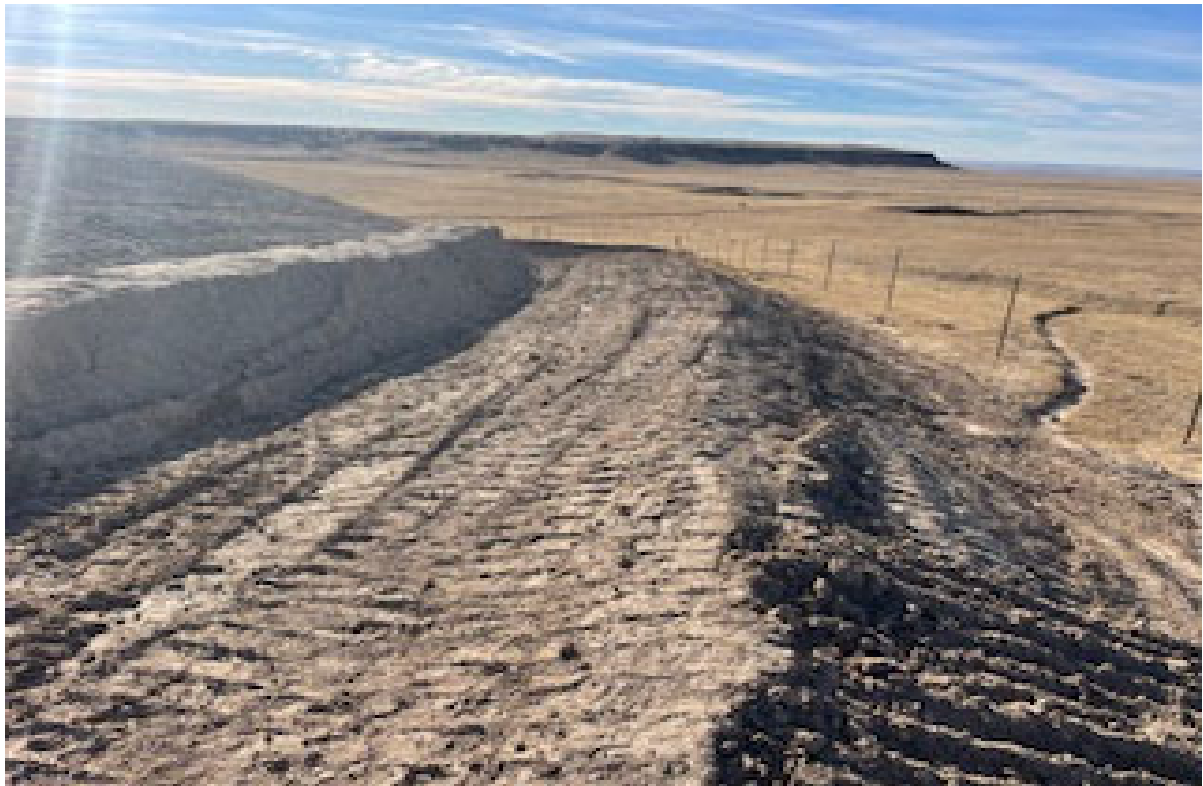
Northwest end of excavation. Perimeter berm has been improved and track packed

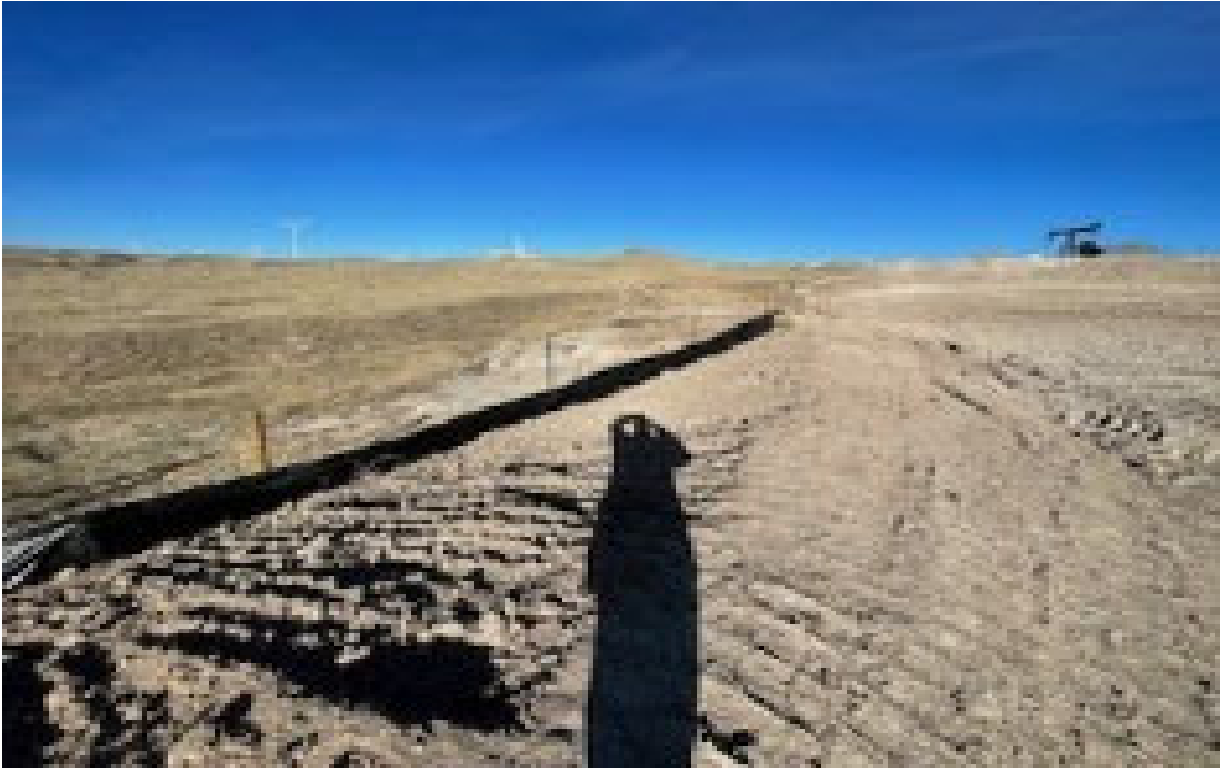
Silt fence has been installed for containment from sediment transporting into natural drainage gully

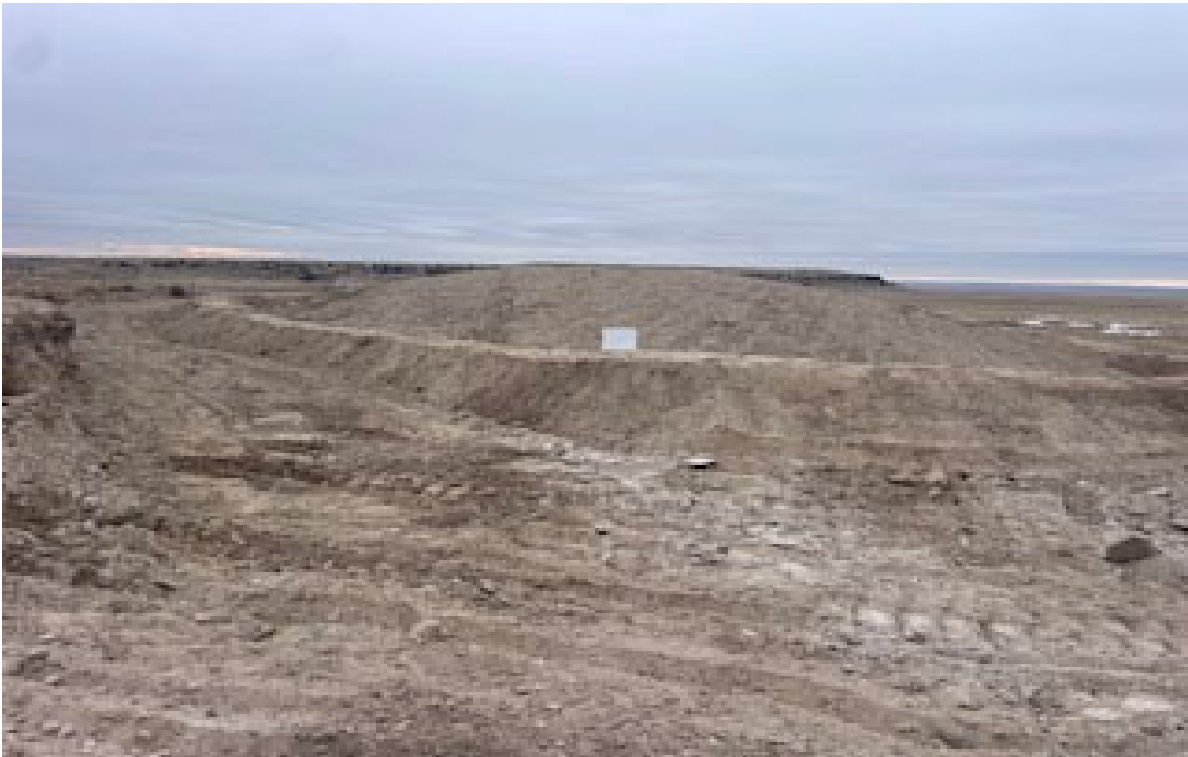
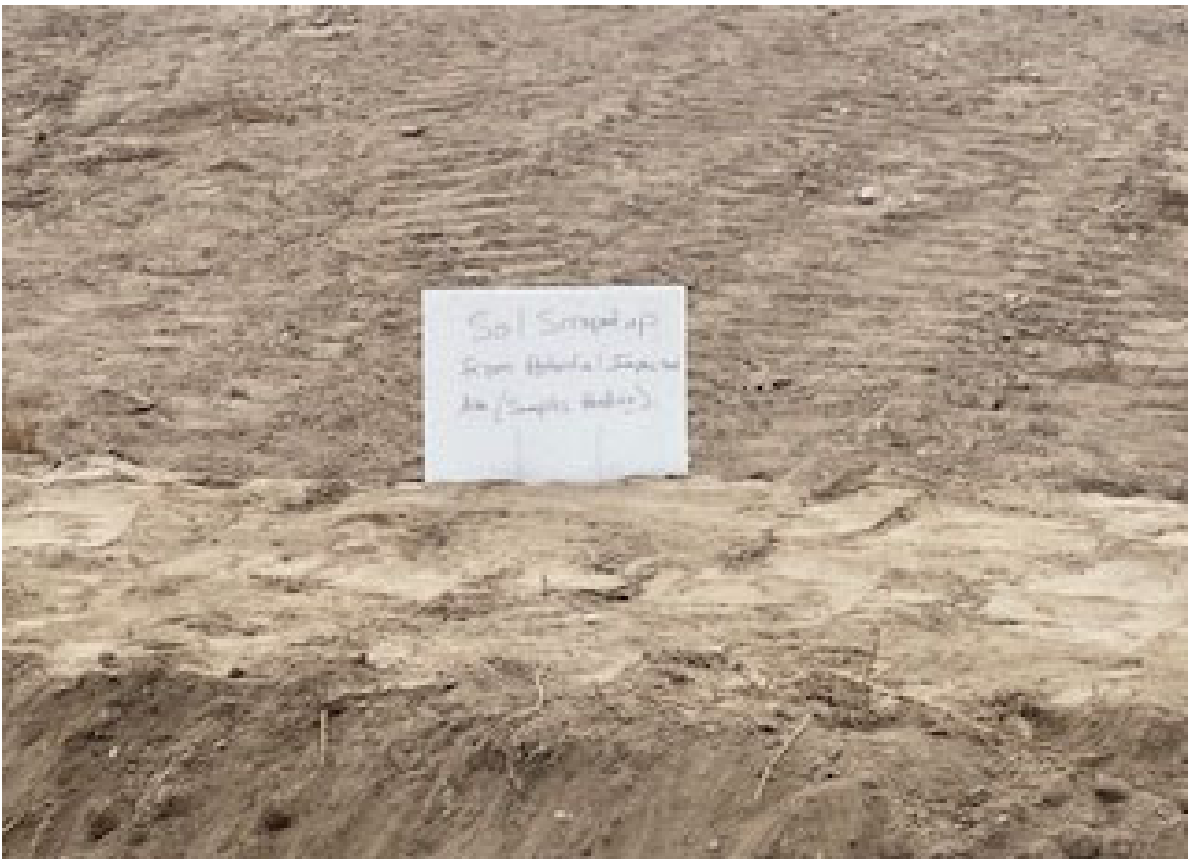
Soil scraped up from potential impacted area on South end of excavation with a berm and signage

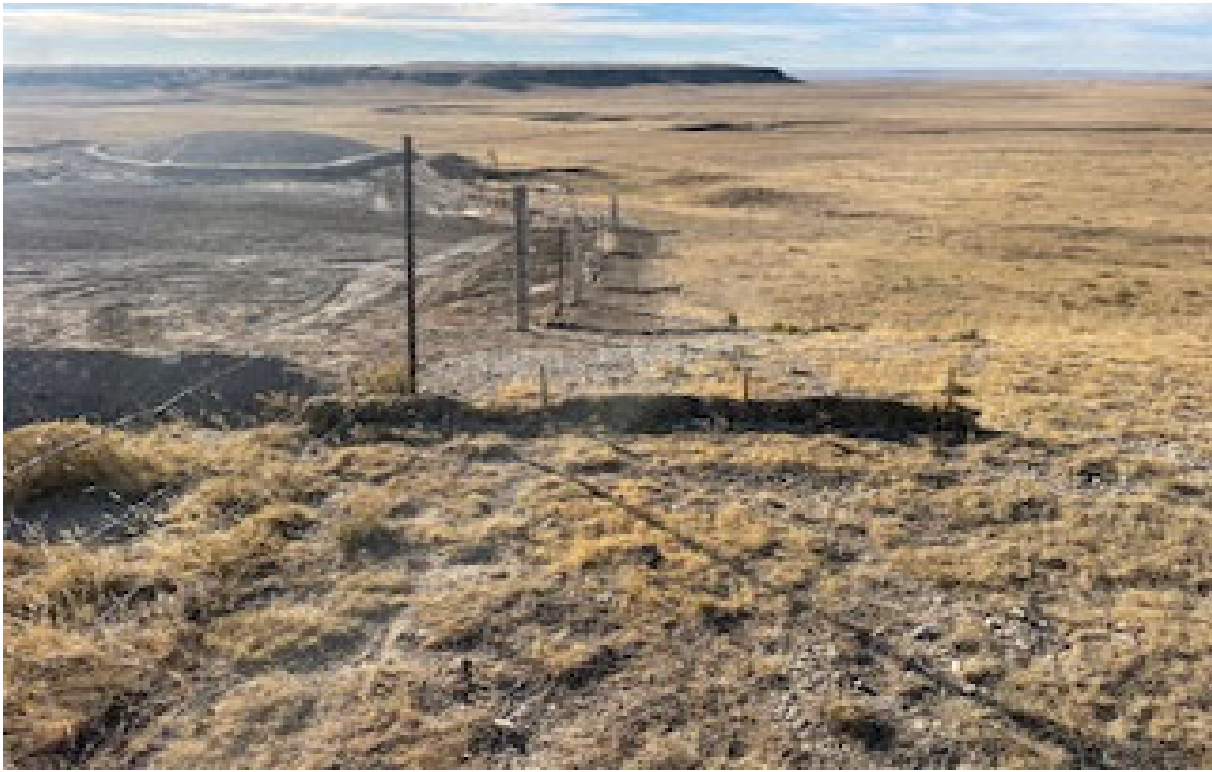
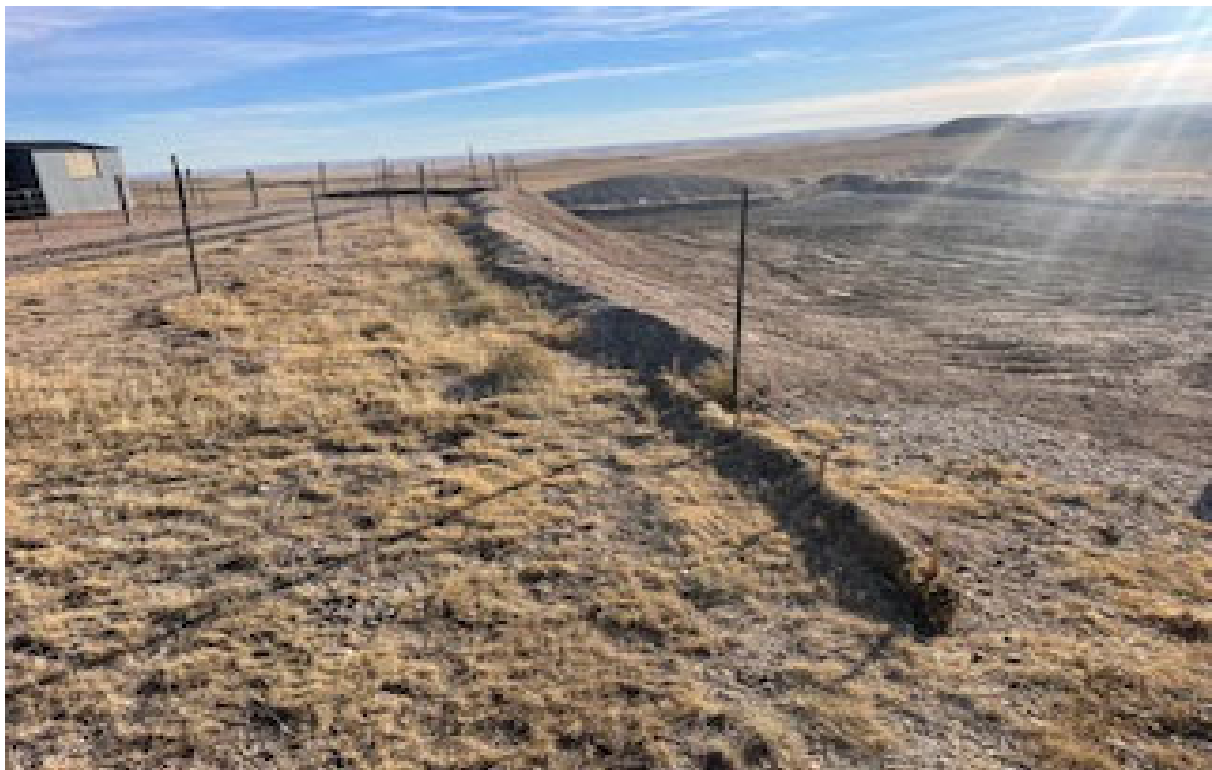
Straw Wattles installed on North end of excavation, trenched and backfilled

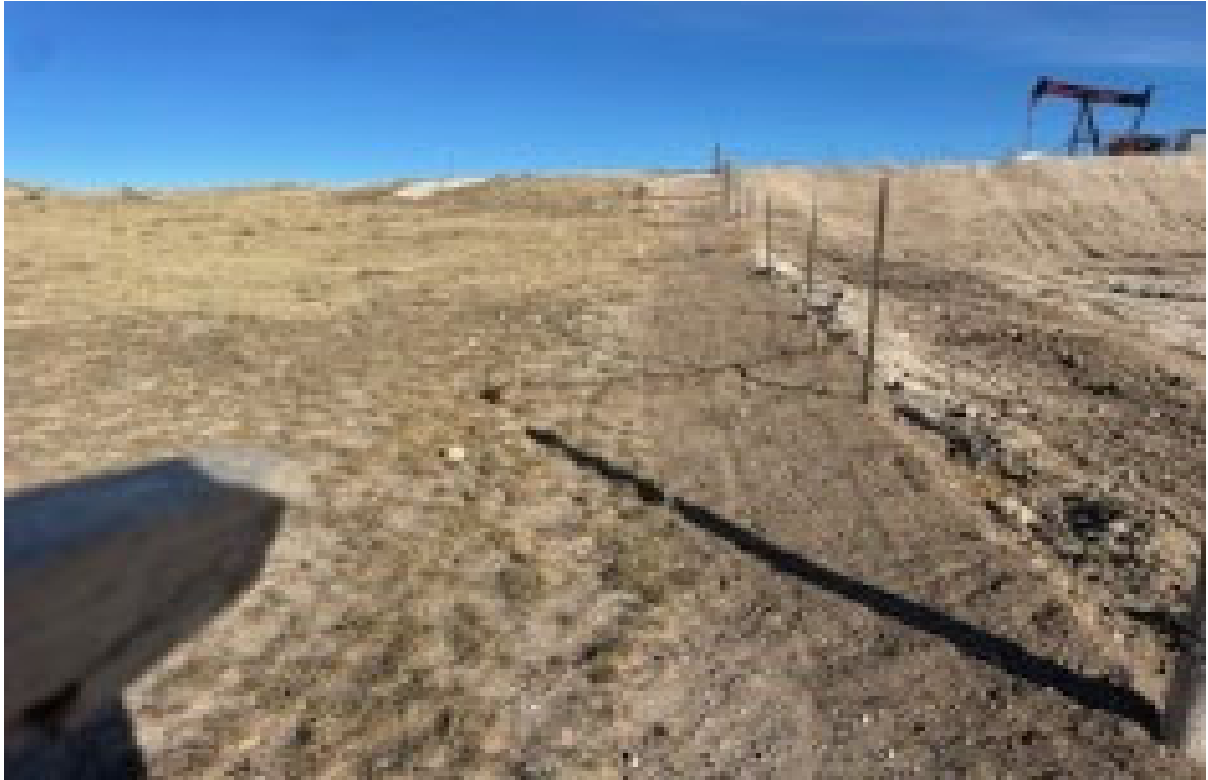
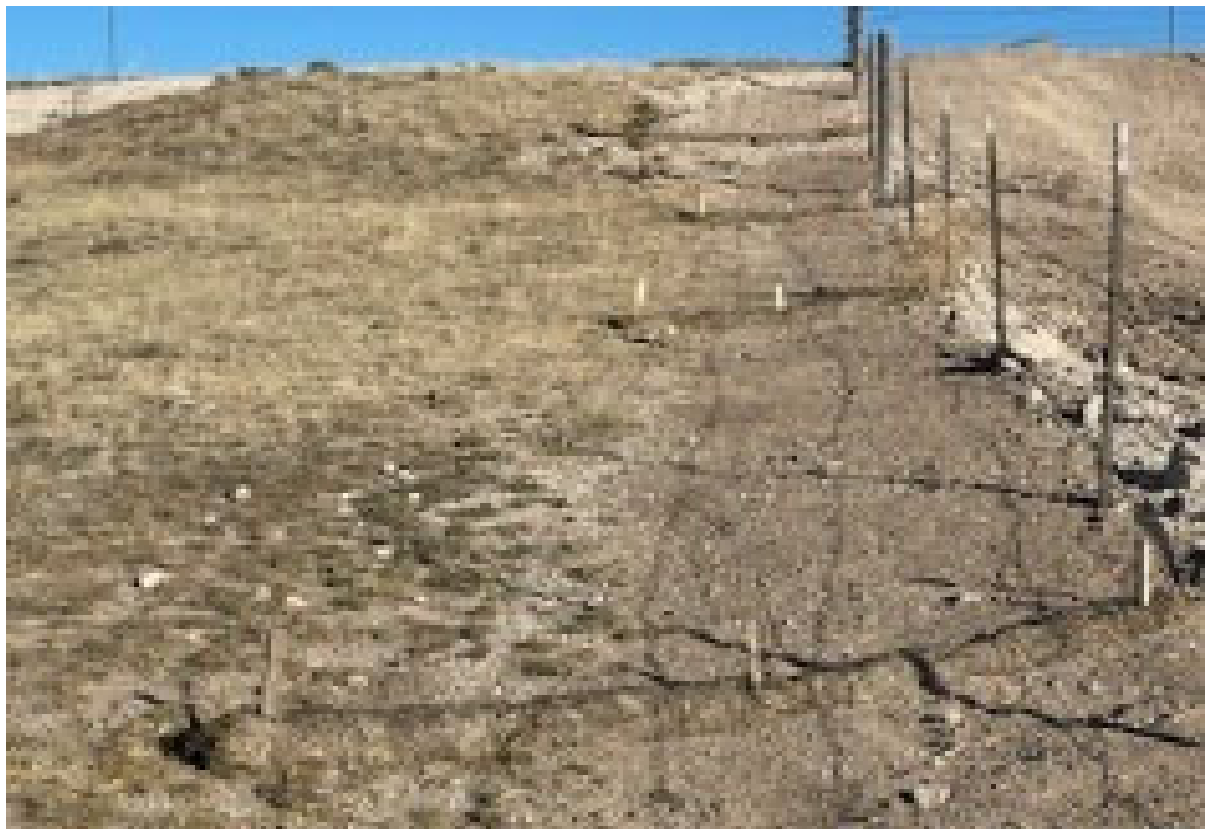
Straw Wattles installed on North end of excavation
