## Inspection Photos

Location Name: TEP ROCKY MOUNTAIN LLC FEDERAL RMV 33-20 Pad

Location ID: 335136

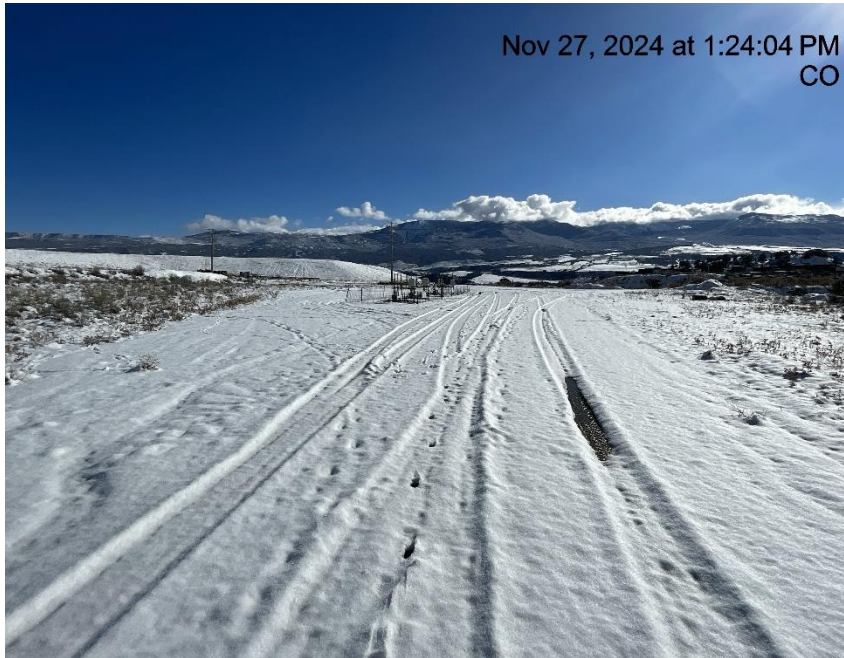
Photo # 1602 From entrance to location

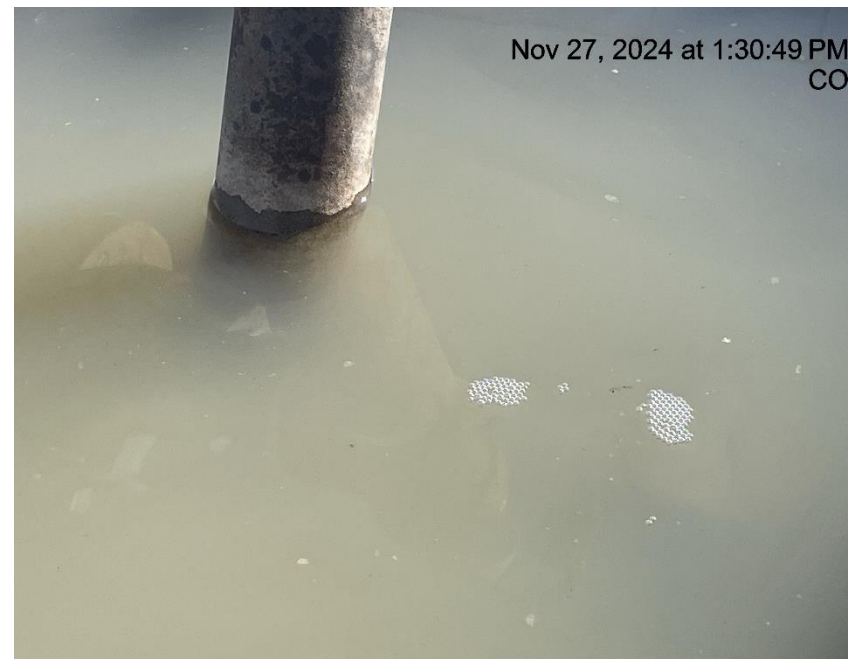
Photo # 1605 Mechanical Condition - possible bradenhead leak on the RMV 33-20 well

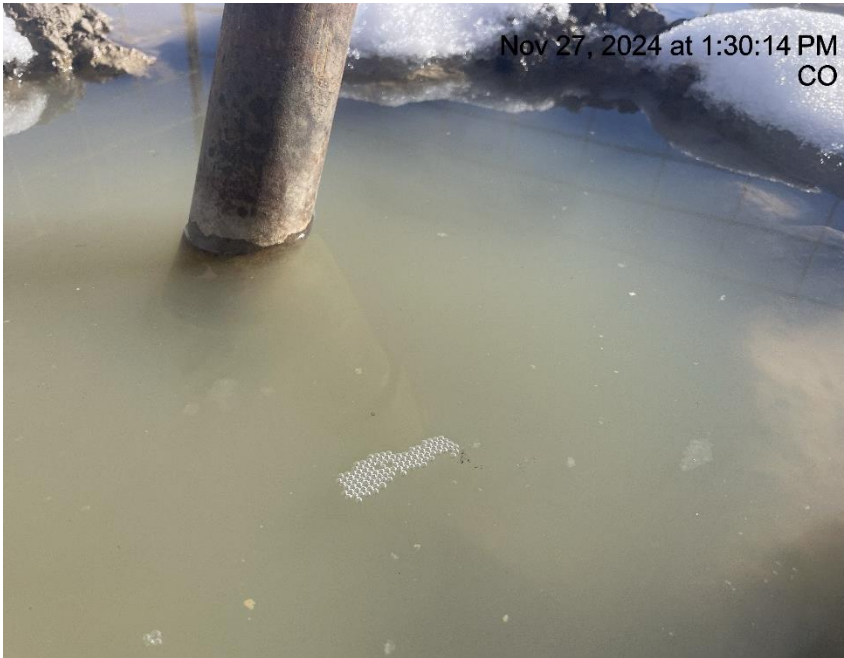
**Photo # 1606 Mechanical Condition - possible bradenhead leak on the RMV 33-20 well**

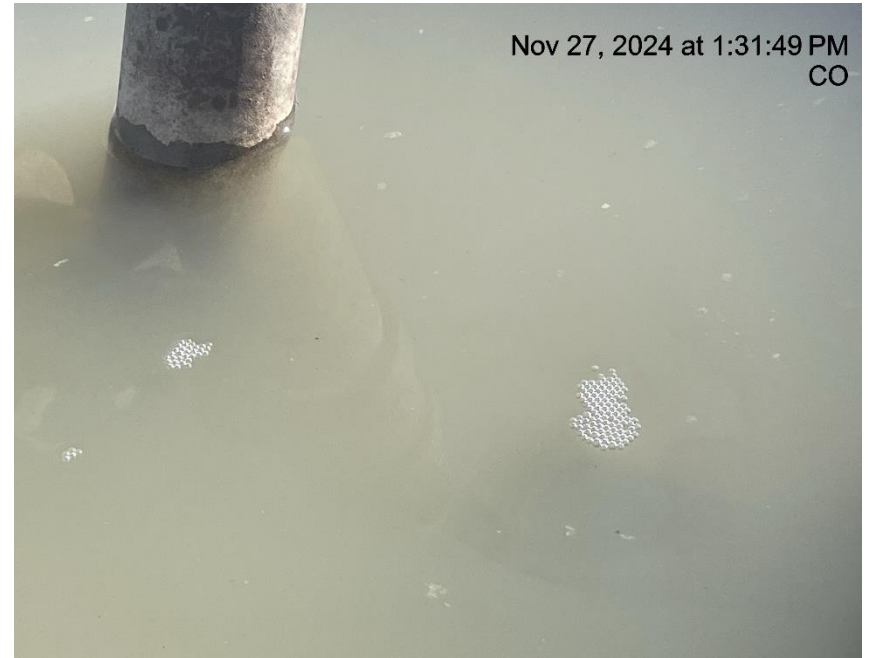
**Photo # 1607 Mechanical Condition - possible bradenhead leak on the RMV 33-20 well**

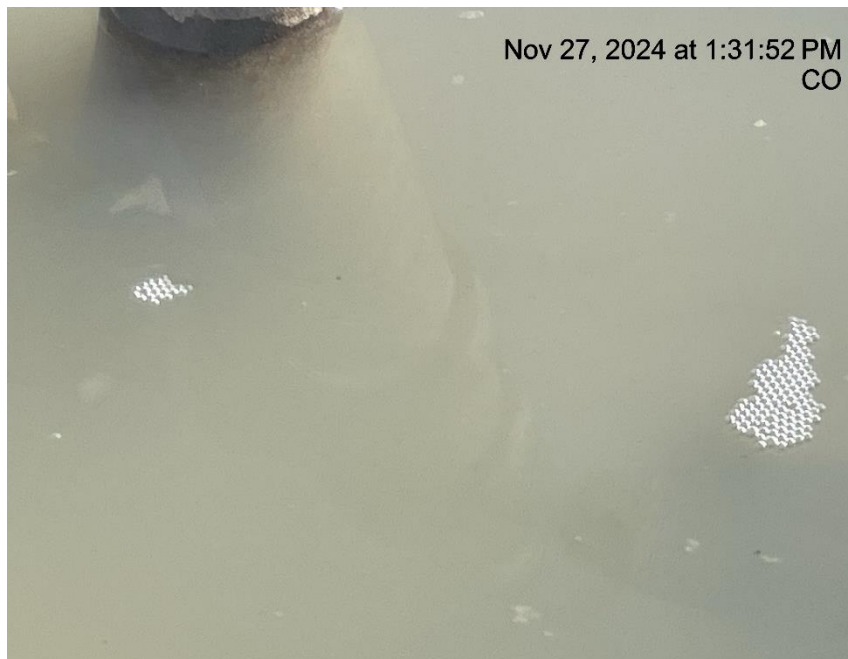
**Photo # 1608 Mechanical Condition - possible bradenhead leak on the RMV 33-20 well**
