Operator: BONANZA CREEK ENERGY OPERATING COMPANY LLC

Location Name: PRONGHORN-65N61W 8SWSW

Loc ID: 305849

Inspection: 708201749

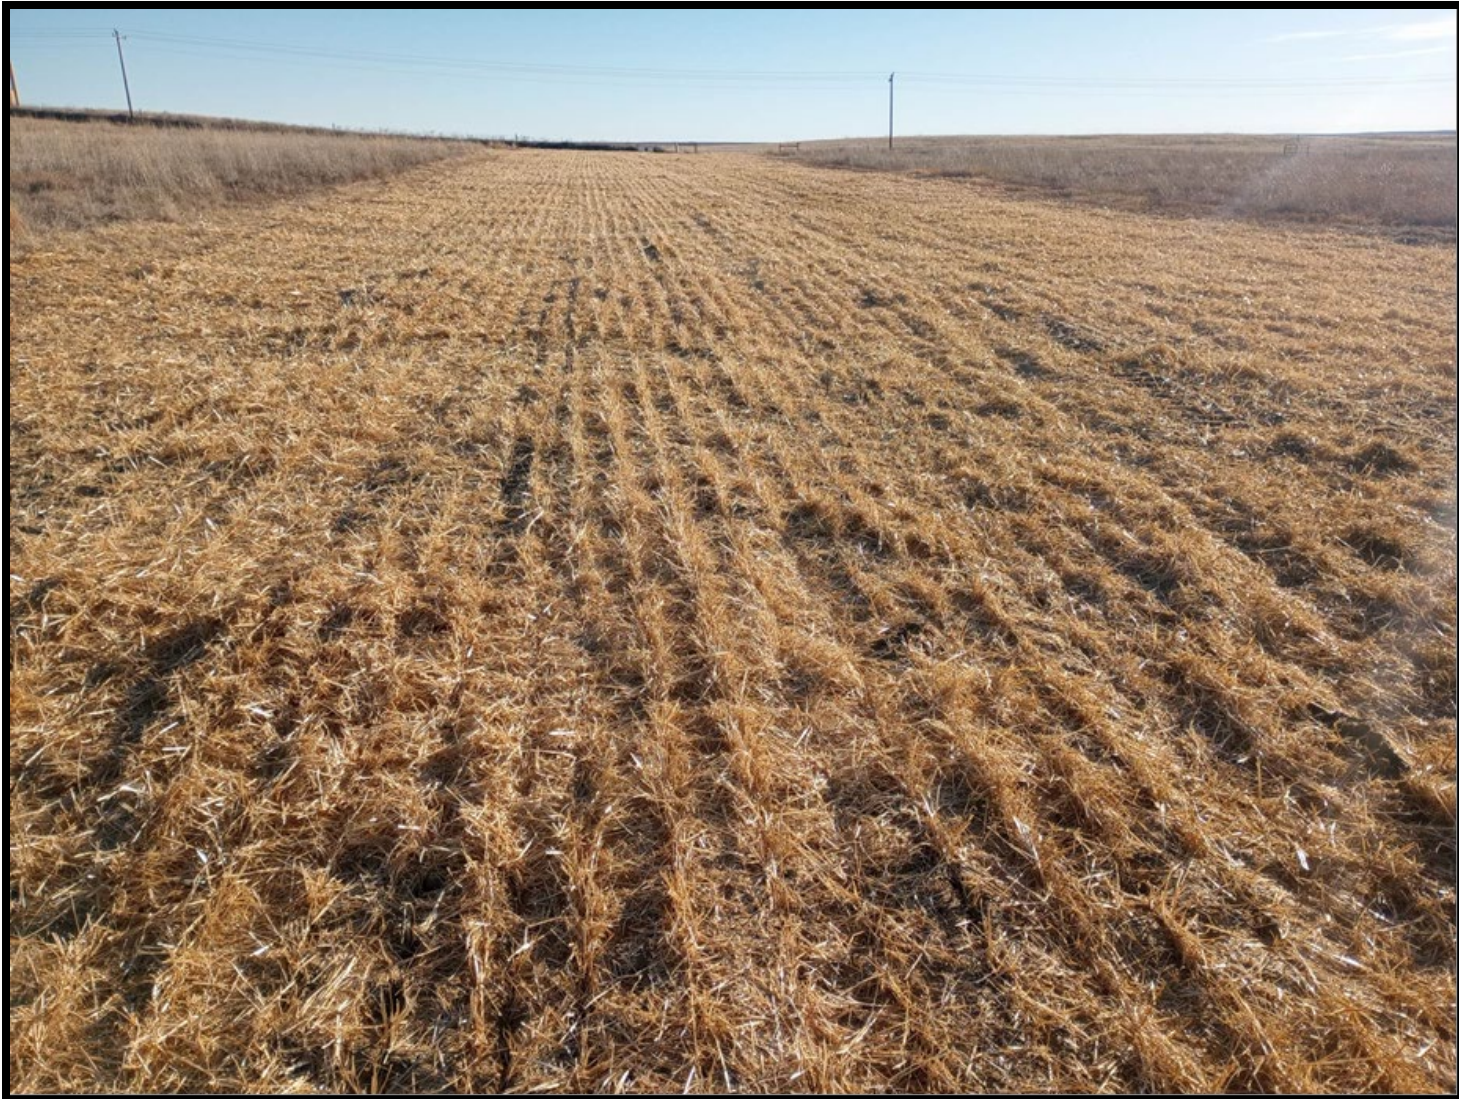
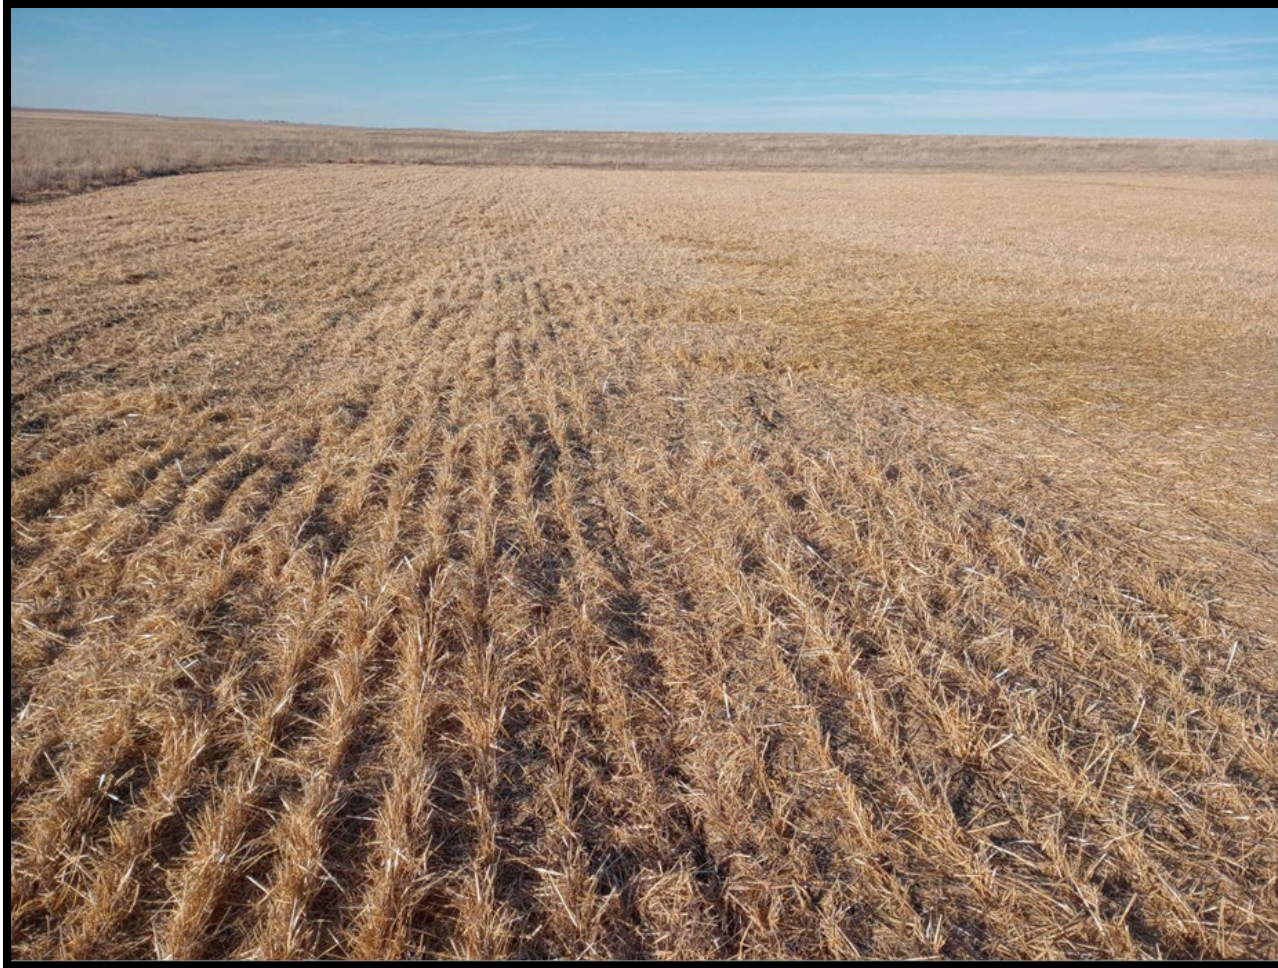
CA: This location does not comply with Rule 1004. It does not appear that the former location or access road has been recontoured or graded to match the existing grade/topography. Additional reclamation work is required to restore grade at the disturbance area. Refer to attached inspection photos. Comply with Rule 1004. Recontour/grade and reseed disturbance areas using a seed mixture requested by the surface owner, or a mixture prescribed by the local county NRCS. Establish vegetation with total perennial, non-invasive uniform plant cover of at least eighty (80) percent of reference area levels. Ensure erosion controls are implemented to stabilize the seeded soil. Operator shall continue to monitor and manage this site until the location meets Rule 1004 standards, including stormwater and weed management.

CA Resolution: Operator has reported that the location has been recontoured and areas of disturbance have been reseeded to comply with Rule 1004. Operator will continue to monitor and manage the location to stay in compliance with reclamation activities.
