Inspection Photos

Location Name: TEP ROCKY MOUNTAIN LLC CLOUGH RMV 3-20 Pad

Location ID: 323886

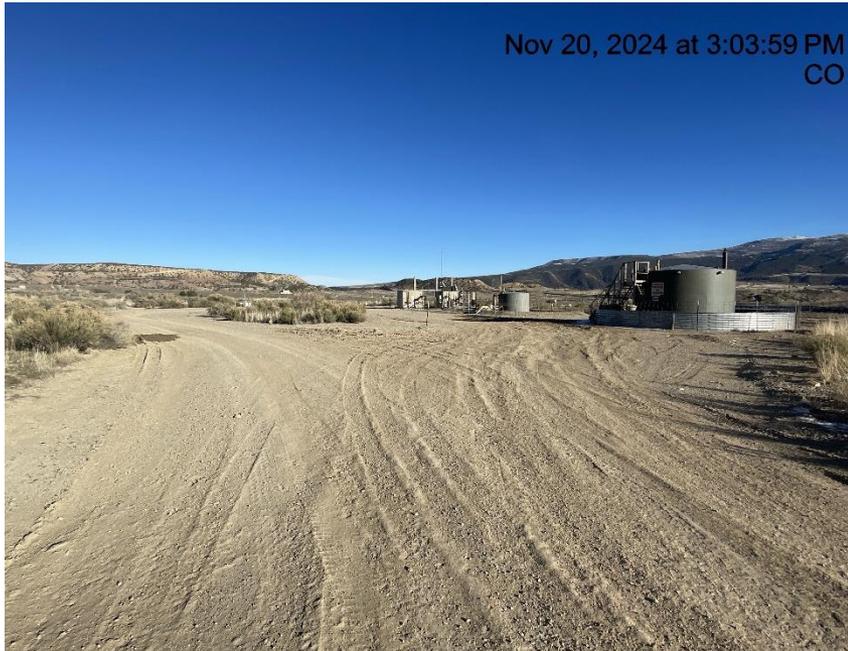
Photo # 484 From entrance to location

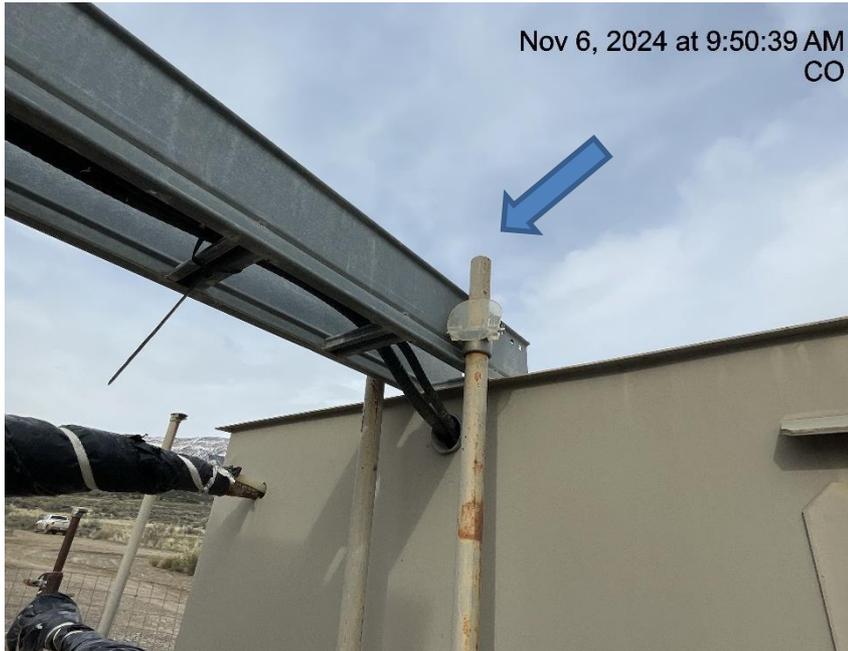
Photo # 9090 From inspection 708904991 conducted on 11/06/2024 PRV vent line does not comply with CECMC pressure safety device rules

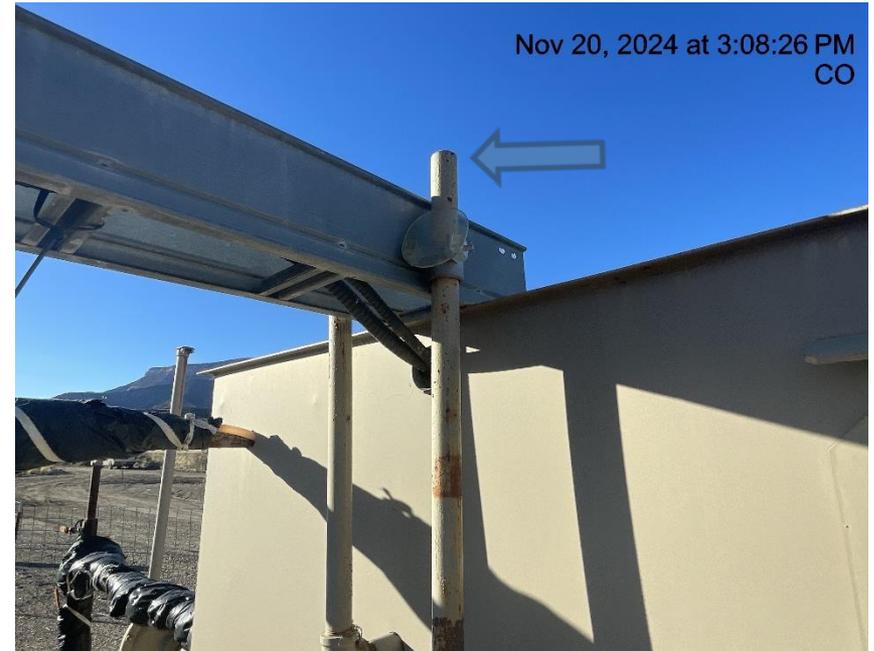
Photo # 490 PRV vent line does not comply with CECMC pressure safety device rules

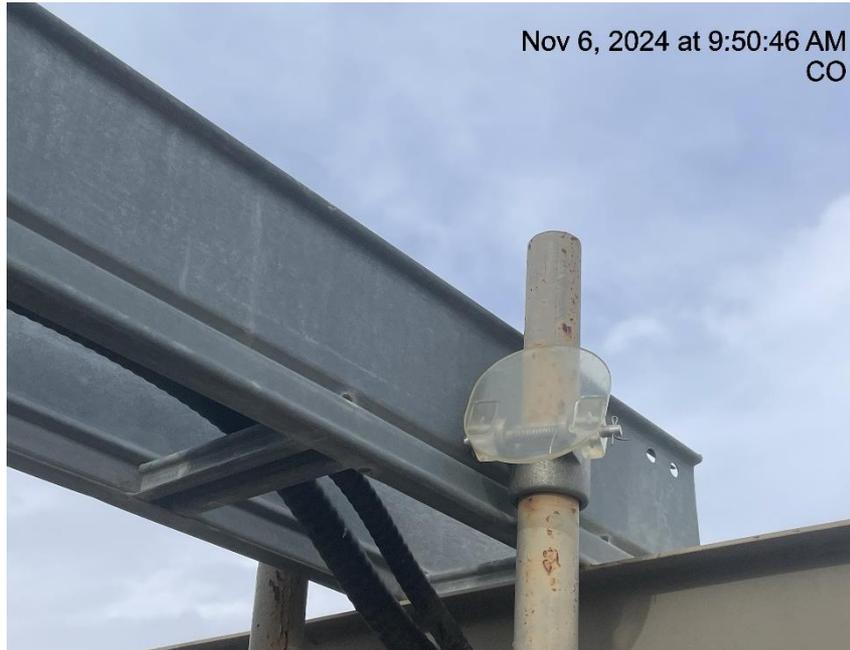
Photo # 9091 From inspection 708904991 conducted on 11/06/2024 PRV vent line does not comply with CECMC pressure safety device rules

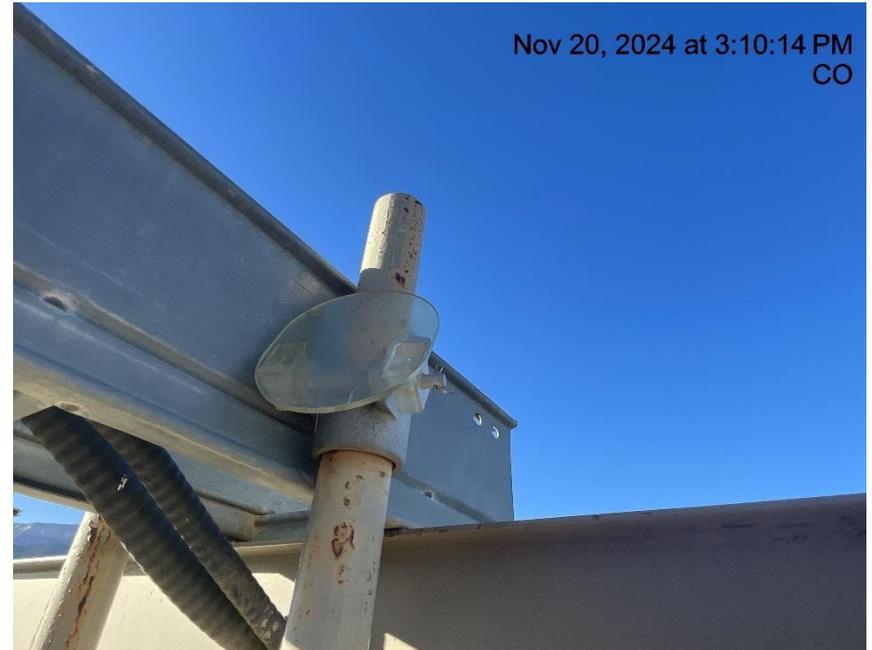
Photo # 491 PRV vent line does not comply with CECMC pressure safety device rules
