## Inspection Photos

Location: LARAMIE ENERGY LLC Woods Spangler/15-13 Pad

Location ID: 334499

Date: 11/25/2024

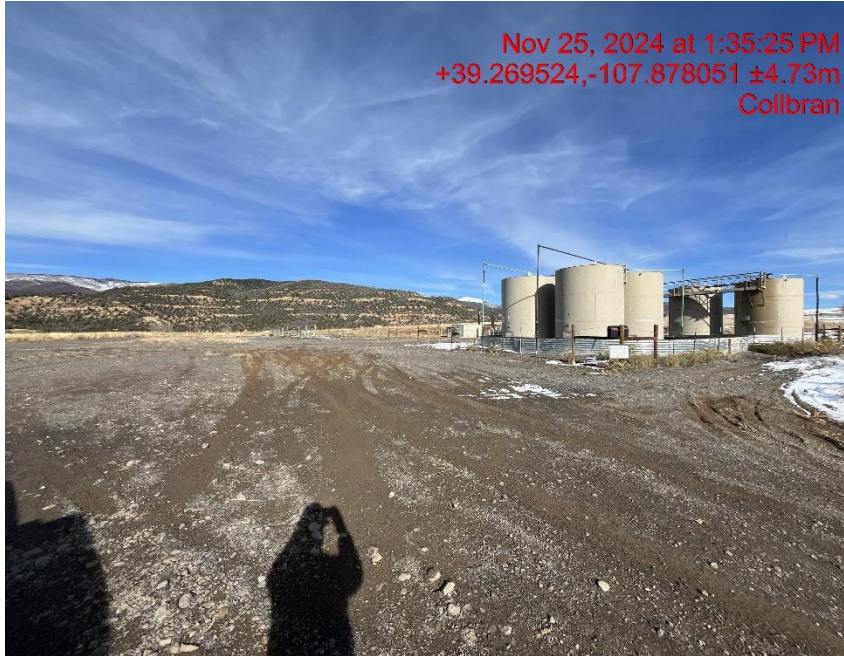
Photo # 9856 Entrance to location

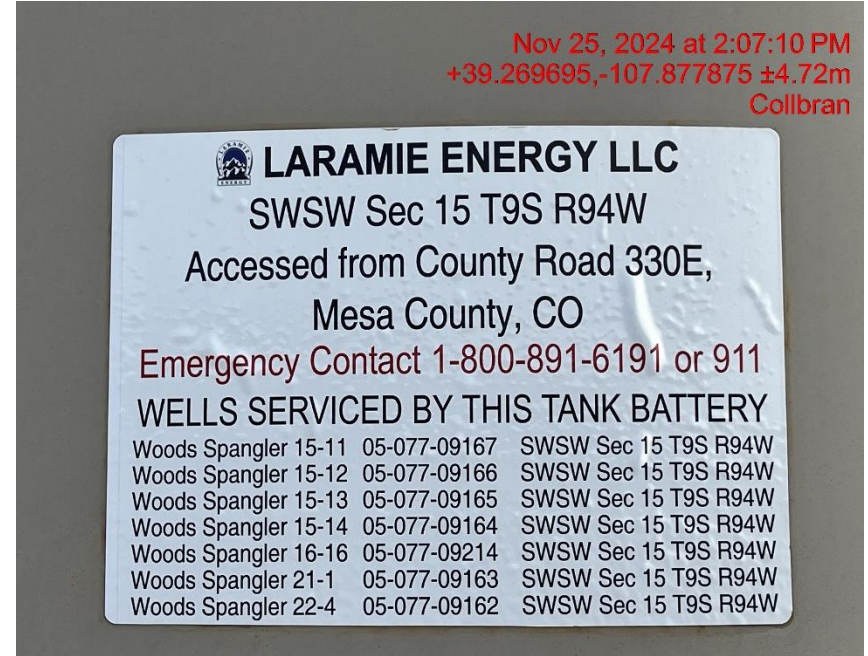
Photo # 9885 Location

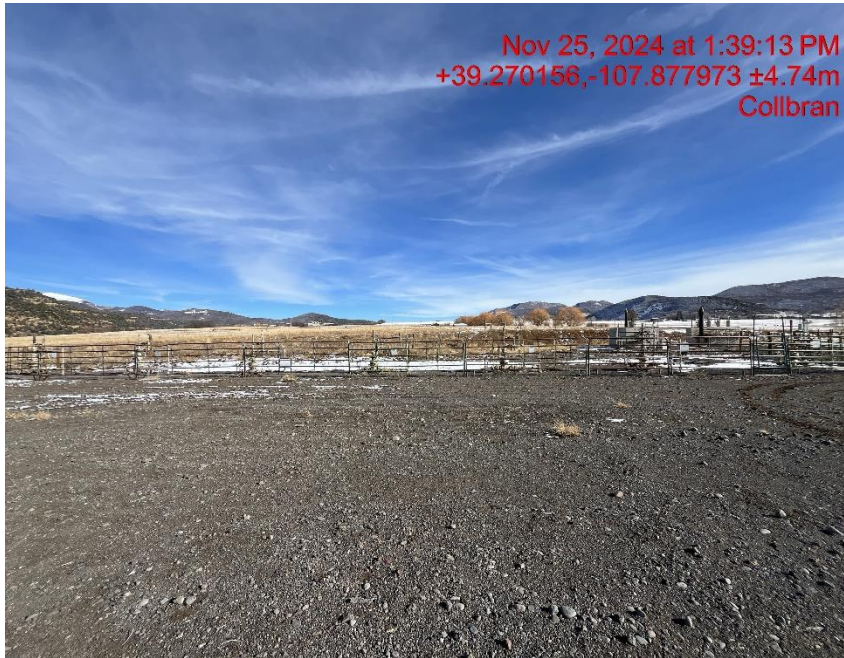
Photo # 9857 Location

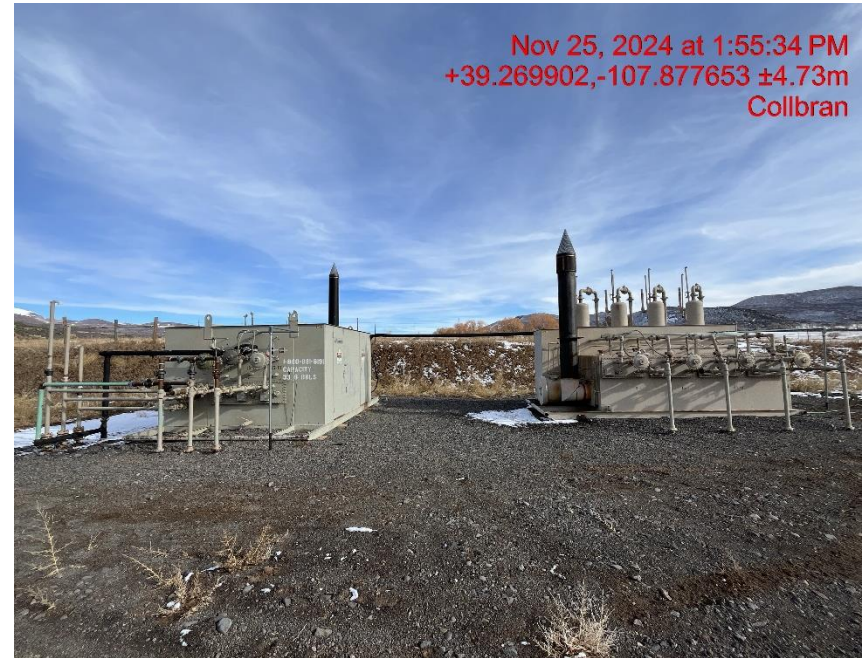
Photo # 9871 Location

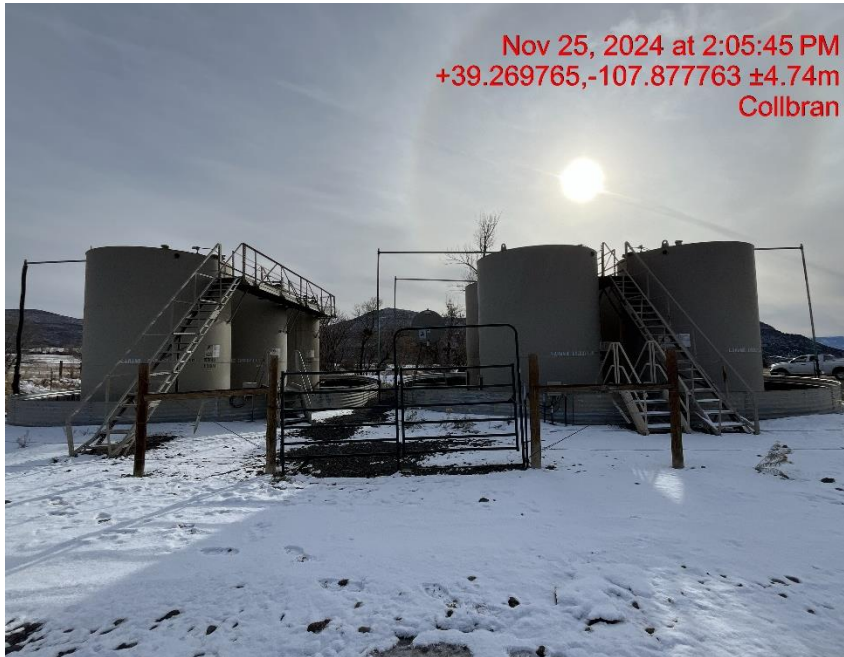
Photo # 9882 Location

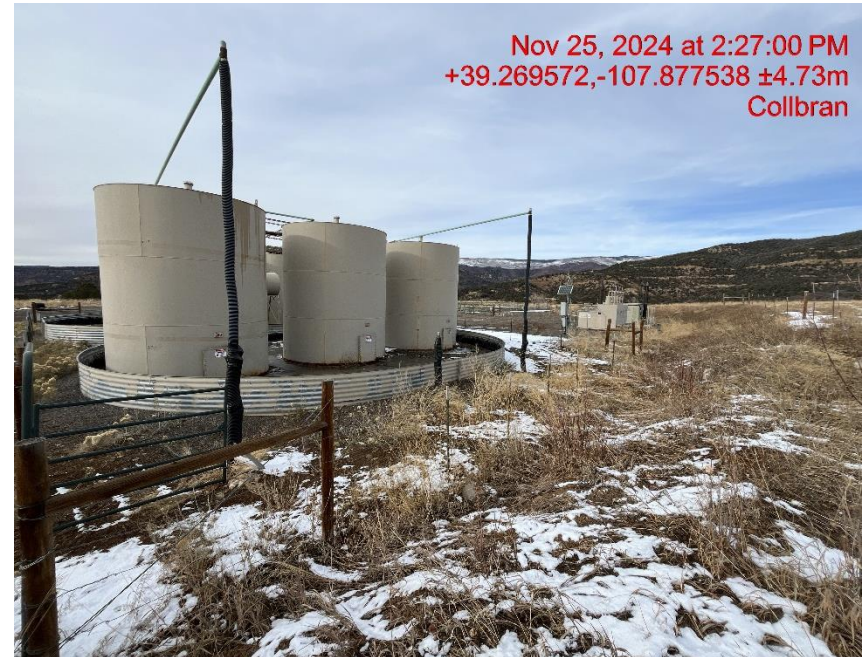
Photo # 9905 SE corner of location

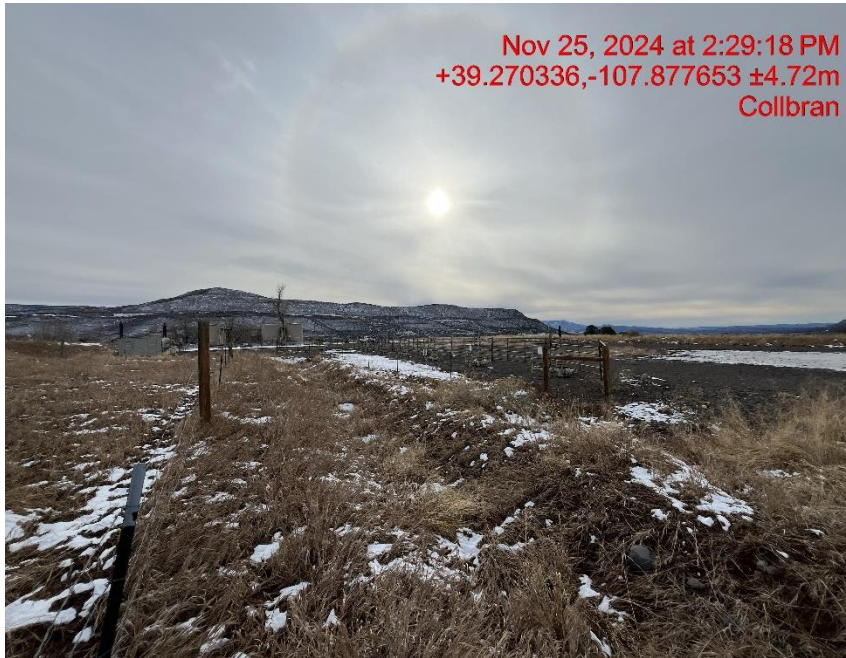
Photo # 9906 NE corner of location

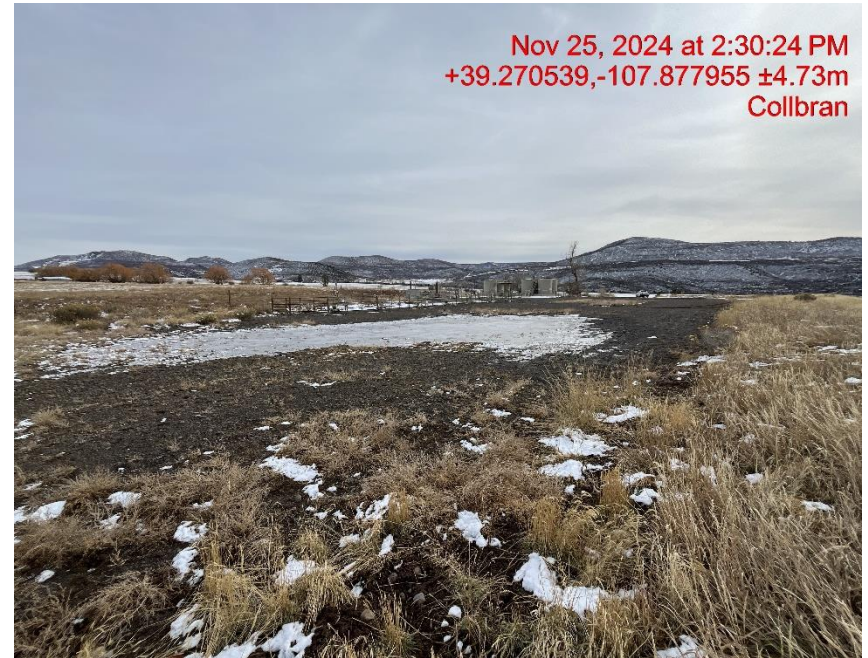
Photo # 9907 NW corner of location

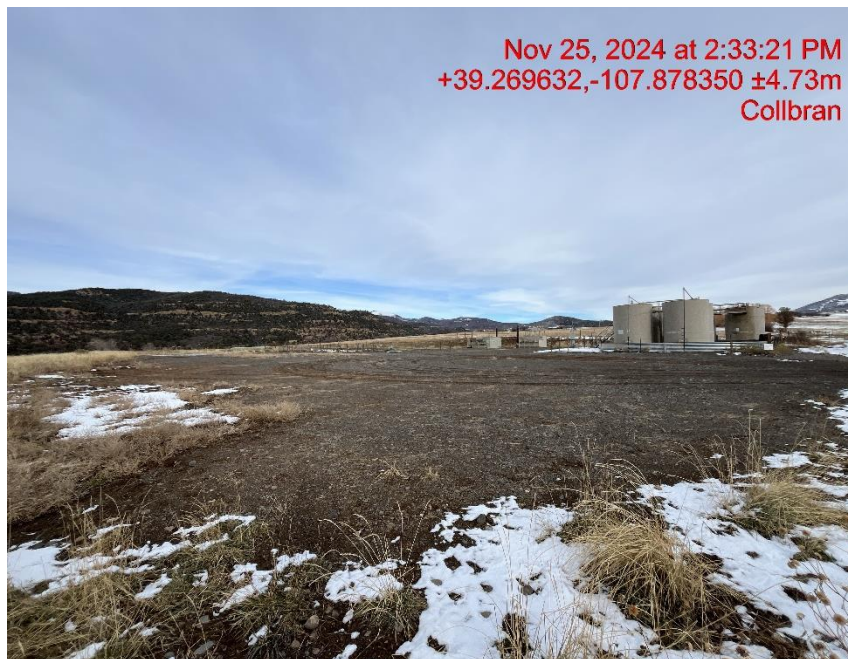
Photo # 9908 SW corner of location

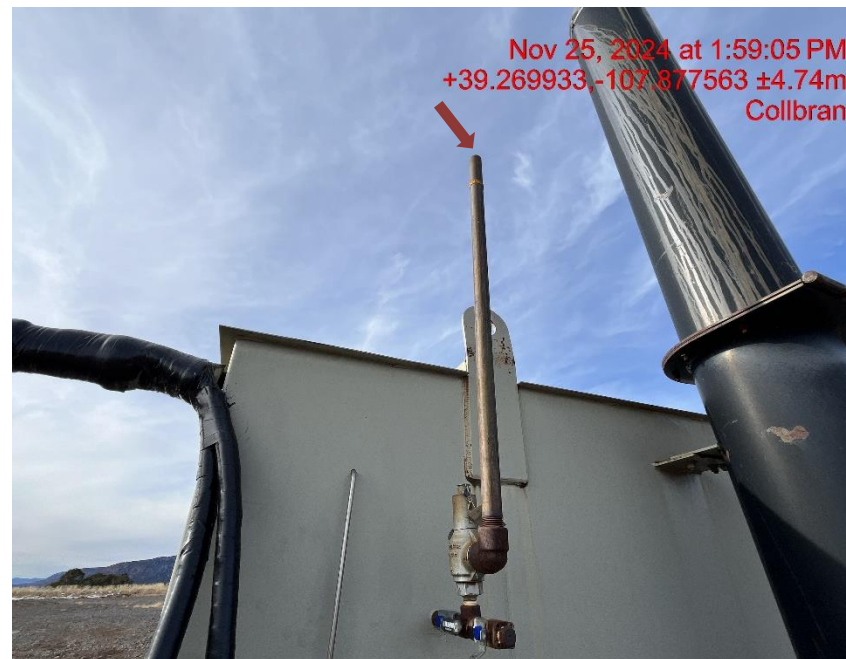
Photo # 9876 PRV vent line does not comply with CECMC pressure safety device rules
