# Inspection Photos

Location Name: TEP ROCKY MOUNTAIN LLC FEDERAL RMV 89-17 Pad

Location #: 335063

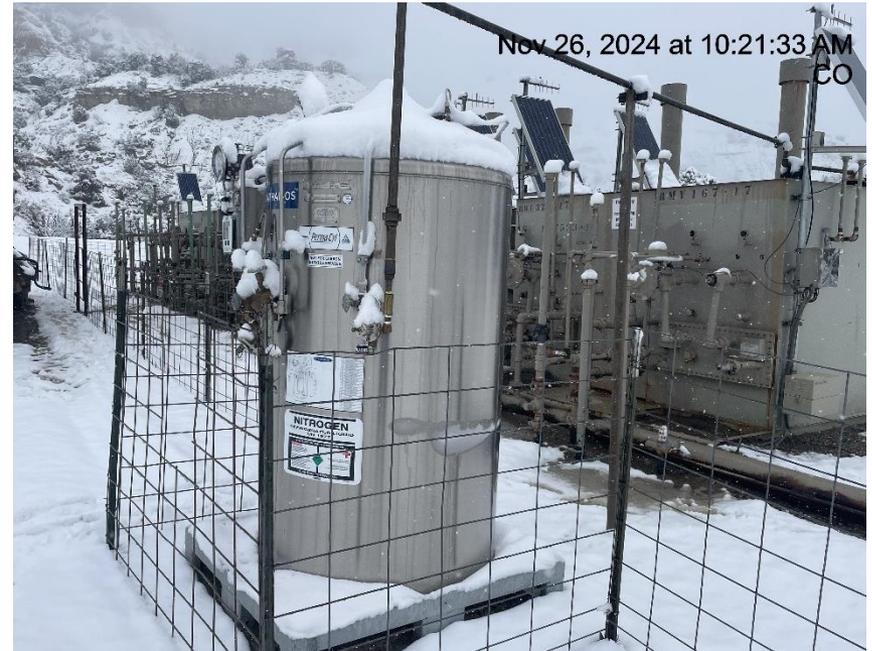
Photo # 1279 Liquid nitrogen tank does not appear to be listed on Form 2A or Form 4 SUNDRY/not in compliance with CECMC rules

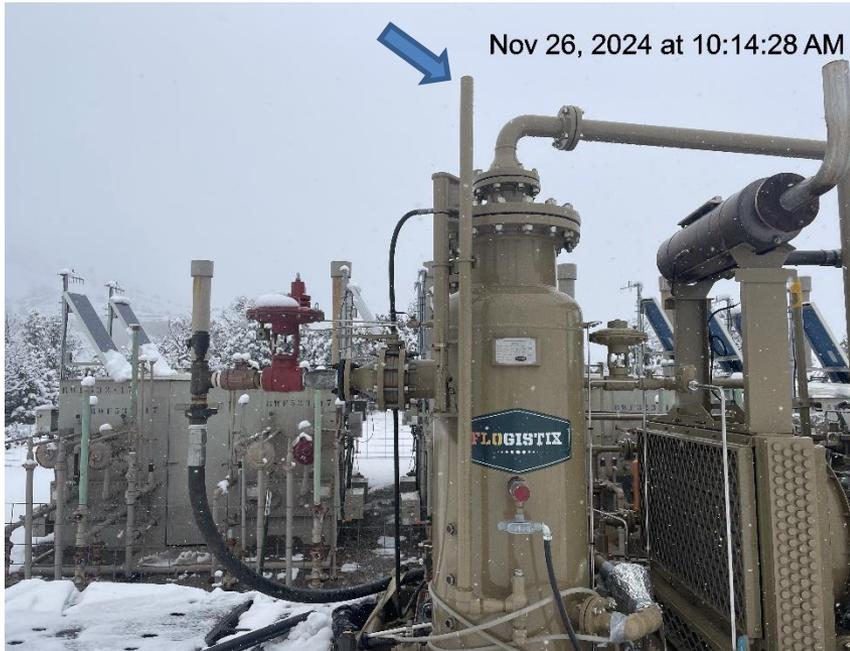
**Photo # 1280 PRV vent line does not comply with CECMC pressure safety device rules**

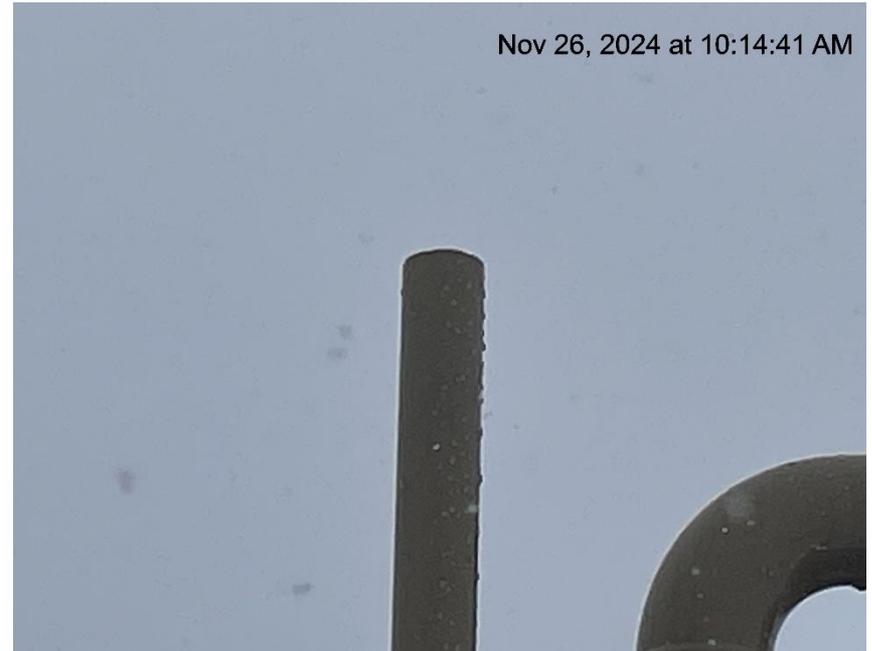
**Photo # 1281 PRV vent line does not comply with CECMC pressure safety device rules**

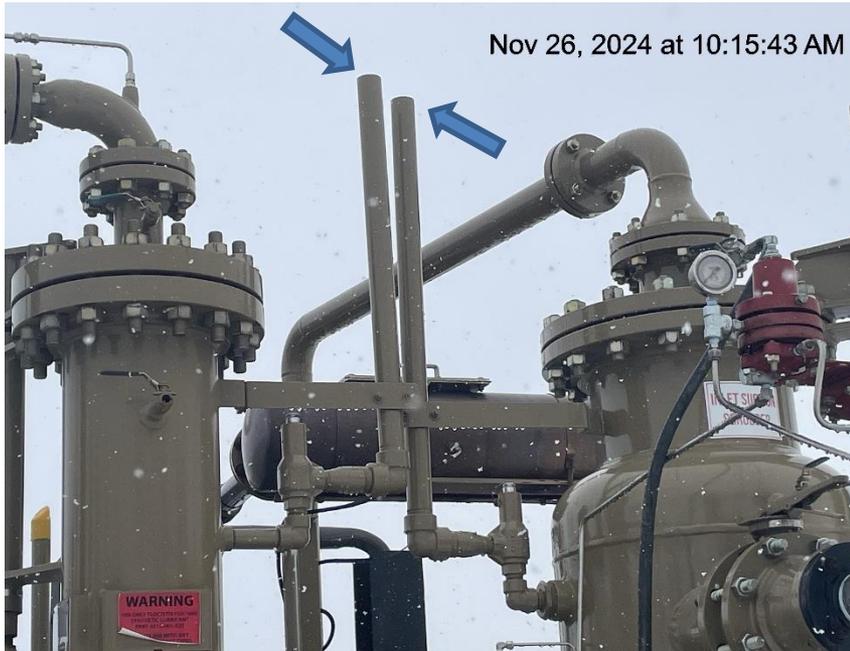
**Photo # 1282 PRV vent lines do not comply with CECMC pressure safety device rules**

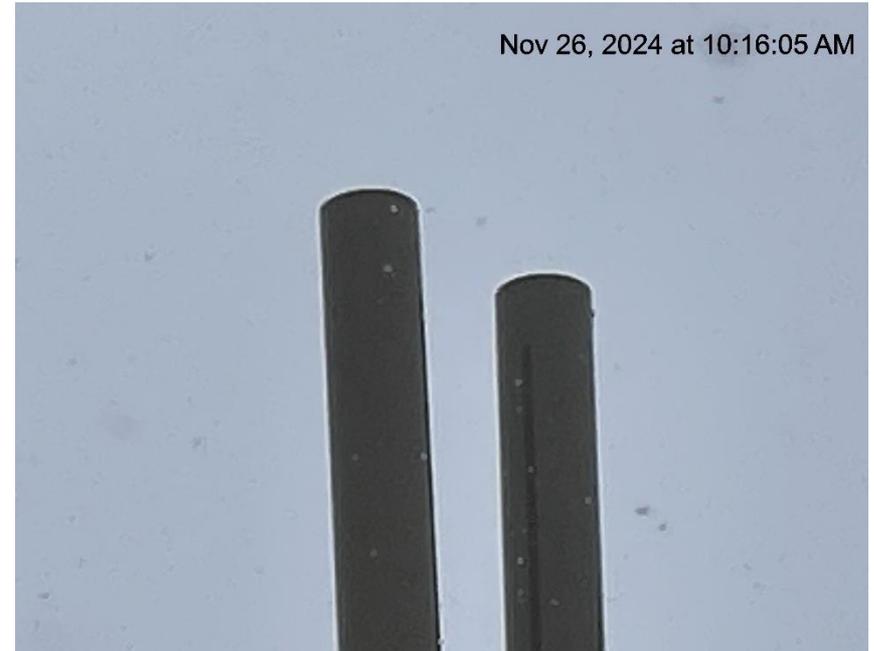
**Photo # 1283 PRV vent lines do not comply with CECMC pressure safety device rules**
