Energy & Carbon Management Commission

Laramie/0993-29-01 #487592 Annotation Report

Captured on November 12, 2024

Laramie/0993-29-01 #487592 Issue Report

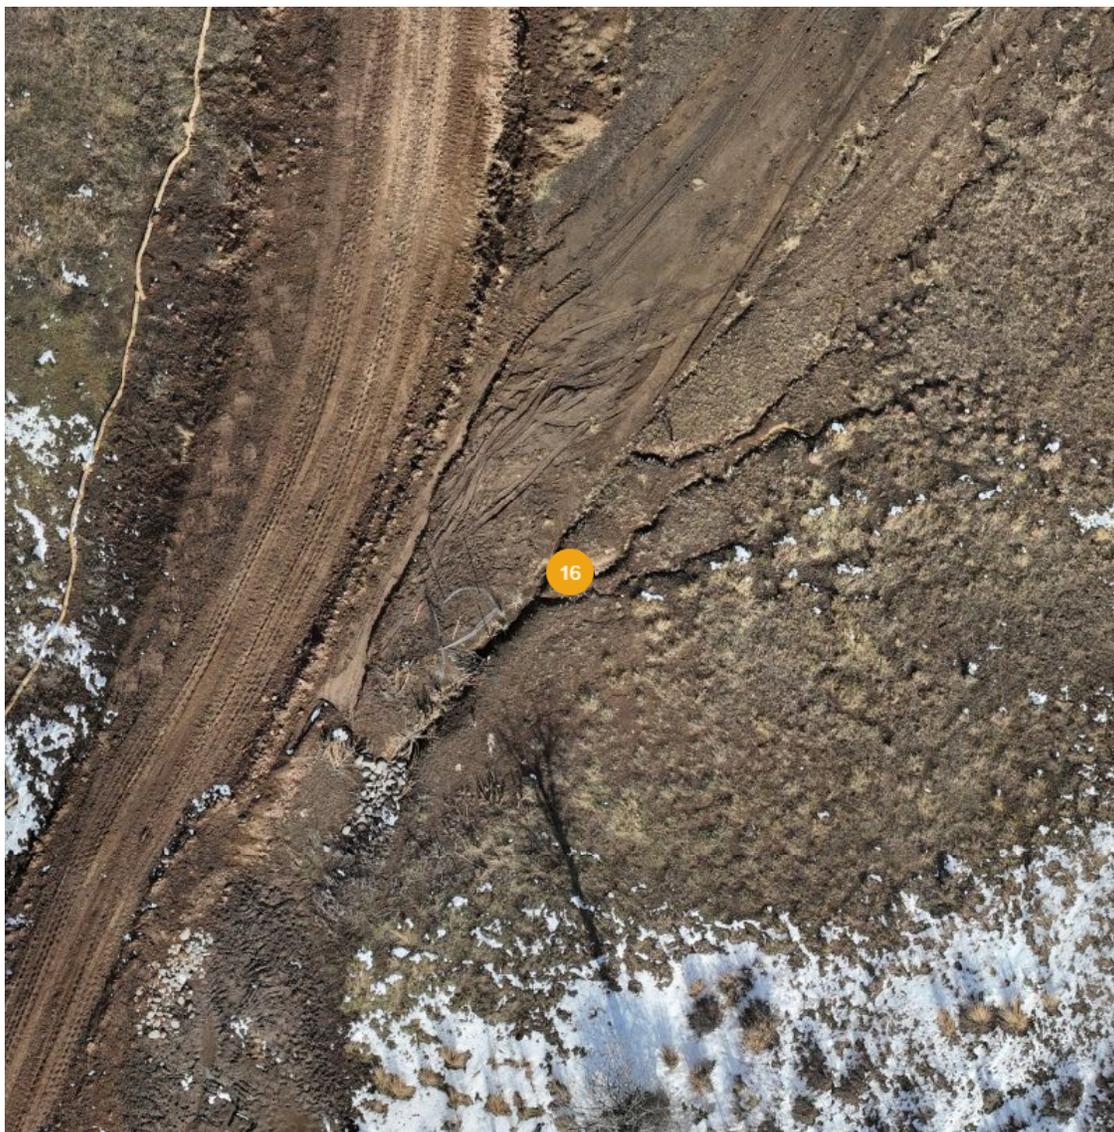
16 - Observation

Summary:	Signage has not been maintained and requires posting at the Location entrance.
Created:	Nov 15, 2024, 10:40am by Aaron Trujillo
Cost of Repair:	—
Lat/Long:	39.2529688, -107.7830474
Northing:	1525151.3 US ft
Easting:	2353566.4 US ft
Elevation:	-1.76 US ft

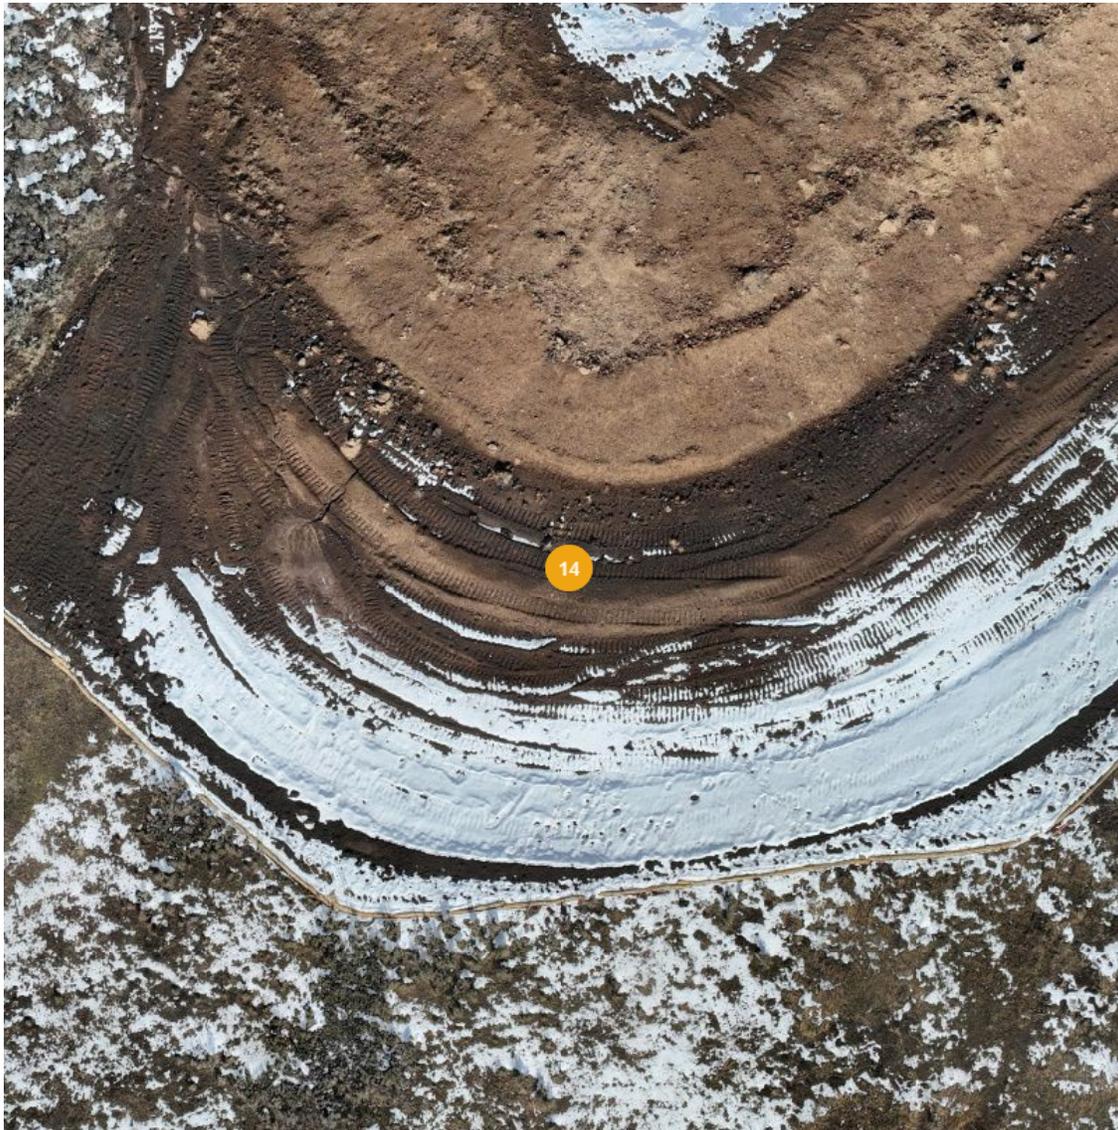
14 - Observation

Summary: Sediment trap has not been constructed with engineered inlet/outlet protections per the Form 2A permitted SWMP and Layout Drawing.

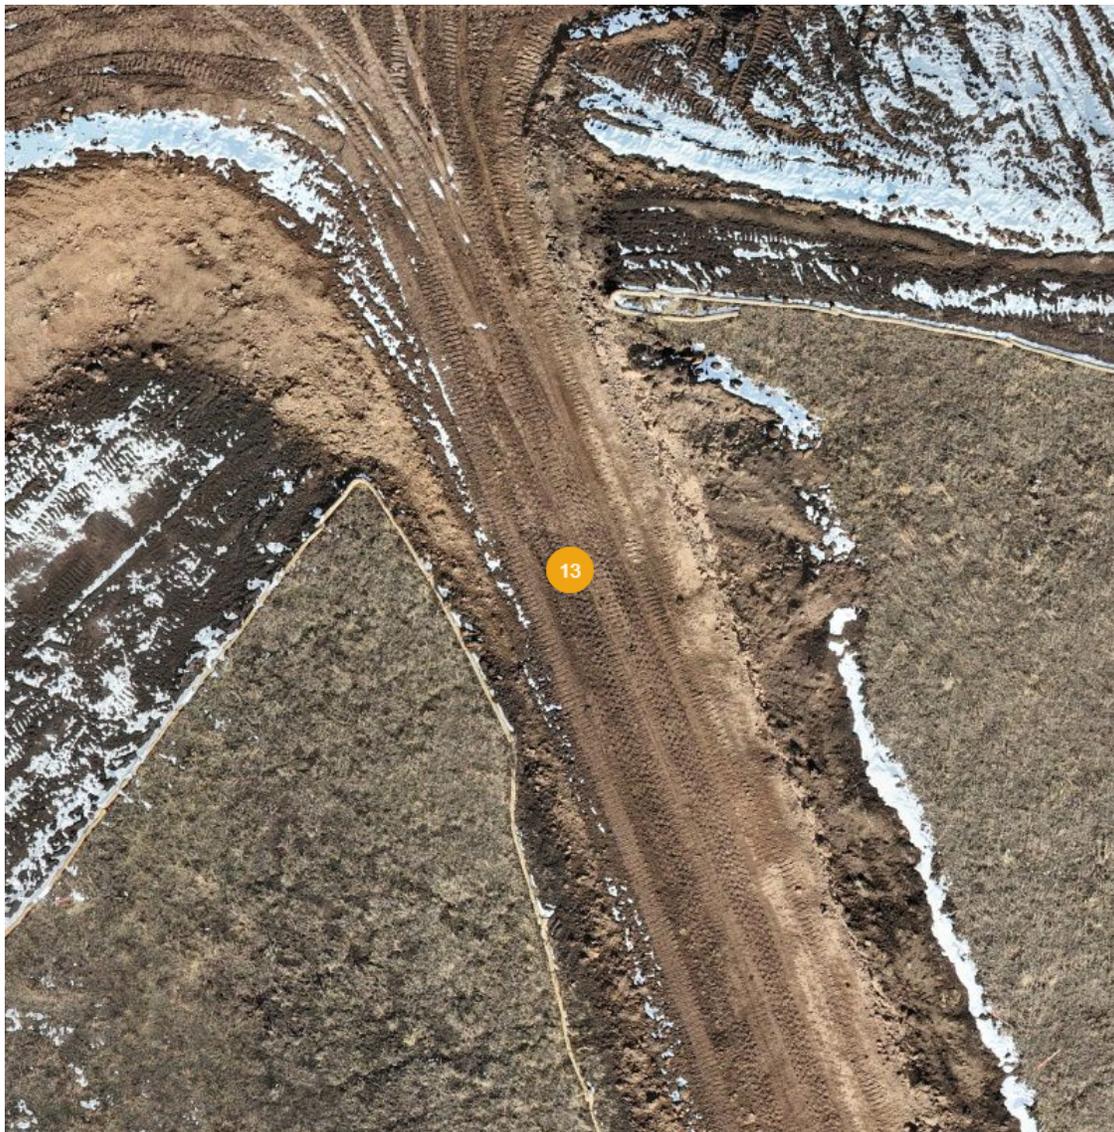
13 - Observation

Summary: Working Pad Surface and Access road lacks stabilization. BMPs, including tracking controls, to stabilize, as well as to minimize degradation, tracking and transport of sediment are missing or insufficient.

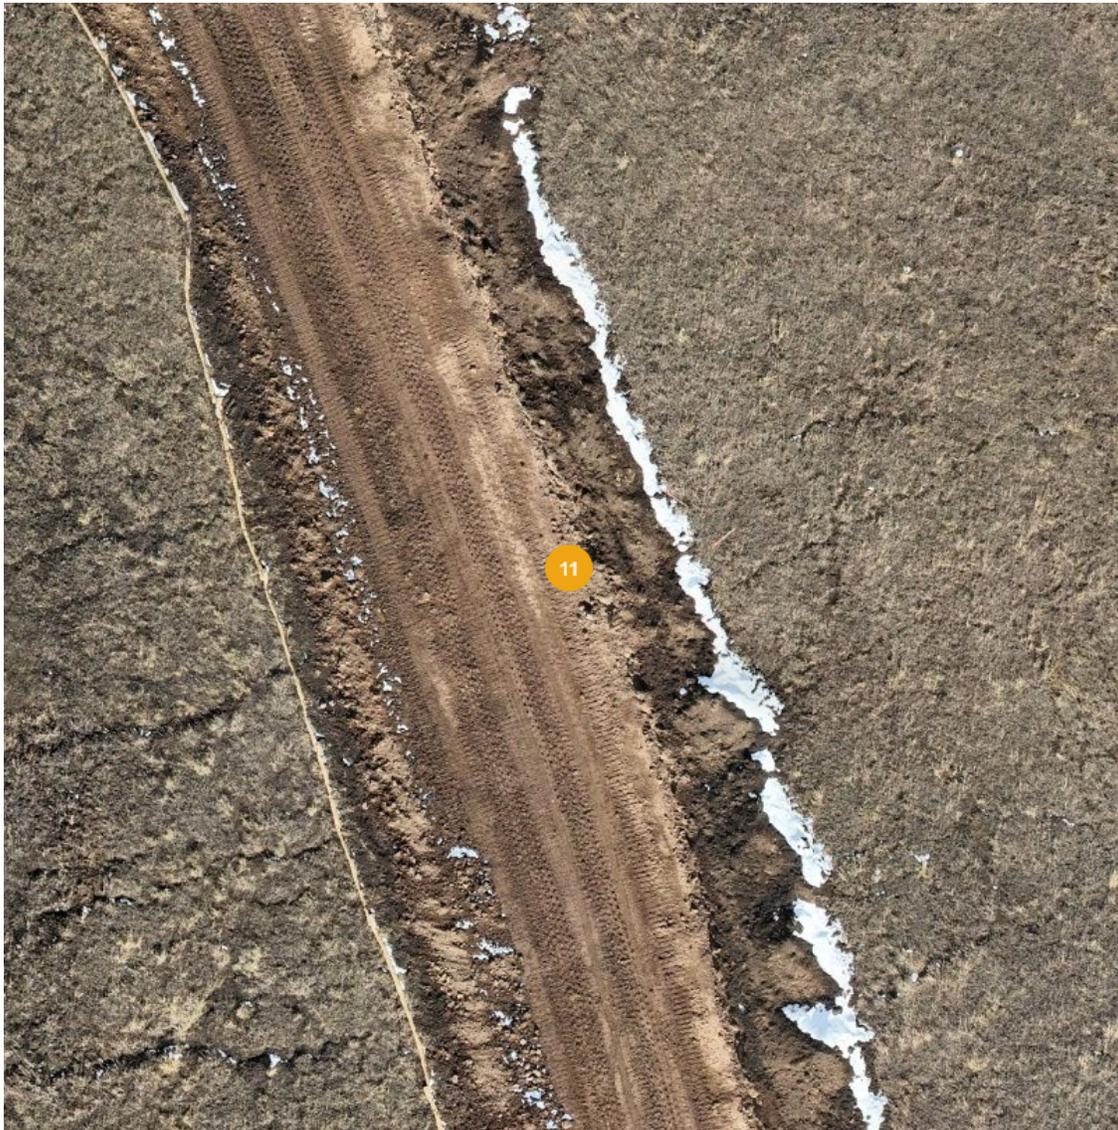
10 - Observation

Summary:	Stormwater diversion ditch not constructed along access road per the Form 2A permitted SWMP and Layout Drawing.
Created:	Nov 13, 2024, 12:28pm by Aaron Trujillo
Cost of Repair:	—
Lat/Long:	39.2537222, -107.7832098
Northing:	1525426.7 US ft
Easting:	2353527.4 US ft
Elevation:	4.33 US ft

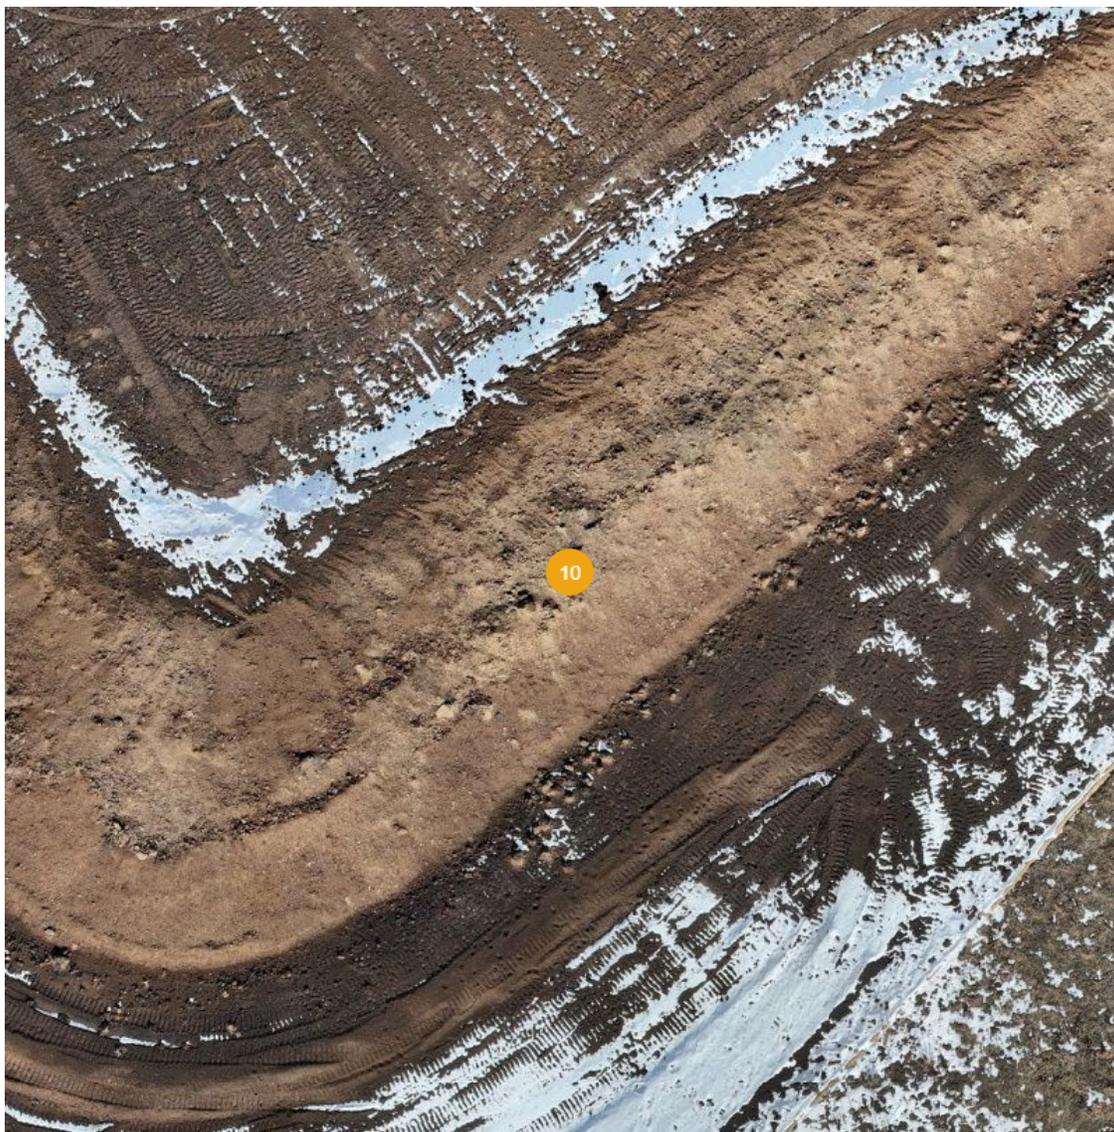
Summary: Fill slopes are bare and exposed soils. BMPs to stabilize, as well as to minimize erosion and degradation are missing or insufficient.

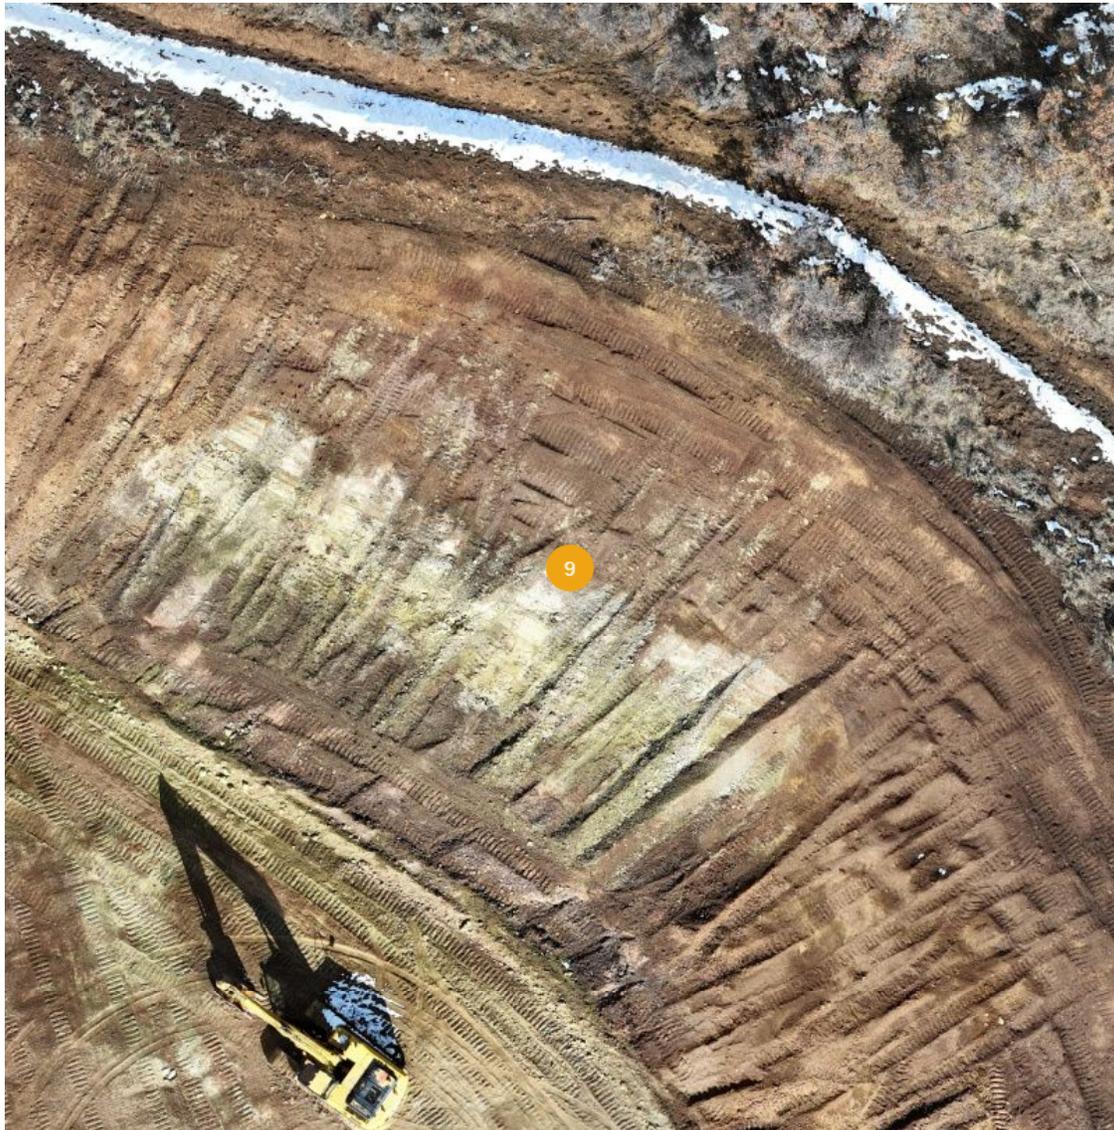
9 - Observation

Summary: Cut slopes are bare and exposed soils. BMPs to stabilize, as well as to minimize erosion and degradation are missing or insufficient.

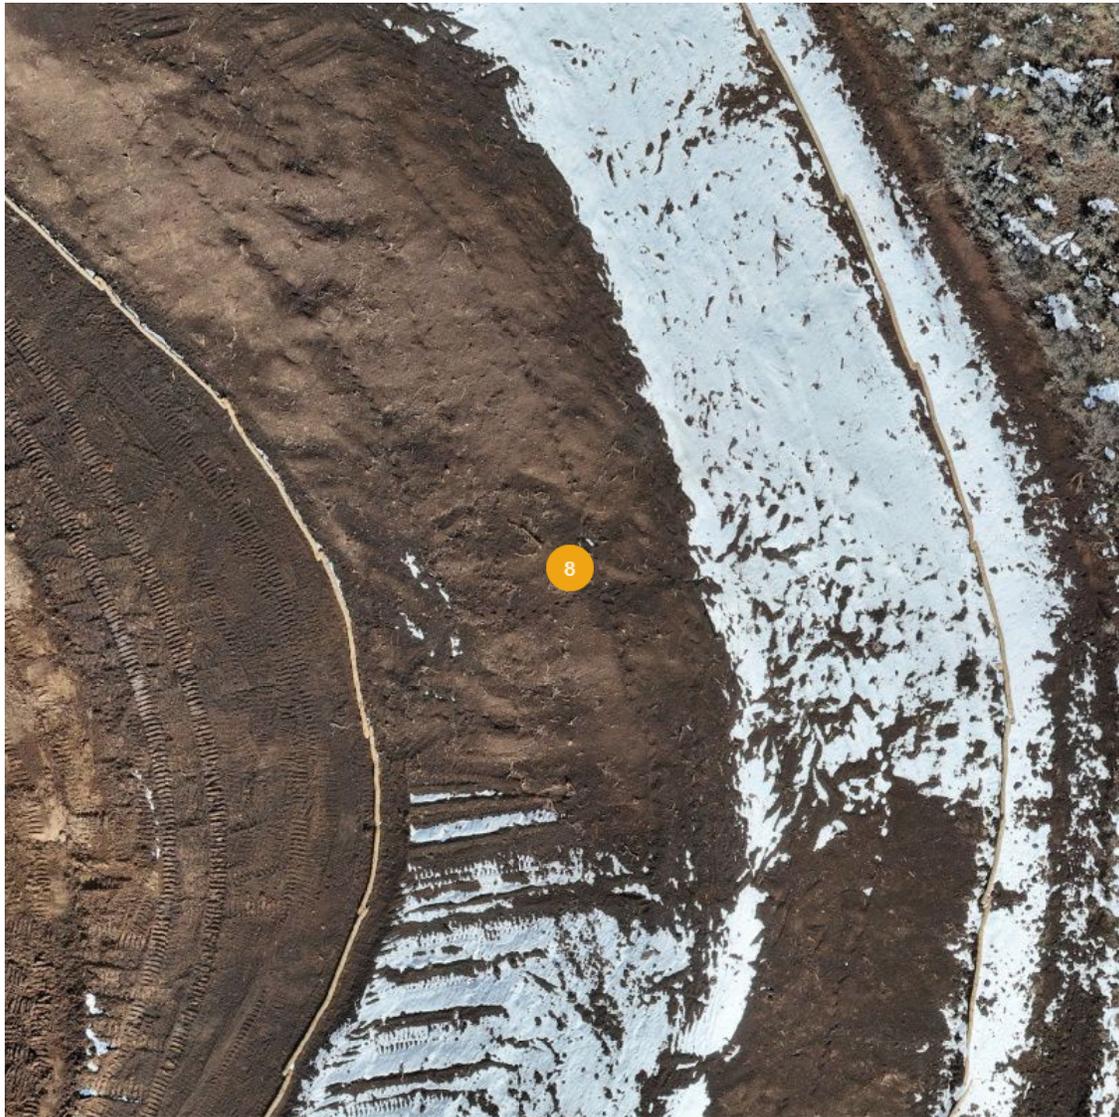
8 - Observation

Summary: Topsoil stockpile bare. BMPs to stabilize, as well as to protect the topsoil stockpile from wind and water erosion missing or insufficient.

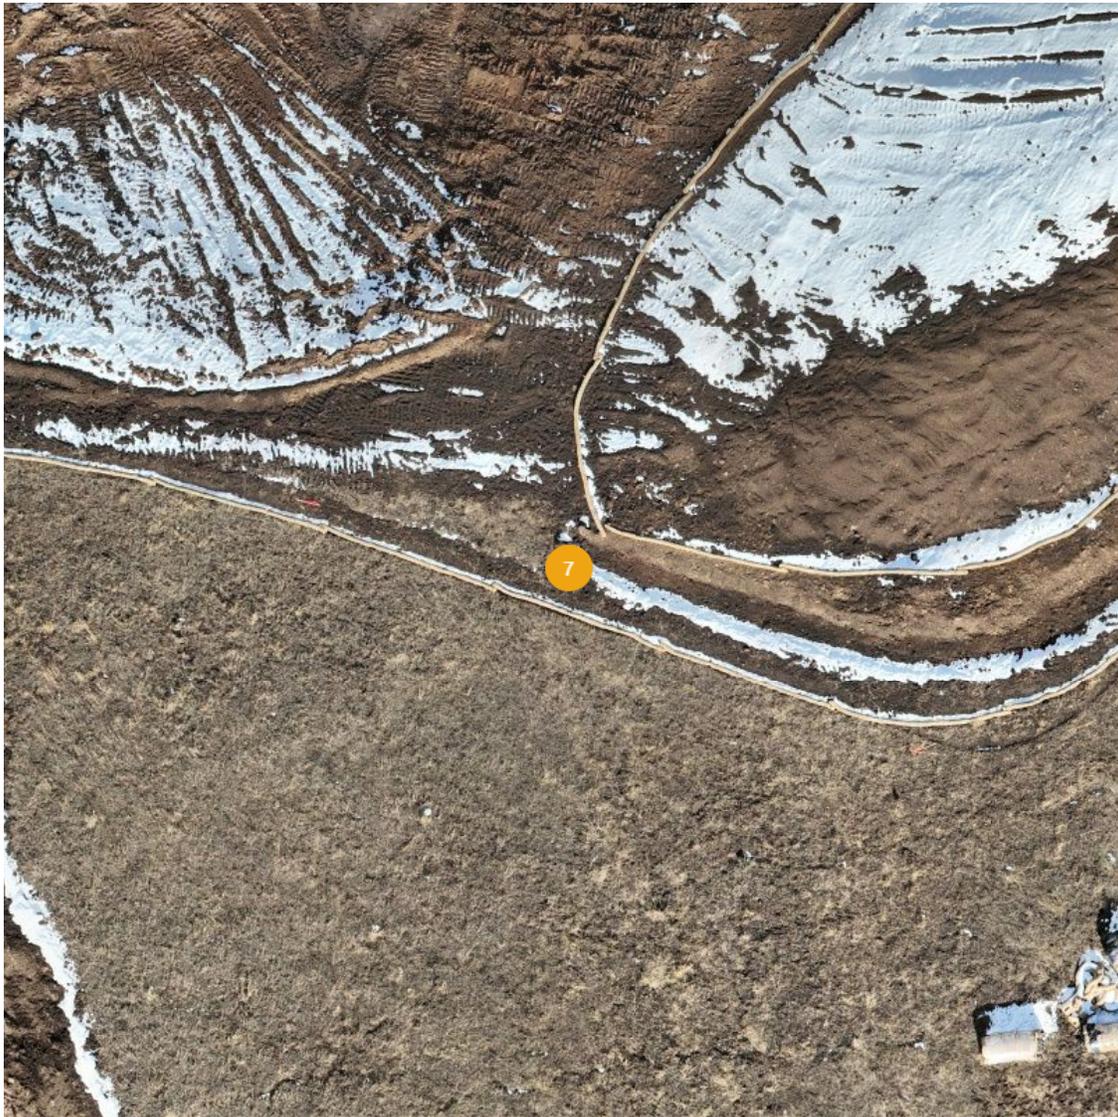
7 - Observation

Summary: Control Measure incomplete and does not divert stormwater into sediment trap per the Form 2A permitted SWMP and Layout Drawing. Rock Checks to reduce flow velocity and minimize erosion have also not been implemented with the diversion ditches.

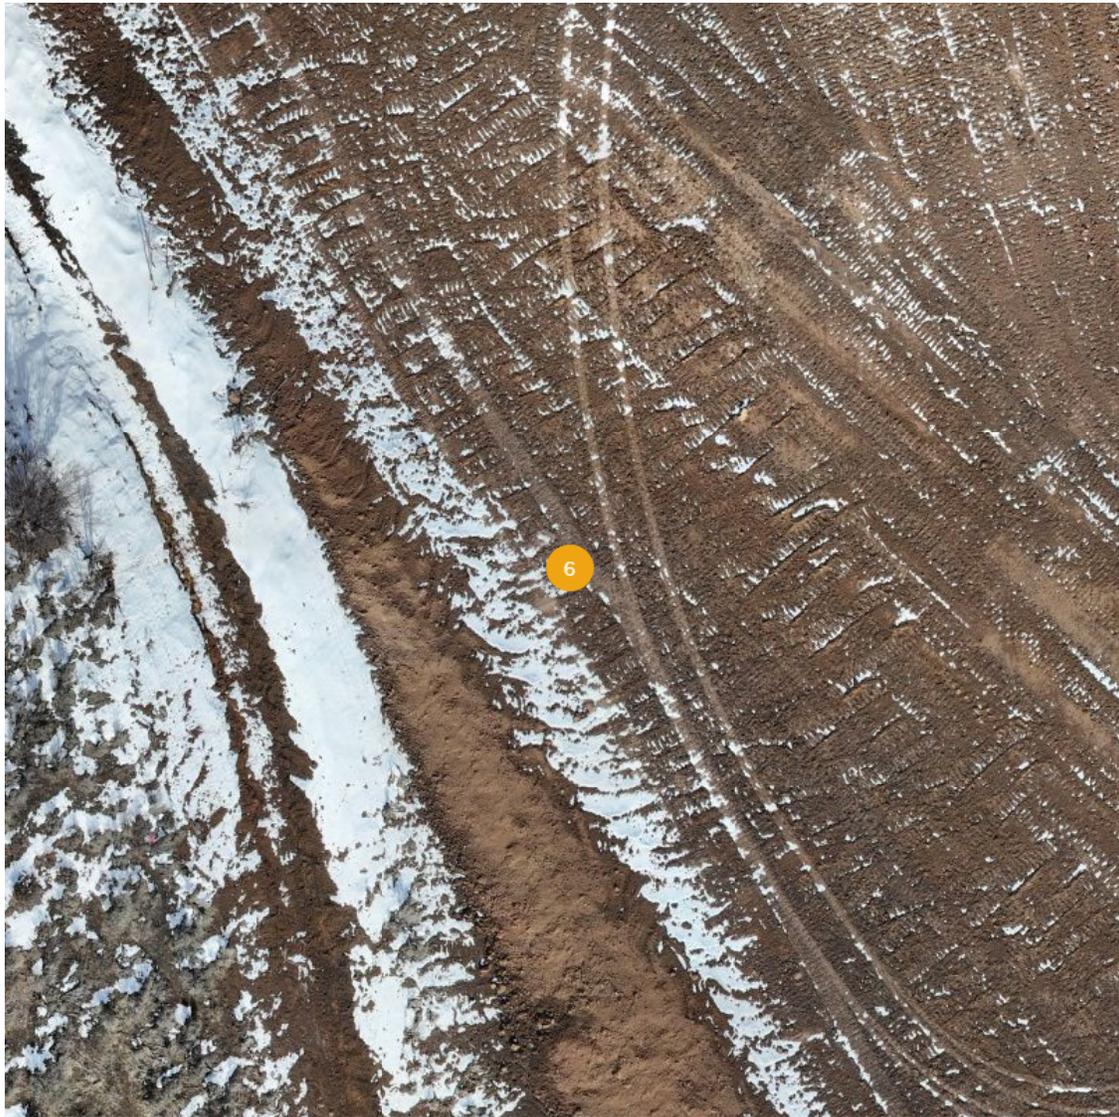
6 - Observation

Summary: "V-Ditch" along the perimeter of the Working Pad Surface not installed per the Form 2A permitted SWMP and Layout Drawing.

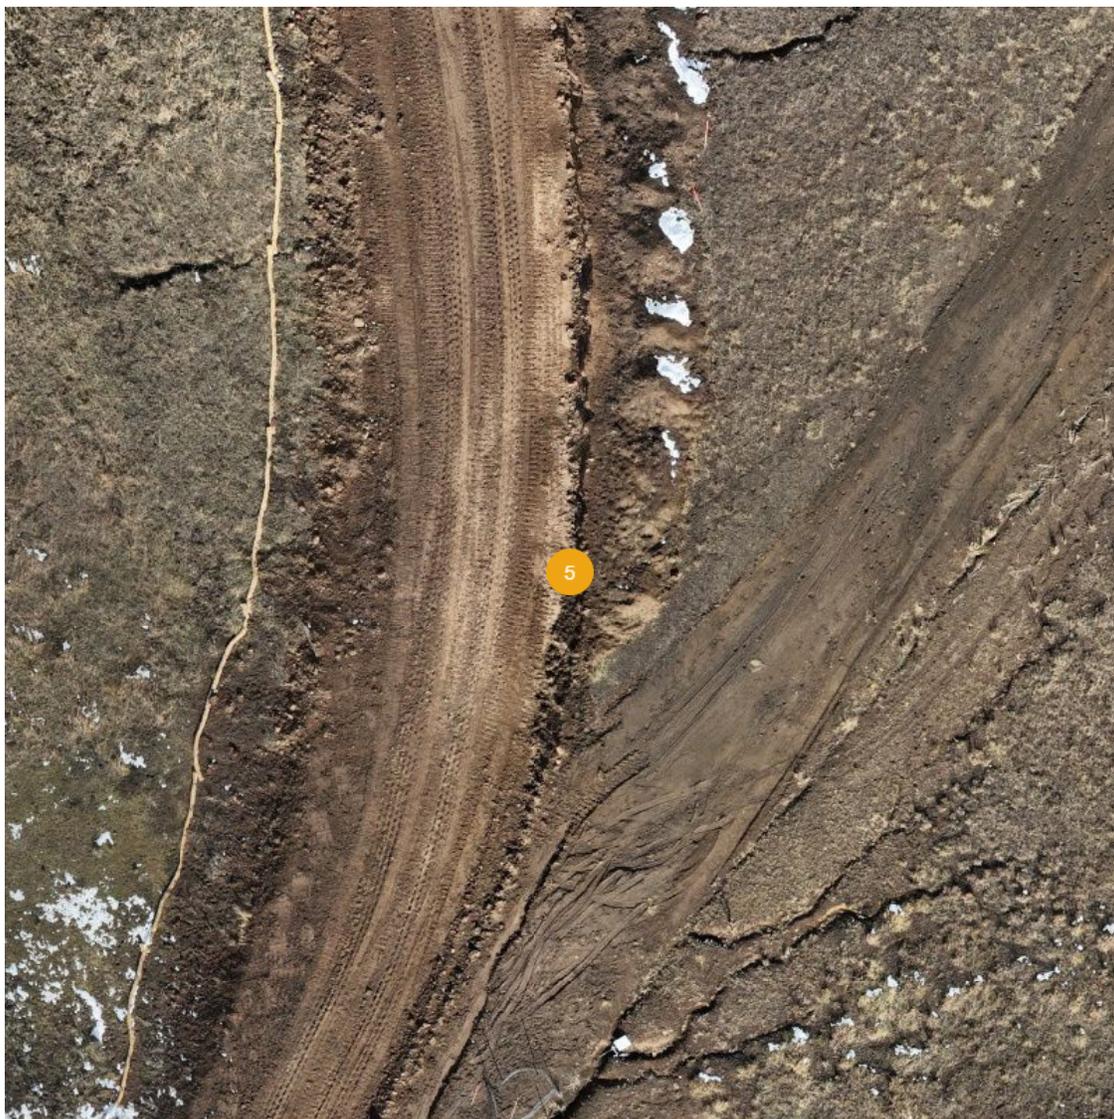
5 - Observation

Summary: 24" Culvert in conjunction with "Trap w/ rock armored rundown" not installed per the Form 2A permitted SWMP.
Created: Nov 13, 2024, 7:55am by Aaron Trujillo
Cost of Repair: —
Lat/Long: 39.2531493, -107.7830751
Northing: 1525217.2 US ft
Easting: 2353560.3 US ft
Elevation: 0.59 US ft
NAD83(2011) / Colorado Central (ftUS) (US survey foot)

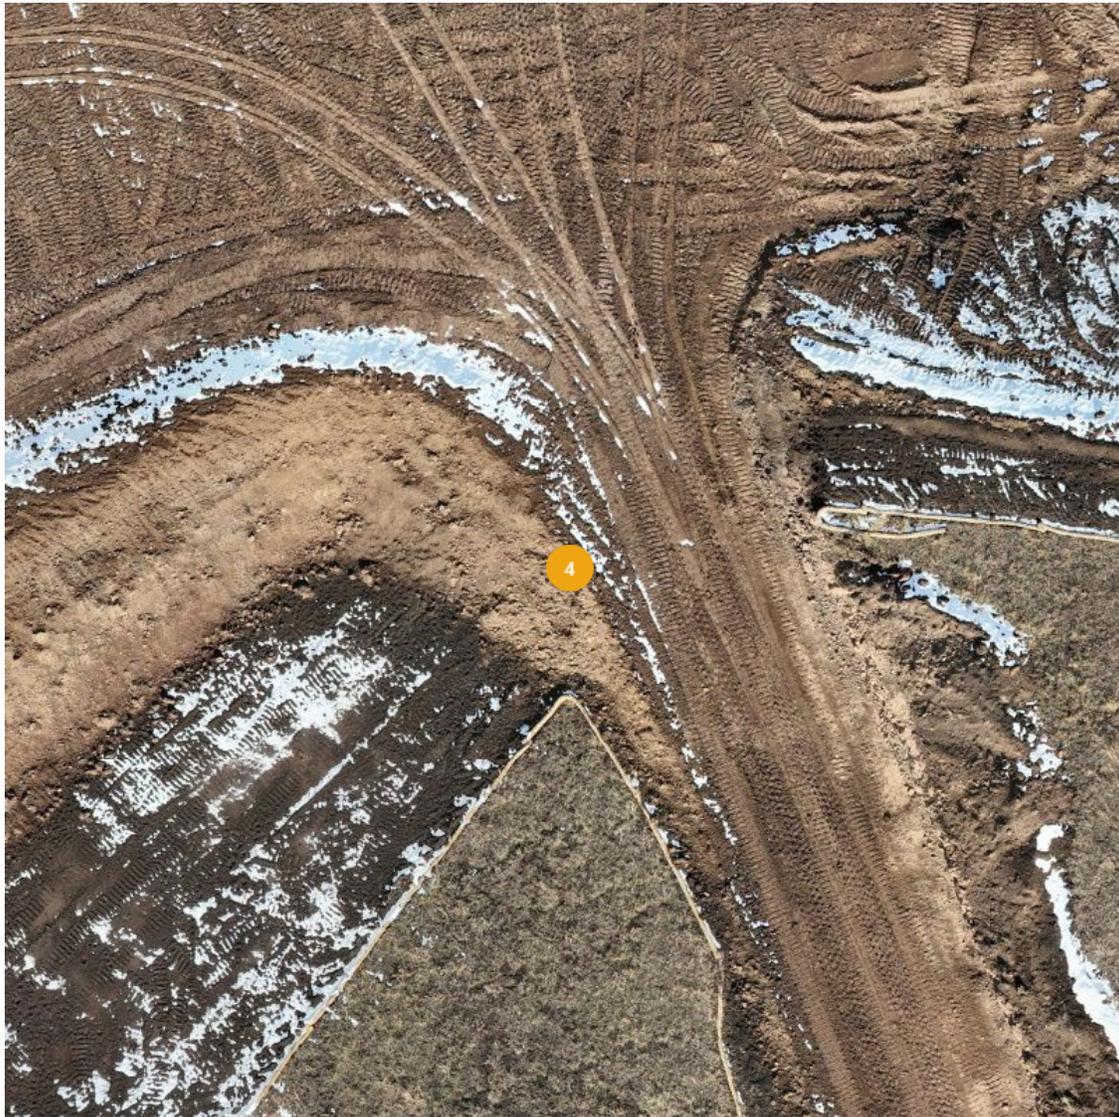
4 - Observation

Summary: 24" Culvert in conjunction with sediment traps at the inlet and outlet have not installed per the Form 2A permitted SWMP and Layout Drawing.

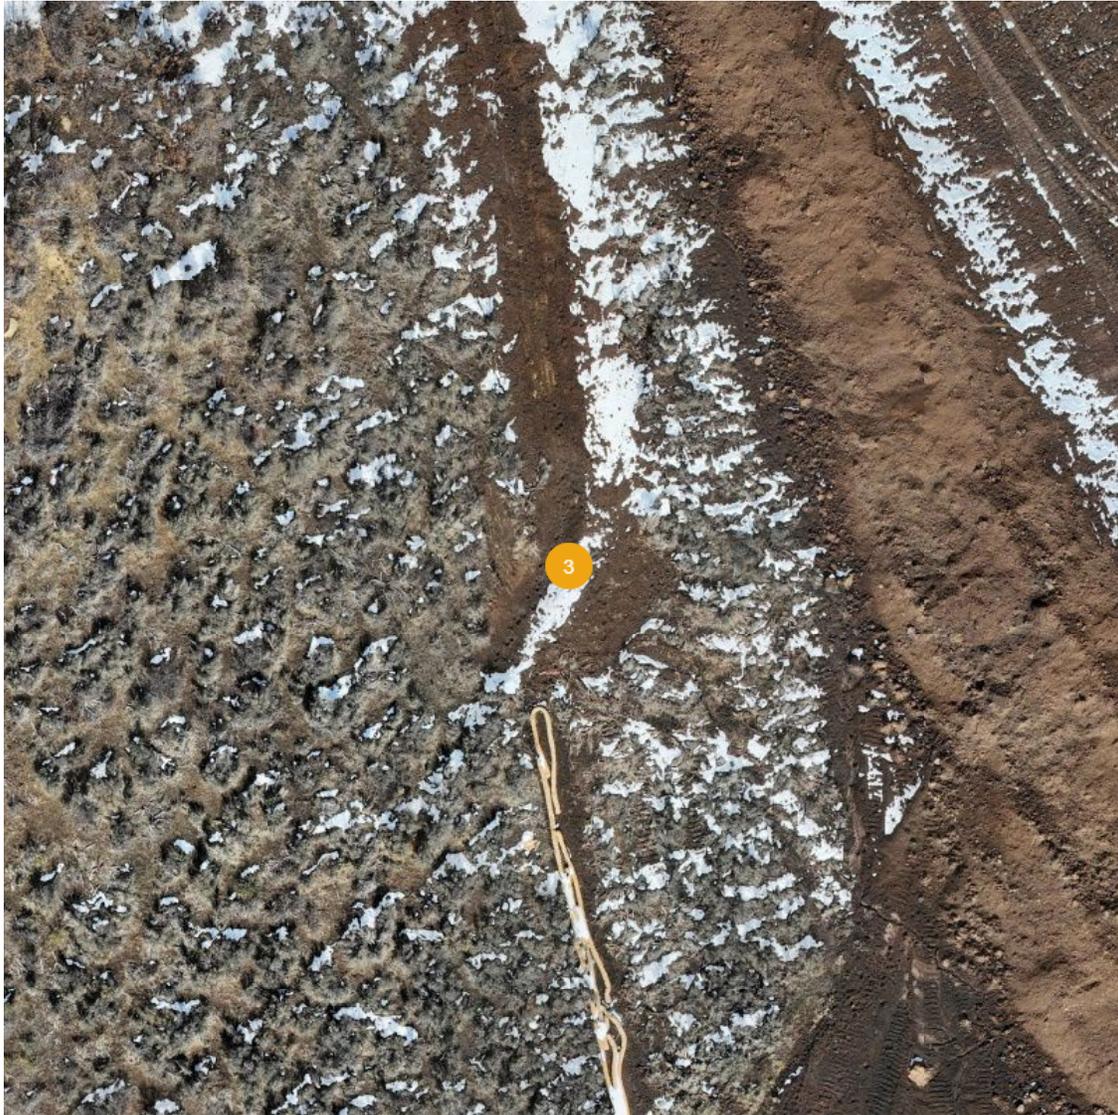
3 - Observation

Summary: Control Measure incomplete and does not divert stormwater into sediment trap per the Form 2A permitted SWMP and Layout Drawing. Rock Checks to reduce flow velocity and minimize erosion have also not been implemented with the diversion ditches.

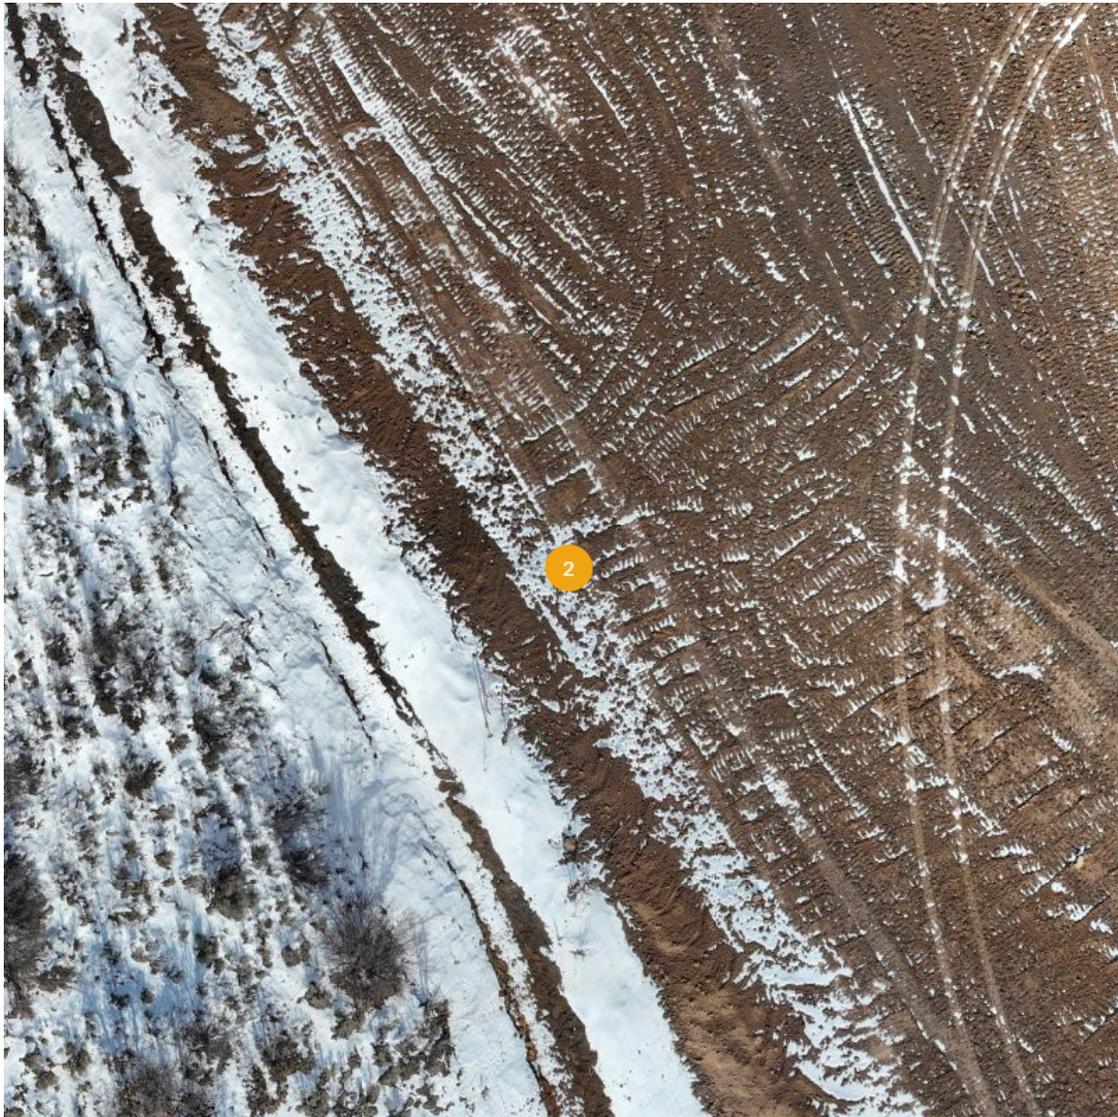
2 - Observation

Summary: Flex Pipe w/rock armor inlet/outlet not installed per the Form 2A permitted SWMP and Layout Drawing.

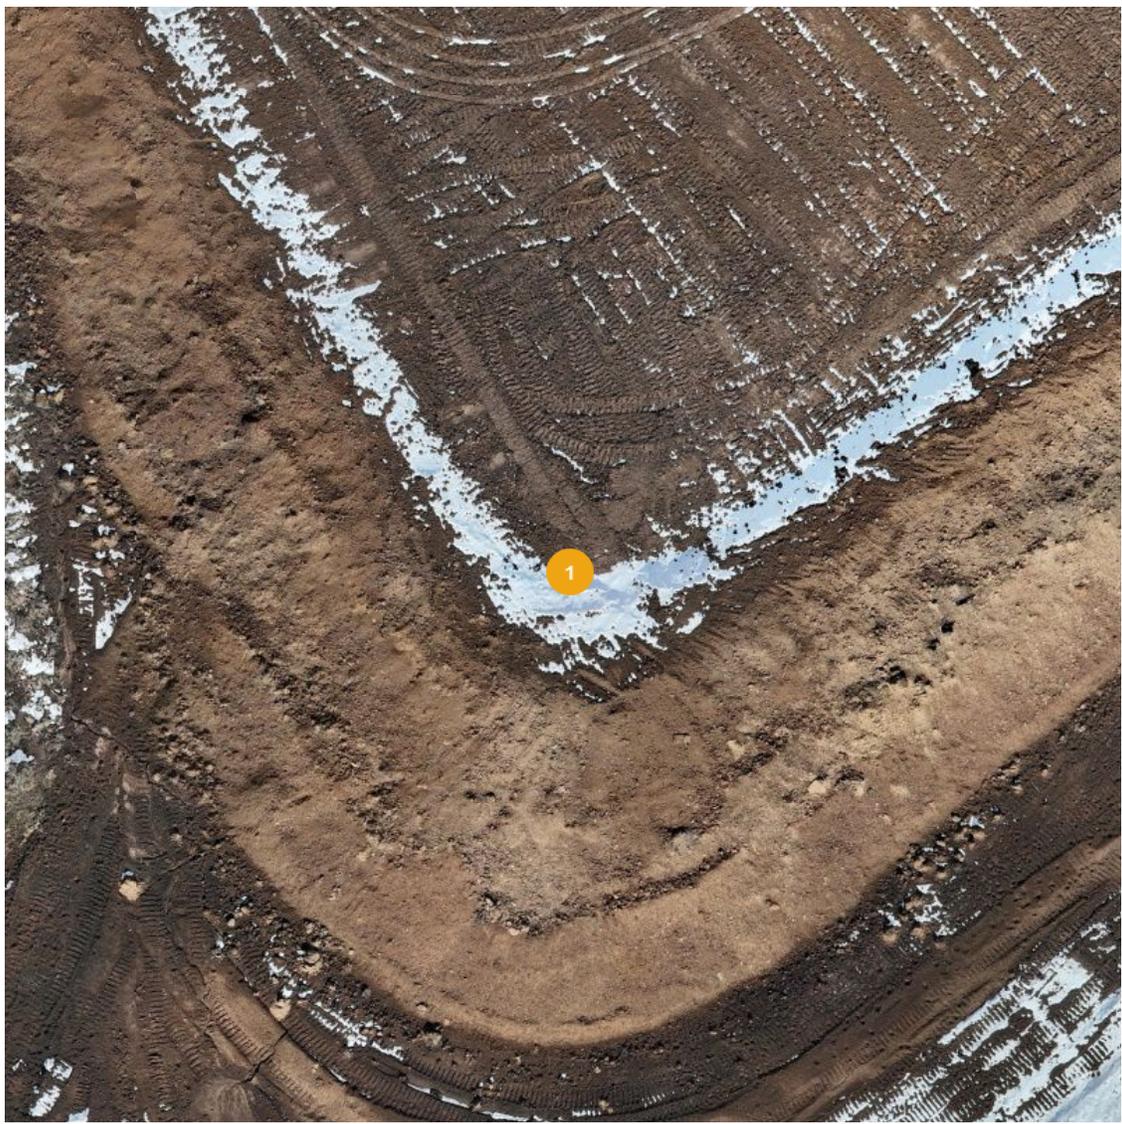
1 - Observation

Summary:	Flex Pipe w/rock armor inlet/outlet not installed per the Form 2A permitted SWMP.
Created:	Nov 13, 2024, 7:50am by Aaron Trujillo
Cost of Repair:	—
Lat/Long:	39.2538806, -107.7840839
Northing:	1525490.6 US ft
Easting:	2353281.4 US ft
Elevation:	0.27 US ft
