# Inspection Photos

**Operator:** LARAMIE ENERGY LLC #10433

**Location ID:** 487592

**Inspection Doc:** 718100019

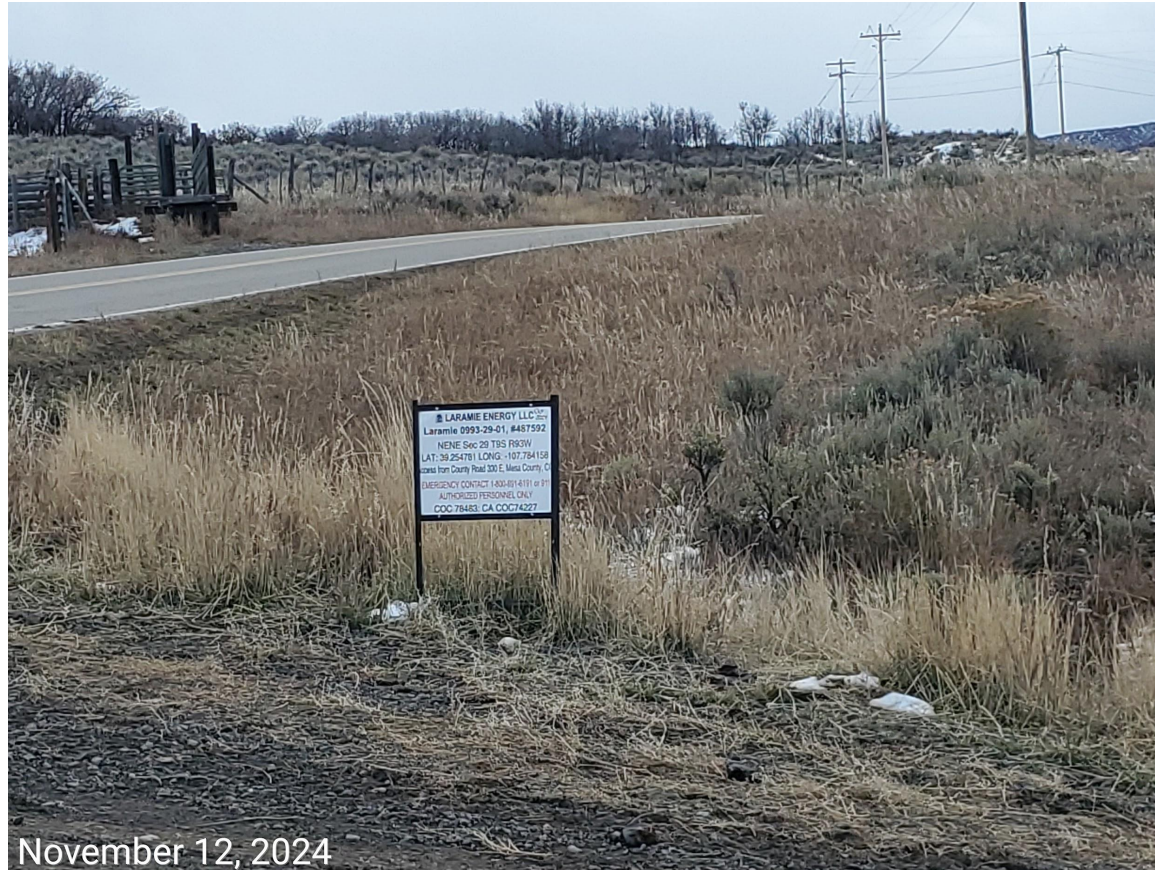
**Photo 1:** Photo taken from the intersection of the lease road and the public road. Photo shows signage per Rule 406.d has been installed.

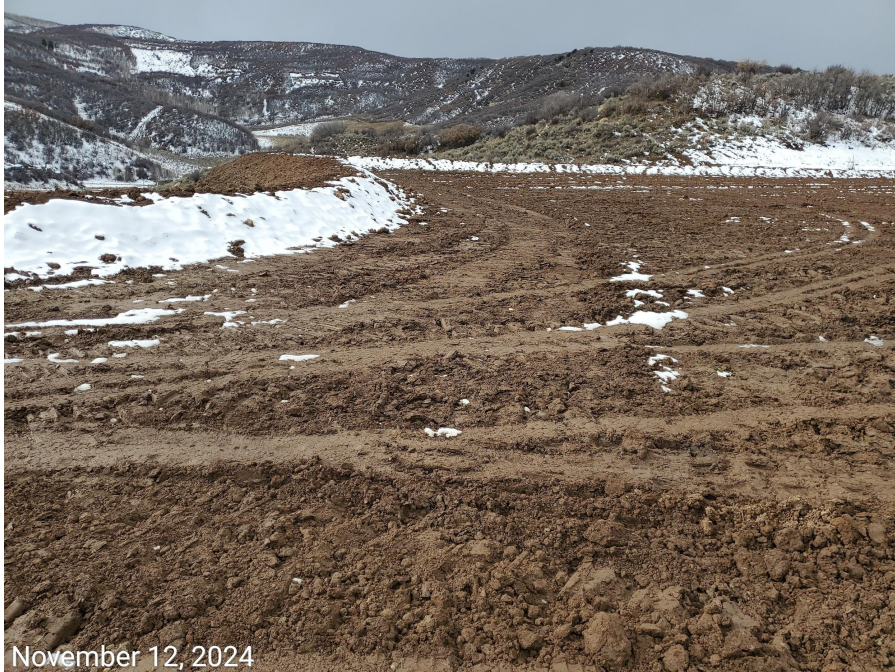
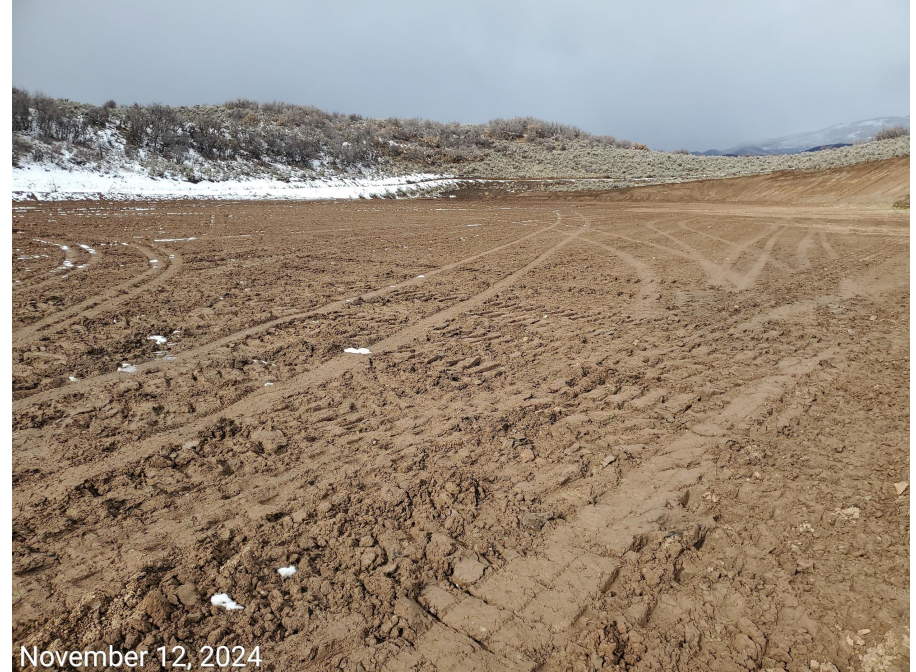
**Photo 2:** Photos 2-3 taken from the Location entrance on the south end of the Location. Photo provides a overview of the pad from west, northwest, northeast to east.

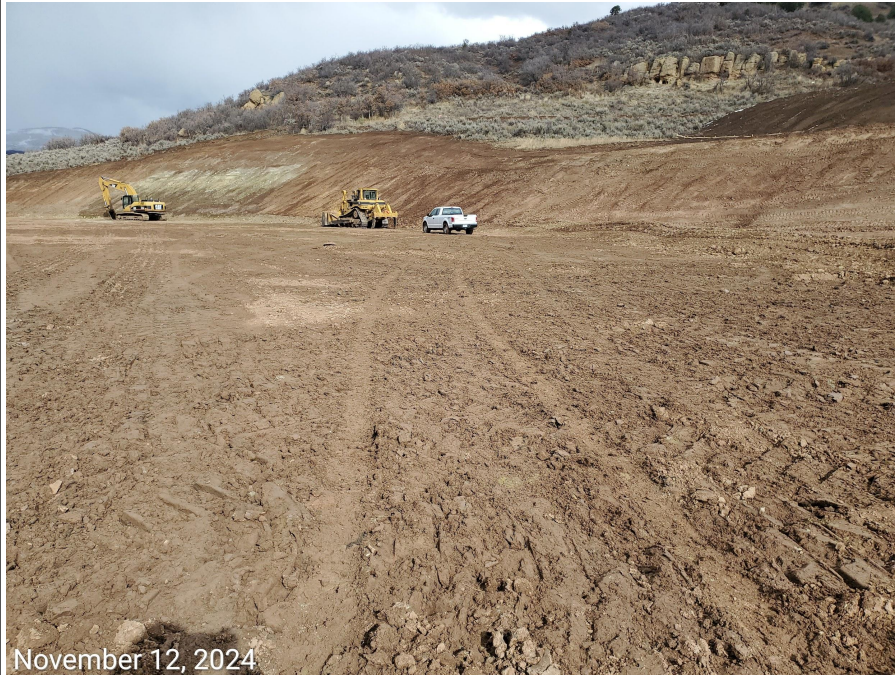
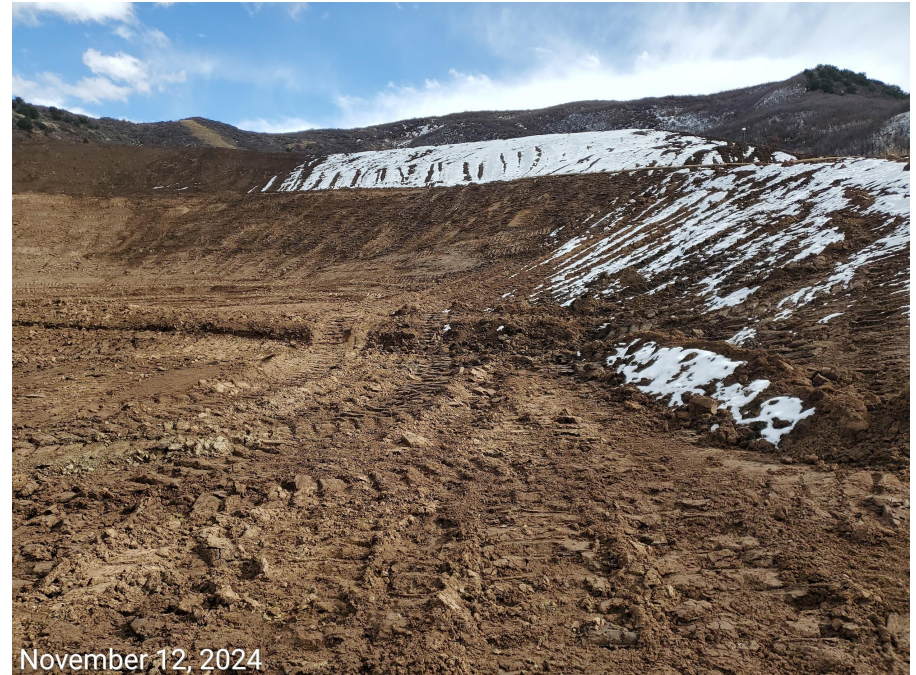
**Photo 3:** See comments under photo 2.

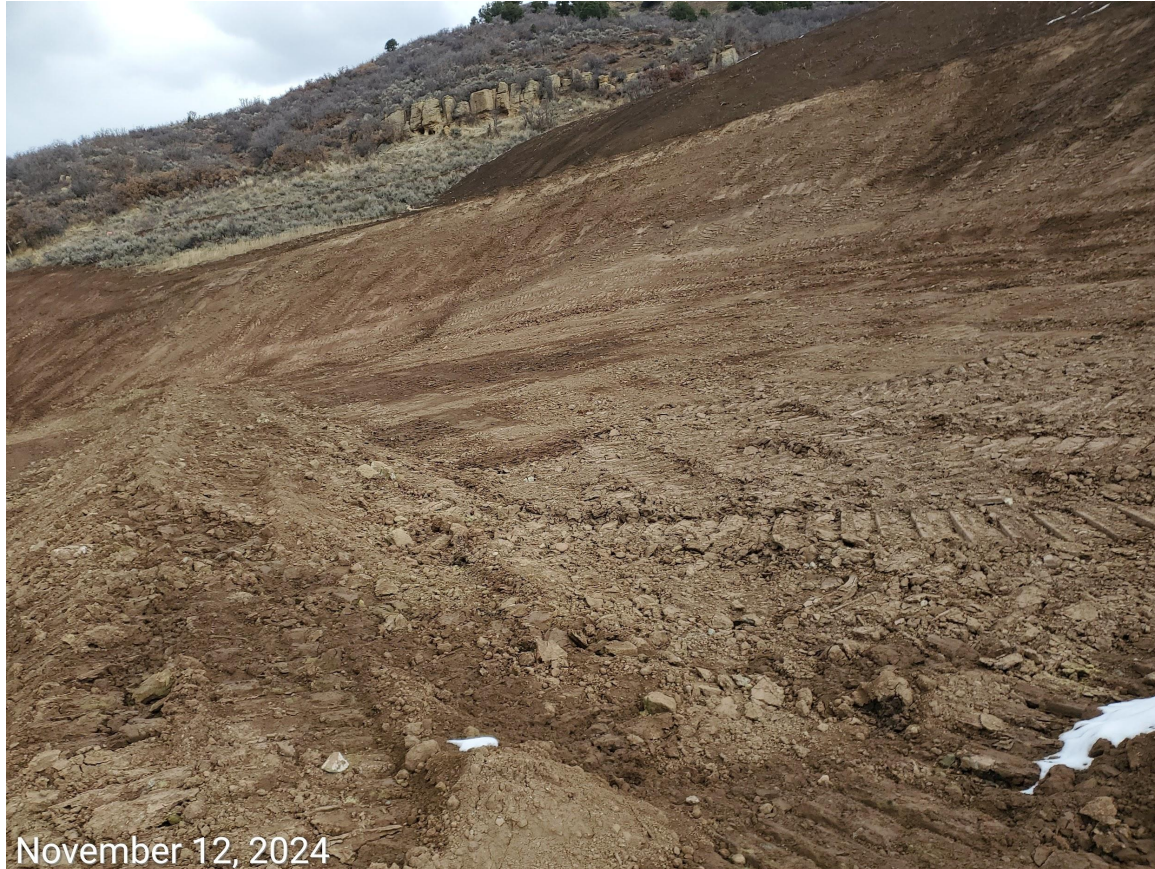
**Photo 4:** Photo taken from the east end of the Location. Photo shows cuttings trench constructed for disposal of drill cuttings. Trench requires permitting via Form 15.

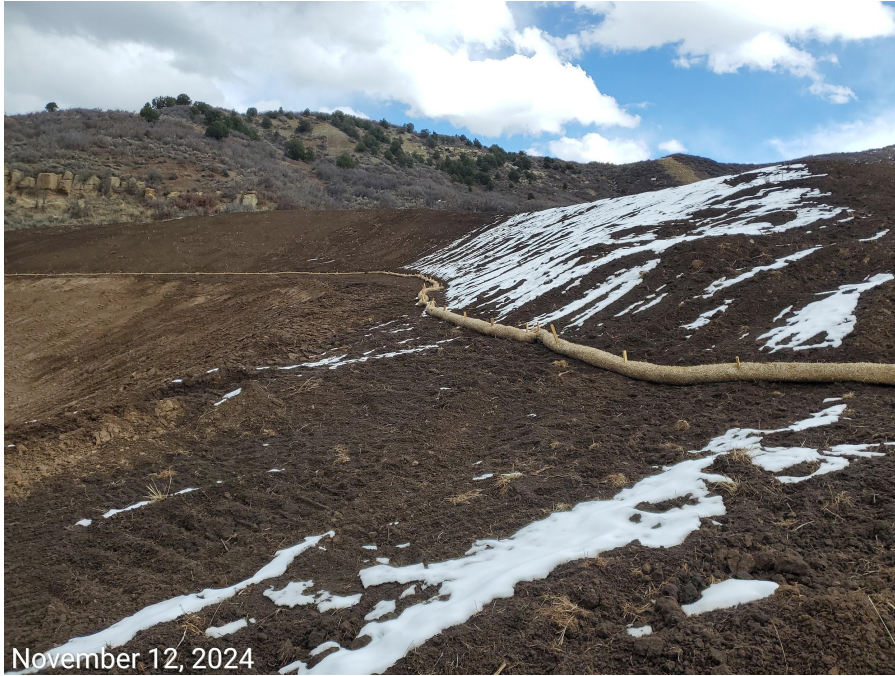
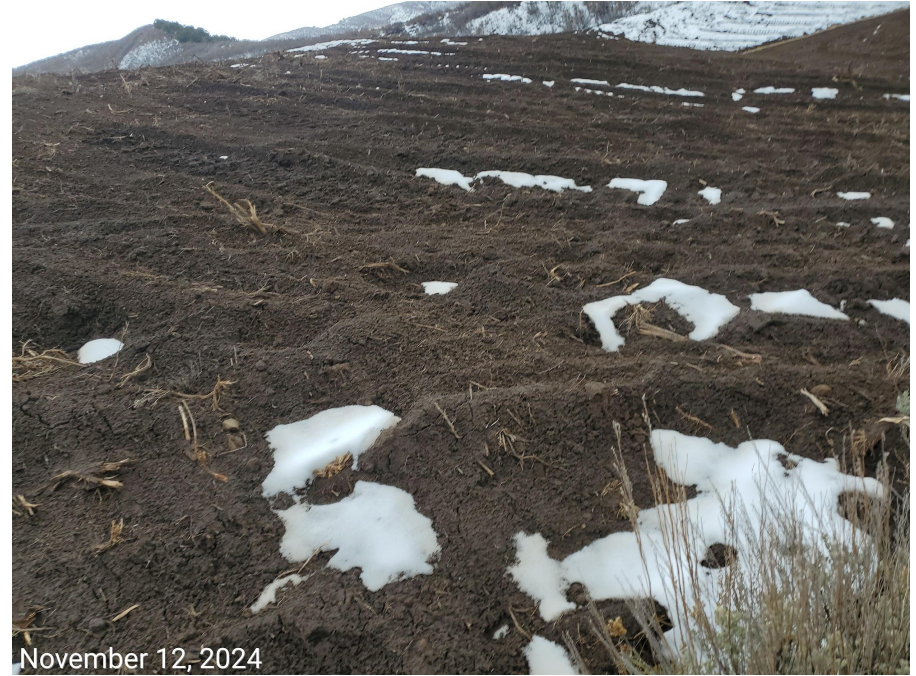
**Photo 5:** Photos taken from the topsoil stockpile on the east/northeast end of the Location. Soils are currently bare and at risk to wind and water erosion; BMPs to protect, as well as to minimize erosion and degradation are missing or insufficient.

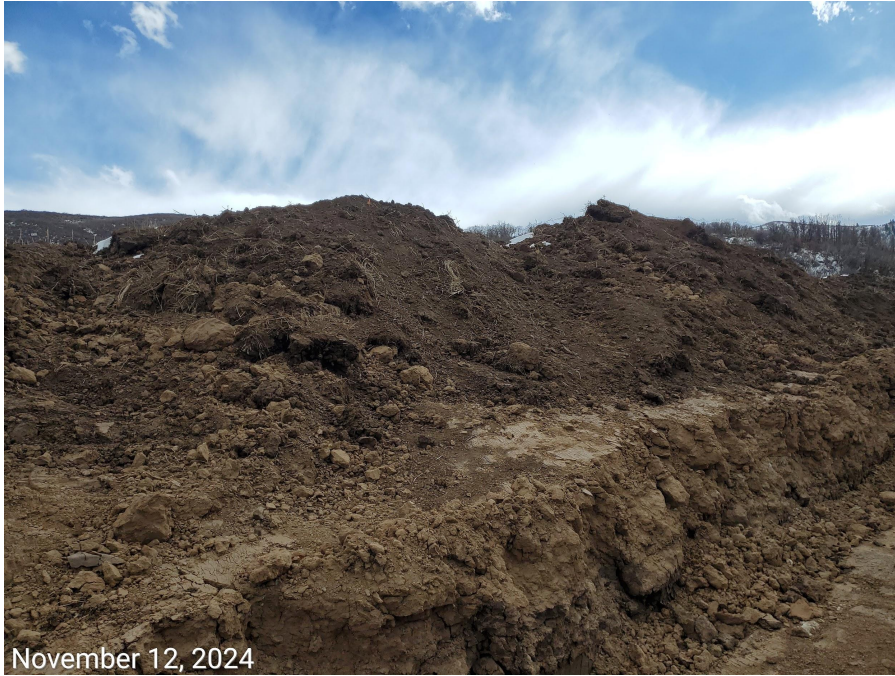
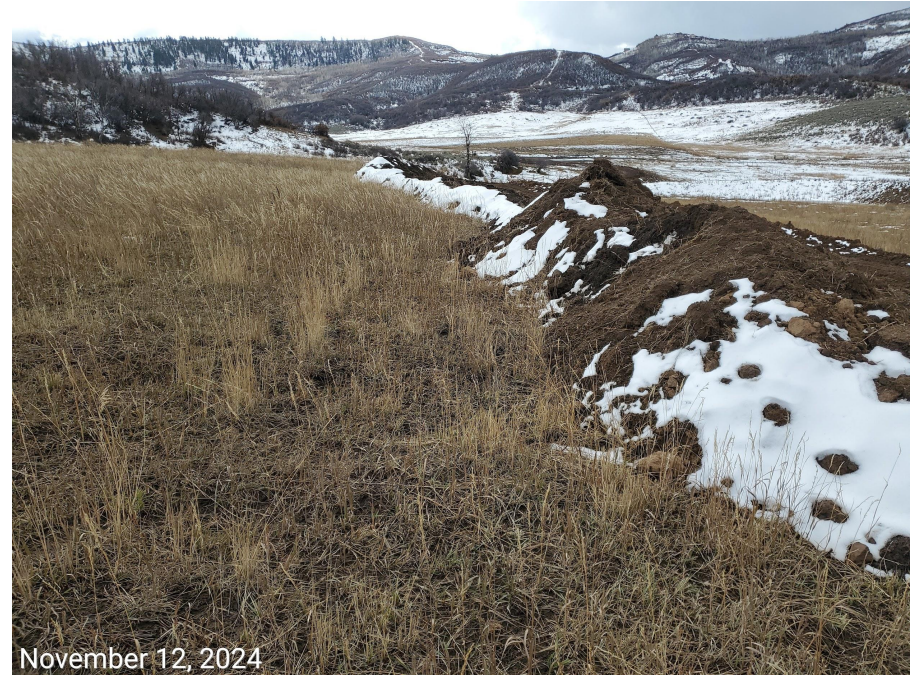
**Photo 6:** Photos taken from the topsoil stockpile along the access road. BMPs to minimize erosion, degradation and sediment transport are missing or insufficient.

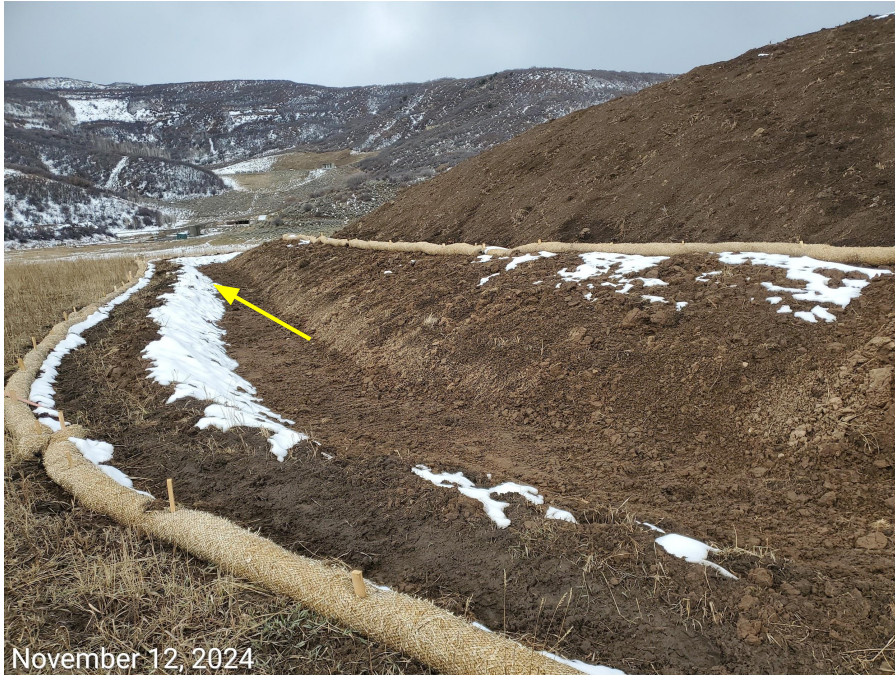
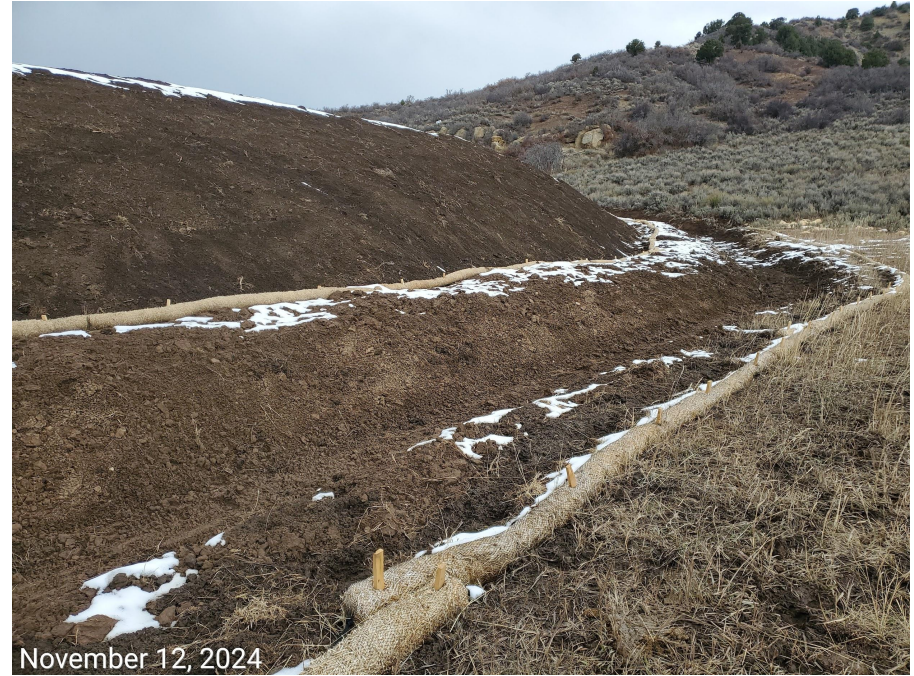
**Photo 7:** Photos taken from the southeast end of the Location. Photo shows stormwater diversion ditch; per the Form 2A permitted SWMP and Layout drawing, ditch would connect and divert stormwater into the sediment trap on the southwest corner of the Location (via a culvert). Ditch is incomplete (arrow) and does not divert stormwater into the sediment trap. Additionally, the culvert at the access road entrance connected to the ditch has not been installed. Rock checks have also not been installed within the ditch.

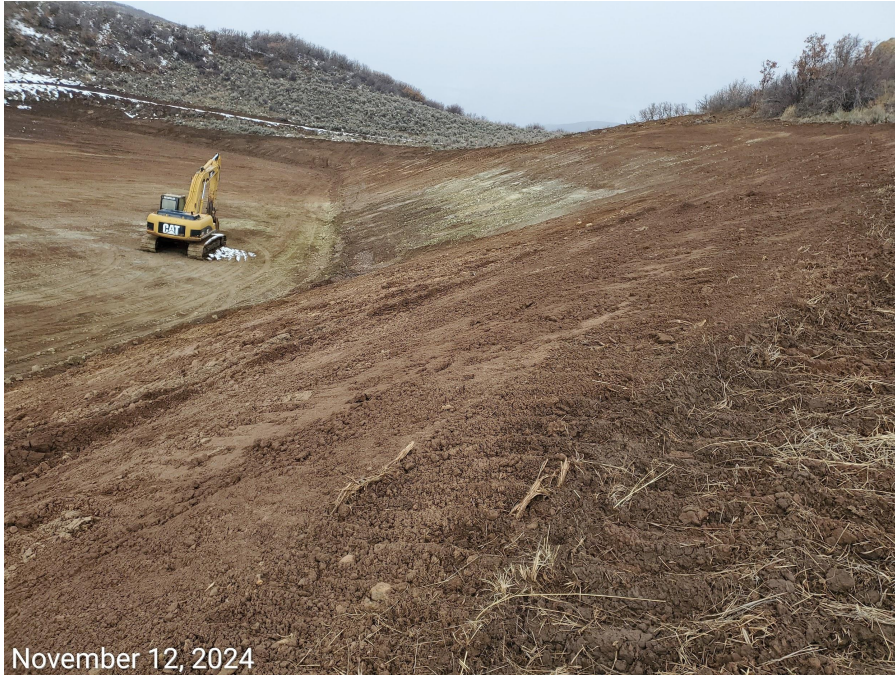
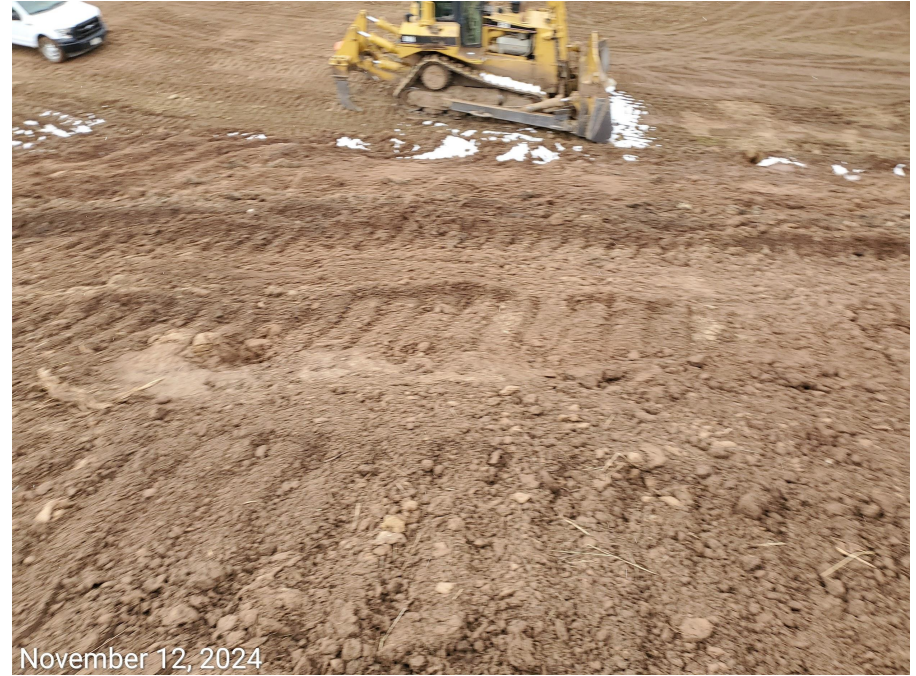
**Photo 8:** Photos taken from the cut slopes on the east end of the Location. Photos examples showing BMPs to minimize erosion and degradation from the cut slopes are missing or insufficient; slopes currently bare unstabilized.

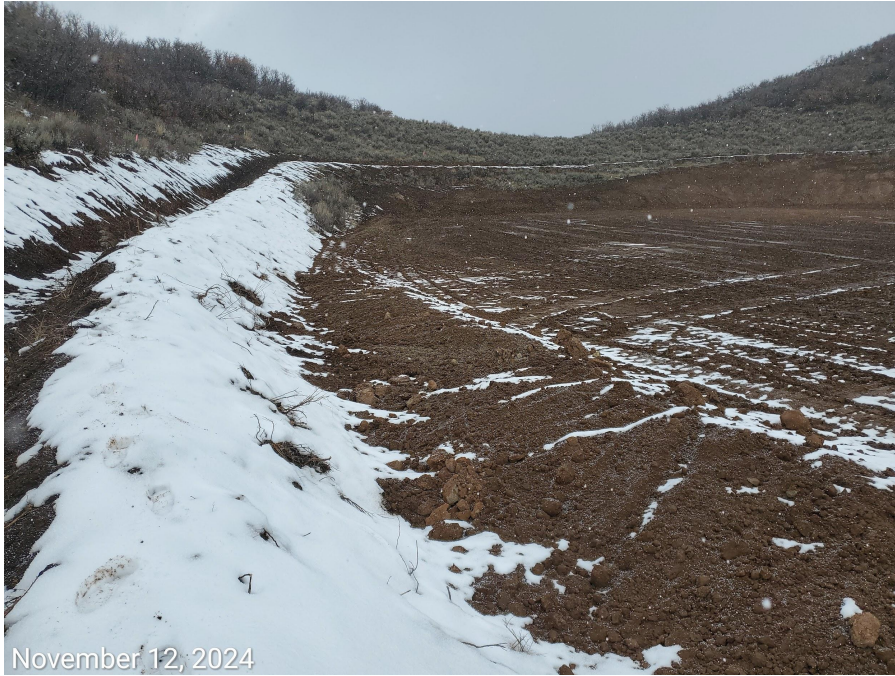
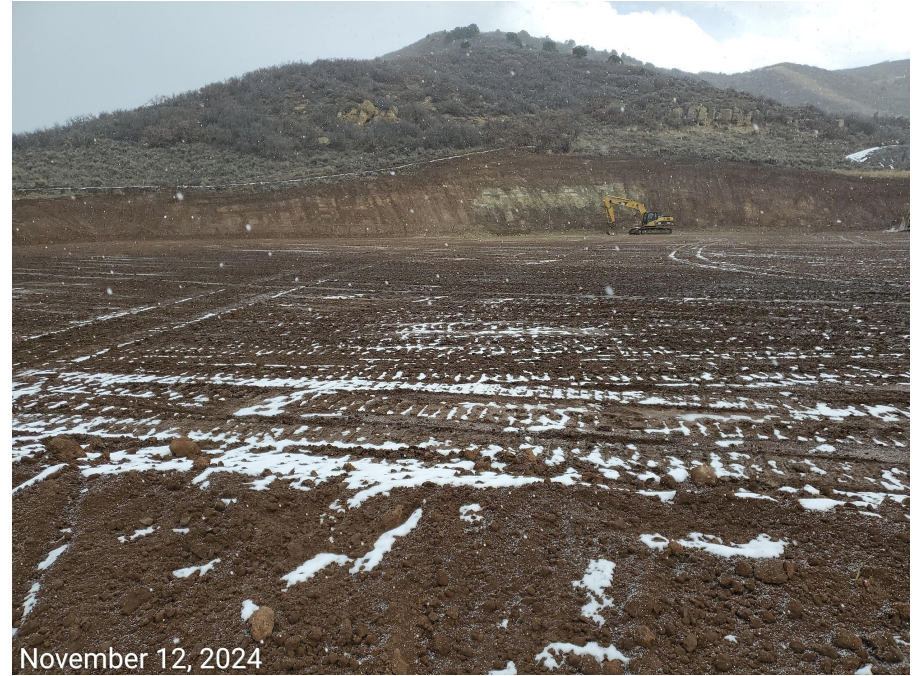
**Photo 9:** Photos 9-10 taken from the west end of the working pad surface. Photos provide an overview from north, northeast, southeast to south. Photos also show ditch along perimeter of the pad has not been installed.

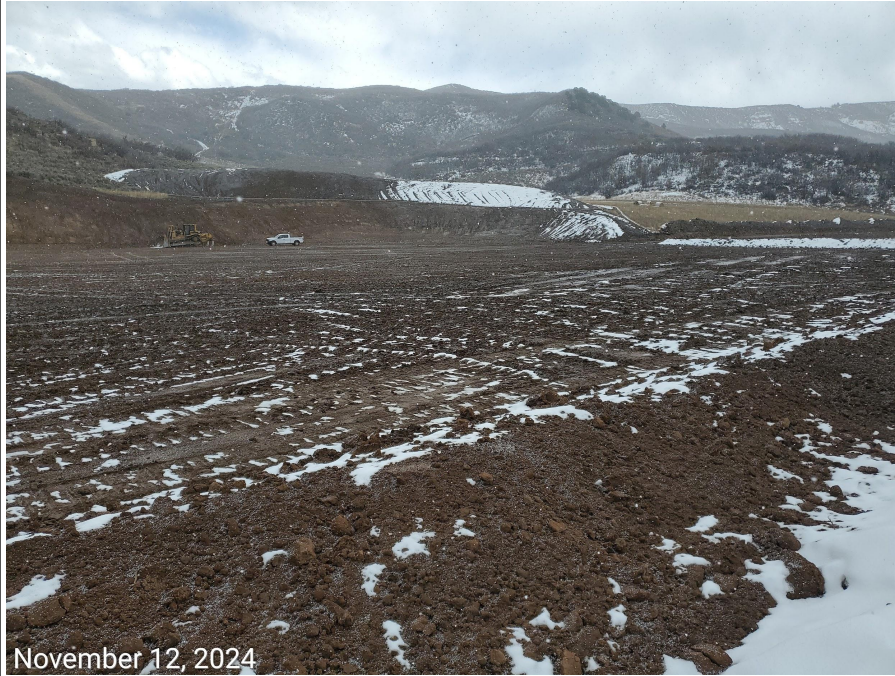
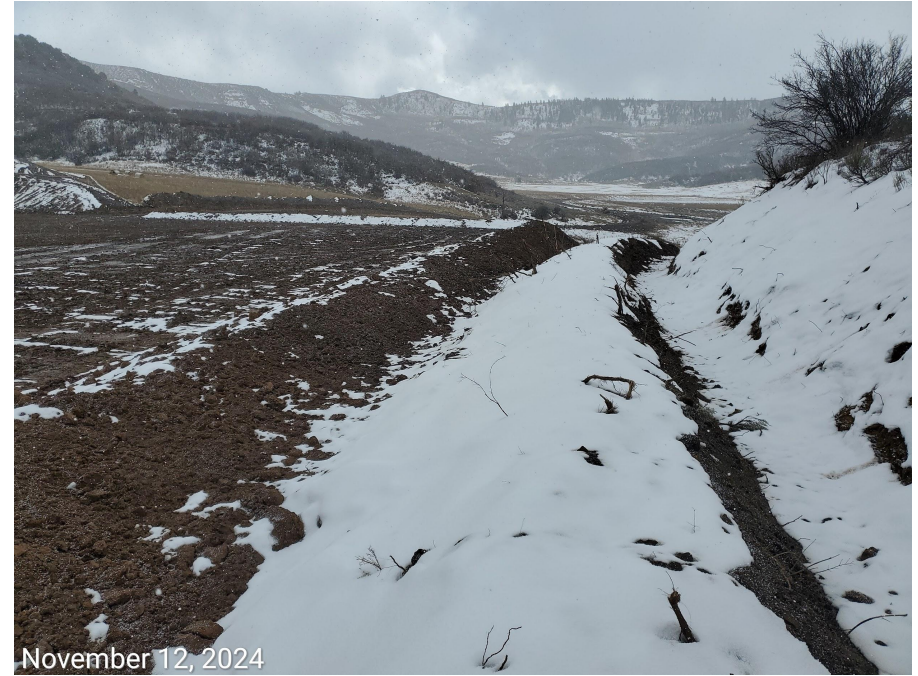
**Photo 10:** See comments under photo 9.

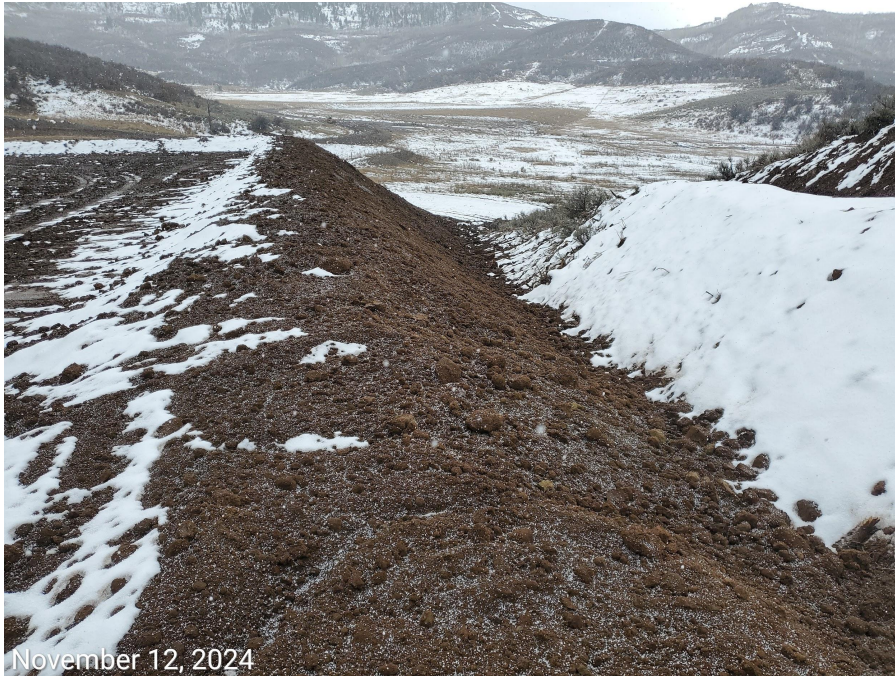
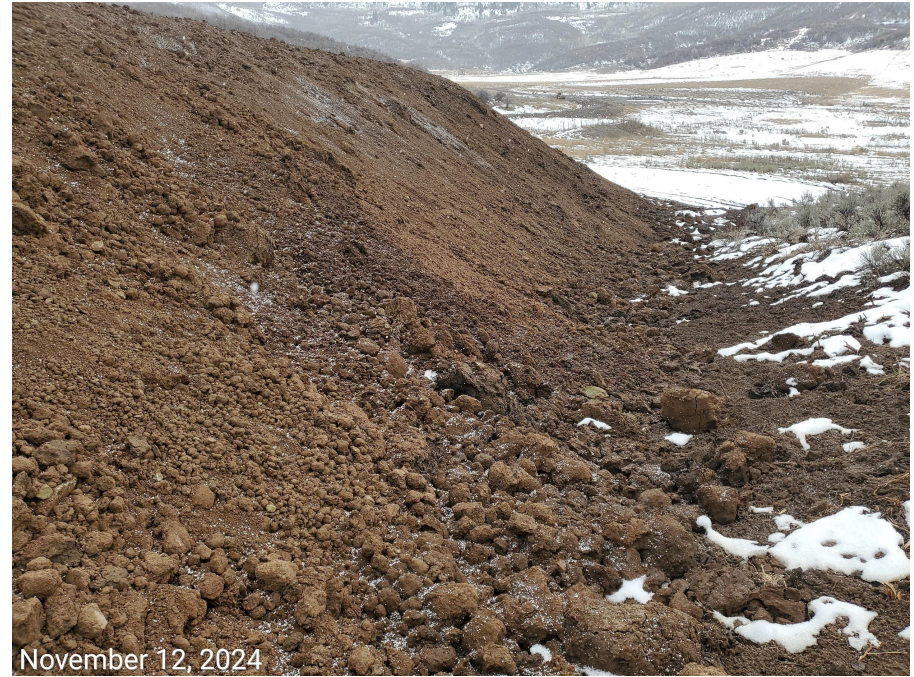
**Photo 11:** Photos taken from the west end of the Location, facing south. Photos examples showing BMPs to minimize erosion and degradation at the fill slopes are missing or insufficient; slopes currently bare unstabilized. Photo left also shows BMPs per the SWMP (Slope drain) have not been installed.

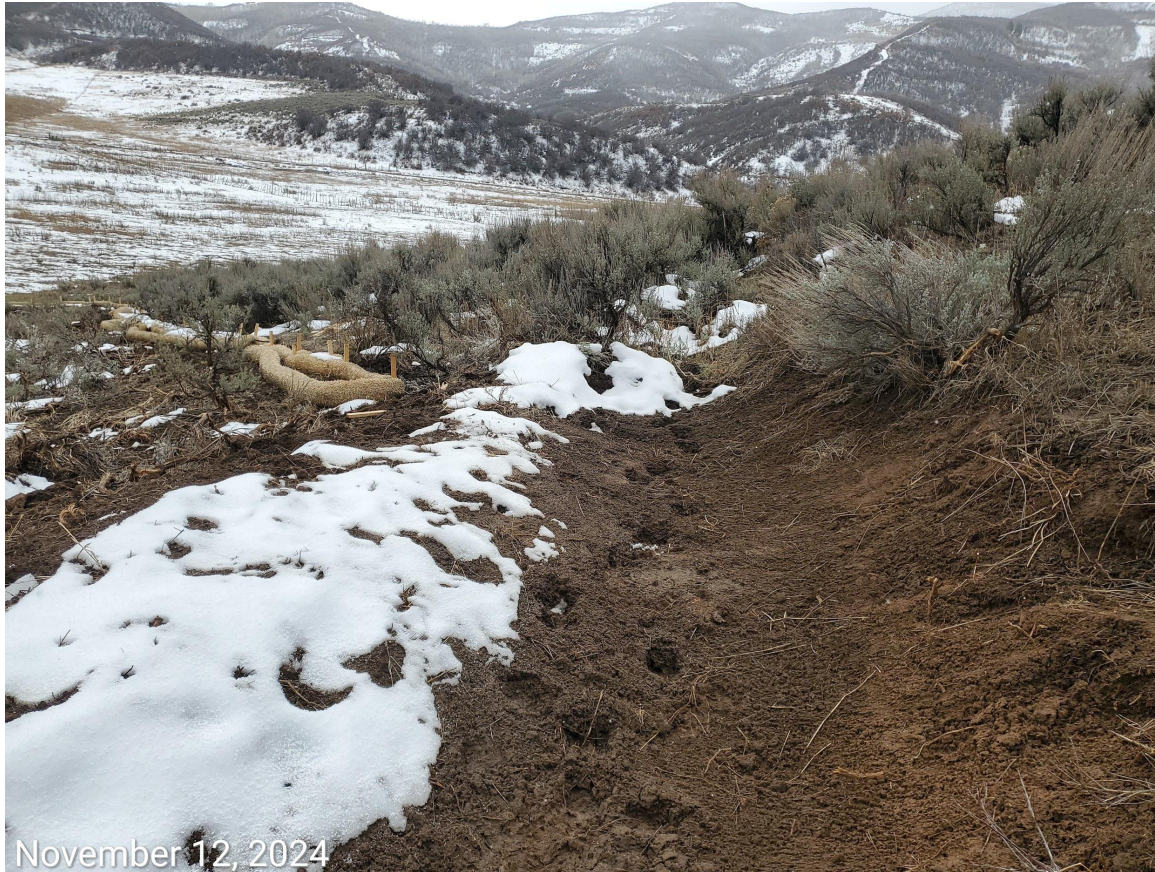
**Photo 12:** Photos taken from the diversion ditch on the west end of the Location, facing south. Photo shows BMP is incomplete and does not divert stormwater to the sediment trap on the southwest end of the Location per the Form 2A Layout drawing and SWMP. BMP currently missing a properly engineered outlet, such as a sediment trap with inlet/outlet protections, per good engineering practice.

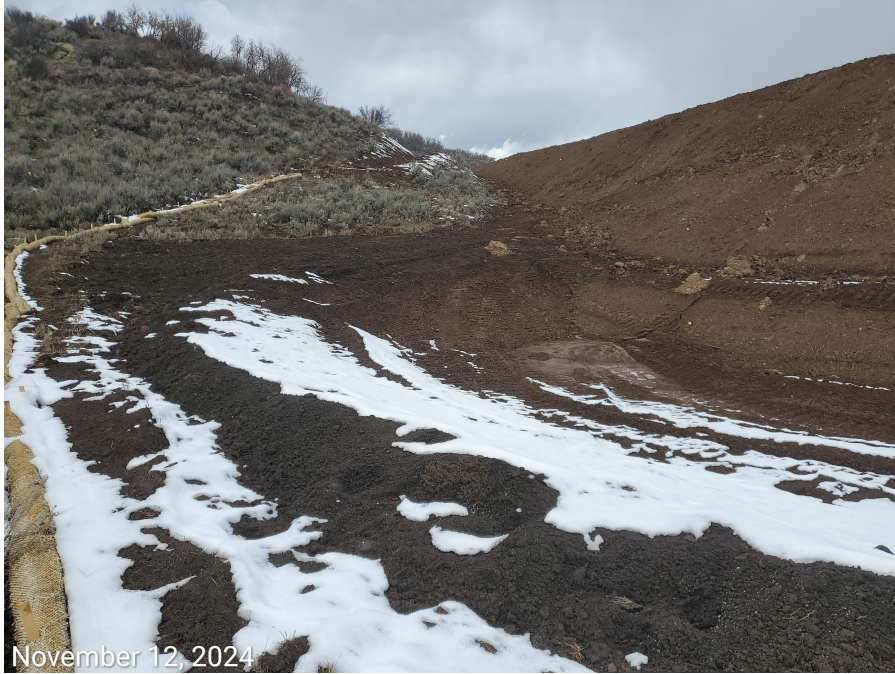
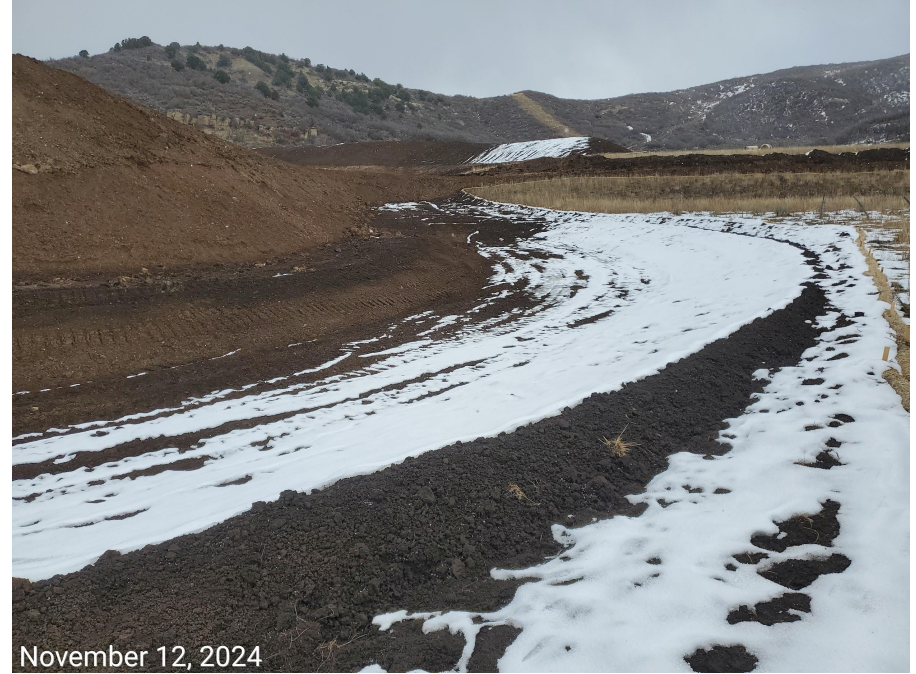
**Photo 13:** Photos taken from the sediment trap on the southwest end of the Location, facing north and northeast. Pursuant to Operator's Form 2A permitted SWMP and Layout Drawing, sediment trap was to be installed with engineered inlet/outlet protections; engineered/armored inlets and outlets have not been installed per the SWMP and good engineering practices.

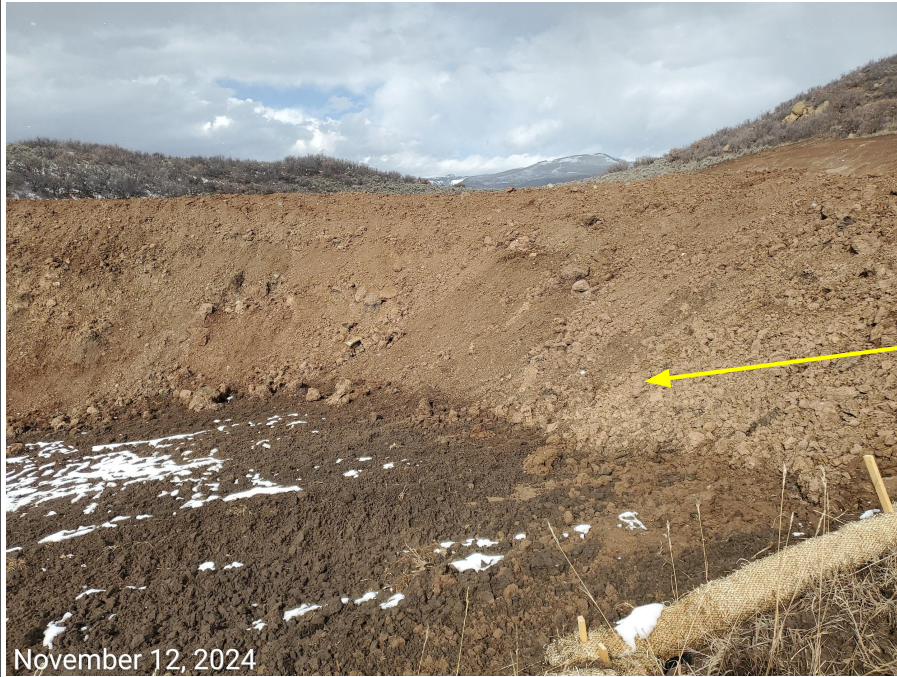
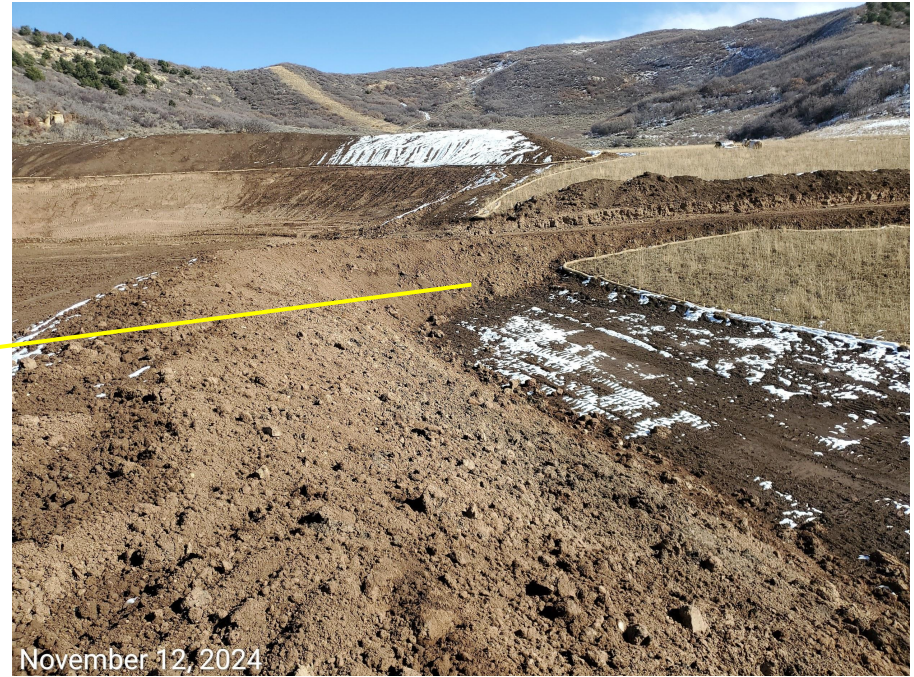
**Photo 14:** Photos taken from the fill slopes and Location entrance. Photos show BMPs to minimize erosion and degradation from the fill slopes are missing or insufficient; slopes currently bare unstabilized. Additionally, photos also show that the culvert/sediment trap/ditch have not been installed per the Form 2A SWMP and Layout drawing.

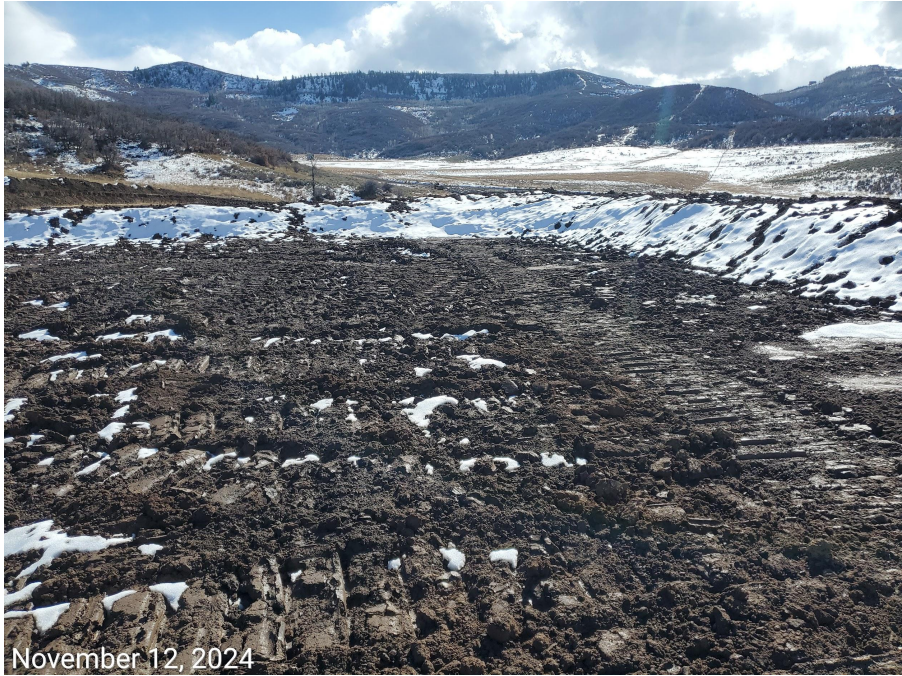
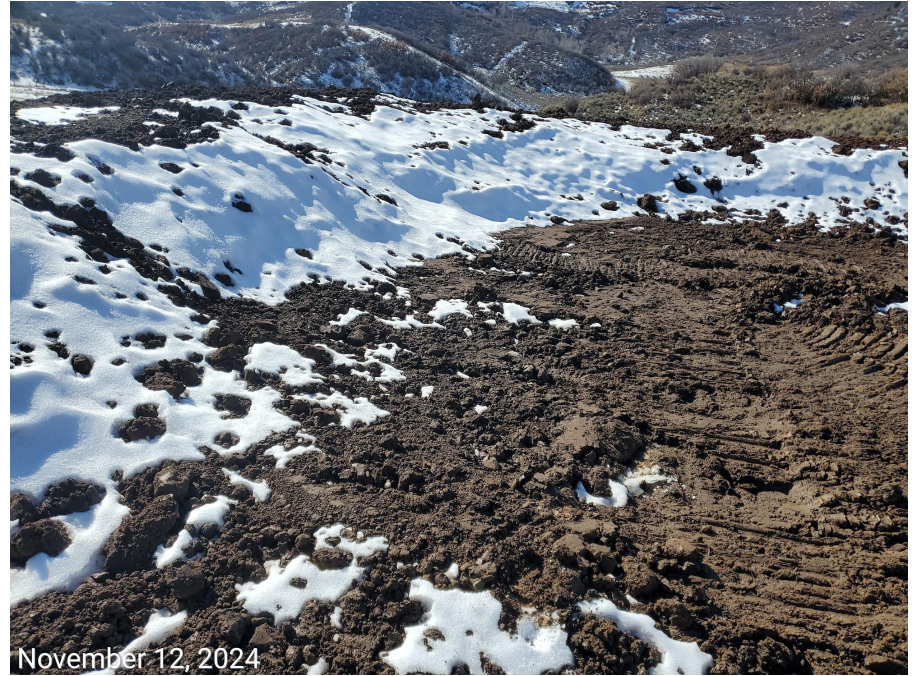
**Photo 15:** Photos taken from the southwest corner of the working pad surface. Photo shows slope drain has not been installed per the Form 2A SWMP and Layout drawing. Photos also examples showing pad surface lacks stabilization.

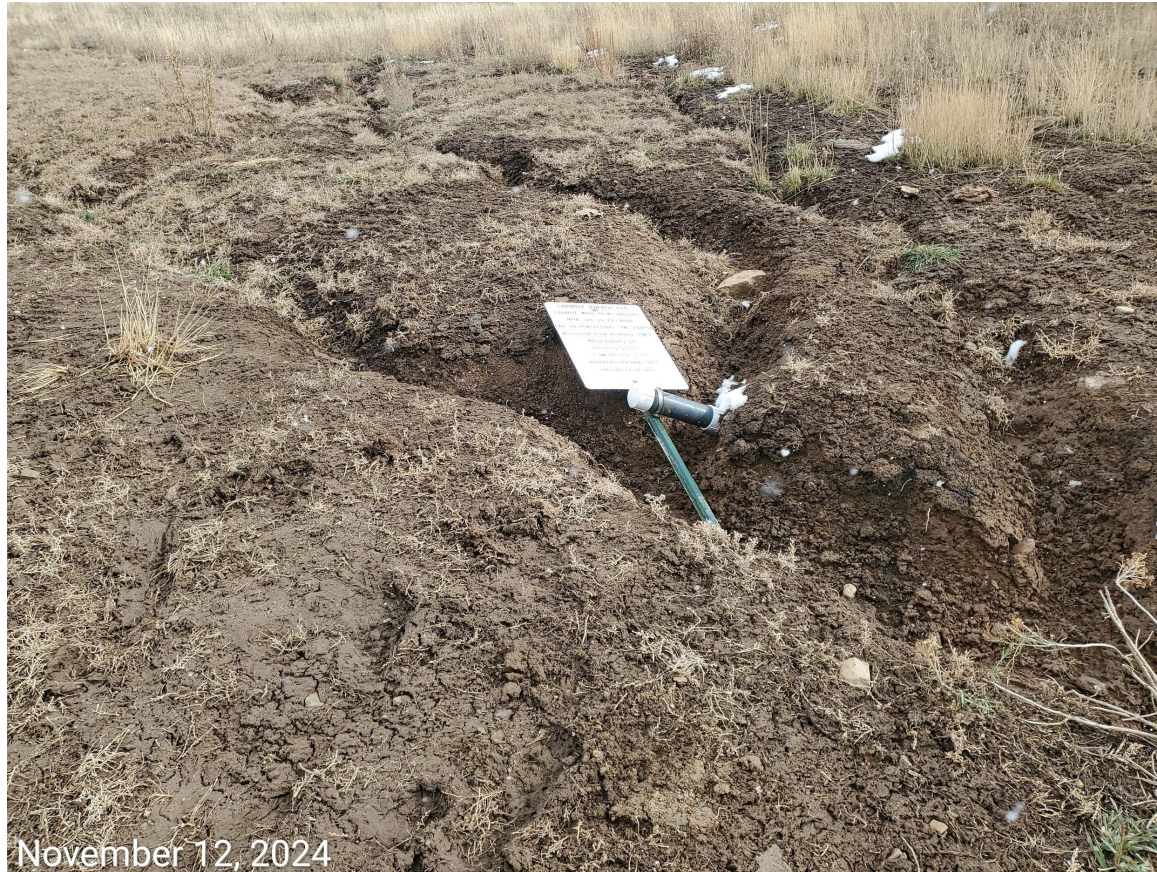
**Photo 17:** Photo shows Location entrance sign has not been maintained or posted at the Location entrance.

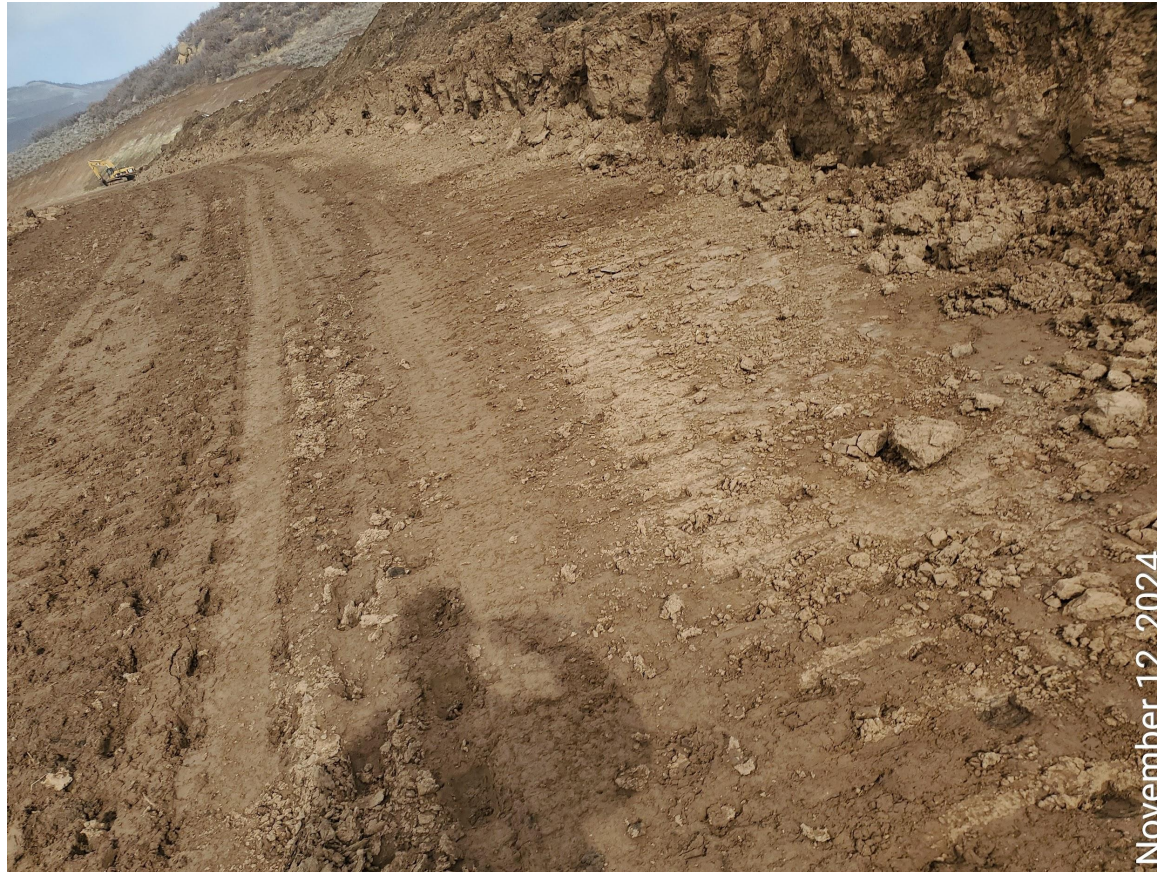
**Photo 18:** Ditch has not been constructed along access road. Culvert also missing along access road per the Form 2A SWMP and Layout drawing.

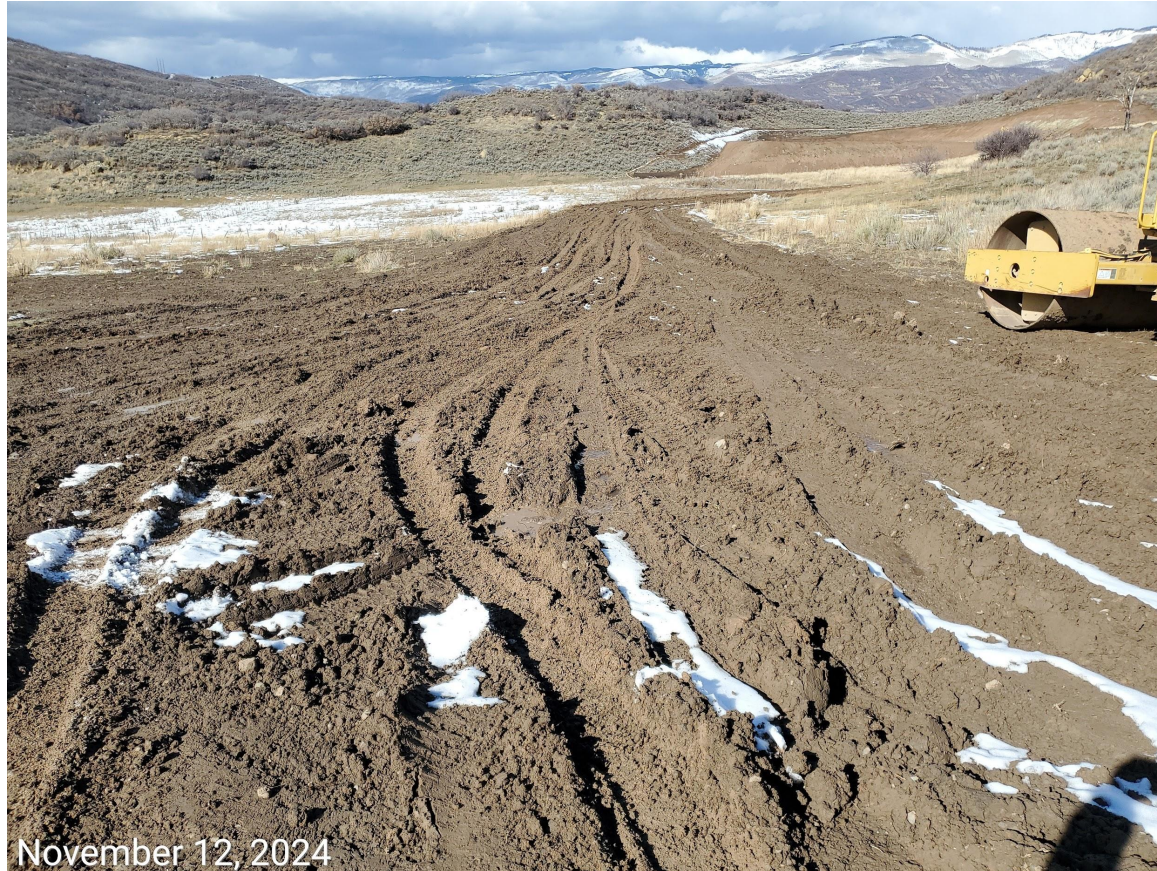
**Photo 19:** Photo example of tracking/stabilization issues observed on Location/Access road. BMPs to stabilize, as well as to minimize degradation and sediment transport are missing or insufficient.
