## Inspection Photos

Location Name: TEP ROCKY MOUNTAIN LLC WEINREIS A Pad

Location ID: 335548

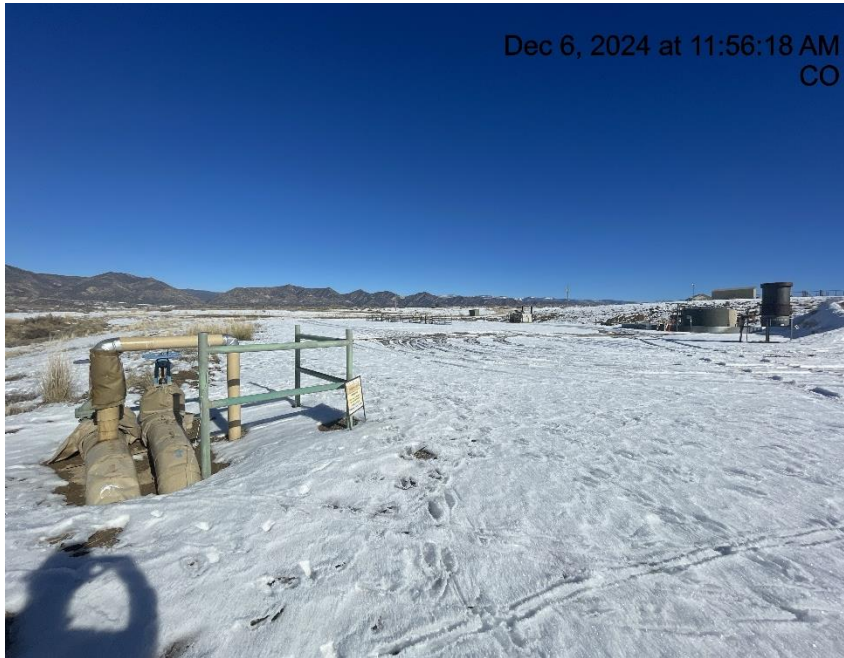
Photo # 2483 From entrance to location

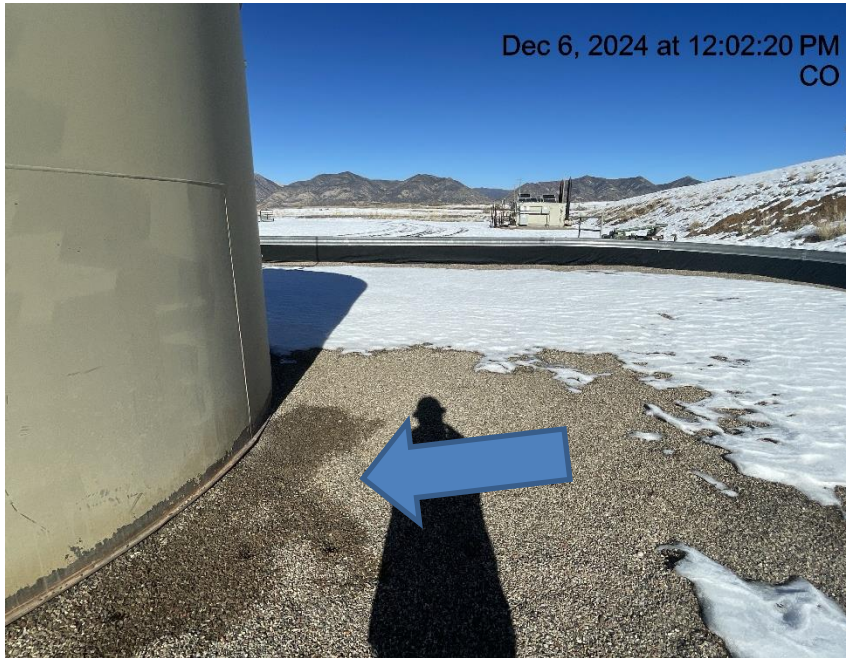
Photo # 2489 Staining in secondary containment

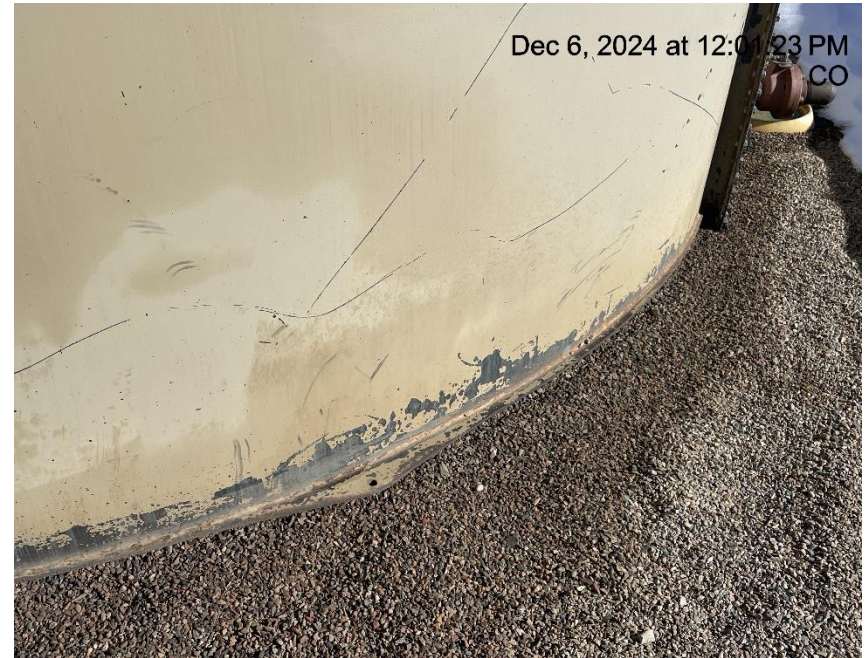
Photo # 2490 Staining in secondary containment

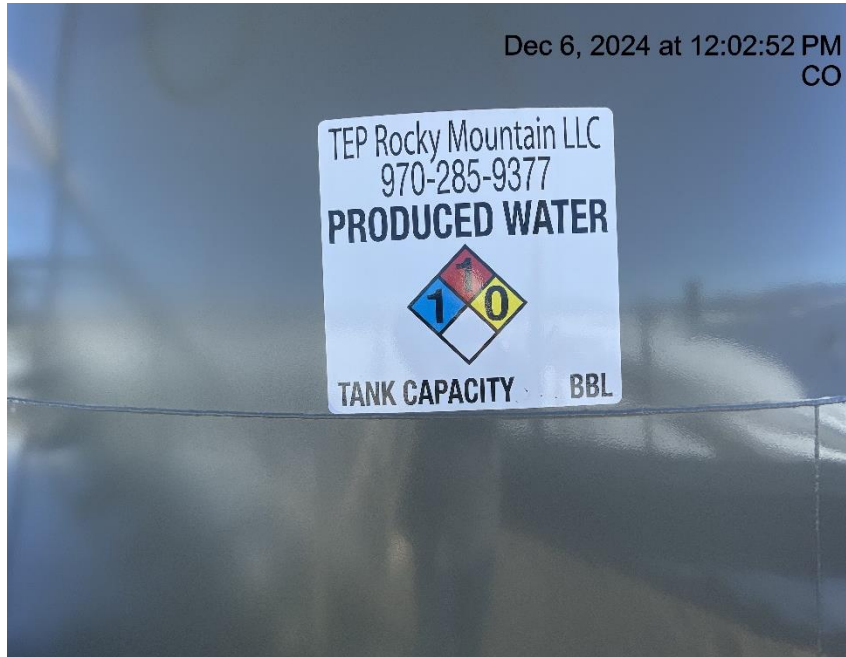
Photo # 2491 Tank capacity faded & illegible

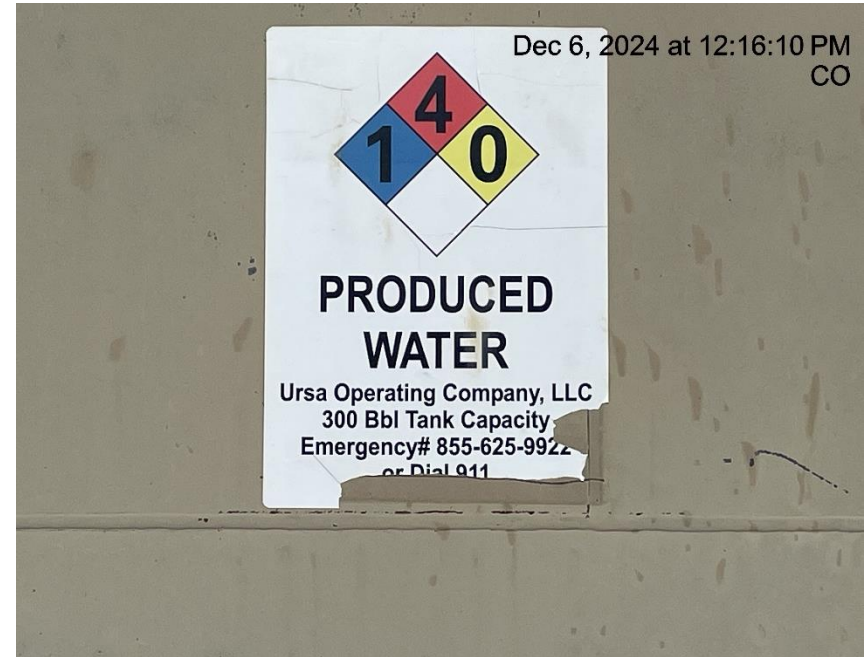
Photo # 2492 Tank label contains inaccurate information

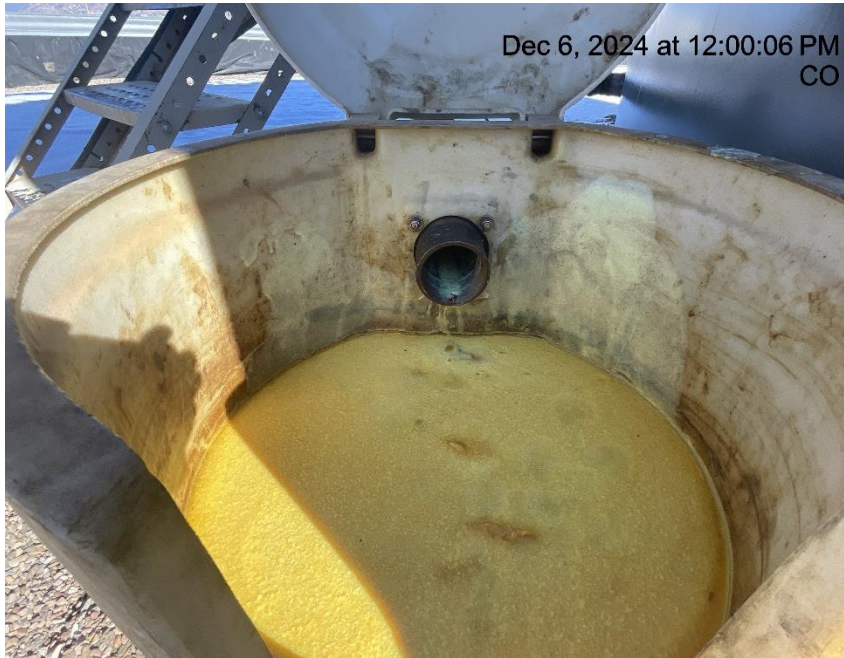
Photo # 2493 Open ended load line
